# Assessing Natural and Mechanical Dune Performance in a Post-Hurricane Environment

**Abstract:** The purpose of this study is to document the geomorphic evolution of a mechanical dune over approximately one year following its installation and compare it to the recovery of a natural dune following the impact of Hurricane Matthew (2016). During the study period, the dunes' integrity was tested by wave and wind events, including king tides, and a second hurricane (Irma, 2017), at the end of the study period. Prior to the impact of the second hurricane, the volumetric increase of the mechanical and natural dune was 32% and 75%, respectively, suggesting that scraping alone is not the optimal protection method. If scraping is employed, we advocate that the dune should be augmented by planting. Ideally, the storm-impacted dune should naturally recover. Post-storm vegetation regrowth was lower around the mechanical dune, which encouraged aeolian transport and dune deflation. Hurricane Irma, an extreme forcing event, substantially impacted the dunes. The natural dune was scarped and the mechanical dune was overtopped; the system was essentially left homogeneous following the hurricane. Th

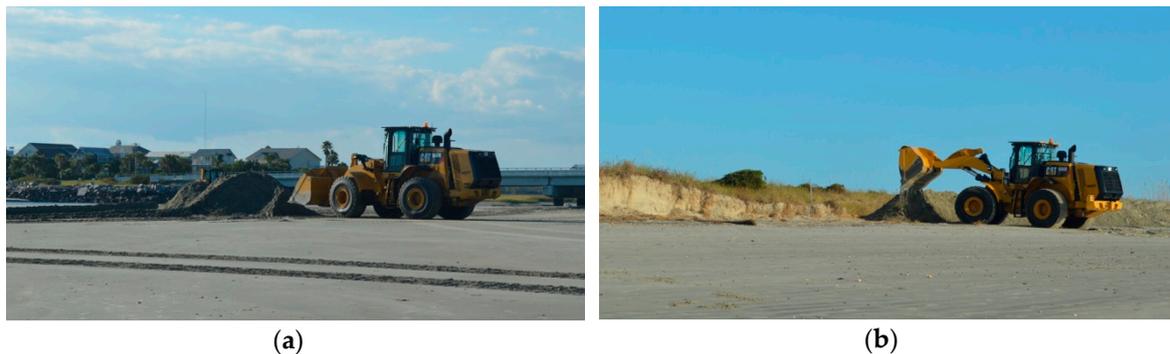
**Figure 1.** Sand scraping along the Isle of Palms, SC where (a) shows the sand source in nearshore and (b) shows the emplacement of the sand along the former primary dune line.

Beach scraping is a soft engineering technique that is not part of the beach nourishment framework because no new sediment is introduced into the system [6]. During scraping, sand is redistributed within the beach-dune system, which artificially disrupts the beach and dune sediment budgets and the long-term environmental resilience of the beach-dune system ([7]; c.f., [8] for a comprehensive review of beach-dune interactions). For example, from a biological perspective, [9] found a decline of ghost crabs for 6–8 months after a beach face was bulldozed for scraping. Figure 1a shows sand being scraped from the nearshore, which was eventually placed along the former primary dune line, which is shown in Figure 1b.

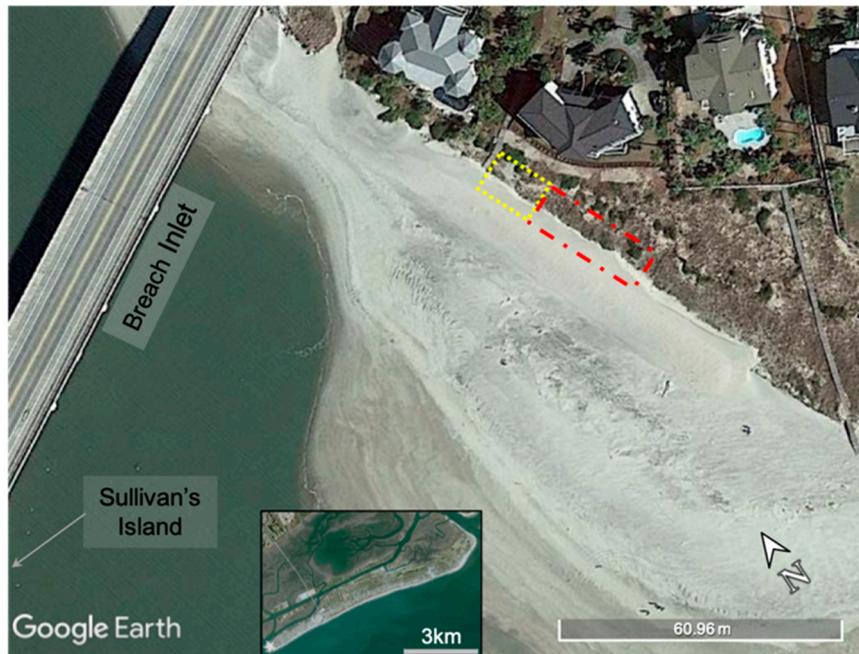
**Figure 2.** Aerial image showing the southwest tip of the Isle of Palms, SC. Yellow and red rectangles highlight the location of the natural and mechanical dunes, respectively. Inset shows the entire Isle of Palms where the star is the southwest tip of the island shown in the larger figure.

Inlet dynamics impact the erosion-accretion dynamics of the Isle of Palms. Most relevant to our study area (Figure 2) is the southwest extent of the island, which is bordered by the Breach Inlet. This inlet has an ebb-tidal delta that has experienced multiple-scale shoal-bypassing events [24]. During the smaller events, shoals detach from the delta, migrate towards the southwest, and attach to the

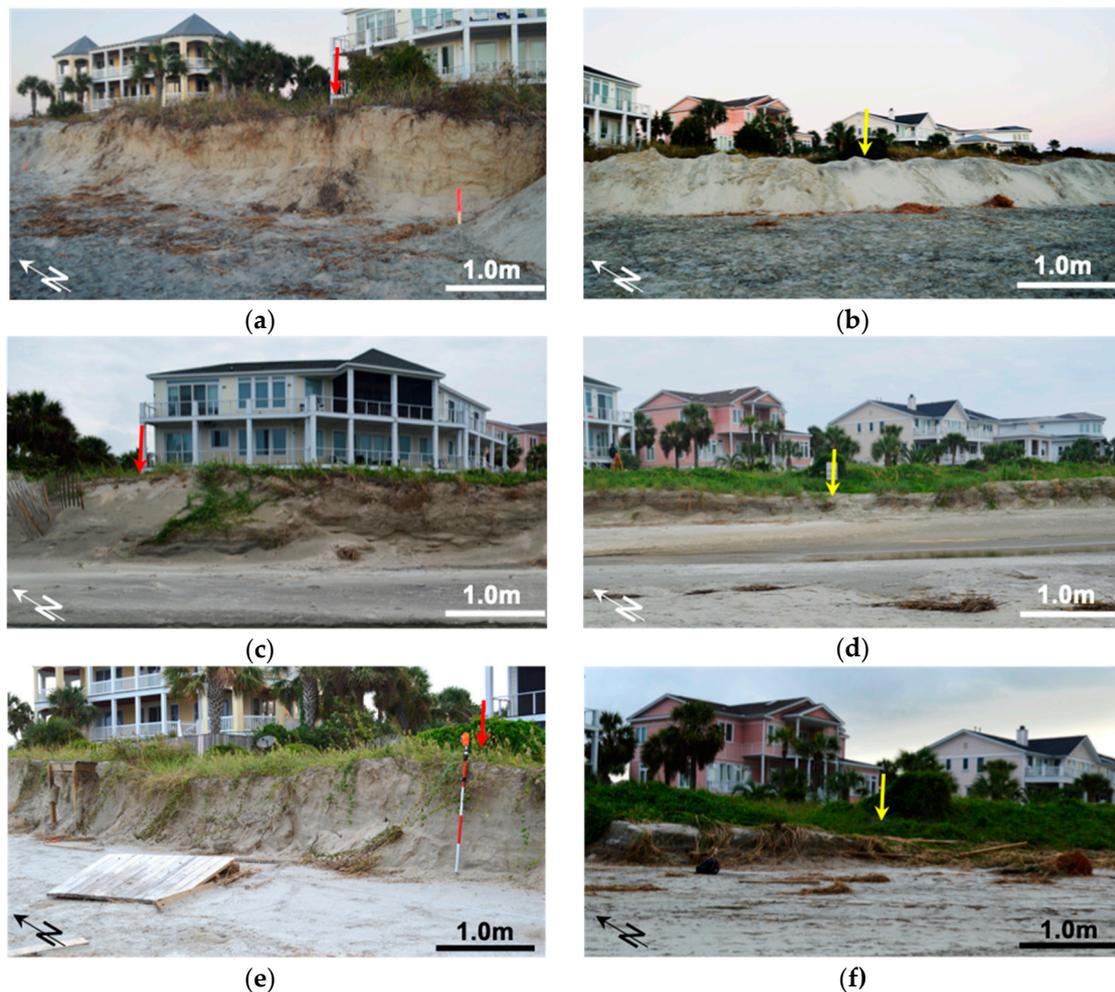
**Figure 3.** Images of the natural (a,c,e) and mechanical dune (b,d,f) following Hurricane Matthew shortly following the establishment of the mechanical dune (10/28/16; (a,b)), after approximately 10 months of recovery (09/07/17; (c,d)), and following the impact of Hurricane Irma (09/14/17; (e,f)) on 09/14/17. Colored arrows point to the same locations.

When the site was first surveyed on 10/28/16 (12 days after Hurricane Matthew), it was characterized by a substantial post-storm scarp (Figure 3a). Figure 3b shows the mechanical dune on 10/28/16 that was emplaced on 10/19/16 under the auspices of the emergency orders (issued on 10/04/16) to protect existing infrastructure. The scraping occurred directly adjacent to our natural site and extended approximately 1000 m alongshore, well beyond our study area. The scraped sand was placed along the former primary dune line. The site recovered for approximately ten months (Figure 3c,d). However, this recovery was truncated by Hurricane Irma because the devastation was so extensive (Figure 3e,f). Hurricane Irma prompted emergency orders to be issued again and the study area was scraped again. This second scraping event is beyond the scope of this paper, but it demonstrates the pervasiveness of this activity in South Carolina.

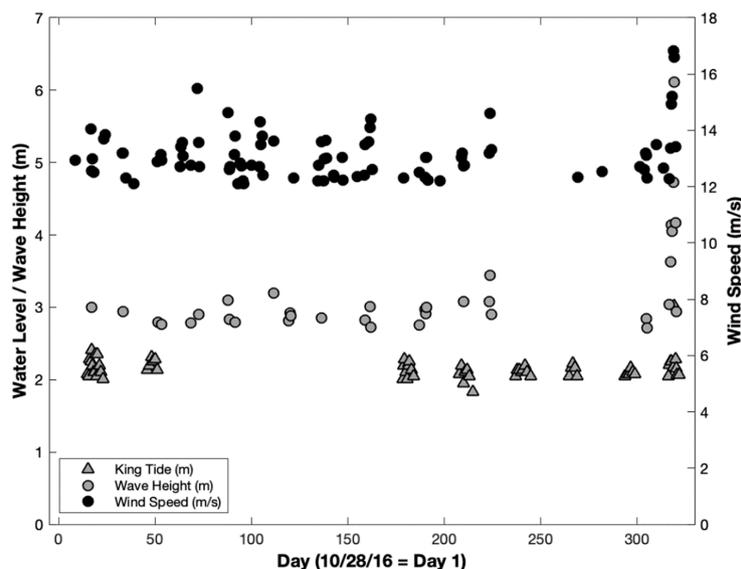
**Figure 4.** Forcing events (king tide and wave and wind events) observed at the Isle of Palms study site. All king tide events are shown. Only wave and wind events exceeding two standard deviations are displayed.

During the 322-day study duration, the site experienced 65 king tides (Figure 4). These occurred approximately every 30 days except between days 52-178 (equivalent to 12/18-04/23). The wind and wave events (defined here as exceeding two standard deviations, which is the same threshold used by [36], occurred more frequently compared to the king tides. During the study period the average wind speed and wave height was 6.12 m/s and 2.71 m, respectively. The periodicity of the wave events roughly corresponds to the lunar tidal cycle, as they occur every ~14-28 days. There was a paucity of wind and wave events between during the early summer (days 225–293 or 06/09–08/16), with exception to the wind events on 07/23 and 08/05. The activity of all forcing agents at the end of the study (on day 316, or 09/08) corresponds with Hurricane Irma.

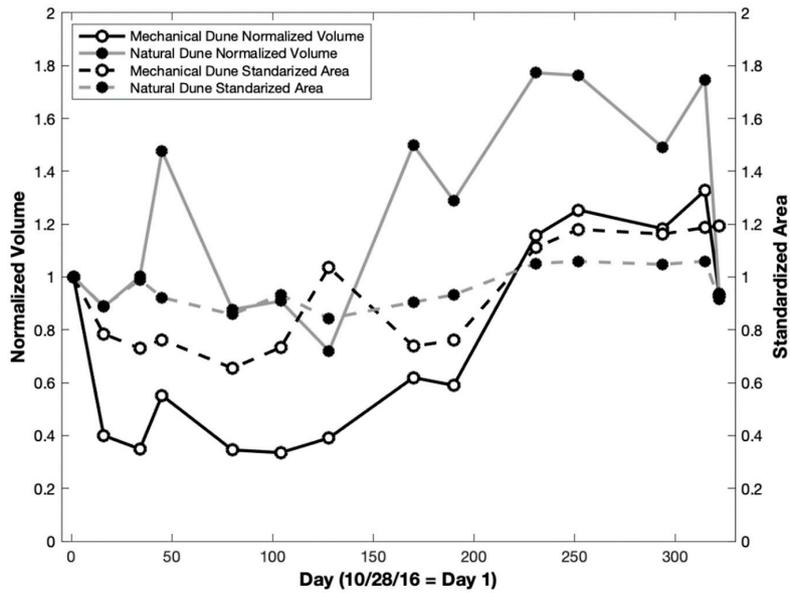
**Figure 5.** Normalized (according to the initial, 10/28/16, survey) volumetric change of the natural and mechanical dunes (left axis; solid lines) where values <1 and >1 indicate dune erosion and accretion, respectively. The standardized area values are calculated according to the 10/28/16 survey where values <1 indicate there is a reduction of initial dune area (right axis; dashed lines). The standardized area is presented because the dune area fluctuated each survey.

Natural and mechanical dune volumes and areas are presented in Table 2. Dune areas are presented to demonstrate that volumetric changes are not correlated to the changing dune areas, except for the case of Hurricane Irma (discussed later). The normalized / standardized values in Table 2 are also presented in Figure 5 where values exceeding 1 indicate an increase from the initial (10/28) survey. In general, the erosion-accretion volumetric trend observed at the natural dune is also observed at the mechanical dune. On 11/30 and 03/04 the mechanical dune eroded while the natural dune accreted. The mechanical dune lost a substantial portion of its volume during the first two weeks (70%). Both dunes experienced a general increase of volume starting on 03/04. By 06/15, the mechanical dune exceeded its initial volume for the first time (by 16%) and it was on this date its normalized volume value exceeded 1. Regarding the natural dune, there were several instances (12/11, 04/15, and every survey following 04/15 until Hurricane Irma) where the volume exceeded the immediate post-Matthew condition measured on 10/28. Figure 5 clearly demonstrates that the natural dune is recovering more effectively, as the pre-Hurricane Irma average normalized volume values for the natural and mechanical dune are 1.29 and 0.71, respectively. The largest between-survey volumetric change resulted from Hurricane Irma (321 m<sup>3</sup>; Table 2), however, the change from 03/06-04/25 was comparable at 309 m<sup>3</sup> (Table 2), but it was accretionary.

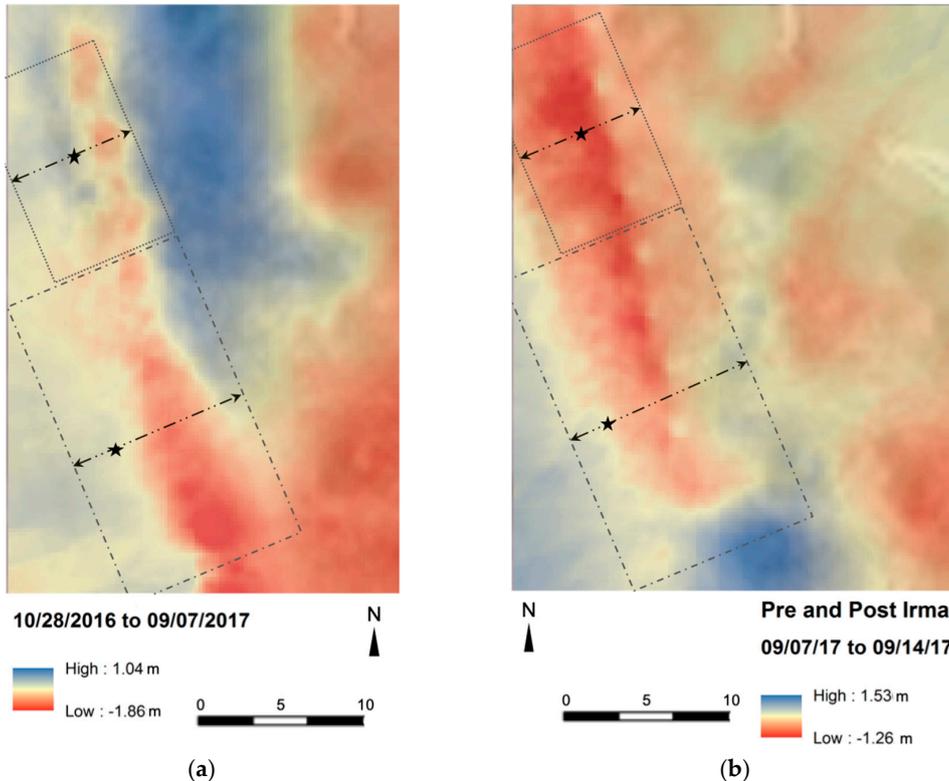
**Figure 6.** DEM change maps where red and blue hues show erosion and accretion, respectively. The secondary dunes are to the right of the dotted boxes. The mechanical and natural dunes (according to the 10/28 survey) are delineated by grey dotted and dash-dotted boxes, respectively. Black stars show the location of the onshore side of the dune toe. (a) Change from 10/28 to 09/07 represents the recovery following Hurricane Matthew. (b) Change from 09/07 to 09/14 isolates the change from Hurricane Irma. The locations of the profiles (see Figure 7) are designated by the black dashed-dotted arrows.

Representative DEM change maps are presented in Figure 6, which show the spatial variability of the accretion-erosion dynamics for the natural and mechanical dune. These DEMs are oriented so that the secondary dune is to the right of the dotted boxes. The recovery of the post-Hurricane Matthew dunes (prior to Hurricane Irma’s impact) is shown in Figure 6a. The natural dune experienced net accretion, which was concentrated at the dune toe due to avalanching. In July an illegal sand fence was constructed on the avalanched sand. Also, around this time, the vegetation that started growing in the spring at the natural dune toe was at its peak, which promoted accretion (evidenced by the linear accretionary blue region within the dotted box). The NW to SE trending red (erosional) region is explained because this is the source sand for the avalanching. Early surveys of the natural dune (data not shown here) indicated the backdune area was stable, so we did not repeatedly survey this region. However, the DEM interpolation artificially and mistakenly created an accretionary lobe (colored blue) in the secondary dune.

The evolution of the mechanical dune post-Hurricane Matthew and prior to Hurricane Irma’s impact is shown in Figure 6a within the dash-dotted box. There was substantial deflation of the mechanical dune—almost 2 m. The mechanical dune had scant vegetation on the dune crest (c.f., Section 4). Some Hurricane Matthew wrack remained seaward of the dune toe for almost the entire study duration shown in Figure 6a, which promoted some accretion. The accretion in the eastern side of the boxes (largely comprises the mechanical dune sand transporting onshore via aeolian mechanisms).

Figure 6b demonstrates the erosive effect of a hurricane on a natural and mechanical dune. The natural dune was wave-cut. The scarping extent was influenced by the vegetation and is visible in Figure 6b by the transition from dark to light shades of red. The storm surge overtopped the artificial dune and removed almost all evidence that a mechanical dune was ever present (see Figure 3b,f). The post-Irma dunescape was fairly homogenous in that there was no demarking line between the natural and mechanical dune. The exception to this was a storm-generated depositional lobe shown at the bottom of Figure 6b. Field observations suggest a large portion of this sand originated from the mechanical dune and it was transported by water during the storm.

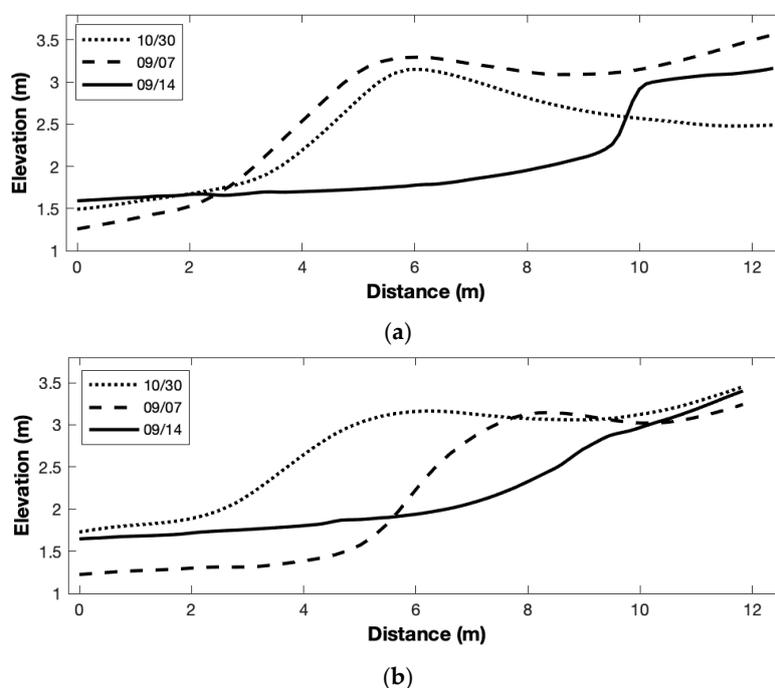
**Figure 7.** Topographic profiles from the mechanical and natural dune obtained during the first survey (10/28), the most recovered profile, which is also the pre-Hurricane Irma survey (09/07), and the post-Irma (09/14) survey. Representative profiles are shown from the natural (a) and mechanical (b) dunes. The elevation information for the profiles were obtained from the DEMs created for each survey.

DEM-based profiles extracted at the approximate midpoint of the natural and mechanical dunes are shown in Figure 7a,b, respectively. We present the three key dates, which allow us to highlight: 1) the Hurricane Matthew recovery using data following Hurricane Matthew (2016) to just prior to Hurricane Irma (10/28-09/07); and 2) the impact of Hurricane Irma using pre and post-Hurricane Irma data (09/07-09/14). During the ~10 months following Hurricane Matthew (10/28-09/07), the natural dune (Figure 7a) mainly accreted. The landward migration of the mechanical dune is evident in Figure 7b. Also visible on the mechanical dune profile (Figure 7b) is the shoreface erosion/deflation (see distances 0-2 m). Similar to the DEMs (Figure 6), the substantial erosion associated with Hurricane Irma is evident in the dune profiles (Figure 7). Hurricane Irma resulted in approximately 4 m and 2 m of landward dune erosion at the natural and mechanical site, respectively. The natural dune was scarped.

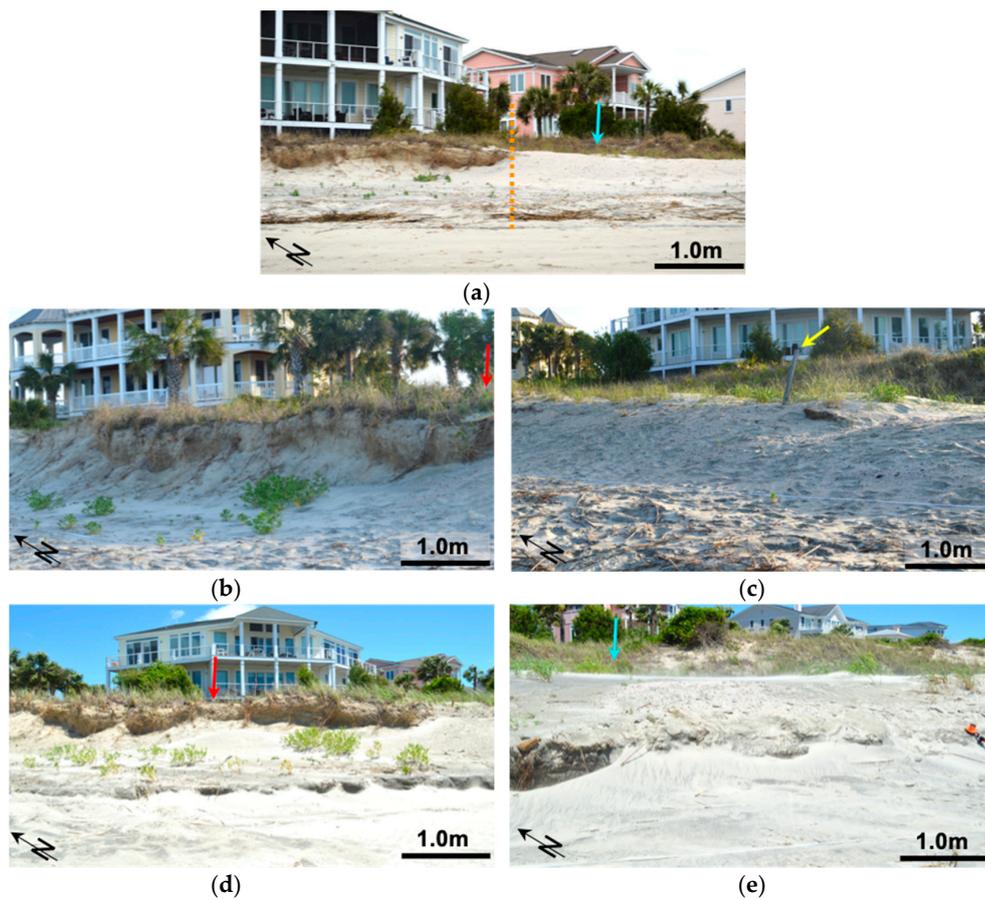
**Figure 8.** Images of the natural (a,b,d) and mechanical dune (a,d,e) on 03/25 (a), 04/15 (b) and (c), and 05/05 (d) and (e). In (a) the natural (left) and mechanical (right) dunes are delineated by the orange dotted line. Colored arrows point to the same locations and are coordinated to the arrows in Figure 3.

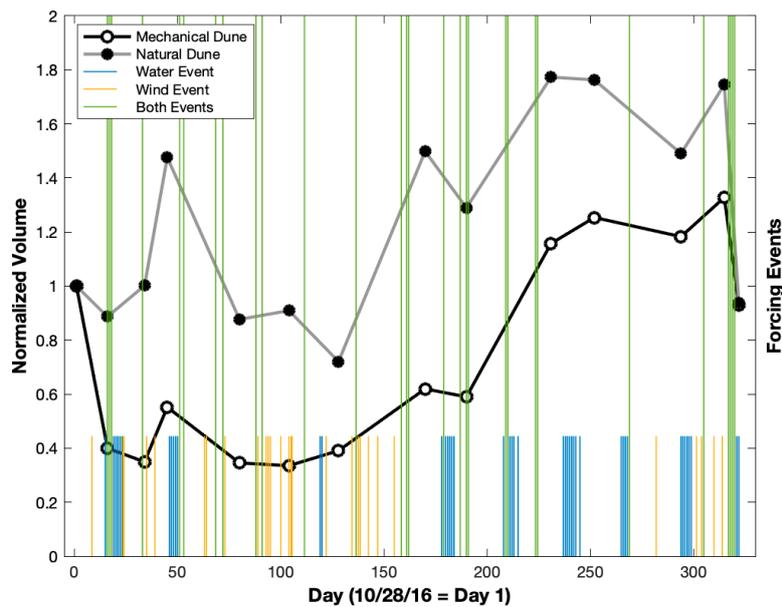
**Figure 9.** Normalized mechanical and natural dune volumes (also shown on Figure 5) plotted with forcing agents (also shown on Figures 4 and 6). The forcing agents are vertical lines where the orange and blue colors indicate wind and water (wave or king tide) events, respectively, and the green lines demark when a king tide, wave, and wind event occur concurrently.

The comparison of forcing events and volumetric change (Figure 9) suggests that the wave and wind events exceeding  $>2\sigma$  and king tide events (i.e., those designated by the green lines) during this study period (with exception to Hurricane Irma) did not strongly influence the erosion-accretion dynamics. A powerful nor'easter (colloquially referred to as Winter Storm Stella) impacted the study site in the days directly following our March survey (03/10-03/18). Despite the above average wind conditions, the natural and artificial system experienced accretion in the one month time span before the next survey. The magnitude of this accretion is roughly equal to the erosion experienced from Hurricane Irma.
