Article

Analysis of High-Friction Surface Texture with Respect to Friction and Wear

Citation: Pranav, C.; Do, M.-T.; Tsai, Y.-C. Analysis of High-Friction Surface Texture with Respect to Friction and Wear. *Coatings* **2021**, *11*, 758. <https://doi.org/10.3390/coatings11070758>

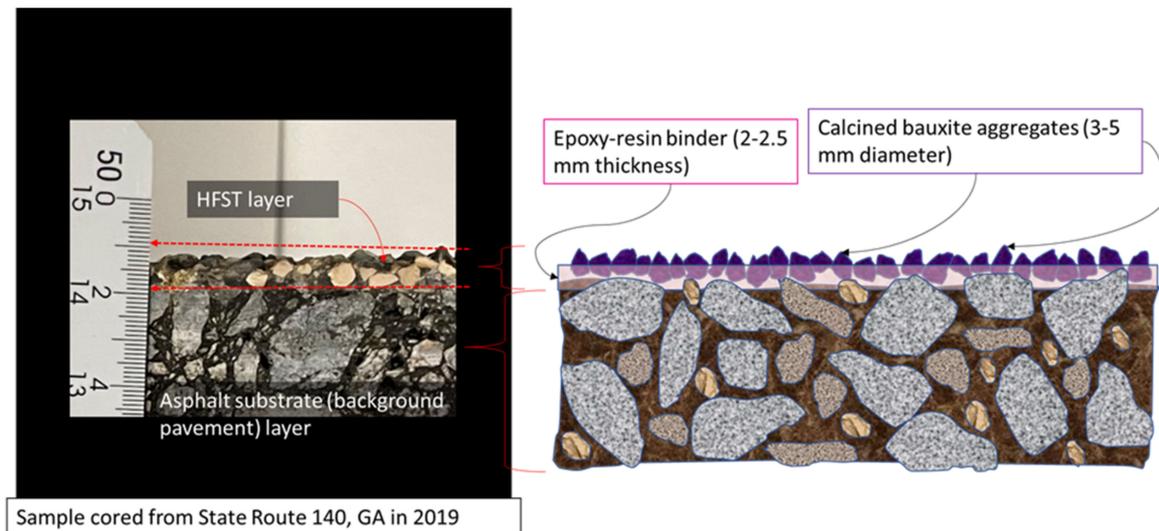
Figure 1. Cross section of HFS and illustration showing the typical dimensions of epoxy and calcined bauxite.

The High Friction Surface (HFS) has been used as one of the low-cost safety countermeasures to address high friction demand concerns on curved roadways. It was developed in the 1960s in the UK by the Greater London Council and the Transport and Road Research Laboratory to restore friction on high-crash road sections [1]. The technology has been adopted in many countries like New-Zealand [2] and the United States [3]. HFS is applied as a thin coating (compared to the thickness of a pavement) on an existing road surface. It is composed of a layer of wear-resistant aggregate like calcined bauxite bonded to the pavement surface with polymer resin binder. Thanks to the high quality and the small size (3–4 mm) of the aggregates, HFS increases the pavement friction value immediately and has proven to significantly reduce roadway departure crashes and wet pavement crashes on horizontal curves and ramps [3]. Figure 1 shows a cross section of pavement installed with the HFS cored out, and it shows the typical dimensions and illustration of HFS.

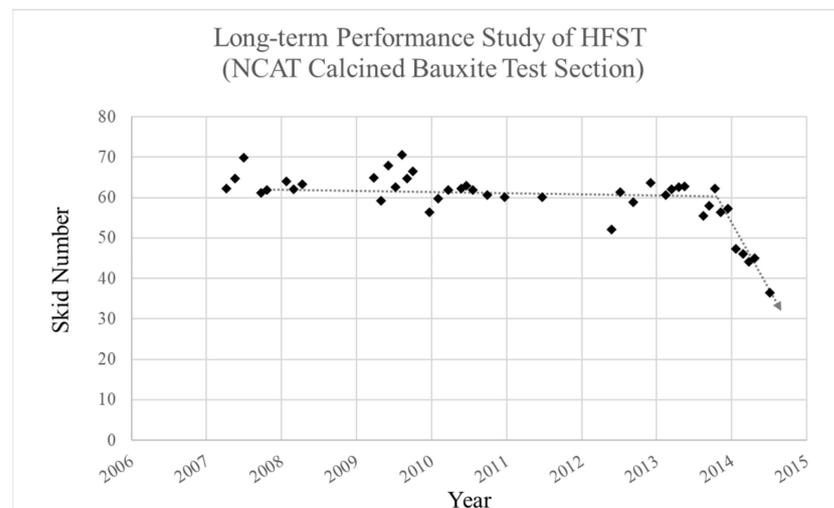
Figure 2 shows the plot of long-term friction performance (measured as a Skid Number) of HFS installed in 2005 at the NCAT test track. The friction performance was measured with a skid trailer fitted with a ribbed tire and run at about 60 km/h (40 mph). It is observed that there is no clear deterioration trend based on Skid Number readings for close to nine years. A rapid friction drop is also observed after nine years in 2014.

Figure 2. Evolution of friction of a HFS surface. Data courtesy of NCAT.

The main differences between the evolutions observed in Figure 2 and references [1,6] are (a) test duration, which is more than nine years in Figure 2, and (b) severity of the simulated traffic, which would be less in [1] in terms of applied loads.

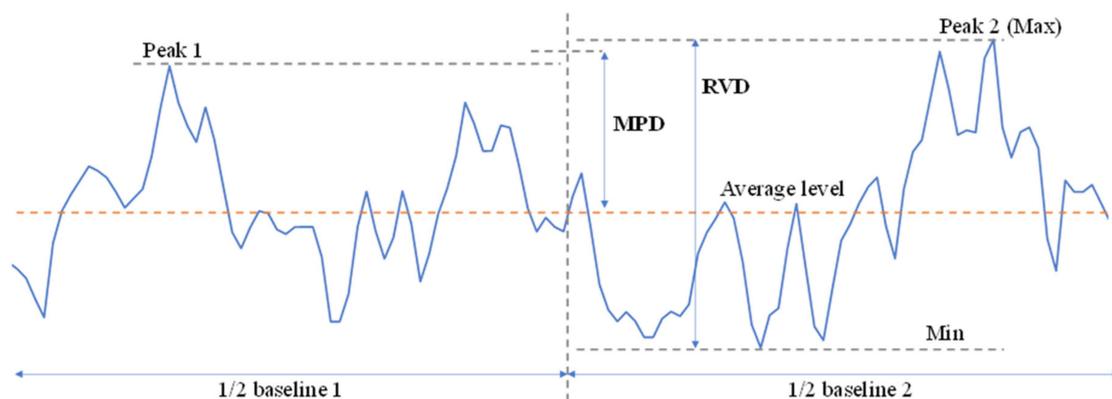
Other authors [13–17] have exploited topographical 2D and 3D maps, measured by laser or other optical noncontact methods, to provide more surface characteristics than the MTD. Mean profile depth (MPD) is the most used texture parameter to characterize HFS surface [13–15]. Some authors [16,17] also use the so-called ridge-to-valley depth (RVD). Figure 3 provides an illustration of MPD and RVD parameters:

where Mean peak level is the average of the two peak levels (numbered one and two, respectively, in Figure 3) determined respectively in the two halves of a profile baseline; and average level is the profile mean level.

- Ridge-to-valley depth characterizes the height difference between the highest peak and deepest valley in a profile (Figure 3).

Figure 3. Definition of the mean profile depth (MPD) and the ridge-to-valley depth (RVD).

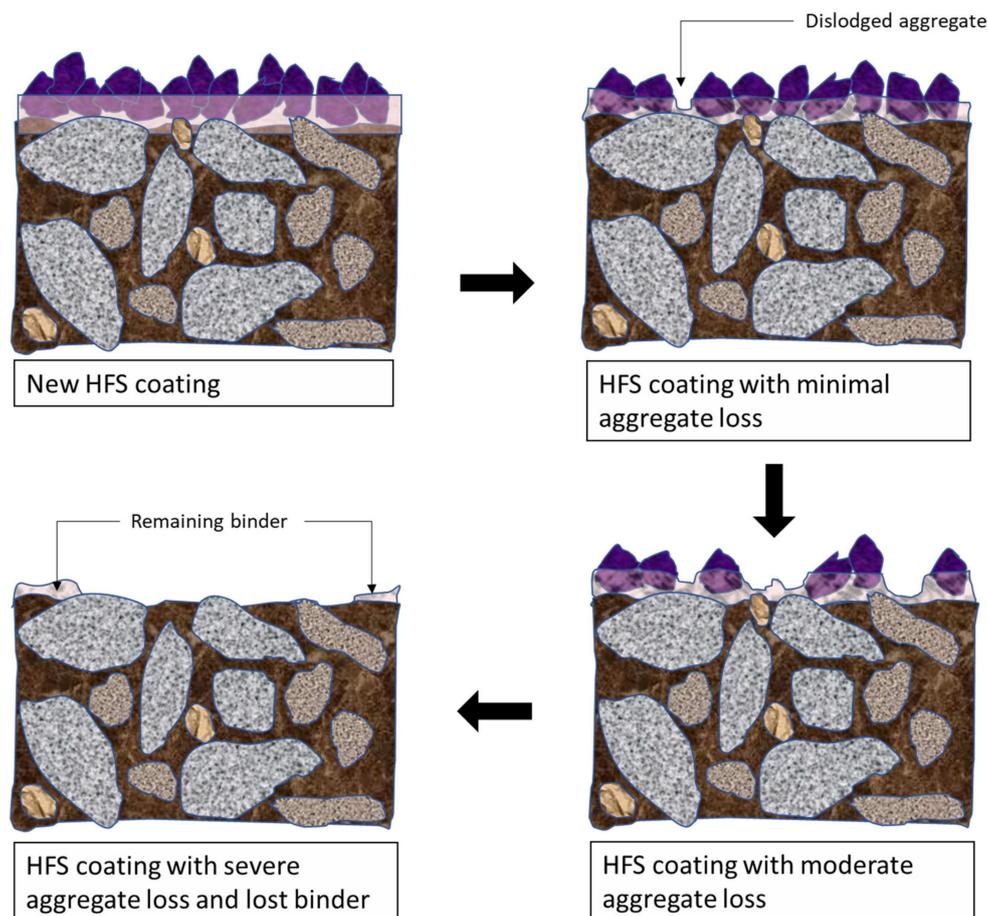
Figure 4. Illustration of the aggregate loss process in a HFS coating.

Illustration of the process in Figure 4 helps to identify three categories of texture parameters:

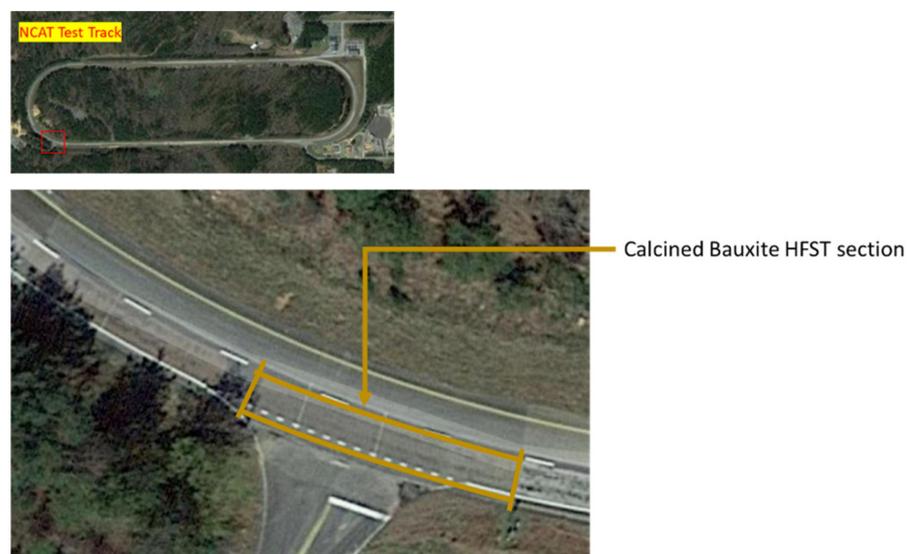
The test location is situated in National Center for Asphalt Technology (NCAT), Alabama, USA. The NCAT Test Track study area involved a thin overlay sections of 30 m in length consisting of HFST (calcined bauxite aggregate) embedded in thin epoxy resin layer, installed in 2011. This section is exposed to 100,000 Equivalent Single Axle Loads (ESAL) every week. Figure 5 shows the test location in NCAT Test Track.

Figure 5. NCAT test track (top) and location of HFST section on the west end of the test track (bottom).

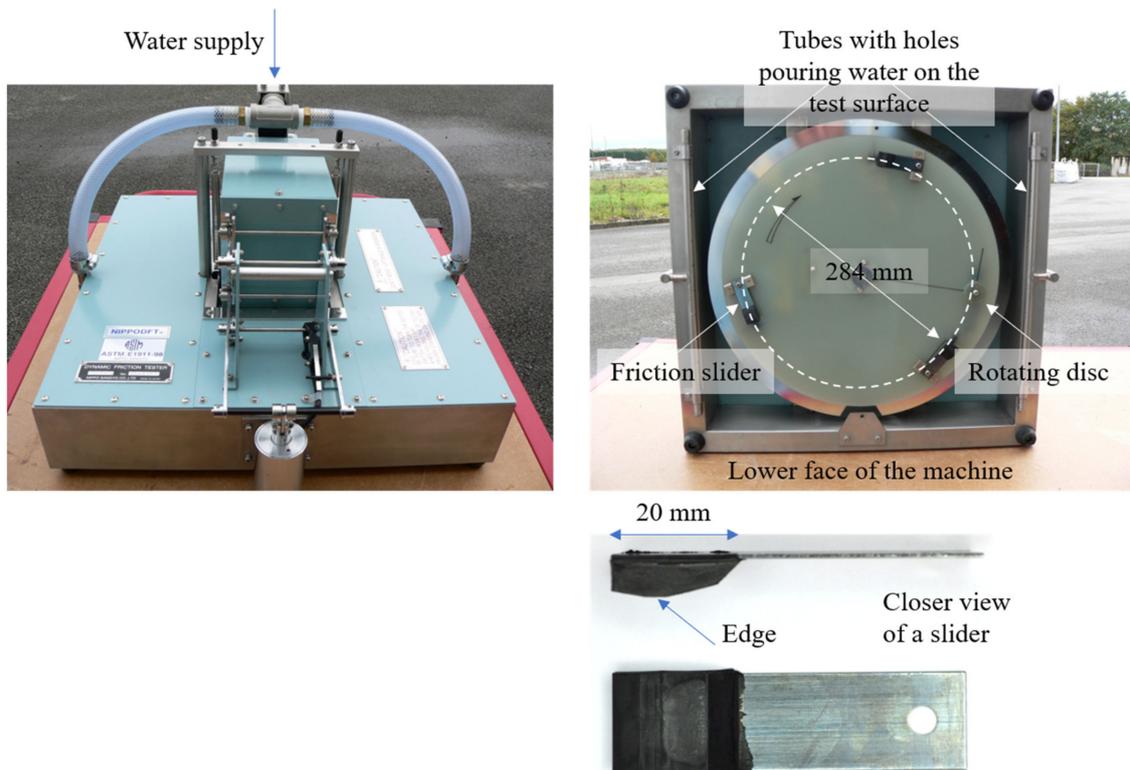
Friction tests are performed by means of the Dynamic Friction Tester (DFT). The machine is composed of a measuring unit (Figure 6, upper left) and a control unit. The measuring unit consists of a horizontal fly wheel and disc, which are driven by a motor (Figure 6, upper right). Three rubber sliders (Figure 6, lower right) are attached to the disc by leaf springs. The rubber compound has a Shore hardness of 58 ± 2 . The sliders are pressed on the test surface by the weight of the device and are loaded to 11.8 N each. When the disc rotates, the sliders follow a circle of 284 mm in diameter. Friction forces are

generated by the contact between the sliders' edges and the test surface. A water tank (not shown in Figure 6) is used to wet the test surface. The flow is maintained at 3.6 l/min to provide a water depth of 1 mm on the test surface.

Figure 6. Dynamic Friction Tester (DFT) machine.

A diameter of 2 mm was chosen for the rolling disk to simulate the geometry of the edge of the rubber slider (Figure 6).

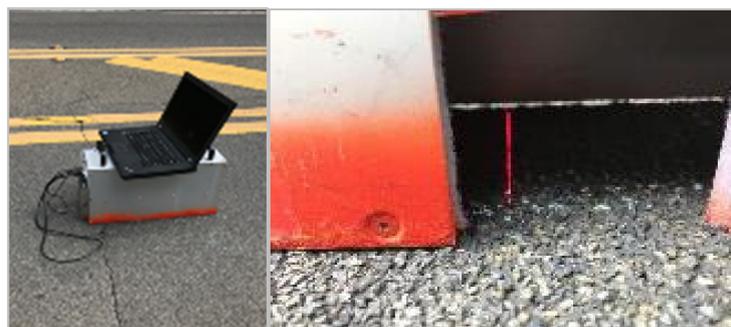
The surface texture is measured by means of the LS-40 device (also known as Laser Texture Scanner 9500), which is similar to ones developed by AMES Engineering (Figure 7). Characteristics of the device: horizontal resolution 0.05 mm and vertical resolution 0.01 mm). The LS-40 uses a line laser to scan an area of 100 mm by 100 mm and collects both elevation height data and scan intensity image. The protocol is simple (push of a button) and rapid (90 s for a full scan). Data are exported as CSV files and can be analyzed by other software, such as MountainsMap (used in this paper).

Figure 7. Laser scanner (LS-40) machine.

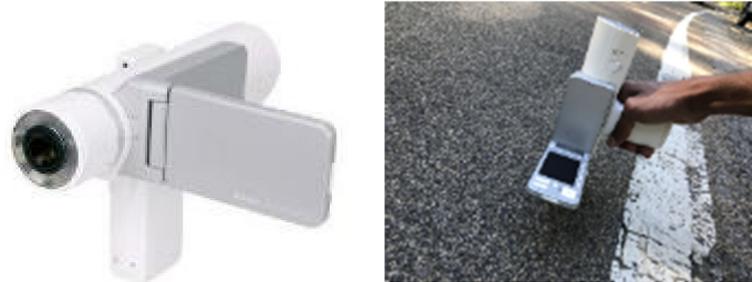
For visual observations of the surface damage, close up images of the surface were collected using a Nikon ShuttlePix P-400R (Figure 8), a high-resolution microscopic imaging camera. It covers an area of 13 mm × 11 mm; it has a resolution of 1600 × 1200 pixels and a horizontal interval 0.009 mm.

Figure 8. ShuttlePix microscopic imaging camera.

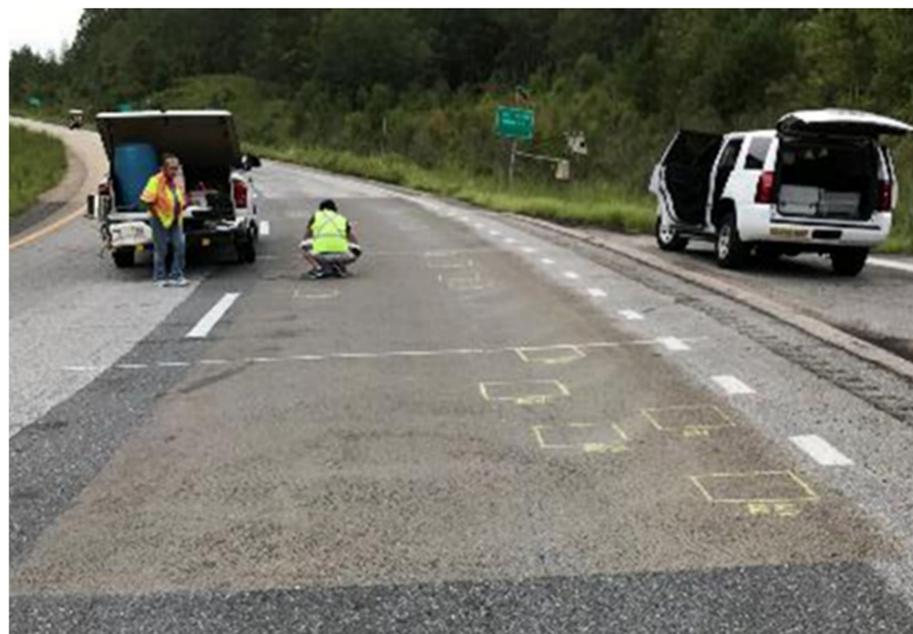
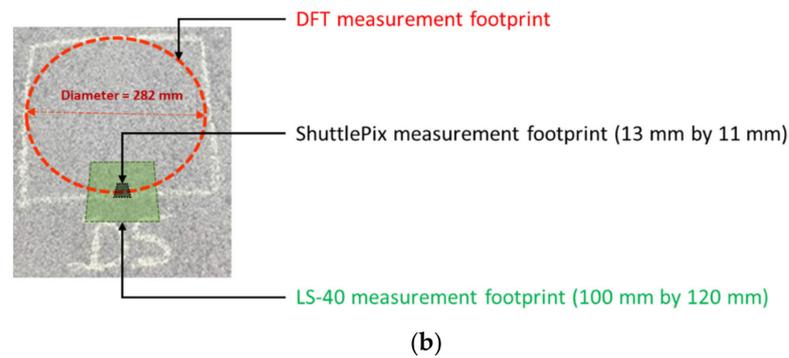
Step 1: Several spots with uniform surface appearance and roughness representing three severity types of HFST aggregate loss were identified manually and marked (Figure 9a). Three severity types were defined as follows:

Step 3: 3D surface data was collected using a high-resolution LS-40 surface area scanner; friction was measured using a DFT (one run); and photos were taken using a smart phone and a ShuttlePix microscopic imaging on the selected spots. The footprint of each measurement device is shown in Figure 9b.

Figure 9. (a) Manual marking of different aggregate loss severity spots on the HFS test section and (b) illustration of different devices' measurement footprint in each spot.

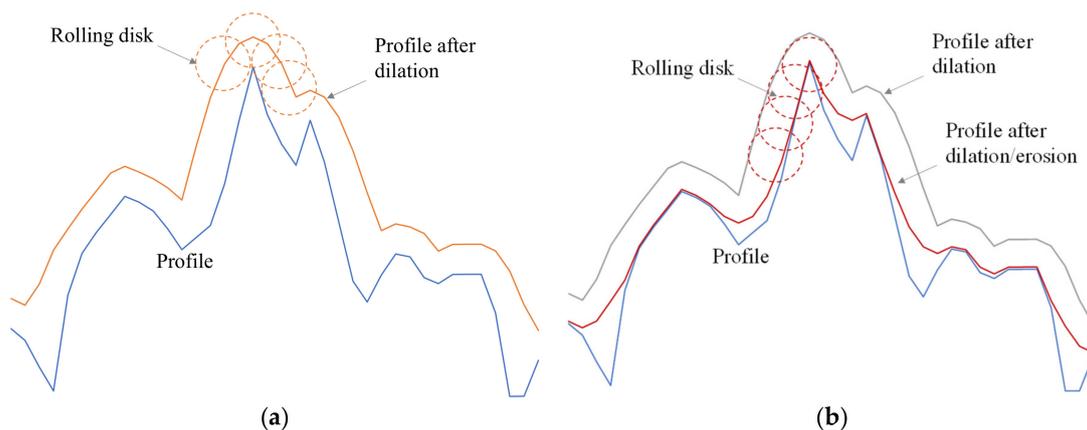
- A dilation operation is first applied by “rolling” a disk over the surface; it creates a dilation line.
- An erosion operation is then applied by rolling the same disk below the dilation line; it creates the upper envelop of the surface.

Figure 10. Operations to create an envelope (a) dilation (blue: profile; orange: dilation line); (b) erosion (blue: profile; grey: dilation line; red: envelop).

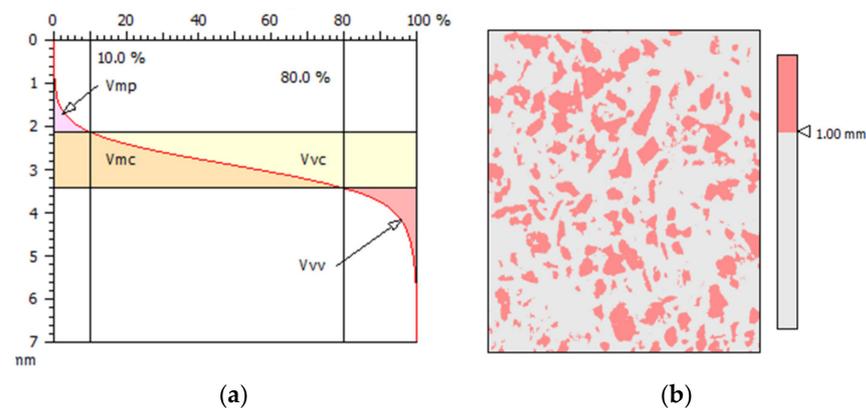
Figure 11 defines the volume parameters (a) and the projected area (b). The projected area (fraction in red) is obtained by looking at the intersection between a horizontal plane located at a predefined depth in the topographical map. Based on the illustrations presented in Figure 4, it was thought that the projected area will reflect the aggregate loss process. The intersection depth was defined at 1 mm from the highest peak of the topographical map. This value, which should represent the indentation depth of the tire, was chosen arbitrarily; a complete modeling of the envelopment of a road surface by a tire would provide a more precise value, but such a study is out of the scope of the paper. Based on Figure 4, when minimal aggregate is lost, the horizontal plane intersects the sharp and pointed aggregates resulting in lower projected area. At severe aggregate loss, the topmost point is either the exposed substrate aggregate or the remaining epoxy and the projected area is likely to be relatively larger. This is because epoxy and asphalt surface contact area are much flatter and wider than the bauxite aggregate, and they also have low height compared to embedded bauxite.

Figure 11. (a) Abbott curve and the volume parameters; (b) projected area (data from MountainsMap®software).

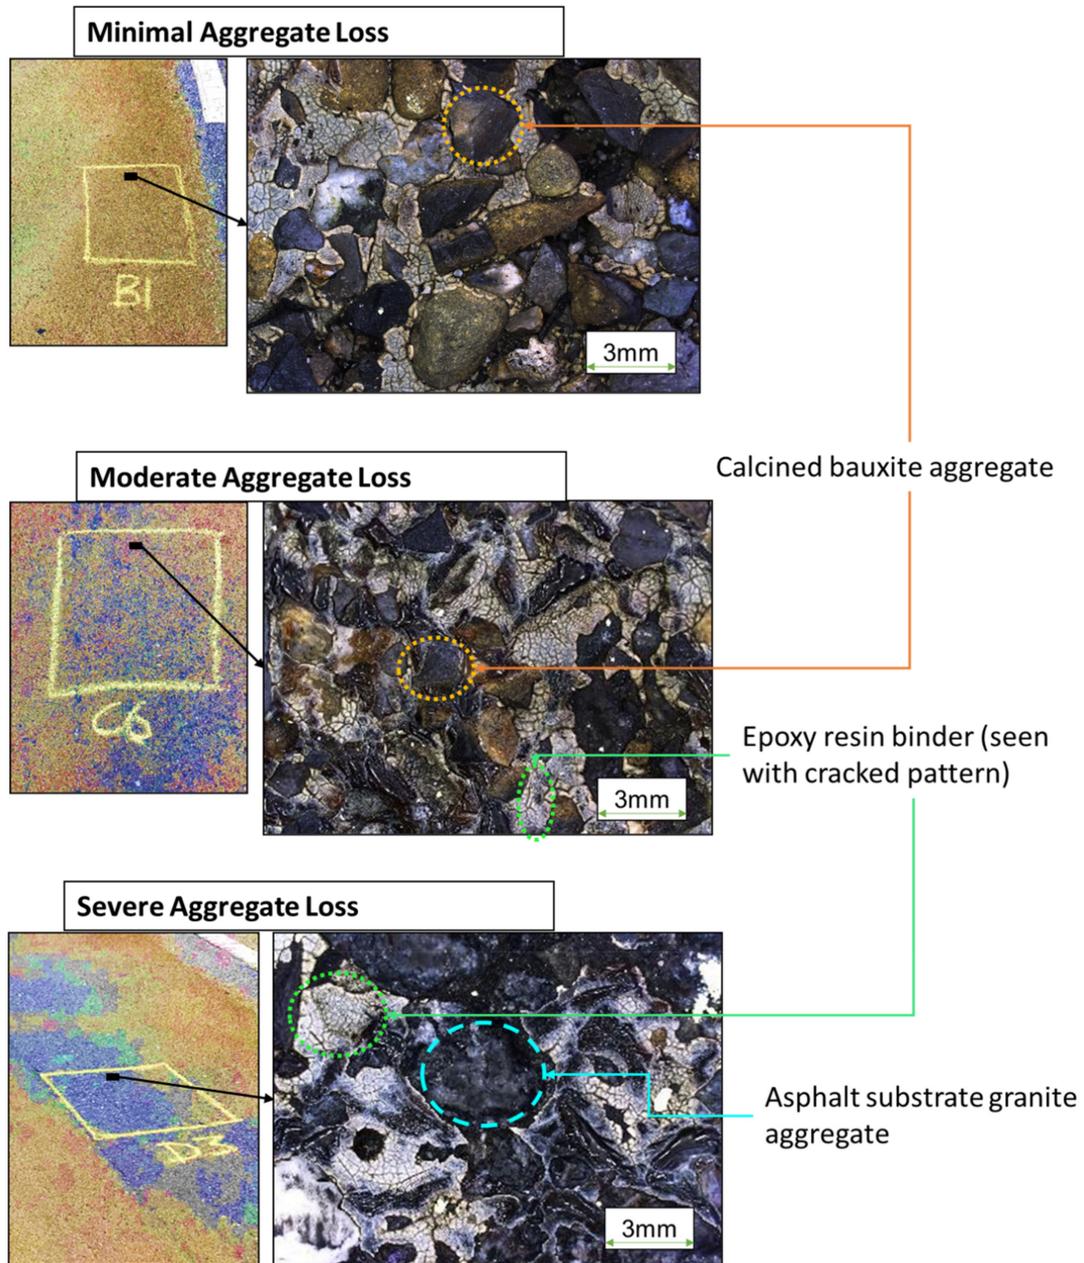
Figure 12. Photos showing example of three different aggregate loss severity types and microscopic image of the corresponding severity type. The photos (left) are enhanced with 400% saturation to distinguish calcined bauxite aggregates (represented as yellow) from epoxy and background asphalt aggregates (represented as green and blue).

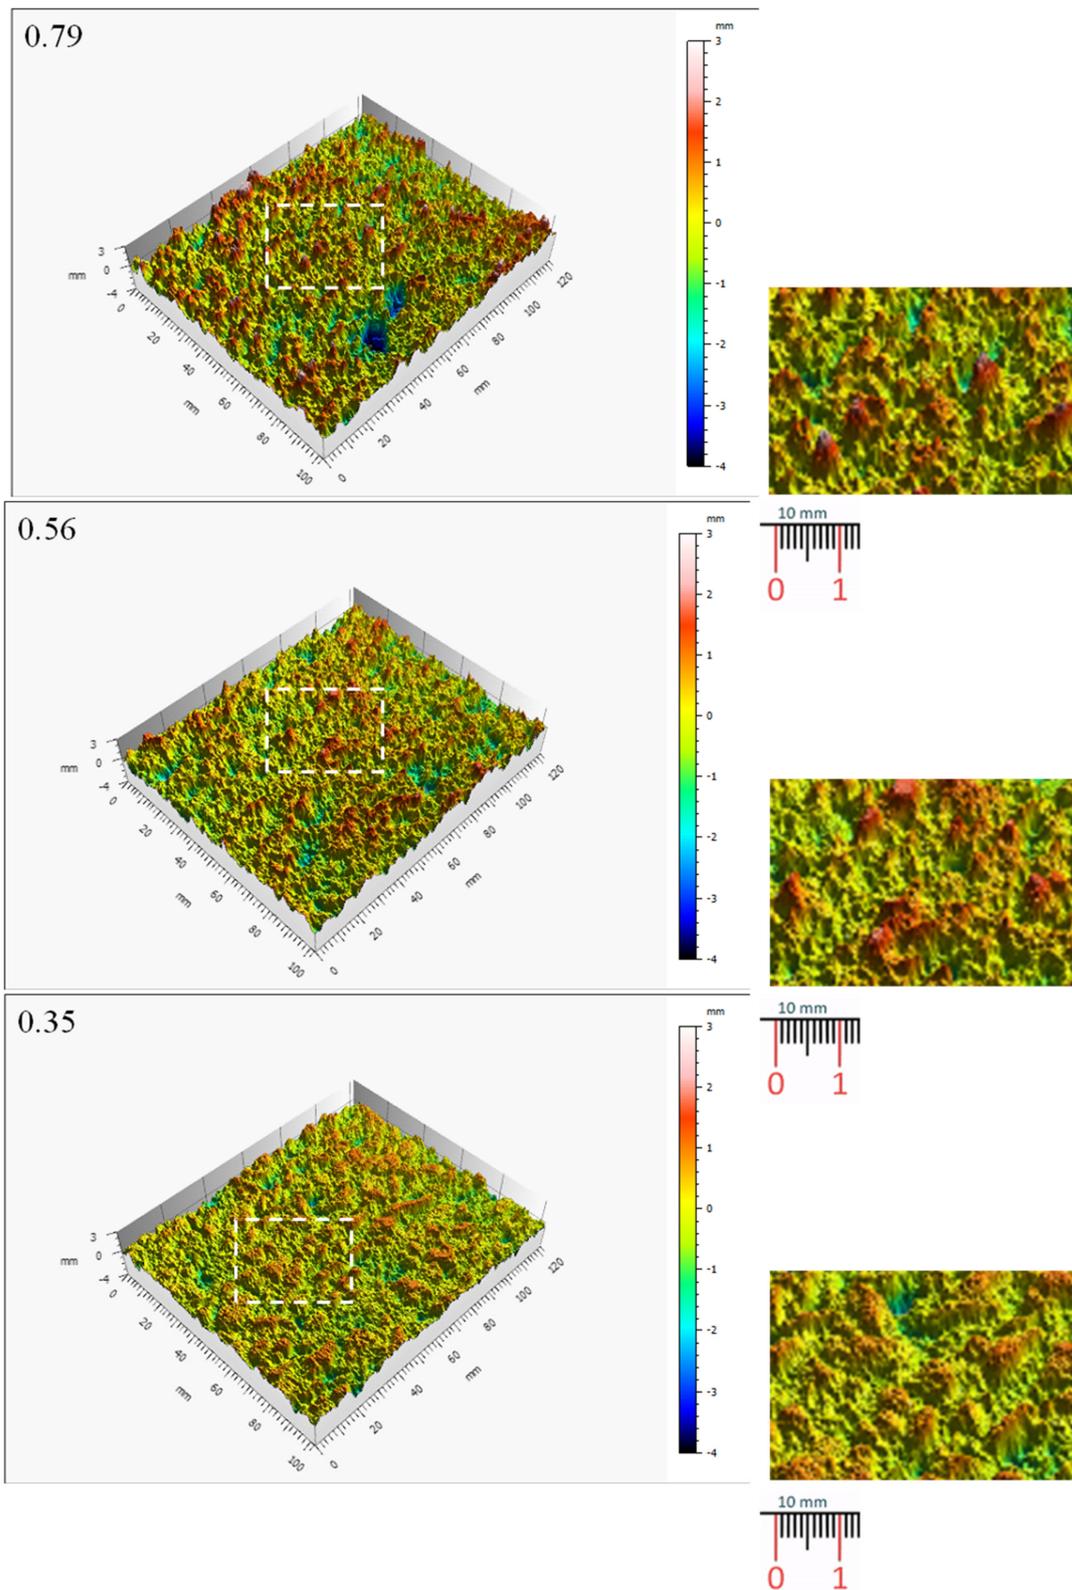
Figure 13. Isometric views of the topographical maps for three deterioration levels (from top to bottom: minimal with a coefficient of friction of 0.79; moderate 0.56; severe 0.35).

Figure 15 shows the relationship between the aggregate characteristics and the DFT60 friction coefficient. It is seen that the higher the friction, the higher and sharper are the asperities. Therefore, the variation of the asperities’ height (S_q) and angularity (S_{dq} and S_{sc}) with the friction coefficient reflects observations made from Figure 13.

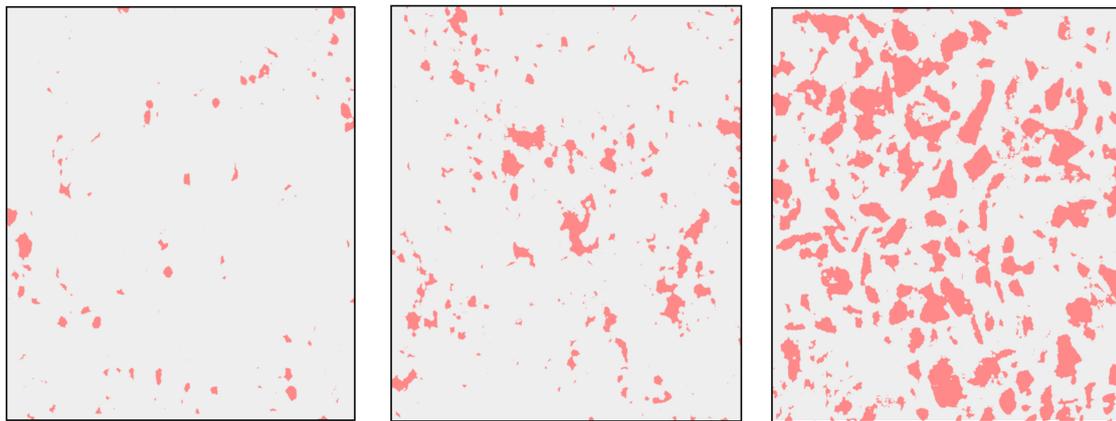
The projected areas of the same topographical maps are shown in Figure 14. The projected area increases as the coefficient of friction decreases. Compared with the aggregate loss process illustrated in Figure 4, this result is partially reasonable. We can see more tire contact with aggregate in minimal and moderate aggregate loss conditions and more contact with binder in severe aggregate loss conditions. On the one hand, the contact points between the tire and the high-friction surface come from the calcined bauxite aggregates with sharp edges (as reported in [1,2]), and so the projected area is low in minimal and moderate aggregate loss. On the other hand, the contact points between the tire and the low-friction surface come mainly from the binder and the underlying pavement (with more rounded aggregates), and so the projected area is high in severe aggregate loss. However, one would expect that the number of contact points (and the projected area) would decrease as the coating is deteriorated from minimal aggregate loss to moderate aggregate loss. This discrepancy needs to be further investigated; it could be possible that the minimal aggregate loss spots chosen in this study may still have excess aggregates on top of the embedded aggregates, leading to much higher elevation of the topmost aggregates. Thus,

only a few points are intersected by the horizontal plane 1mm below the topmost point. After the excess aggregates are removed, it is possible that the projected area decreases with increasing aggregate loss, and, when severe aggregate loss is reached, the projected area suddenly increases; the highest point is now the remaining epoxy, or the background substrate aggregates instead of the calcined bauxite aggregates.

Figure 14. Projected areas for three aggregate loss levels (from left to right: minimal with a coefficient of friction of 0.79; moderate 0.56; severe 0.35).

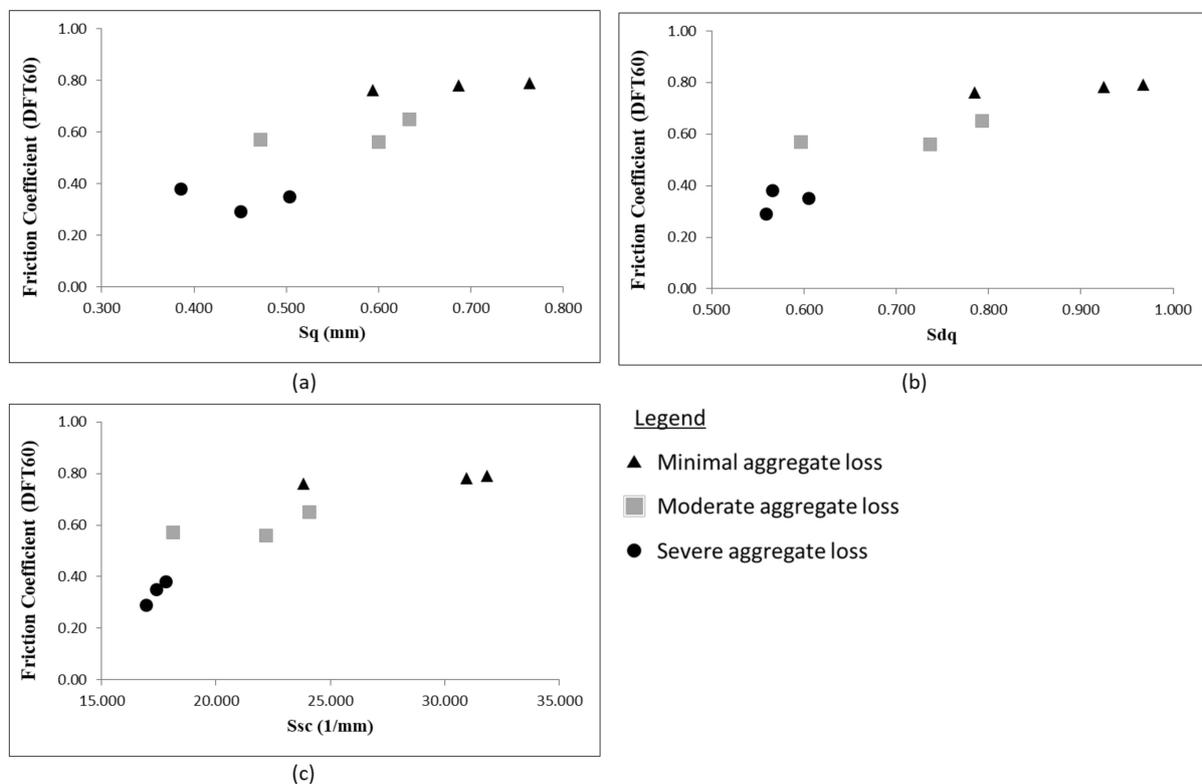
Figure 15. Relationship between DFT60 friction coefficient and parameters related to the aggregate characteristics including (a) root mean square height (S_q), (b) mean quadratic slope (S_{dq}), and (c) curvature (S_{sc}).

The relationship between the chosen texture parameters and the DFT friction coefficient, shown in Figures 15–17, corresponds to the three categories of parameters expressing the aggregates’ characteristics, distribution, and aggregate loss physical process, respectively. Surfaces corresponding to three aggregate loss severity levels (minimal, moderate, and severe) are represented by triangles, squares, and circles, respectively.

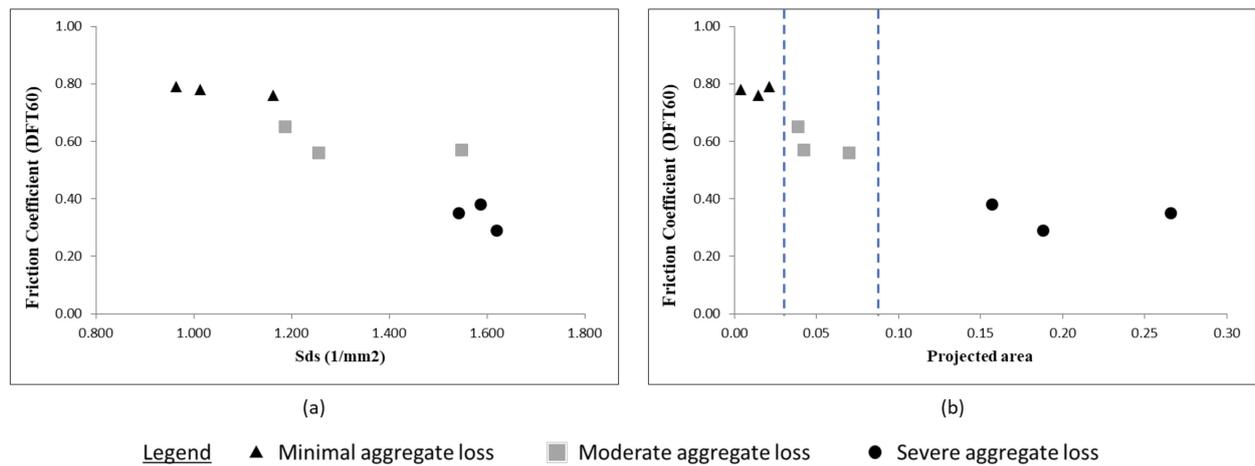
Figure 16. Relationship between DFT60 friction coefficient and parameters related to the aggregate distribution including (a) density (S_{ds}) and (b) projected area.

Figure 16 shows the relationship between the aggregate distribution and the DFT60 friction coefficient. Again, the increase of the asperities' density and projected area reflects the observations made from Figure 14. Furthermore, it seems that the projected area allows separating the three aggregate loss levels (the dotted lines are placed arbitrarily to illustrate the separation); however, the test population is too small, so further validation is needed.

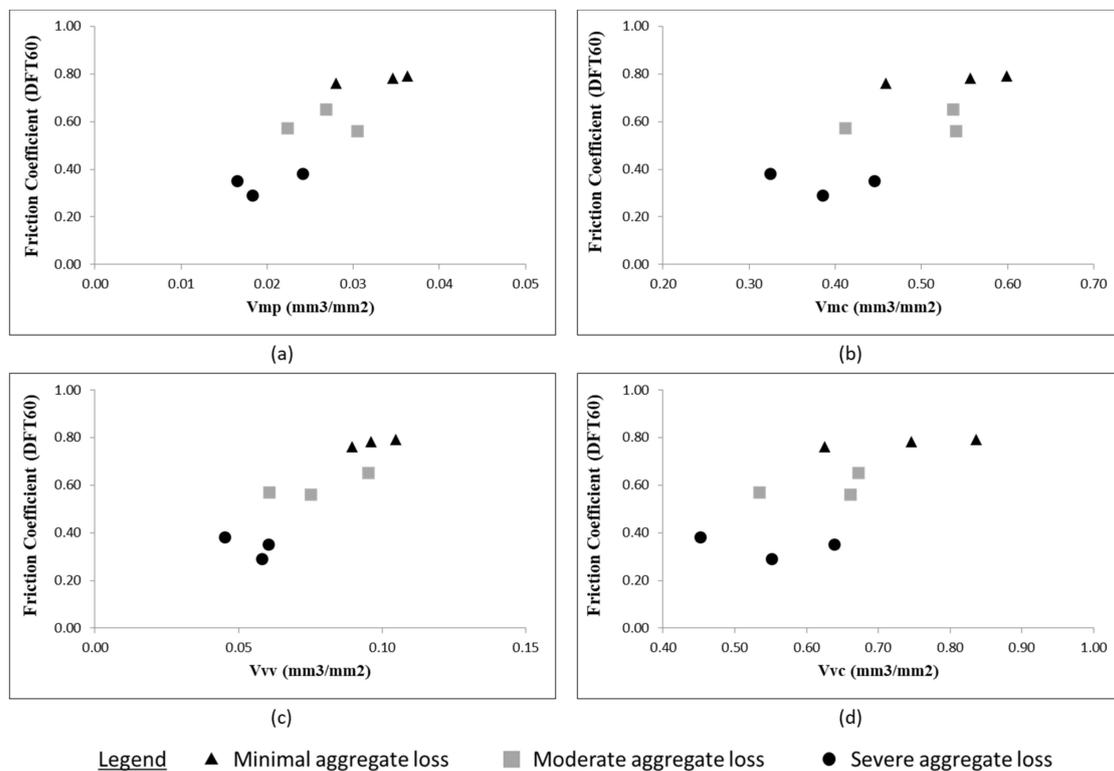
Figure 17. Relationship between DFT60 friction coefficient and volume parameters including (a) peak material volume (V_{mp}), (b) core material volume (V_{mc}), (c) valley void volume (V_{vv}), and (d) core void volume (V_{vc}).

Figure 17 shows the relationship between the volume parameters and the DFT60 friction coefficient. The trend obtained with material volumes (V_{mp} and V_{mc} , corresponding to material peaks and material core) reflects the fact that as the HFS aggregate loss progresses (decrease of friction), there are less matter that can be removed by wear; it is then consistent with the progressive loss of aggregates. The decrease of the void vol-

umes for increasing deterioration expresses the flattening of the HFS surface following the material removal.

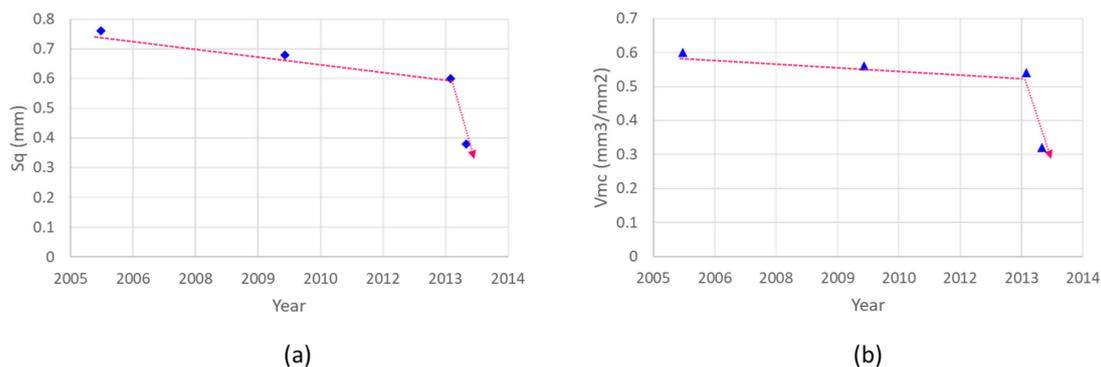
To illustrate the relevance of texture parameters, they are plotted against an artificial timeline corresponding to friction deterioration observed at the NCAT test track. Four points are chosen in the friction timeline (from Figure 2) and corresponding texture parameter values are plotted on the friction timeline as shown in Figure 18. S_q and V_{mc} are chosen for illustration based on their high correlation with friction. From the graphs, we can find the two texture parameters mimic the friction deterioration, and the two parameters show a sudden deterioration corresponding to friction deterioration.

Figure 18. Plot of (a) S_q and (b) V_{mc} texture parameter values based on an artificial timeline corresponding to friction deterioration.

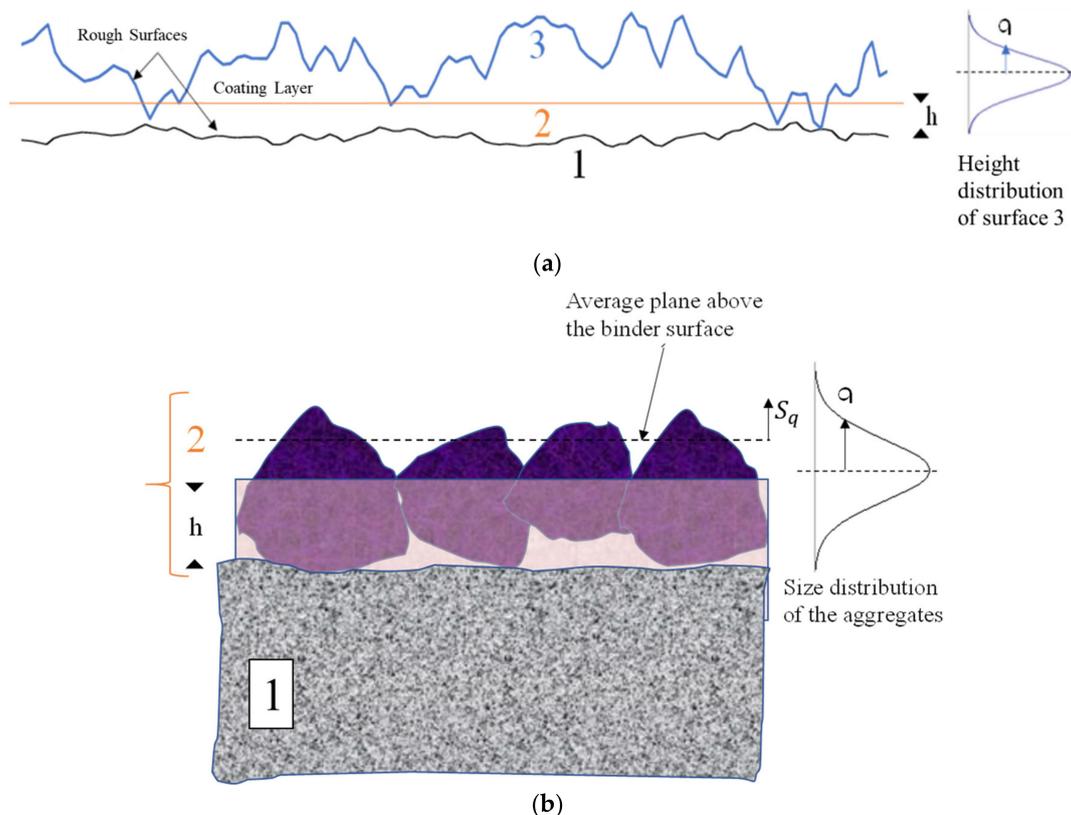
the friction and wear behavior of a system formed by two rough surfaces (numbered as 1 and 3 in Figure 19a), one of which is covered by a coating layer (Number 2 in Figure 19a).

Figure 19. Geometry of the contact and related parameters (a) from Halling's work [22] and (b) adapted to tire/HFS contact (Coating 2 includes the binder and the aggregates).

To adapt Halling's geometry of contact, one can assume the following: Surface 1 is that of the underlying pavement; Surface 3 is that of the tire and can be considered, as a first approximation, as smooth; and Surface 2 is that of the HFS with h is the thickness of the epoxy binder and σ is the standard deviation of the height distribution of the calcined bauxite aggregates (Figure 19b). Considering an embedment of the aggregates of 50% (which is a good application of the HFS [7]), a first approximation of σ could be $\sigma = 2S_q$ (Figure 19b). With increasing wear, e.g., increasing loss of aggregates and then decreasing S_q (based on Figure 15a), the ratio h/σ should increase from 0.5 (initial application) to 1 when the tire touches the binder. To plot the graph in Figure 20b, it was assumed that $h/\sigma = 0.5$ for the minimal aggregate loss (close to the surface state just after the application); an adjusted value of $h = 0.7$ mm. A thicker layer ($h = 1.5$ mm) would be more representative, considering the usual size of the aggregates employed for HFS (3–4 mm after [3]). It should be noted that h could be higher if one considers maximum height parameter from the

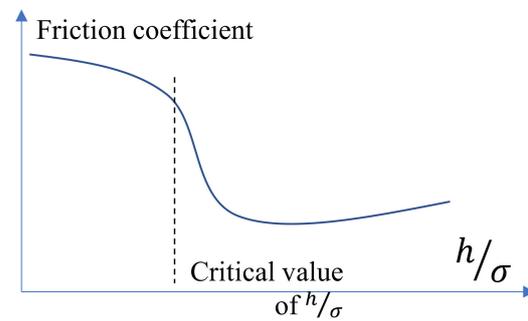
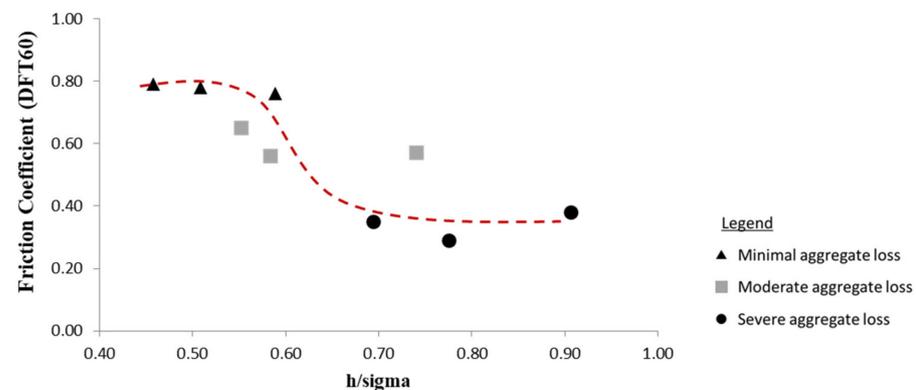
A friction model, based on a distribution of friction between Surface 3/Coating 2 contact and Surfaces 3/1 contact, leads to a variation of the coefficient of friction resulting from this contact as illustrated in Figure 20a.

Figure 20. Variation of the coefficient of friction with the ratio h/σ (a) trend from Halling’s work [22] and (b) data from the present study.
