Article

Field Evaluation of Red-Coloured Hot Mix Asphalt Pavements for Bus Rapid Transit Lanes in Ontario, Canada

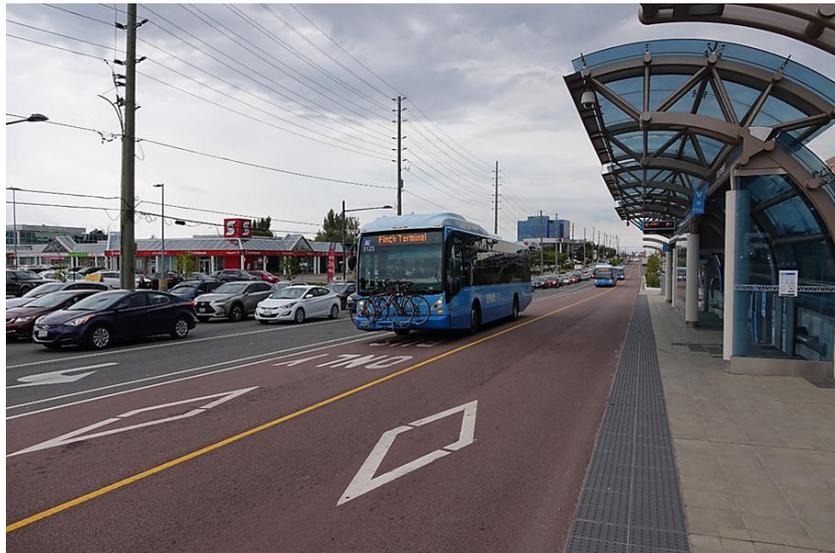
Figure 1. A section of coloured bus rapid transit (BRT) lane at York Region, ON, Canada.

Located in north of Toronto in the Province of Ontario in Canada, the regional Municipality of York has adopted a combination of coloured aggregate and red pigment for its BRT lanes as shown in Figure 1. The coloured asphalt pavement was to improve the level of safety through enhanced visibility.

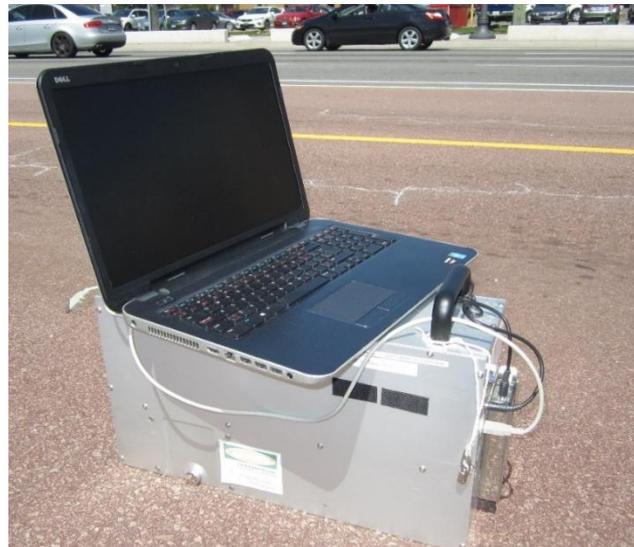
Figure 2. Pavement texture measurement: (a) a line-laser scanner; (b) a recovered 3D texture height map.

The pavement surface texture was assessed by using a line-laser scanner, 3D non-contact line-laser pavement texture measurement system (Version 1002.05.20, Measurement Instrument Technology, Austin, TX, USA) [10] and based on the laser triangulation principle for a 3D texture measurement. The width of laser line for the line-laser scanner is 0.1 mm. A centre of gravity algorithm is employed to refine the laser line position for precise measurement to achieve the horizontal sampling interval of <0.05 mm. The line-laser scanner produces 3D surface texture measurements with a horizontal sample interval finer than 0.05 mm, and covering partially both microtexture and macrotexture ranges of the pavement surface. The accuracy of the line-laser scanner vertical texture height measurement is better than 0.05 mm. The recovered 3D texture height map was decomposed by using discrete wavelet transform to classify macrotexture and microtexture at various scales. Figure 2 shows a line-laser pavement texture scanner and a recovered 3D texture height map.

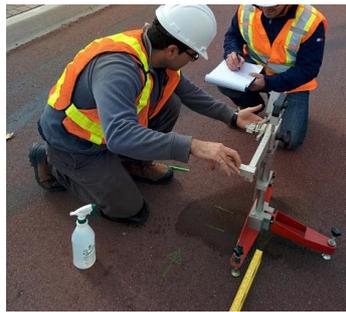
Figure 3. Pavement friction assessment by using a British Pendulum tester (BPT).

Pavement frictional property was assessed by using a British pendulum tester (BPT) (Munro Instruments, Harlow, UK) following ASTM E303 standard [12]. BPT can provide an indirect measure of relative micro-texture and the well accepted pavement friction index: the British pendulum number (BPN) [13]. Figure 3 shows field test by using a BPT. The BPT tests were conducted in outer wheelpath at a surface temperature of 21 ± 1 °C. Other temperatures were not tested.
