Article

Gully Erosion Mapping and Monitoring at Multiple Scales Based on Multi-Source Remote Sensing Data of the Sancha River Catchment, Northeast China

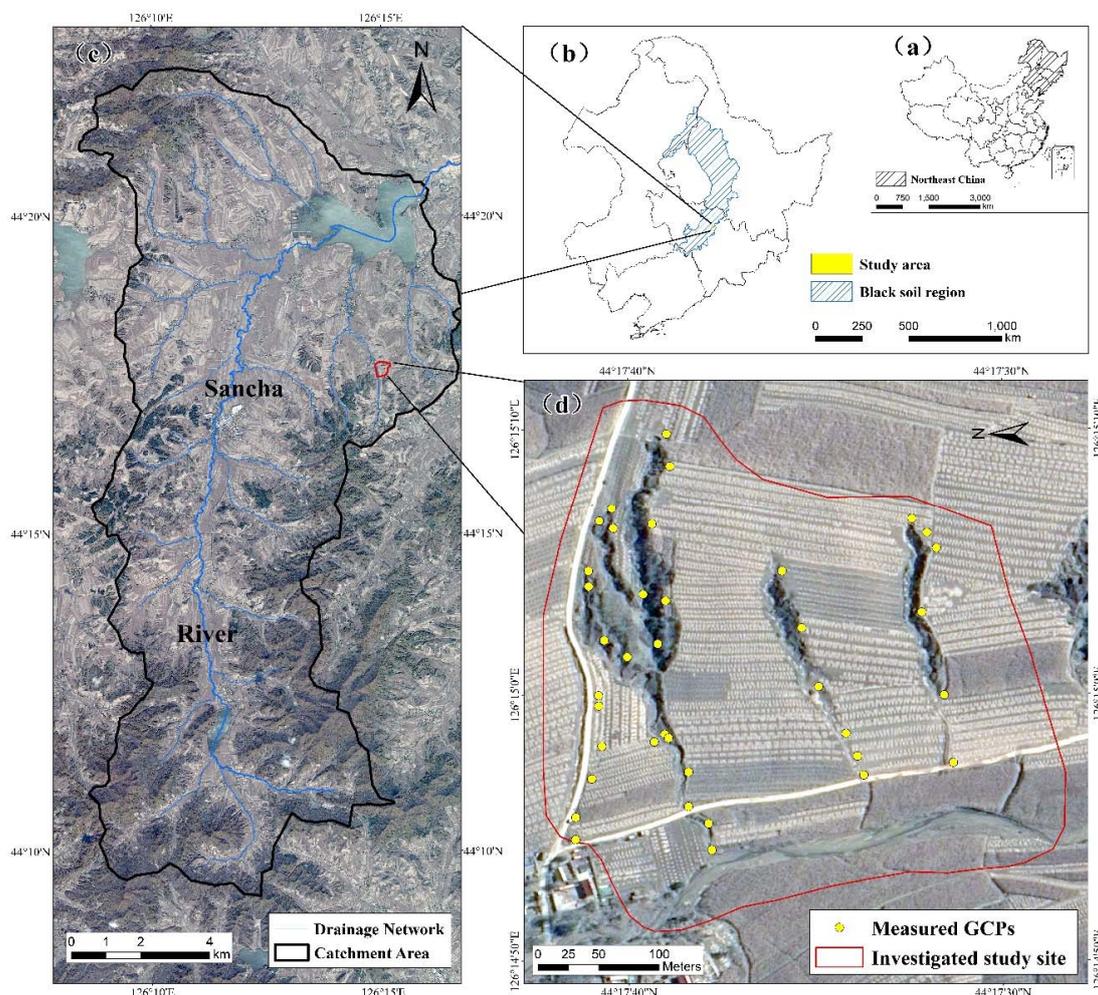
Figure 1. Location of the study area: (a) map of Northeast China; (b) map of the study area, situated at the southeastern edge of the black soil region; (c) overview of the study area with a detailed view of the survey site—the detailed RGB-321 Pleiades-1A satellite image includes the Sancha River catchment (12 October 2013); and (d) the investigated site was used for detailed mapping and the Ground Control Points (GCPs) were distributed over the site.

A small study site (Figure 1d) in the Sancha River catchment was selected for detailed mapping using UAV, as it includes typical gullies (for example, Gully-4) and is located near the road. The image acquisition workflow is as follows: Firstly, Ground Control Points (GCPs) were distributed over the chosen study site prior to the airborne campaign (Figure 1d). The GCPs were installed and precisely measured with JLCORS, as well as used for georeferencing during further image processing. The geographic coordinate system and projection were set to China Geodetic Coordinate System 2000 (CGCS 2000) and Gauss Kruger, respectively. Secondly, the UAV was operated in the field by a trained operator and controlled autonomously by the autopilot software DJI GO (DJI, Shenzhen, China) and Pix4Dcapture (Pix4d, Lausanne, Switzerland) to follow predefined flight plans for imagery acquisition during takeoff, flight and landing. The flight plans were designed for longitudinal overlap of 80% and lateral overlap of 60% to avoid gaps between single photographs and ensure successful photo-reconstruction. The lens of the camera was set in the 90-degree position, and the flying height was set at 120 m above the ground for the duration of the imaging process.

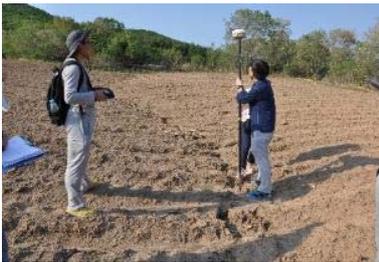
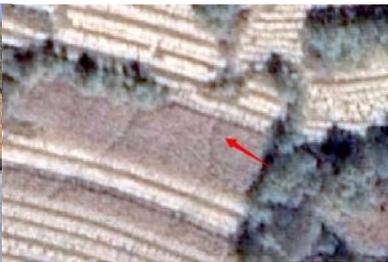
Types of Gully Appearance	Ground Photos	Pleiades Images
Gully-1: Ephemeral gully

Table 1. Interpretation signs: four types of gully appearance in the high-resolution satellite images and ground photographs of the study area.

A ground-level photograph showing two people standing in a shallow, narrow, and dry gully cut into a field of tilled soil. The gully is surrounded by green vegetation in the background.

A high-resolution satellite image showing a narrow, linear depression in the terrain, highlighted by a red arrow. The surrounding area shows agricultural fields with distinct patterns.
Gully-2: Small permanent gully

Visual interpretation and vectorization were used to obtain gully distribution data of the study area. Table 1 shows four types of possible gullies in the high-resolution satellite images and ground photos of the study area. Gully-1 is typical of ephemeral gullies, which generally have long narrow structures and occur on farmland. Ephemeral gullies are small channels eroded by concentrated flow that can be easily filled by normal tillage, but reappear in the same location by additional runoff events [2]. As Gully-2 shows, the further developed linear gullies are much more deeply incised. The channels are too deep and wide to level with ordinary farm tillage equipment and are referred to as permanent gullies [2]. Gully-3 represents a larger and wider permanent gully, in which the gully bottom is sparsely covered by plants. The gully headcut and steeper gully walls further decrease in the adjacent flat lands. Compared with the single gully of Gully-3, a ramified gully system with several branches can be observed in Gully-4. Between the individual branches, smaller flat parts of the original surface remain, and have even been reclaimed. However, gullies in forests were not the object of this study since these gullies are difficult to recognize from optical satellite images.

The Pleiades imagery displayed high feasibility for the recognition of various gully types, especially ephemeral gullies in this study (e.g., Gully-1 in Table 1). However, with the enhancement of satellite image resolution, the phenomena of “noise” and “different objects with the same spectrum” as well as “the same objects with different spectra” increase [45]. In the present study, a small farm path was easily mistaken for an ephemeral gully because their spectral characteristics and geomorphological structures were similar in the Pleiades imagery. Meanwhile, it is difficult to distinguish narrow roadside gullies from the road, as they were too similar to be differentiated from the imagery. Nevertheless, the obtained interpretation result was satisfactory due to the high accuracy (Table 3). However, achieving the satisfactory result was time consuming and required a certain expertise. According to previous studies, with respect to high spatial resolution satellite images (such as Pleiades-1A), although the visual interpretation of gully erosion with field verification achieved much higher accuracies [8,46], (semi-)automatic mapping of gullies at a regional scale or larger scales showed great potential for obtaining a general statement of the distribution of gullies to a wider extent [43,47,48].

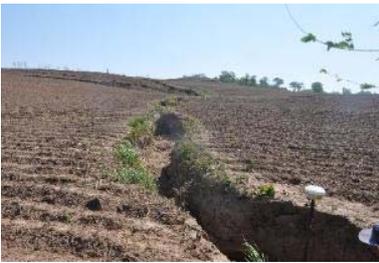
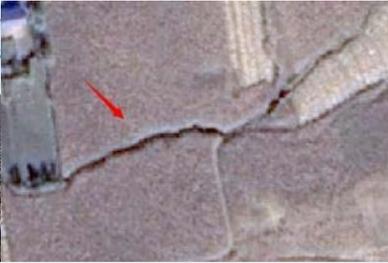
A ground-level photograph of a small, permanent gully with a visible water channel, cutting through a field. The gully is bordered by a concrete curb on one side.

A high-resolution satellite image showing a small, permanent gully with a distinct water channel, highlighted by a red arrow. The gully is clearly defined against the surrounding agricultural fields.

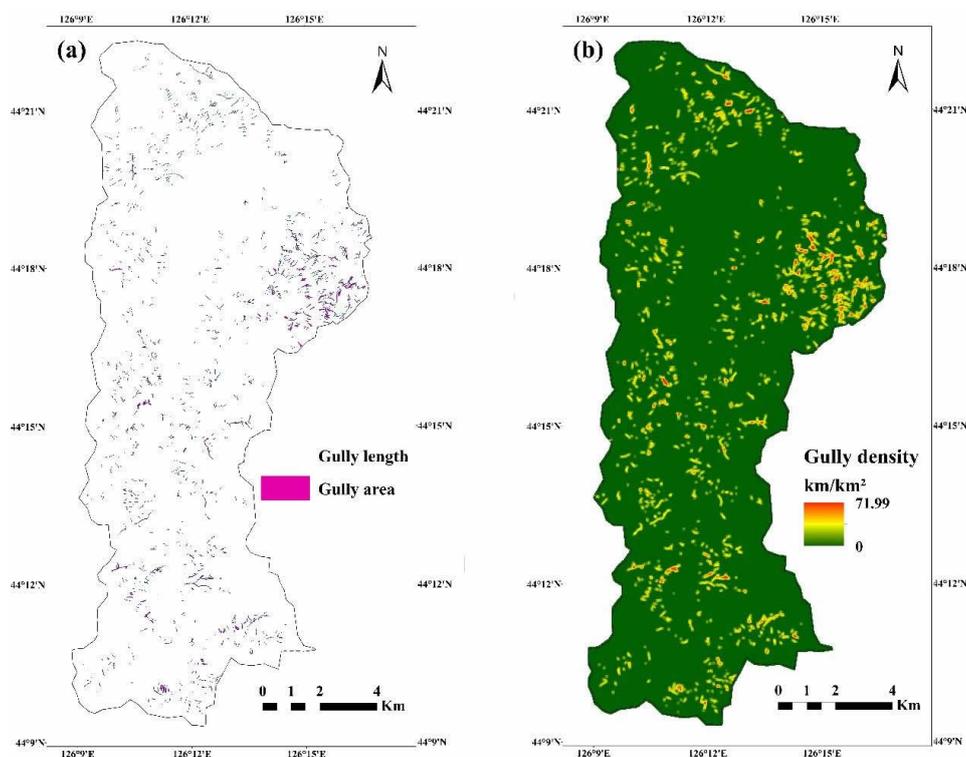
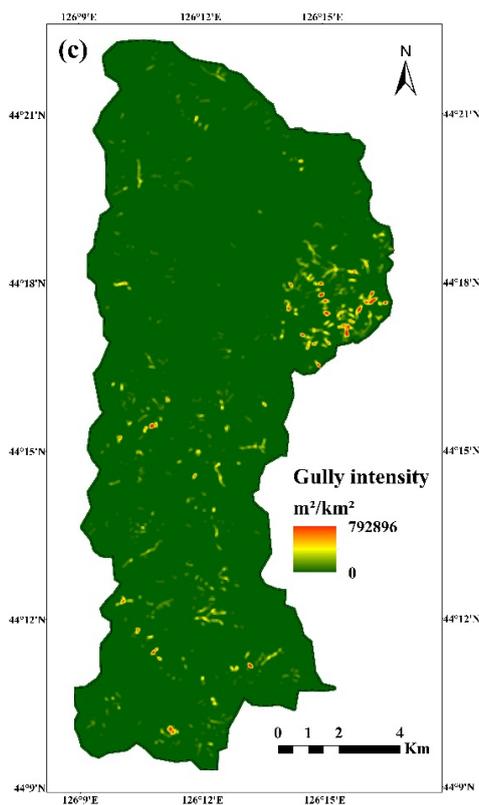
Figure 2 displays the spatial distribution of gully erosion across the Sancha River catchment. Figure 2a illustrates that gullies are widespread across the catchment, especially in the northeastern part. Figure 2b,c shows that the gully density and gully intensity ranged from 0 to 71.99 km/km^2 and from 0 to $792,896 \text{ m}^2/\text{km}^2$, respectively. The results all indicate that gully erosion in the northeastern part was most serious. However, there are differences between the spatial distribution of gully density and intensity. The high gully intensity generally indicates that the lateral erosion of the gully erosion is significant, which results in notable widening of ditch sides and an increase in the area.

Figure 2. The distribution map of: (a) erosion gullies; (b) gully density; and (c) gully intensity in the study area.

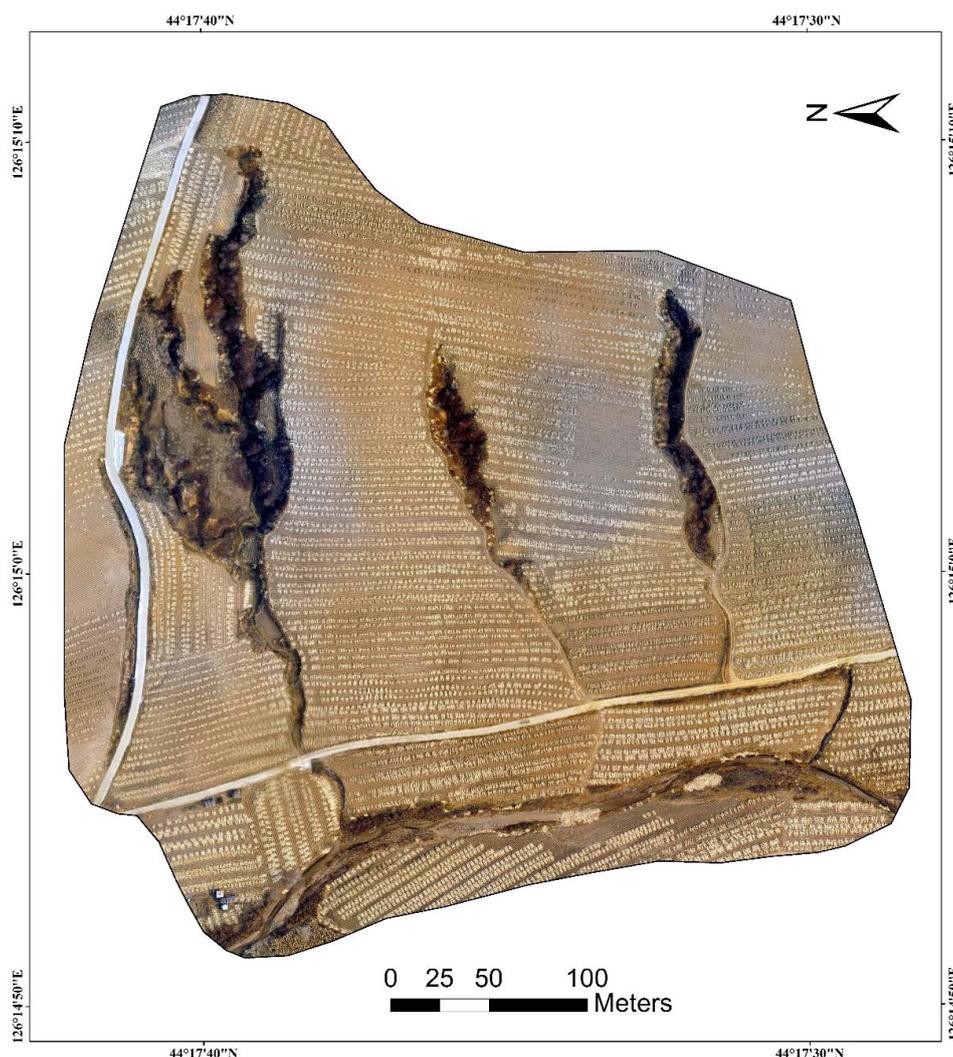
Figure 3. Orthorectified image mosaic of the small study site (31 October 2015). Darker areas within the gully system are withered vegetation. The main gully in the northern section is Gully-4, as mentioned above.

The resulting ortho-image mosaics and DSM reveal the area of agricultural utilization and its shaping by human agricultural activities and water erosion in detail. The maize straws with accumulation on the flat farmland are visible along with landfill within the headcut. The cultivated

land in the bottom of the gully is even distinguishable. In addition, the depression of existing gully erosion is highly visible. In addition to the three main gullies, a roadside gully and small rills are visible. In Figure 4, the light blue part illustrates the lowest area at the Wadi bottom. However, the maximum incision depth of the gullies reaches 10.32 m in the upper leftmost main gully (i.e., Gully-4 mentioned above). The gully volumes were calculated as 68,145 m³, 12,240 m³ and 5405 m³ for the three main gullies (from north to south in Figure 4, respectively). Meanwhile, a precise and comprehensive 3D model of the gullies was calculated (Figure 5). The enlarged inset shows the 3D structure of the gully sidewall and headcut in detail. The results shown in Figures 3–5 illustrate the high degree of detail achievable with the method of UAV-based remote sensing and 3D photo-reconstruction.

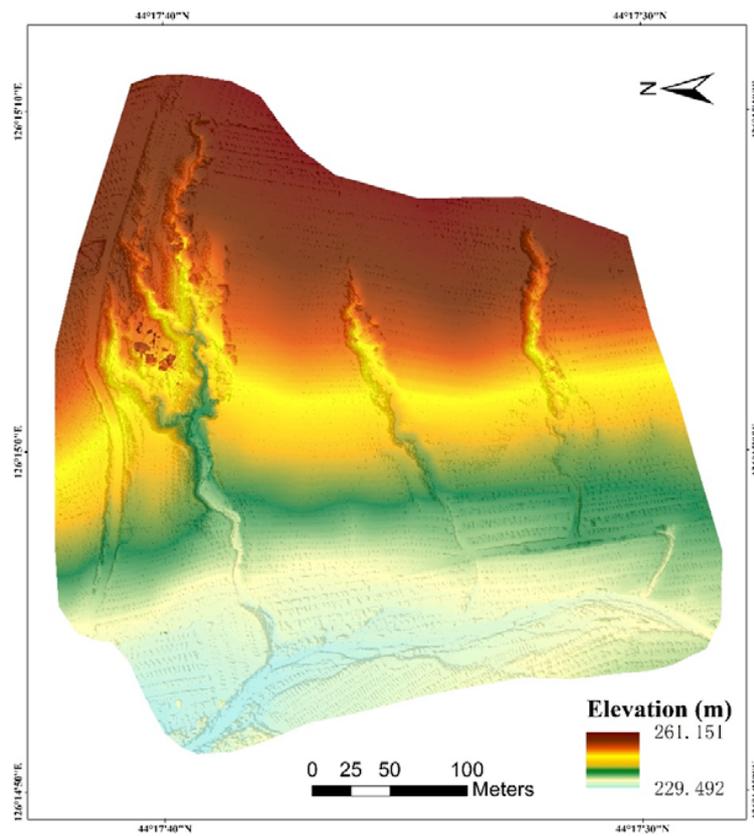
Figure 4. Digital Surface Model (DSM) of the small study site. It was applied by hill-shading.

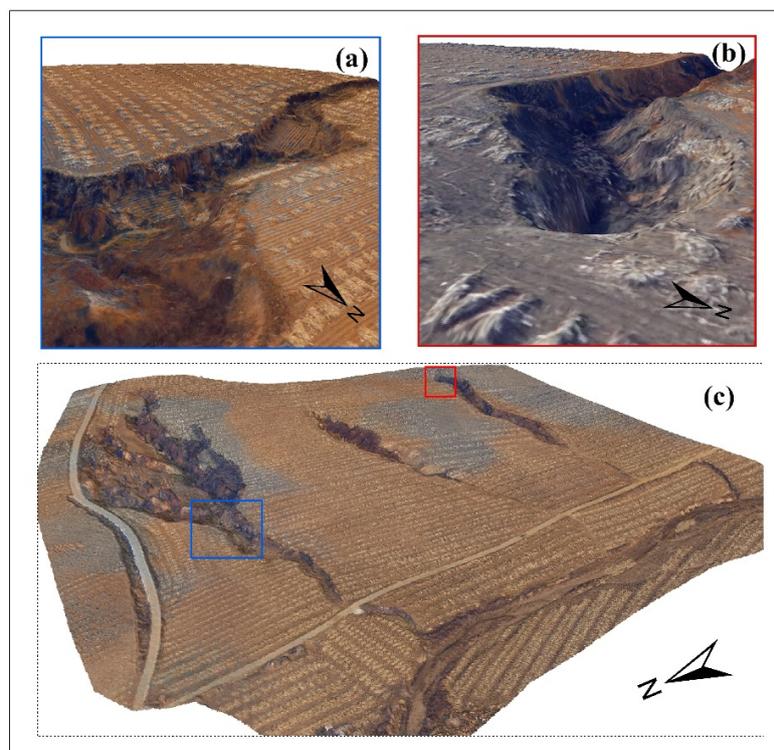
Figure 5. (a–c). 3D model of the small study site (c). The blue (a); and red (b) enlarged insets show the 3D structure of the gully sidewall and headcut in detail, respectively.

from the single Pleiades imagery, and stereoscopic Pleiades images are not available in this study. In addition, the 3D model provided more details about the 3D structure of the gully sidewall and headcut (Figure 5), but 3D information was lacking in the Pleiades image. The high resolution and precision of the data products derived from UAV enable detailed 2D and 3D analysis, which is not possible at the satellite scale level.

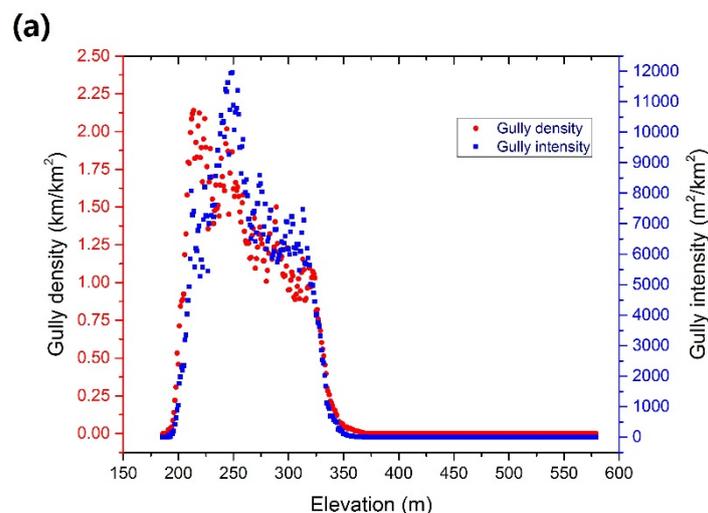
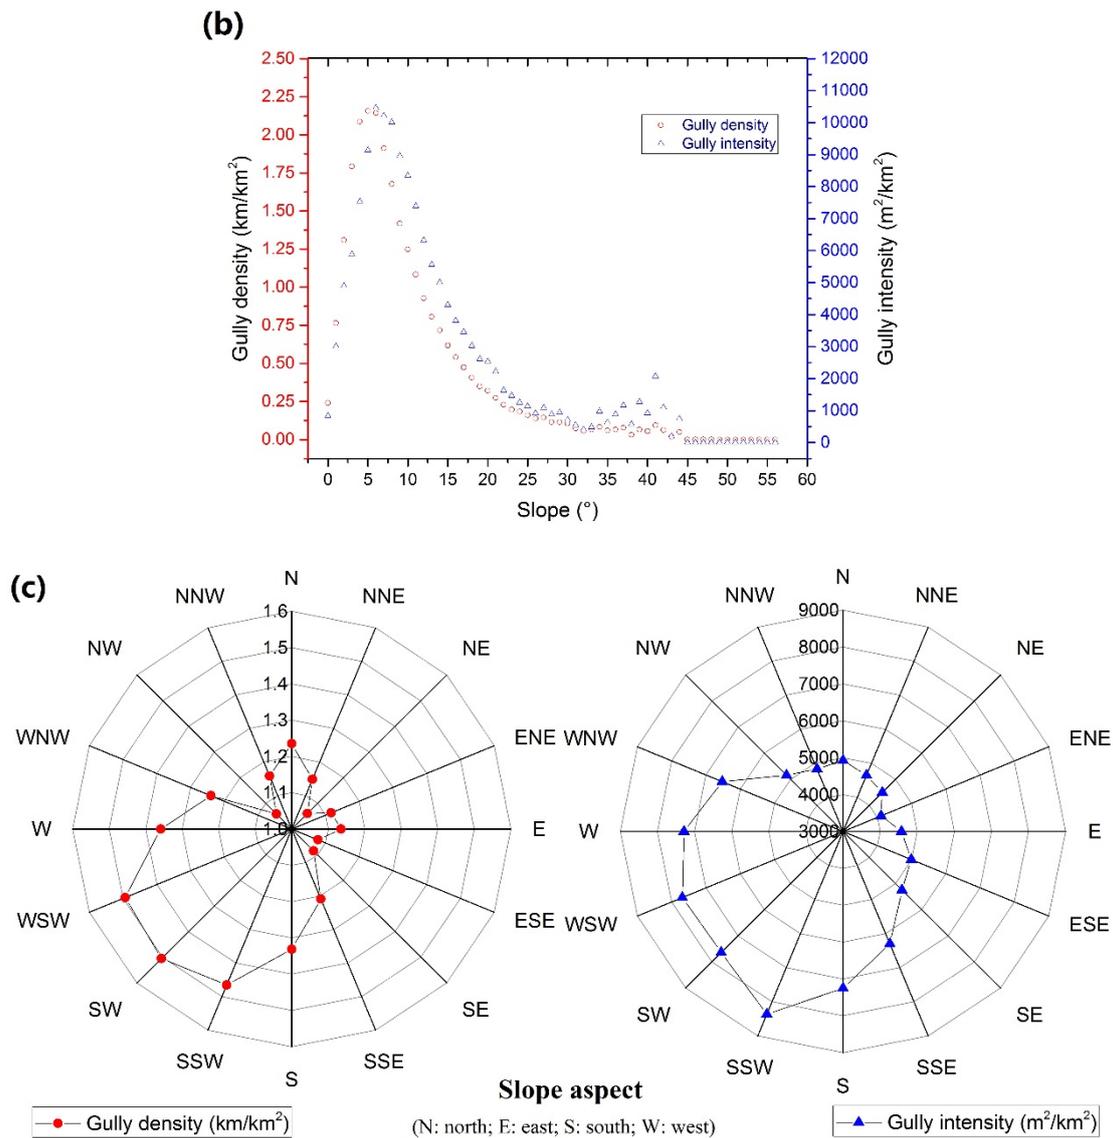
Figure 6. Topographic differentiation of gully erosion: (a) elevation; (b) slope; and (c) slope aspect.

The higher spatial resolution of satellite images made it possible to identify gullies with complex surroundings as well as with a wide range of factors that control the development and distribution of gully erosion [49,50]. The topographic differentiation characteristics of gully erosion at a large scale were obvious (see Figure 6). Figure 6a illustrates a layered distribution of gully erosion in the vertical direction. This result indicates that the slope land between geomorphic types of lower elevations (e.g., valley plain) and higher elevations (e.g., hill) is more conducive to the formation and development of gully erosion due to a longer slope and larger catchment area [5]. Figure 6b shows that gully density and intensity all increase first and then decrease as the slope increases. Although the steeper slope will increase the shear force of the soil particles [51], the slope is not the main factor restricting the form of erosion gully, which was more affected by slope length, catchment area, slope shape and other terrain factors [52] when the slope was greater than six degrees. The relation between slope aspect and gully erosion was analyzed (Figure 6c). The results indicate that the gully erosion on windward slopes (S, SSW, SW, WSW, and W) was greater than on leeward slopes because the prevailing southwest winds result in stronger rainfall erosivity on windward slopes than on leeward slopes. Furthermore, the difference between gully density and intensity on various terrain factors should be given further consideration.

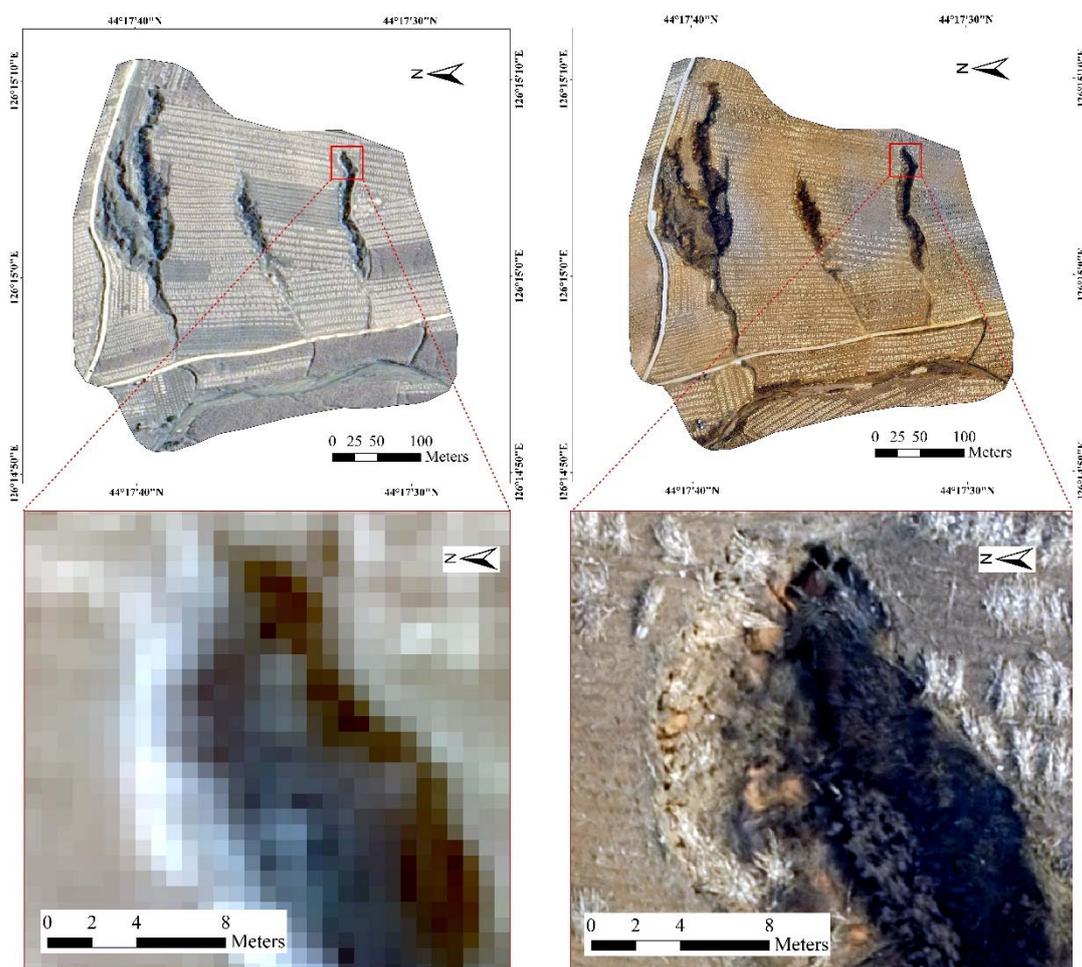
Figure 7. Comparison of the satellite image (12 October 2013; left) and UAV image (31 October 2015; right).

Even though the very high resolution Pleiades-1A satellite imagery has significantly improved the identification of gully erosion, it does not allow for a more detailed analysis of an individual gully compared with UAV imagery. For instance, the use of corn straw mulch buffer within the gully headcut is a simple and common gully prevention measure in sloping farmland in the black soil region of Northeast China [58]. Pleiades-1A with 0.7 m does not provide more detailed information about the corn straws within the gully headcut. However, the corn straw mulch is visible in the ortho-image derived from UAV (0.042 m) (Figure 7). According to the enlarged view of the UAV image (the lower right of Figure 7), we can see the vegetation in the bottom clearly, and even distinguish the active gully headcut, which was eroding the farmland.
