# Investigation of a CubeSat in Orbit Anomaly through Verification on Ground

**Abstract:** Given the role of Cubesats in the new space economy, a statistically relevant number of CubeSats have flown, and considering the high percentage of failed missions, the investigation of in-orbit anomalies becomes of paramount importance. It is rare to find data about mission failures, probably because the partial or total absence of telemetry does not encourage any analysis. The lack of data from the spacecraft in orbit can be mitigated through ad-hoc verification campaigns on satellite models when in-orbit anomalies are experienced. This paper shows an effective testing activity conducted on models of the spacecraft to understand the root cause of a severe anomaly that occurred during mission operations. The tests are part of a comprehensive methodology for root causes analysis. The paper aims at sharing the experience built upon a practical case of interest. More importantly, this work has the ambition of fostering the research on key topics of reliability, mission operations and assembly, and integration and verification/test processes, which have shown to be critical. The activity presen

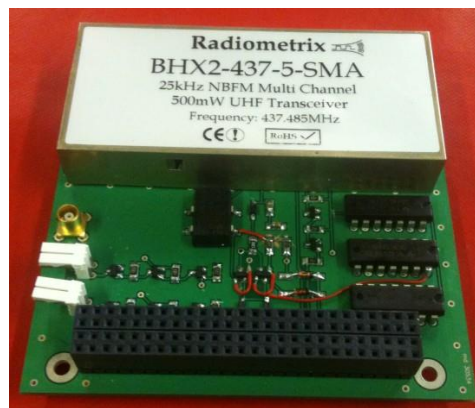
Figure 5. COMSYS board.

A single electronic board (Figure 5) hosts the following items: the UHF radio-transceiver from Radiometrix Ltd. (model BHX2); the Microchip PIC16F88 microprocessor that acts as a complete Terminal Node Controller (TNC), implementing all the modem functions and protocol adaptation to interface the radio and the OBC; a watch-dog electronics for fault detections; and a crystal oscillator and electrical devices to amplify and filter the signal, and to support the microcontroller operations.
