Article

Channel Morphology Change after Restoration: Drone Laser Scanning versus Traditional Surveying Techniques

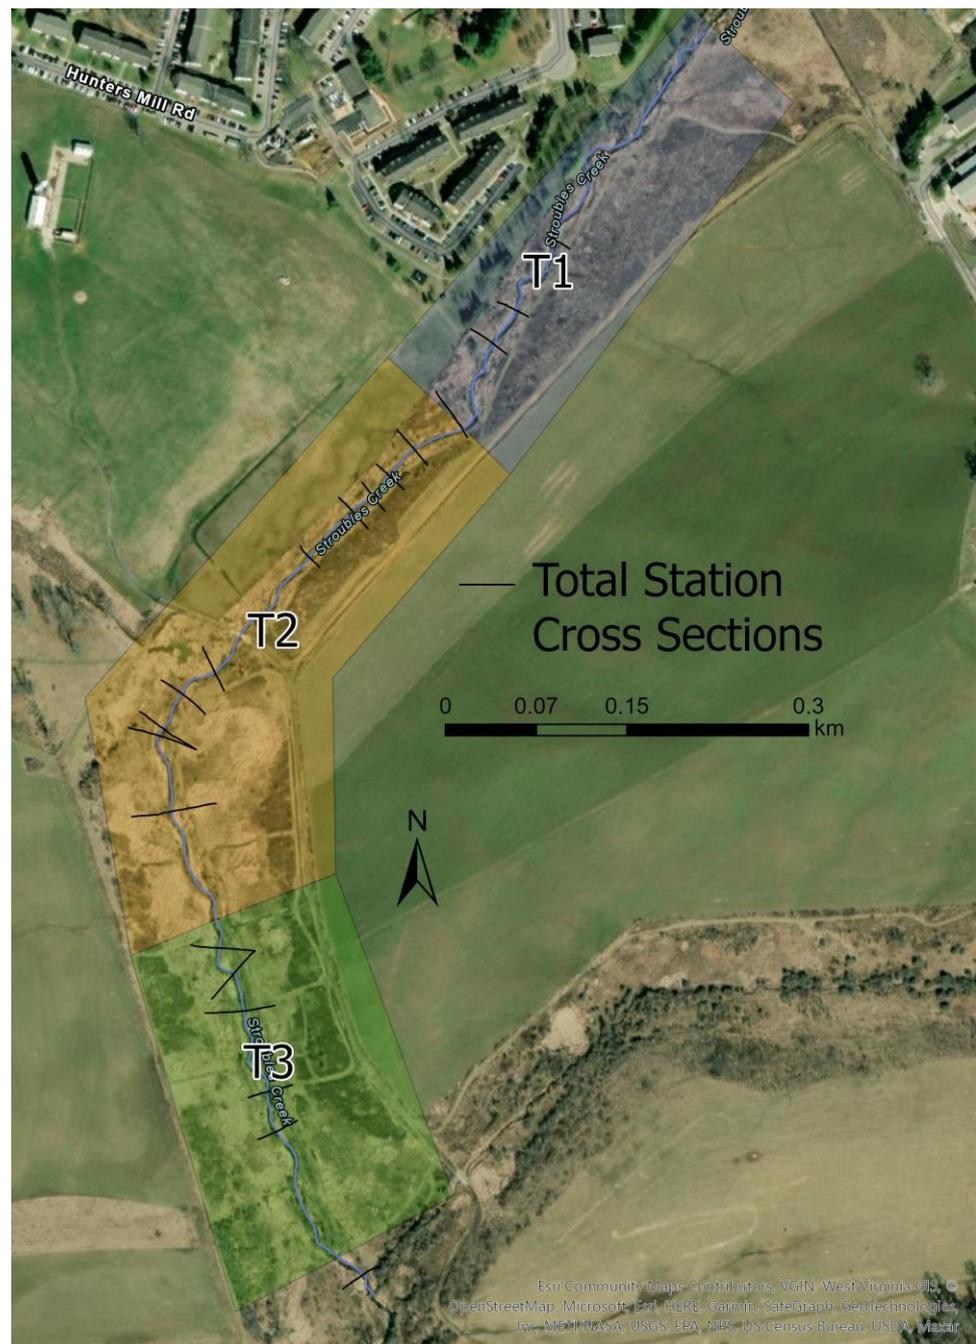
Figure 1. The three stream restoration treatments applied to Stroubles Creek: T1 (livestock exclusion), T2 (livestock exclusion and bank treatment), and T3 (livestock exclusion, bank treatment, and inset floodplain). Twenty cross sections over the study reach were surveyed in 2010 and 2021 via total station. The background image is ArcGIS Pro World Imagery, dated February 2020.

The study area is a 1.3 km reach of Stroubles Creek, which is the research site for the StREAM Lab at Virginia Tech [44]. This reach underwent a stream restoration that was completed in May 2010 [42]. The restoration project divided the reach into three different restoration treatment areas (Figure 1) [42,45]. For the first treatment (T1; 0.5 km), the only action performed was livestock (i.e., cattle) exclusion from the riparian area (Figure 2a). In the second treatment (T2; 0.6 km), in addition to livestock exclusion, the banks were reshaped to a stable grade (3:1) and native woody vegetation was planted (Figure 2b). In the third treatment (T3; 0.3 km), in addition to livestock exclusion and planting vegetation, an inset floodplain was sized to ensure entrainment of sand-sized bed material annually and the D50 of the riffles on average every five years (Figure 2c). While the active restoration activities formally ended in 2010, long-term goals included continually monitoring post-restoration changes in channel morphology through topographic surveys (Figure 1) [42].

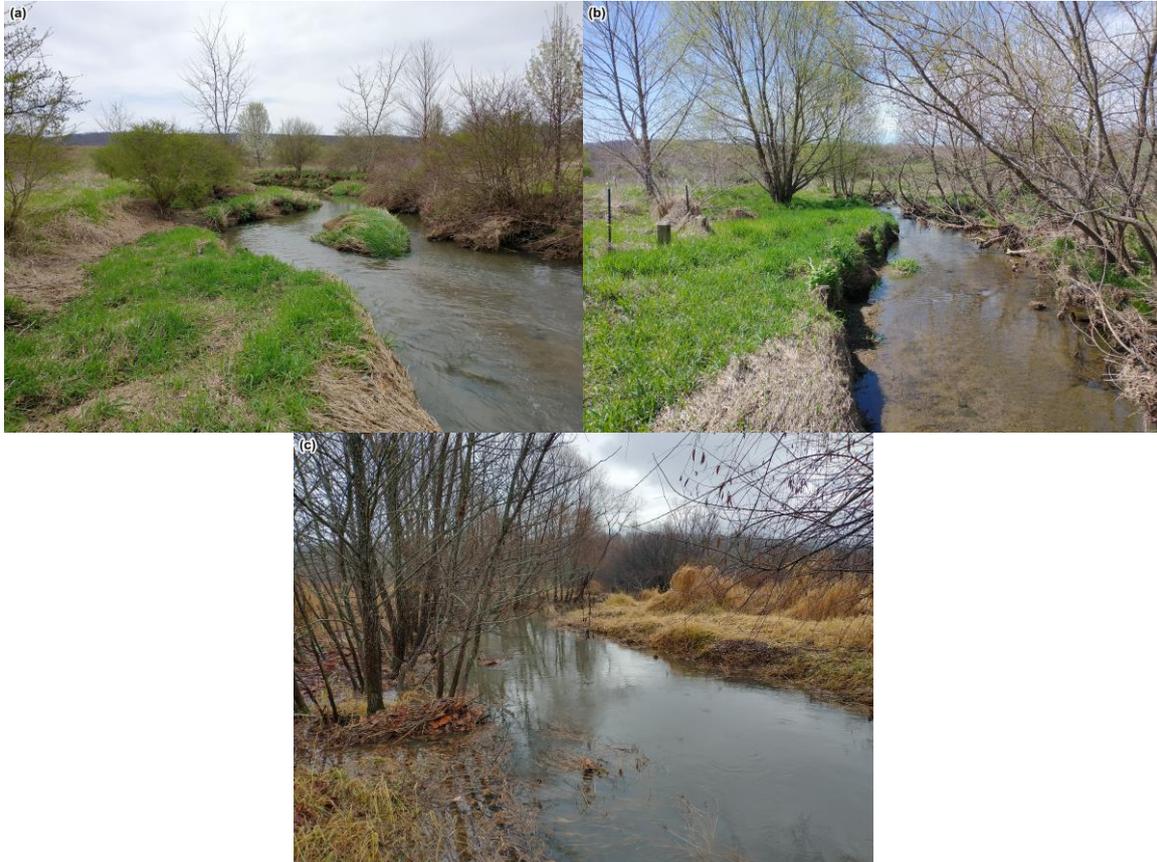
Figure 2. Photos of Stroubles Creek at each of the three stream restoration treatment reaches: (a) T1 (livestock exclusion; taken April 2022), (b) T2 (livestock exclusion and bank treatment; taken April 2022), and (c) T3 (livestock exclusion, bank treatment, and inset floodplain; taken December 2022).

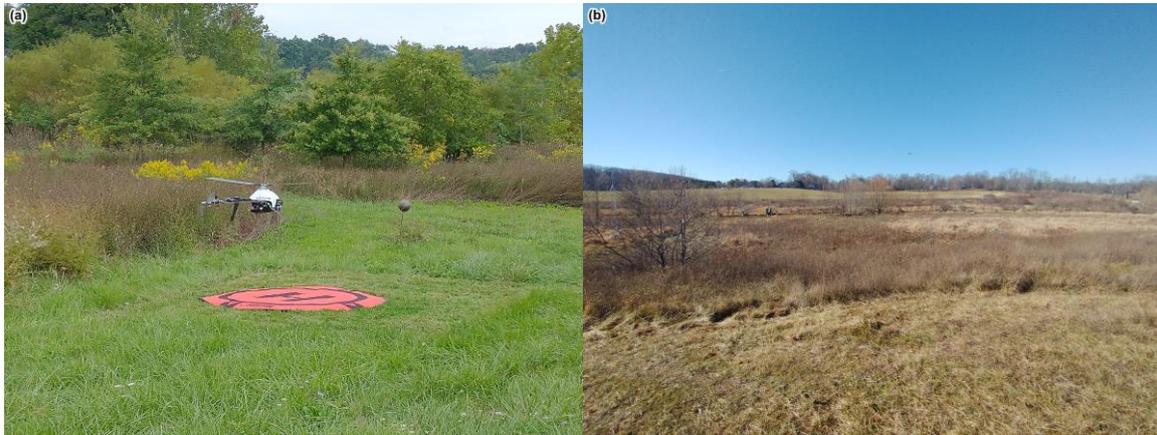
Figure 3. (a) The drone taking off for a test flight in September 2021 and (b) the drone flying over Stroubles Creek for a survey in December 2021.

surveys [47] (Figure 3). At this altitude, previous studies with this DLS system reported point densities over 400 points/m² [36,47].

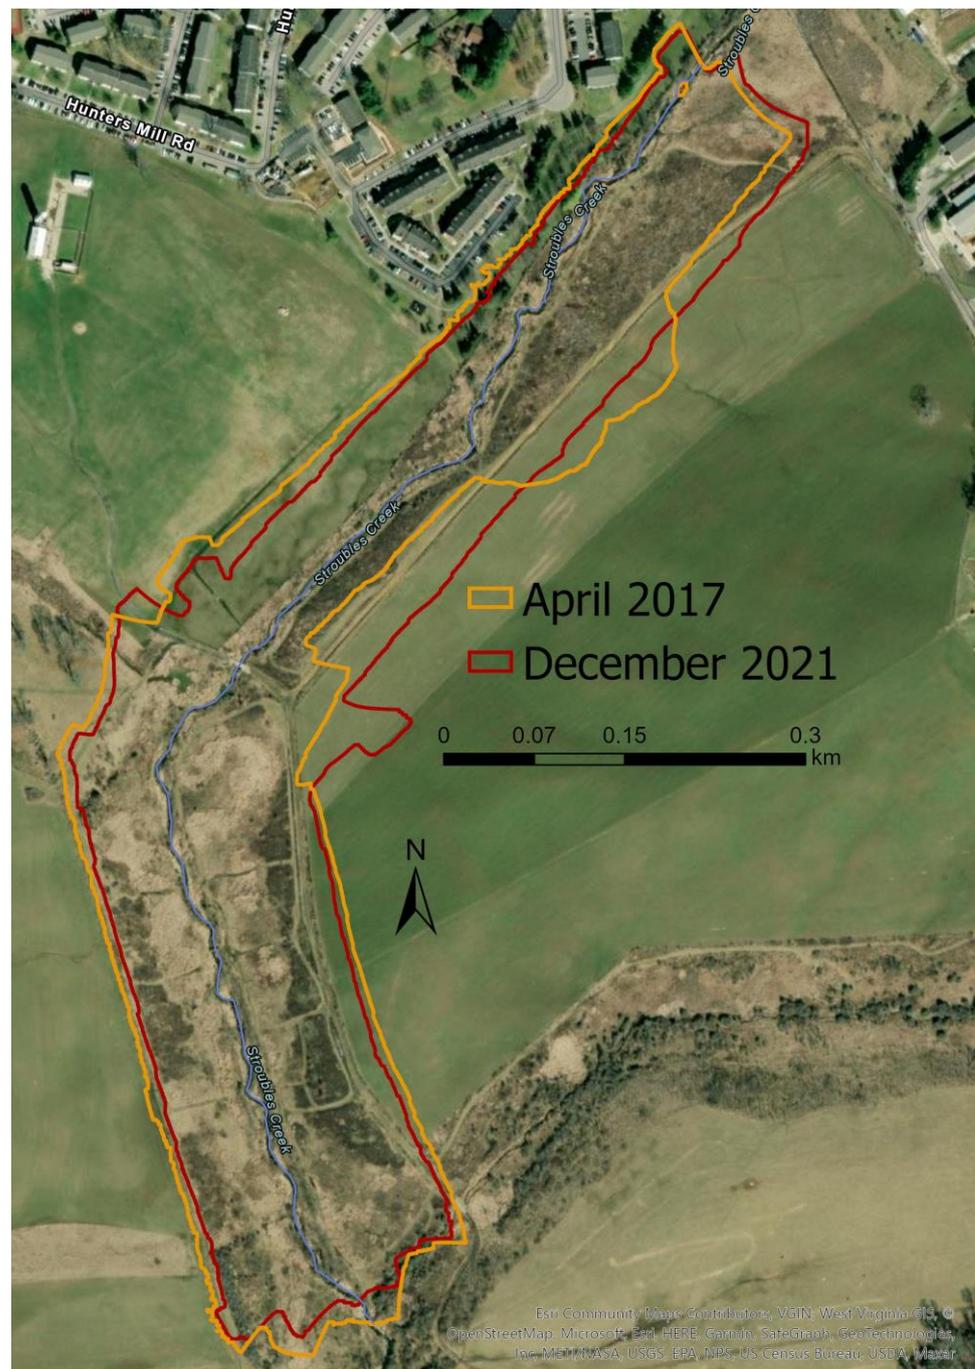
Figure 4. The scan extents of the two drone lidar surveys flown over the study area. The background image is ArcGIS Pro World Imagery, dated February 2020.

The DLS flights were merged into a single point cloud for each survey (2017 and 2021) and processed as LAS datasets using ArcGIS Desktop 10.6 and ArcGIS Pro 3.1 (Redlands, CA, USA). The datasets were projected to NAD 83 UTM Zone 17N and vertical datum NAVD 88. Both DLS surveys consisted of similar scan extents over the study area (Figure 4) and the point clouds had similar densities (Table 2).

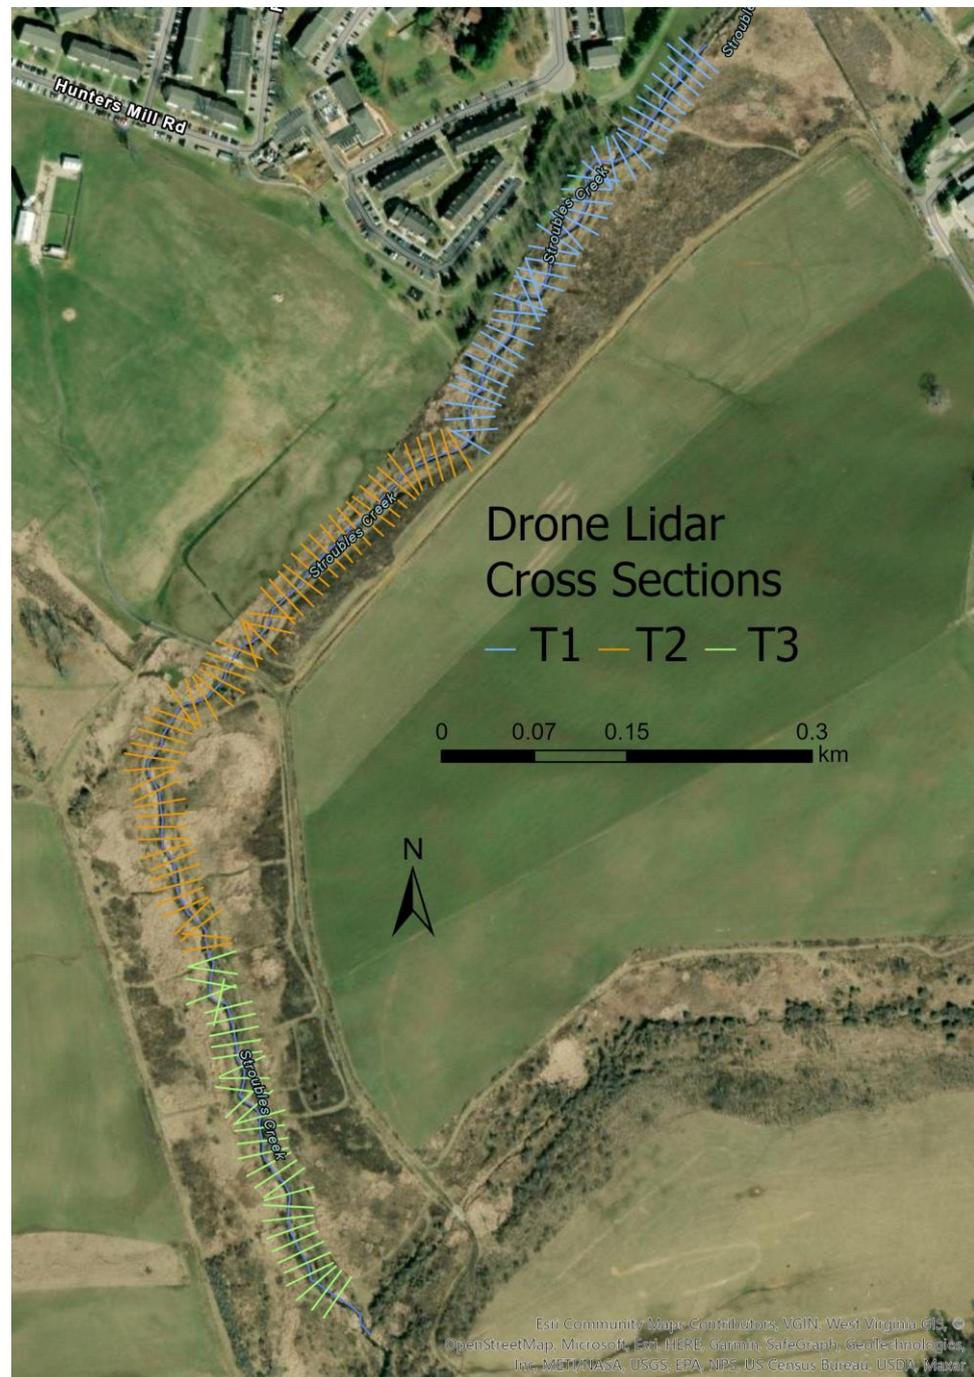
Figure 5. Cross sections generated every 10 m from the drone laser scanning (DLS) data for each treatment reach: T1 (livestock exclusion), T2 (livestock exclusion and bank treatment), and T3 (livestock exclusion, bank treatment, and inset floodplain). The background image is ArcGIS Pro World Imagery, dated February 2020.

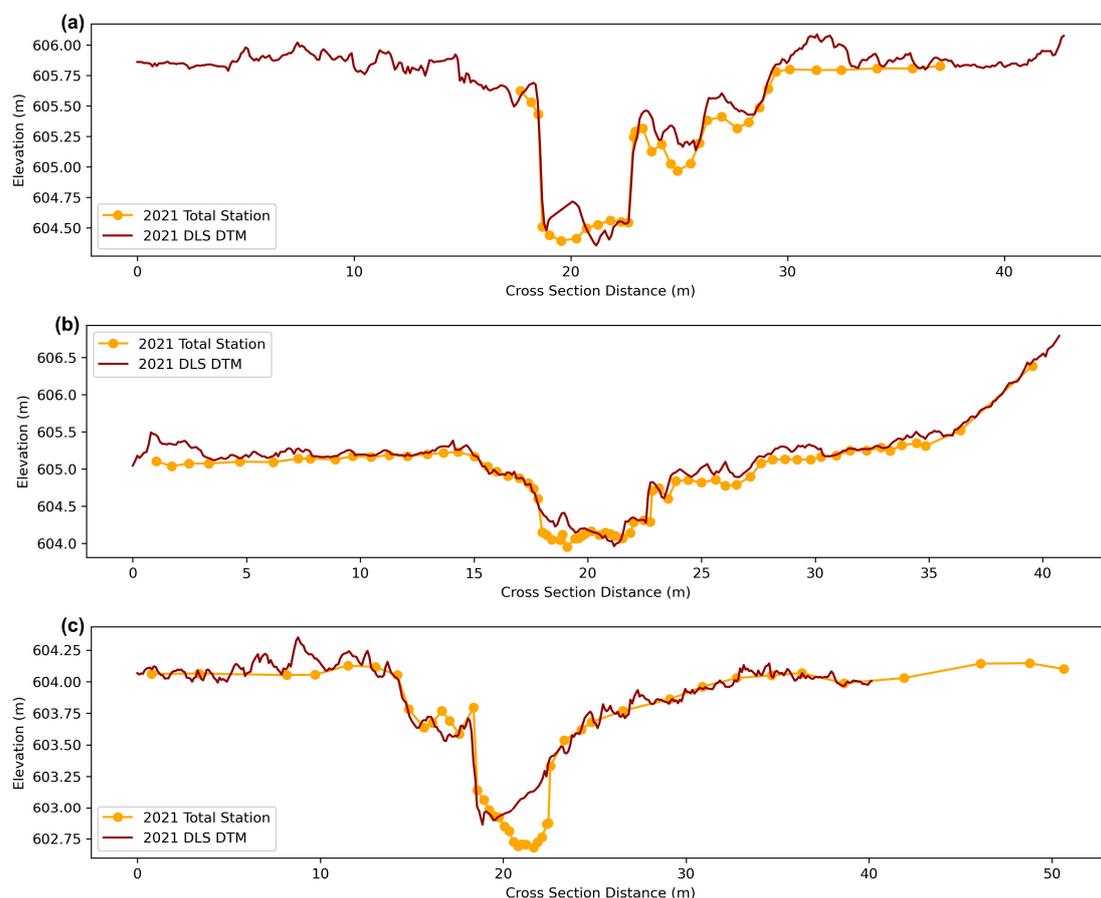
Figure 6. Example cross sections (in treatment reaches (a) T1, (b) T2, and (c) T3) comparing the total station points to the 0.1-m digital terrain model (DTM) produced with drone laser scanning (DLS).

The mean bias of the bank points (0.095 m) was slightly larger than the bed points (0.082 m) (Table 4). This indicates that the previously noted expectation, that the lidar bias would be greater under the water surface due to NIR absorption, was not as significant as anticipated and likely due to conducting the DLS surveys during baseflow when this reach of Stroubles Creek has an observed depth between 0.13 and 0.34 m [58]. For most cross sections, the bias under the water surface was within the overall bias observed between the

total station and DLS measurements (Figure 6). This bias was largest for pool cross sections and cross sections with overhanging vegetation. Both were the case for the example cross section in T3 shown in Figure 6c.

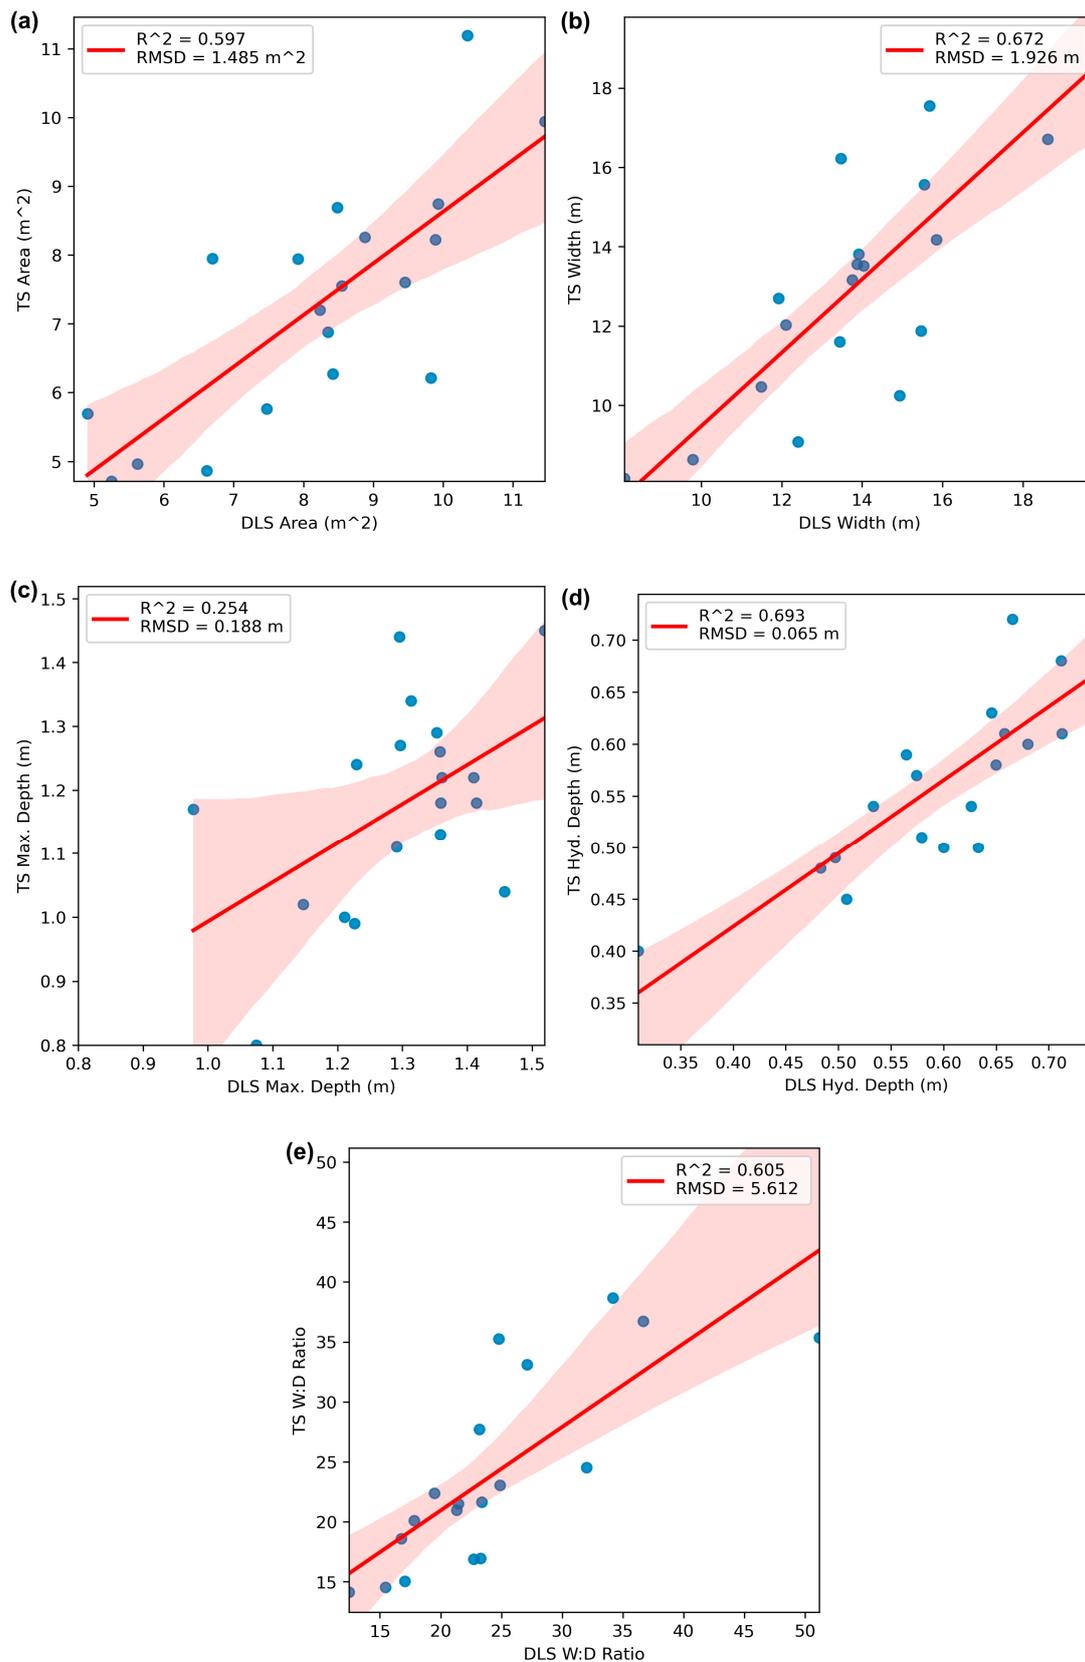
Figure 7. Correlation between the 2021 total station (TS) data ($n = 19$ cross sections; blue dots) and drone laser scanning (DLS) data represented by the linear regression best-fit line and 95% confidence interval (red area) for each of the channel morphology metrics ((a) cross-sectional area, (b) channel width, (c) maximum depth, (d) hydraulic depth, (e) width-to-depth ratio).

The cross-sectional metrics derived from the 2021 DLS data showed good agreement with those calculated from the total station data over the 19 cross sections (Figure 7). In particular, the metrics with the best agreement were hydraulic depth ($R^2 = 0.693$), channel width ($R^2 = 0.672$), width-to-depth ratio ($R^2 = 0.605$), and cross-sectional area ($R^2 = 0.597$), which produced good correlations between the DLS and total station data. This indicates DLS accurately replicated the channel morphology measured with a total station. The metric with the worst agreement was maximum depth ($R^2 = 0.254$), which makes sense considering the limitation of DLS in scanning under water surfaces. The RMSD for maximum depth was 0.188 m, which was similar to the RMSD_z for streambed points (0.168 m) (Table 4) and within the range of the observed baseflow depth previously noted.

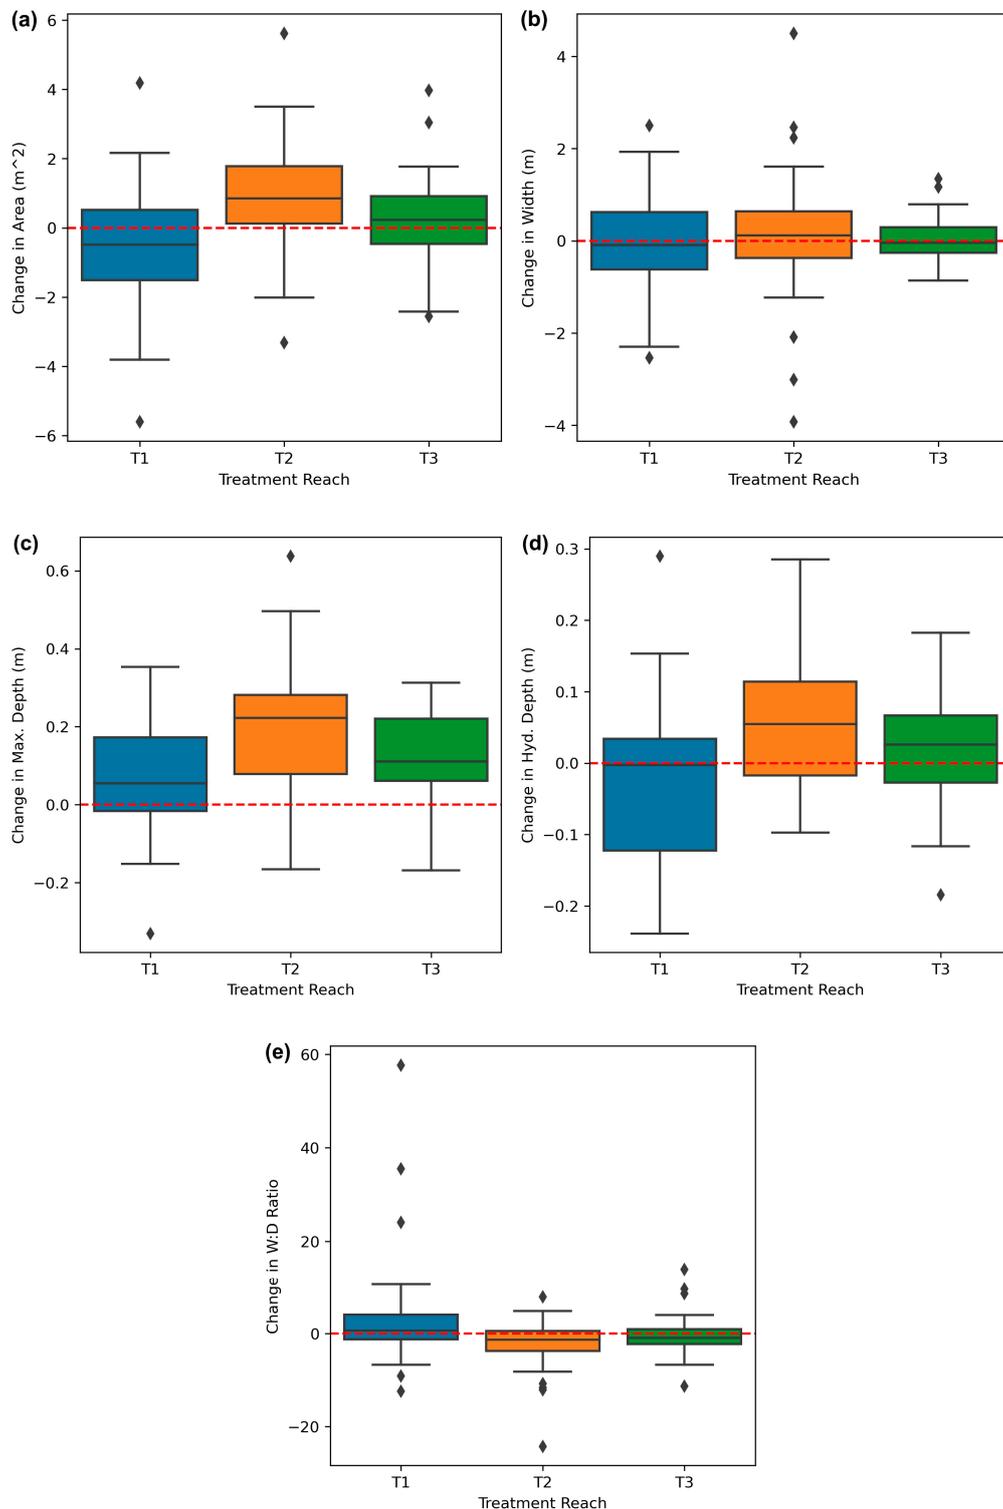
Figure 8. Change in cross-sectional metrics ((a) cross-sectional area, (b) channel width, (c) maximum depth, (d) hydraulic depth, (e) width-to-depth ratio), summarized by treatment reach, as measured by drone laser scanning (DLS) from 2017 to 2021 ($n = 130$ cross sections). The box represents the interquartile range (IQR), the line in the box represents the median, and the diamonds represent outliers. Change was calculated as 2021–2017.

Stability was also quantified as having a smaller IQR or variability in cross section change. A smaller variability means the cross sections within the treatment reach demonstrated similar changes in morphology from 2017 to 2021. Channel morphology generally increased in stability (i.e., decreased in variability) going from treatment reach T1 to T2 to T3. For example, the IQR for change in cross-sectional area decreased from T1 (2.031 m^2) to T2 (1.655 m^2) to T3 (1.371 m^2), channel width decreased from T1 (1.243 m) to T2 (1.010 m) to T3 (0.549 m), and width-to-depth ratio decreased from T1 (5.255) to T2 (4.246) to T3 (3.164) (Figure 8). Generally, T3 showed the least variability in cross section change for all channel morphology metrics except for maximum depth, which was more similar between the three treatment reaches (Figure 8).

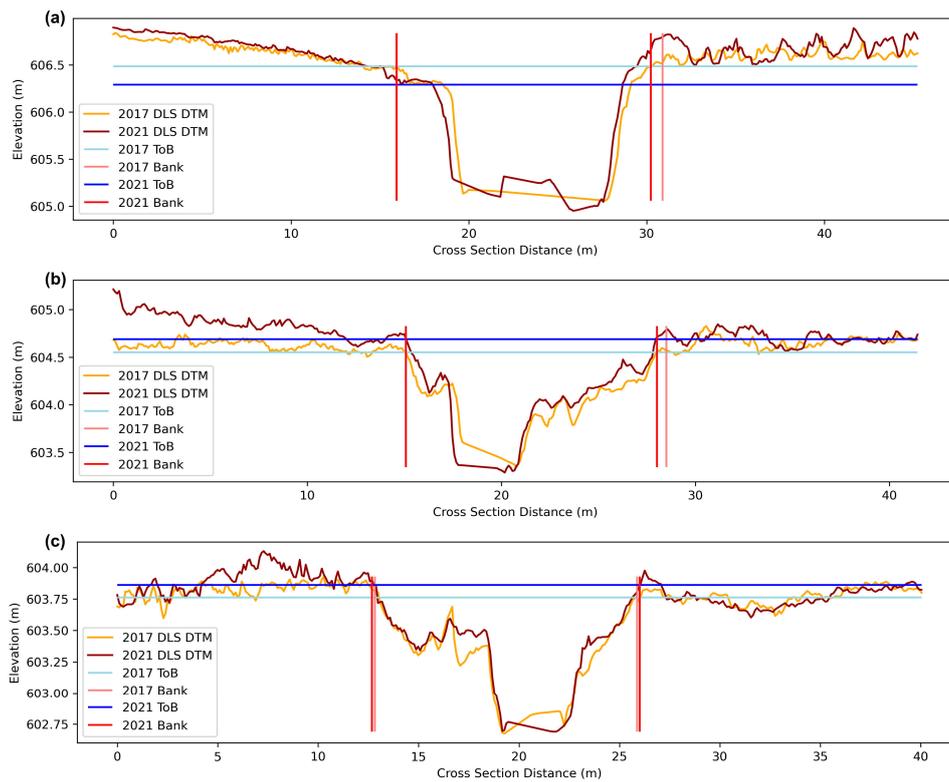
Figure 9. The cross section in each treatment reach ((a) T1, (b) T2, and (c) T3) with the median absolute change in width from 2017 to 2021 based on the drone laser scanning (DLS) data.

As a specific comparison between treatments, the cross section with the median absolute change in channel width was selected for each reach (Figure 9). Absolute change was used to represent the magnitude of change and prevent positive and negative values from canceling out. The median absolute change in channel width was 0.633 m , 0.474 m , and 0.292 m for T1, T2, and T3, respectively. Generally, the absolute change in channel width decreased going from T1 to T2 to T3. These cross sections demonstrate that all three reaches showed considerable consistency between 2017 and 2021; however, reach T3 was more stable over this time period compared to the other two reaches.

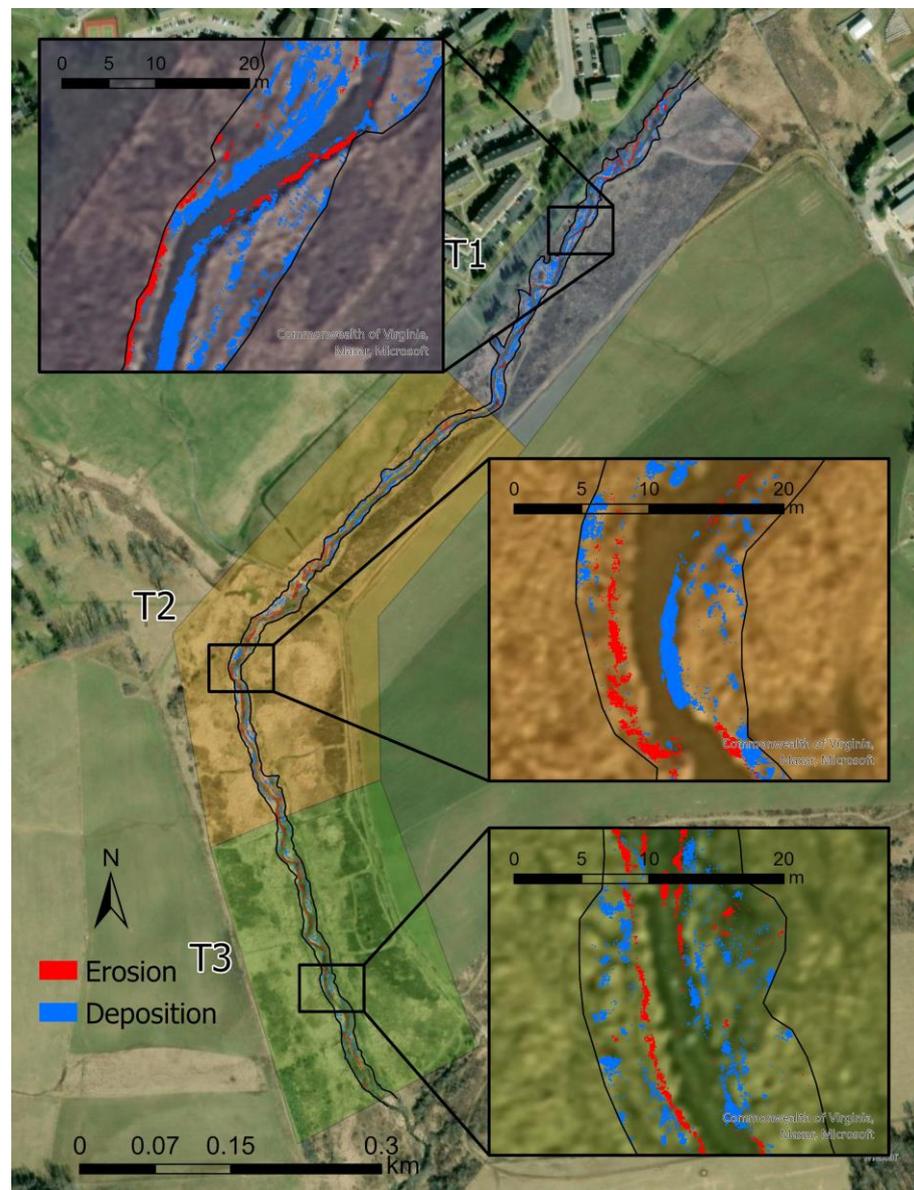
Figure 10. DEM of Difference (DoD) showing areas of erosion and deposition between 2017 and 2021 from drone laser scanning (DLS) 0.1 m digital terrain models (DTMs) over treatment reaches: T1 (livestock exclusion), T2 (livestock exclusion and bank treatment), and T3 (livestock exclusion, bank treatment, and inset floodplain). Elevation difference was calculated as 2021–2017. The background image is ArcGIS Pro World Imagery, dated February 2020.

In addition to comparing the DLS-derived cross sections, a 0.1 m DoD was calculated between the 2017 and 2021 DTMs, representing the areas of erosion and deposition over the study reach at high resolution (Figure 10). The stream showed classic patterns of erosion and deposition, particularly along bends and curves in the reach, as the channel migrated over time. Areas of erosion were more likely to occur along the outside of meander bends of the stream channel and areas of deposition were more likely along the point bars and on the inset floodplains. Particularly in treatment reach T1, the erosion areas demonstrated toe erosion and slumping of the upper bank, resulting in slump blocks in the channel. These results show evidence of bank retreat (through erosion) and bank advance (through
