Article

# Experimental Analysis of the Strengthening of Reinforced Concrete Beams in Shear Using Steel Plates

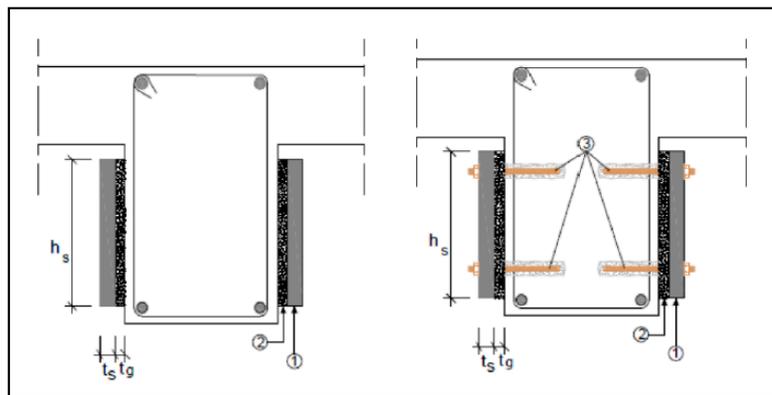
Figure 1 presents the technique related to reinforcement with steel plates due to deficiencies in the shear force and indicates the two possibilities: The first with the steel plates and the epoxy resin and the second with the steel plates, epoxy resin, and the bushings expansive (Sousa [14] apud Higashi [5]).

**Figure 1.** Strengthening with steel plates due to shear force with and without bushes, respectively. 1 = steel plate; 2 = resin; 3 = bushing;  $t_s$  = plate thickness;  $t_g$  = epoxy resin thickness;  $h_s$  = plate height; Sousa [14] apud Higashi [5].

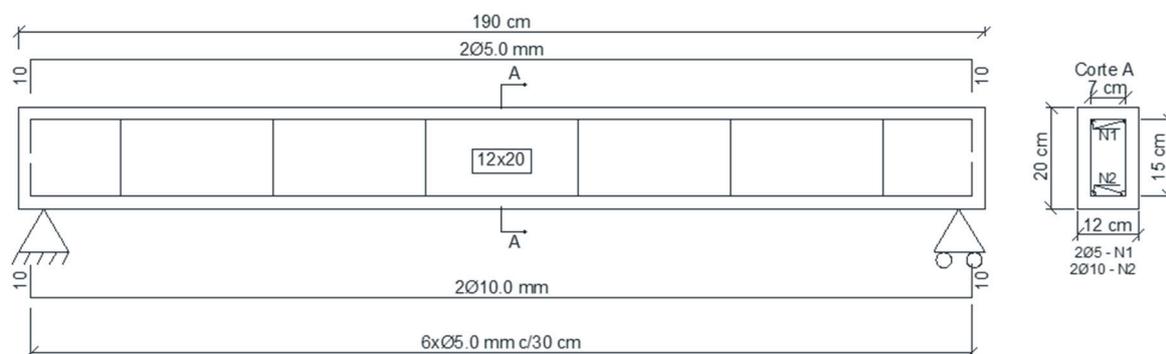
The beams were made with cross-sections of  $12 \times 20$  cm and a length of 190 cm containing 6 stirrups of 5 mm in diameter and a spacing of 30 cm. These beams did not meet the criteria in specification NBR 6118 [16] because the intention was to generate shear rupture. For the reinforcements, we used CA-50 steel and followed the criteria of NBR 6118 [16]. Thus, two steel bars of 10 mm diameter were used for flexural reinforcement totaling an area of  $1.6 \text{ cm}^2$  of steel. Figure 2 shows the details of the reinforcements in the beams. Figure 3 shows the five beams C25 (the class which represents the characteristic compressive strength of 25 MPa at 28 days) concreted. The concrete was made at Concretar Concreto Usinado, Araranguá-SC, Brazil and the concrete was densified with the aid of immersion vibrators.

**Figure 2.** Details of the reinforcements in beams.

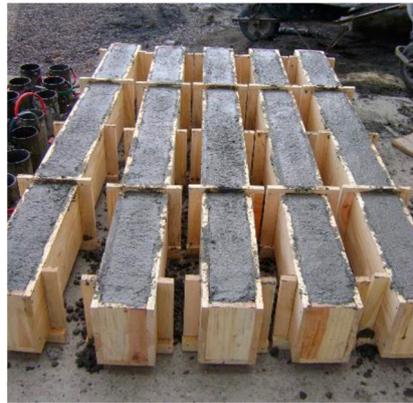
Figure 3. Beams after concreting.

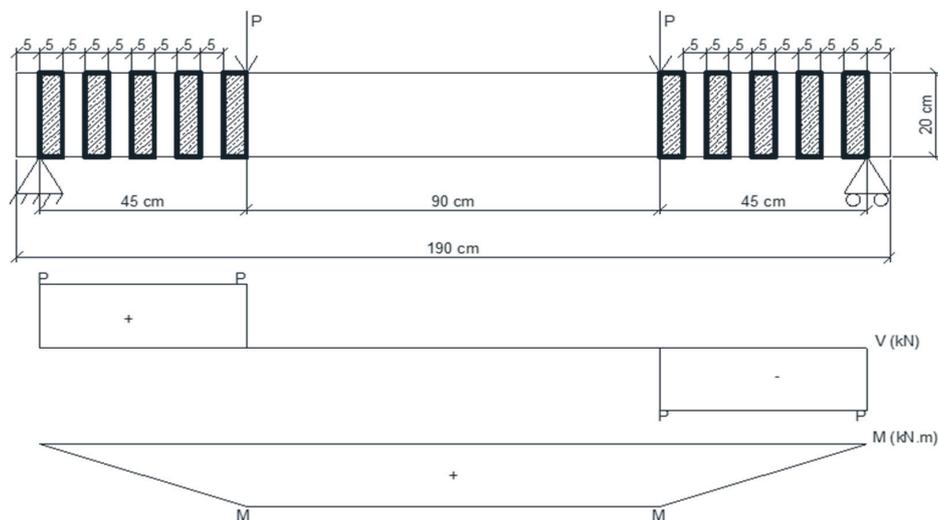
We used twenty  $750 \mu\text{m}$  thick SAE 1020 steel plates, with dimensions of  $5 \times 20$  cm (width  $\times$  length) and a spacing of 5 cm between them. The plates were applied in the shear area on both faces of the beam. Figure 4 shows the application of the steel plates following the diagrams of the shear and bending moment of the beam.

Figure 4. Scheme of the application of steel plates versus the shear diagram and versus the bending moment diagram.

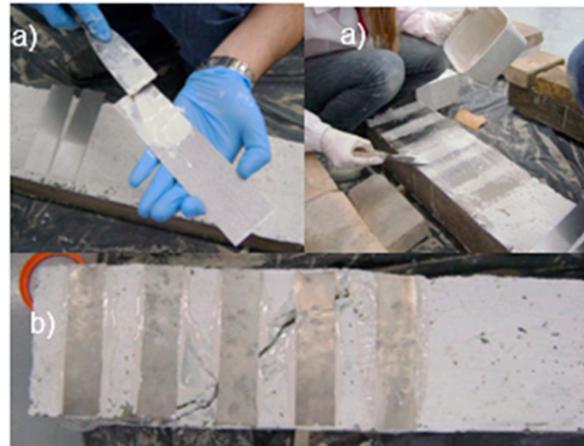
bonding, grooves were made in the steel plates and in the concrete beams with the aid of an N50 sandpaper. The epoxy-based structural adhesive was applied with a maximum thickness of 2.0 mm and with the aid of spatulas. Figure 5 shows the application of the structural adhesive on the steel plates, the bonding process, and the concrete beam after the bonding.

**Figure 5.** Beam strengthening. (a) Application of the structural adhesive. (b) Concrete beam after bonding.

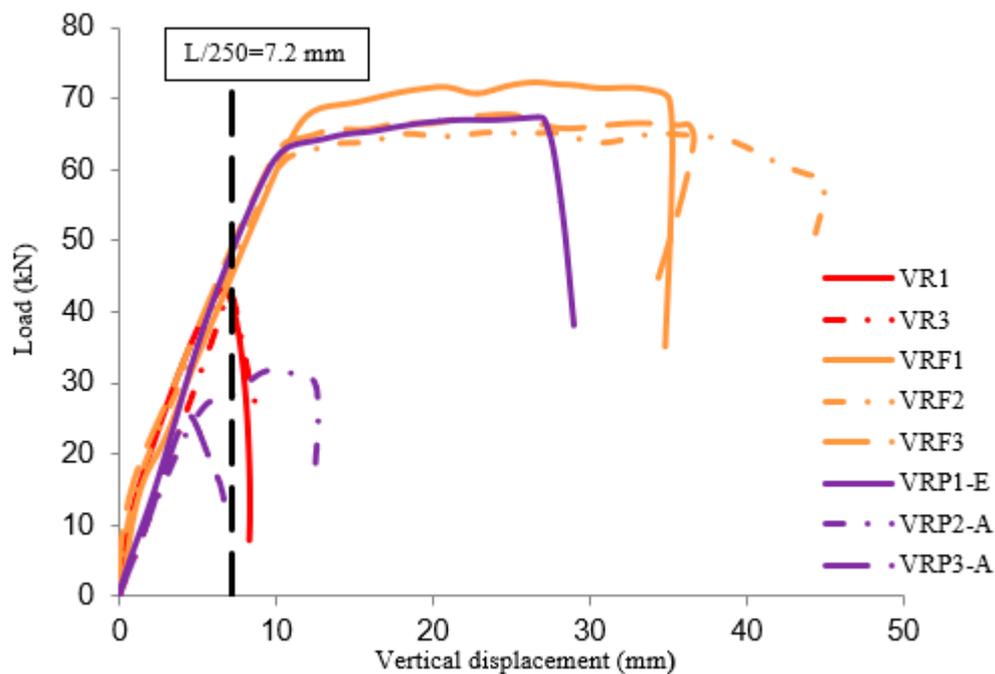
Figure 6 presents the load versus displacement curves during the bending test.

**Figure 6.** Load diagram versus displacement.

By applying the load until the beams reached their breaking point, we have obtained the maximum displacement according to the regulation, which specifies that this value should be obtained from dividing its length by 250 ( $L/250$ ). The reference beams (VR) had their rupture mode by shear at the breaking point with a maximum load average of 45.20 kN. The strengthened healthy beams, with steel plates, had their rupture mode by bending, showing that the strengthening behaved as expected.

Three beams with fissure filling after rupture, one beam with epoxy adhesive (VRP-E), and two with mortar (VRP-A), when subjected to the four-point flexural test again, presented very different shear ruptures. In VRP1-E, a new fissure was opened, and the beam supported a 67.44 kN load. However, VRP2-A and VRP3-A presented rupture in the same fissure that was opened in the first test and supported an average of 28.58 kN.

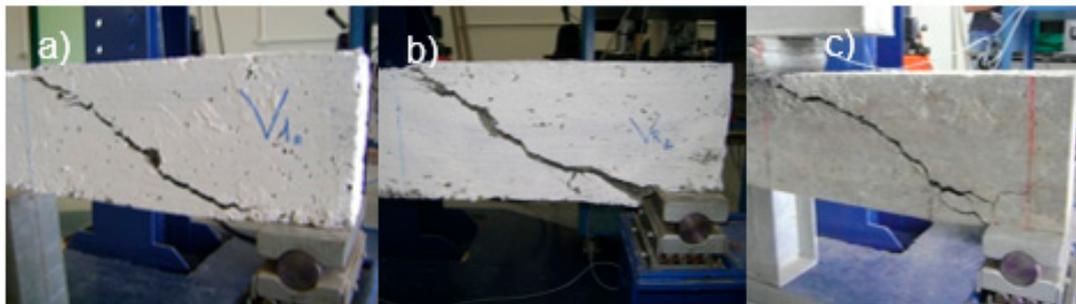
Figure 7 presents the reference beams after the test.

**Figure 7.** Reference beams after the test: (a) VR1; (b) VR2; and (c) VR3.

Each beam group showed different behaviors. The reference beams (VR1, VR2, and VR3) obtained rupture values on the shear area, while the strengthened healthy beams, i.e., those reinforced with steel plates (VRF1, VRF2, and VRF3), obtained rupture values in the bending area, and the beams that were strengthened after the rupture obtained rupture values on the shear area.

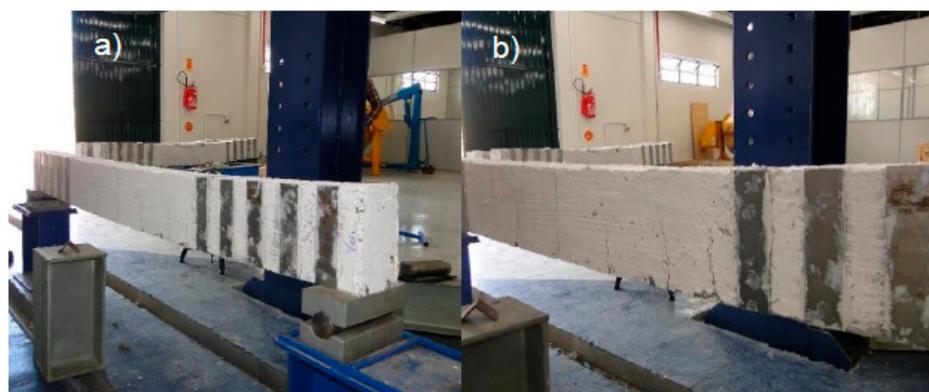
Figures 8–10 present the healthy beams strengthened with steel plates after the test.

**Figure 8.** Beam VRF1 after the test. (a) Beam overview. (b) Fissure details.

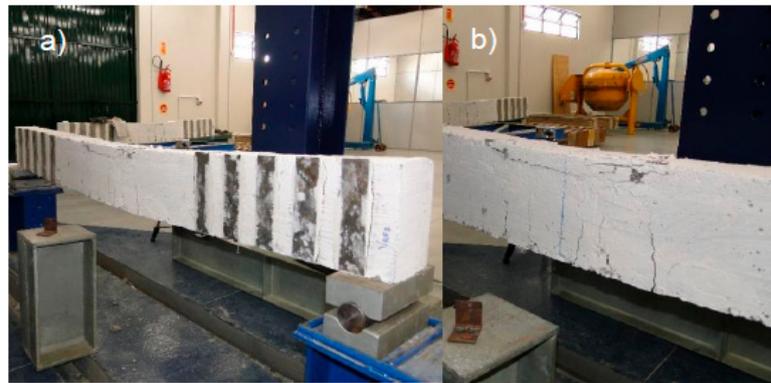
Figure 9. Beam VRF2 after the test. (a) Beam overview. (b) Fissure details.

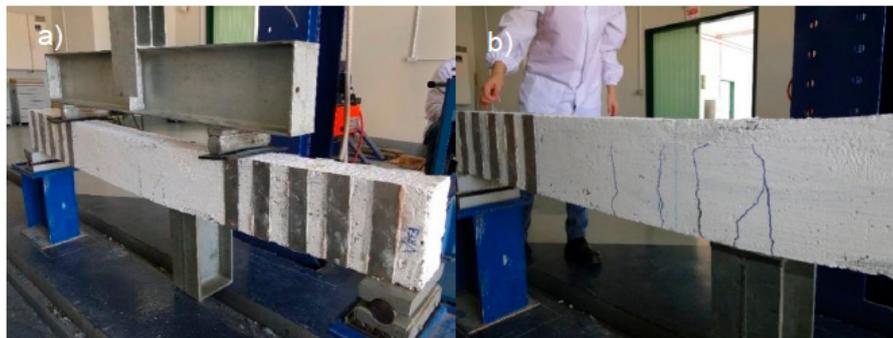
Figure 10. Beam VRF3 after the test. (a) Beam overview. (b) Fissure details.

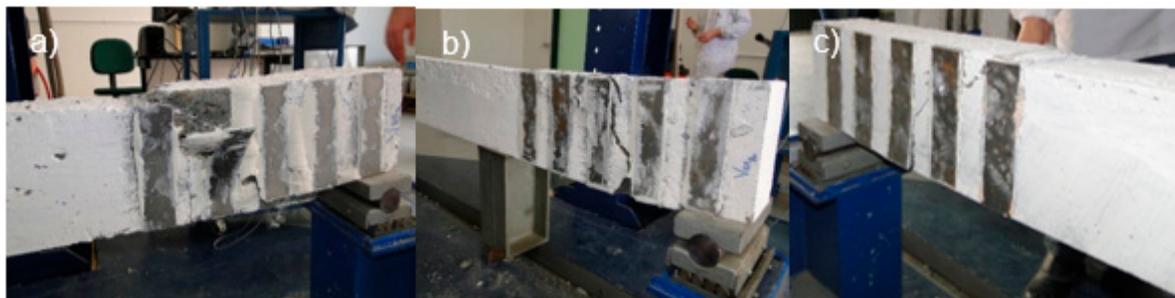
Figure 11 presents the results of the beams, called VRP-E and VRP-A, that had the fissures filled and were reinforced with steel plates after rupture.

Figure 11. Strengthened beams after the test: (a) VRP1-E; (b) VRP2-A; and (c) VRP3-A.
