# Geophysical Evaluation of the Inner Structure of a Historical Earth-Filled Dam <sup>†</sup>

<sup>†</sup> Presented at the 3rd EWaS International Conference on “Insights on the Water-Energy-Food Nexus”, Lefkada Island, Greece, 27–30 June 2018.

**Abstract:** Small earth dams usually lack the detailed seepage monitoring system that would provide high resolution data on changes in seepage flow. Alternative solution is monitoring of the temperature and electrical resistivity in the body of the dams. Geophysical methods are useful techniques for a non-destructive exploration of the subsurface. We have utilized the combination of electrical resistivity tomography (ERT), ground penetrating radar (GPR) and multi-depth electromagnetical conductivity meter (CMD) techniques to observe the inner structure, especially internal failures, of the historical earth-filled dams. Longitudinal and transversal profiles of four typical fishpond dams in the Czech Republic were measured within this research. The dams were constructed as early as in the 15th century, some of them went through minor reconstruction. The aim of the application of geophysical methods for investigation of old fishpond dams wa

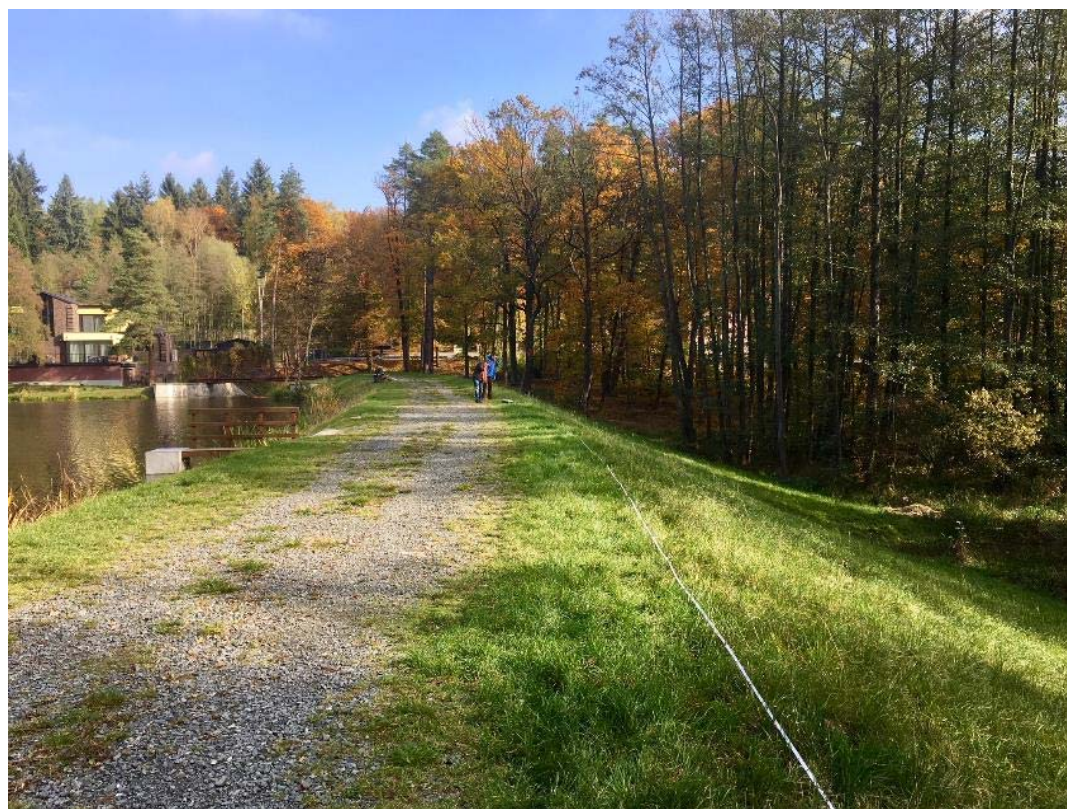
**Figure 1.** Dam of the fishpond Jan after the reconstruction.

topsoil sliding. At the same time the reservoir outlet with diameter of 0.5 m and the spillway were completely renovated. The technical objects were newly made of the reinforced concrete, steel and granite stone. The actual state of the earth-dam is on Figure 1.

- (i) Longitudinal profile was placed on the dam's crest, closer to the downstream side. We had to omit the center of the crest as it was complicated to install the steel electrodes into the gravel road. The length of the profile was 118 m. The passive multi-electrode cable with 96 electrodes was used, the span between the electrodes was 1 m. We surveyed the longitudinal profile in three steps, each 55 m long. Second and third sections overlaid the previous one and was shifted by 23 m. The pathway of the ERT profile is visible on Figure 1.

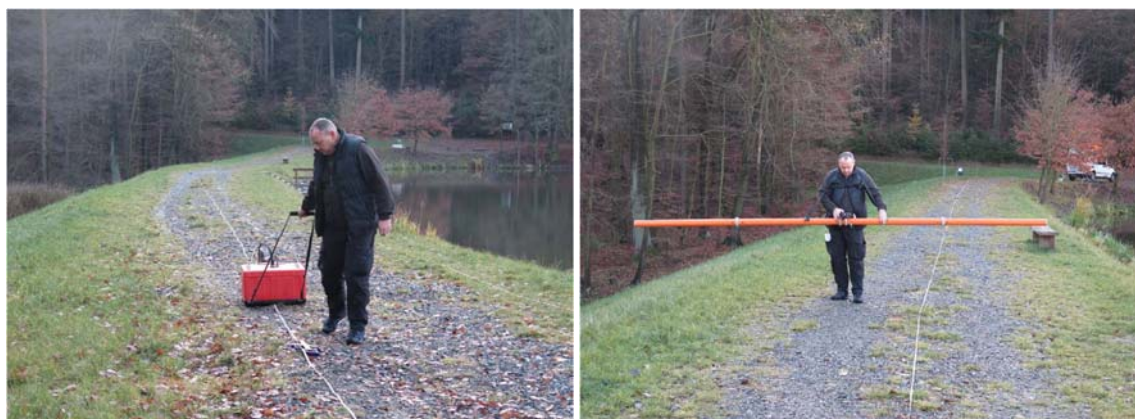
**Figure 2.** Geophysical survey with ground penetrating radar (**left**) and dipole electromagnetic meter (**right**).

The GPR and CMD surveys were done in the identical line as the longitudinal ERT profile (Figure 2). The GPR measurement was performed with use of the SIR-20 radar (GSSI, USA) with 200 MHz antenna system. The dipole electromagnetic profiling (CMD) was done with CMD-Explorer (GF Instruments, Czech Republic). The measurement along the profile were done in 1 cm (GPR) and 1 m (CMD) longitudinal steps. The procedure was repeated with different dipoles distance, which were set to 1.48, 2.28 and 4.49 m, and coil orientation to reach observation depths of 1.1 to 6.7 m.

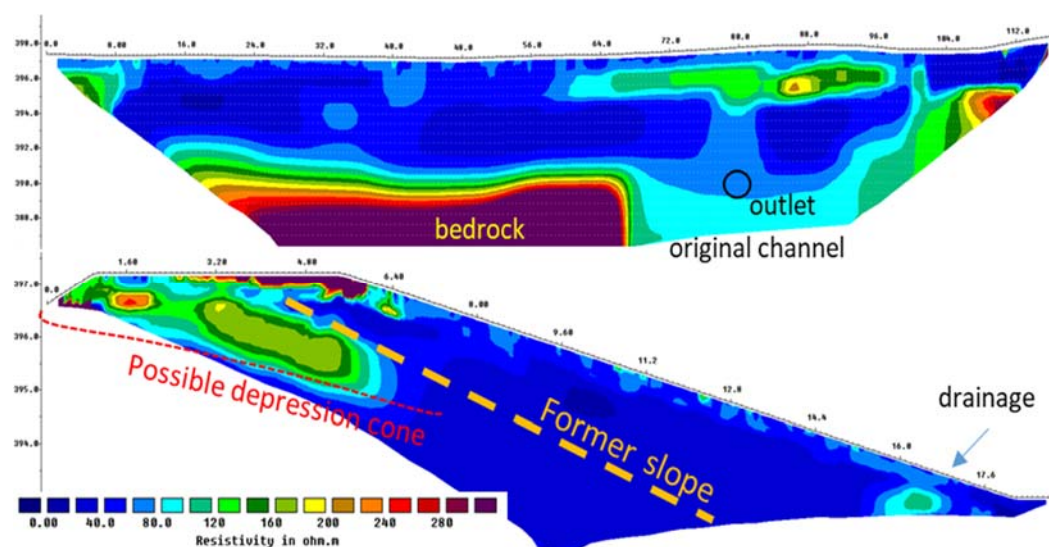
**Figure 3.** Longitudinal (top) and transversal (bottom) ERT transects. Blue color represents nearly saturated regions, green to violet are dry areas or bedrock.

Transversal ERT profile (Figure 3b) shows high electrical resistivity below the dam's crest. The reason is twofold. The soil texture at the dam's top is very different from the remaining material. The surface is covered with less conductive gravel; the gravel can be found also under the surface. Second reason is lower saturation, as the crest is above the water depression cone and is not protected by vegetation. Close to the dam's crest there is a hint of the historical dam boundary (outlined with the dashed orange line). In the depth of roughly 2 m the newly added sediment and old material are nearly saturated, which results in very similar values of the electrical resistivity.

Longitudinal ERT profile, which reaches a depth of 6 m bellow the dam's top, shows a clear divide between the dam's body and the bedrock with high electrical resistivity. The foundation position 4 m below the surface is very regular for the first 70 m. Then is the bedrock replaced by very compacted soil material, possibly in combination with the newly added concrete structures. This area is very probably the location of the original stream channel pathway. The outlet is positioned exactly at this point. The less conductive material above the outlet (green color) is newly added unsaturated soil during to the recent reconstruction of the reservoir outlet.

Cone of water depression could be seen only on the ERT transversal profile, other techniques were not tested. The saturated zone is not clearly visible on the longitudinal transects.

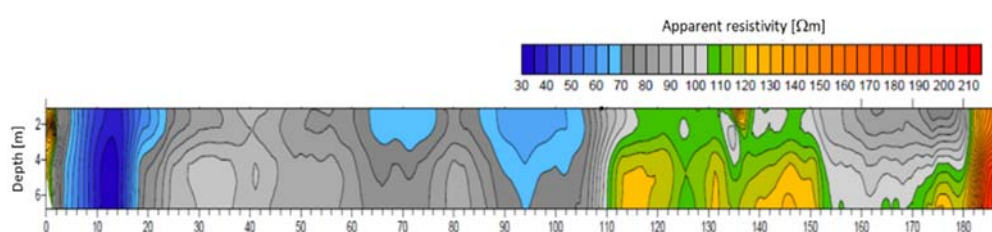
**Figure 4.** Distribution of apparent el. resistivity as surveyed with CMD.

The area of higher resistivity is also visible on the CMD result (Figure 4), even though the CMD could not observe the saturated zone bellow the unsaturated material. It is important to note that the Figure 4 represents apparent electrical resistivity and not the spatial distribution of the inverted values, as is the case of the ERT (Figure 3). The CMD does not provide sufficient resolution in the vertical direction and does not show the bedrock. The shallow profile up to approximately 2 m corresponds well to the ERT results.

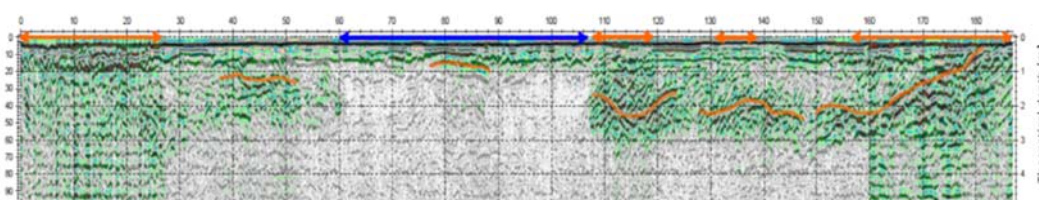
**Figure 5.** Result of the GPR monitoring. The orange arrows above the surface represent areas with heterogeneous material, blue arrow stands for high signal attenuation representing moist material or shallow layer with high clay content.

The GPR filtered data (Figure 5) complement the information from the ERT and CMD techniques. The radar reached theoretical depth of 3 m. Based on the measured reflectivity, the dam body can be divided into several quasi-homogeneous zones with similar characteristics (orange and

blue arrows on Figure 5). The orange lines inside the dam represent areas with a sharp change of the material or water content. These anomalies are attributed to the reconstruction works, the deepest position of the boundary was found above the newly installed outlet.
