# Thermal Investigation of a Turbocharger Using IR Thermography

**Abstract:** An experimental thermal survey of a turbocharger was performed in an engine test cell using IR thermography. The emissivity coefficients of housings were specified using a furnace and camera. It was shown that the emissivity of the turbine, compressor, and bearing housings are 0.92, 0.65, and 0.74, respectively. In addition, thermocouples were mounted on the housing to validate the temperature of the thermal camera while running in an engine test cell. To compare the data of the thermocouple with data from the thermal camera, an image was taken from the sensor's location on the housing. The experimental results show that the temperature prediction of the thermal camera has less than 1 percent error. Steady-state tests at various working points and unsteady tests including warm-up and cool-down were performed. The measurements indicate that the turbine casing's maximum temperature is 839 °C. Furthermore, a thermal image of the bearing housing shows that the area's average temperature, which is close to the turbine housing, is 7 °C lower than the area close to the compressor housing. The temperature of the

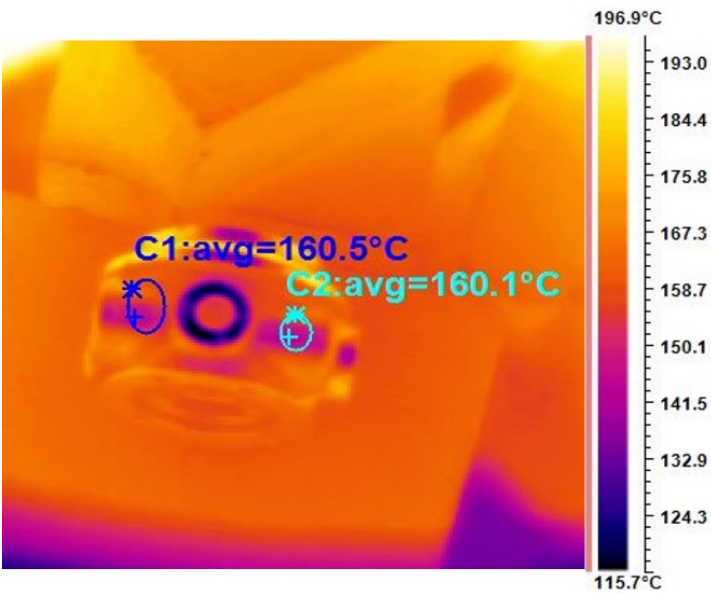
**Figure 3.** Bearing housing at 160 °C and emissivity of 0.74.

The bearing housing thermal image was taken with the thermal camera and is shown in Figure 3. It is seen that, at a furnace temperature of 160 °C, the correct emissivity of the bearing housing is 0.74. The emissivity of 0.74 for the bearing leads to an error of less than 1 °C in temperature measurements. The experiments were repeated three times to check the repeatability of the test.

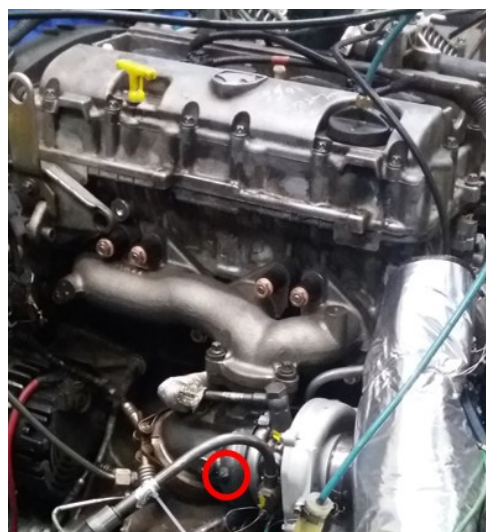
**Figure 5.** Location of a thermocouple on the turbocharger housing.

In this experiment, thermocouples were placed at a depth of 1 mm from the turbocharger surface at different points around the compressor, bearing, and turbine housing. For instance, the location of one sensor on the turbine housing is shown in Figure 5. Sensors were installed around the housings' volute. It should be noted that one of the main constraints on adding points is the packaging limitation of the turbocharger on the engine. Figure 6 shows the location of some thermocouples on the turbocharger.

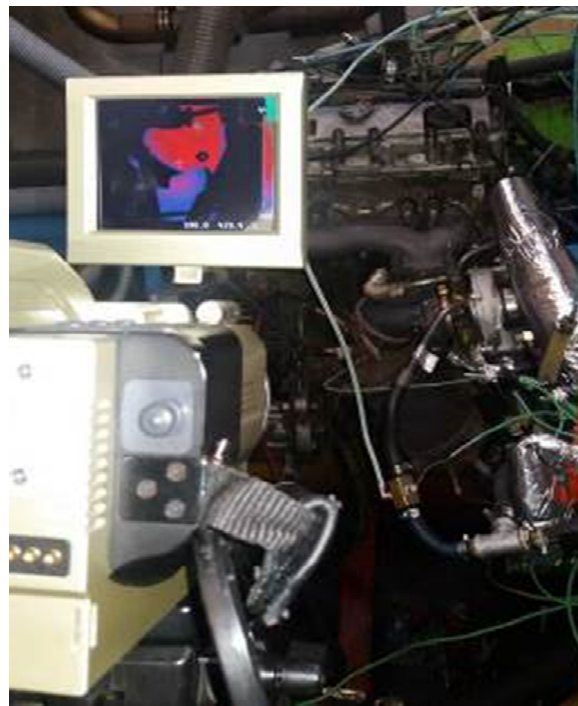
**Figure 7.** Engine test cell overview.

At each working condition, thermal images were captured after the turbocharger temperature stabilized. The location of the camera inside the engine test cell is shown in Figure 7. The camera shows the turbine housing and the catalyst, which are the hot parts of the engine. The appropriate emissivity of the housing was applied. The temperature and humidity of the test cell were determined by the test cell sensors. Each test was repeated three times to ensure the repeatability of the measurements.
