# Diagnostics and Monitoring to Preserve a Hypogeum Site: The Case of the Mithraeum of Marino Laziale (Rome)

**Keywords:** hypogeum; Mithraeum; conservation; frescoes; decay; microclimate; diagnostics

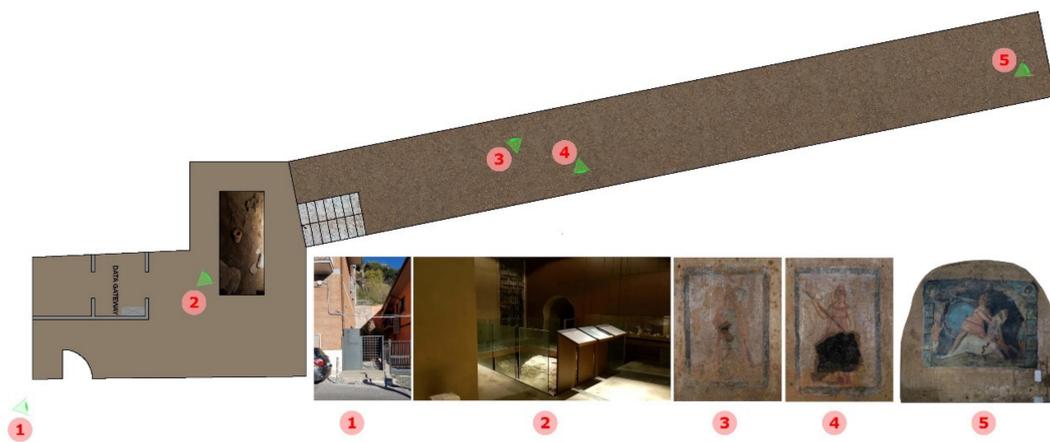
**Figure 1.** Plan of the Mithraeum showing: the entrance on the street (1); the exhibition area (2), with the exhibition set up before 2021; the three painted scenes: *tauroctonia* (5) and the two dadophores, *Cautopates* (3) and *Cautes* (4).

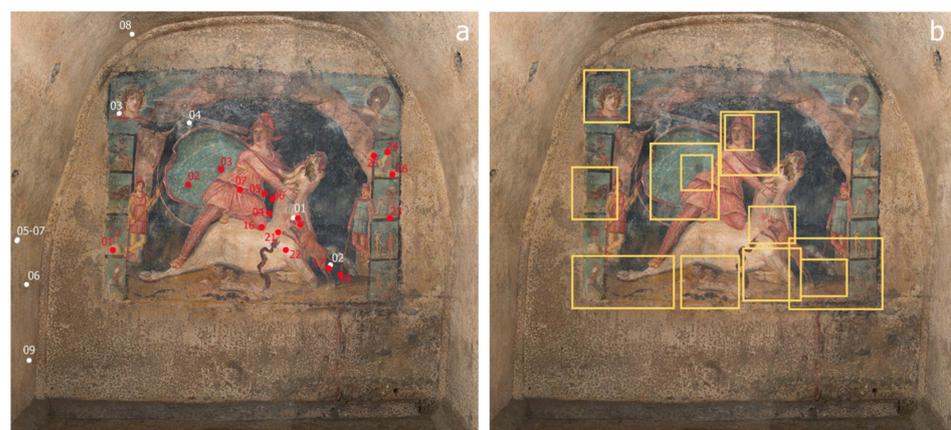
Based on the preliminary results of the first analytical steps and addressed by imaging survey, few areas were selected and samples were taken from the surfaces by the use of a lancet, gently scratching the surface to obtain the powder. The sampling was performed following the methodology of Cultural Heritage standard [35]. Sampling was done to gain chemical and morphological information about alteration materials on painted surfaces not otherwise obtainable by non-invasive methods. In Figure 2a is shown the image with the sampling points, listed in Table 1 with relative labels and the descriptions, while in Figure 2b are highlighted the areas investigated by UVL survey.

**Figure 2.** Mithraic scene: (a) location of sampling points (in white) and microscope images (in red); (b) UVL investigations areas.

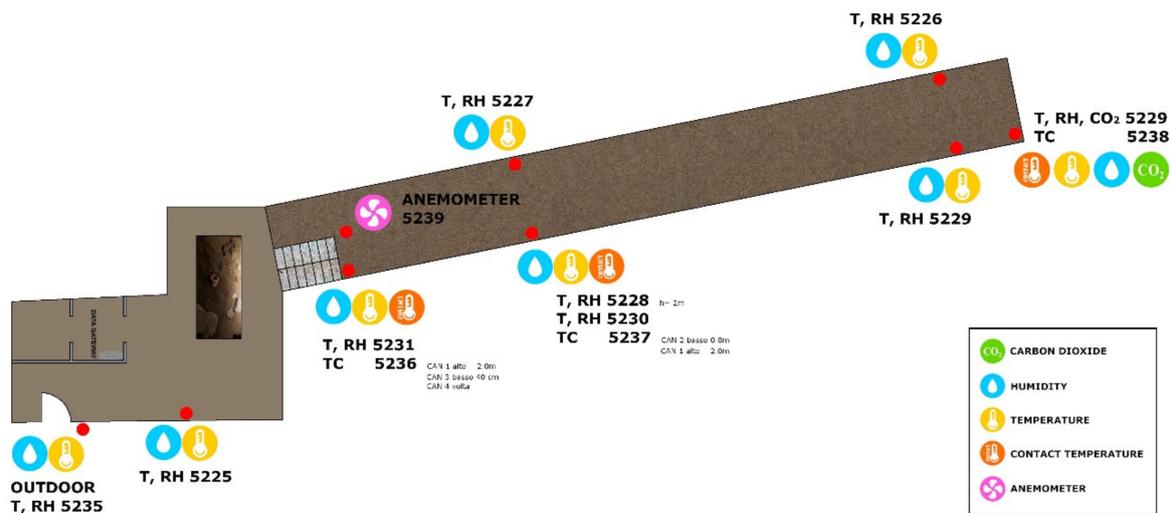
The indoor monitoring system was positioned according to Cultural Heritage standards [15,16,55,56], as shown in Figure 3, at different distances from the entrance of the gallery up to the wall where the Mithraic scene is depicted and at different heights (50 cm, 150 cm, on the vault) from the floor to the vault. For fixing the sensors in a hypogeum environment, low-impact supports made with a stainless material suitable for an environment with high relative humidity values were adopted.

**Figure 3.** Plan of the Mithraeum with the location of the sensors.

Specifically, a system of Delta Ohm sensors were placed to detect the following microclimatic/physical parameters: 8 temperature and relative humidity sensors (HD 35EDW model); 6 surface temperature sensors (HD 35EDW model); 1 CO<sub>2</sub> sensor (HD 35EDW model); 1 sensor for measuring air flows (sonic anemometer) (HD52.3D model) (Figure 3).

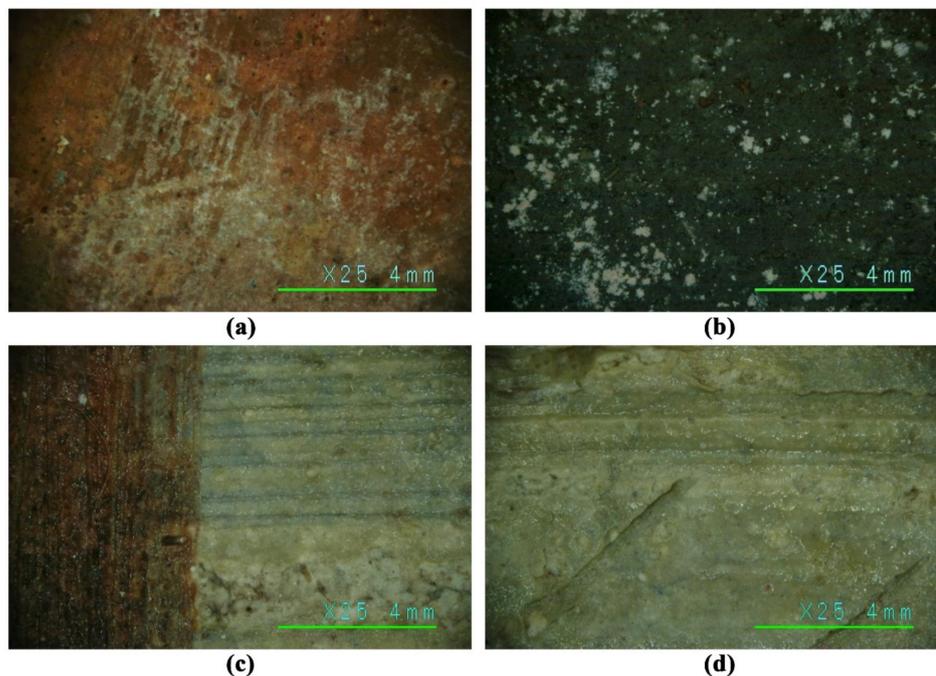
In particular, the painted wall presents the same problem spread over the entire pictorial layer but in less concentration than 10 years ago, as only four years have passed since the end of the restoration.

**Figure 4.** Details with high magnification by portable microscope: (a) Snout of the dog; (b) tail of the dog; (c) brushstroke on the first panel at the top from the right side, under the legs of the bull; (d) scratch on the first panel at the top from the right side, under Mithra's feet.

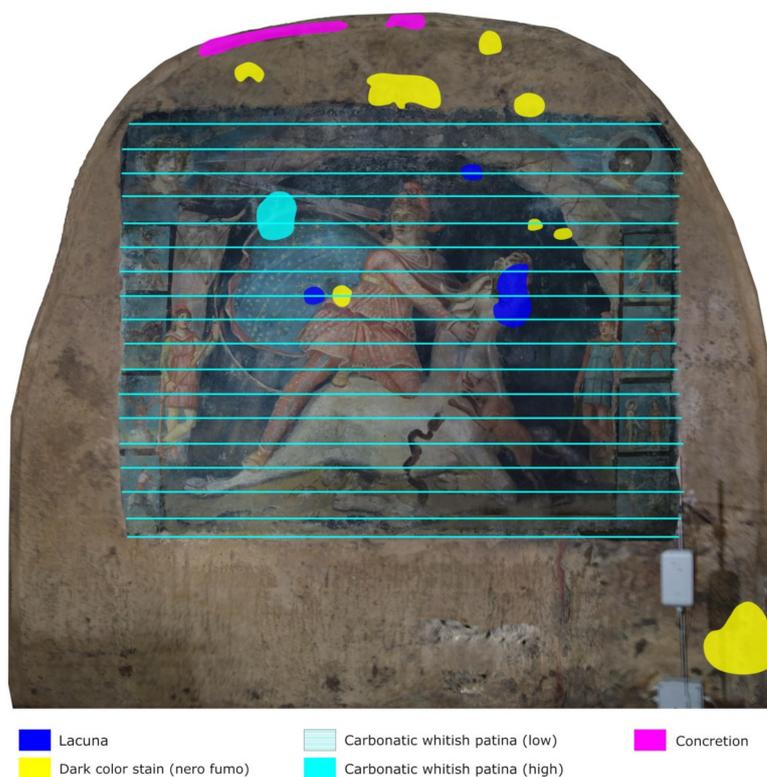
In fact, during the 2008 diagnostic campaign, thematic tables were drawn up on the constituent materials and the phenomena of alteration present both on the walls of the gallery and on the painting. These tables were updated in 2018 (Figure 5). The recurrence of the whitening of the surfaces due to the concentration of carbonate salts was observed.

**Figure 5.** Wall with Mithraic scene: map of alteration phenomena (October 2018).

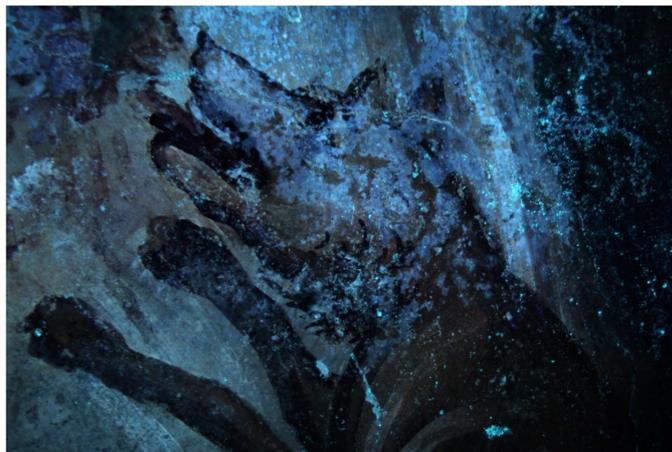
The UVL survey carried out on the three painted scenes highlights some areas affected by a light-bluish fluorescence response due to the presence of salt efflorescence patinas (Figure 6).

**Figure 6.** Mithraic scene: details of UVL on the snout of the dog.

FT-IR analysis carried out on micro-samples picked up from these whitish patina pointed out the presence of calcium carbonate. This evidence is confirmed by the results obtained by XRD that highlights the ongoing carbonatic crystallization. In some samples, the carbonatic precipitation incorporates silicatic impurities, probably coming from the substrate on which the tunnel was excavated.

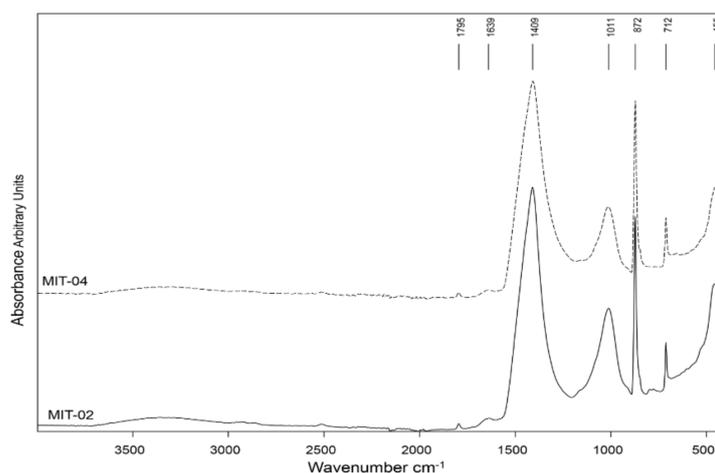
In detail, the spectra of the samples show the same absorption bands at 1408, 872 and 712  $\text{cm}^{-1}$  assignable to calcite [57–59]. The absence of high frequency bands suggests that the mineral is not deteriorated (powdery). Absorption bands at 1014 and 453  $\text{cm}^{-1}$  suggest the presence of silicates attributable to mica (Figure 7) [59].

**Figure 7.** ATR FT-IR spectra of MIT-02 (line) and MIT-04 (dots) samples.

This result is confirmed by XRD analyses, which identify the annite mineral. This mineral is linked to the composition of the stone substrate brought to the surface by capillary rising.

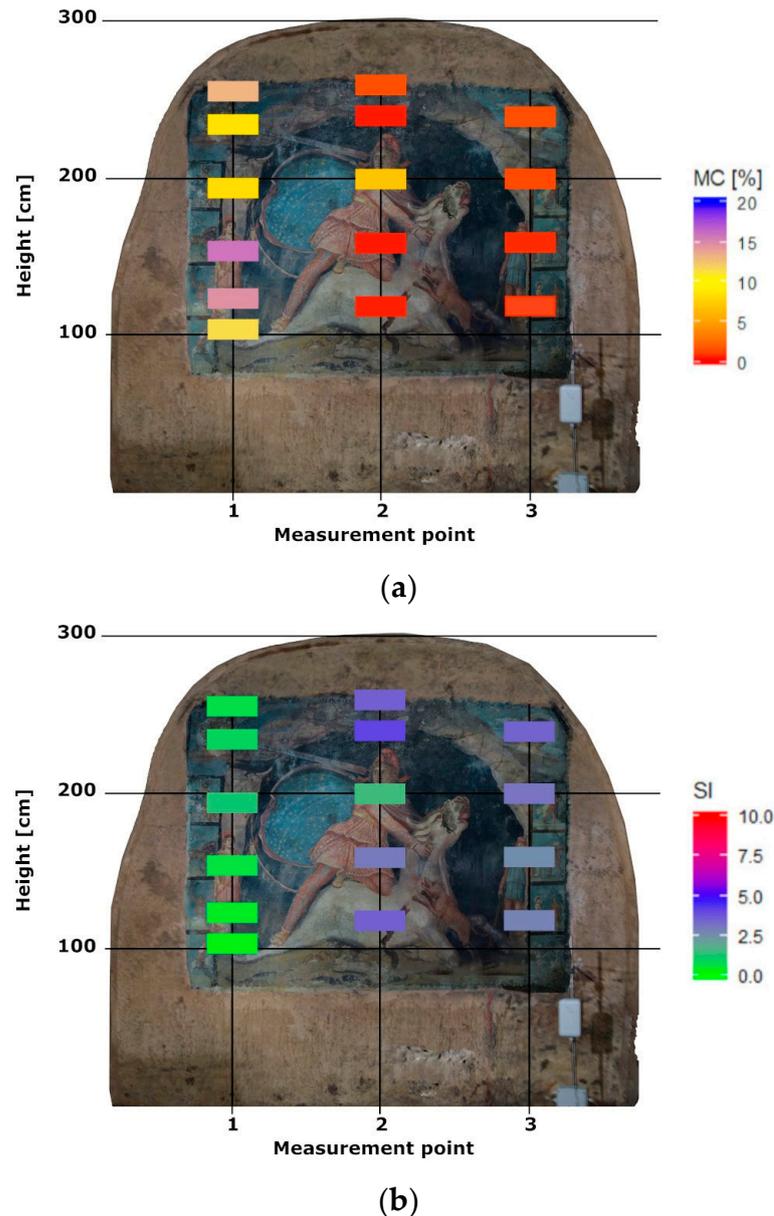
The amount of MC is higher in the left area of the painting and it decreases from the center to the right side of the wall (Figure 8a). On the contrary, the salinity index SI shows an opposite situation: lower values on the left side and higher ones from the center to the right side (Figure 8b).

**Figure 8.** Mithraic scene, measurements by EDS on the surface of the painting: (a) distribution of moisture content (MC) and (b) salinity index (SI).

This phenomenon could be attributed to the fact that, in the areas where the moisture content shows higher values, the salts are more diluted and, therefore, the SI salinity index is lower.

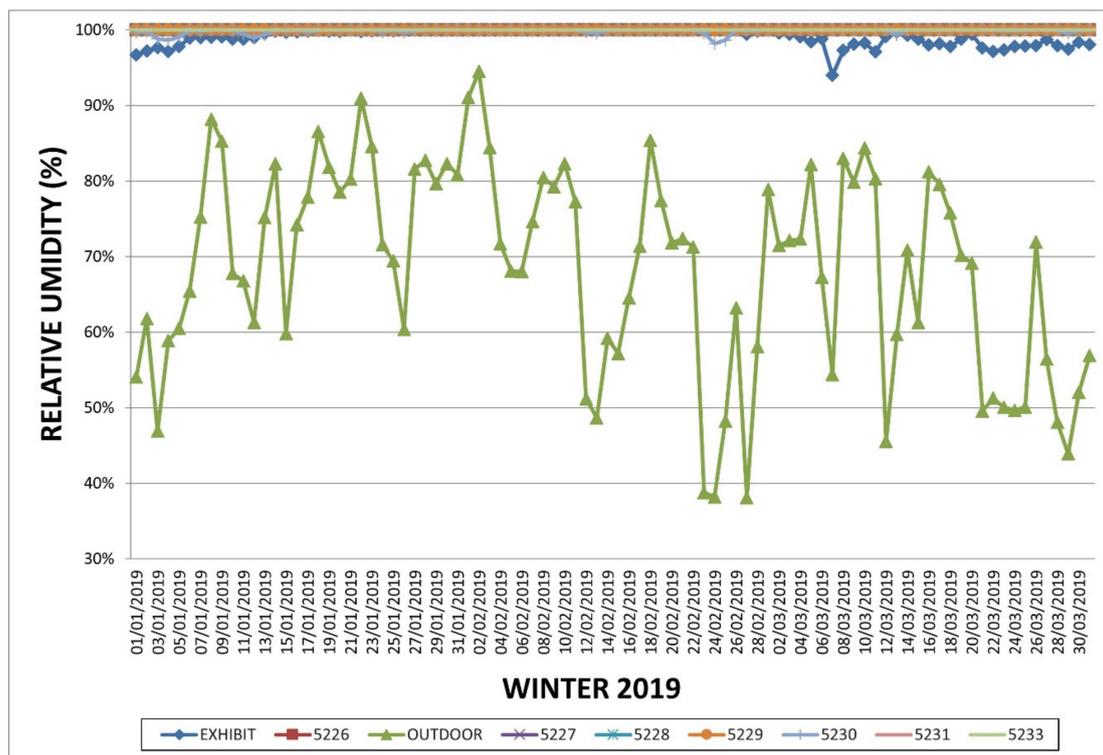
Inside the gallery, the relative humidity values are stable (summer and winter around 100%) while in the exhibition area are revealed slight oscillations with values between 94% and 97% during the winter (Figures 9 and 10). In summer, similar values have been measured, until the end of June 2019 when the reopening of the windows was completed.

**Figure 9.** Indoor relative humidity values inside the exhibition area and the Mithraic gallery in comparison with the outdoor values during winter 2019 (from 1 January to 31 March).

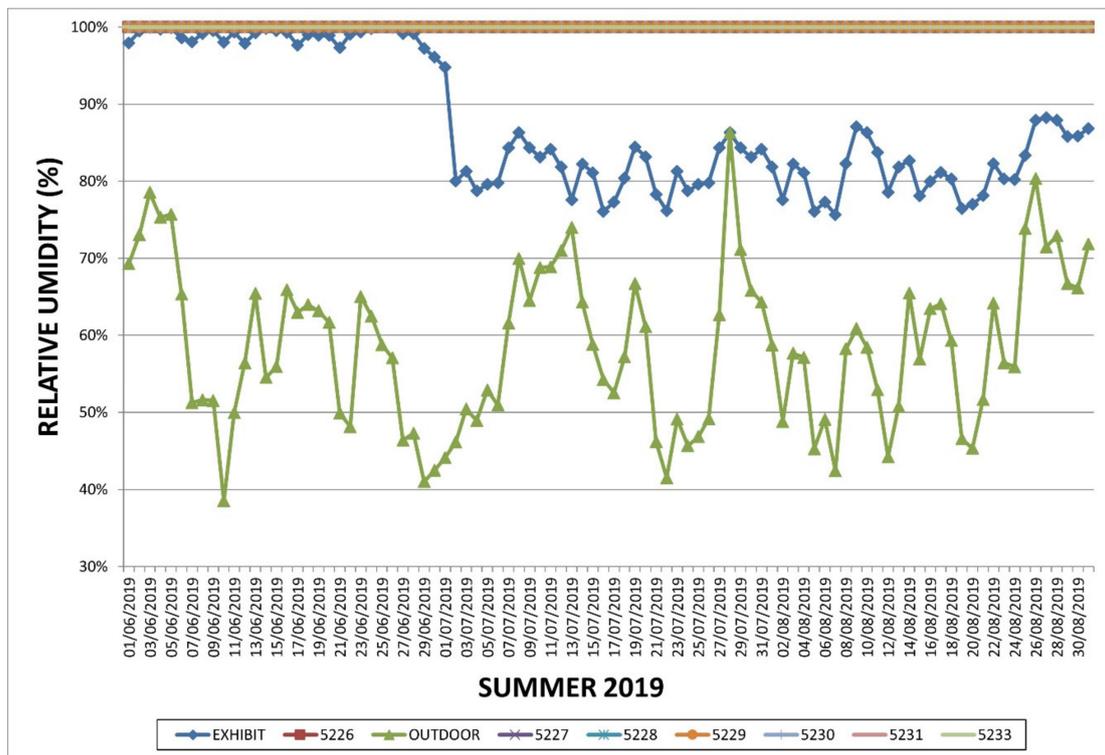
**Figure 10.** Indoor relative humidity values inside the exhibition area and the Mithraic gallery in comparison with the outdoor values during summer 2019 (from 1 June to 31 August).

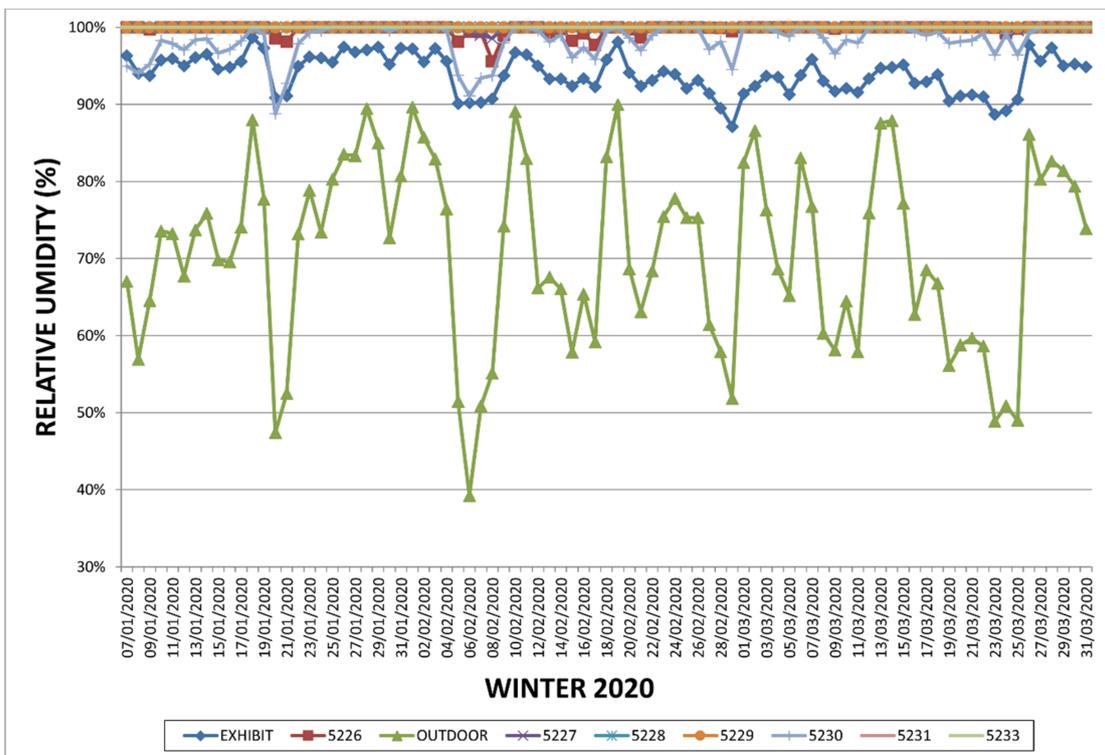
On the other hand, in the exhibition area the relative humidity values range from 75% to 100%, with a maximum reduction registered compared to the Mithraic gallery of 25% in summer (Figures 11 and 12). This variation is probably due to a greater influx of hot air into the exhibition area in the summer/autumn period following the reopening of the two windows. However, the environmental conditions of the exhibition area do not affect the thermo-hygrometric behavior of the Mithraic gallery.

**Figure 11.** Indoor relative humidity values inside the exhibition area and the Mithraic gallery in comparison with the outdoor values during winter 2020 (from 7 January to 31 March).

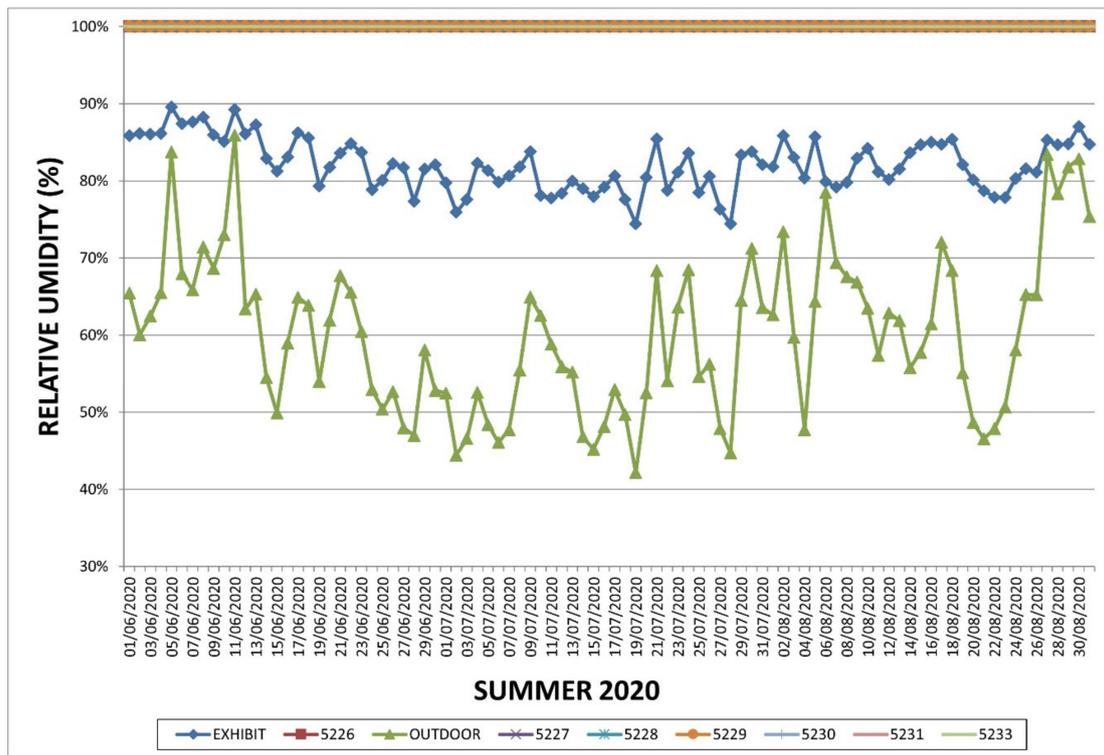
**Figure 12.** Indoor relative humidity values inside the exhibition area and the Mithraic gallery in comparison with the outdoor values during summer 2020 (from 1 June to 31 August).

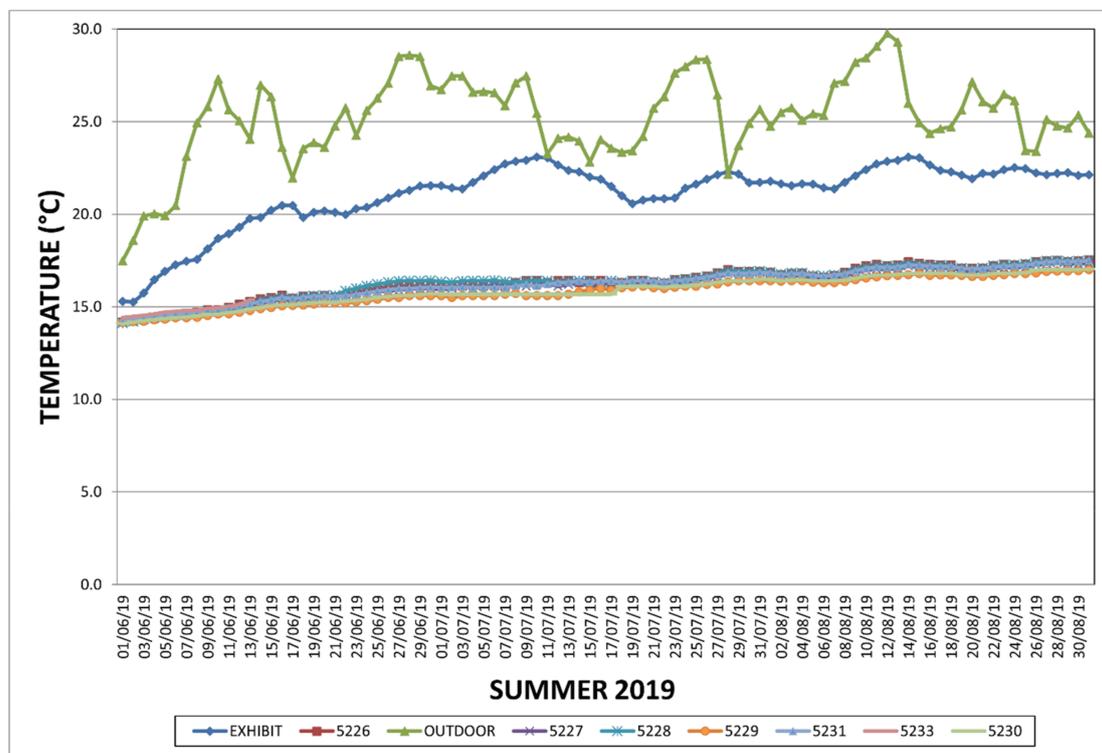
**Figure A1.** The indoor temperature values inside the exhibition area and the Mithraic gallery in comparison with the outdoor values during summer 2019 (from 1 June to 31 August).

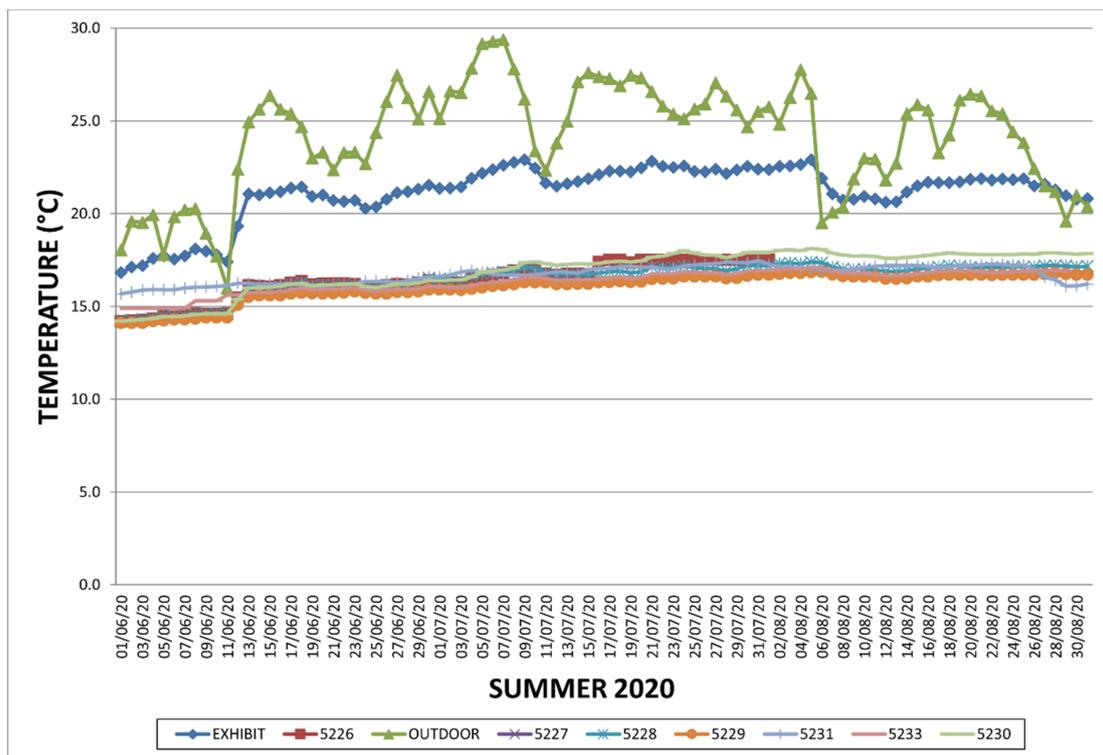
**Figure A2.** The indoor temperature values inside the exhibition area and the Mithraic gallery in comparison with the outdoor values during summer 2020 (from 1 June to 31 August).

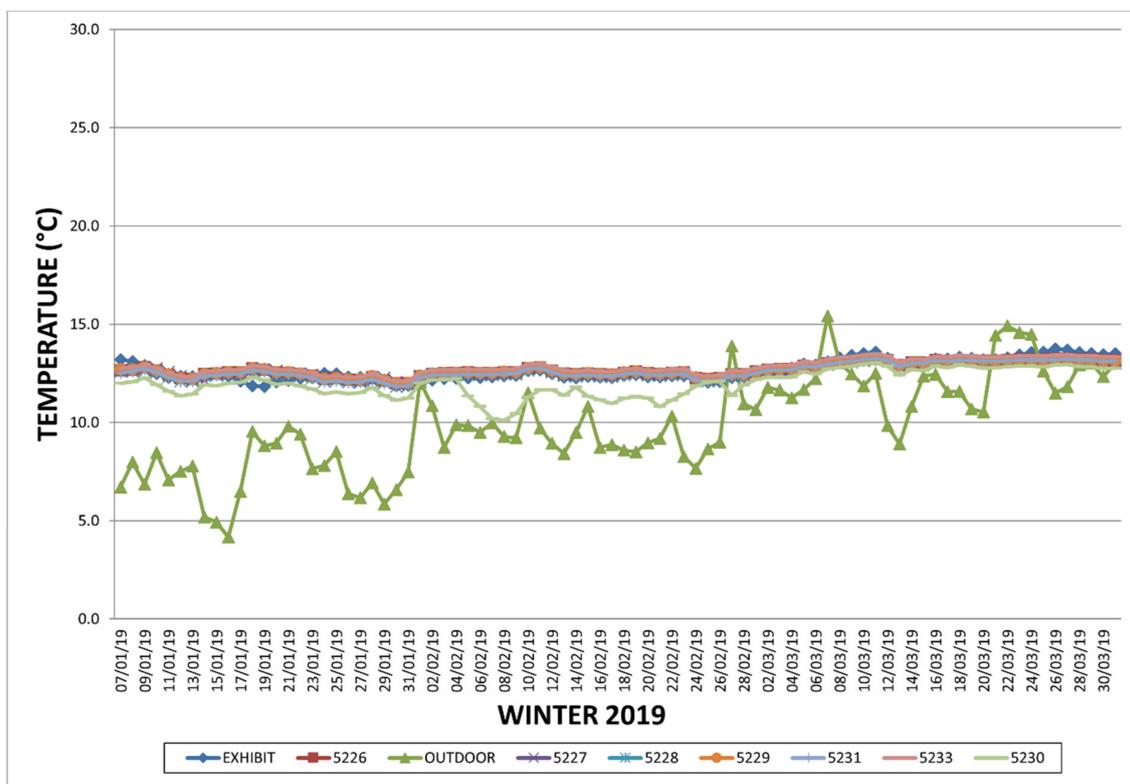
**Figure A3.** The indoor temperature values inside the exhibition area and the Mithraic gallery in comparison with the outdoor values during winter 2019 (from 1 January to 31 March).

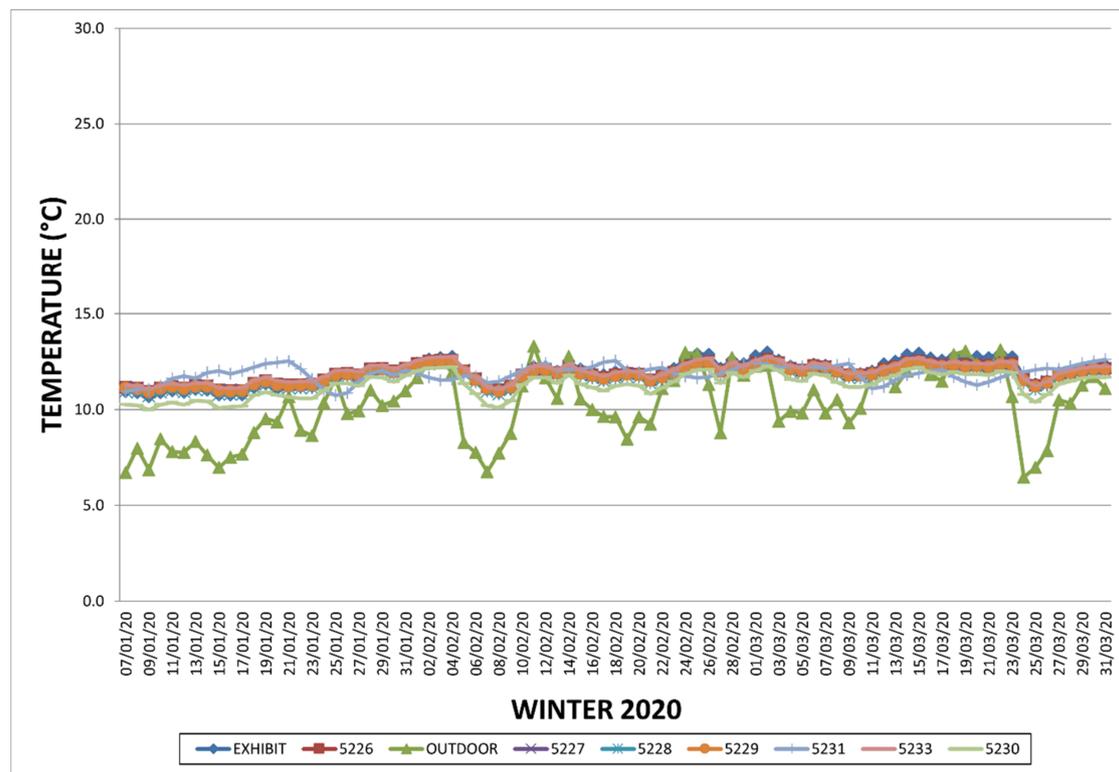
**Figure A4.** The indoor temperature values inside the exhibition area and the Mithraic gallery in comparison with the outdoor values during winter 2020 (from 1 January to 31 March).
