# Lost Heritage—Architectural Replacement of an Atrium and a Courtyard of the Roman Houses of Armea (Allariz, Ourense)

**Abstract:** Francisco Conde-Valvís’s so-called “stone treasure” is a set of unique carved stone pieces, such as bases, column shafts, a mortar, and decorated fragments (trisques and rosettes), found during the 2018 excavation campaign in the Cibdá de Armea (Allariz, Ourense). They had been piled up and re-buried—no records existed as to where—at the western end of the Finca de A Atalaia, which was excavated in the 1950s under the direction of Conde-Valvís and began to be excavated again in 2011. The thorough review of the graphic and textual material available from the old excavations allowed us to determine the original archaeological context of the pieces. Most of these elements belonged to the atria of the so-called “Domus of Hexasquel” (North house) and “Domus of the Rosette” (South house). Once we established the origin of all the elements, especially with the aid of the old photographs, it was decided to reintegrate them into the site, to increase the educational and interpretive value of Armea, instead of burying them indefinitely in the warehouses of a m

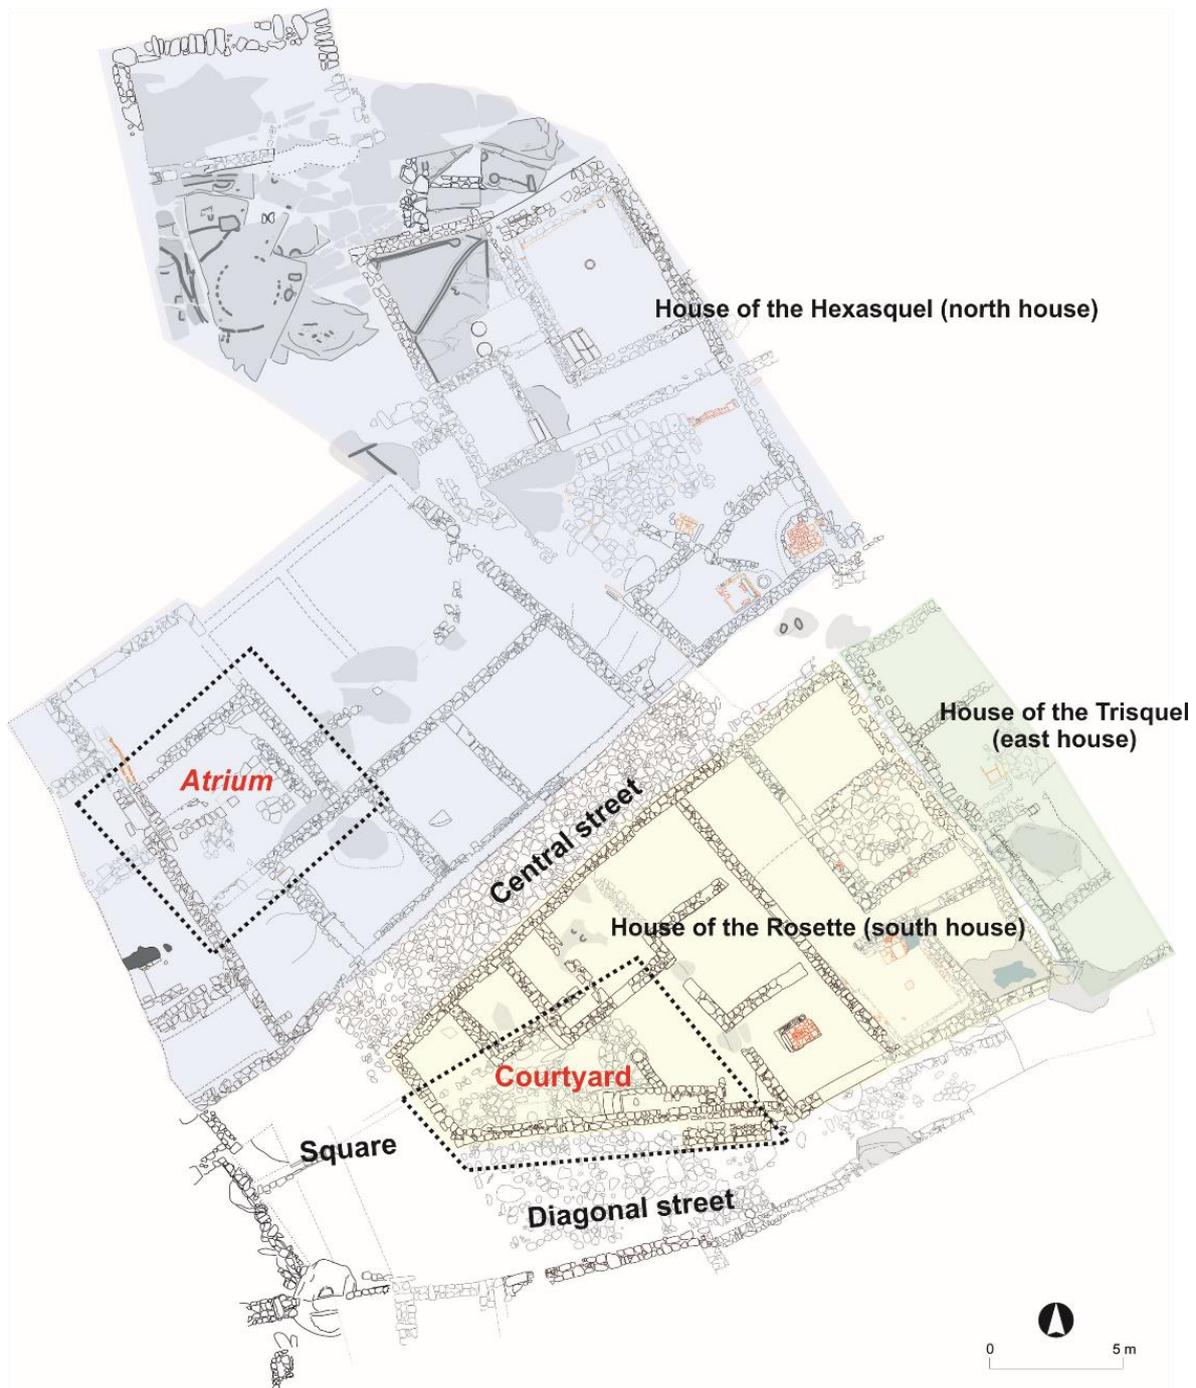
**Figure 3.** Plan of the excavated Roman settlement in A Atalaia.

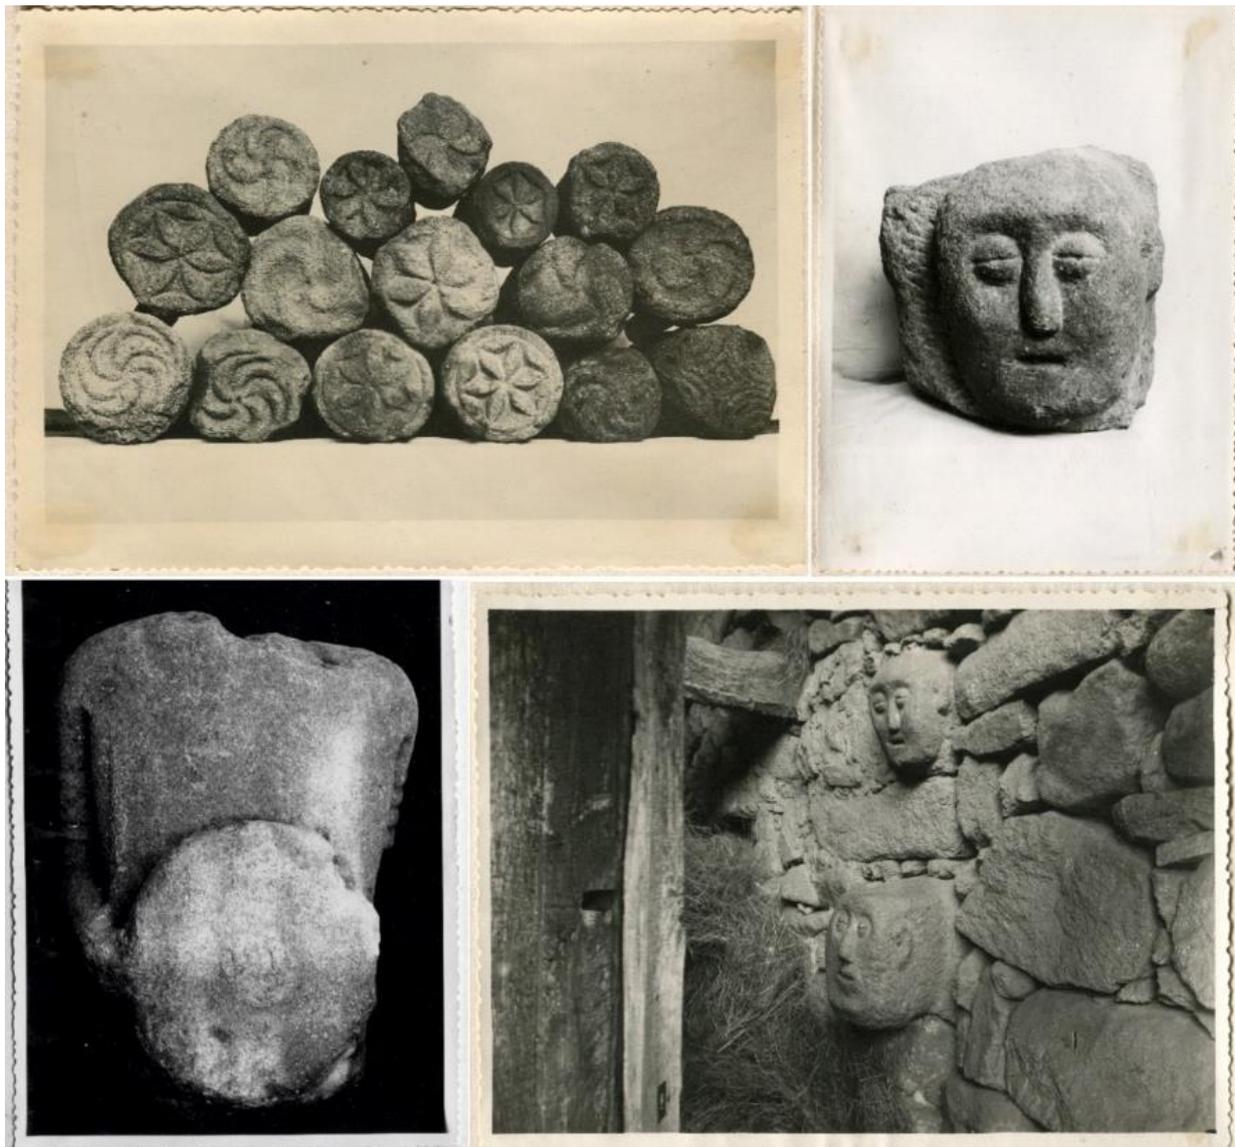
**Figure 4.** Photographs of some of the remains found in the 1950s [7] (Plates V, VIII, XXIII, XXVIII, and XXIX).

In the early 1950s, the Allariz-born engineer and amateur archaeologist Francisco Conde-Valvís Fernández undertook, following his father's footsteps, the study of Santa Mariña and Armea. He surveyed, recorded, and collected numerous archaeological remains and even opened a few soundings [18] (pp. 44–46). He has discovered the most substantial and best-known remains found to date in Armea, such as the warrior torsos, the “severed heads”, and a large number of decorative stone pieces, such as triskelia, hexasquels, and rosettes, which are currently held in the Archaeological Museum of Ourense (Figure 4).

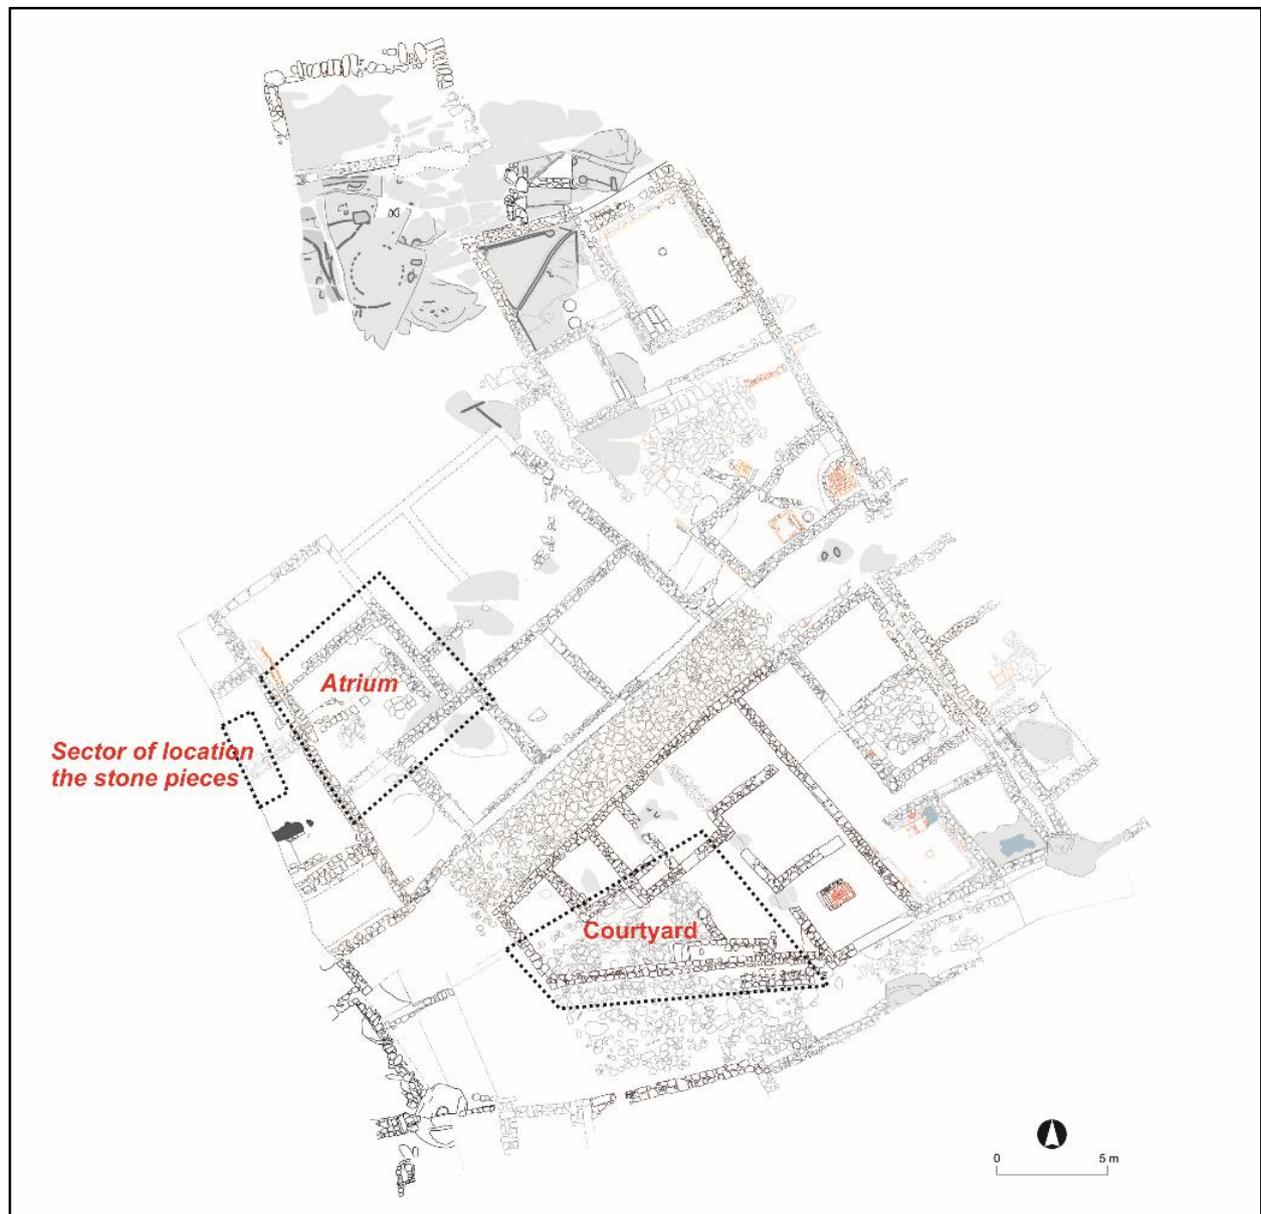
In 2018, during the excavation of so-called Sector 14, at the western end of the northern domus (of the Hexasquel), near one of the atria, a fill associated with numerous carved stone pieces was identified (Figure 5); it was clear that the stone fragments had been piled up and interred deliberately during the 1950s. This find caught the excavators by surprise, as no records existed of this deposit. As they were not included in the collection held

**Figure 5.** Plan of the site with the location of the finds.

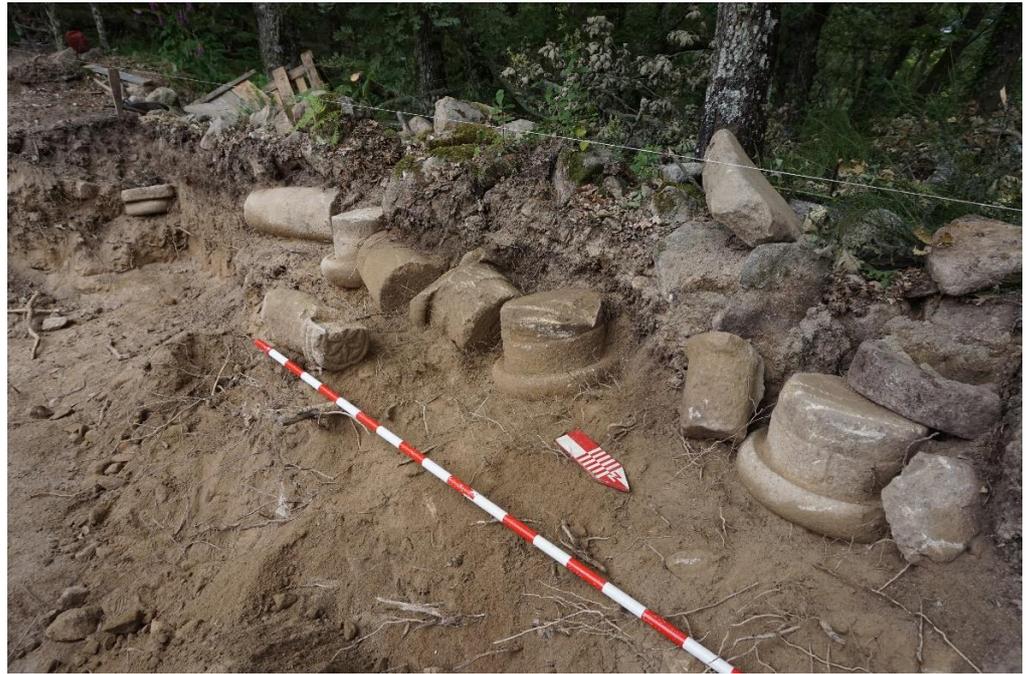
Figure 6. Discovery of the stone fragments.

When they were found and, especially, after their origin was established, the University of Vigo team began referring to this assemblage as “Conde-Valvís’s stone hoard”, to highlight the exceptional value of the pieces. The assemblage includes four bases, two column shaft fragments, a capital, the fragment of a possible millstone, a stone mortar, and several fragments of decorative rosettes and triskelia. Until 2019, the assemblage was securely held in a warehouse owned by the City Council of Allariz (Figures 6 and 7). Once the original location of the pieces was determined, they were returned to the site.

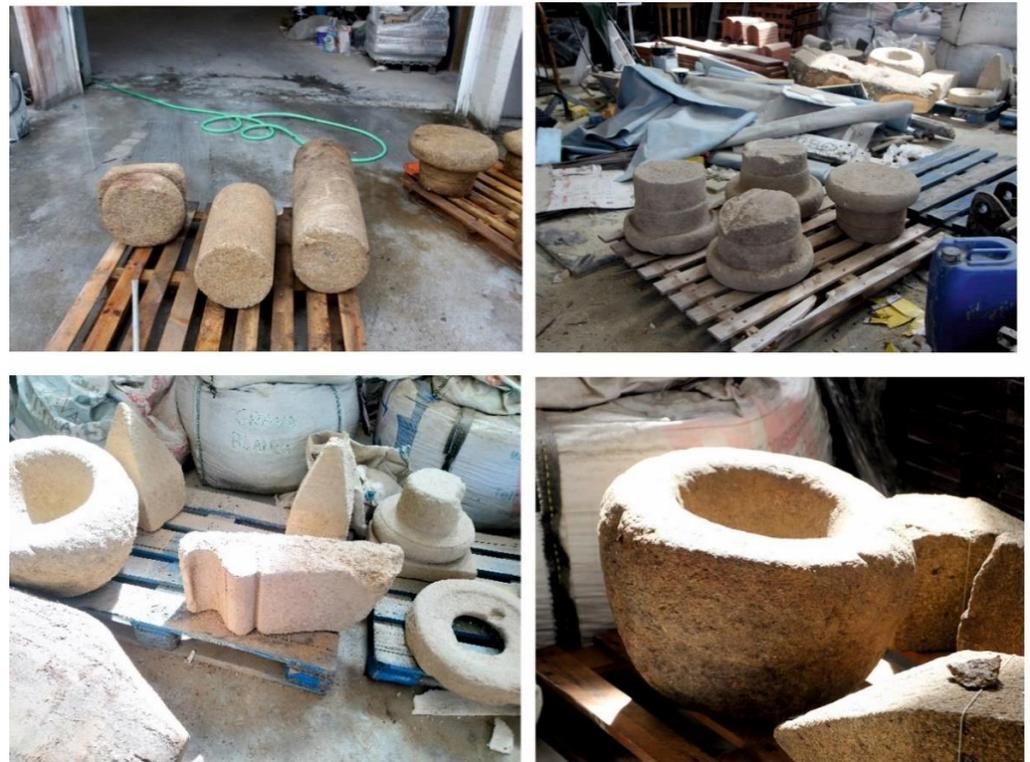
Figure 7. "Conde-Valvís's stone hoard" stored in a City Council of Allariz warehouse.

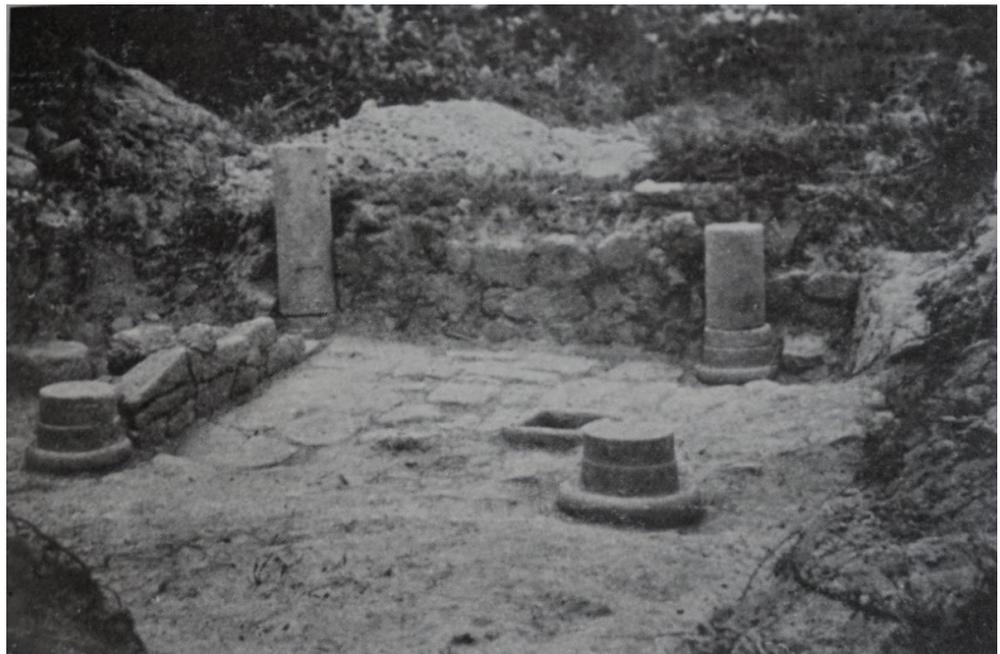
Conde-Valvís [14] (pp. 479–483) describes an atrium with four column bases at its centre, forming a perfect square with 2.5 m sides (Figures 8 and 9). He also found two column shaft fragments among the debris, which Valvís placed over the bases, somewhat randomly, to take a picture of the courtyard. It has been impossible to establish whether a capital was also found, as the text is unclear in this regard. Although at first he writes that none of the four capitals were found, in the same article, he claims that three of the four capitals were missing, so this suggests that at least one of them was found. The atrium was paved with small, unevenly sized, stone slabs, and a channel ran across the room from E to W; a square drain, similar to that which is still visible in the southern domus, was also identified. In his article, Conde-Valvís uses the terms *impluvium* and *compluvium* incorrectly. He refers to the square drains in the atrium and the courtyards of both houses as *compluvium* and to the paved areas as *impluvium*. Interpreting this small drain, used to evacuate rainwater, as a *compluvium* is a mistake, for *compluvia* are the openings left on the roofs of atria to let in light and air, as well as to let rainwater fill the *impluvium*, a pool from which water ran into the house's waterpipe system. In Armea, rainwater entered through this opening, which can be regarded as a *compluvium*, but not into an *impluvium*, but directly onto the paved floor. Rainwater filtered through the stone slabs and was channelled to the rest of the house through the quadrangular drain and a stone channel built beneath the pavement.

Figure 8. Photograph of the atrium after the excavation (Conde-Valvís 1959: Plate I).

Conde-Valvís finishes his description by saying that, a few days after closing the excavation and taking the picture “[...] a group of vandals walked by, grounded the columns, took the bases out of place, yanked at the slabs [...], in short, these soulless miscreants left behind them the mark of barbarism” [14] (pp. 481–483). After this incident, the soil beneath the slabs could be excavated. Nothing is said about whether the vandalised elements were destroyed, stolen, or partially recovered. The 2018 excavation revealed that at least some of them had remained on site and had been interred by the excavators at the edge of the property, next to the atrium. At the end of the excavation, the trenches, including this atrium, were backfilled [20].

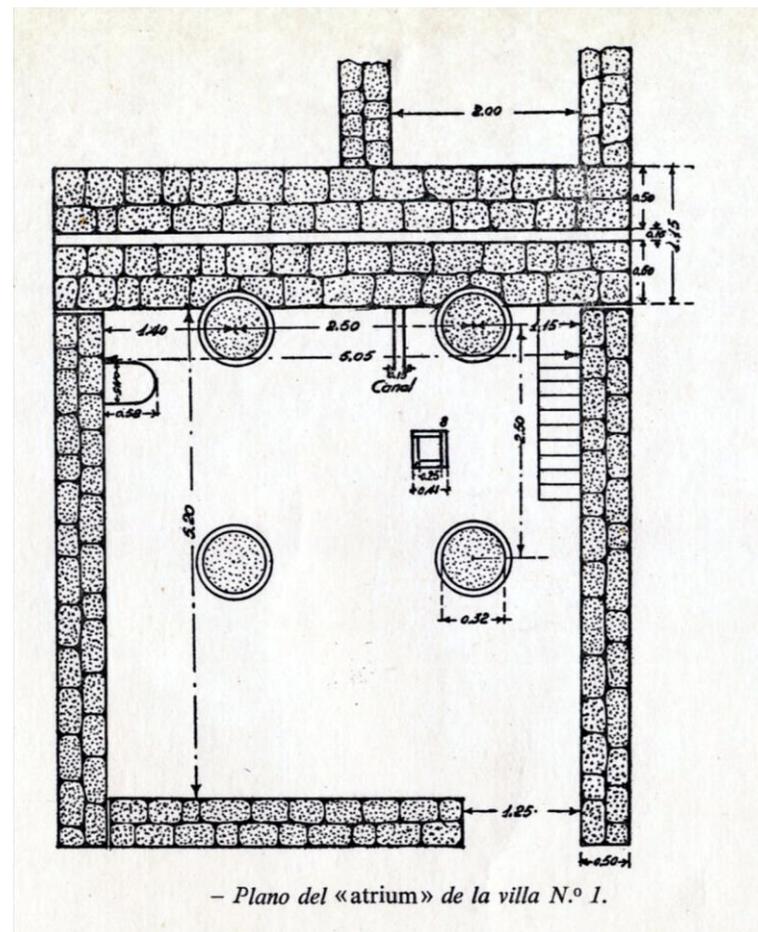
**Figure 9.** Plan drawn by Conde-Valvís in 1955 (Conde-Valvís 1959: 482).

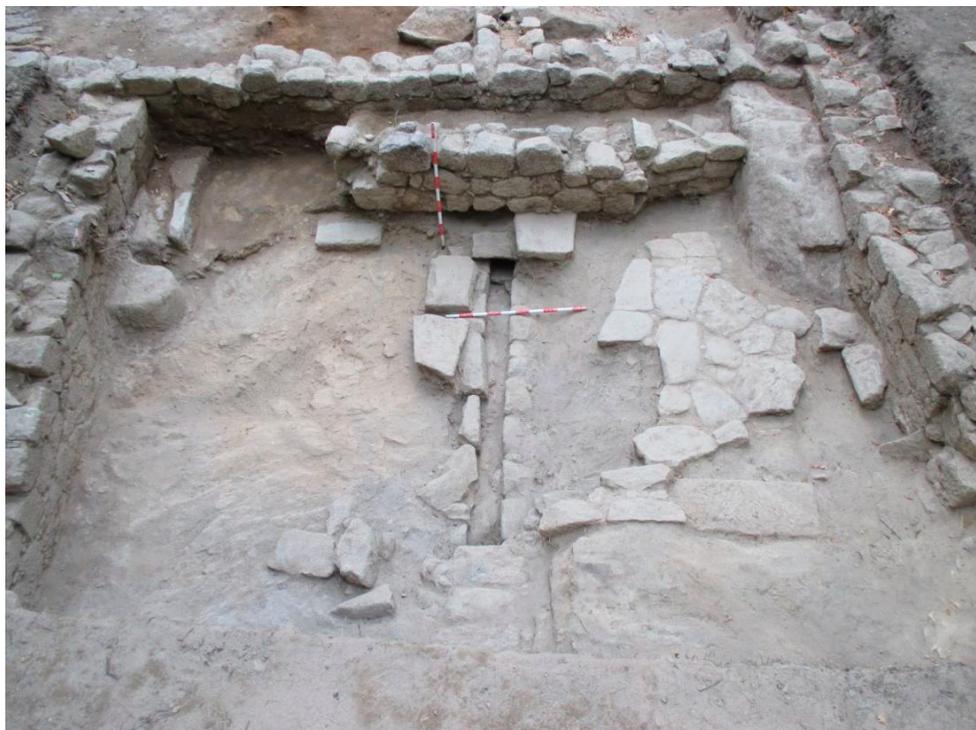
The consolidation and musealisation works in 2018 included raising the walls by adding a few protective courses and the restitution of part of the pavement and the drain lids, using slabs found among the fills that covered the rooms (Figures 10 and 11). Additionally, in the words of the director of the excavations, “In order to present a discourse that is closer to reality, two fragments of Roman columns found in the vicinity were placed on the bases, conveying an image that helps to reflect the archaeological discourse” [20] (pp. 89–90). After consulting some of the archaeologists, it was concluded that the original location of these column shafts cannot be established with any certainty, and that it is not even clear that they belong to Armea. They were brought to the site in 2014 from the house where they were found out of context in Allariz’s historical quarters. The analysis of their raw material (granite), morphology and typology, and their comparison with other columns found in the archaeological context in Armea, strongly suggest that they are foreign to the Cibdá, and they cannot even be securely dated to the Roman period to which the site is

**Figure 10.** State of the courtyard after the 2014 excavation. Photograph: David Pérez.

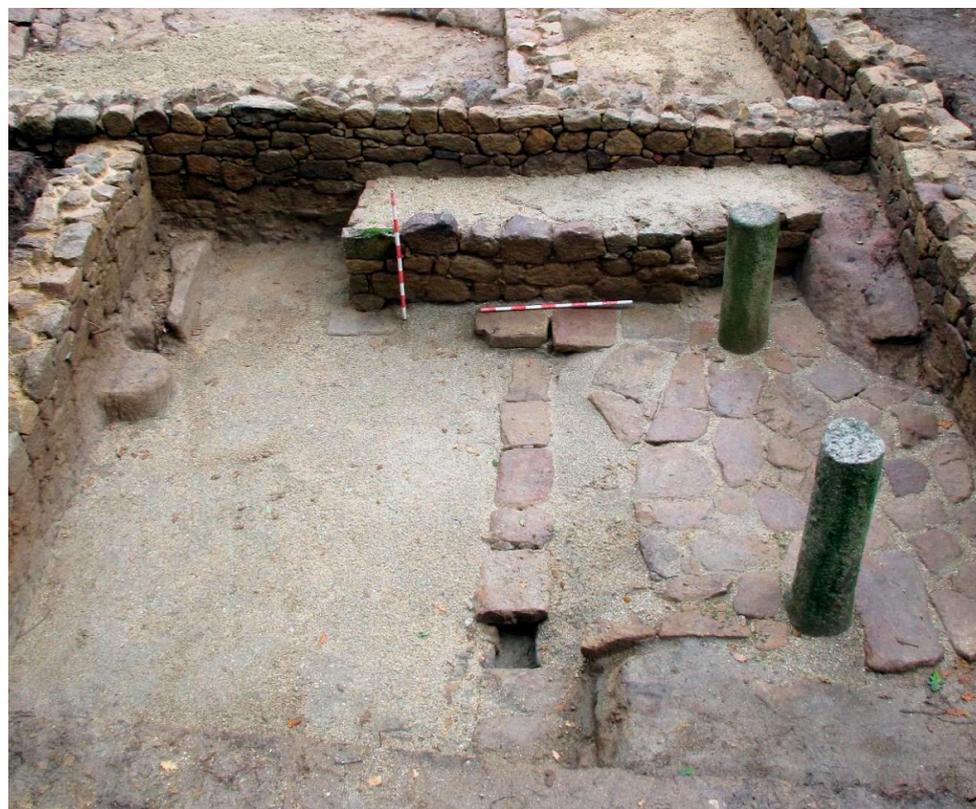
**Figure 11.** Final state of the atrium after the restoration works in 2014. Photograph: David Pérez.

dated. Following this, it was decided to remove these columns, especially after the original column shafts were found in “Conde-Valvís’s stone hoard”.

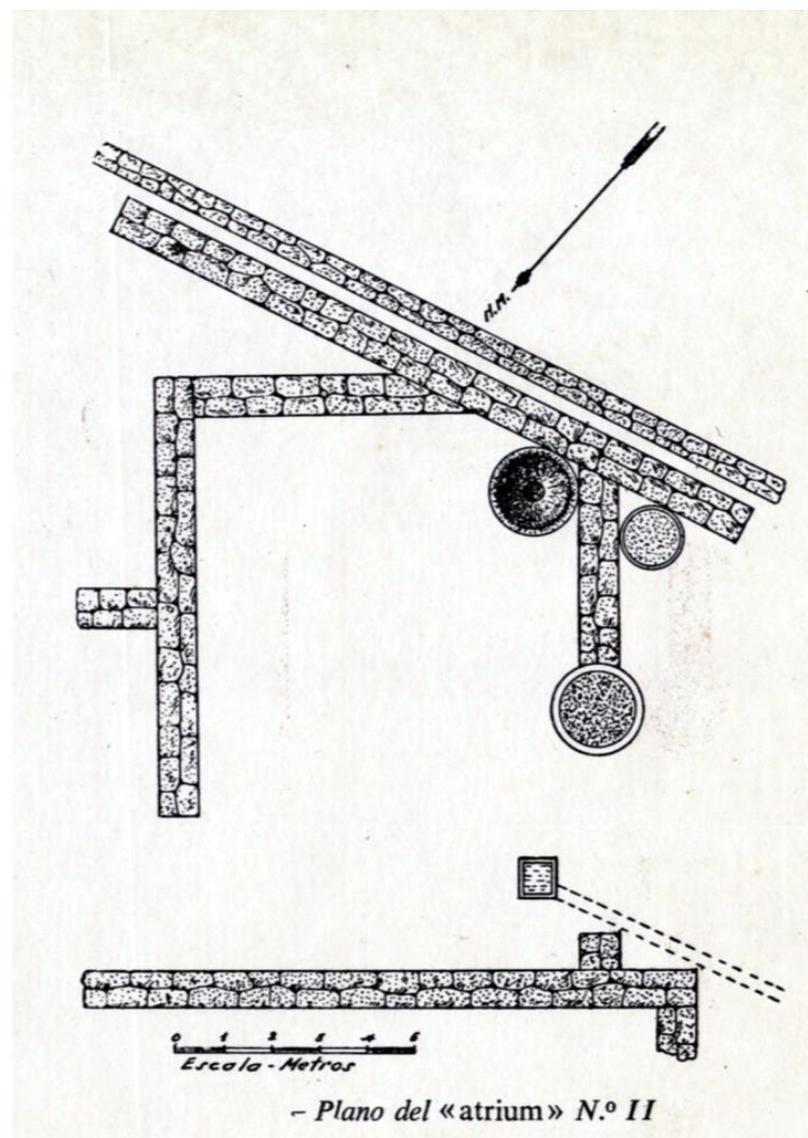
Conde-Valvís [14] (pp. 483–484) describes this courtyard as a floor paved by small, unevenly sized, stone slabs, with a channel running across it, from E to W, and a *compluivium* built with four stones, 0.12 m thick, forming a square deposit with 0.25 m sides (inner measurements). A staircase on the south side of the wall gave access to an upper storey. A small wall projects from the staircase towards the centre of the courtyard. It is 0.80 m long and 0.40 m thick, and it ends in a crudely carved granite block, which is approximately 0.50 m high (Figure 12). In his publication, Conde-Valvís, along with the general arrangement of the courtyard, describes different architectural elements found during his excavation, including the base of a column that probably sat on the granite block and a column shaft fragment which he placed on the base to take a photograph (Figure 13). He also describes a mortar found to the east of the small wall. Finally, he mentions a fragmentary millstone that sat vertically on the channel, acting as a water sluice. Like with the atrium in the house of the Hexasquel, the building was backfilled after the excavation. Again, no information is provided as to the whereabouts of the stone elements found, whether they were interred in situ, or taken to a different location.

Figure 12. Plan drawn in 1955 [14] (Conde Valvís 1959: 486).

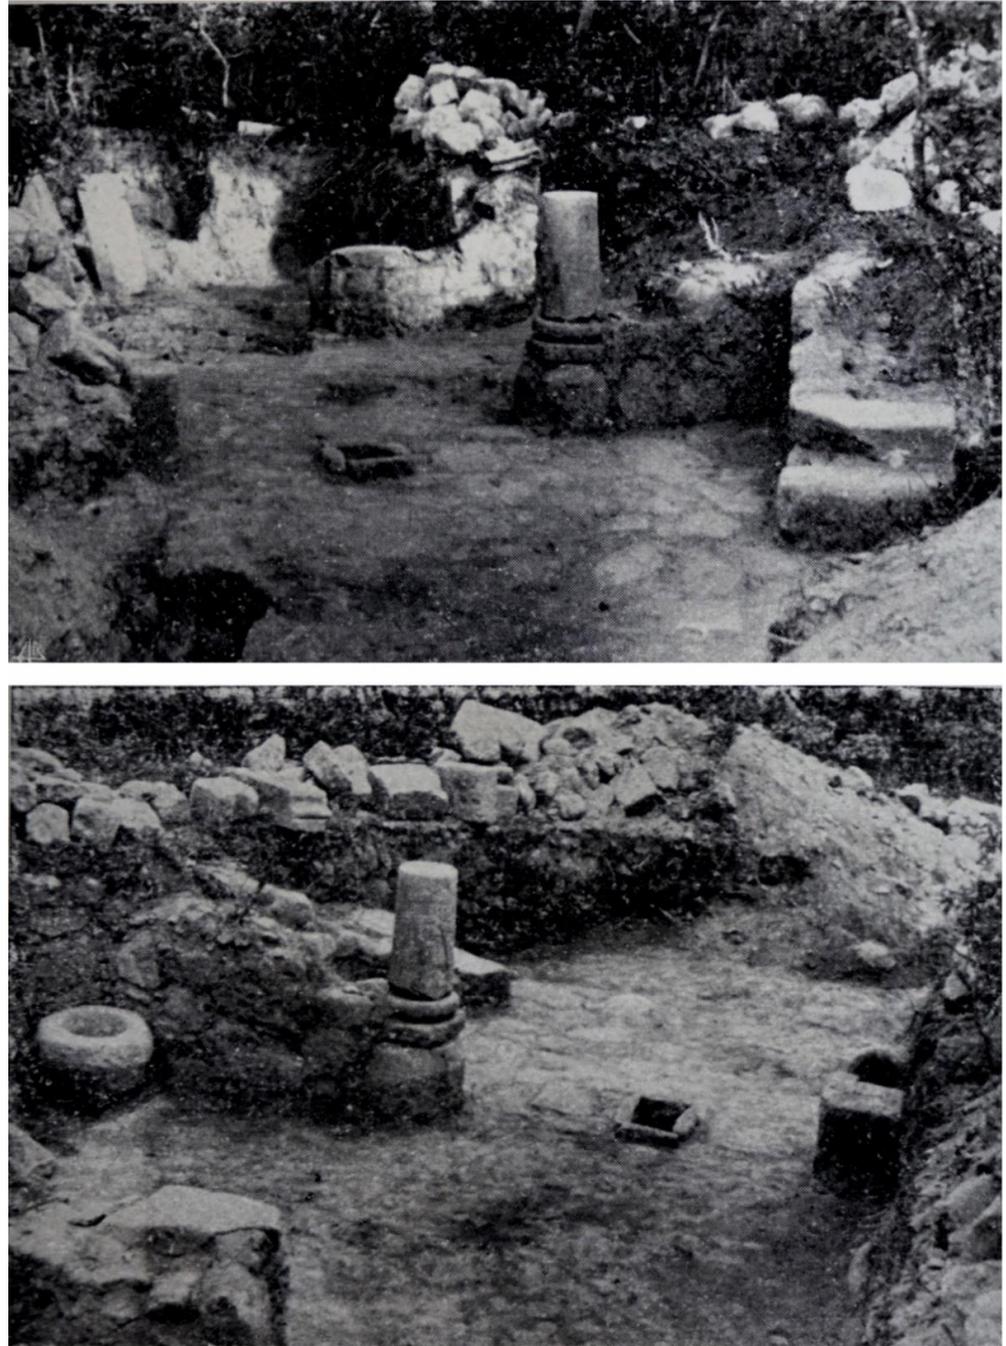
**Figure 13.** Several views of the courtyard of the Rosette after excavation [14] (Conde Valvís 1959: Plate II).

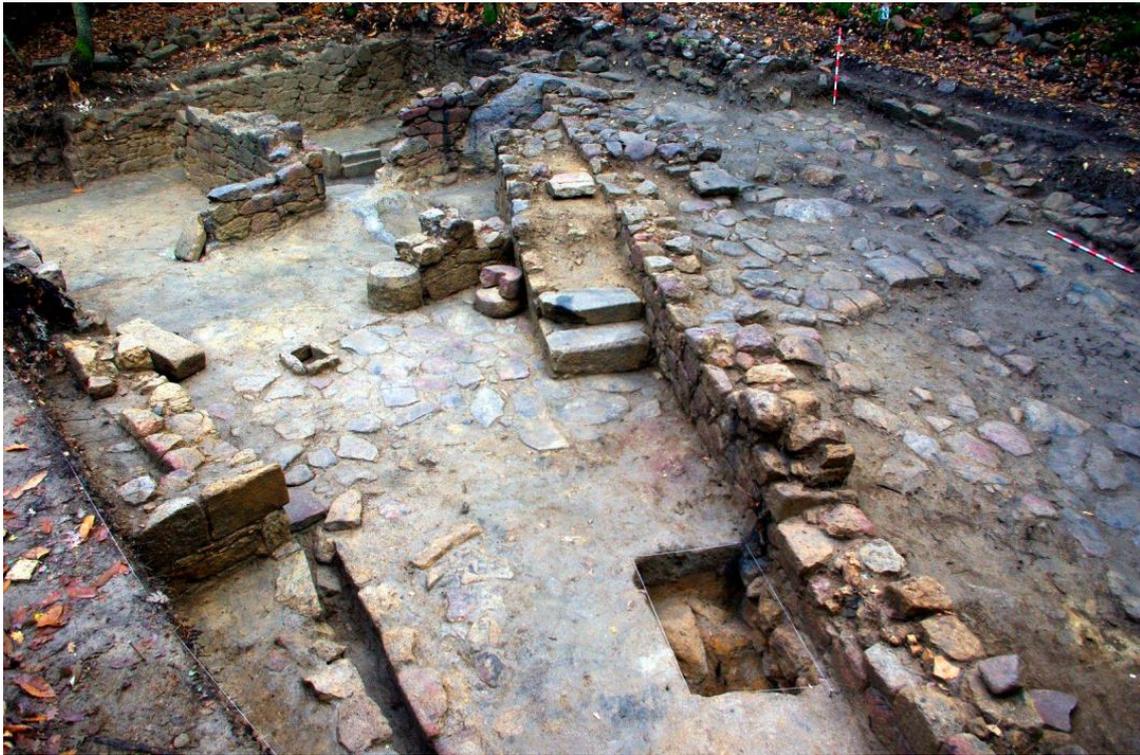
Between 2011 and 2012, the City Council of Allariz resumed the excavation of this area; the excavation was directed by David Pérez. The loose objects described by Valvís could not be found, except for a few threshold stones that had been piled near the site (Figures 14 and 15). The crude granite base was found in situ, and a small column shaft found near the estate's perimeter wall was placed on top, in an attempt to recreate Valvís's old photographs [20] (p. 89).

**Figure 14.** View of the atrium of the Domus of the Rosette after the 2011 excavations. Photograph: David Pérez.

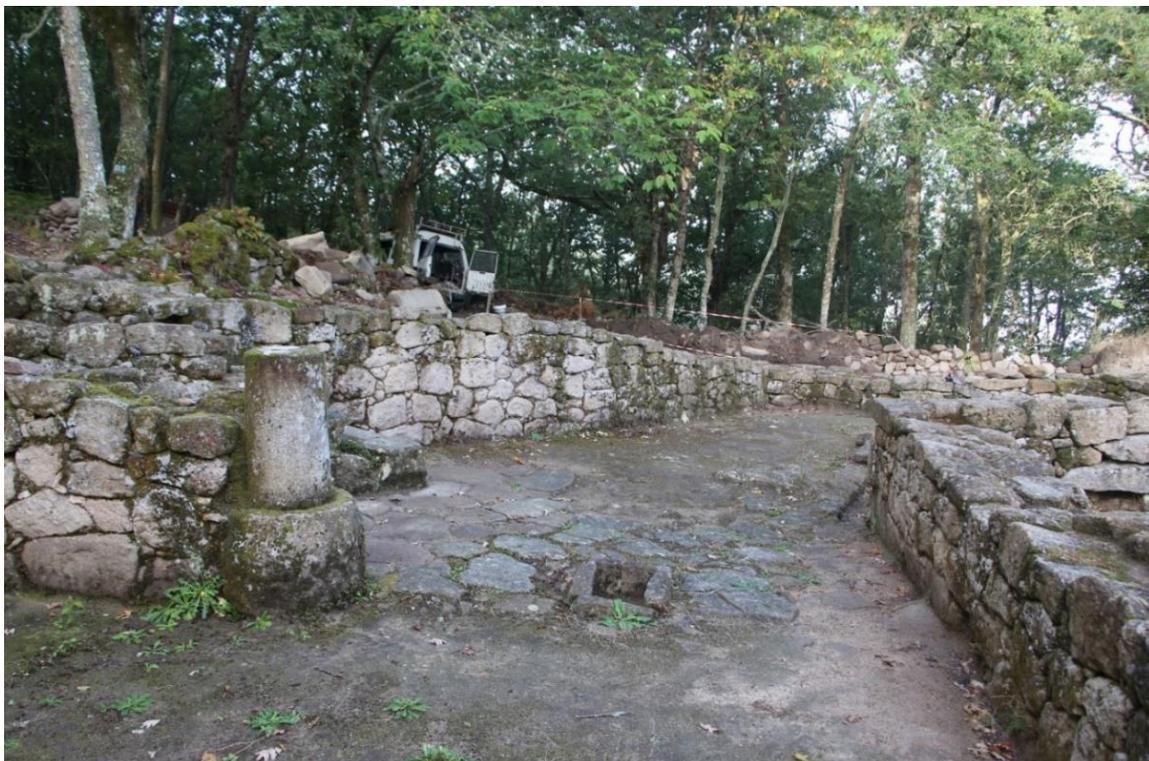
**Figure 15.** View of the site after the 2011 and 2012 works: Photograph: Council of Allariz.

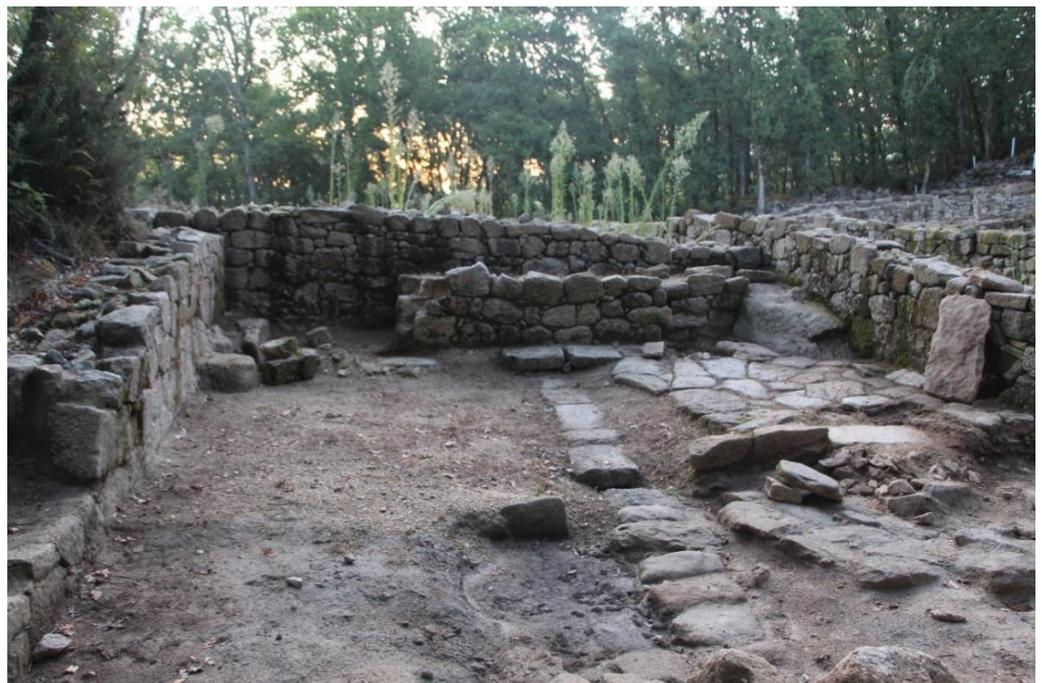
**Figure 16.** The atrium during works undertaken after the removal of the column shafts erected in 2014.

Two column shafts erected in 2014 were removed and replaced with the column bases and shafts found in 2018, whose original location was established through the examination of the excavation records. The pieces were carefully removed, and no elements in the vicinity were damaged as a result. In addition, in order to situate the four original column bases in their original position, the small earth banks erected after the 2014 excavation were dismantled from both the pavement and the back wall of the atrium (Figure 16). Before removing these added elements, the original pieces were stained with clay, following the photographs of the state of the atrium immediately before the 2014 excavation.

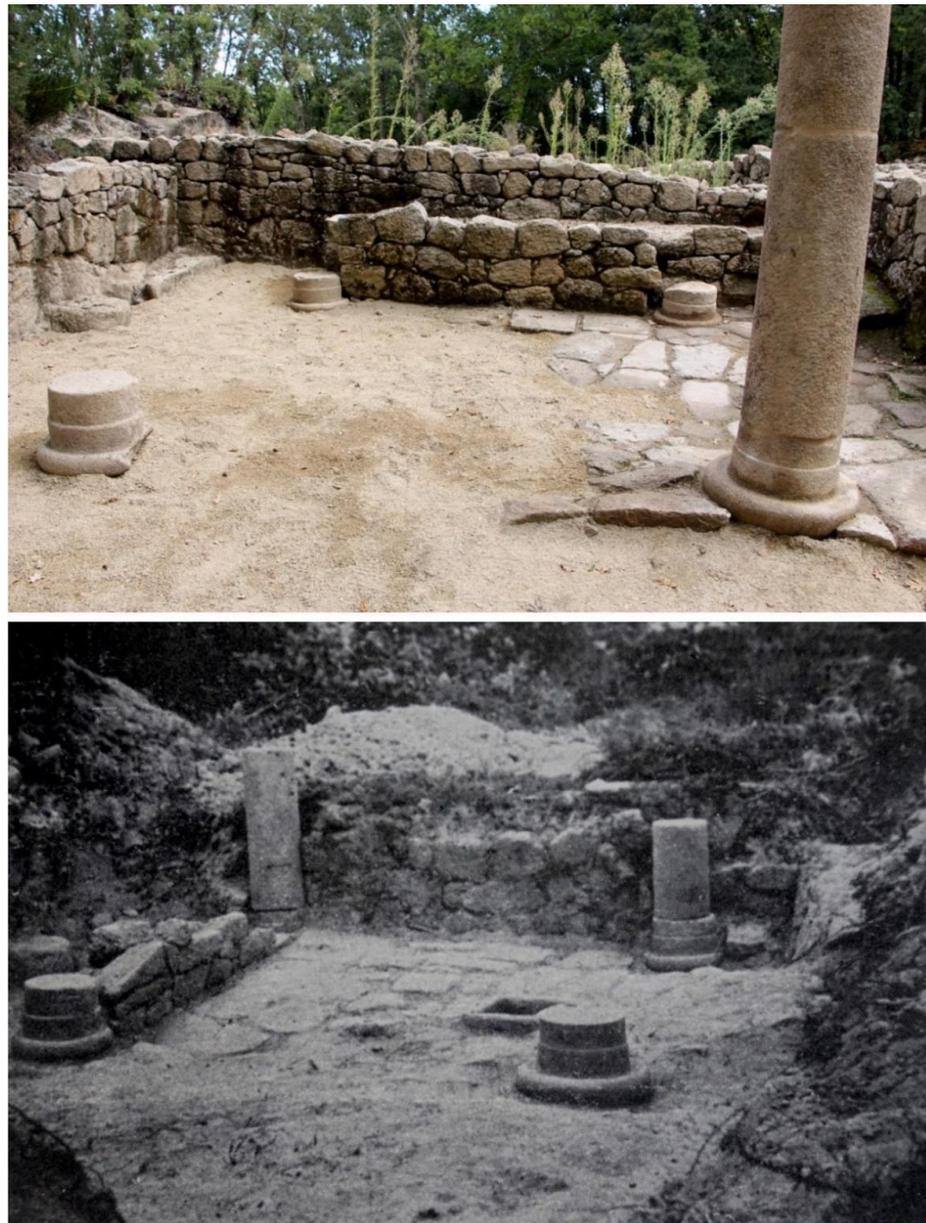
**Figure 17.** Comparison of the atrium in 1955 and after the 2019 works once the stone elements had been restored to their original location and the floor had been levelled.

After removing the foreign stone pieces, the four original stone bases were put back in their original location. The analysis of the two column shaft fragments revealed that they belonged to the same column, one of them sitting atop the other, and their lower diameter only fitted one of the bases. One of the old photographs (Figure 17) shows a small wall between the two bases on the north side of the courtyard, but this wall features in no other record, either textual or graphic, so its reconstruction was decided against. Similarly, the drain could not be restored, but its location was marked on the pavement.

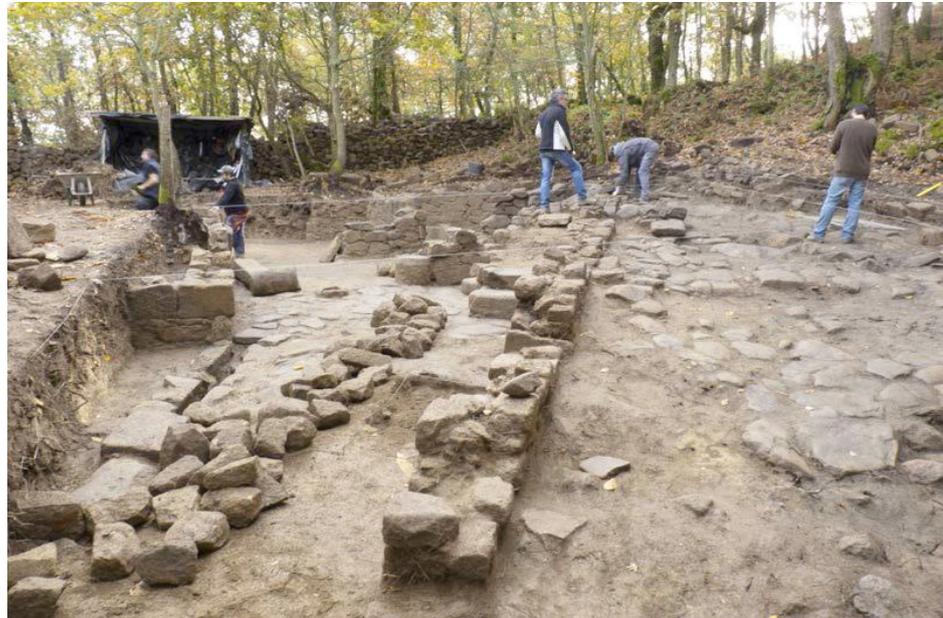
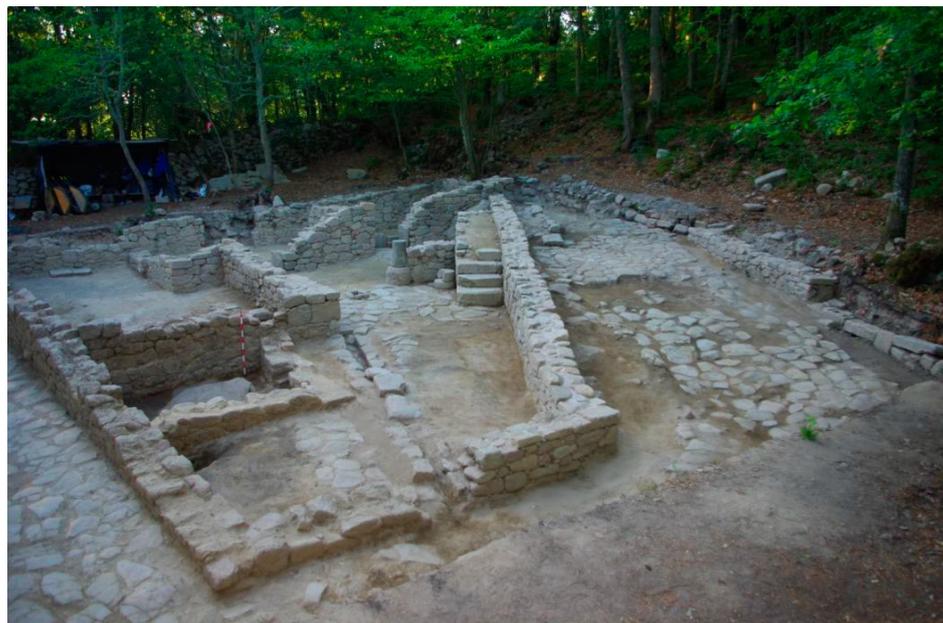
The wall that closes the courtyard to the west was excavated and backfilled in the 1950s, but none of the old photographs shows its condition at the time. The wall was found again between 2011 and 2012, and during the restoration process, several protective courses were raised. The preserved height of the wall was low, especially in the south, where it barely raised from the ground. With this information, it was thought that this might

have been the location of a threshold, which had been wrongly elevated. The presence of a drainage channel to evacuate water from the house reinforces this hypothesis, as this channel may have run beneath the threshold (Figure 18).

**Figure 18.** Above: view of the western wall in 2011; below: the wall, from the south, after the construction of the protective courses.

In order to open the entranceway, the protective courses were removed from the south end of the wall, always following the photographs and using the schist slabs placed in 2011 to separate the original wall from the reconstruction as guides. After the removal of these additions, one of the thresholds found in the old excavations (Plate VI) was placed on the entranceway [14] (Figure 19). The seat of the threshold was raised slightly to allow the channel to run underneath it. The other doors in the site were used as a model for the reconstruction, which was flush with the house's south wall (Figure 20).

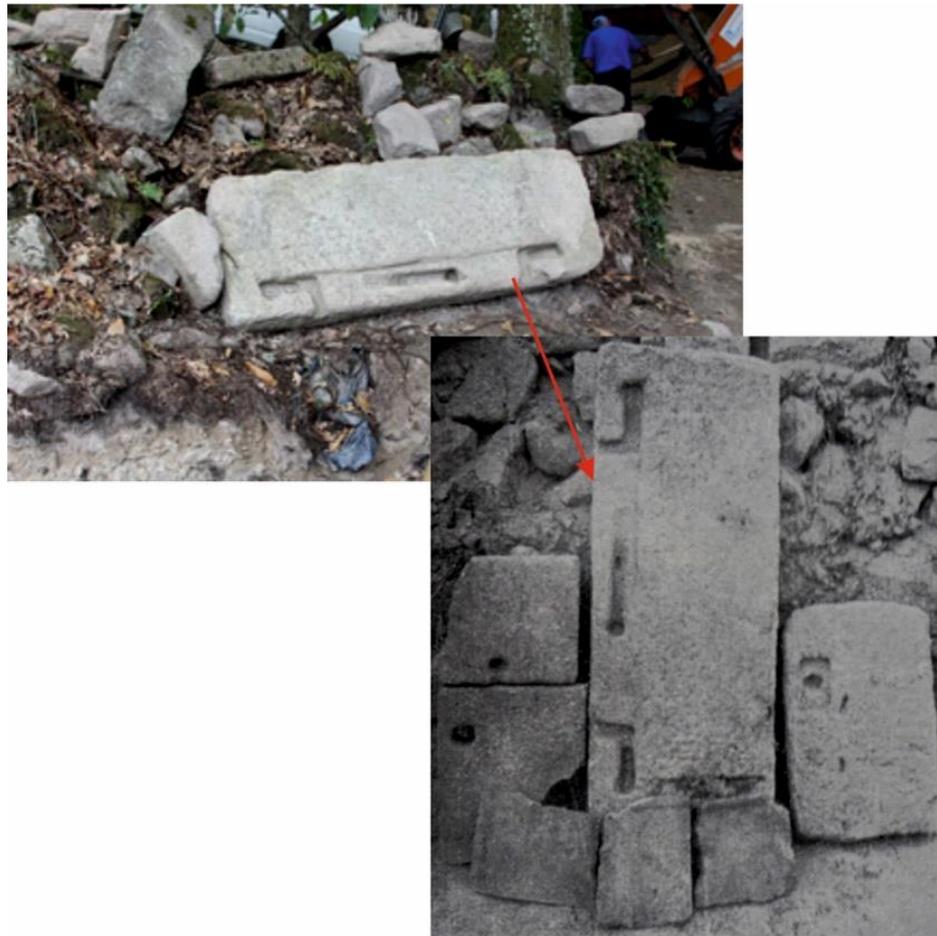
**Figure 19.** Above: view of the threshold in 2019, before it was put in place; below: the same threshold in 1955, when it was found by Conde-Valvís.

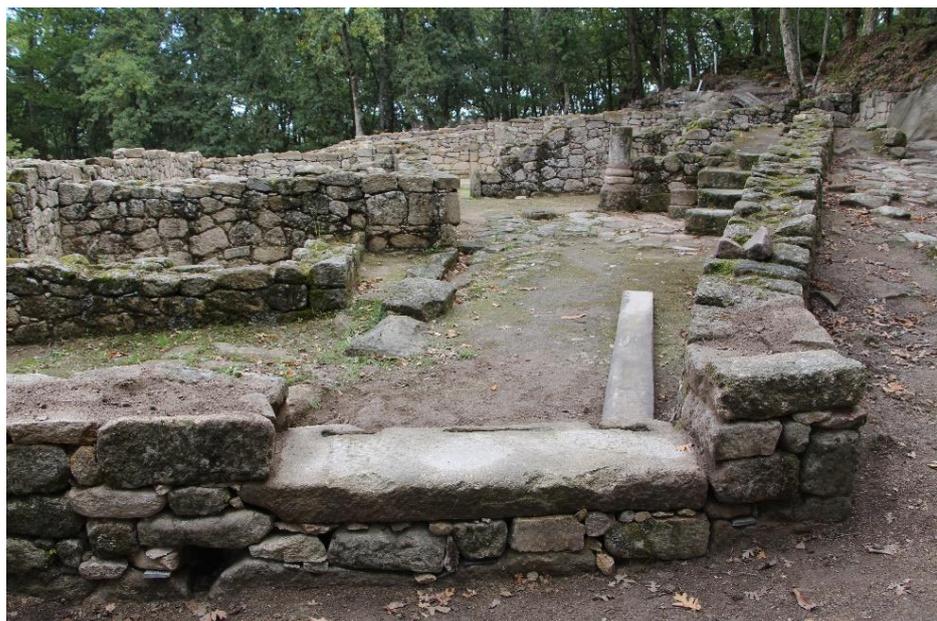
**Figure 20.** Final view of the area after the opening of the entranceway and the installation of the threshold.

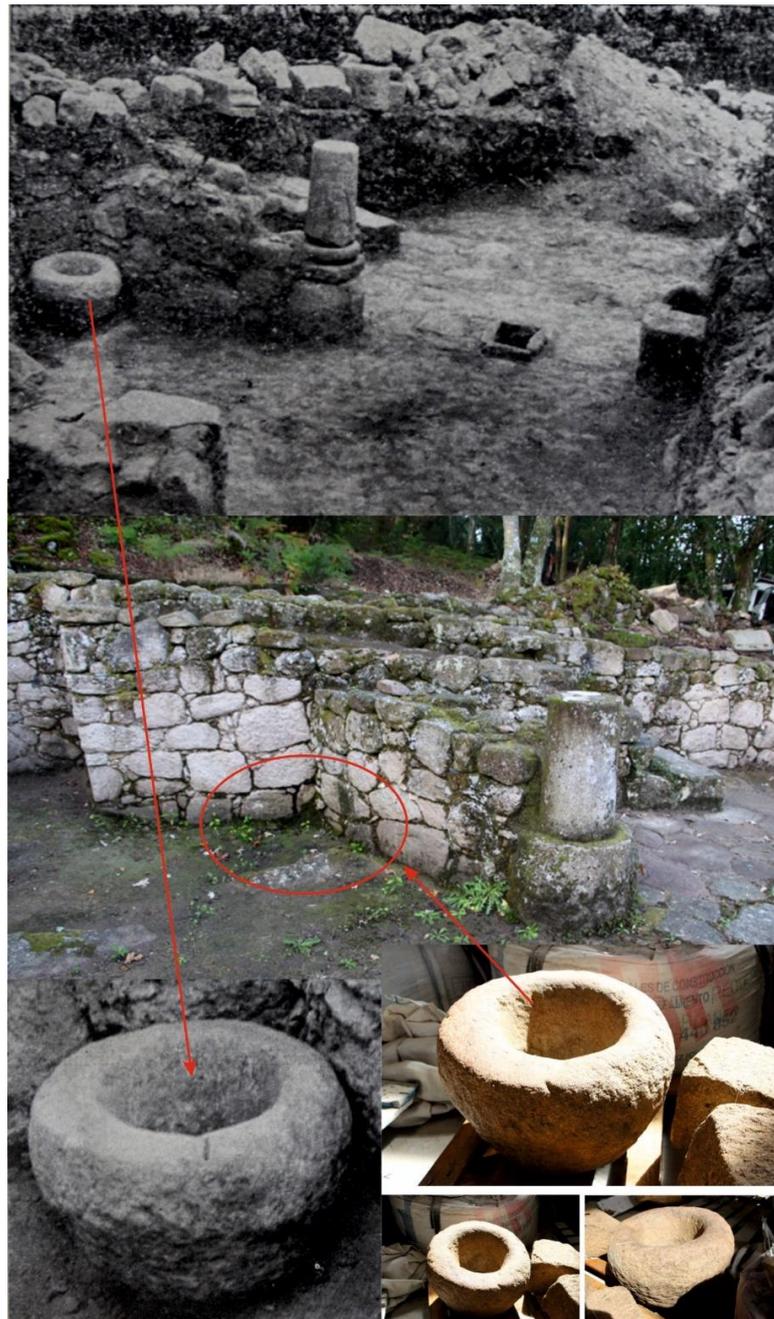
**Figure 21.** The mortar in 1955, when it was first found, and in 2019, before it was restored to its original location.

The mortar and the capital (maybe reused in Roman times as a column base) were also placed in their original position inside the courtyard [14] (Plates II and IV). It was believed that, owing to its great weight, it was safe to simply place the mortar on its own, without any other form of support, only dug somewhat deeper into the ground. The capital, on the other hand, was bound with lime mortar and used as a base for the column shaft that had already been placed on it in 2011. Although no hard evidence exists to ascertain that it was the one found and placed by Conde-Valvís for the photograph in 1955, it was very similar in terms of size and morphology, so it was thought advisable to place it on the base for the capital's own protection (Figures 21–23).
