# Lost Heritage—Architectural Replacement of an Atrium and a Courtyard of the Roman Houses of Armea (Allariz, Ourense)

**Abstract:** Francisco Conde-Valvís’s so-called “stone treasure” is a set of unique carved stone pieces, such as bases, column shafts, a mortar, and decorated fragments (trisques and rosettes), found during the 2018 excavation campaign in the Cibdá de Armea (Allariz, Ourense). They had been piled up and re-buried—no records existed as to where—at the western end of the Finca de A Atalaia, which was excavated in the 1950s under the direction of Conde-Valvís and began to be excavated again in 2011. The thorough review of the graphic and textual material available from the old excavations allowed us to determine the original archaeological context of the pieces. Most of these elements belonged to the atria of the so-called “Domus of Hexasquel” (North house) and “Domus of the Rosette” (South house). Once we established the origin of all the elements, especially with the aid of the old photographs, it was decided to reintegrate them into the site, to increase the educational and interpretive value of Armea, instead of burying them indefinitely in the warehouses of a m

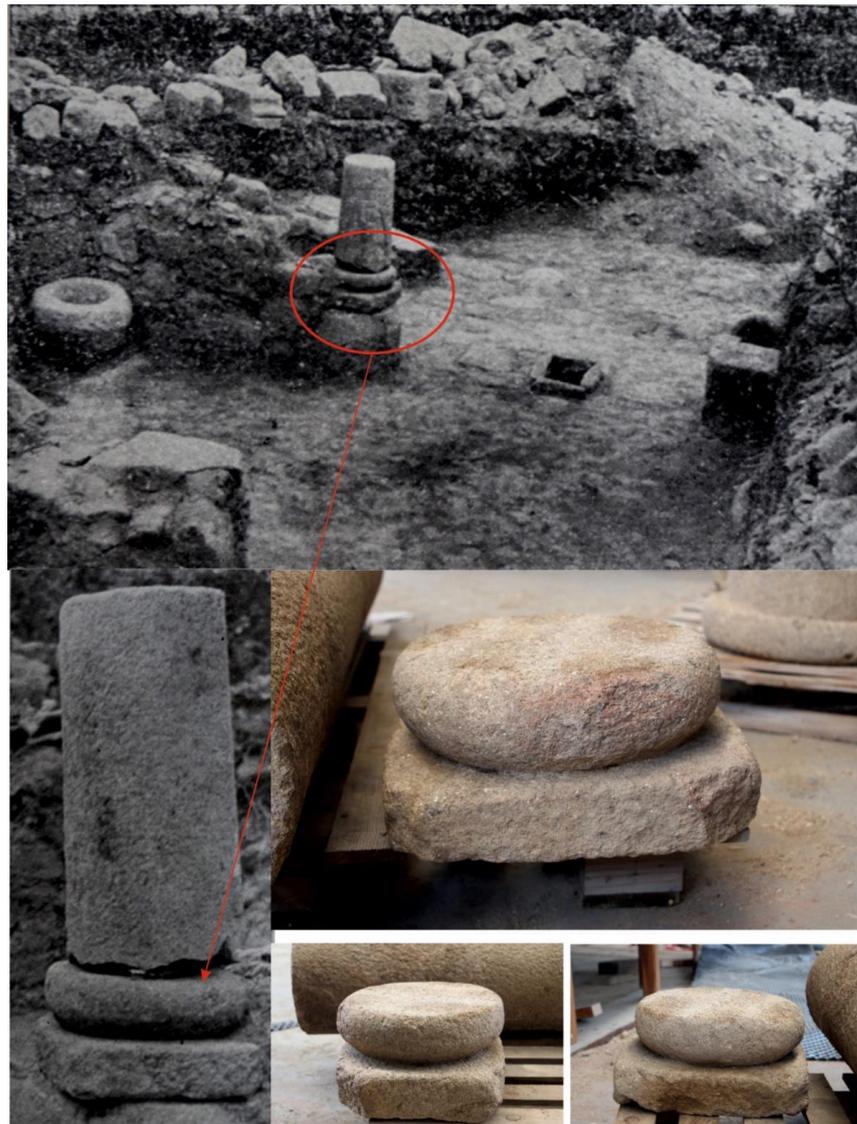
**Figure 22.** The capital in 1955, when it was first found, and in 2019, before it was restored to its original location.

The mortar and the capital (maybe reused in Roman times as a column base) were also placed in their original position inside the courtyard [14] (Plates II and IV). It was believed that, owing to its great weight, it was safe to simply place the mortar on its own, without any other form of support, only dug somewhat deeper into the ground. The capital, on the other hand, was bound with lime mortar and used as a base for the column shaft that had already been placed on it in 2011. Although no hard evidence exists to ascertain that it was the one found and placed by Conde-Valvís for the photograph in 1955, it was very similar in terms of size and morphology, so it was thought advisable to place it on the base for the capital's own protection (Figures 21–23).

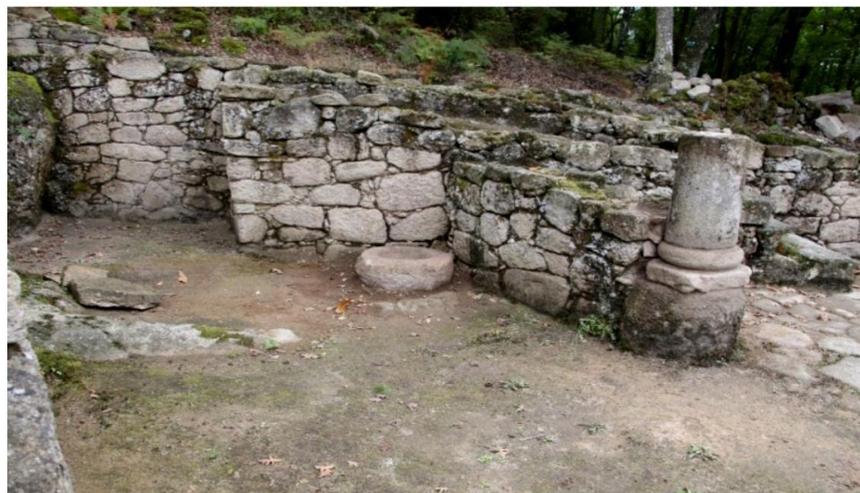
**Figure 23.** Final view of the capital and the mortar in their original location.
