# The Flight of Saint Mary Magdalene—A Case Study of the Dismantling, Repositioning and Restoration of a Votive Aedicule and Wall Painting in Nardò, Lecce, Italy

**Abstract:** The work carried out as part of construction on a ring road around Nardò (Lecce, South Italy) involved a votive aedicule attached to the perimeter wall of a rural building that had been scheduled for demolition. Provision was made for the movement and relocation of the building, dedicated to St. Mary Magdalene, to an adjacent area, in addition to the restoration of the pictorial decoration itself. The intervention was designed to conserve the building as testimony of its use for future generations, given its value and sense of identity for the local community. The project was largely conservatory, thus guaranteeing the continuity of its still active devotional function. In this sense, the restoration of the building was also associated with an educational aim of raising awareness of the importance of eco-compatible care of the landscape. So, this project highlights the importance of social, as much as environmental, sustainability.

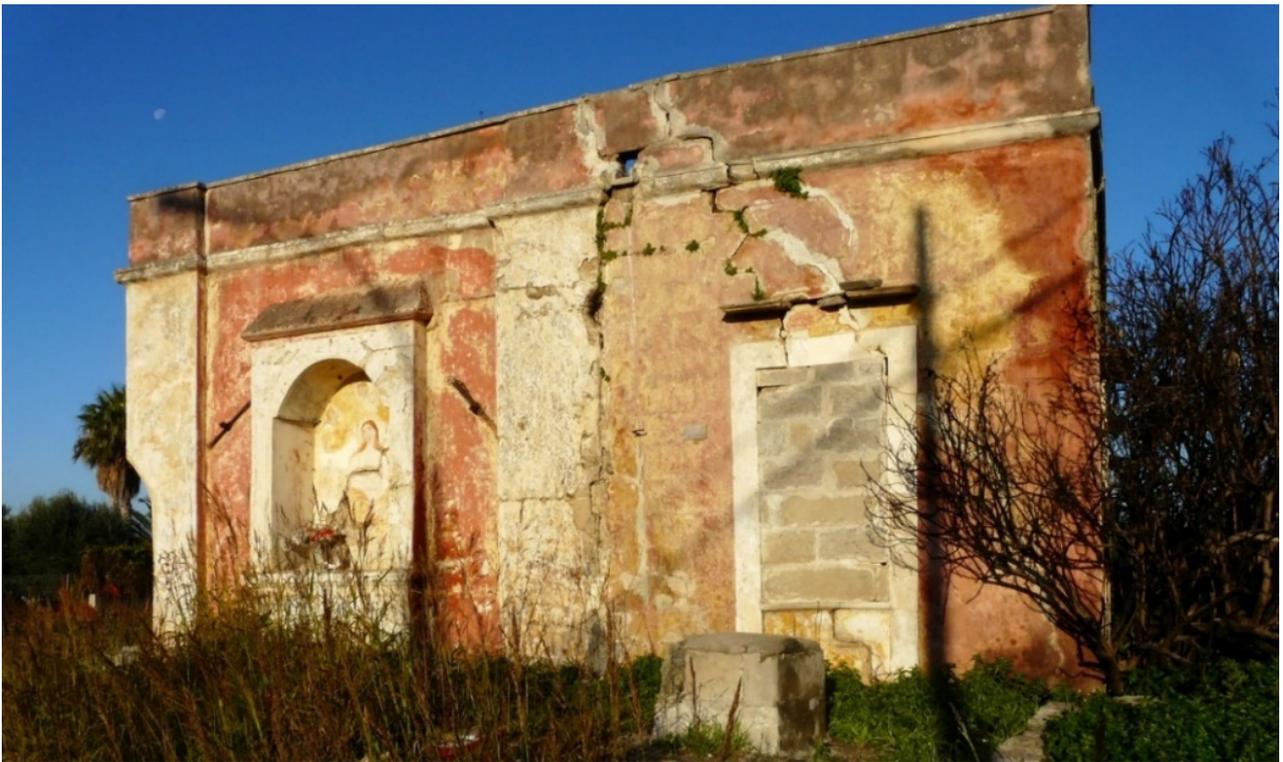
**Figure 1.** The rural building, from the southeast; on the left, the Magdalene aedicule.

The small rural building, devoid of architectural value that housed the Magdalene aedicule (Figure 1) in the countryside around Nardò, northwest of the ancient village was at the crossroads of a historic road system. The road connects the town to the sea, close to Sant'Isidoro (Figure 2) [1–7], passing through the town's San Francesco gate to the Castle of Agnano, on to Masseria Corsari and Villaggio Resta. Even though the area is now besieged by the expansion of the urban periphery, the building and its aedicule still retains its rural characteristics and retains the toponym La Maddalena, referring directly to Saint Mary Magdalene (Figure 3).

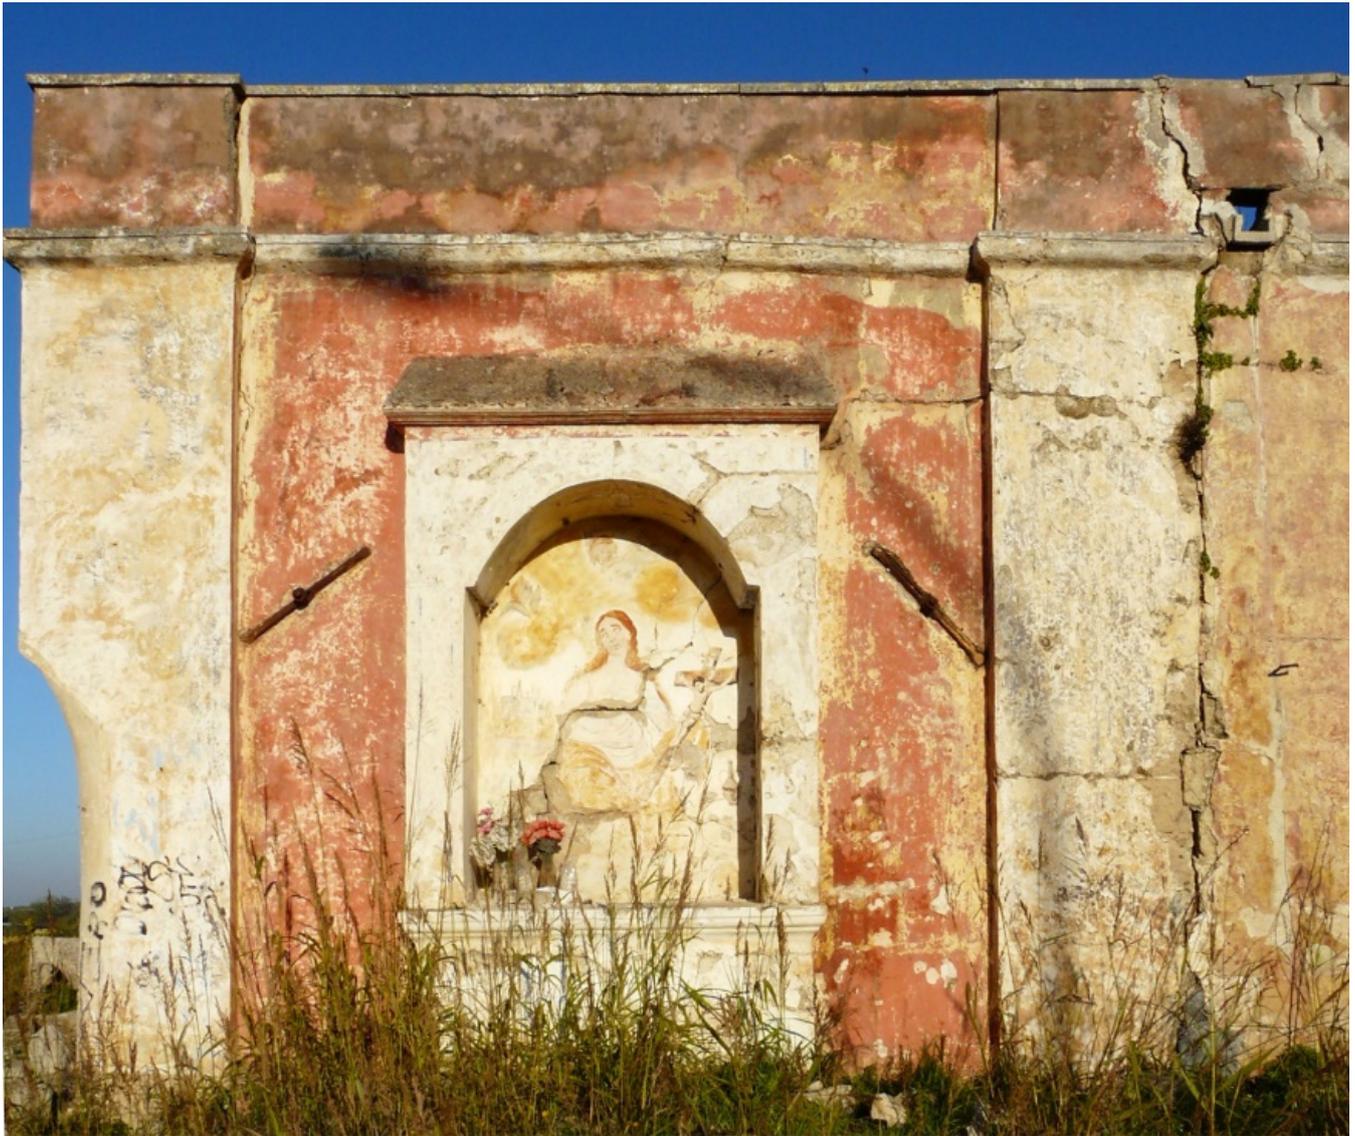
**Figure 4.** Votive aedicule.

The aedicule, entirely stuccoed and decorated, sits on a base resembling an altar table finished at the top with a moulded cornice. On the front are fragmentary traces of a now illegible epigraph. Flanked by two lateral jambs, it ends at the top with an arch surmounted by a further cornice protected by a short roofing overhang made with opus signinum (Figure 4). It leans against a plastered curtain wall framed by two pilasters (the one on the left rounded to accommodate passing vehicles), delimited at the top by a cornice surmounted by a parapet protected by a layer of Lecce stone paving.

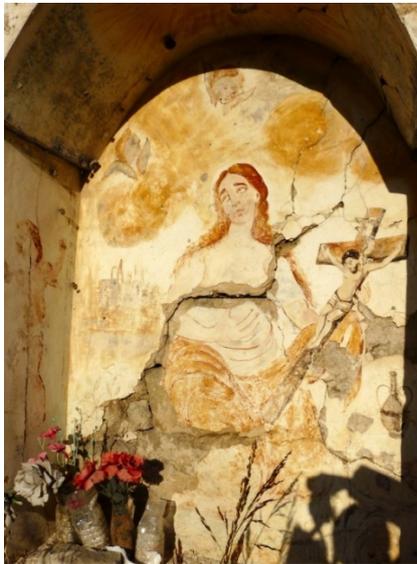
The painting here is enclosed in a minimal architecture. It is a poor and simple reworking of the canons of the local iconographic tradition. Mary is depicted in the center of the aedicule, kneeling with her long hair loose on her shoulders, her head bowed and

her gaze turned to heaven. She holds the Crucifix with her left hand, while her right hand is delicately placed on her abdomen as if to protect it. In addition to the wooden Crucifix, we note the ointment jar and the skull which represent the iconographic attributes of the classical tradition. In the background, we see a sky with clouds enlivened by two cherubs and a cluster of houses, which could refer to the town of Nardò (Figure 6a,b).

**Figure 6.** Central panel, general (a) and particular (b).

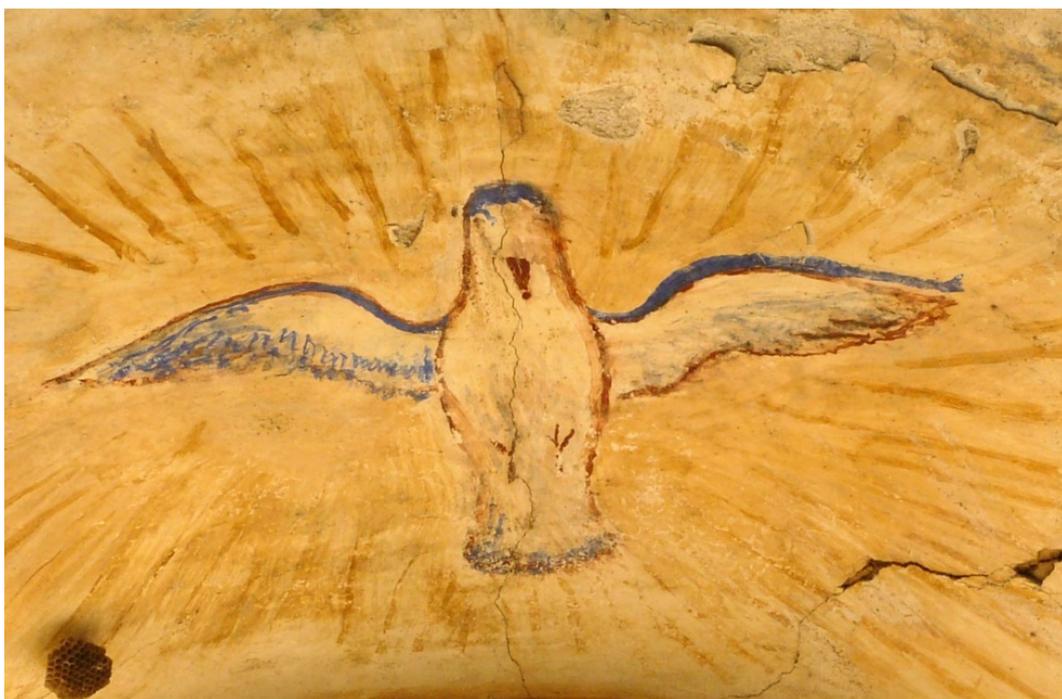
**Figure 7.** The Holy Spirit.

In the intrados of the summit arch, a dove with a radiated crown, a symbol of the Holy Spirit, is depicted (Figure 7); in the left jamb, there is an angelic figure while the one on the right houses the effigy of the patron Saint of Nardò, *San Gregorio Armeno* (Saint Gregory the Armenian), in the robes of a bishop in a gesture of benediction.

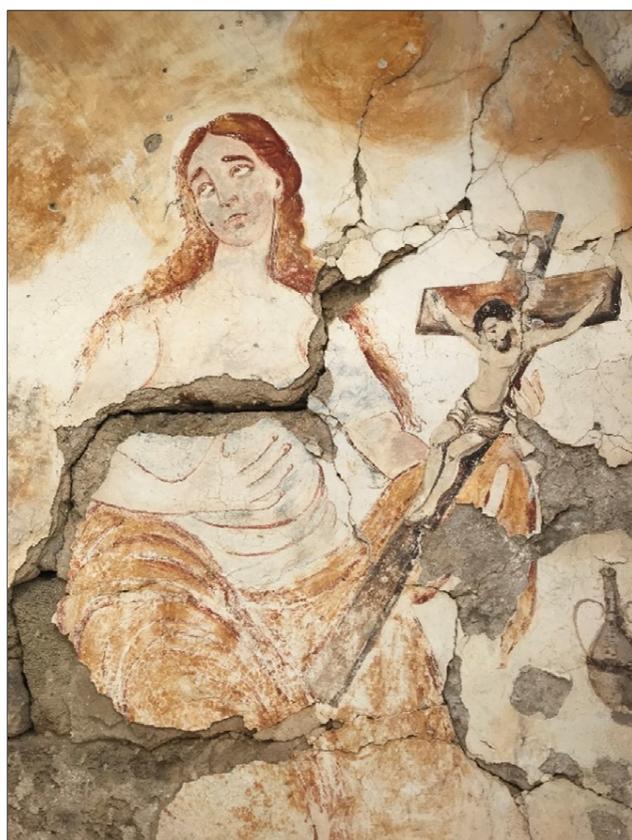
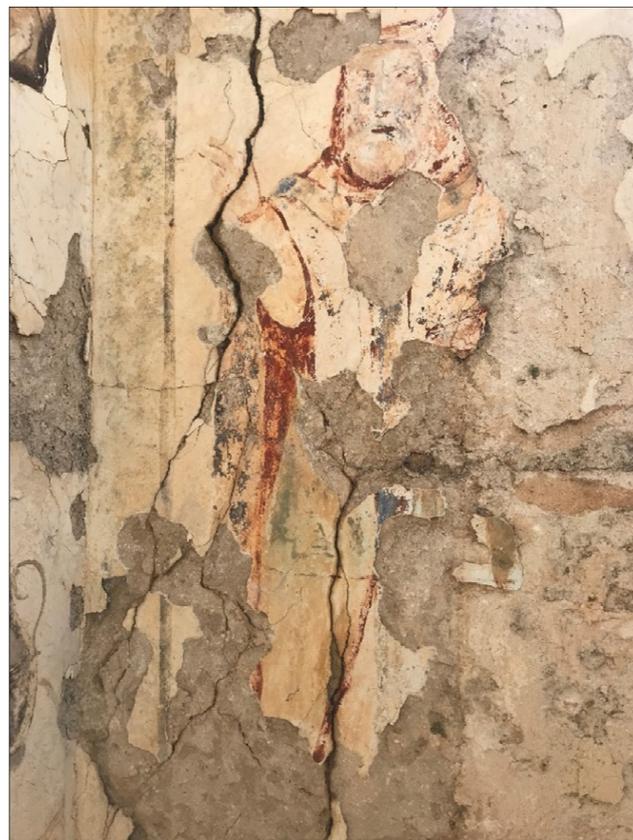
**Figure 8.** Details highlighting the poor state of conservation: St. Mary Magdalene (a); *San Gregorio Armeno* (b).

The pictorial decoration appeared in a very bad state of conservation. It is a “mixed” painting, with “dry” parts—lime paint, probably tempera—on single-layer plaster laid on the masonry face in regular ashlars of local tuff (Pliocene biocalcarenite). Execution appears simple and without the canonical rough coat-*arriccio-intonachino* stratification, which would have been typical of better-quality wall paintings, especially when using the *a fresco* or *mezzo fresco* techniques.

Adhesive qualities of the plaster to the masonry support were compromised in several points due to the poor grip qualities of the underlying stone, favoring its detachment with the consequent formation of pockets and visible areas of layer lifting, which entailed the loss of parts of the paintings (lacunas), concentrated above all in the intradossal portion of the vault. The plaster, in addition to a dense network of micro and macro cracks, has suffered widespread biological attack (biological patina) and surface deposits.

Generally abraded due to exposure to atmospheric agents, the pictorial film presented lacunas and was fragile and partially or totally missing, mainly in the lower part of the painting, with the greatest loss in the lower area of the image of Mary Magdalene and *San Gregorio Armeno* (Figure 8a,b).

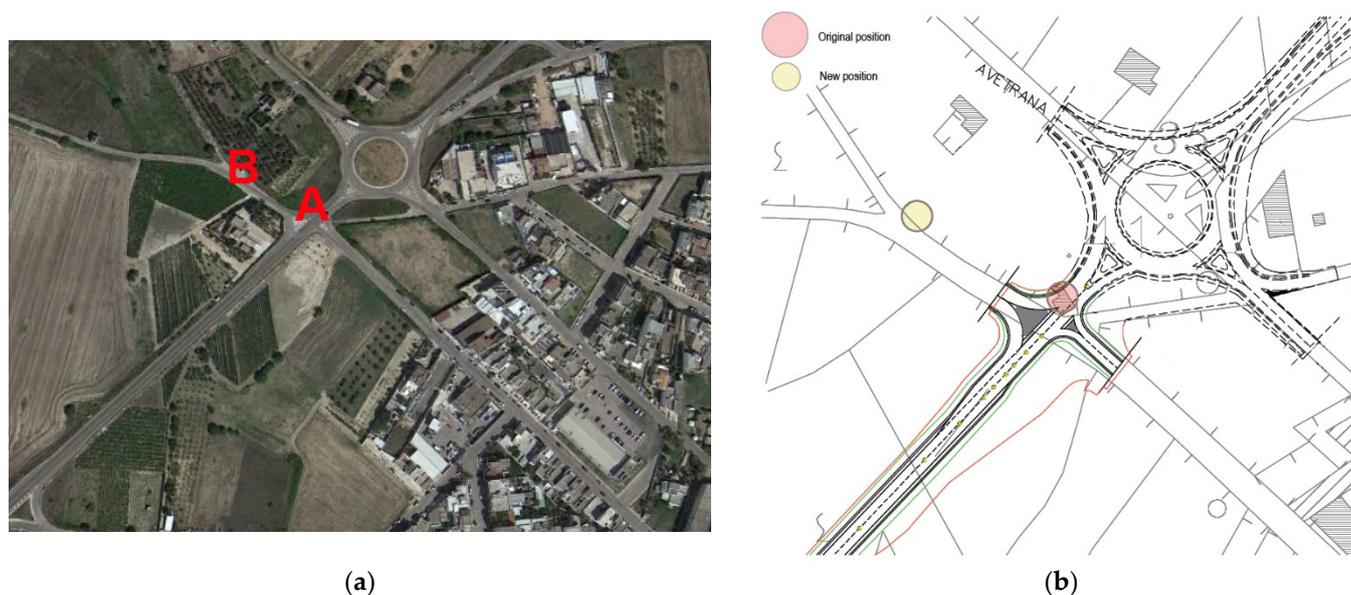
**Figure 9.** Satellite image (a) of the original location of the building (A) and of the new location (B). Project plan on and aerophotogrammetric map (b).

Returning to the aedicule discussed here, the solution proposed was disassembly, anastylosis of the building, and relocation to a bordering area, compatible with safety standards and to the new road layout. In consideration of the inseparable relationship between the aedicule, the historical road system and the desire to maintain an active devotional function, an unused area of municipal property was found a short distance from the original position along Via dei Bernardini (Figure 9a,b).
