Article

A Critical Assessment of the Current State and Governance of the UNESCO Cultural Heritage Site in Cartagena de Indias, Colombia

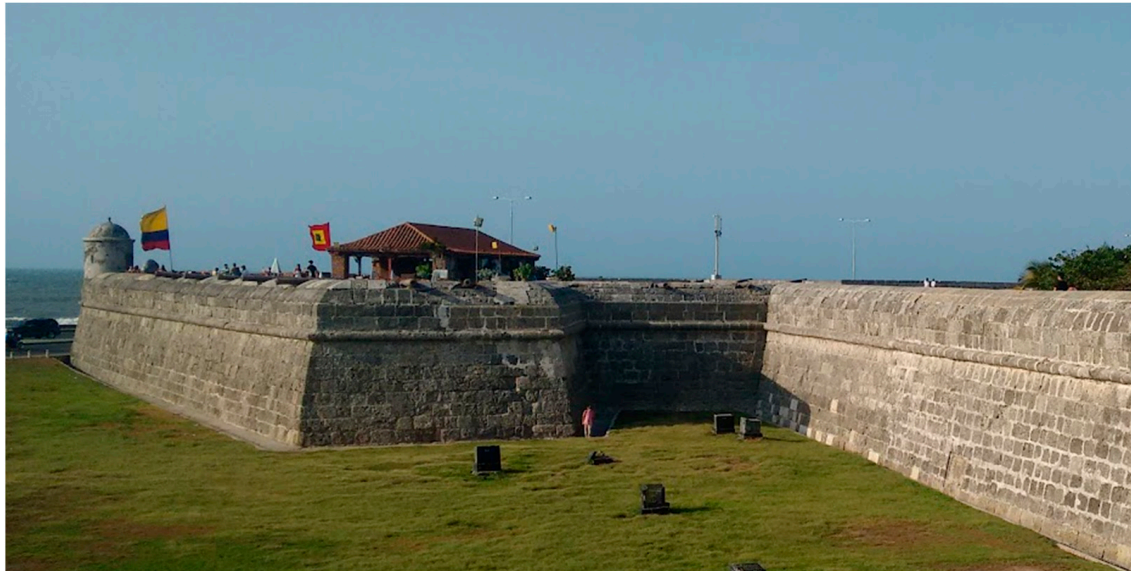
Figure 2. The Santo Domingo Bastion is the oldest section of the fortification.

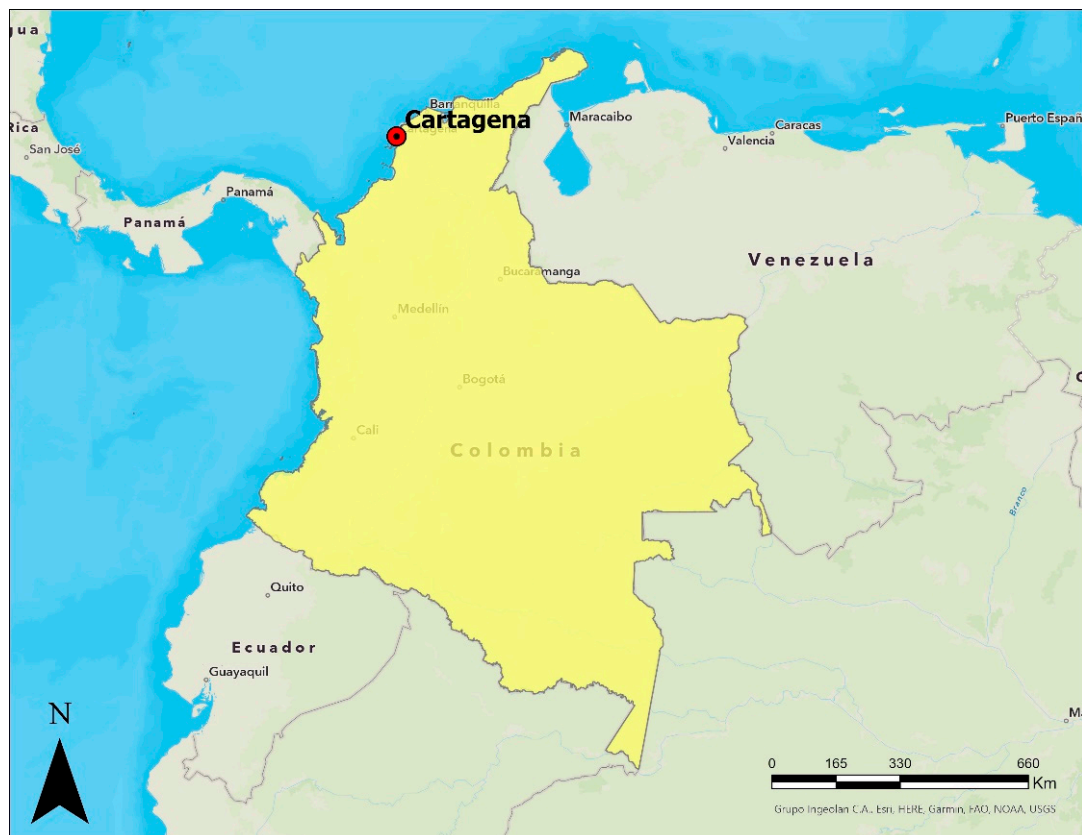
Figure 3. (a) General localization of Colombia; (b) Location of the Cartagena World Heritage Sites.

Cartagena de Indias is a historic port city located on the Caribbean coast of Colombia, founded in 1533 by the Spanish crown (Figures 2 and 3).

The city's rich cultural heritage has been recognized by UNESCO, which declared the historic center and surrounding fortifications of Cartagena de Indias a World Heritage Site in 1984. The site encompasses a 100-hectare area that includes 4 km of fortification system (Figures 2 and 3), the defensive fortifications of the Cartagena Bay, and the San Felipe Castle.

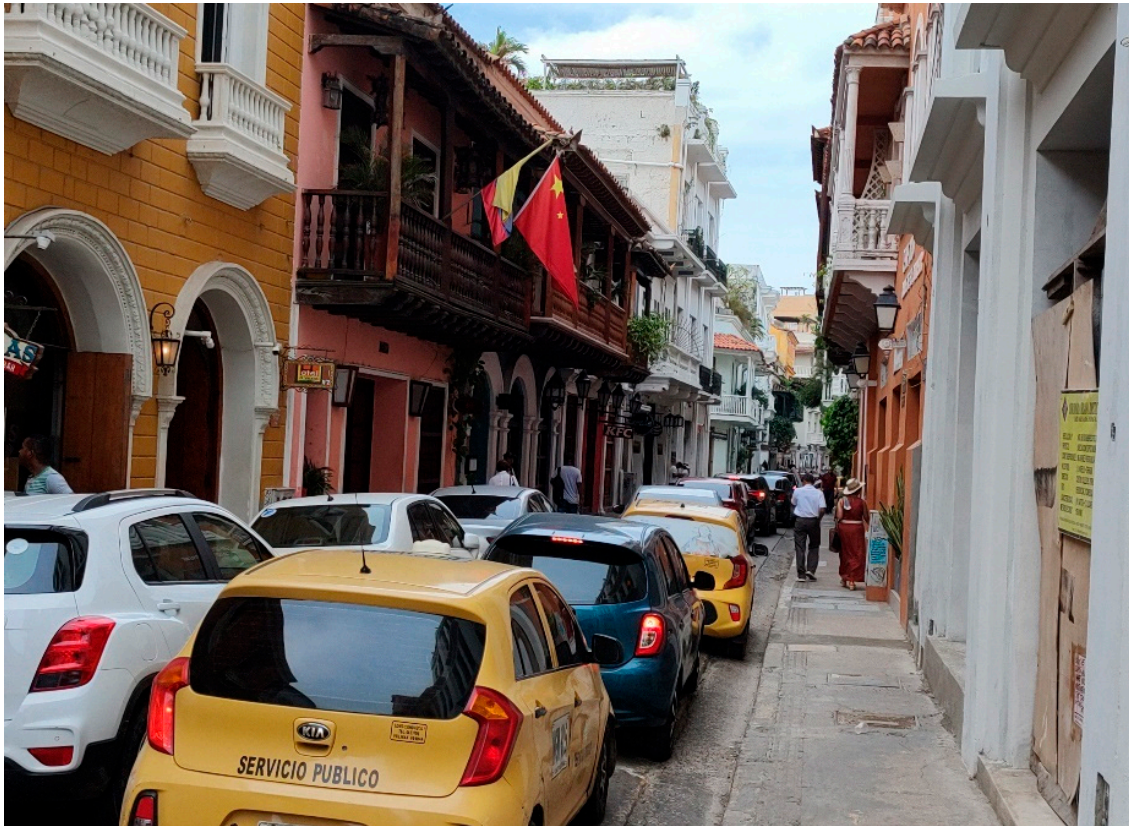
The first problem is related to the lack of regulation of vehicular traffic in the narrow streets of the historic center, a heritage area with tens of thousands of tourists and residents who travel daily (Figure 6).

Figure 6. Typical situation of vehicular traffic in the historic streets of Cartagena during non-peak hours. Furthermore, cars parked in the city center without any type of restriction (neither payment nor time control) are noted on the left side. This situation is widespread all over the city.

The circulation of vehicles in the narrow streets of the historical district not only engenders noise and congestion but also poses a significant hazard to the structural integrity of heritage buildings and monuments. Furthermore, this situation leads to an unpleasant experience for visitors and locals and exacerbates the decay of heritage components such as pavements, facades and walls, frequently composed of delicate and fragile materials. The issue of total or partial pedestrianization of the historical center, which has received inadequate attention to date, is interrelated with this problem. Moreover, the absence of parking regulations in the heritage zone results in residents, employees, tourists, and the general populace parking inappropriately, thereby restricting the already-limited space available for vehicular traffic or loading and unloading goods for commercial activities. This often triggers long queues of honking vehicles in the downtown streets, contributing to significant noise pollution.

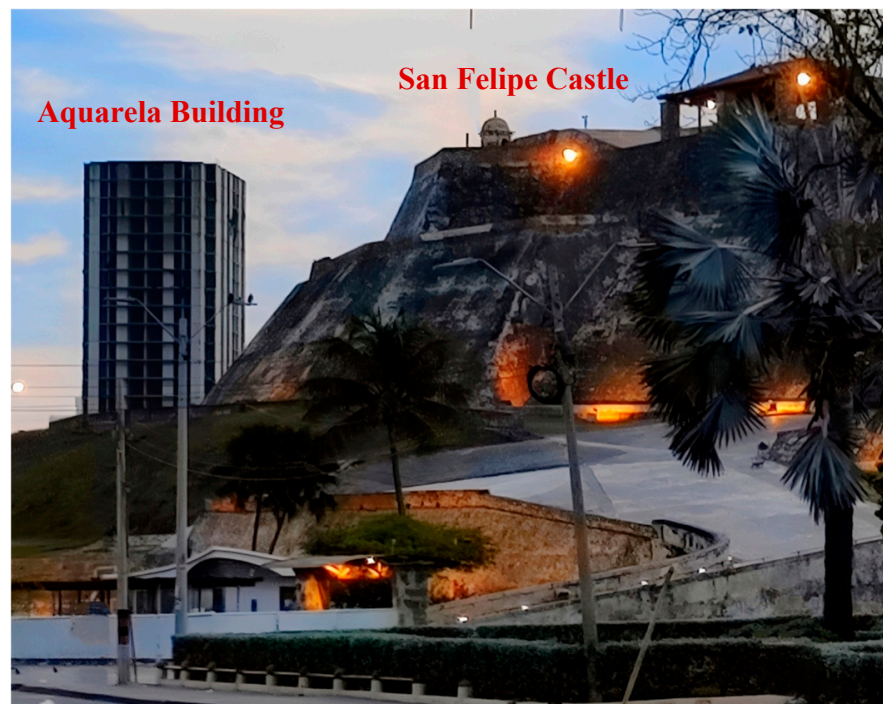
The eighth problem refers to the construction of the Aquarela project located less than 200 m from the San Felipe de Barajas Castle in the area of heritage interest. This real estate project initially included five towers between 31 and 32 floors (approximately 100 m high) each, [62]. It is worth mentioning that the castle at its highest point is 40 m high. This would disturb and destroy the historical visual and symbolic relationship between the castle and its surroundings, jeopardizing one of the attributes that support the property's outstanding universal value. The construction of this real estate project stopped when the first tower under construction had barely 20 floors (60 m high, which is its current state). The competent authorities and the public realized only at that moment that this project was going to alter the image of the historic urban landscape, creating a visual interruption in the horizon line. In addition, its height and its modern design contrast with the colonial architecture of the city, which negatively affects the aesthetics and cohesion of the historic center. This situation was generated due to the lack of a comprehensive heritage management plan and the lack of effective regulation by the competent authorities in heritage preservation. As mentioned above, UNESCO, in one of its recent committees on the heritage of Cartagena, expresses its strong concern, in line with the evaluation of the ICOMOS advisory mission of 2017 [28,58,59], on the impact of the Aquarela project on the values that support the outstanding universal value (OUV) of the property. Similar conclusions are underlined by the National Council for Cultural Affairs on this point. However, 7 years after the ICOMOS report on the subject and countless legal proceedings, the building is still there, as shown in Figure 7.

Figure 7. Aquarela Building breaks the horizon in the heritage area of interest at less than 200 m from San Felipe Castle.

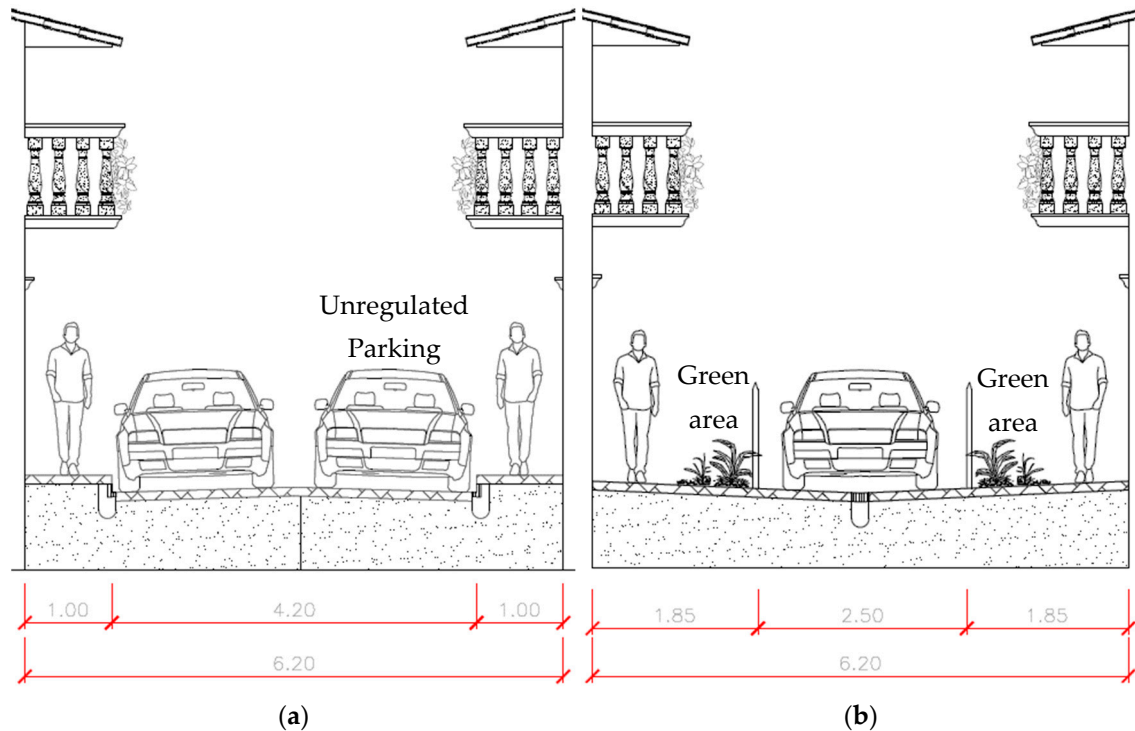
Figure 10a shows the typical cross-sectional profile of the historic streets of Cartagena. Its classic profile is observed, with more than 70% of the space dedicated to vehicular lanes, which thus become abusive parking lots, generating an oversaturation of vehicles in the center in search of parking. On the other hand, Figure 10b proposes a reduction in the space for the vehicular lane, eliminating the possibility of parking in the narrow streets of the center in order to reduce vehicular flow. Additionally, the space for pedestrians is expanded. It is suggested to create a green space in the streets, now completely absent.

The change in the slope of the street profile will allow for optimizing the maintenance of rainwater drainage. Spaces for unloading and loading goods should be identified in the city with a specific study on the concentration of commercial activities that have the greatest demand. There is currently no strategy to deal with this problem whereby loading and unloading vehicles enter, exit, and park without any restrictions of any kind.

Figure 10. (a) Current Street transversal section scheme; (b) Improved Street transversal section scheme proposed.
