Structural Behaviour and Strength Evaluation of a Venetian Church through Finite-Element Analysis

Abstract: The evaluation of the structural behaviour of a masonry Venetian church with a pointed barrel vault is presented in this paper through an analysis following the necessary steps of a monument study. With a detailed geometric model and material estimation, the finite-element method is used to investigate the influence of specific structural parts of the structure, like masonry buttresses and wall connections, on the structural behaviour. The operational modal analysis is used to identify the structure dynamically. The comparison of the eigenfrequencies, which are estimated by in situ measurements and finite-element modal analysis, is used to perform a model identification. The response spectrum analysis, the static analysis after the subsistence of some parts following strengthening proposals, and the transient analysis of specific seismic excitations are used for the evaluation of the structural behaviour. The purpose of the work is to highlight the need for an interdisciplinary approach to the study of a monumental complex structure, regardless of its scale. The coexistence

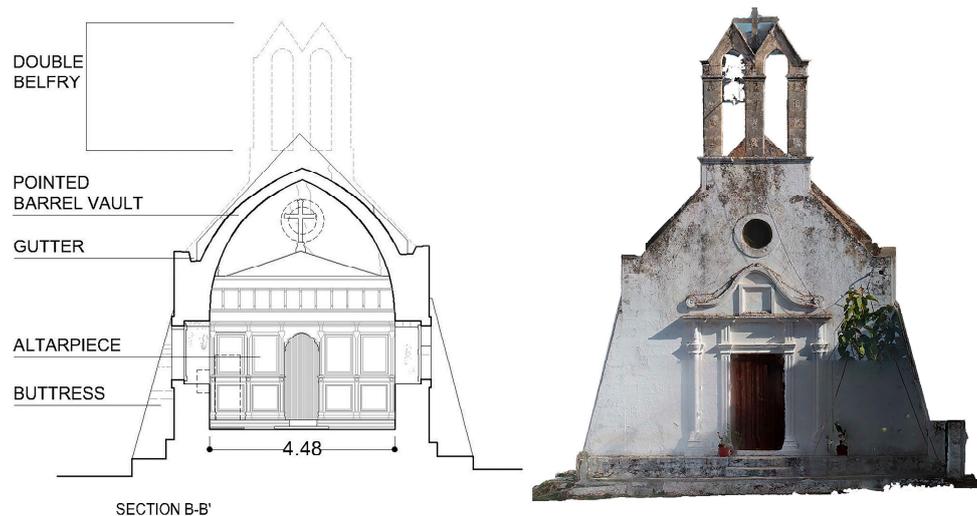
Figure 4. Section B-B' and west façade with the main entrance (orthophoto).

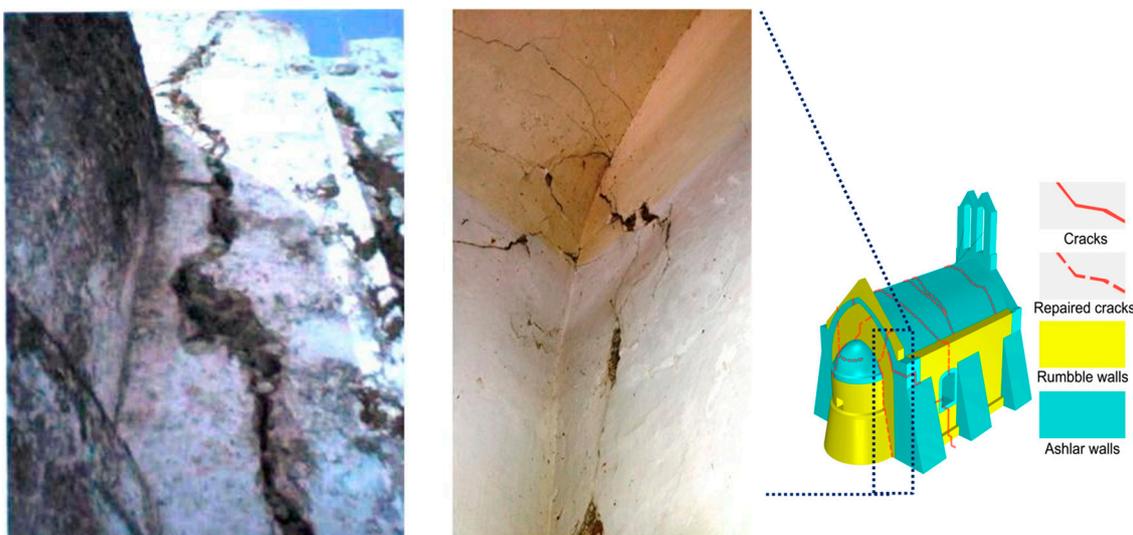
- The northeast corner, along with the buttress, is almost detached, with a range of cracks from the top to the foundation, as shown in Figure 8. The active mechanism seems to be a combination of ground subsidence and seismic excitation with a simultaneous overturning tendency. In addition, the failure of the mortar of the gutters causes the accelerated corrosion of the masonry since the water flows into the joints and the local cracks.

Figure 8. External (photo from 28th Ephorate of Antiquities of Chania, 2007) and internal damage on the northeast corner of the church (2022).

1. Archaeological research and excavation to uncover new evidence;
2. Excavation of the foundation for autopsy and then deciding how to strengthen it either using piles or by adding reinforced concrete beams;
3. Use of joint mortars of the same composition as existing ones, limestone of the same dimensions, stone jointing (with stones and metal plates);
4. Soil filling beneath the concha is approximately 0.50 m;
5. Maintain and recover old gutters according to the trace on the wall;
6. Restoration of belfry;
7. Colour restoration on the exterior, with priority to preserving the existing colour traces, based on witness reports.

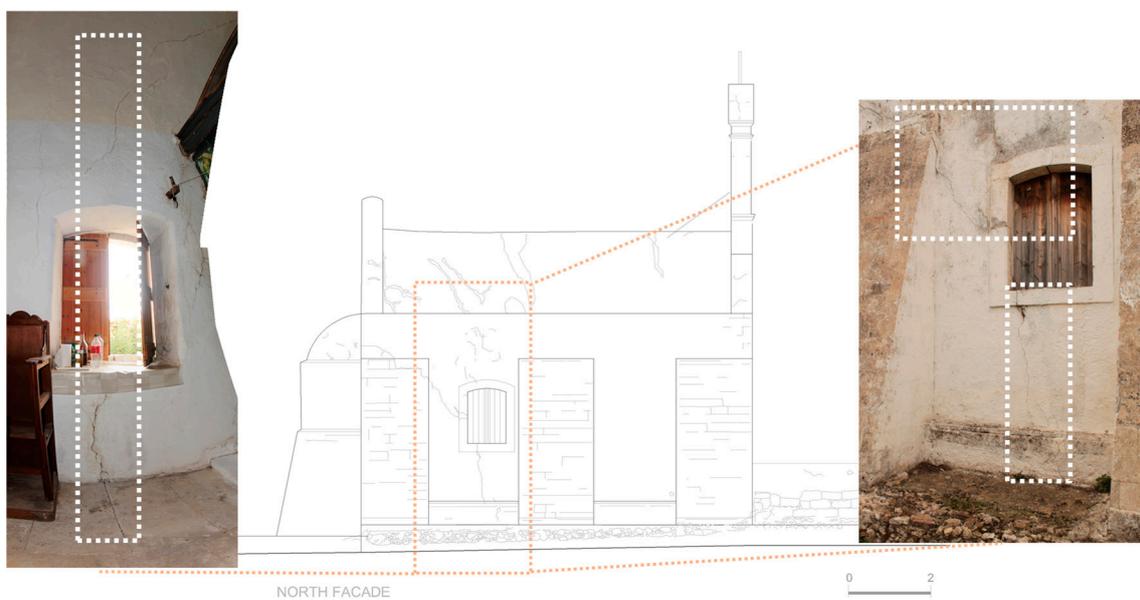
- A tendency also to cut off the eastern half of the church in a direction towards the northeast corner is indicated through continuous cracks, as shown in Figures 9–11.

Figure 11. Internal and external damage to the north masonry of the church (2022).

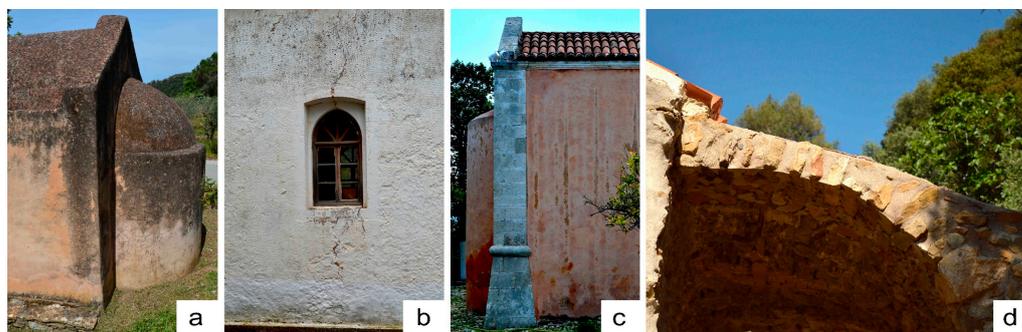
Similar damage and erosion are present in churches that are located in the Chania region: (a) Biological colonization on Saint George's church at Drakena village; (b) Constructive cracking on Prophet Helia's church at Mournies; (c) Rising damp, erosions due to rain, efflorescence, and discoloration on Saint George's church at Vrysses (Figure 13). The type of vault construction can be seen in the vault of Saints George and Nickolaos church (Figure 13).

Figure 13. (a) Biological colonization on Saint George's church at Drakena village; (b) Constructive cracking on Prophet Helia's church at Mournies; (c) Moisture problems on Saint George's church at Vrysses; (d) Construction detail of dome on Saints George and Nickolaos church (author).
