Article

# Localization of Cracks in Concrete Structures Using an Unmanned Aerial Vehicle

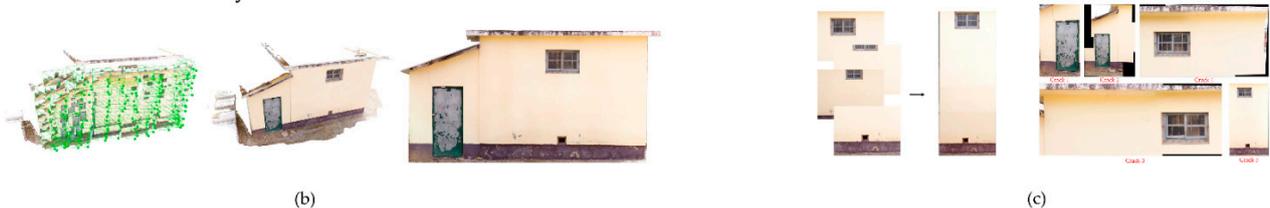
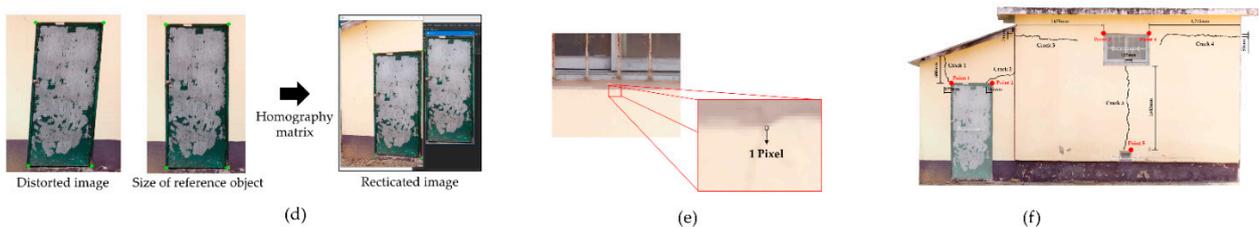
**Figure 1.** Overview of the UAV-based concrete crack localization: (a) Drone-based aerial photography;

(b) Point cloud-based orthoimage generation for estimating sizes of reference objects; (c) Construction of image stitching-based reference object and crack visualization image data; (d) Image rectification using reference object size-based homography matrix; (e) Estimation of unit pixel size by defining the relationship of reference objects in orthoimage and crack images; (f) Estimating the relative position of cracks with respect to the reference object using the unit pixel size.

Figure 1 presents a schematic of the methodology for the UAV-based localization of cracks in concrete structures. The UAV-based concrete crack localization method consists of three steps as follows: (1) Data acquisition: drone-based aerial photography. (2) Construction of analysis data: (a) Point cloud-based orthoimage generation for estimating sizes of reference objects and (b) construction of image stitching-based reference object and crack visualization image data. (3) Crack localization: (a) Image rectification using reference object size-based homography matrix, (b) estimation of unit pixel size by defining the relationship of reference objects in orthoimage and crack images, and (c) estimating the relative position of cracks with respect to the reference object using the unit pixel size.

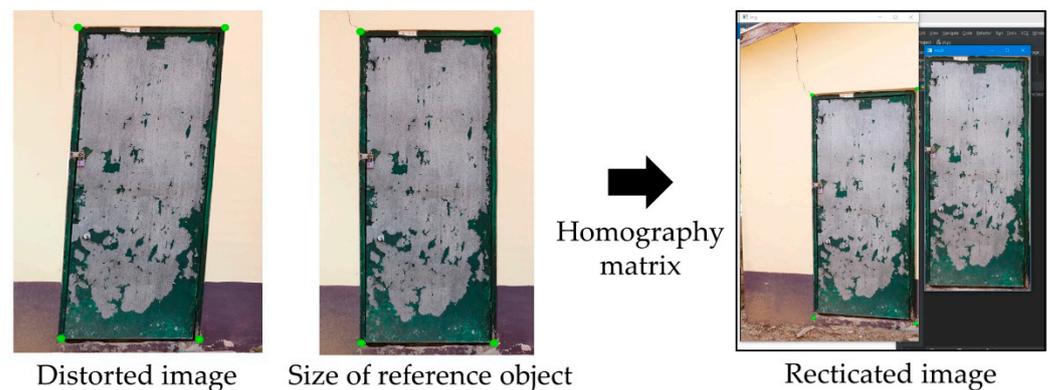
**Figure 2.** Image rectification using a homography matrix based on the size of the reference object.

In the process of image stitching before crack localization, if an image captured by a camera is used, image distortion may occur because of different parallax. By applying a homography matrix, it is possible to rectify image distortion due to parallax [34]. The feature points used in a homography matrix can be set with the size estimates of the reference objects using the point cloud-based orthoimage data as constructed in Section 2.3 [35]. Figure 2 shows image rectification using a homography matrix based on the size of the reference object.

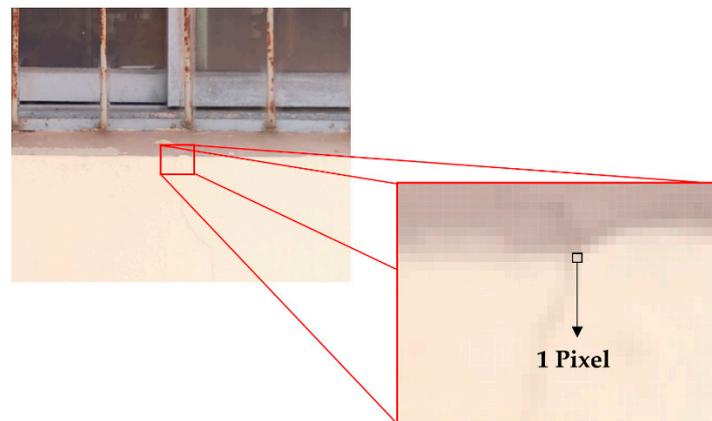
**Figure 3.** Unit pixel size for the analysis data image.

In the next step, based on the size of the reference object using the point cloud-based orthoimage data and the reference object and crack visualization image data, the unit pixel size was calculated. Figure 3 shows the unit pixel size of the analysis data constructed in this study.

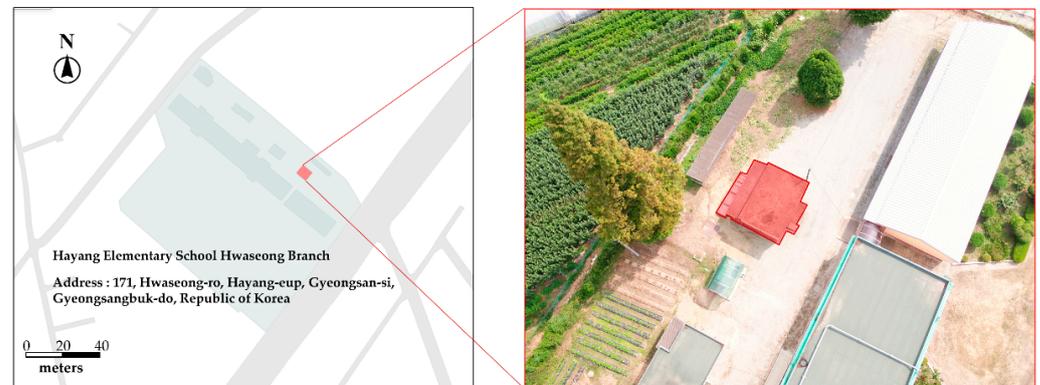
**Figure 4.** Overview of target site.

A study area was selected for the testing and verification of the proposed method of localizing cracks in a facility based on a rotary UAV of the Inspire 2 model fitted with a high-resolution camera. The target site was an aging annex building of an elementary school

located in Gyeongsan-si, Gyeongsangbuk-do, Republic of Korea. Cracks and reference objects were identified on the exterior of the facility, enabling the estimation of the relative position of the cracks. The overview of the target site is shown in Figure 4.

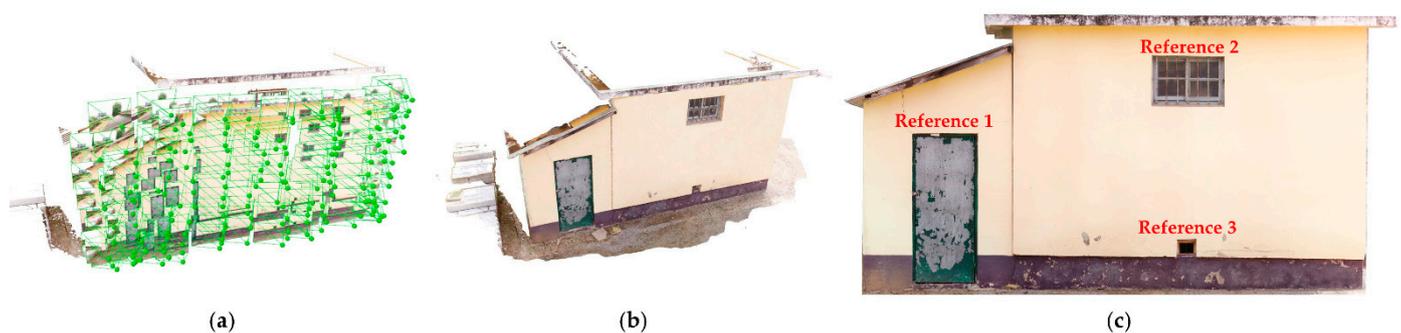
**Figure 5.** Process of orthoimage generation. (a) Initial processing; (b) Tie point matching and point clouding; (c) Orthoimage.

To estimate the size of the reference object, based on the acquired aerial photos, a point cloud-based orthoimage was created. Figure 5 shows the process of orthoimage generation, and the size of the reference objects through a 3D model analysis is presented in Table 1 below.

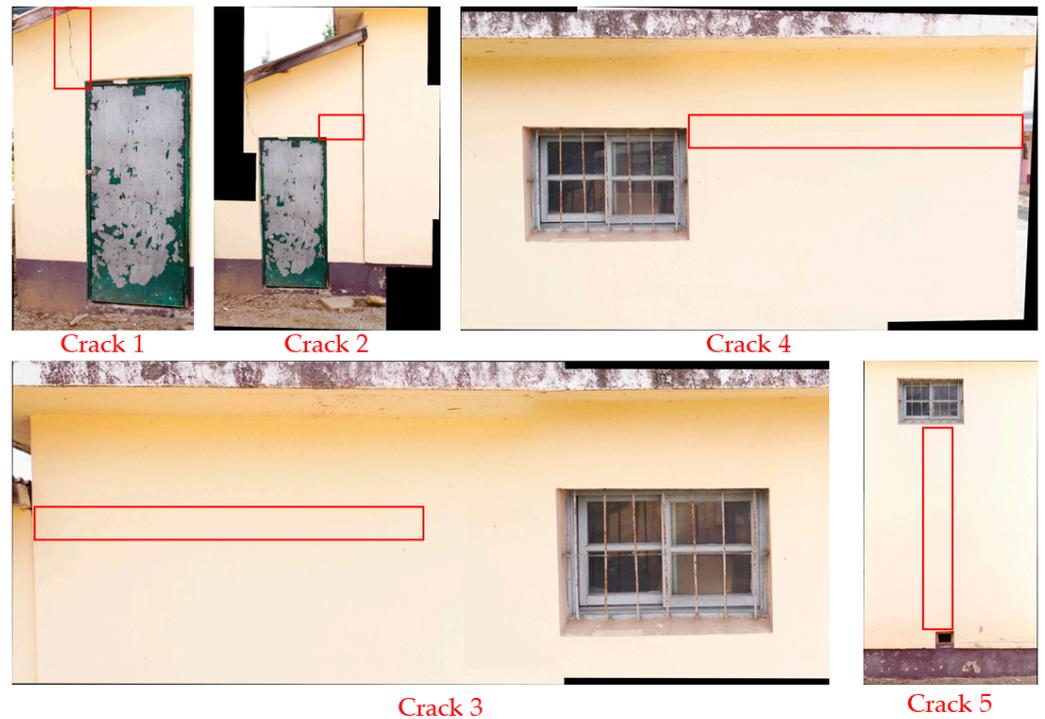
**Figure 6.** Analysis data including both reference object and cracks based on image stitching.

Next, data were constructed using both the reference object and the crack visualization image based on image stitching. Using the SIFT algorithm and the RANSAC method, data showing both the reference object and the crack were constructed. Five constructed images were obtained, and the analysis data showing both the reference object and cracks are illustrated in Figure 6.

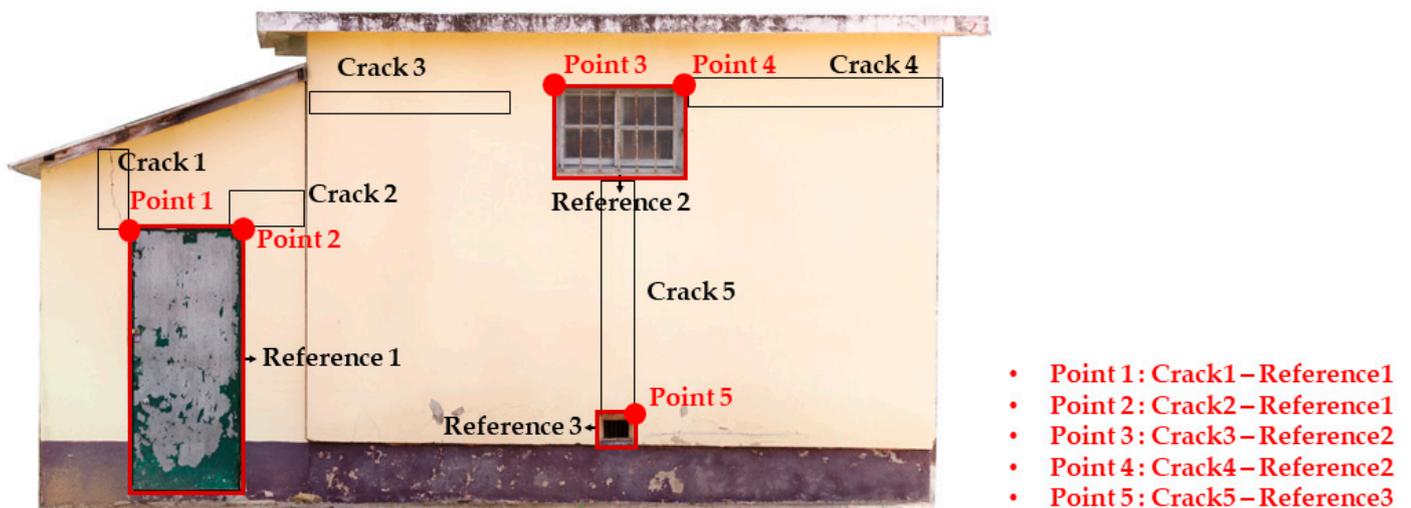
**Figure 7.** Analysis data after image rectification.

The above-mentioned constructed analysis data contained errors depending on the actual angle of the UAV photography. Therefore, in this study, the size of the reference object was estimated using a homography matrix, and the distorted analysis data were rectified. The analysis data after image rectification are shown in Figure 7.

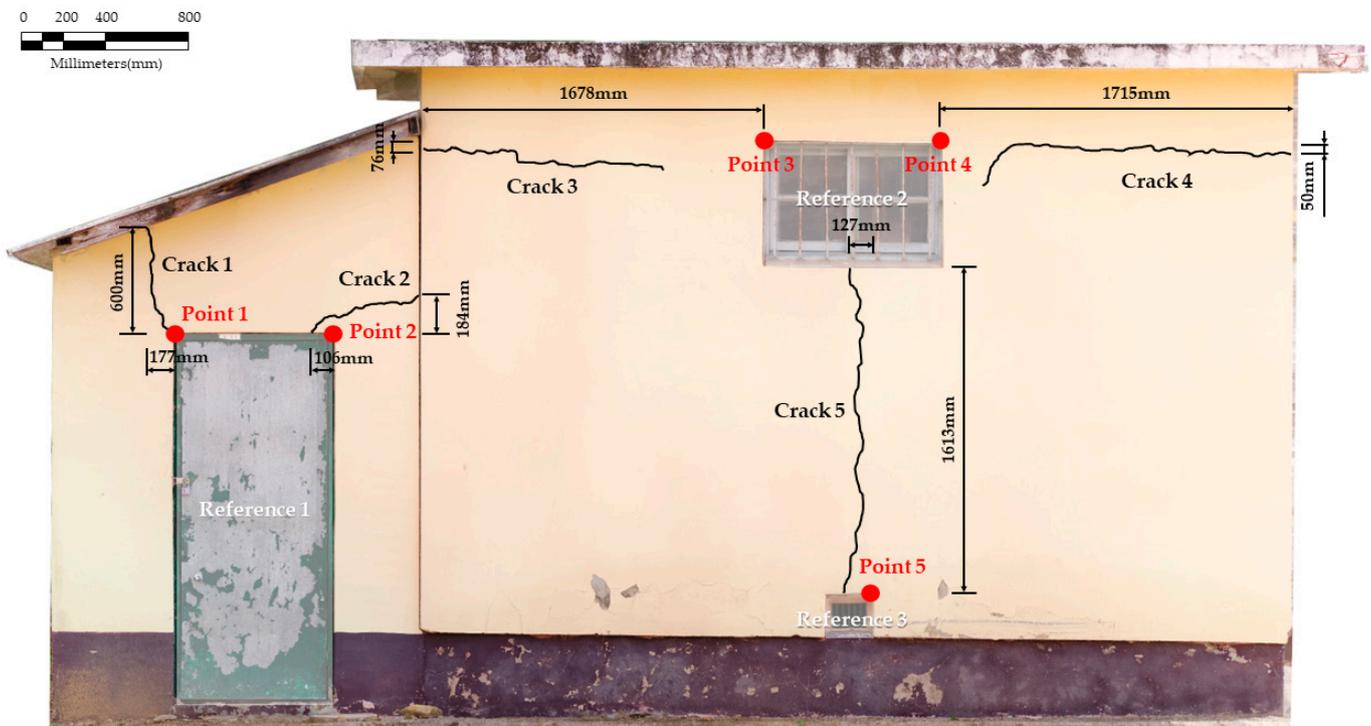
**Figure 8.** Visualization measured ground truth distance to cracks and reference object. (Location from reference point to remote points of cracks).

To test the value of the relative position of the crack estimated through the pixel size between the reference point and the crack, field measurements were conducted. Compared with the size of the crack, the measured ground truth was expressed in millimeters. A total of five measured reference points was obtained. The values of the ground truth are outlined in Table 4, and the visualization of the ground truth values is presented in Figure 8.
