# The Health Monitoring of Bonded Composite Joints Using Both Thickness and Radial Impedance Resonance Responses

**Citation:** Caldwell, S.P.; Radford, D.W. The Health Monitoring of Bonded Composite Joints Using Both Thickness and Radial Impedance Resonance Responses. *Sensors* **2024**, *24*, 2508. <https://doi.org/10.3390/s24082508>

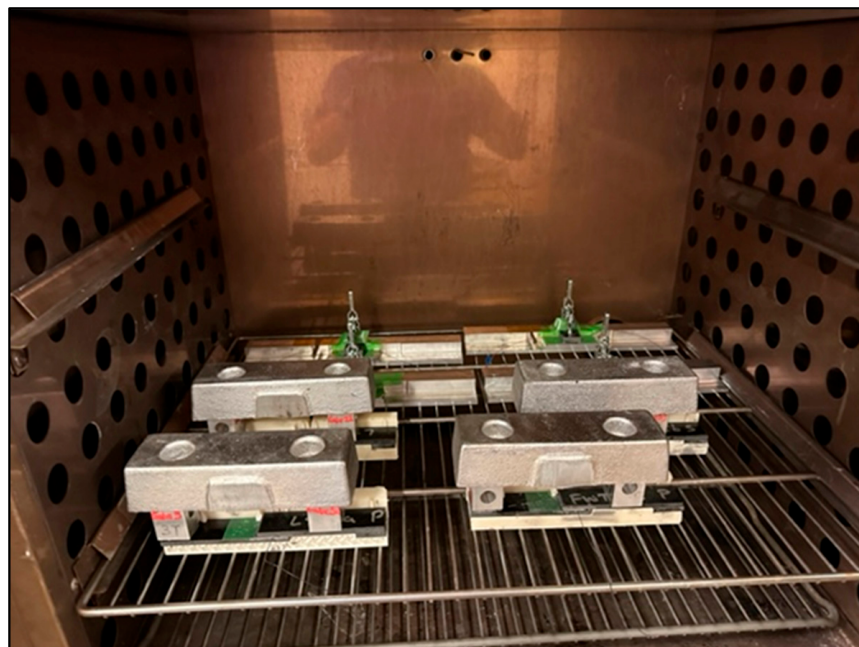
**Figure 3.** Coupons placed in the oven for accelerated curing.

The two-part structural paste adhesive was mixed together, applied to the prepped composite adherend surfaces and fit into the bond fixture. The coupons were placed in the oven for accelerated curing at 66 °C for 1 h, as shown in Figure 3. There were four lap-shear bond fixtures; therefore, three cures were required to fabricate 12 test coupons. Weights are placed on the coupons to ensure consolidation of the adhesive.

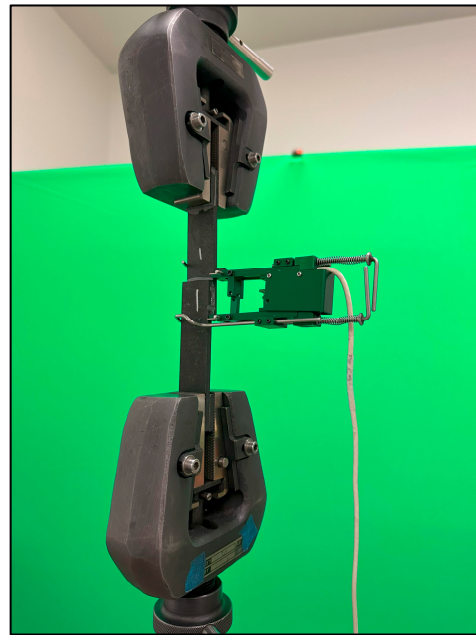
**Figure 15.** Coupon #1 loaded in the test machine.

The pristine coupons were each inserted into the test machine and loaded until failure, as shown in Figure 15 for coupon #1. The average failure load for the pristine coupons is 8201 N. The embedded sensor coupons were tested incrementally, similar to the first set of experiments, until failure. The average failure load for the embedded sensor coupons is 8289 N. Note that the electromechanical impedance was measured between the incremental load applications while the coupon was in the unloaded state. Table 4 shows the failure load for each coupon test.

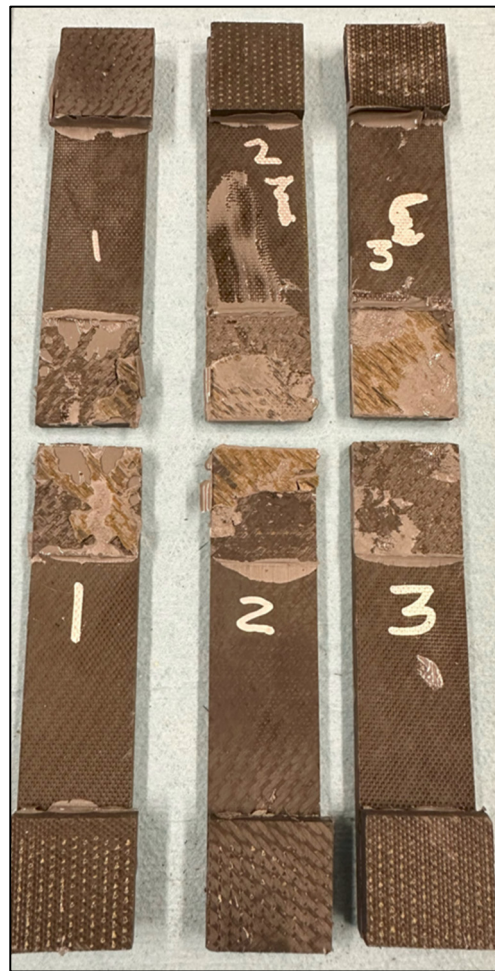
Figure 16. Failed pristine coupon adherends.

The failure loads between the pristine and embedded sensor coupons are much closer than the loads in the first set of paste bond experiments, with only a 1% difference in the average failure load. Figure 16 shows the failed pristine coupons, which all look similar, exhibiting mixed-mode failure (adhesion/cohesion/fiber tear), and Figure 17 shows the load-versus-displacement test curves.
