Article

Retrofit Methodology Based on Energy Simulation Modeling Applied for the Enhancement of a Historical Building in L'Aquila

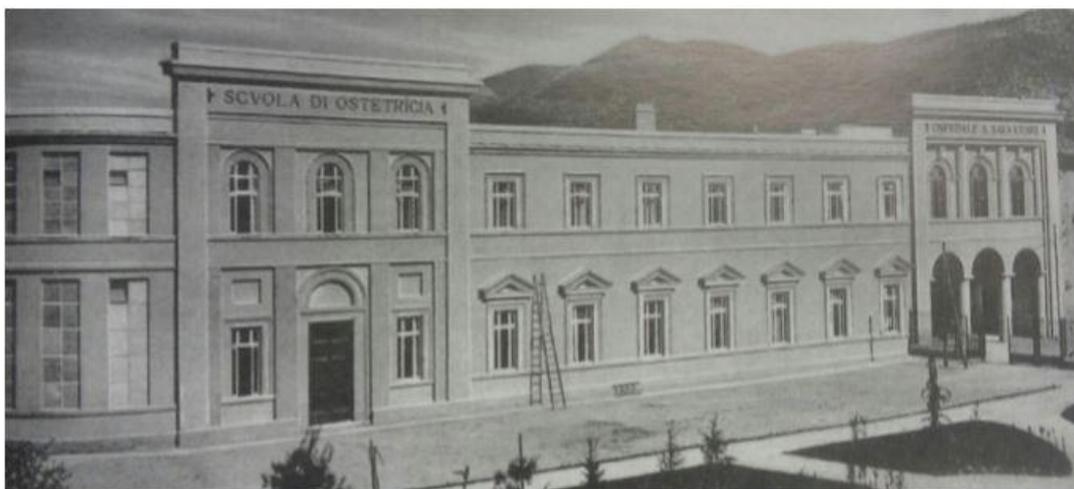
Figure 4. Historical photo of the hospital dating back to the completion of the expansion works in the 1930s.

Figure 4 shows the resulting extension: a single front aligned with the original position of the ancient church of Sant’Agnese, one of the few testimonies of the previous monastery, remodeled in the 700s following a devastating earthquake. The position of the church is thought to correspond to the right access at the front of the building, while the left access is that to the new extension. In this historical photo it is possible to recognize characteristic features of the Italian monumental architecture of the Fascist period: the front was in fact listed by the S.A.B.A.P. (superintendence of cultural heritage).

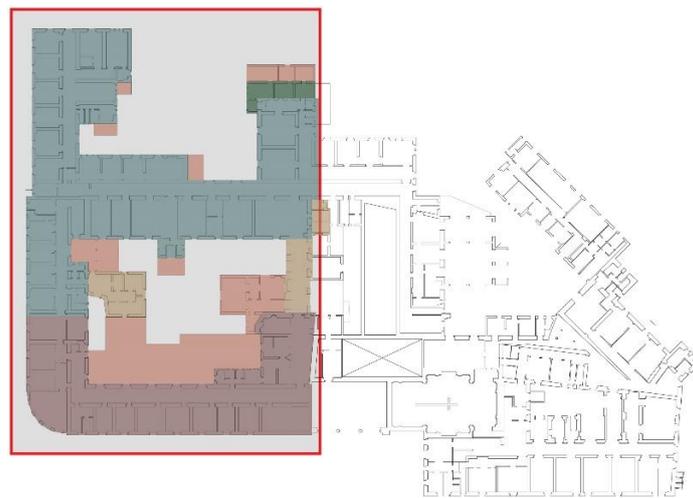
Figure 5. Extension carried out between 1931 and 1939.

It is particularly interesting to note the evolution of construction technology in the extensions made over the years. Substantial differences were found in both vertical and horizontal closures, starting from the original nucleus—characterized by load-bearing masonry on uneven stone and floors with iron beams and brick hollow slabs or solid brick vaults, continuing with the extensions that took place in subsequent years. The work presented in this paper concerns the extension built between 1931–1939 to house operating rooms, chemistry laboratories, and the obstetrics department and school (Figures 4–6).

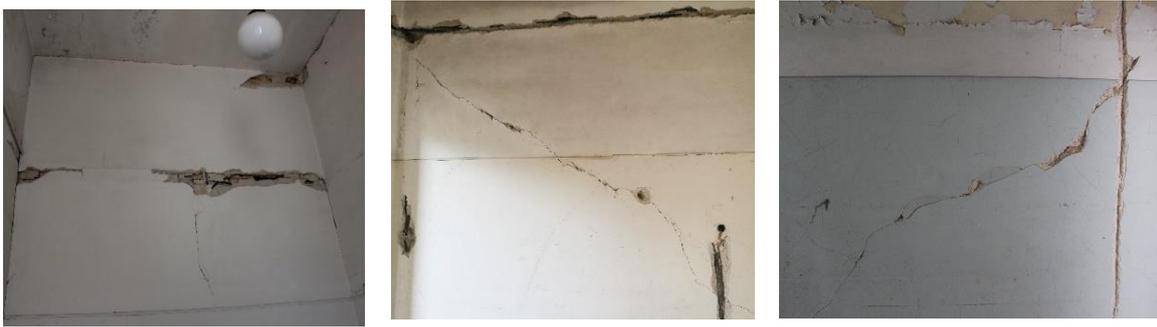
The damage analysis of a building, especially after a seismic event, is essential for assessing its structural state. The crack pattern of the interior and exterior of the building was carried out at a qualitative level for the evaluation of future consolidation interventions. The crack pattern was recorded over the floors of the building and on the elevations (including the extension of 1931–1939). It was possible to examine these thanks to the presence of scaffolding, installed after the earthquake to ensure the stability of the structure. Vertical structures in most cases had isolated or diffuse deep cracks and architrave lesions, while horizontal closures had ceiling-wall detachments and deep cracks, as shown in the Figure 8. On the elevations, there were no significant cracks but widespread lesions at the architraves.

Figure 8. Examples of damage on structural elements.

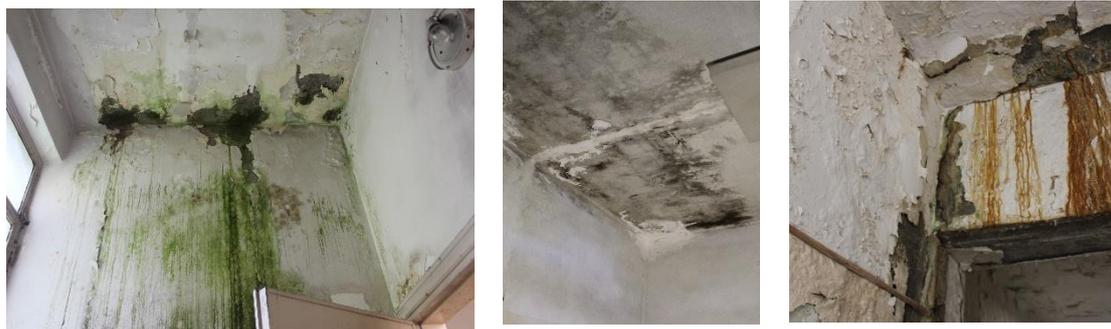
Internally, water was the primary cause of degradation in the form of humidity inside the masonry due to capillary rising, infiltration, and condensation, as shown in Figure 9.

Figure 9. Examples of degradation inside the building.

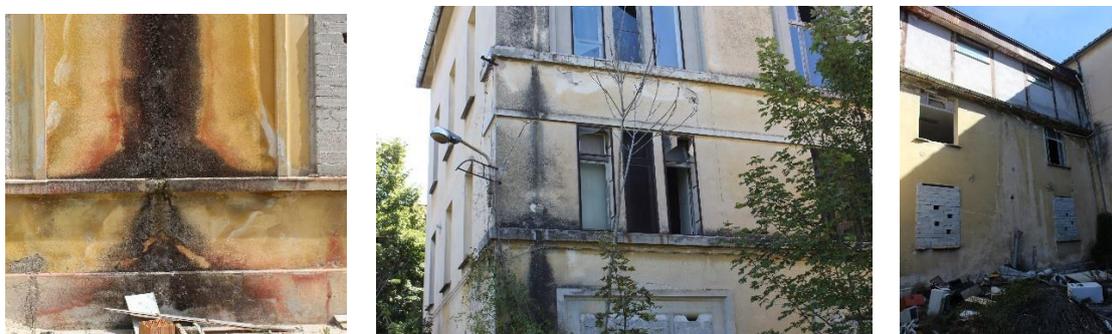
Externally, stains from rising infiltration, oxidation of metal elements and high water content were found (Figure 10). Another phenomenon noted was the chromatic alteration from solar radiation and atmospheric pollutants.

Figure 10. Examples of degradation outside the building.
