Article

Impact of Electrocautery on Fatigue Life of Spinal Fusion Constructs—An In Vitro Biomechanical Study

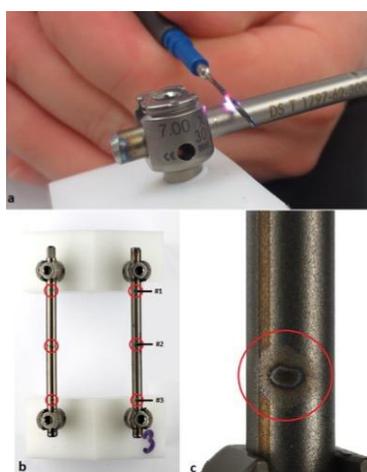
Figure 1. Electrocautery application. (a) Electric light arc, (b) sites, and (c) magnified view of the surface impact post electrocautery application. The first site was approximately 5 mm from the cephalic pedicle screw (#1). (#2 was at the center and #3 was analogous to #1 on the other side).

Electrocautery application (VIO-300, Erbe Elektromedizin, Tübingen, Germany) was performed by an experienced spine surgeon. Analogous settings used in the operation room of our institution were utilized (mode: swift-coag, 90 Watt, effect: 3, duration: ~4 s). High-frequency monopolar-electrocautery was applied on the surface of each rod at three defined positions (Figure 1). Under these conditions electric light arc was visible in all cases and discoloration of the rod surface was observed.

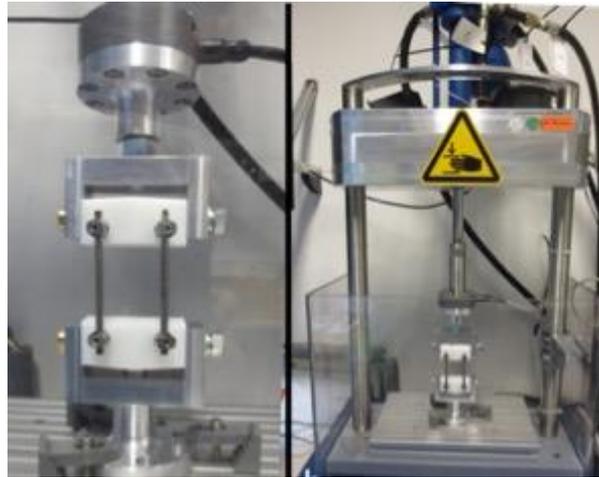
Figure 2. Frontal view of the fatigue testing setup.

Models were mounted in a servo-hydraulic uniaxial testing apparatus (HCE, Bosch-Rexroth, Lohr a. Main, Germany) under dry conditions such that the rods were aligned in the direction of vertical force application. The upper and lower vertebrae blocks were free to rotate in order to account for any bending of the rods during dynamic testing. A multistep fatigue test was performed at a frequency of 12 Hz (Figure 2).

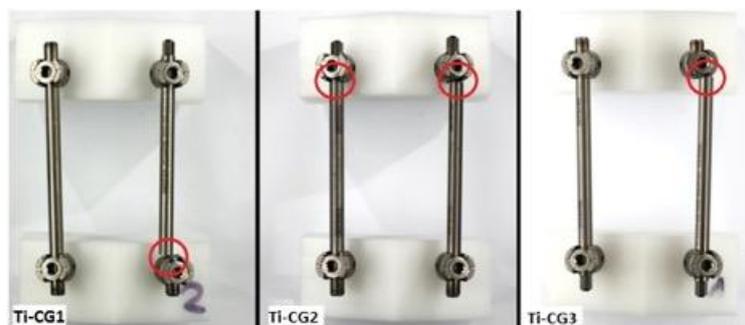
Figure 3. Sites of rod fracture of titanium control group (Ti-CG) post biomechanical testing and fatigue fractures of the rods at the rod-screw junction.

All specimens exhibited fatigue fracture of the rod at the rod-screw junction (Figure 3).

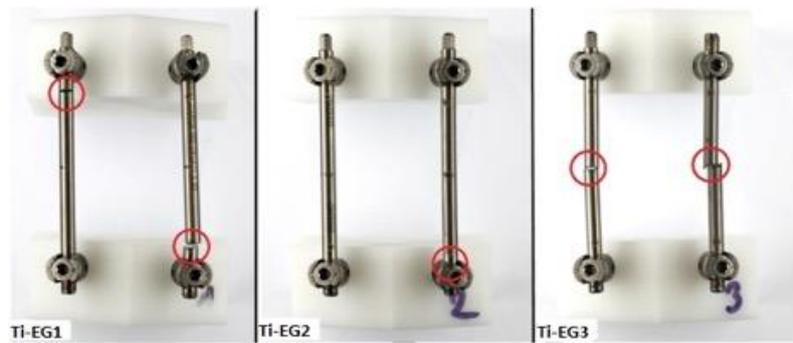
Figure 4. Sites of rod fracture of titanium electrocautery group (Ti-EG) post biomechanical testing.

In two specimens (Ti-EG1 and Ti-EG3), failure sites corresponded to the sites of electrocautery application (Figure 4).

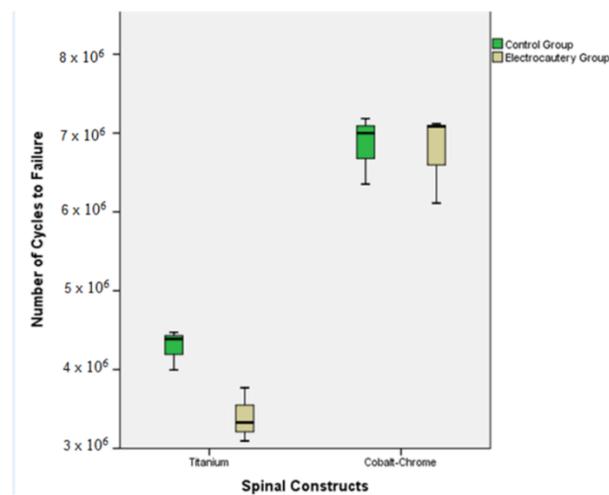
Figure 5. Boxplot representing the mean and 25% and 75% interquartile range of the total number of cycles to failure among the four tested groups.

Ti-EG revealed a significantly lower load-to-failure than Ti-CG (17% decrease, $p = 0.023$). Intergroup comparison of cycles to failure revealed a significant mean decrease of almost 9×10^5 cycles ($p = 0.03$). (Figure 5).

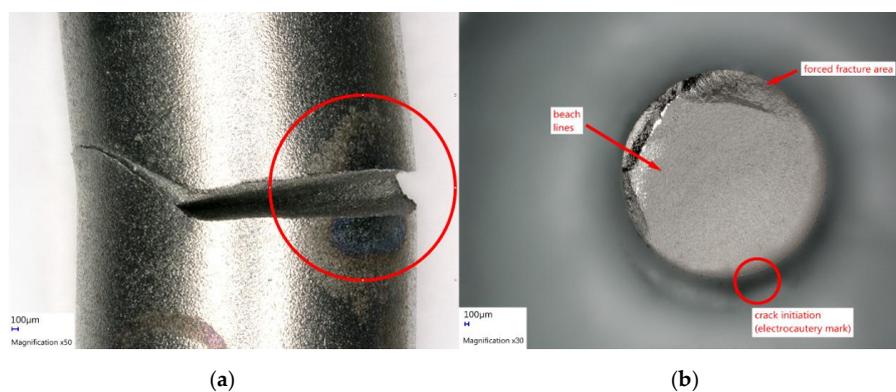
Figure 6. Microscopic analysis of fractured titanium rod after electrocautery (VHX-5000, Keyence, Osaka, Japan). (a) Post-fracture situation at the electrocautery mark. (b) Fracture surface with typical signs of fatigue fracture (beach lines and forced fracture area). The circle shows the location of crack initiation at the electrocautery mark.

Fatigue failure was confirmed by microscopic analysis of the fractured surface (Figure 6).

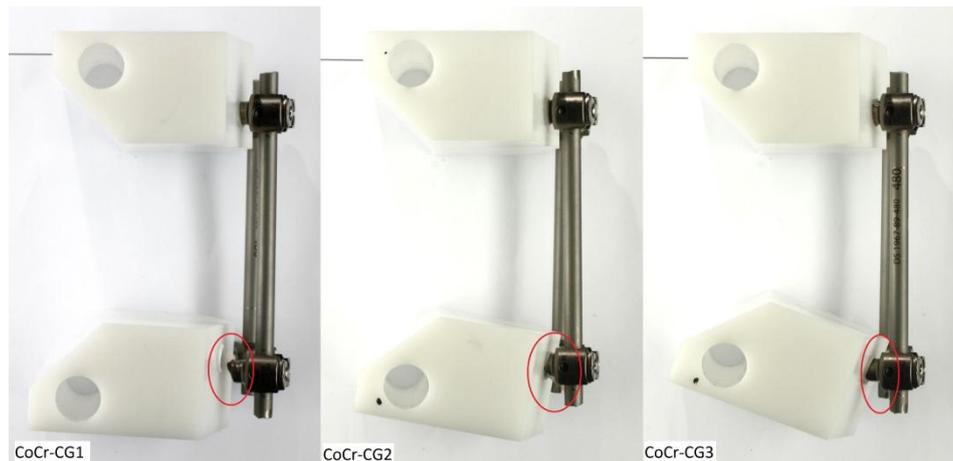
Figure 7. Sites of the titanium screw fracture of CoCr control group (CoCr-CG) post biomechanical testing.

Intergroup differences were insignificant across all outcome measures. This implies that, in these tested constructs, the pedicle screw proved to be the weakest component under cyclic loading. In all specimens of these two groups, fatigue fracture transpired at the first thread of the titanium pedicle screw (Figures 7 and 8).

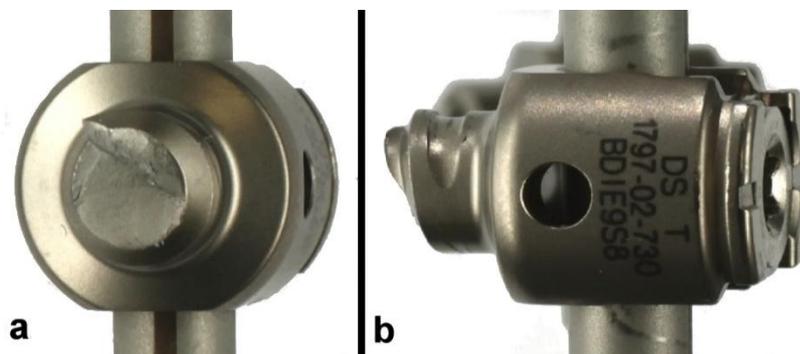
Figure 8. Magnified frontal (a) and lateral (b) views of the titanium screw fracture of one of CoCr electrocautery group constructs (CoCr-EG 3).

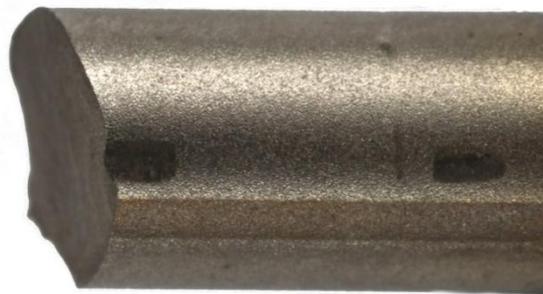
Figure 9. Magnified lateral view of Ti-CG post biomechanical testing: fatigue fracture of the rod at the rod-screw junction, illustrating surface marks of the tightened screws on the rod.

Among all Ti-CG and one of the Ti-EG specimens, a crack nucleation site was visually detected in the proximity of the locking screw. Tightening of the screw leaves surface marks on the rods and could account for this failure (Figure 9). The presented results echo previously published findings: Lindsey et al. and Ngyuen et al. [21,22] detected an increased trend of CoCr rod failure at the same location of our tested constructs. Yamanaka et al. [40] described the same phenomenon on Ti rods. Dick et al. [31] suggested that surgeons should avoid severe tightening of the screws as this would lead to notch formation on the surface of Ti rods. Hence, a modification of the operating manual might be indicated to avoid severe tightening of the screw. This, however, requires specific testing and is a secondary outcome of this study.
