# Flexural Strengthening of Stone Masonry Walls Using Textile-Reinforced Sarooj Mortar

Abdullah Hilal Al-Saidy <sup>1,\*</sup>

**Citation:** Al-Saidy, A.H.; Al-Busaidi, M.; El-Gamal, S.; Abu Sohel, K.M. Flexural Strengthening of Stone Masonry Walls Using Textile-Reinforced Sarooj Mortar. *Materials* **2023**, *16*, 5703. <https://doi.org/10.3390/ma16165703>

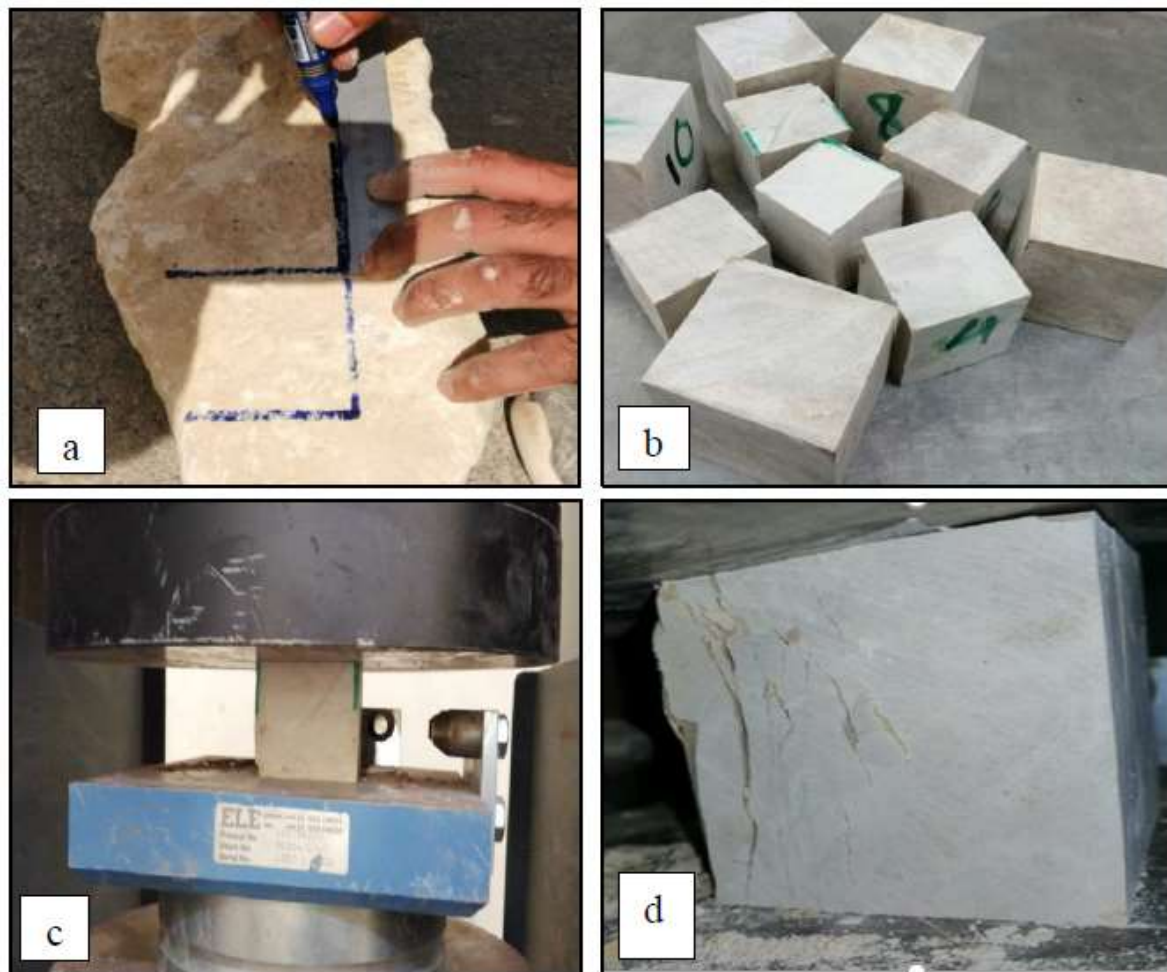
**Figure 3.** Photographs of (a,b) cutting and extracting stone cube samples; (c,d) compressive test and failure modes.

The uniaxial compressive strength of the limestone was determined by extracting 10 cubes with dimensions of approximately  $70.7 \times 70.7 \times 70.7$  mm from random limestone samples (see Figure 3). The uniaxial compressive strength was determined as per ASTM D7012, 2004 [24]. It was found to be 57 MPa, as an average value from 10 samples (with a standard deviation of 8 MPa).

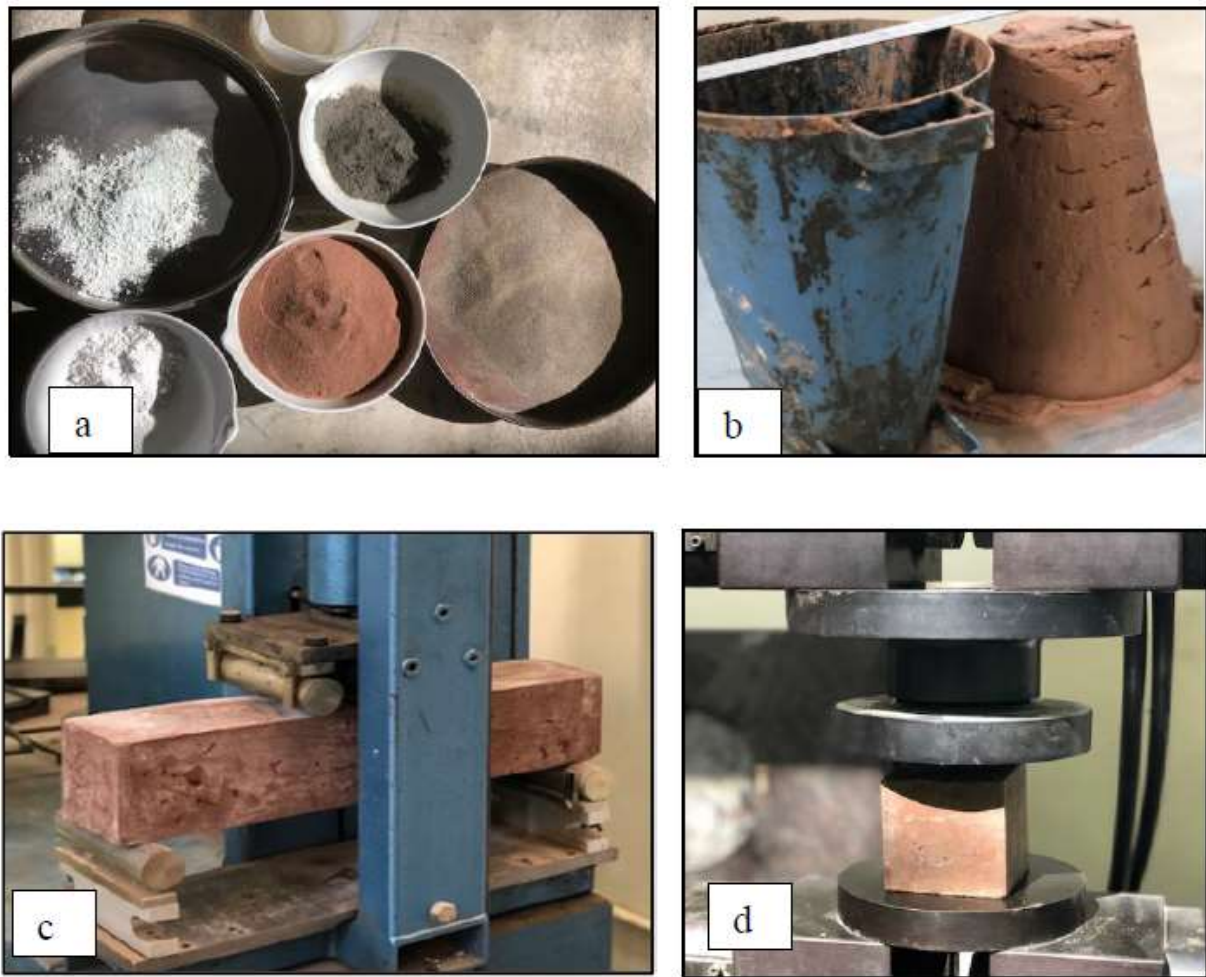
**Figure 4.** Jointing mortar (a) materials used; (b) slump test; (c) flexural test; (d) compression test.

The plaster mortar mix was sarooj, sand, white cement, lime, and water with proportions by weight of 1:0.5:0.5:0.375:0.75, respectively (see Figure 4). The measured slump for the plaster mortar mix was measured to be 34 mm. This mix was selected from several mix trials based on workability and mechanical properties. A similar procedure as used in the jointing mortar was adopted in casting and curing the specimens. The recommendations by Hago et al. [21] were adopted for the selected optimum design mix ratios of sarooj, sand, and cement to produce the maximum strength. The uniaxial test of the cubes resulted in an average 28-day compressive strength and tensile strength of 11.67 MPa and 1.7 MPa, respectively.

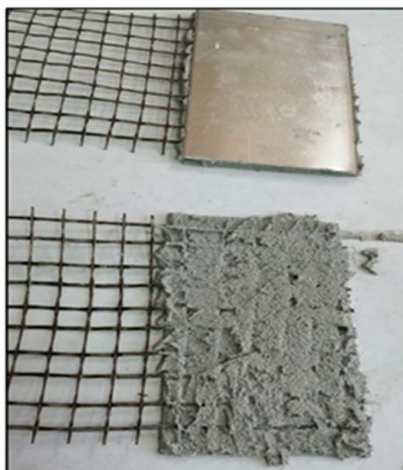
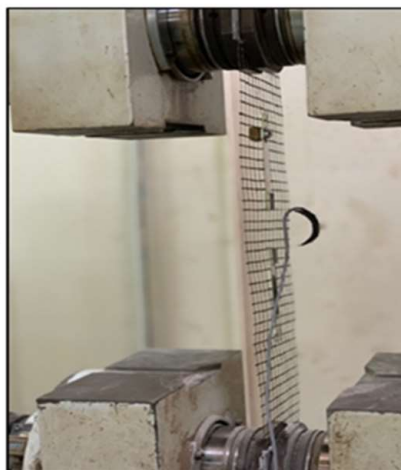
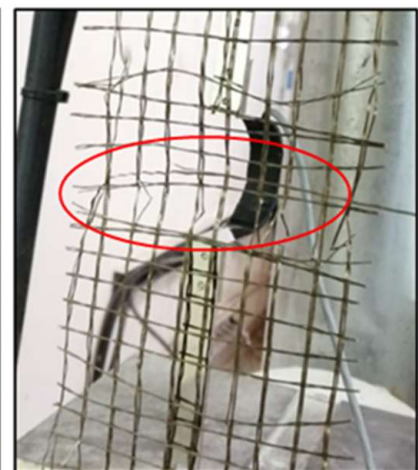
**Figure 6.** Tensile test set up: (a) sketch of basalt textile grid testing sample; (b) preparing the sample with steel plate ends; (c,d) test set up with LVDT.

A uniaxial tensile strength was conducted according to ASTM D5034—09(2013) [28]. The textile tensile test samples were cut to be 500 mm long and 100 mm wide, as shown in Figure 6. In addition, composite coupon specimens consisting of one layer of textile fibers embedded in sarooj mortar were also tested to determine the uniaxial tensile strength as

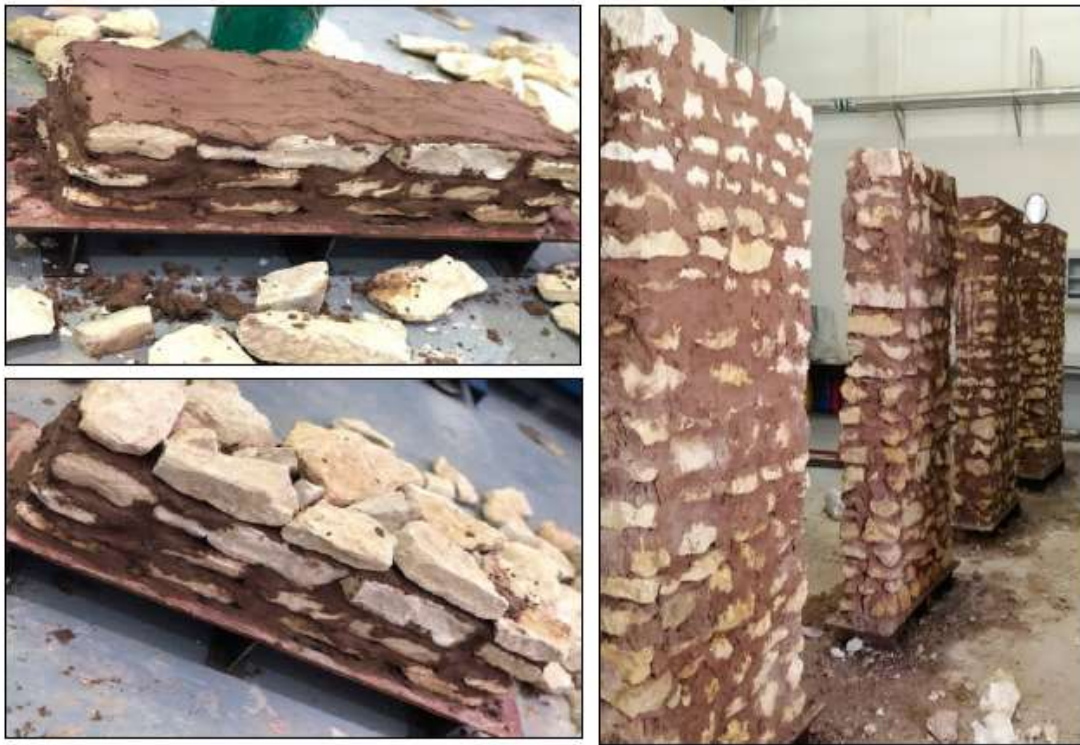
**Figure 12.** Construction of stone masonry wall specimens.

This wall is considered the reference wall. It was constructed from stones and jointing mortar only. All walls were constructed by layering alternative layers of stone and mortar. Each wall was constructed until reaching a height of approximately 60 cm and the wall was then left for the mortar to set (24 h). The construction of the following layers was then resumed until reaching a full height of 2.0 m. Figure 12 shows photos of the construction of the unreinforced masonry wall specimens.

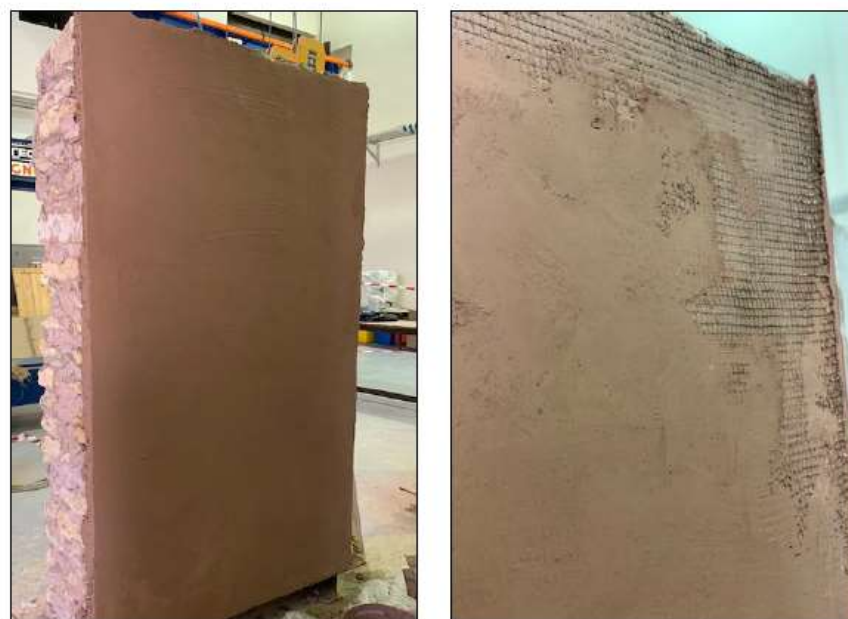
**Figure 13.** Strengthening of first wall with one textile layer (RT).

The second wall was strengthened using basalt fiber textile. The first layer of sarooj mortar was applied to one face of the wall (tension face) to receive the textile mesh. The first layer of plaster varied between 2 and 3 cm to level the face to stick the basalt mesh. A textile layer then was applied and pressed by hand to stick to the first layer of mortar. A second plaster layer of 0.5 cm thick was applied to cover the mesh. Photos of the wall construction are presented in Figure 13.

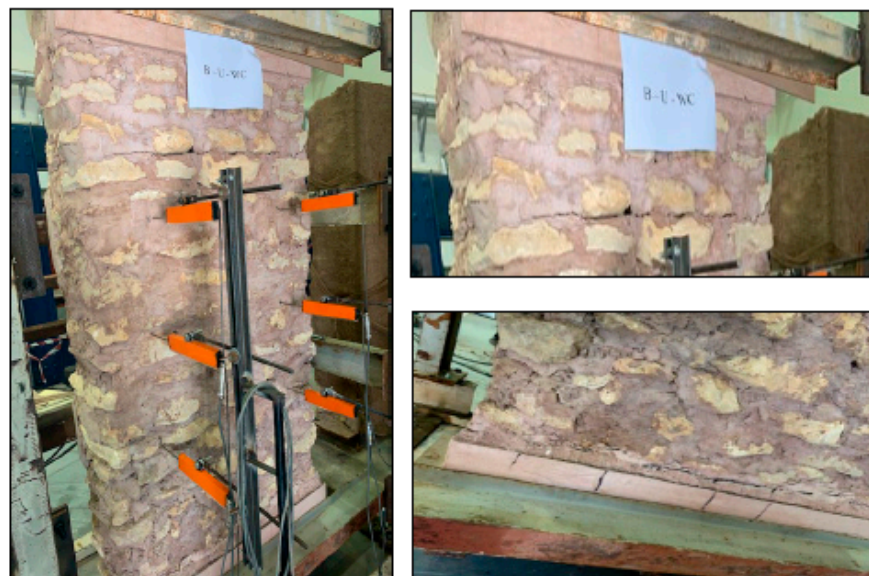
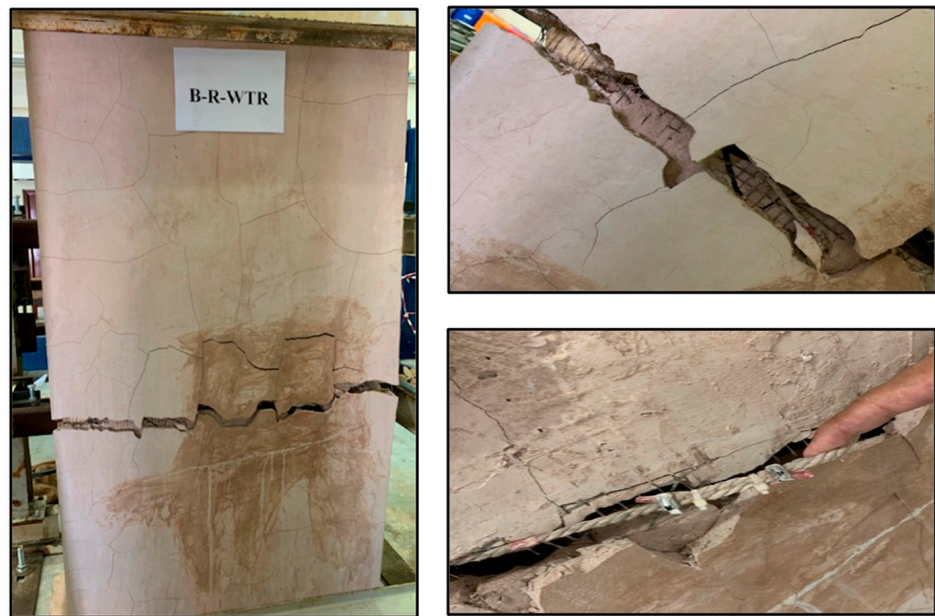
(a) Cracks in the control wall (UC)

(b) Cracks in wall RT

(c) Cracks in wall RTS

(d)Cracks in wall RTR

**Figure 18.** Failure modes and crack patterns.

The wall strengthened with one layer of textile (RT) shows, at the initial stage, a relatively linear behavior and no cracks were observed on the wall up to a 20 kN load. Beyond this load, a horizontal crack started to develop in the mortar at about the mid-height point of the tension side of the wall (see Figure 18b). Consequently, basalt textiles started to bear tension loads, leading to a continuous widening of the crack until failure. The walls failed after the rupture of the textile layer. The crack affected the masonry mortar interface and involved the whole masonry thickness. At the maximum failure load of 25.8 kN, the mid-point exhibited a displacement of 4.61 mm. Figure 19 shows the displacement profile along the wall height. The wall displacement was at a maximum at the mid-height of the wall. The test was stopped after reaching the maximum load to prevent wall overturning collapse. The main crack (where the textile fibers ruptured) involved the whole masonry thickness, and no debonding was observed between the mesh and substrate.

The second strengthened wall (RTS) was strengthened with one layer of textile and augmented with mechanical connectors consisting of brass screws and washers. A similar response of linear behavior was observed before cracking at 18 kN, at which cracks developed around the center of the top third of the wall. A small shift in the load versus the mid-span deflection curve was observed due to the initiation of the crack, with a minor change in the slope of the curve indicating a minor stiffness decrease (Figure 17). This wall performed the best in terms of the maximum load attained compared to the reference wall. At the maximum failure load of 30.9 kN, the mid-point exhibited a displacement of 4.1 mm. Figure 19 shows the displacement profile along the wall height. The wall displacement was at a maximum at the top third of the wall. The effect of the screws' mechanical anchoring and the stabilizing of the textile mesh obviously augmented the bond strength provided by the mortar. The disadvantage was the extra work required to install the screws. The main crack (where the textile fibers ruptured) involved the whole masonry thickness, and there was no debonding observed between the mesh, substrate, and screws, as shown in Figure 18c.
