Article

Degradation Behavior and Lifetime Prediction of Polyurea Anti-Seepage Coating for Concrete Lining in Water Conveyance Tunnels

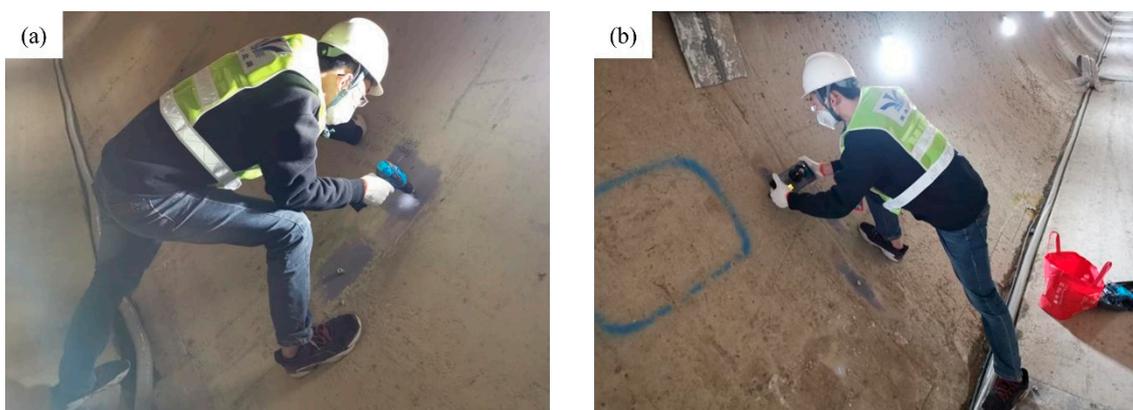
Figure 1. Pull-off test between polyurea coating and concrete lining substrates in the tunnel. (a) Cutting polyurea on site. (b) Pull-off test.

In the middle of November 2019, during the maintenance of the water supply in Zhengzhou, China, the tunnel, the polyurea material at the structural joint and anchor groove was investigated, and the bond strength between the polyurea material and the concrete lining of the tunnel was sampled and tested on site. The pull-off test is a dependable method that offers several benefits. It is a simple, reliable, and easy-to-use technique for evaluating the in situ strength of concrete and the bond strength between coatings and the concrete substrate in situ. Due to the smooth surface of polyurea, achieving a strong bond with the pull head for testing is challenging. This limitation hinders the use of adhesive failure tests to directly measure the bond strength between polyurea and the concrete matrix. During the test process, the sediment is first cleaned from the coating surface. The coating surface is then roughened using sandpaper. This roughening process ensures a strong bond between the coating and the pull head. After 24 h of adhesive curing of the pull head, the circumference of the pull head by the cutting device is used to penetrate the coating to the concrete matrix. Then, a cohesive strength measuring instrument (Proceq-Dy216) is used on the roughened surface to test the cohesive strength (Figure 1).

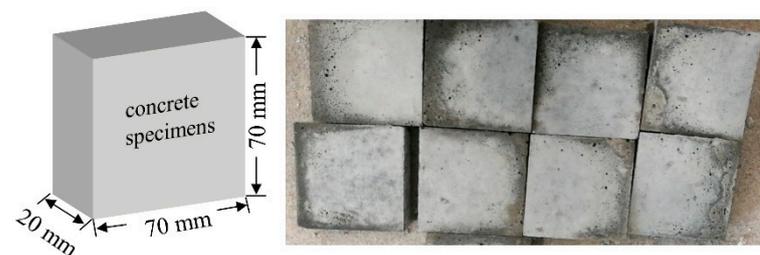
Figure 2. Diagram of concrete specimen preparation.

The prism concrete specimens (Figure 2) were prepared with dimensions of 70 mm × 70 mm × 20 mm for the spraying polyurea coating, aiming to conduct the pull-off test. Commercial composite Portland cement P.O.42.5 was used in the specimens, with medium sand (fineness modulus between 2.3 and 3.0) and 5–10 mm diameter crushed stones mixed with pure water. The specimens underwent standard curing conditions (20 ± 2 °C, 95% relative humidity) for a duration of 28 days. The mix ratio of the concrete specimens was cement: water: sand: crushed stone: water reducer at 2.88:1:6.33:5.17:5.2%. Subsequently, the concrete surfaces were dried at 60 °C for 48 h until the moisture content dropped below 8%, following which the polyurea material was sprayed for pull-off testing (Figure 3).

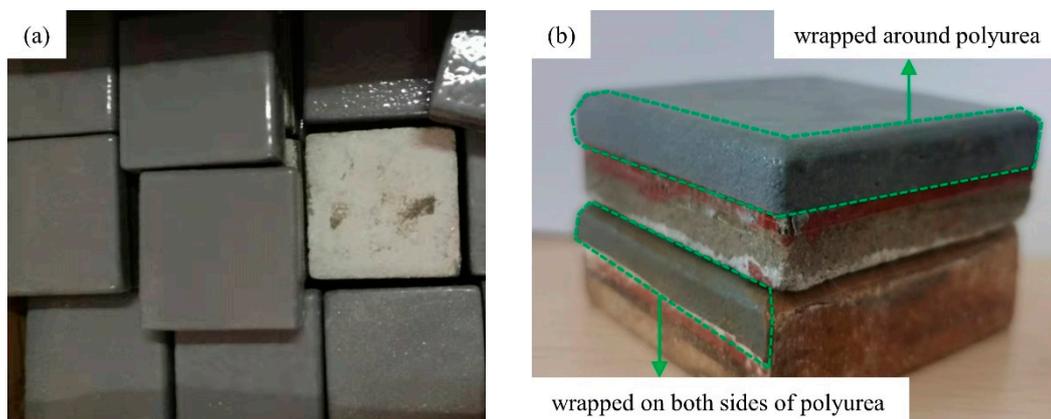
Figure 3. Concrete specimens after spraying polyurea elastomer. (a) The top surface of the concrete sample sprayed with polyurea coating. (b) The side of the concrete sample sprayed with polyurea coating.

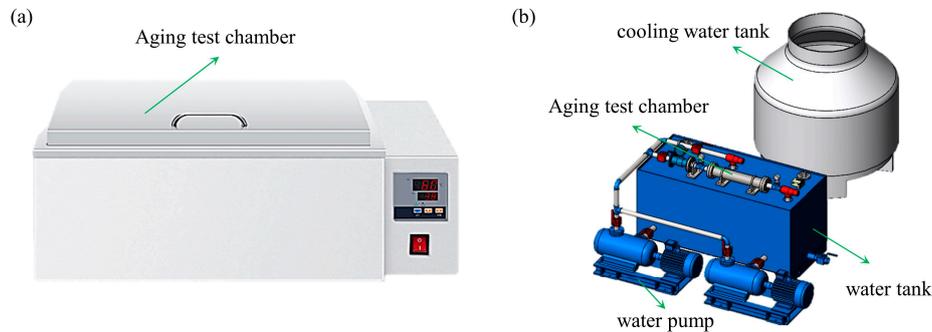
Figure 4. Schematic diagram of the test apparatus for the aging test. (a) Thermostatic water bath box. (b) Aging test equipment for simulating the operating environment of water conveyance tunnels.

Traditional accelerated aging experiments use hydrothermal aging methods. In this study, the first step is to conduct traditional hydrothermal aging experiments using a thermostatic water bath box with a heating temperature of 20–90 °C (Figure 4a).

The polyurea material in the water conveyance tunnel is mainly used for surface sealing and the anti-seepage effect of the joints in the lining structure. It is affected by multiple compound factors such as water flow impact, water pressure, and temperature changes in the tunnel for a long time. Therefore, this study combines the actual engineering environment and designs and manufactures an aging test device that can simulate the environmental conditions of the water conveyance tunnel site. It can be used to study the performance deterioration process of polyurea material under the combined effects of multiple factors such as temperature, water flow, and pressure in the tunnel (Figure 4b).

The apparatus replicates the conditions of a water conveyance tunnel, facilitating accelerated specimen aging through temperature elevation (Figure 4b). This device can examine the variation in cohesive strength of polyurea specimens under a composite influence of temperature, dynamic water flow, and pressure. The testing apparatus consists of a water tank, two constant water pumps, an aging test chamber, a cooling water tank, a temperature measurement, a flow meter, two pressure gauges, and a control device. To fulfill the demands of prolonged continuous operation, two constant water pumps operate alternately. A heating device and a temperature sensor were incorporated into the water tank to elevate the temperature and expedite specimen aging. Aligned with the real water flow conditions of a water conveyance tunnel in Henan Province, the test apparatus can simultaneously simulate aging environments with varying water pressures of up to 0.65 MPa (with a maximum water temperature reaching 80 °C). Concrete specimens coated with polyurea material on the surface, each measuring 70 mm by 70 mm by 20 mm, were positioned on both sides of the unit, with a polyurea material placed in the middle (Figure 5). During the experiment, water was heated to the designated temperature in a water tank. A water pump was used to continuously circulate water with a certain pressure and flow rate into the aging test chamber, simulating the operating conditions of a real water delivery tunnel.

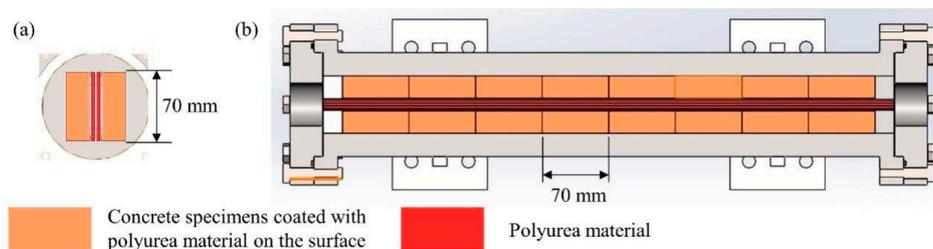
Figure 5. Schematic diagram of internal specimen placement of aging test chamber. (a) Left view of the aging test chamber. (b) Vertical view of the aging test chamber.

The test water temperatures were set at 50 °C, 65 °C, and 80 °C during indoor tests on the degradation behavior of polyurea materials in simulated on-site environments. The polyurea coating–concrete specimen was placed in the central slot of the primary testing apparatus to expose it to the combined effects of these factors. This configuration allows water to flow over the material’s surface, simulating a hydraulic tunnel’s internal water flow conditions. To prevent water erosion from undermining the bond between the polyurea and the concrete specimen, the polyurea coating was applied to the side of the specimen (Figure 3b). The aging period spans 1, 3, 7, 14, 21, 25, 27, and 28 days. Previous research indicates significant discrepancies in cohesive strength measurement results due to test instrument and method variations. Hence, to ensure comparability with field measurements, the cohesive strength of the specimen was also assessed using the same portable instrument (Prodeq-DY216) [33]. The following table (Table 1) details the various experimental designs employed for the aging test of polyurea coatings.

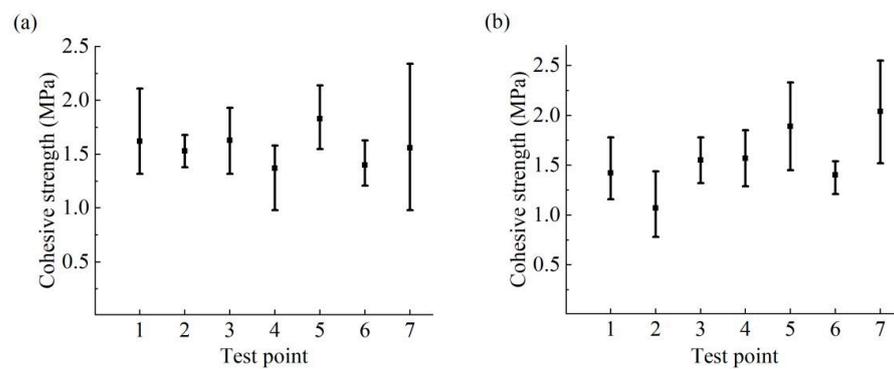
Figure 6. The cohesive strength of polyurea coating samples in Zhengzhou water conveyance tunnel. (a) Land sections of the water conveyance tunnel. (b) Underwater sections of the water conveyance tunnel.

(Table 2) details each sampling point. Test points 1 to 3 were chosen along the tunnel’s sidewall, points 4 to 6 on the tunnel floor, and point 7 at the anchor channel. The result of in situ testing is presented in the following figure (Figure 6). The average cohesive strength recorded for the tunnel was 1.827 MPa and 1.367 MPa, with minimum values of 2.035 MPa and 1.067 MPa, respectively.

Notably, test results at the same position exhibited significant variability. It is noted that the cohesive strength between polyurea coating and the concrete lining can reach 2.2 MPa in wet or water environments. However, a substantial decrease in cohesive strength between polyurea and the concrete lining was observed along the tunnel’s length, compared to initial values, under the influence of the tunnel environment [32].

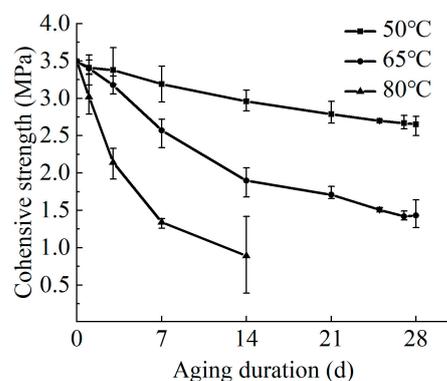
Figure 7. The variation of cohesive strength after simulated water tunnel environmental aging test over time at different temperatures.

This section presents the experimental results of aging tests under a simulated on-site environment. The effect of aging on cohesive strength is shown in the following figure (Figure 7).

As expected, increasing ambient temperature and test duration significantly reduced cohesive strength. This effect was particularly pronounced at 80 °C, where a rapid decline in cohesive strength was observed, potentially leading to debonding after a short test period. These findings are consistent with previous results of the hydrothermal aging test. Notably, comparative analysis revealed that cohesive strength under water flow and pressure conditions was superior to that observed in the current test, highlighting the influence of these factors.

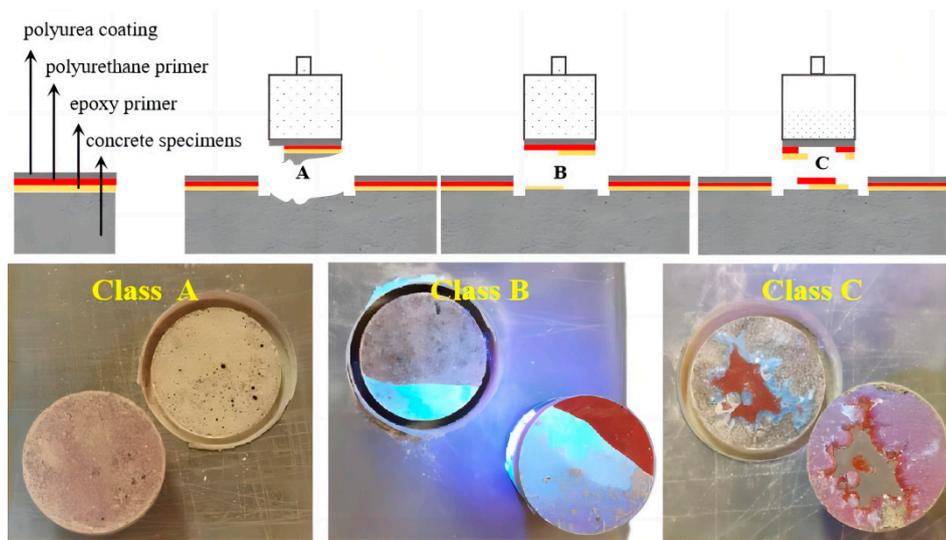
Figure 8. Specimens of the three different bond failure types.

To aid in understanding the failure mechanisms, Figure 8 defines and summarizes the various failure types observed during the aging tests. Based on the different bond failure types observed after cohesive strength measurement, the specimens can be classified into three categories: A, B, and C. Type A damage can be summarized as cohesive failure between concrete and epoxy resin, type B damage can be summarized as interfacial failure between the epoxy resin and polyurethane primer, and type C damage can be summarized as interfacial failure between polyurea and primer.

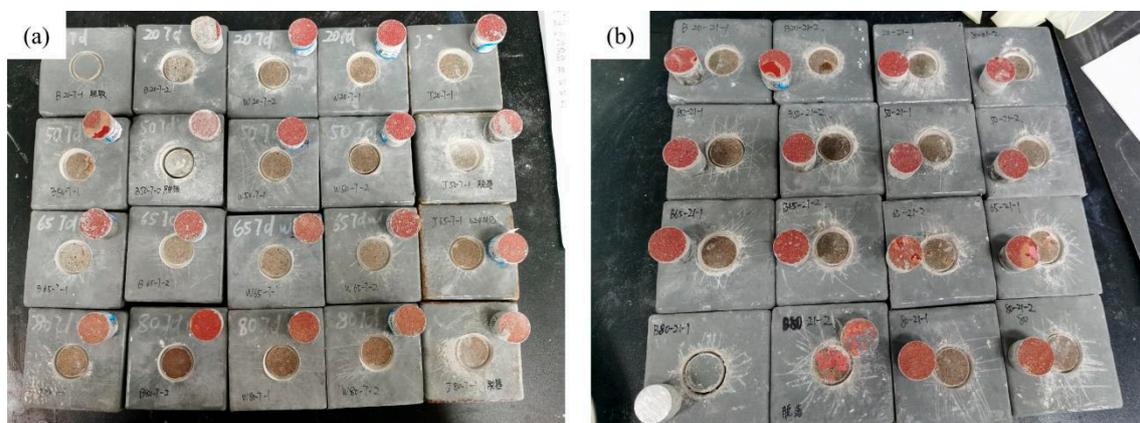
Figure 9. The failure types of polyurea–concrete specimens after the hydrothermal aging test. (a) Aging duration is 7 days. (b) Aging duration is 21 days.

This section illustrates the bond failure types of polyurea–concrete specimens after the hydrothermal aging test (Figure 9). The first row in the figure shows the specimens at a water temperature of 20 °C, the second row shows the specimens at 50 °C, the third row shows the specimens at 65 °C, and the fourth row shows the specimens at 80 °C. Under the experimental aging duration of 7 days, the failure modes of almost all specimens were of class A. Under the aging duration of 21 days, when the test water temperature was 65 and 80 °C, the failure types of the test specimens appeared to be of class B/C.

Under mild aging conditions (short duration, low temperature), class A failure was observed, characterized by an adhesive failure within the concrete layer and residual concrete adhering to the epoxy surface. As aging time increased, debonding at the concrete–epoxy interface became the dominant failure mode. Notably, at 80 °C for 21 days, specimens wrapped around polyurea exhibited debonding with damage to the epoxy and polyurethane coatings. Red polyurethane primer degradation was particularly evident at 65 °C and 80 °C water temperatures, consistent with previous studies. Hydrothermal aging demonstrably weakens the adhesive performance of the epoxy layer. The observed failure progression suggests initial damage within the concrete substrates, debonding at

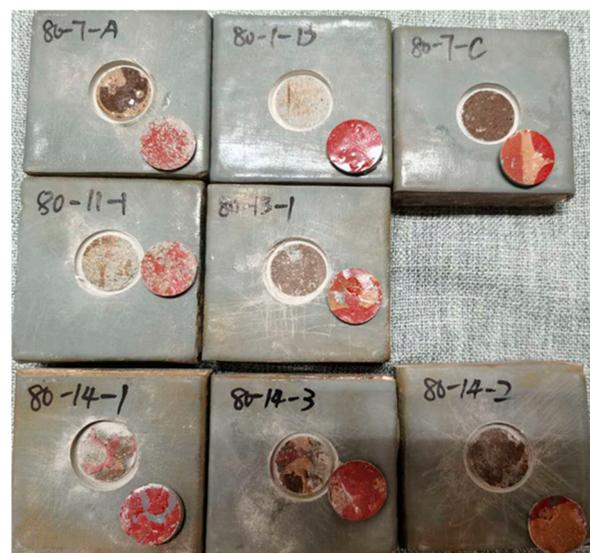
Figure 10. The bond failure types of specimens at 80 °C water during the aging test simulated in the tunnel environment.

Following the simulated tunnel environment aging test, the bond failure types of the specimens were observed to be as follows. At a test water temperature of 50 °C, the specimens exhibited the failure type of class A. At a test water temperature of 65 °C, type B failure occurred after 21 days of the aging duration. At a test water temperature of 80 °C, type B/C failure occurred after only 7 days of the aging duration.

Consistent with prior observations, at shorter aging times, failure is dominated by class A detachment, where the epoxy resin separates from the concrete base surface. As aging temperature and duration increase, the destruction mode transitions to class B and class C failures, characterized by the retention of epoxy and polyurethane undercoating on the exposed concrete surface. These findings corroborate those reported by other researchers [19,31,34]. At 80 °C water temperature, the adhesive interface degrades more rapidly due to water pressure (Figure 10). The first row in figure shows the bond failure types of specimens tested at 80 °C for 7 days. The second row shows the specimens tested for 11 and 13 days, and the third row shows the specimens tested for 14 days. We propose that water ingress along the concrete–polyurea interface triggers a reaction between the epoxy resin and polyurethane primer with water, leading to the observed bulges on some sample surfaces. By day 14, bond strength is significantly reduced, with an uneven polyurea–concrete interface exhibiting exposed gray polyurea coating in some areas.

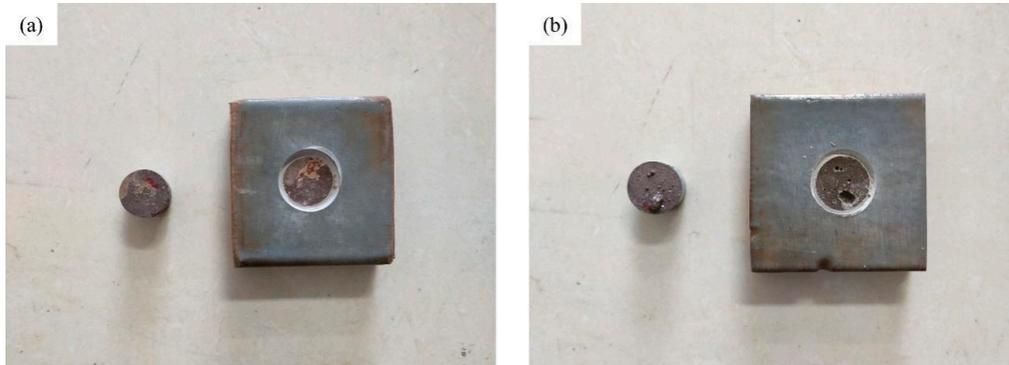
Figure 11. Macroscopic morphology of the fracture surface. (a) Case 3-8. (b) Case 3-1.

Following pull-off strength testing, scanning electron microscopy (SEM) was employed to analyze the microscopic morphology of the fractured interface. The interfacial analysis after exposure to Case 3-8 is depicted in the following figures (Figures 11a and 12a). Post-fracture analysis revealed the presence of residual epoxy resin and polyurethane undercoating on the concrete base surface. Microscopic magnification clearly visualized the coating and fracture texture (Figure 11b). A specimen from the test Case 3-1 observed that there were obvious defects on the concrete surface (Figure 11b). Preexisting defects necessitated epoxy resin repair before spraying. The fractured interface displayed visible epoxy resin and concrete, with the repair material completely filling the defect. High magnification revealed the epoxy resin–concrete interface with small adhering concrete fragments. The bond strength measured

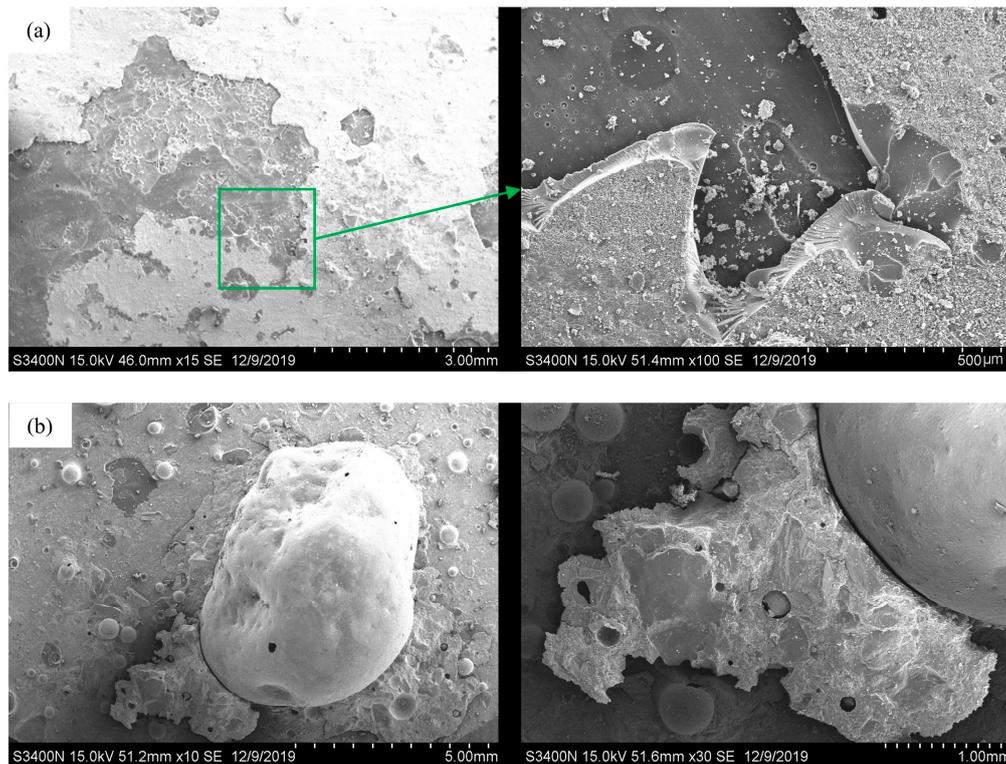
Figure 12. Micro morphology of the fracture surface. (a) Case 3-8. (b) Case 3-1.

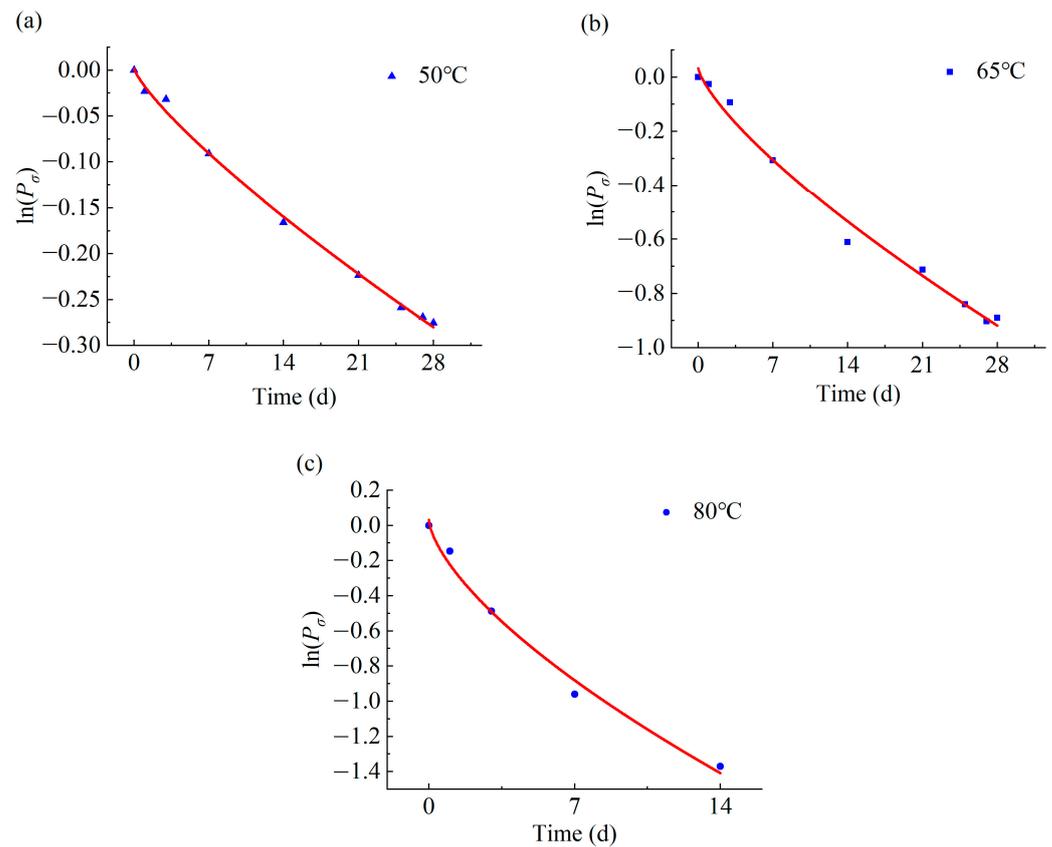
Figure 13. Relationship between cohesive strength and aging time. (a) Aging temperature is 50 °C. (b) Aging temperature is 65 °C. (c) Aging temperature is 80 °C.

Equation (2) was employed to establish a mathematical relationship between cohesive strength and aging time under varying temperature conditions within the simulated tunnel environment aging test. The following table (Table 4) presents the fitting parameters, while Figure 13 depicts the corresponding fitting curves.

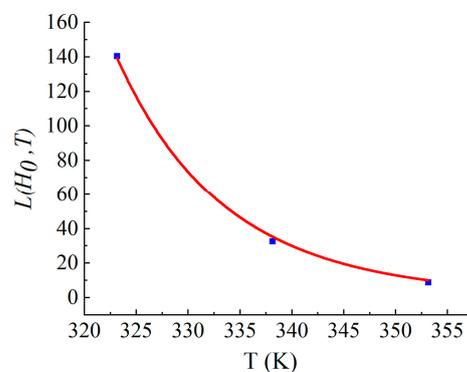
Figure 14. Fitting results of the water–thermal aging lifetime model.

According to the specification GB/T 23446-2009 [38], the bond strength of polyurea must exceed 2.5 MPa. The critical value of bond strength was set at 50% of this value. The critical value of cohesive strength was also set at 1.25 MPa. After fitting, the parameter substitution Equation (5) was obtained, as shown in Figure 14. If the annual average temperature of the water conveyance tunnel is 15 °C, the estimated service life of the polyurea coatings is approximately 16.52 years.

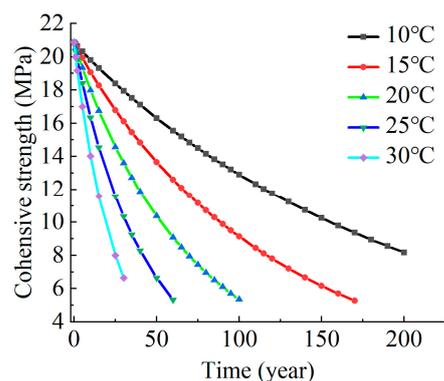
Figure 15. Predicted time-dependent cohesive strength profile.

The water–thermal aging lifetime model suggests a service life for the polyurea coating. This is attributed to the combined effects of temperature, water flow, and other factors encountered during real-world engineering applications, as reflected by the time-dependent cohesive strength profile in Figure 15. In the water conveyance tunnel project, with a predicted temperature range of 10~30 °C and a service life of 5 years, the measured cohesive strength of the polyurea exhibited a range of 0.83~2.93 MPa. The average estimated value was 1.56 MPa, with the lowest and highest values being 1.067 MPa and 2.035 MPa, respectively. These results demonstrate good agreement with the predicted values.
