# Artificial Weathering Test Methods of Waterborne Acrylic Coatings for Steel Structure Corrosion Protection

**Abstract:** Corrosion protection technologies based on waterborne paints have become increasingly popular as steel structure protection, which implies the need to determine relevant assessment methods considering the conditions of use and product-specific characteristics. This study attempts to evaluate the fitness of standard corrosion protection weathering methods and an original cyclic test for verifying the resistance of waterborne acrylic coatings to environmental conditions. Changes to the properties of artificially weathered coatings were analysed with reference to those observed during exposure in natural conditions. The degree of coating degradation after exposure to neutral salt spray and condensation humidity was determined to significantly exceed the changes observed in natural conditions. An original cyclic test caused changes in the appearance, microstructure, FT-IR spectrum and utility properties of the coatings, such as thickness, colour, hardness, adhesion and impedance, similar to those observed in the natural environment. The results confirm that the pr

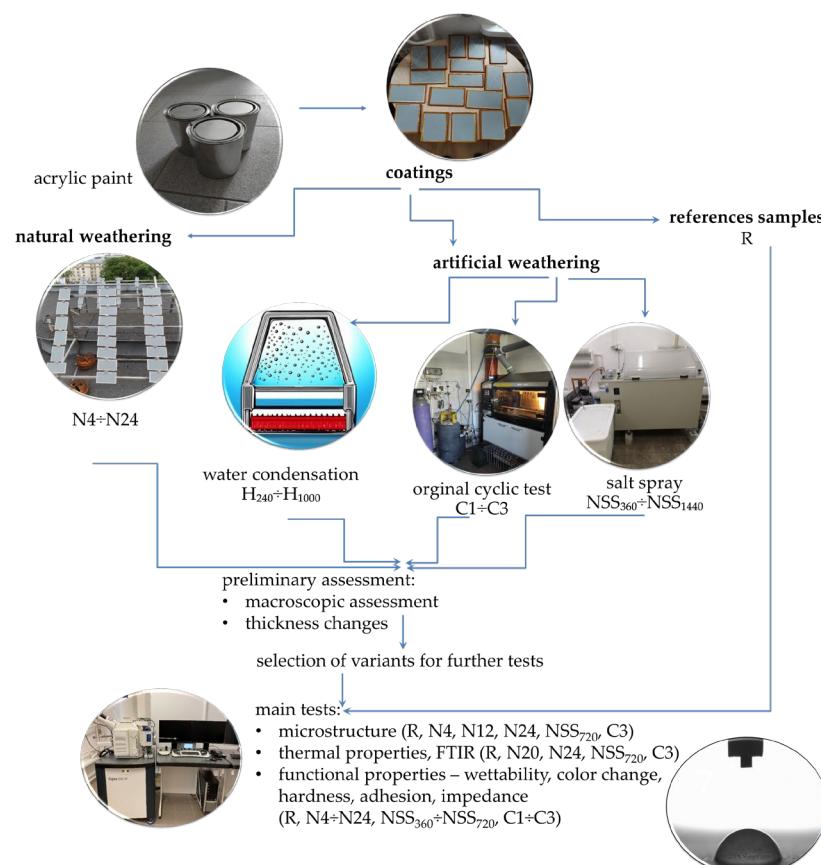
**Figure 1.** Experimental flowchart with photos.

Methods for testing the resistance of waterborne coatings to environmental conditions have not been determined so far. That is why this study attempts to assess the fitness of standard accelerated weathering methods for corrosion protection in the new category of the coatings mentioned above, which has not been analysed so far. In addition, the unprecedented original cyclic test was developed that simulates the impact of a broad spectrum of environmental factors: UV radiation, condensation humidity, neutral salt spray, negative and elevated temperature, and sulphur dioxide. An analysis was performed of the changes in waterborne acrylic coating characteristics under the influence of artificial weathering carried out with different techniques. The changes observed in accelerated tests were those observed during exposure in natural conditions. Macroscopic and microscopic evaluations were carried out, and thermal properties and spectra were analysed with FTIR. Moreover, the utility properties of the coatings were evaluated for their thickness, colour, adhesion and impedance. A flowchart of works versus the whole experiment is summarised in Figure 1.

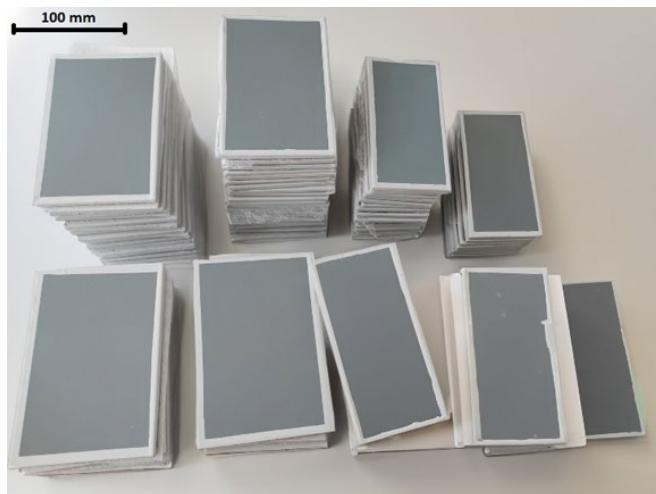
**Figure 2.** Test samples—steel panels with acrylic paint coating.

One hundred 150 × 100 × 5 mm panels and one hundred 150 × 75 × 5 mm panels were prepared for the tests. The panel edges were protected with an extra coating layer and epoxy resin/paraffin to intensify corrosion protection of sensitive areas. A general view of selected panels is shown in Figure 2. On some panels meant for scratch corrosion evaluation tests, 100 mm long and 1 mm wide X-shaped scribes (incisions) were made. The coating was incised up to the steel substrate depth. The panels were conditioned under laboratory conditions (temp.  $23 \pm 2^\circ\text{C}$ , 50 ± 5% RH) for thirty days from paint application.

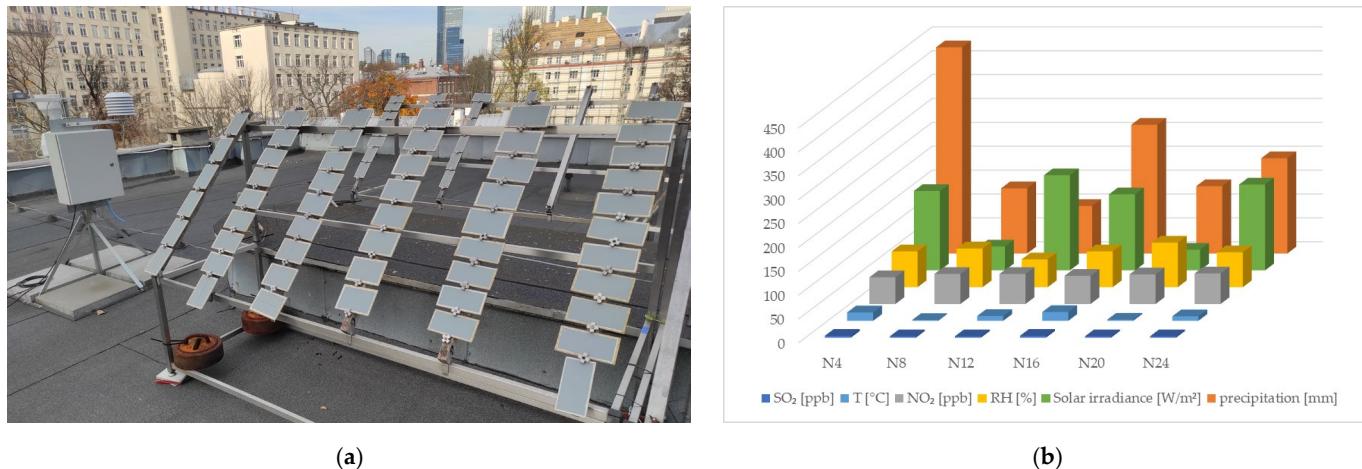
**Figure 3.** Natural weathering: (a) test site with test panel frames and weather station, (b) environmental conditions recorded by the weather station. The data cover 24-month exposure and are presented either as a sum (precipitation) or median (other), recorded during 4 months (N4), 8 months (N8) and 24 months (N24).

A half of the panels were subject to natural weathering. This involved exposure on a test site (Figure 3a) in a C3 corrosion-category environment [29]. The test site was situated on the flat roof of the Building Research Institute, on the fourth floor, with geographical coordinates  $52^{\circ}13' N$   $21^{\circ}0' E$ . The panels were fixed to frames (display stands) made of stainless steel and wood. The samples were positioned at  $60^{\circ}$  against the surface. A weather station Meteo LB-490, (LAB-EL, Reguły, Poland) was placed in the direct vicinity of the samples. The weather station was supposed to record environmental conditions, i.e., temperature, air relative humidity, rainfall, solar radiation intensity and  $NO_2$  and  $SO_2$  content. The data were recorded in ten-minute intervals. The exposure on the test site and registration of environmental conditions were carried out for twenty-four months, from June 2021 to June 2023. The weather station data are summarised in Figure 3b. All parameters except for precipitation are presented as a median. The median of the solar radiation intensity covered only the period with intensity values  $> 0$ . Atmospheric precipitation is presented as a total for the given period. The test series are marked as N4, N8... and N24, where the numerical component stands for natural weathering time in months, i.e., 4, 8... and 24 months, respectively.

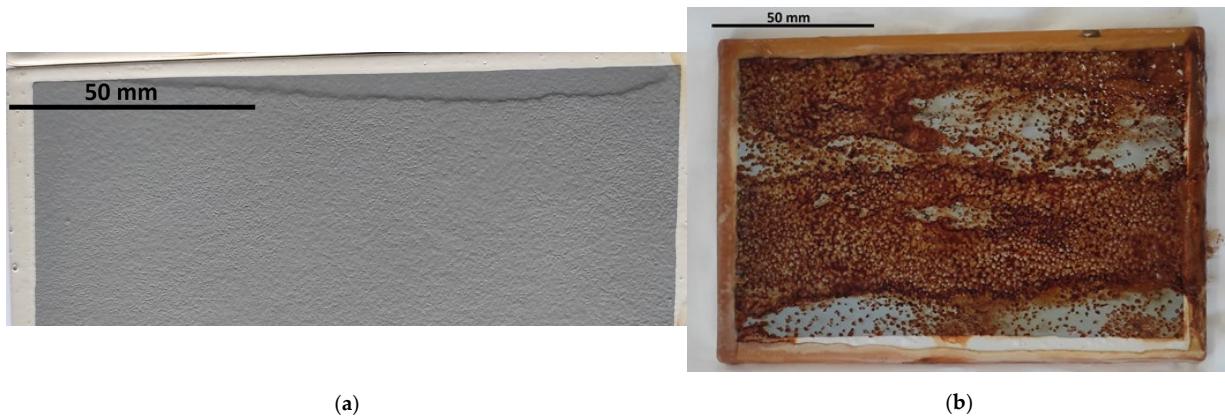
**Figure 4.** General view of the artificially weathered sample: (a) coating swelling after 1000 h of water condensation exposure, (b) corrosion after 1440 h exposure to neutral salt spray atmosphere (NSS<sub>1440</sub>).

Blistering was the dominant type of change. It shall be highlighted that they were not observed at any exposure stage in natural conditions. The N4–N24 series samples revealed no traces of blistering, even at magnification  $\times 10$ , which corresponded to grade 0(S0). Blistering was visible during artificial weathering but occurred at different stages of selected exposures and with varied intensity. Blistering was not observed at the initial stage of water condensation exposure. A minimal number of changes, noticeable only at magnification  $\times 10$ —grade 1S(1)—was observed only after 1000 h of exposure (H<sub>1000</sub>). Nevertheless, it shall be emphasised that coating swelling was observed right from the first exposure stage (as presented in Figure 4a and discussed in detail in Section 3.2), making blistering evaluation difficult. The exposure to neutral salt spray caused coating blistering at the very first stage of exposure, whereby for the NSS<sub>360</sub> series with no scribes, minor blistering was reported, visible only at magnification  $\times 10$ —2S(1). In the case of incised samples, the damage pattern was dense but barely noticeable with the naked eye—5S(2). The longer the weathering time was, both for samples with and without a scribe, the blistering intensified, respectively, up to grade 3(S2), moderate quantity of blistering barely noticeable with the naked eye, and 5(S3), dense blistering pattern up to 0.5 mm in size. The coating behaved completely differently during exposure in the original cyclic test. Non-incised samples had no traces of blistering throughout the entire exposure period, similar to the C1 series with scribes. A significant quantity of blistering was reported for the incised samples after C2 and C3, barely noticeable with the naked eye, 4(S2). The samples with and without scribes are presented in Figure 5a,b.

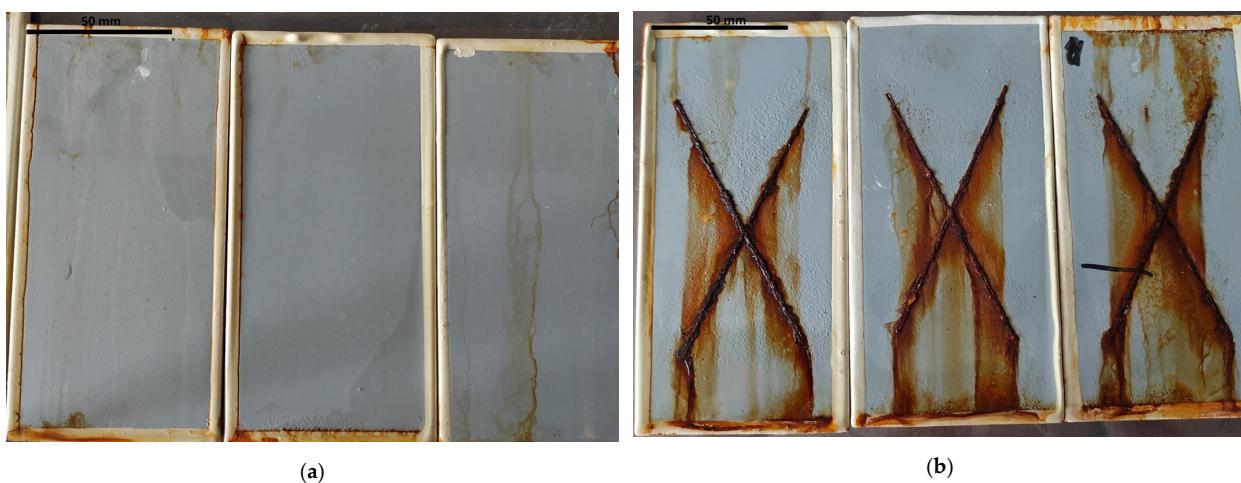
**Figure 5.** General view of the artificially weathered samples after 3 cycles of original test exposure: (a) coating without scribes, (b) coating with 1 mm scribes.

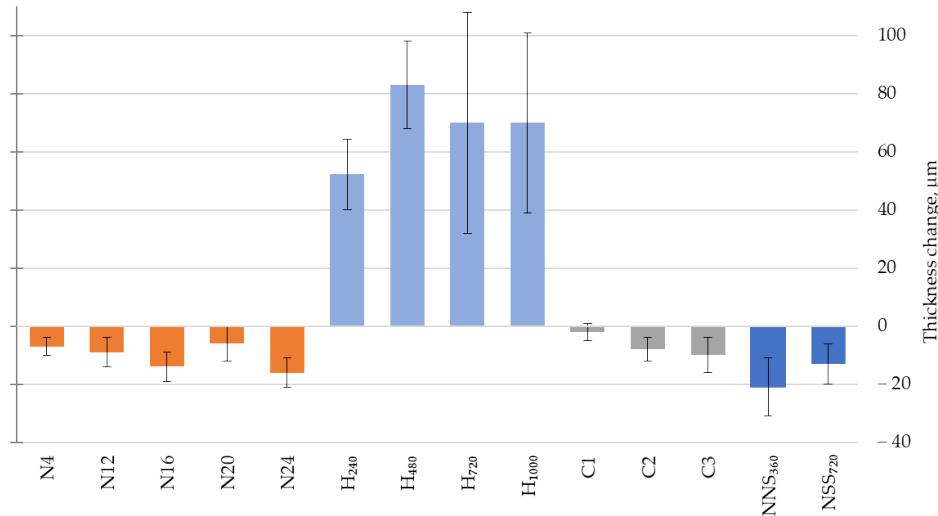
**Figure 6.** Change in the coating thickness after ■ natural weathering for a period between 0 and 24 months, including intermediate evaluation after 4, 12, 16, 20 and 24 months (N4–N24); ■ artificial weathering by water condensation for a period between 0 and 1000 h, including intermediate evaluation after 240 h, 480 h and 720 h (H<sub>240</sub>–H<sub>1000</sub>); ■ after artificial weathering according to the original cyclic test between 1 (C1) and 3 (C3) cycles; ■ artificial weathering in a neutral salt mist for a period between 0 and 720 h, including intermediate evaluation after 360 h (NSS<sub>360</sub>–NSS<sub>720</sub>); the error bars represent standard deviation.

An analysis of the coating thickness measurement results reveals that both natural and artificial weathering cause changes that aggravate with the increasing exposure duration (Figure 6). For the coating exposed in natural conditions (N4–N24), exposed to a neutral salt spray atmosphere (NSS<sub>360</sub>–NSS<sub>720</sub>) and subjected to the original cyclic test (C1–C2), reduced thickness was observed, which matches previous study results [11,26,38]. The reduction did not exceed 10% of the original value, which amounted to ca. 200 µm. The

decrease in the polymer coating thickness may be related to erosion caused by precipitation and wind-transferred mechanical pollution [39,40], additionally accelerated by the impact of UV radiation [41].

The coating thickness being higher for the N20 series than for N24 is most likely related to different weather conditions during the measurement. The highest relative humidity median amounting to 93% at a relatively low temperature of ca. 3 °C was observed during the N20 series measurements (Figure 3b). A significant thickness decrease was reported for the N24 series samples, corresponding to the trend observed throughout the exposure period of 0–24 months. It should be highlighted that during the N24 measurements, the median of air relative humidity was ca. 70% RH, and the air temperature was ca. 10 °C (Figure 3b). Considering that waterborne paint systems tend to absorb water [13,14], which might cause their blistering [37], a higher thickness after exposure to humid conditions seems justified. An acrylic coating's susceptibility to swelling due to a long-term water impact was demonstrated by its thickness, higher by 50–80  $\mu\text{m}$  after artificial weathering using condensation water (H<sub>240</sub>–H<sub>1000</sub>). A thickness increase of 25–40% against the initial state was observed in this test but not for any other exposures. Considering the significant difference against other exposures, especially in comparison with natural conditions, and simultaneously taking into account some technical constraints in performing tests on such a swollen coating, a decision was made to abandon further testing on the H<sub>240</sub>–H<sub>1000</sub> series. Based on the observations above, a weathering test involving long-term exposure to condensation humidity required a separate, in-depth analysis of its fitness for evaluating acrylic coatings. The impact of time and samples' seasoning conditions between the end of exposure and making the measurement is among the factors to be analysed. It seems that under adequate conditions, water evaporates from the coating, and the observed thickness increase after condensation tests can be temporary [13].

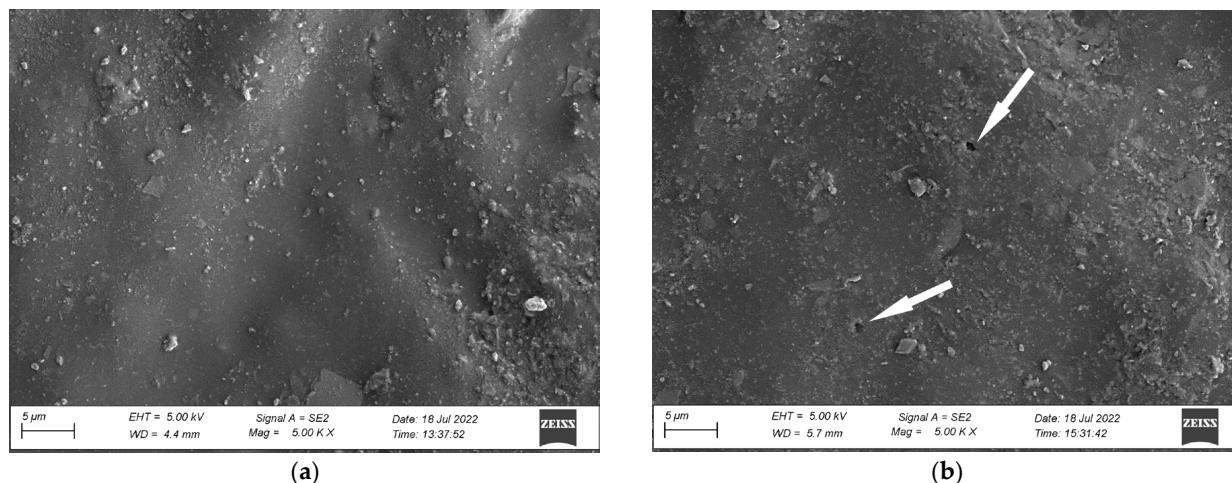
**Figure 7.** Microstructure of the coating's surface: (a) initial state (R), (b) after natural weathering for 4 months (N4); pitting is marked by an arrow; magnification  $\times 5000$ .

An analysis of the coating's surface microstructure in the initial state revealed a uniform and continuous coating (Figure 7a). The images show only minor contamination of the coating and particles of mineral fillers. Exposing the coating to natural environmental conditions for four months (N4) resulted in slight changes in the microstructure. The SEM revealed small pits with sizes around 1 µm (Figure 7b). The surface morphology analysis, carried out after twelve months of exposure (N12), demonstrated pits with sizes ranging from 5 µm to 10 µm and smaller pits in a size range between 1 µm and 2 µm (Figure 8a). The presence of these pits clearly shows polymer degradation [42,43]. Moreover, significant contamination of the material surface can be observed in the images. The change in the coating's microstructure under an environmental impact can harm the performance of the analysed materials [40,43].

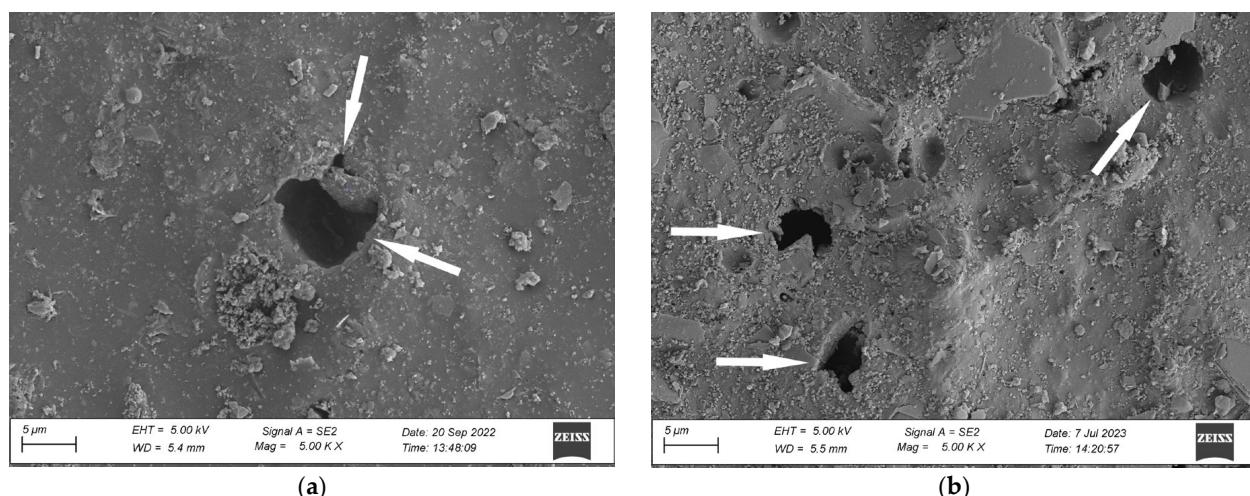
**Figure 8.** Microstructure of the coating's surface after natural weathering for (a) 12 months (N12), (b) 24 months (N24); pitting is marked by an arrow; magnification  $\times 5000$ .

Further exposure to natural conditions for twenty-four months (N24) did not intensify the coating's surface degradation. The images show pits with sizes ranging from 1  $\mu\text{m}$  to 6  $\mu\text{m}$  (Figure 8b), i.e., smaller ones than after twelve months of exposure. Smaller sizes of the coating defects can result from the difference in the atmospheric conditions during sampling. For the samples weathered on the test site, the microstructure change can be attributed to the impact of UV radiation, erosion due to rain and hail, and wind-transferred mechanical pollution [40]. Microscopic observations confirm the results of measurements of utility properties presented further in this study and show a correlation between surface degradation and material properties. The samples subjected to natural weathering reveal degradation changes such as contamination anchored in the material and the presence of voids and larger pits.

The coating's microstructure changes after artificial weathering according to the original cyclic test C3 (Figure 9b) were similar to those reported for the N<sub>12</sub> series samples naturally weathered for twelve months (Figure 8a) and N<sub>24</sub> series samples weathered for twenty-four months (Figure 8b).

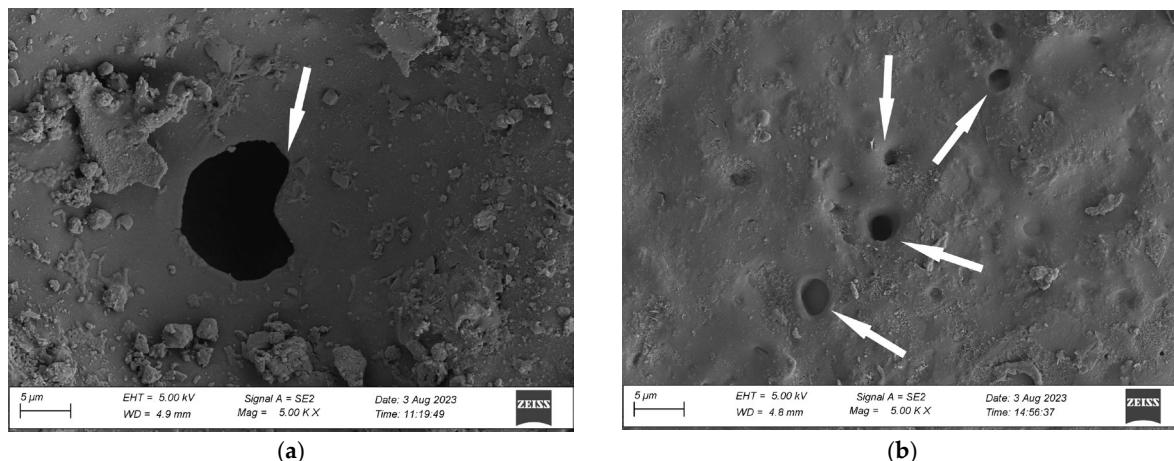
**Figure 9.** Microstructure of the coating's surface after (a) exposure to neutral salt spray (NSS<sub>720</sub>), (b) original cyclic test (C3); pitting is marked by an arrow; magnification  $\times 5000$ .

In the next stage of work, the coating's microstructure after exposure to natural conditions was compared with the microstructure after artificial weathering, including exposure to neutral salt spray (NSS<sub>720</sub>) and according to the original cyclic test (C3). The results of microscopic observations reveal a significantly higher degradation rate of the coating after exposure to salt spray. The images show voids with sizes ranging from 15  $\mu\text{m}$  to 20  $\mu\text{m}$  (Figure 9a). The NSS<sub>720</sub> series coating degradation was more significant than after the cyclic test, where the pit sizes ranged from 1  $\mu\text{m}$  to 5  $\mu\text{m}$  (Figure 9b).

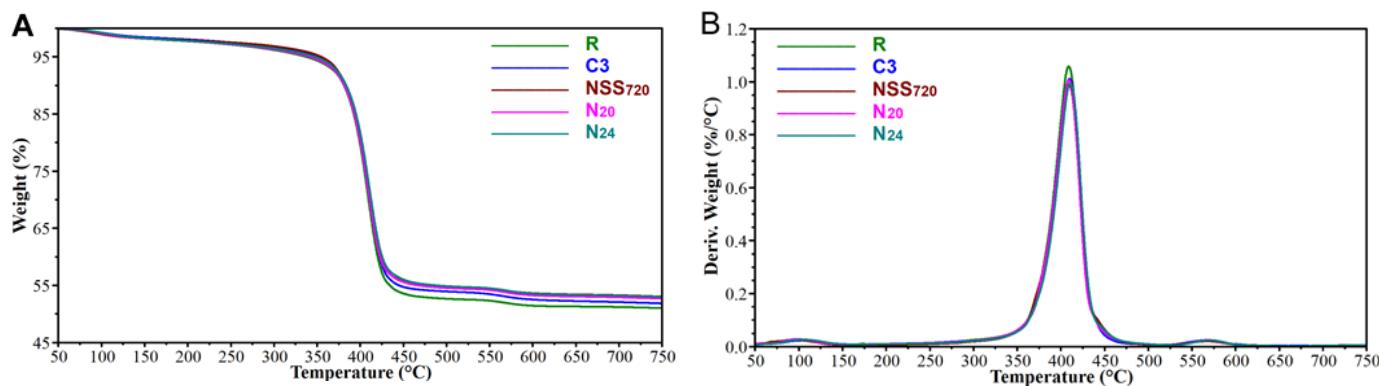
**Figure 10.** TGA (A) and DTGA (B) curves recorded for the tested coatings.

Three stages of mass loss were observed for all coatings. The first stage, progressing most intensively for temperatures of ca. 100 °C, is related to the dehydration of the coatings and the potential evaporation of additives with low thermal stability, e.g., 2-butoxyethanol (cf. Table 1). The mass loss corresponding to the process was minor, within a 1.6–1.9% range. Then, a further slow mass loss was observed, related to the formation of anhydrides from carboxylic acids in the polymer or the loss of hydrogen atoms from the main chain [44]. The second significant decomposition stage occurs within a temperature range of ca. 350–450 °C

and is related to the primary degradation of the acrylic matrix. The third decomposition stage, characterised by mass losses of 1.4–1.7%, occurring within a temperature range of ca. 525–600 °C, is the result of matrix residue carbonisation [44]. The total mass loss related to polymer degradation (marked as  $m_2$  in the Table), i.e., covering anhydrite formation, hydrogen atom loss from the primary chain and main pyrolysis, was most significant for non-weathered samples (R) and alleviated for naturally weathered (N<sub>20</sub> and N<sub>24</sub>) and artificially weathered samples, both in the salt spray atmosphere (NSS<sub>720</sub>) and according to the original cyclic test (C3). Consequently, the share of inorganic fillers changed, which was identified after pyrolysis carried out up to 750 °C. The observed reduction in the polymer fraction content suggests that the erosion rate of the polymer coating matrix is much higher than that of the inorganic filler.

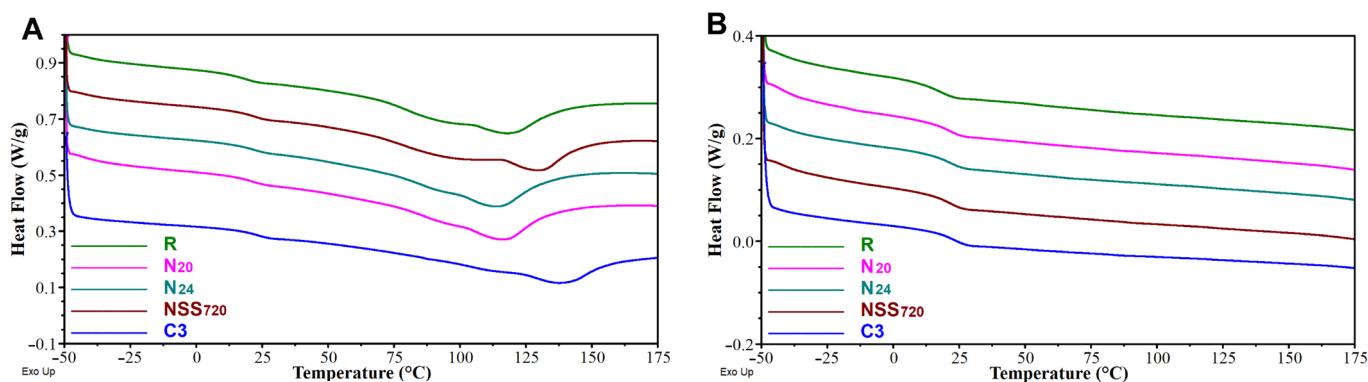
**Figure 11.** DSC curves recorded for 1st (A) and 2nd (B) heating cycles of non-weathered and artificially weathered coatings.

The results of the DSC analysis are summarised in Table 7 and Figure 11. For all analysed coating states, in the first heating cycle, a transition from a vitreous to a visco-elastic state (vitrification) was observed, accompanied by a broad endothermic peak of a more or less noticeable but always bimodal nature. Since it occurs only in the first cycle, it is most likely caused by water evaporation and also by evaporation or melting of the additives (e.g., 2-butoxyethanol). The vitrification temperature was observed to increase slightly due to coating weathering. This suggests that a coating-softening ingredient is washed out. The identified temperatures were slightly lower in the first heating cycle, which can be explained by the presence of water and/or other additives acting like plasticisers. The effect observed for the non-weathered sample was the opposite, i.e.,  $T_g$  was slightly lower in the second cycle. From an application point of view, the results do not reveal any significant differences between the materials.

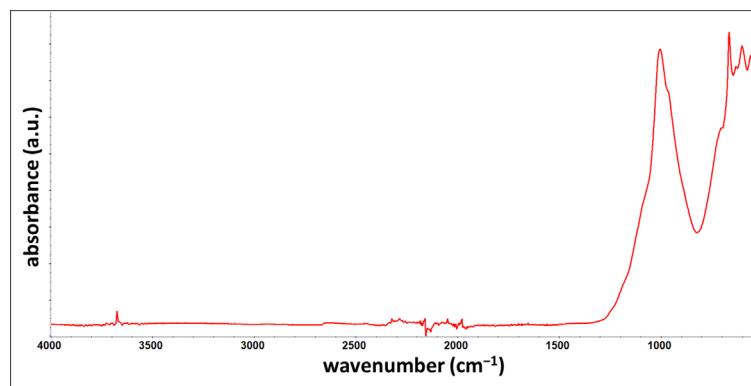
**Figure 12.** Spectrum recorded for residues of pyrolysed non-weathered coating.

The coatings were also tested using Fourier-transform infrared spectroscopy (FTIR). The spectra of inorganic pyrolysis residues were additionally recorded (Figure 12). Titanium dioxide should be the primary inorganic filler (Table 1). Nonetheless, the recorded spectrum is not typical of the referenced compound [45,46] talc spectrum [47,48]. The most intensive band with a peak at  $1004\text{ cm}^{-1}$ , similar to the peak at  $666\text{ cm}^{-1}$ , originates from the Si-O stretching vibrations, whereas the band at  $3675\text{ cm}^{-1}$  originates from stretching of O-H surrounded by the MgMgMg triplet [49,50].

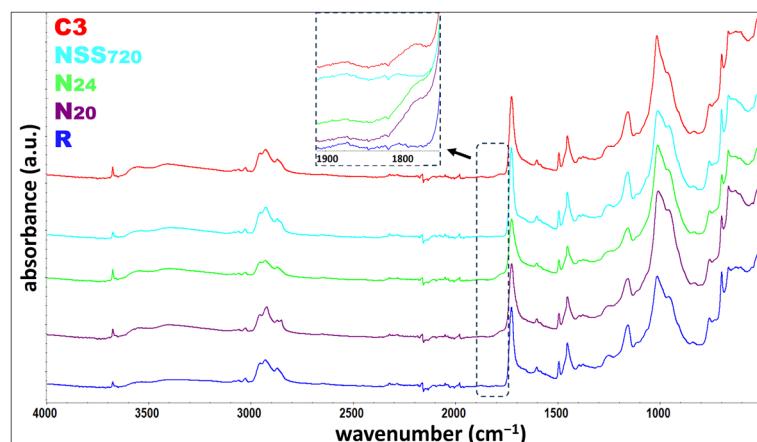
**Figure 13.** ATR-FTIR spectra recorded for non-weathered and artificially weathered coatings.

The spectra recorded for the non-weathered coating and coatings weathered in natural conditions (N<sub>20</sub> and N<sub>24</sub>) and artificially weathered, in the salt spray atmosphere (NSS<sub>720</sub>) and according to the original cyclic test (C3) (Figure 13), did not reveal significant differences between samples of different states. The positions of the main characteristic bands (Table 8) did not change. Nonetheless, a thorough analysis showed that as a result

of coating weathering, the intensity ratio of bands characteristic for the filler ( $\sim 1011\text{ cm}^{-1}$  and  $3675\text{ cm}^{-1}$ ) to the intensity of the band characteristic for the polyacrylic matrix (i.e.,  $1725\text{ cm}^{-1}$ ,  $1452\text{ cm}^{-1}$ ,  $1158\text{ cm}^{-1}$ , and  $698\text{ cm}^{-1}$ ) rises. This is testimony for the reduced share of the polymer phase in the coating, which complies with the TGA results. Most importantly, for the naturally weathered coatings and those exposed to artificial weathering according to the original cyclic test (C3), broadening was observed at the peak base from the C=O stretching vibrations, as shown in Figure 13. The effect is caused by the formation of photodegradation products under UV radiation [51]. The effect was not observed for the coating weathered in a salt spray environment (NSS<sub>720</sub>).

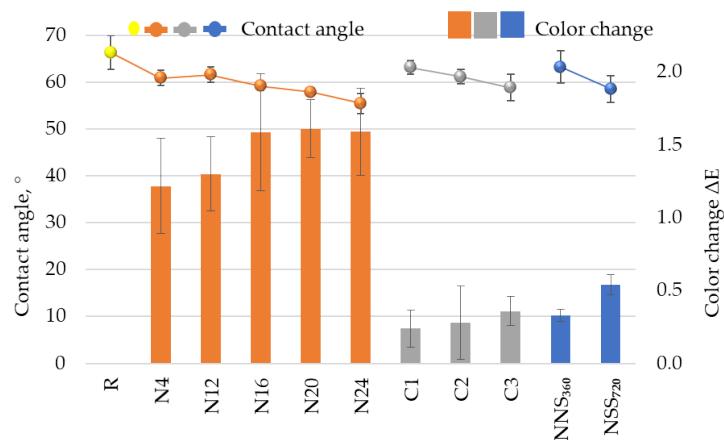
**Figure 14.** Change in the colour and contact angle • reference samples, ■ natural weathering for a period between 0 and 24 months, including intermediate evaluation after 4, 12, 16, 20 and 24 months (N4–N24), ▨ artificial weathering according to the original cyclic test—between 1 (C1) and 3 (C3) cycles, ■ artificial weathering in a neutral salt mist for a period between 0 and 720 h, including intermediate evaluation after 360 h (NSS<sub>360</sub>–NSS<sub>720</sub>); the error bars represent standard deviation.

Natural weathering resulted in a contact angle change (Figure 14). Data analysis for the N4–N24 sample series shows a declining trend. The contact angle for N24 samples dropped by  $11^\circ$  compared to the reference sample R. A similar trend was observed for the C1–C3 series samples. The NSS<sub>720</sub> samples were characterised by contact angles similar to those of N24 and C3. The decrease in the contact angle value in the function of time

suggests an increase in the coating's hydrophilic nature due to weathering exposure. The coating's increasing wettability means its higher susceptibility to absorb moisture [3], consequently reducing its corrosion protection capability due to a larger contact area with corrosive media. The contact angle value slightly deviating from the general trend for the N12 series could be related to the atmospheric conditions during the measurement. The air relative humidity median reported for the measurement period was the lowest for the entire exposure duration, i.e., ~58% RH, whereas the solar radiation intensity was the highest ~200 W/m<sup>2</sup>; moreover, the total precipitation in the referenced period was the lowest—~100 mm (Figure 3b). Analysing the contact angle values and changes in the coating thickness against the environmental conditions recorded by the weather station, one can observe the relationship between the measurement results and temporary conditions on the test site. The observations confirm the changing nature described in the literature, hampering test programming with accelerated methods [27].

The coating colour change observed in this study was adversely correlated with the changes in the contact angle (Figure 14). For the N4–N24 series samples, the total colour change  $\Delta E^*_{ab}$  amounted to 1.2–1.5, which is considered a very low value. A change of fewer than five units is unnoticeable to the human eye [19,26]. Under artificial conditions, a gradual colour change was observed with longer exposure times for the C1–C3 and NSS<sub>360</sub>–NSS<sub>720</sub> series samples, but it was over three-times lower than the change for the N4–N24 series samples. Considering the above, it can be stated that the set exposure under artificial conditions, despite taking into account the factors primarily responsible for the colour change in waterborne paint samples, i.e., UV radiation, elevated temperature and humidity [37,52], did not exert an impact similar to that during natural weathering, even in comparison with the first four months of exposure. Exposure to neutral salt spray, for which a correlation with natural weathering was reported [19] for the colour change, did not bring the expected convergence. The authors of other studies [16] indicated that the colour change after tests in weathering chambers featured with fluorescent lamps may not correspond to the actual colour change in natural conditions. Even though UV radiation is essential to colour changes, a different exposure angle, snowfall and other environmental factors can significantly contribute to the parameter change. The colour change measurement results collected during this study suggest a need to consider future modifications to the cyclic weathering test, e.g., by more prolonged exposure to UV radiation and humidity. Due to high fluctuations in solar radiation intensity in natural conditions (Figure 3b), accelerated weathering involving UV radiation is hard to simulate in a laboratory. The authors of [20]

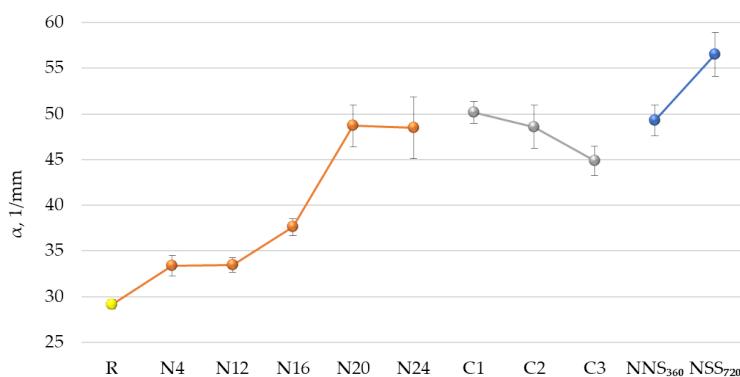
**Figure 15.** Coating hardness  $\alpha$  ● reference samples, ■ natural weathering for a period between 0 and 24 months, including intermediate evaluation after 4, 12, 16, 20 and 24 months (N4–N24), ▨ artificial weathering according to the original cyclic test—between 1 (C1) and 3 (C3) cycles, ■ artificial weathering in a neutral salt mist for a period between 0 and 720 h, including intermediate evaluation after 360 h (NSS<sub>360</sub>–NSS<sub>720</sub>); the error bars represent standard deviation.

An analysis of hardness test results (Figure 15), expressing the coating's susceptibility to denting, reveals that exposure in natural conditions increases the hardness, which is illustrated by the results obtained for the N4–N24 series. For the C1–C3 series samples, a slight decrease in hardness was observed with every cycle. Still, it should be highlighted that the results obtained in the original test were similar to those reported for the N20 and N24 series. The coating hardness for the NSS<sub>360</sub> and NSS<sub>720</sub> series samples increased twice against the reference sample, reaching values considerably higher than those for N20–N24.

The hardness increases and decreases observed for the N4–24 sample series are most likely related to momentary atmospheric conditions on the test site when the samples were collected. A noticeable hardness drop observed during the cyclic test was caused by the impact of a low concentration of sulphurous acid formed in a humid atmosphere during the SO<sub>2</sub> test ( $H_2O + SO_2 \rightarrow H_2SO_3$ ). The sulphurous acid concentration in the accelerated test was much higher than in natural conditions (Figure 3b) and contributed to accelerated coating oxidation, decreasing the coating hardness [53]. The above suggests a need to consider future modifications in the original cyclic test by reducing the SO<sub>2</sub> concentration.

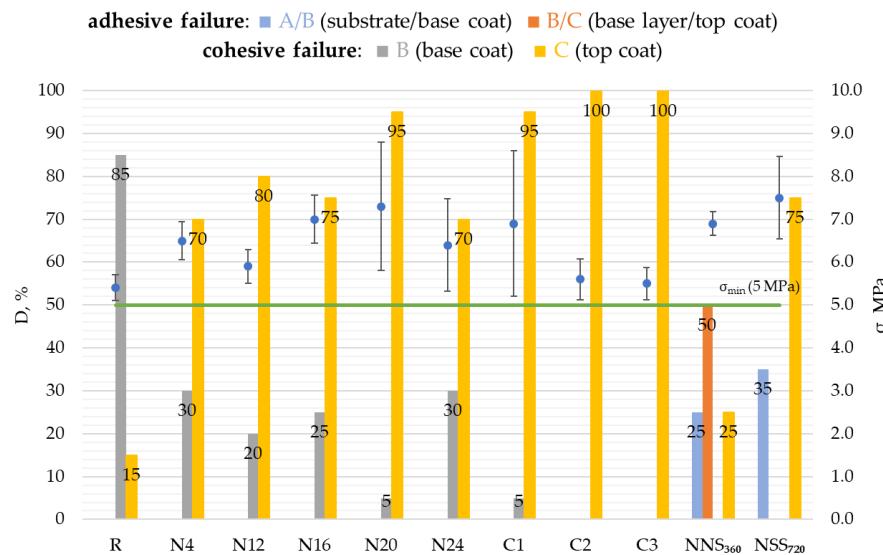
**Figure 16.** Results of adhesion tests expressed by the bond stress level ( $\sigma$ ) and nature of failure (D) obtained for samples weathered naturally for a period between 0 and 24 months, including intermediate evaluation after 4, 12, 16, 20 and 24 months (N4–N24), artificially weathered according to the original cyclic test for 1 (C1) to 3 (C3) cycles, artificially weathered in neutral salt mist for a period between 0 and 720 h, including intermediate evaluation after 360 h (NSS<sub>360</sub>–NSS<sub>720</sub>); the error bars represent standard deviation.

The adhesion of coatings after natural weathering ranged from 5.9 MPa to 7.3 MPa (Figure 16). During exposure in natural conditions (N4–N24), no decrease in the bond stress was reported compared to the initial state (R) values. After artificial weathering, the bond stress for the NSS<sub>360</sub> and NSS<sub>720</sub> series samples ranged from 5.6 MPa to 6.9 MPa, while after natural weathering for the C1–C3 series, it was between 6.9 MPa and 7.5 MPa, i.e., at a level not lower than in the initial state.

The nature of the samples' failure in the adhesion test is particularly interesting. In the initial state (R), after exposure to natural conditions (N4–N24) and after accelerated weathering according to the original cycle (C1–C3), cohesive failure was observed, though it occurred in different layers (Figure 16). For the initial state, failure in the base coat (B) dominated (85%). After N4–N24 weathering, top-coat (C) failure prevailed (70–95%) but with a noticeable share of the base coat (B). After C1–C3, the failure share shifted significantly towards the top coat (C), reaching values over 90%. The breaking nature of the NSS<sub>360</sub>–NSS<sub>720</sub> samples differed significantly. Cohesive–adhesive failure was observed. Adhesive failure dominated for the NSS<sub>360</sub> samples, 25% between the base coat and the

steel substrate (A/B) and 50% between the base coat and top coat (B/C). The remaining 25% was cohesive failure within the top coat (C). After extending the exposure time for the NSS<sub>720</sub> samples, a significant (35%) share was observed of the base coat separation from the substrate with steel corrosion exposure and a high (75%) share of the top-coat (C) failure.

By analysing the adhesion test results, one can observe the impact of environmental conditions on the periodic changes of this property. The lowest air humidity medians and the highest solar radiation intensity medians were recorded for the N12 and N24 periods (Figure 3b), which could contribute to tiny drops in the coating's adhesion to the substrate. The adhesion values obtained for the samples' exposure to weathering factors under artificial conditions (C1–C3, NSS<sub>360</sub>–NSS<sub>720</sub>) differed only slightly from the reference samples. It should be emphasised that the stress values for all tested variants exceeded the 5 MPa threshold considered satisfactory for steel structure corrosion protection coatings [4]. Moreover, analysing the nature of the coating failure after the adhesion test, it can be noticed that it was similar for N4–N24 natural weathering and C1–C2 accelerated weathering in the cyclic test. Cohesive failure (breaking) of the samples occurred in the base coat or top coat. Adhesive failure of the coating was, in turn, observed for the samples after a neutral salt spray test (NSS<sub>360</sub>–NSS<sub>720</sub>).

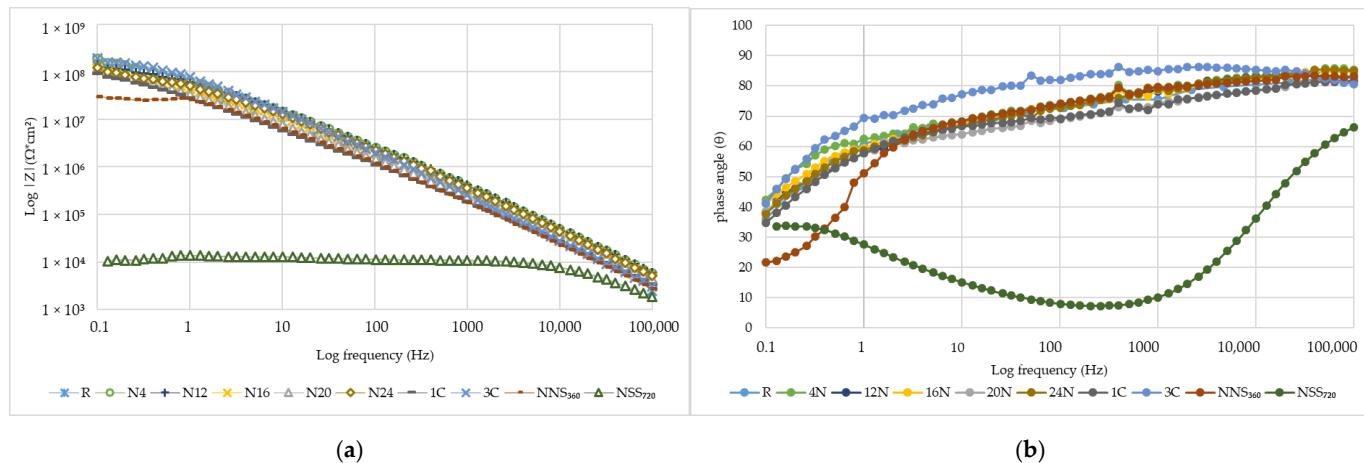
**Figure 17.** Coating impedance parameters for naturally weathered samples for a period between 0 and 24 months, including intermediate evaluation after 4, 12, 16, 20 and 24 months (N4–N24), artificially weathered according to the original cyclic test—from 1 (C1) to 3 (C3) cycles, artificial weathering in a neutral salt mist for a period between 0 and 720 h, including intermediate evaluation after 360 h (NSS<sub>360</sub>–NSS<sub>720</sub>); Bode plot; impedance module  $\log |Z|$  (a), phase angle (b).

The coating's impedance parameter results are shown in Figure 17a,b as Bode plots [54]. The impedance modules and phase angle suggest that the impedance of the naturally weathered samples (N4–N24) remained at a similarly high level over  $1 \times 10^8 \Omega \text{ cm}^2$ , and the initial value of the phase angle was  $80^\circ$ . The coating's resistance to ion penetration is reached when the impedance module value at low frequencies exceeds  $10^8 \Omega \text{ cm}^2$  [7]. Only a minor impedance drop was observed at a low frequency ( $|Z|_{0.01\text{Hz}}$ ) for the N4–N24 samples as weathering time progressed. In laboratory tests, the impedance module and phase angle values for the C1–C3 series samples were highly similar to those obtained for the N4–N24 series samples. The samples exposed to neutral salt spray were characterised by lower impedance values. For the NSS<sub>360</sub> samples, at frequencies  $< 1 \text{ Hz}$ , the curve flattening was observed at  $10^7 \Omega \text{ cm}^2$ , as well as a significant decrease in the phase angle value up to  $20^\circ$ . The measurement results of the impedance module for the NSS<sub>720</sub> samples revealed a loss in the coating's barrier function, even at high frequencies, which was

demonstrated by the impedance module values of  $1 \times 10^4 \Omega \text{ cm}^2$  and a violent drop in the phase angle.

A slight decrease in the impedance module at 0.01 Hz for the N4–N24 naturally weathered samples is a testament to slow degradation changes occurring in the coating's barrier mechanism, e.g., as a result of electrolyte penetration and enlargement of the pores [55], which was observed in microstructure tests (Figure 8a,b). The impedance values  $|Z|_{0.01\text{Hz}}$  correspond to the resistance generated by the coating due to electrolyte flow to the substrate; the higher the values, the better the coating's barrier effect is. Consequently, when the electrolyte penetrates towards the substrate, the value decreases [23]. The drop in the impedance module and phase angle for the NSS<sub>360</sub> and NSS<sub>720</sub> samples confirm macroscopic observations, where the first traces of the steel substrate corrosion occurred due to the presence of aggressive ions that accelerated corrosion; the coating's microstructure (Figure 8b) revealed pore sizes higher than for other series. Analysing the test results, it can be concluded that similarities occur in  $|Z|_{0.01\text{Hz}}$  for the N4–N24 naturally weathered samples and after the cyclic test (C1–C3). Moreover, the EIS test results reveal that the NSS causes too severe a coating degradation. Similar conclusions were drawn by the researchers, who discovered that the salt spray test caused more considerable coating degradation than natural weathering [19]. A similarity was observed only for exposure in marine environments [17,56].
