## Article

# High-Temperature Storage Testing of ACF Attached Sensor Structures

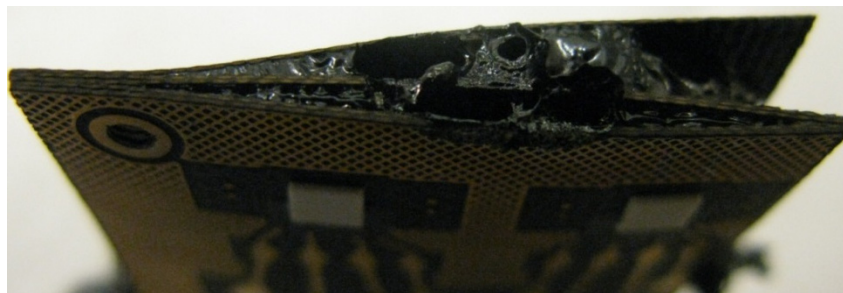
Figure 9. Inner layer after testing.

The electrical behavior of the FR-4 board was observed to be poor and unstable during testing. Clear changes in the FR-4 material could be seen during testing. Immediately after starting aging at both testing temperatures, the inner layer of the board reacted to the heat and started to degrade quickly, as shown in Figure 9. However, as all the functionality of the board was on the top layer, the samples did not necessarily fail due to the degradation of the inner layer.

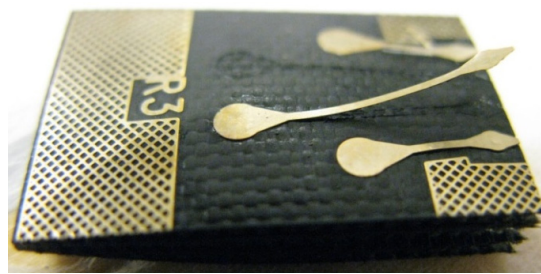
Figure 10. Detachment of the measurement wires in the corroded FR-4.

Additionally, the top layer of the FR-4 board corroded severely during the aging and clearly impaired the adhesion of copper traces to the board material (Figure 10). Therefore, the reliability of the measurement wires and their connections also markedly decreased. Severe corrosion of the substrate and interconnection materials, delamination between the sensor chip and the copper pads, as well as large voids in the pads were seen within the samples after short aging times (Figure 11). Consequently, the stability of the FR-4 material was observed to be poor even for short-duration high-temperature applications.
