Article

Fatigue of Ti6Al4V Structural Health Monitoring Systems Produced by Selective Laser Melting

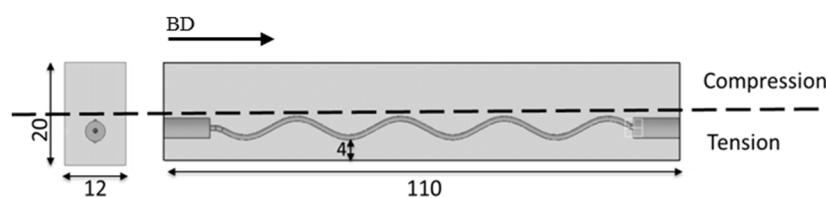
Figure 1. Four-point bending specimen's dimensions (mm): 2D side and front views.

The integrated capillary for the SLM Ti6Al4V specimens had a diameter of 1 mm and a sinusoidal shape with an amplitude of 2 mm. The period of the sinusoidal shape was 20 mm for the first four samples and the stress relieved specimen and 22.4 mm for the last two samples. After the SLM production the specimens were milled to final dimensions as specified in Figure 1. The capillary is not placed symmetrically in the middle of the specimens but close to the surface (4 mm away from the surface) on the tension side during the four-point bending test. The building direction (BD) is also indicated in Figure 1. The static tensile properties for the SLM Ti6Al4V were previously published in the literature [21] and are presented in Table 1. For the six SLM specimens that remained in as-built conditions, no stress relief or any heat treatment conditions were applied prior testing, while for one specimen a heat treatment of 2 h for 530° was applied in order to obtain SR conditions without altering the microstructure.

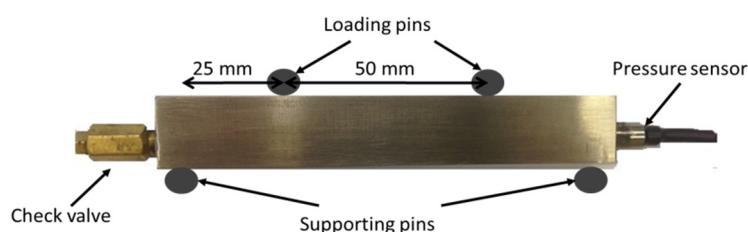
Figure 2. Schematic of four-point bending setup with the specimen and the installed pressure sensor.

The specimens were subjected to a cyclic fatigue loading in a four-point bending setup. A schematic representation of the four-point bending fatigue test is depicted in Figure 2. The locations with the highest probability for crack initiation from the capillary are situated at the capillary borders that are furthest away from the neutral axis in the tension area of a four-point bending test specimen (see Figure 1). The principal reason for this higher probability is directly related to the higher stress concentration at these locations. According to the step-method the initial stress amplitude is chosen below the fatigue limit of a specimen. For each step a large number of cycles N (500,000) with the same loading are applied. If failure does not occur, the stress amplitude is increased with a selected step and again a block of N cycles is applied [22,23]. This procedure is repeated until failure occurs. This approach is known as step-method, and it is suggested in the literature as a fast methodology for the generation of Haigh diagrams and determines the fatigue limit of a specimen. In the current study the attention is focused on the fatigue life of the specimen on the last step and on the stress level of the crack detection by means of the eSHM system. There are a few studies in the literature that demonstrate results on Ti6Al4V specimens produced by the SLM process [24–26]. However, since no previous results were available for the endurance limit of the additive manufactured Ti6Al4V of similar specimens with capillaries, a sufficiently low stress starting points was chosen.

A pressure transducer (Kulite XTL-123C-190M-1, 7-BAR-A, Leonia, USA) was placed at one side and a check valve (Clippard MCV-1-M5, Cincinnati, USA) at the other side of the specimen, as shown in Figure 2. After sealing, each specimen was placed in a vacuum chamber at a pressure of 0.5 bar. As a last stage an extra stop (Clippard 11755-M5-PKG, Cincinnati, USA) was installed on the check valve. The final test specimen is shown in Figure 2. After the crack detection, the test was stopped and the specimens were inspected by liquid penetrant inspection (LPI) in order to locate the crack. After this inspection, samples were again subjected to the fatigue test until failure occurred. To analyze the influence of the eSHM system on the microcrack initiation, the fracture surfaces obtained after the fatigue tests were analyzed with the optical microscope and the SEM. For the microstructural examination, the specimens were embedded in epoxy resin, ground using 1200 grit SiC paper and polished using a $0.25\ \mu\text{m}$ $\text{SiO}_2/\text{H}_2\text{O}/\text{H}_2\text{O}_2$ suspension. After the preparation the specimens were etched for 10 s in a solution of 50 mL H_2O , 25 mL HNO_3 and 5 mL HF. A Leica Mettalovert microscope was used in order to examine the microstructure.

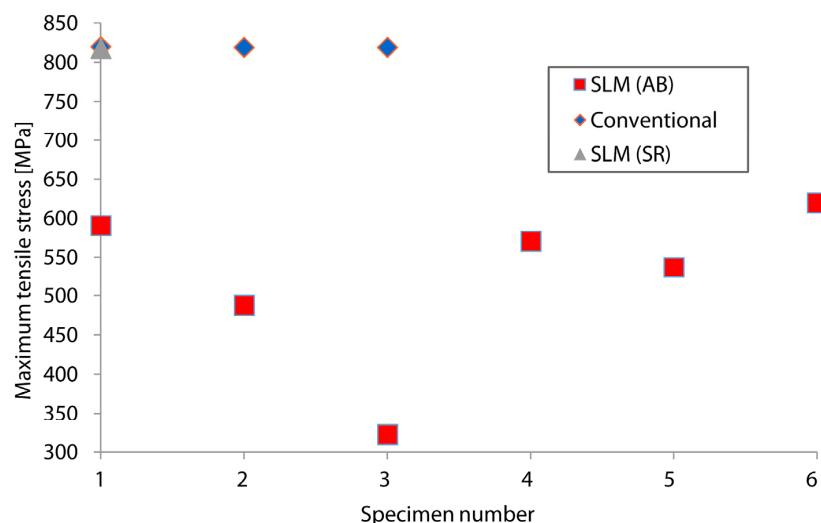
Figure 3. Maximum stress *vs.* specimen numbers for the conventional and SLM Ti6Al4V specimens in as-built (AB) and stress relieved (SR) conditions.

Figure 3 indicates the maximum tensile stresses obtained by conventional and SLM titanium specimens. Severe scatter is noted for the fatigue stress levels of components produced by SLM in as-built conditions (between 488 and 620 MPa). In contrast, conventional specimens show higher repeatability since the probability of internal defects is negligible compared to additively manufactured

specimens. The stress level of Specimen 3 is significantly lower than the average value of the other five SLM samples. The obtained value of the conventional Ti6Al4V specimens is 32.3% higher than the highest value obtained for SLM parts in Specimen 6. On the other hand, the maximum tensile stress obtained by the SR SLM specimen reached similar stress level (818 MPa) as the conventional Ti6Al4V specimen. This is an indication that residual stresses significantly affect the fatigue behavior of SLM produced parts, as suggested in the literature [28]. Overall, in additively manufactured components and especially on specimens with vertical building direction, vertical stresses are dominant over the horizontal stresses. Compressive residual stresses in the middle of the specimen are balanced by high tensile stresses that are present at the edges of the specimens [7,29,30]. As a consequence, the expected tensile stresses of the specimens' sides could be released by a stress relief heat treatment and improve the fatigue response. Due to the lack of more stress relieved specimens, this influence is not discussed in detail in this article. The scatter on the maximum stress levels and the fatigue life may be attributed to local porosity, residual stresses and microstructure of the SLM specimens. It is known that imperfections due to the SLM process may have a big effect on the mechanical properties of samples [28].

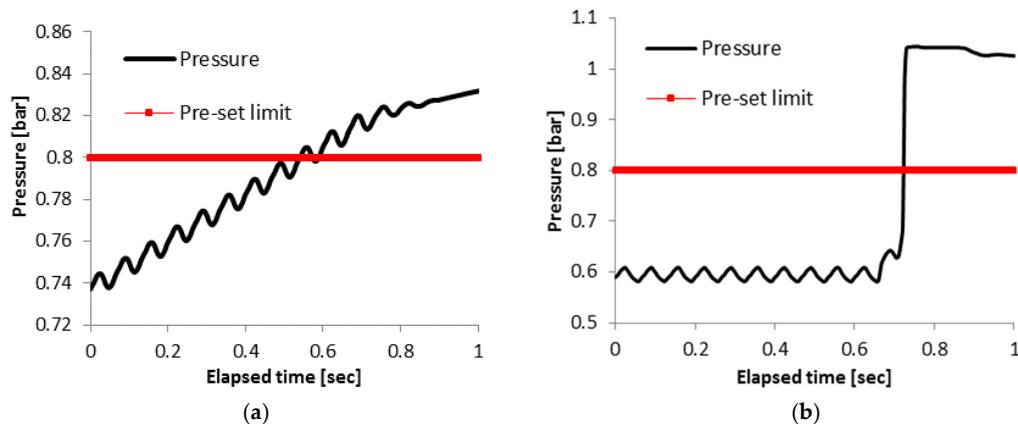
Figure 4. Pressure *vs.* elapsed time for (a) Specimen 3; and (b) Specimen 5 produced by SLM during the last second of the fatigue test.

During fatigue experiments the pressure in the capillary was continuously monitored by the pressure sensor. For both specimens the pre-set limit was set to 0.8 bar at the beginning of the test. When a crack penetrates the capillary, the pre-set limit of the pressure sensor is reached, and the fatigue test stops. Figure 4 shows the pressure as a function of the time for the last second of the fatigue test for Specimens 3 and 5. A periodic variation in the pressure due to the cyclic deformation of the specimens is clearly observed for the last load cycles applied to Specimens 3 and 5 (see Figure 4a,b).

When a crack opens, the pressure inside the capillary will increase and finally reach atmospheric pressure. Since the loading is cyclic, and the crack is open only a fraction of each cycle, the pressure will thus approach atmospheric pressure in steps. Examining these graphs, one can observe that there is a difference in the pressure behavior between Figure 4a,b. In Specimen 3 (Figure 4a), the pressure increased gradually until the threshold is reached. As it is depicted from Figure 4a, the increasing behavior possibly took place already from the previous applied cycles, which are not graphically presented in the current graph. In Figure 4b the pressure is stable until 0.64 s, where there is a sudden increase, and, a tenth of a second later, the pressure has already reached ambient pressure. Specimen

4 showed behavior similar to Figure 4a, while Specimens 1, 2, 6 and the SR specimen exhibited a pressure-time evolution comparable to Figure 4b.

It is important to mention that in Specimen 5 the maximum pressure is the ambient pressure which is approximately 1 bar, while in Specimen 3 the maximum pressure is only 0.83 bar. For both specimens the last 0.2 s of the test was in stress-free conditions since the pre-set limit activated the stopping procedure of the fatigue test. In the case of Specimen 5 the crack opening was large enough to reach atmospheric pressure in the capillary. In Specimen 3, although it looks like the pressure is still rising, after the last second, the crack was sealed, since a pressure of 0.83 bar could be maintained within the capillary. Evidence of crack closure was further provided by the LPI that was conducted in order to locate the crack [23]. In the case of Specimen 3 the liquid penetrant did not give a correct crack indication due to the fact that the crack was sufficiently closed to prevent the penetration of the liquid. In Specimen 5 the crack opening was probably wider than in Specimen 3. In addition to that, the stress level of Specimen 5 is higher (537 MPa) than the stress level of Specimen 3 (323 MPa). It is important to note that, although the increase in capillary pressure in Specimen 5 was sudden, the specimen did not fail completely, indicating that the structural health monitoring system discussed in this paper can also be used in the case of fast crack propagation.

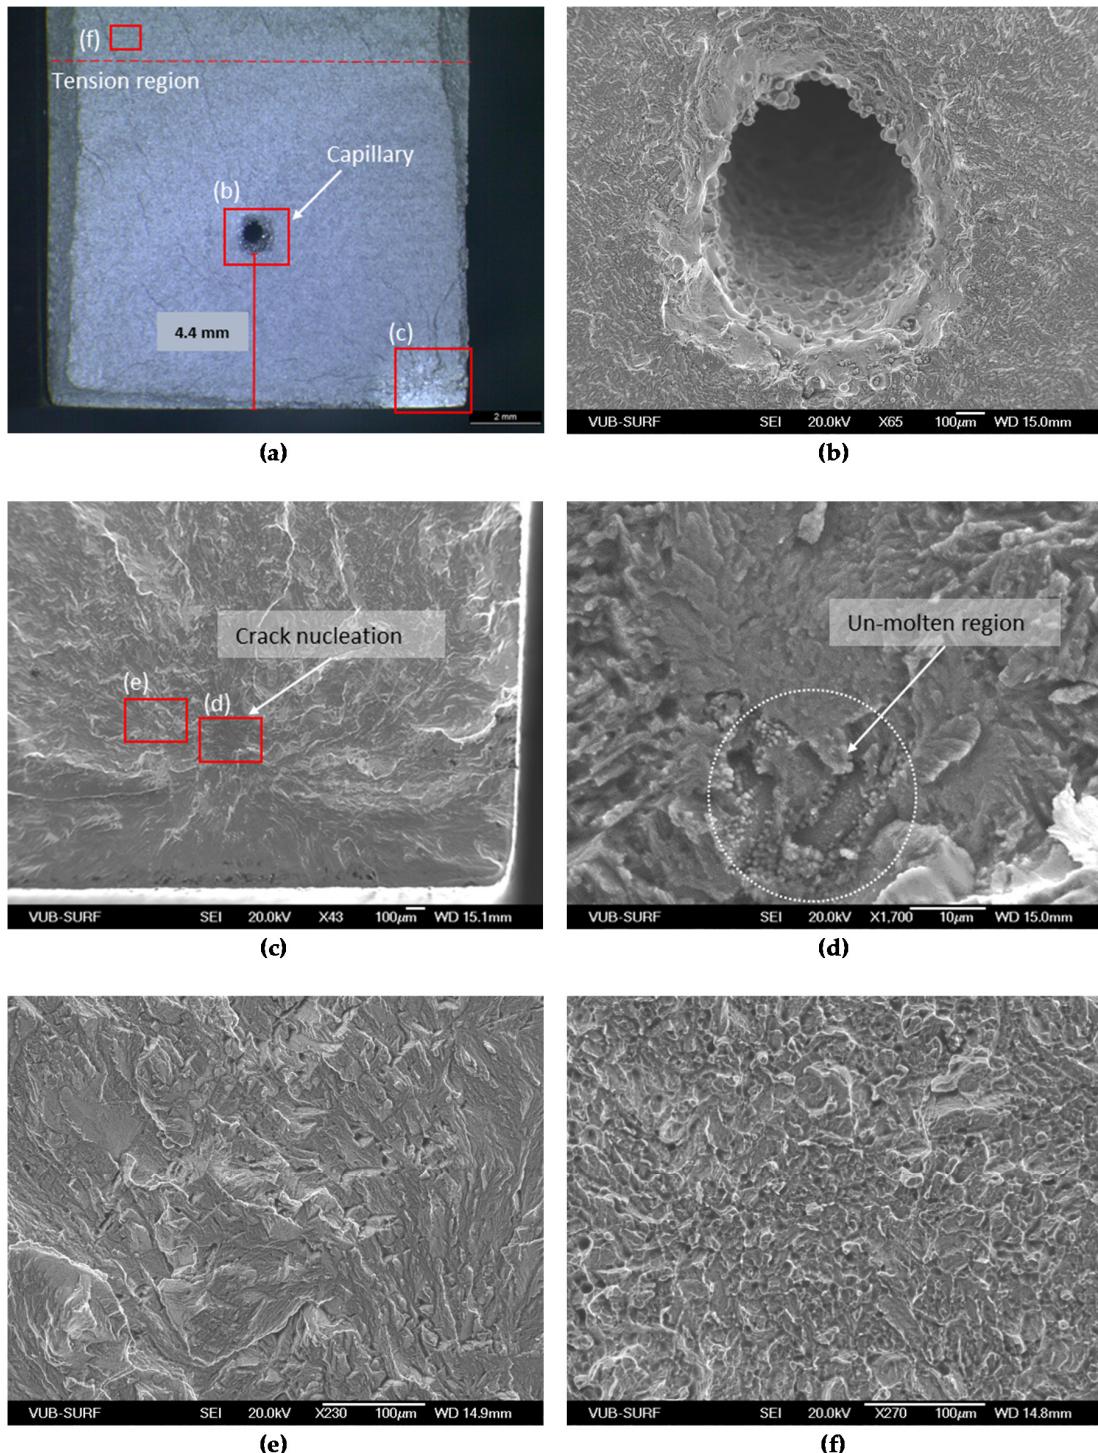
Figure 5. SEM micrographs of a fracture surface of Specimen 6 with maximum stress of 620 MPa. The fracture surface is shown in (a) and the capillary region is shown in (b) in high magnification; (c,d,e) depict the corresponding crack initiation point, while (f) shows the fast fracture region.

In order to study the presence of porosity and the influence of the capillary on the crack initiation and the fatigue life, the obtained fracture surfaces were examined. Figures 5–7 show micrographs of the crack initiation sites and the capillary regions for selected specimens produced by SLM. As previously mentioned, Specimen 6 was the specimen with the highest stress level at the crack detection. Figure 5 shows the micrograph of the fracture surface of Specimen 6. It can be seen that the crack nucleated due to a subsurface defect situated in the tension area of the specimen (Figure 5a). The red squares shown in Figure 5a are the regions shown at higher magnification in the next pictures of Figure 5. The capillary region is visible in Figure 5b, and no crack initiation signs can be seen. In Figure 5c,d, it is observed that the defect is very small lack-of-fusion region, showing rounded blister-like patterns on the surface, which indicates that it is not part of the fracture surface. The area around the nucleation site displayed brittle fracture (Figure 5e), while the fast fracture surface (see Figure 5f) exhibits a ductile fracture behavior, which is common for as-built specimens [9]. In the case of Specimen 6, although the stress level was high compared to the other specimens, the fatigue life was fairly low in the last stress level.

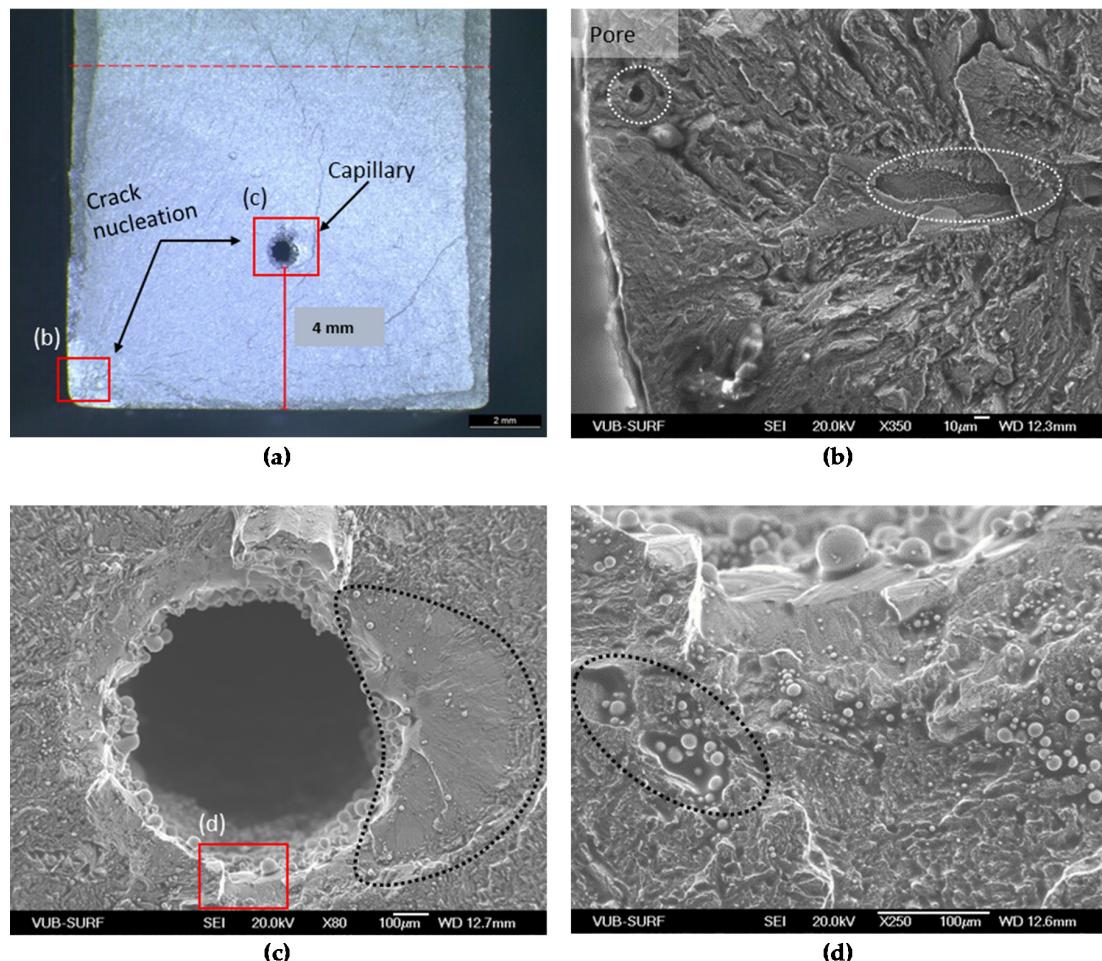
Figure 6. Fracture surface of Specimen 5 with maximum stress of 537 MPa. The fracture surface is shown in (a) and the defect is visible in (b); the capillary region is depicted in (c) in high magnification, while (d) shows un-molten powder particles concentrated around the capillary.

Figure 6 indicates that the crack initiated at two places in Specimen 5, namely at the capillary region and close to the corner of the specimen. The defects concentrated at the bottom of the specimen consist of pore inclusions with a diameter of approximately 10 µm and lack-of-fusion regions, see Figure 6b. On the other hand, another crack initiation site was detected on the right side of the capillary (see dashed region in Figure 6c). Furthermore, un-molten regions with powder and

splatter particles were also located around the capillary, which can increase detrimentally the stress concentration in that region (see dashed region in Figure 6d).

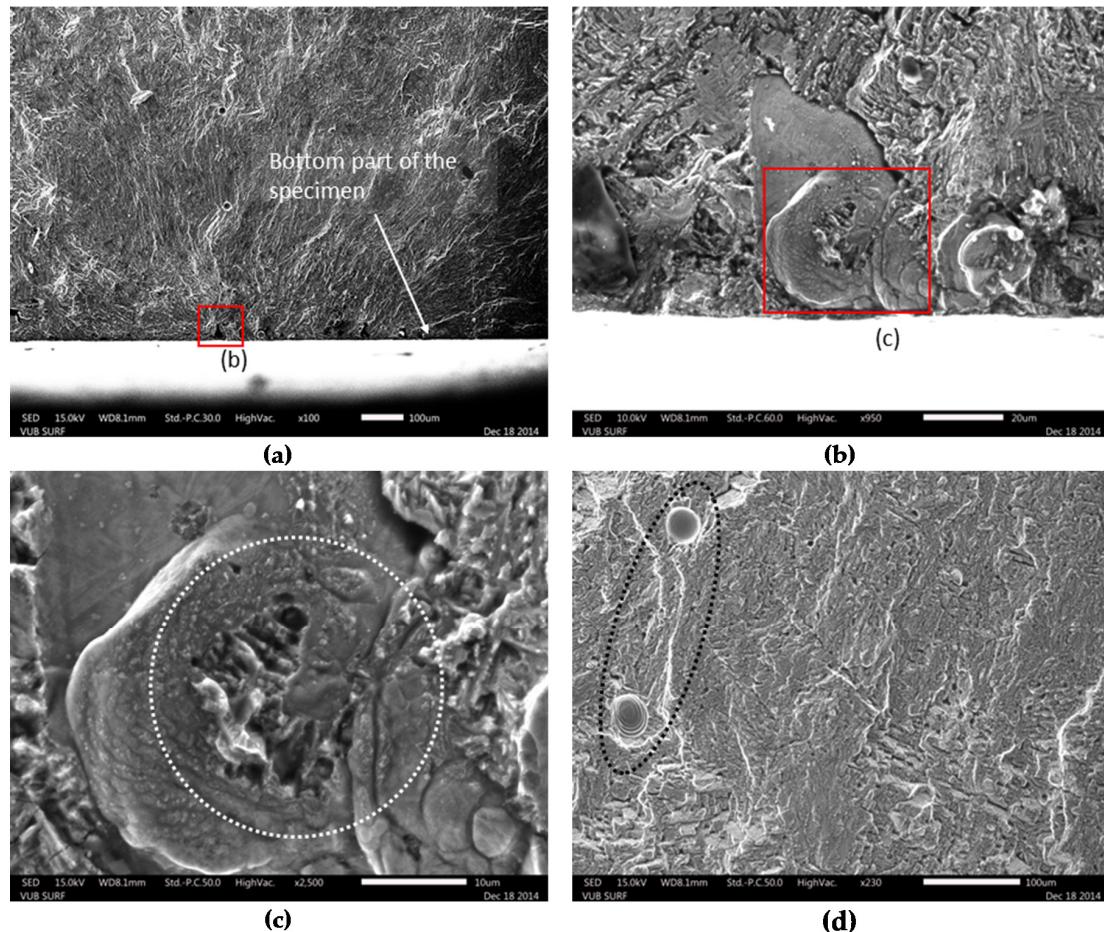
Figure 7. Fracture surface of Specimen 3 with maximum stress of 323 MPa. The defect is shown in (a), a close-up of the defect in (b,c) while a part of the fracture surface with gas inclusions is depicted in (d).

Similar observations on the defects' nature are also noticed in Figure 7, where the fracture surface of Specimen 3 is depicted. Specimen 3 is the only specimen for which the eSHM system detected the crack in the stress level of 323 MPa, which is considered a low value compared to the other specimens. As shown in Figure 7a, the fracture surface shows crack initiation from sub-surface defects really close to the surface of the specimen. Figure 7b,c show SEM images from some of the concentrated defects. It is obvious that un-molten regions with concentrated pore inclusions can act as detrimental stress concentrators. In general, the total surface of the current sample included a certain amount of pores and gas inclusions that were encapsulated during the SLM process (see ellipse in Figure 7d). The high amount of defects in this sample explains the fast failure during fatigue at low stress level. However, from the fractographic pictures, it is revealed that Specimen 5 (Figure 6) had more internal defects than Specimen 3 (Figure 7). As a result, the crack path of Specimen 5 had more internal defects than the one of Specimen 3. Those observations could also be connected with the difference of pressure behaviors of these specimens from Section 3.2.

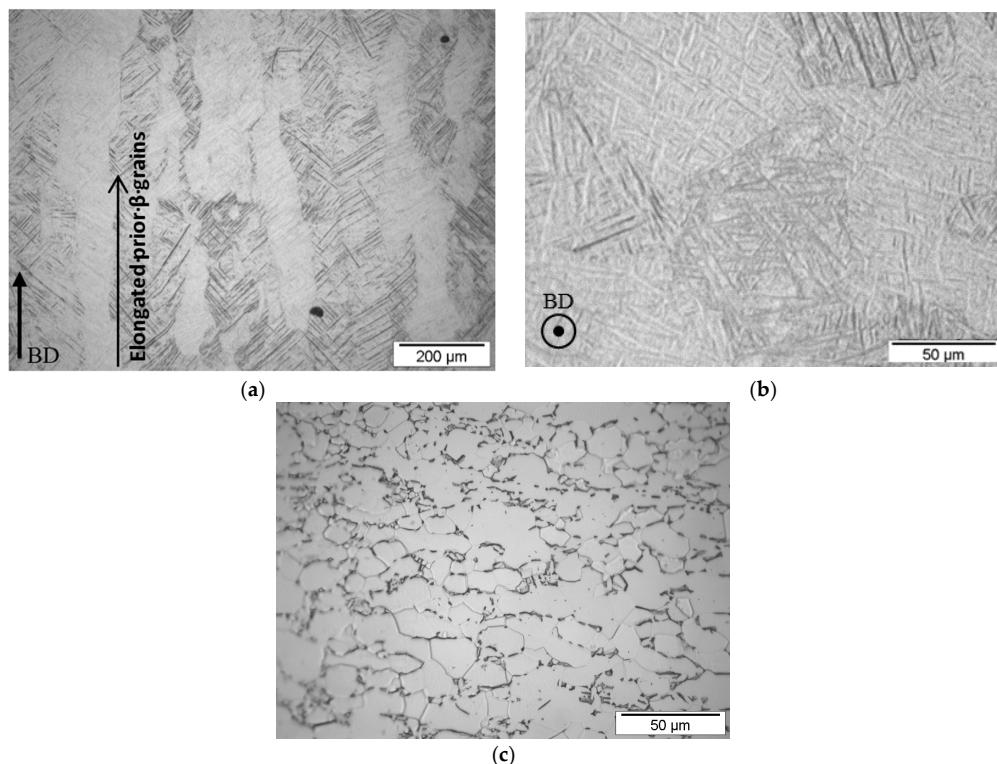
Figure 8. Micrographs of the macrostructure of (a) side view parallel to the building direction (BD) of Ti6Al4V SLM Specimen 3; (b) top view perpendicular to the BD of Ti6Al4V SLM Specimen 3 and (c) top view of the Ti6Al4V conventional specimen.

Apart from the internal defects and the residual stresses, other parameters that can have an impact on the crack initiation are crystallographic anisotropy or surface finish, while in some cases complex microstructures may cause crack initiation during fatigue [31]. It is known that Ti6Al4V contains both α and β phases. The fatigue life of Ti6Al4V components is also affected by the morphology of both phases. The crack nucleation in lamellar $\alpha + \beta$ microstructures is known to initiate at slips bands within α (or α') lamellae or at α (or α') along prior β grain boundaries [10,32]. In Figure 8, the micrographs of the macrostructure of the SLM Specimen 3 and the conventional Specimen 3 are compared. In the side view of the SLM specimen (Figure 8a), large, vertical columnar prior β phase grains are present. The long columnar β phase grains are growing along the BD. This is a result of the re-melting of the prior solidified layers during the SLM process, which leads to an epitaxial and directional solidification [5]. The macrostructure of the top view of the SLM specimen is shown in Figure 8b. Acicular α' martensitic formed inside the β phase grains. On the other hand, there is a distinct difference between the SLM macrostructures and the macrostructure of the conventional Ti6Al4V specimens, shown in Figure 8c. The macrostructure of the conventional Ti6Al4V consists of a bimodal distribution of primary α phase grains (light color) and lamellar $\alpha + \beta$ colonies within small

transformed β grains. Figure 8c shows that the conventional Ti6Al4V almost completely consists of primary alpha grains, with only a few transformed beta grains in which a coarse lamellar $\alpha + \beta$ is found. It is demonstrated in the literature that lamellar microstructures have a beneficial effect on the crack growth rates of small cracks. This is attributed to the high density grain boundaries. On the other hand, bimodal microstructures have a good resistance against crack initiation due to the finer grains that are reducing the dislocation slip lengths [33].

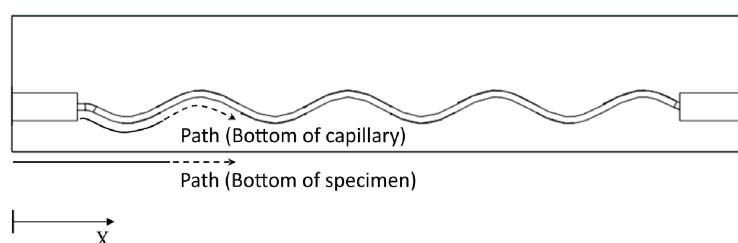
Figure 9. Schematic description of the paths used for extracting stresses in the numerical simulations.

The stress levels reached during testing at the bottom edge of the capillary and at the bottom of the specimens were calculated by FEM simulations. The comparison of the calculated stresses provides further understanding of the crack initiation positions observed in the SEM images. Four-point bending specimens as shown in Figure 9 were considered. For both capillary structures (period of 20 mm and 22.4 mm) this comparison was performed at a loading of 20 kN, which was the crack initiation loading for Specimen 3. Two paths, illustrated in Figure 9, were considered for extracting the maximum principle stresses: at the bottom (edge) of the capillary and at the bottom of the specimen.

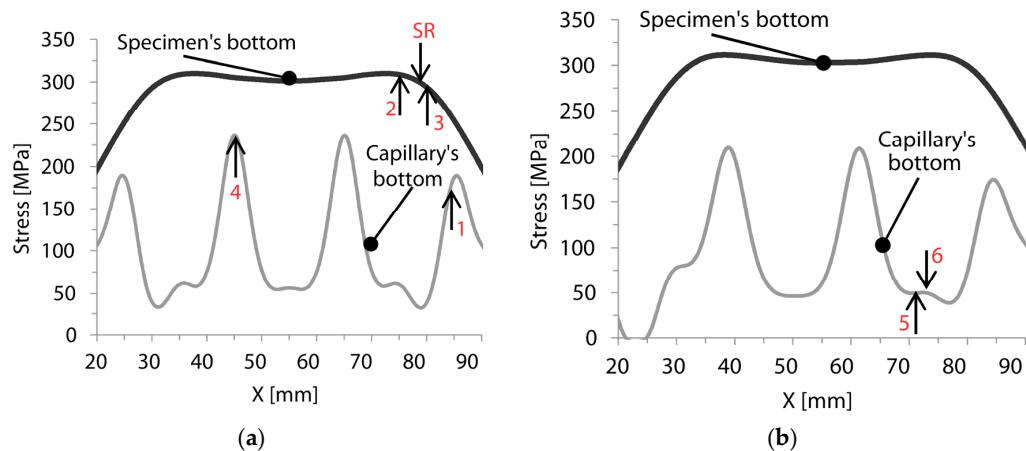
Figure 10. Comparing the stress distributions for a load of 20 kN for the capillary structure with (a) a period of 20 mm (Specimens 1, 2, 3, 4 and stress relieved (SR)); and (b) a period of 22.4 mm (Specimens 5 and 6).

The results for the additive manufactured specimens are depicted in Figure 10, while the crack locations of the specimens are indicated with arrows. In order to compare the stresses at the bottom of both the specimen and the capillary, the length interval of 70 mm at the middle of the specimen is considered. According to four-point bending setup (see Figure 2), the center region of 50 mm is subjected to the highest stress level in the longitudinal direction. The results shown in Figure 10a are representative for Specimens 1, 2, 3, 4 and the SR specimen with a period of the sinusoidal shape of 20 mm. The failure of Specimens 2 and 3 occurred at $X = 75$ mm and 80 mm respectively, while in the SR specimen the failure occurred at the position of 79 mm. The crack initiation sites were located on the bottom of the specimen. At these positions, the stress level at the bottom of the specimen is high, while stresses are rather low at the bottom of the capillary, see Figure 10a. Specimens 1 and 4 broke respectively at $X = 84$ mm and 45 mm. From (not-shown) SEM images it was observed that the crack was initiated from the capillary region in these specimens. Considering that the calculated stress level at the capillary's sites is high at $X = 84$ mm and 45 mm (Figure 10a), it can be concluded that these initiation locations were a result of the combination of high stress levels and internal defects like porosity close to the capillary. The failure of Specimens 5 and 6, with a period of the sinusoidal shape of 22.4 mm, occurred respectively at $X = 71$ mm and $X = 73$ mm. In the case of Specimen 6, the crack initiated from an internal defect close to the bottom of the specimen, while in Specimen 5 the main crack initiated from the bottom of the specimen (see SEM images shown Figures 5 and 6). According to the stress analysis results of Figure 10b, the stress level around the capillary is quite low at $X = 71$ mm and 73 mm, while the stress level at the bottom of the specimen is substantial, and this leads to the crack initiation.

For both types of capillary geometries, the calculated stress levels at the bottom of the capillaries are lower than the stresses at the specimen's bottom. From this perspective, it is expected that cracks would always initiate from the bottom of the specimens. This highlights the fact that an integrated capillary would not have a critical impact on the crack initiation in an SLM component. It should be mentioned that the capillary surface is expected to have roughness in the order of the powder particle [34]. Internal defects on the capillary region and the surface roughness of the capillary could increase the local stress level and as a consequence affect the crack initiation behavior. This phenomena are extensively discussed by Lipinski *et al.* [34]. However, in the current study the simulations do not take into account parameters such as defects or surface roughness. From the fracture surface analysis performed with the SEM, it was observed that in some cases cracks initiated from the region of the capillary. This is principally due to the defects present in the specimens, rather than the presence of the capillary itself. The location of these defects (porosities and lack-of-fusion regions) can be closer or
