Livestock and Small-Scale Irrigation Scheme Interactions as a Key Source for Sedimentation during the Irrigation Season: Four Case Studies from South-West Shoa, Ethiopia

Abstract: Small-scale irrigation (SSI) development can play a major role in Ethiopia's economic development, but sedimentation is a major threat to its sustainability. The focus of the dominant discourse around the sedimentation of SSI schemes lies in upstream catchment protection during the rainy season, neglecting both protection against erosion through overland flow along the margins of the canal network and sedimentation caused by livestock disturbances. Remedies against the latter causes of sedimentation during the irrigation season have been ineffective due to erroneous assumptions regarding its cause. This study aimed to identify the sources and extent of sedimentation in SSI schemes. The accumulated sediment in the canal pre-irrigation season was measured from four SSI schemes and suspended sediment samples *during* irrigation season were collected from one SSI scheme. The accumulated sediment in the canal pre-irrigation season was measured from four SSI and suspended sediment samples *during* irrigation s

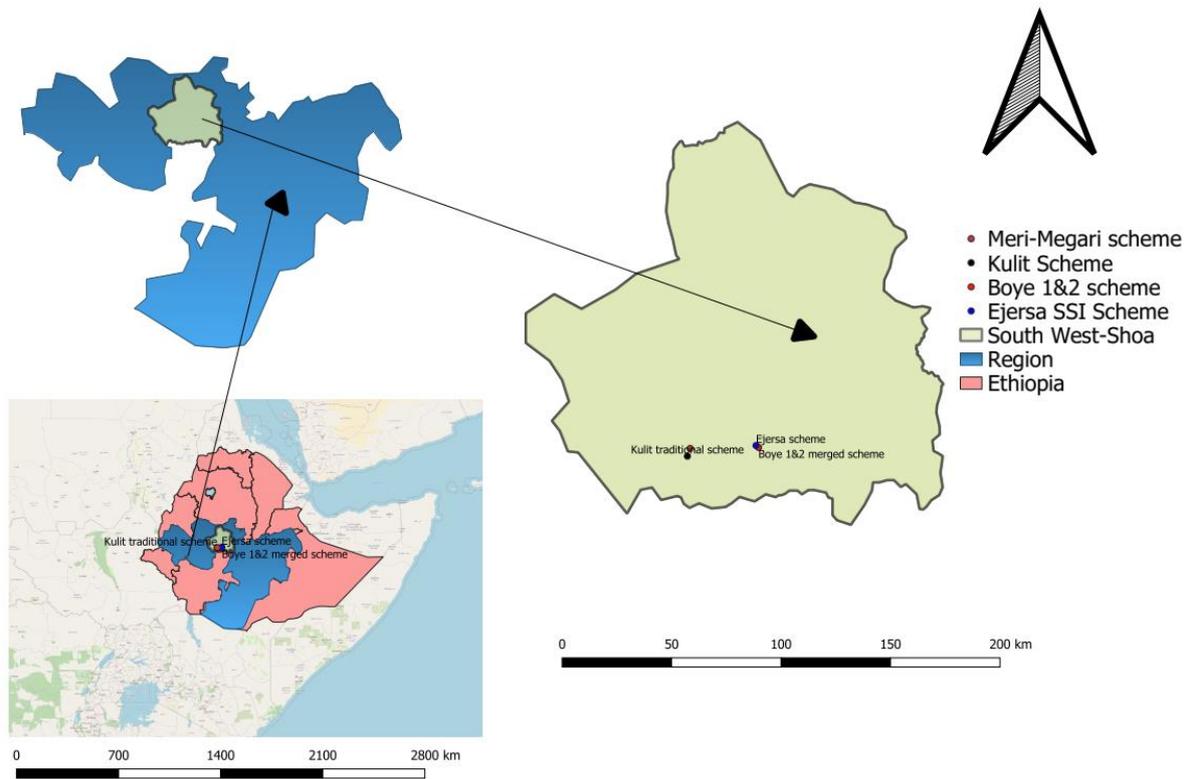
Figure 1. (A) Location of the study area with the four case study irrigation schemes. (B) Ejersa small-scale irrigation scheme. (C) Boye 1 and 2 merged small-scale irrigation schemes. (D) Meri-Megari scheme and Kulit traditional small-scale irrigation scheme. (Source: Hanan Tadele, own material.)

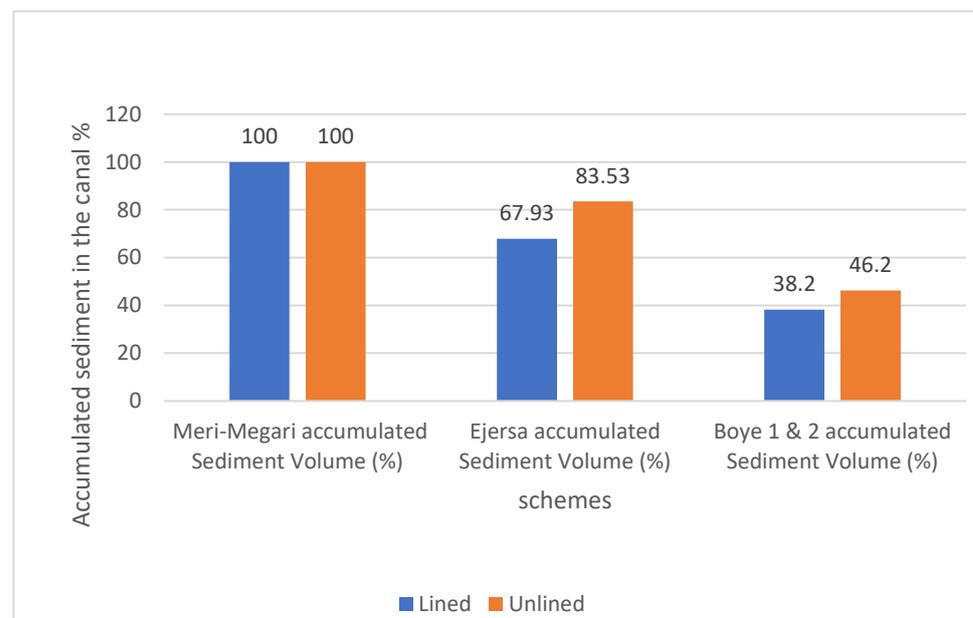
Figure 2. Percentage of accumulated sediment in the canal at the start of the irrigation season in three schemes. (Source: own measurements, 2019.) (Page: 11 The accumulated sediment in Meri-Megari scheme was observed after 3 years of abandonment. For the Kulit scheme, we could not measure the accumulated sediment before irrigation season because of the challenges in road access (muddy roads) after the rainy season.)

The Ejersa scheme comes in the second position regarding its vulnerability to sedimentation. It suffers from a heavy sediment load. However, the Ejersa scheme users are well organized, with a strong water user committee capable of keeping the scheme functional. While the scheme is irrigating its full command area, the amount of labor that is required to clean the canals each season is considerable. About 68% of the lined canals and 84% of the unlined canals were found filled with sedimentation in 2019 before the start of the irrigation season (Figure 2). The farmers removed the accumulated sediment before the beginning of the irrigation season in September. Moreover, the farmers clean the scheme every month to keep it operating at full potential. The accumulated sediment load in the canal network was observed to be heavier at the furthest point from the intake, showing a tendency for suspended sediments to settle as current flow velocity dwindles.

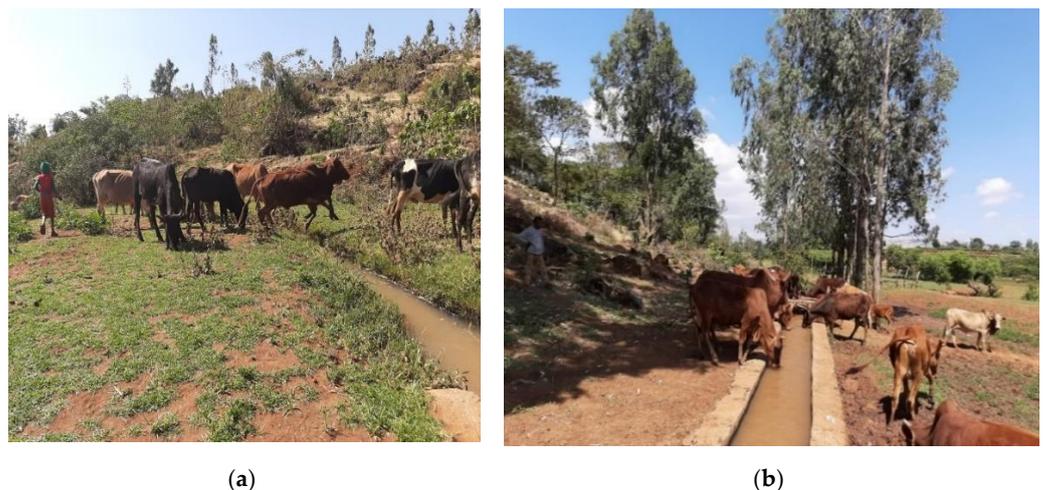
Figure 3. (a) Cattle grazing and crossing the canal. (b) Cattle drinking from the canal. (Source: Ejersa scheme pictures by Hanan Tadele, 2019.)

The Ejersa scheme is one of the schemes that faces a challenge of sedimentation caused by strong livestock disturbance due to livestock grazing along the canal bank. It causes a significant sediment deposition in the canal during the irrigation season. In this scheme, 60 households use the grazing land along the main canal. On average, a household has about 11.93 livestock with a standard deviation of 7.4 [26] per household involving mostly cattle. On average, over 600 heads of livestock graze along the canal banks every day. They cross the canals frequently, pushing the sediment into the canal (Figure 3a).

Furthermore, lacking cattle troughs along the irrigation canal, the canal is the only means of drinking water supply for the livestock when the river is low (Figure 3b). The livestock farmers put blocking barriers consisting of local material inside the canal to raise the water level for the livestock to drink safely. The cattle farmers raise the water level to 163% by adding those materials (Figure 4a,b).

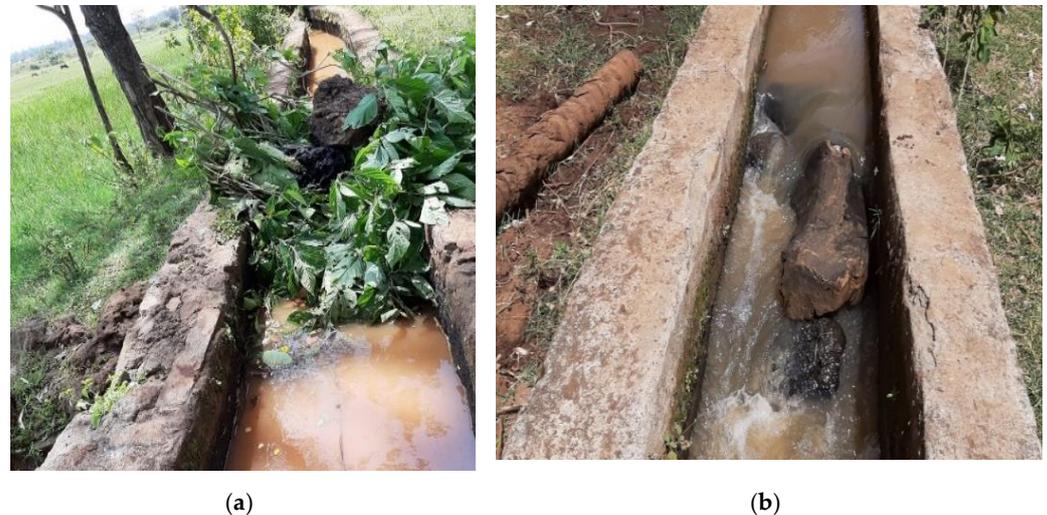
Figure 4. (a,b). Canals blocked by local material in Ejersa scheme. (Source: pictures by Hanan Tadele, 2019.).

A common practice among the livestock farmers is to put local material in the canal to block and raise the water level for the livestock to drink safely. The herders who construct the blockage never remove the material once the cattle have had their fill, thus disturbing

irrigation water supply and, perhaps more importantly, creating local hubs for sediments to accumulate (Figure 4a,b).

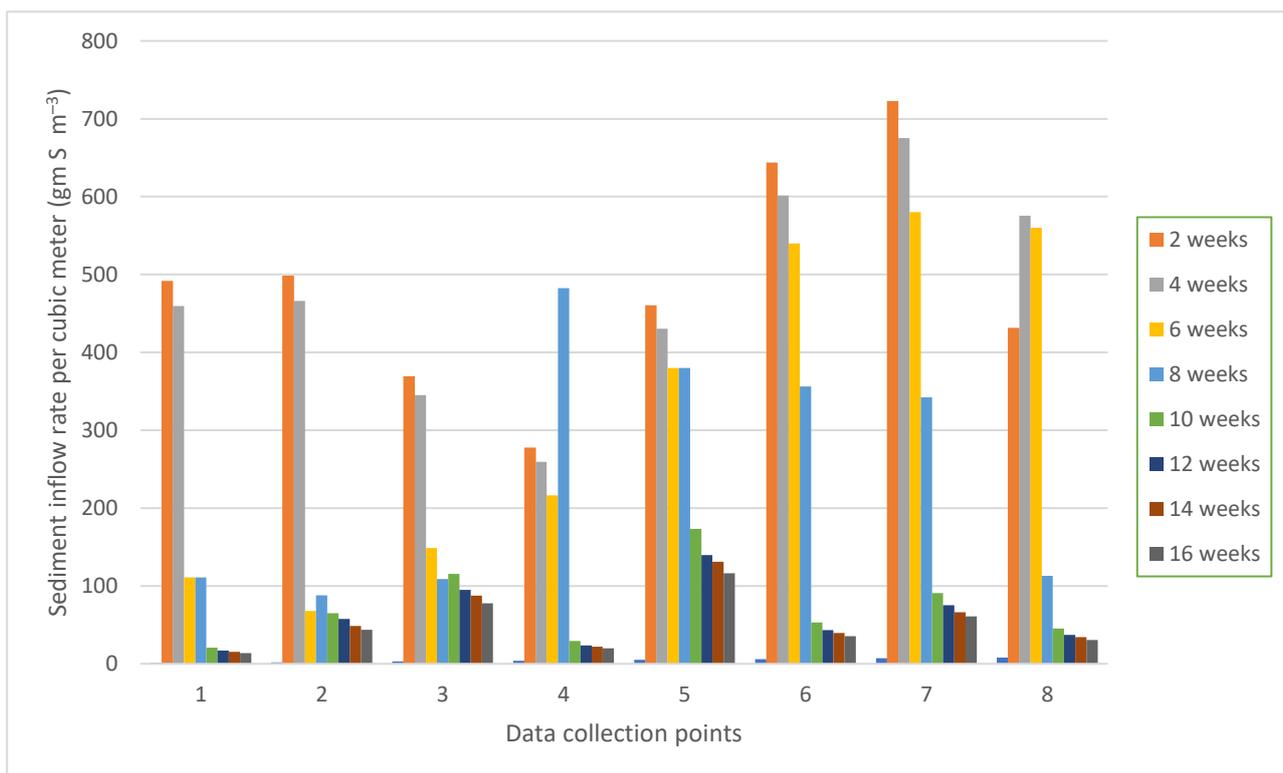
Figure 5. Sediment inflow per 2 weeks at data collection points (from intake (data collection point 1) to most downstream along the main canal (point 8)).

The sediment inflow to the Ejersa irrigation scheme was measured weekly at eight points along the 1.85 km of lined main intake canal. The sediment inflow level varies from one data collection point to another. Figure 5 shows a variation in sediment concentration across the data collection stations; the maximum and minimum sediment concentrations were found in different stations due to livestock disturbances. The minimum sediment inflow per cubic meter per second was observed in the fourth station for the first 4 weeks followed by station two from week four to week eight, and from week 8–16, the minimum sediment inflow was observed at the first station or the intake.

However, the maximum sediment inflow per cubic meter per second was observed at the seventh station for the first 6 weeks, followed by station six for the first 4 weeks. Higher sediment inflow was measured at the point downstream of the livestock grazing and drinking point during the disturbance compared with the upstream of the access point [34]. The livestock disturbance was primarily observed at a certain distance from the intake. In some cases, the disturbance occurred at the weir of the scheme: the livestock

re-suspend the deposited sediment while drinking the water or crossing the grazing area through the weir. Other times, swimming kids at the weir intake re-suspend the sediment and then relatively higher concentrations are found at the intake than other consecutive data collection points.

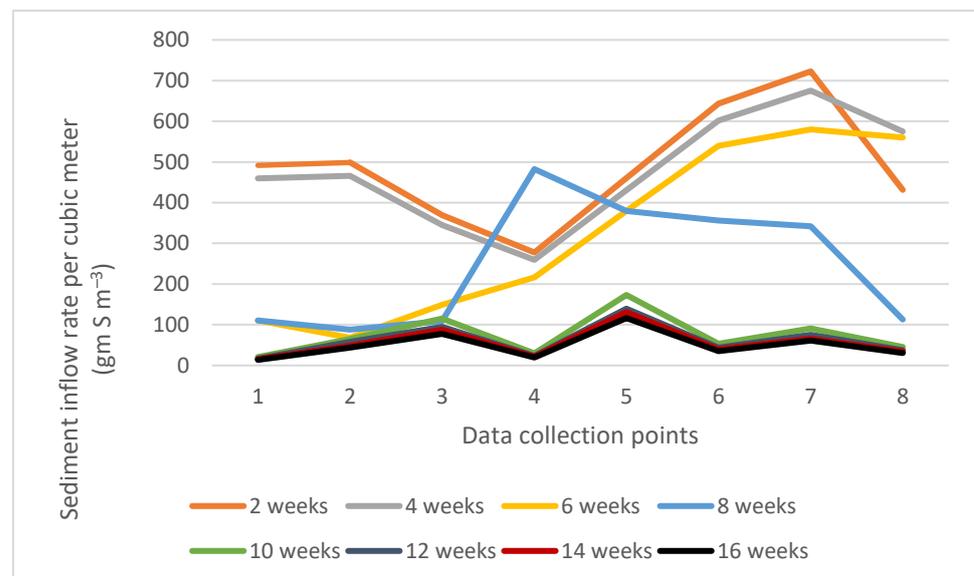
Figure 6. Sediment inflow trend lines per 2 weeks at data collection points (from intake (point 1) to most downstream along the main canal (point 8)).

The trend of Figure 6 shows that during the irrigation season, the sediment inflow rate per cubic meter increases from the intake to the furthest point and the sediment concentration spike was found at the place where there was a disturbance. Moreover, the inconsistencies in peaks demonstrate that rather than sediments originating from upstream catchment erosion, disturbances caused by livestock and swimming kids explain the values at any point along the canal during the irrigation season. Moreover, it also shows a reduction in sediment concentration over time. The possible reasons might be that the quantity of water that arrives at the Ejersa scheme reduces significantly since the Ejersa scheme is the fifth scheme that has been constructed on the same river, and as a result, the sediment concentration that is carried by the water would be less. Discharge and sediment concentration show a direct correlation. The other possible reason is that the kids who swim at the intake and re-suspend the sediment at some point stop swimming because the water level at the intake is too low to swim in. As a result, the disturbance would be less and thus sediment concentration in the canal is reduced.
