Article

Mechanistic Investigation of Typical Loess Landslide Disasters in Ili Basin, Xinjiang, China

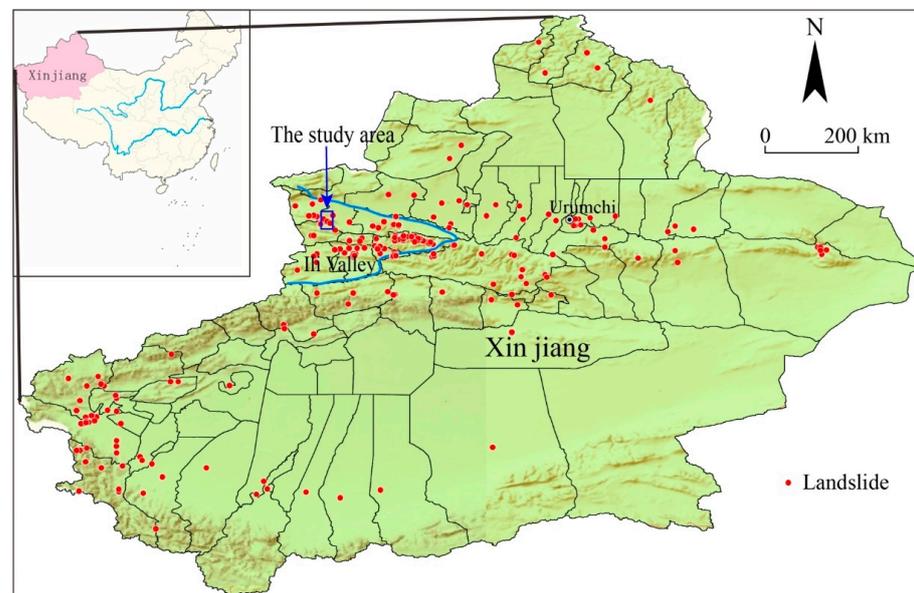
Figure 1. Distribution of landslide disasters in the Ili River Valley region of Xinjiang.

well as intense human activities. According to the survey data of the China Geological Environment Monitoring Institute, a total of 302 geological disasters occurred in Xinjiang from 2010 to 2018, of which 136 occurred in the Ili Basin (Figure 1), accounting for 45.03%, with landslides as the main type of geological disasters but fewer debris flows and collapse.

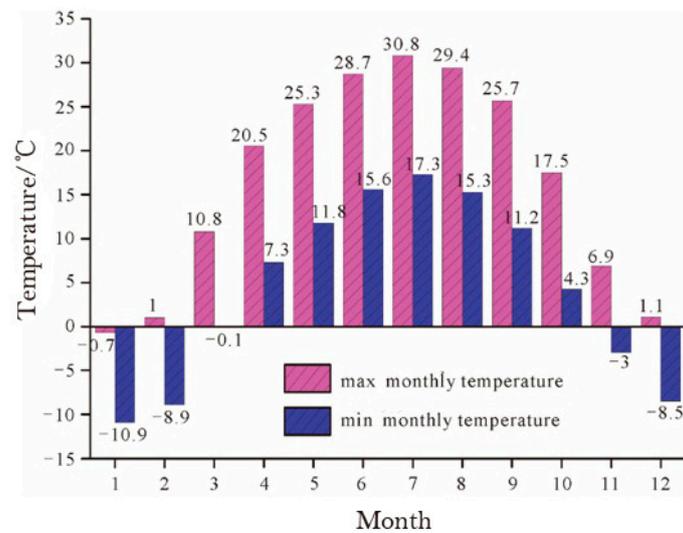
Figure 2. Monthly temperature in Ili between 2010 and 2018.

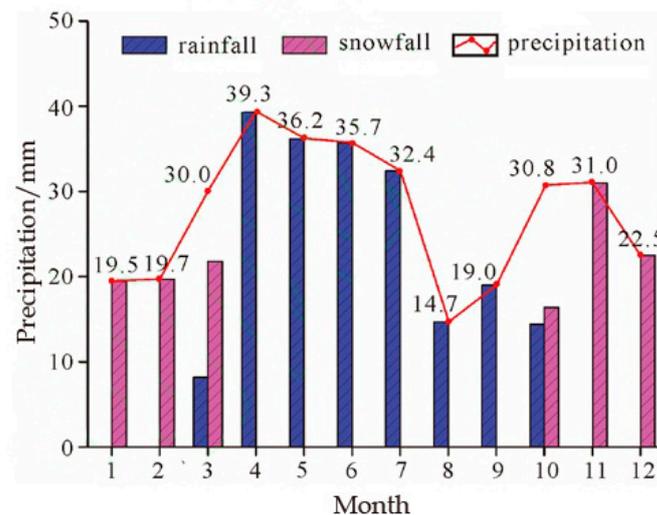
Figure 3. Monthly precipitation in Ili between 2010 and 2018.

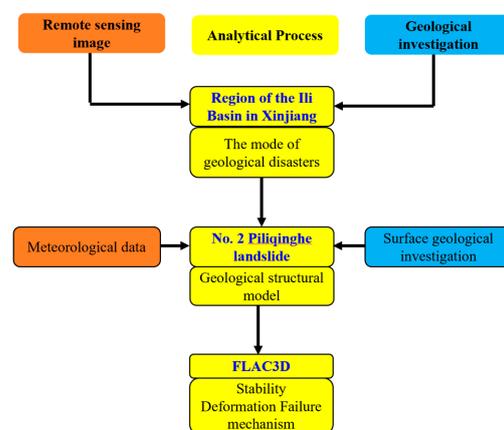
Figure 4. Schematic diagram of the landslides research methods.

A schematic diagram of the landslides research methods of this study is detailed in Figure 4. First, we research the landslides in the slope region of the Ili Basin in Xinjiang using remote sensing image analysis and geological investigation. Then, we build a geological structural model of the landslide and simulate its deformation and failure process using the numerical software FLAC^{3D} 5.00. Finally, we discuss the loess landslide's stability, deformation and failure mechanism.

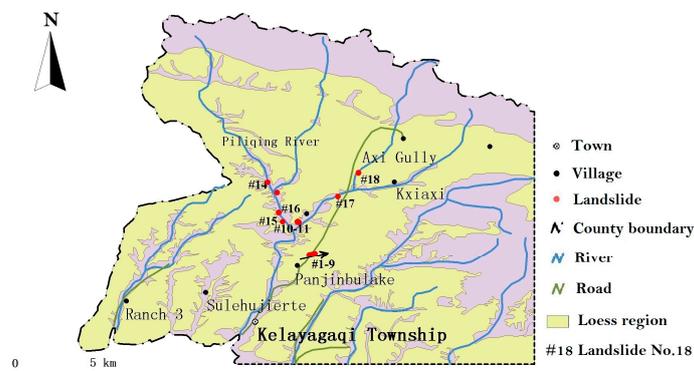
Figure 5. Distribution of the Piliqinghe landslides.

Located in the west of the Ili Valley, the Piliqinghe River is a typical area in the Ili region that experiences loess landslide disasters. As shown in the remote sensing image of the Kezilesai Gully (Figure 5), the survey found that there were 14 loess landslides in the Piliqinghe River Basin, all of which developed in the three first-level tributaries in the upper reaches of the Piliqinghe River. Among them, the third branch gully (the Kezilesai Gully in Figure 6, the remote sensing image was taken by UAV(Unmanned Aerial Vehicle) with a resolution of 50 cm), which is relatively small, developed nine landslides (No. 1 to 9), with the leading edges of two landslides located on floodplains; the branch gully on the right side of the two main branches is the Piliqinghe River, which developed five landslides (No. 10 to 14), with the leading edges of four landslides located on first-level terraces or floodplains; and the branch gully on the left side is the Axi Gully, which developed four landslides (nos. 15 to 18), with the leading edges of two landslides located on first-order terraces or river floodplains.

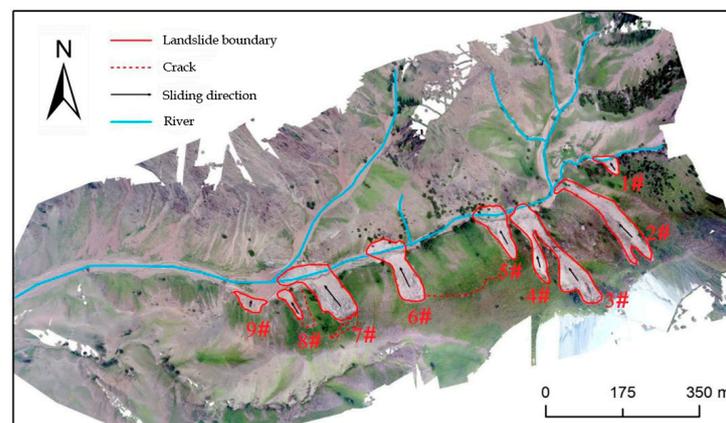
Figure 6. Remote sensing image of the Kezilesai Gully landslides in the Piliqinghe basin.

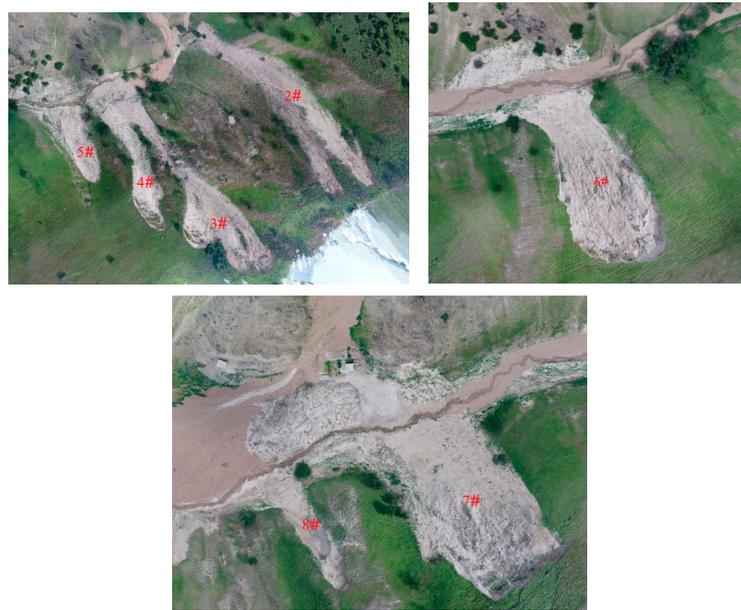
Figure 7. The Kezilesai Gully landslide in the Piliqinghe basin.

The Kezilesai Gully landslides in the Piliqinghe Basin are shown in Figure 7; the Piliqinghe landslide is a homogeneous loess landslide of a single lithology. The Ili loess is Quaternary aeolian loess, which has a highly uniform grain size composition and mainly consists of silt. Comparison of the Ili loess with the loess from the Loess Plateau found that the content of the grain size of 0.05–0.005 mm in the Ili loess is markedly higher than those in the Malan loess from eastern China and the loess from the northern piedmont of the Tianshan Mountains.

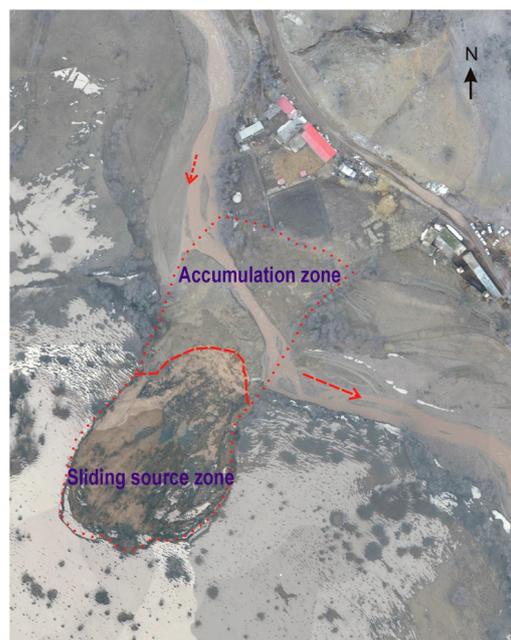
Figure 8. Remote sensing image of the No. 2 Piliqinghe landslide.

The landslide that occurred on 24 March 2017 in the Kalayagaqi Village of Kalayagaqi Township was typical of those developed in the Piliqinghe basin. This landslide, referred to as the No. 2 Piliqinghe landslide, blocked the Piliqinghe River, forming a barrier lake (Figure 8). This landslide buried a farmer's fishpond (with an area of 2000 m²), a farmhouse, a small tractor, an excavator, and dozens of fruit trees on the north bank of the Piliqinghe River, with a direct economic loss of more than 200,000 yuan. The Piliqinghe landslide had a clear perimeter and a tongue-shaped pattern in plane, with a gradient of 37° and a main sliding direction of 32° (Figures 9 and 10). The landslide had a width of 96 m, a smallest width of 60 m at the leading edge, a maximum longitudinal length of 175 m, a thickness of 3–6 m, and a total volume of approximately 6.08×10^4 m³. The landslide was covered with snow approximately 20 cm thick (Figure 11).

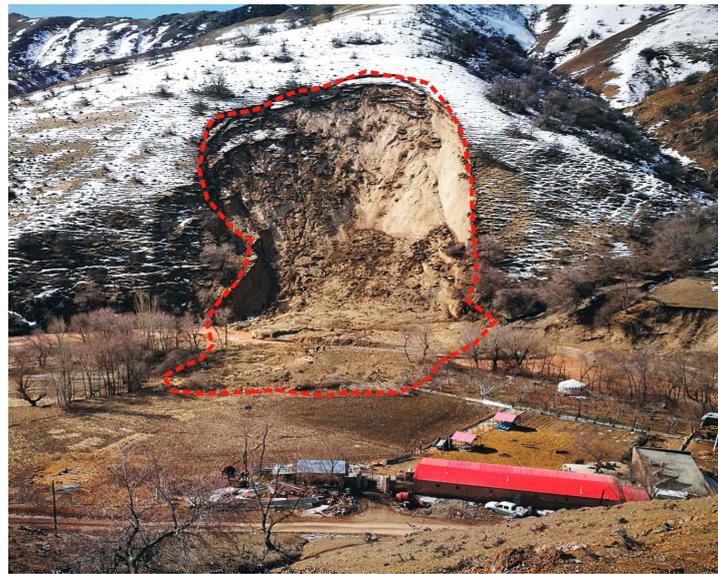
Figure 9. Panoramic view of the No. 2 Piliqinghe landslide.

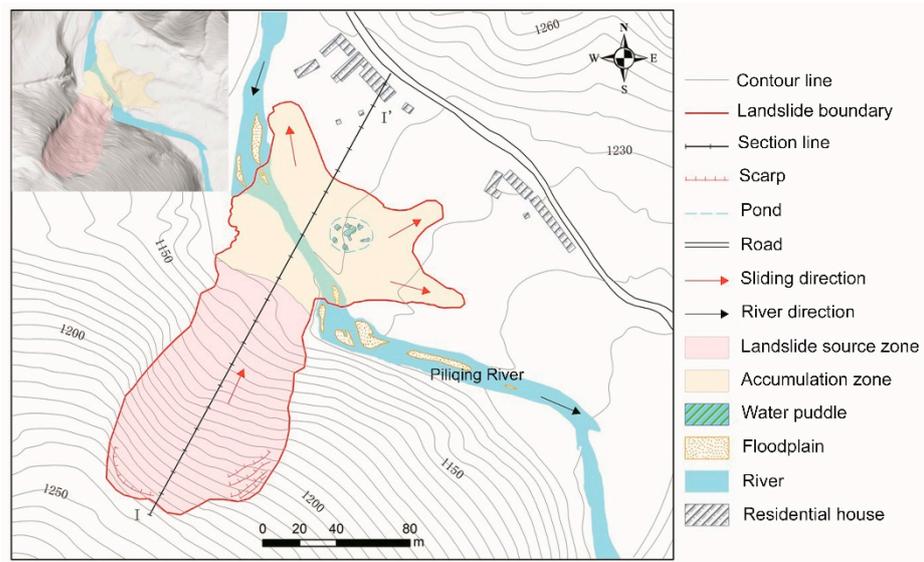
Figure 10. Scheme of the engineering geology of the No. 2 Piliqinghe landslide.

A numerical model (Figure 14) was established based on the engineering geological model (Figure 10). The whole model was meshed using 5078 quadrilateral elements and 68,448 nodes. The default static mode of FLAC was adopted in the simulation. In the model, the displacements in the x-direction on the two sides, all displacements in the y-direction, and the displacement in the z-direction at the bottom were constrained. The surfaces of the landslide model were set as free boundaries. The ideal elastic–plastic constitutive model and the Mohr–Coulomb strength criterion were adopted, and the slope stability factor was calculated using the strength reduction method.

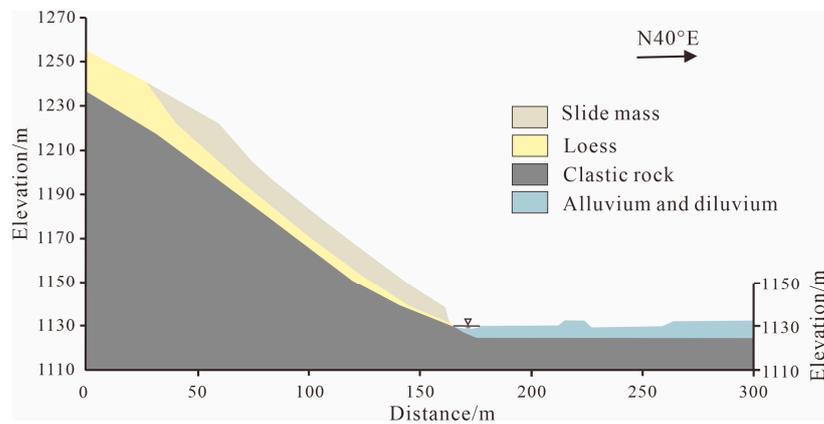
Figure 11. Longitudinal profile of the No. 2 Piliqinghe landslide.

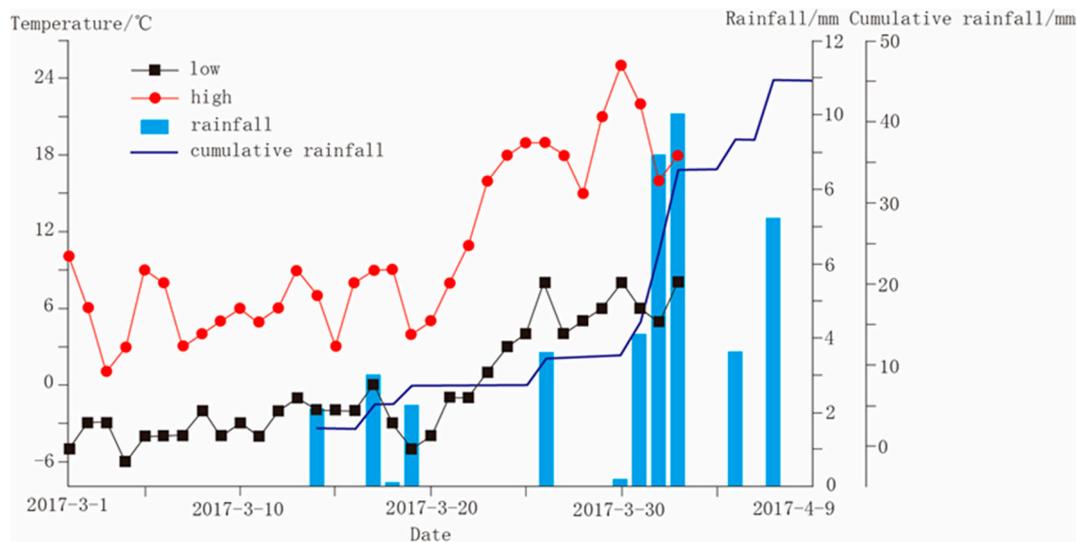
As shown in Figure 12, according to the data of the Yining County Meteorological Station, from 1 March to 22 March 2017, the daily minimum and maximum temperatures in the Piliqinghe Basin were below and above 0 °C, respectively, and there was an intense freeze–thaw cycle before the disaster. The rainfall data showed that the total rainfall in the region before the occurrence of the No. 2 Piliqinghe landslide from 10 to 24 March was approximately 20 mm, and there was no rainfall from 19 to 24 March; hence, it was unlikely that rainfall induced the landslide, which occurred on 24 March 2017.

Figure 12. Daily minimum and maximum temperatures and rainfall before and after the occurrence of the No. 2 Piliqinghe landslide on 24 March 2017.

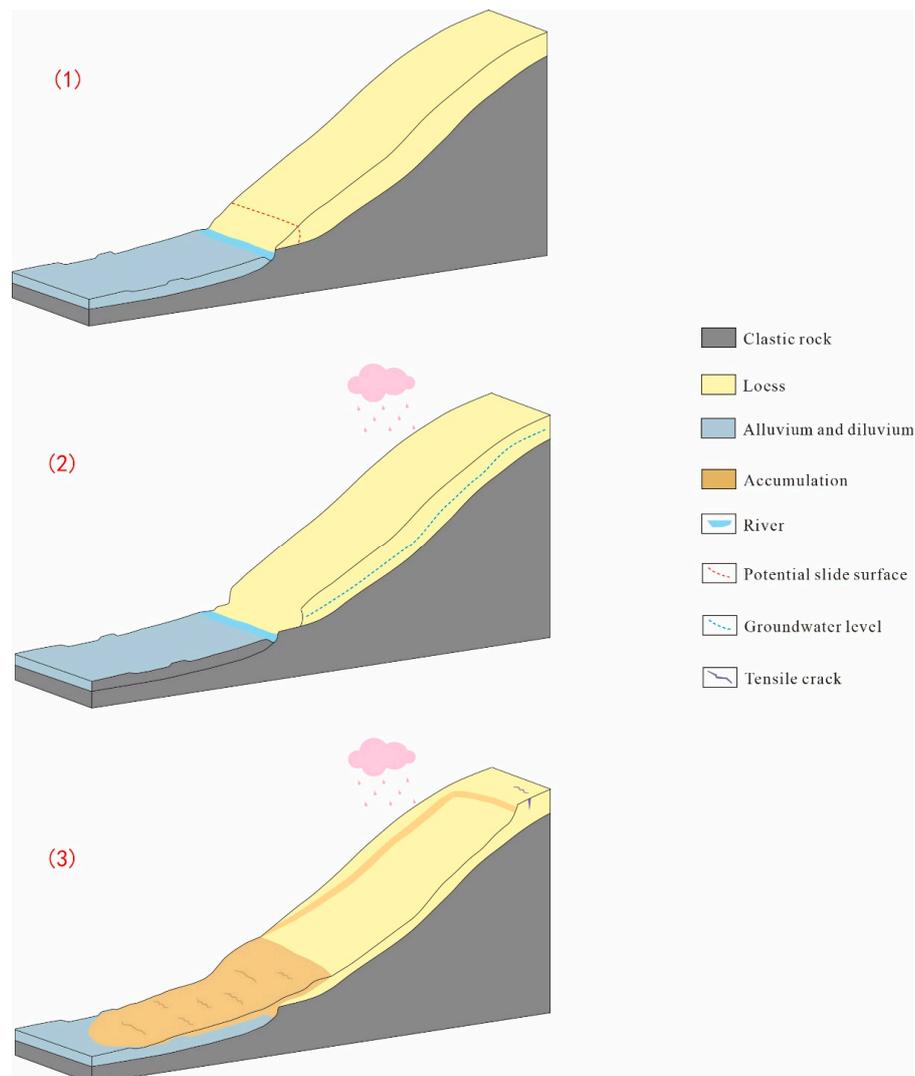
Combined with the field investigation results and Zhu Sainan’s investigation in this area [32], the results showed that since 1 March 2017, the temperature in this region gradually increased, leading to an increase in snowmelt. As a result, the volume of the Piliqinghe River increased dramatically, the water level rose, and the flow velocity increased. Consequently, the lateral erosion of the leading edge of the landslide on the concave bank was intensified, the strength of the soil at the leading edge decreased, and collapsed occurred, and there was serious scouring of the rock mass at the slope toe, which was the main factor causing the landslide. In addition, as the weather warmed, the snowmelt infiltrated along the cracks in the soil, increasing the sliding force and deadweight of the sliding mass, which was another important factor in the landslide. Therefore, the mechanism of the No. 2 Piliqinghe landslide can be summarized by the following three stages: local collapse at the leading edge → creep sliding and tension cracking of the surface → overall sliding (Figure 13).

- (1) Erosion and collapse of the leading edge. In the spring, the snowmelt increased the flow rate of the Piliqinghe River. As a result, the lateral erosion was intensified, and the bank slope was undercut, forming a free face. Therefore, the leading edge of the landslide was partially unbalanced, and multiple sliding collapses occurred, as can be observed in the multi-period remote sensing images.

- (2) Creep sliding and tension cracking of the surface. As the snowmelt infiltrated into the slope, the variation in the diurnal temperature around 0 °C led to intense freeze–thaw cycles, which reduced the mechanical strength of the soil, resulting in the formation of cracks on the landslide surface. Meanwhile, as the water content of the soil increased, shear creep occurred on the slope surface, causing creep tension cracking under gravity. Hence, the cracks in the slope were widened, and continuous tensile cracks occurred at the trailing edge.

- (3) Overall deformation and sliding. As the freeze–thaw cycles continued, the frost heave effect further increased the cracks at the trailing edge of the landslide. With the infiltration of a large amount of snowmelt along the cracks, the water content rose sharply, and the soil became nearly saturated. As a result, the friction decreased dramatically, disrupting the original force balance of the loess structure. Consequently, the landslide slid down at high speed, rushing into and burying the fishpond and blocking the Piliqinghe River to form a barrier lake.

Figure 13. Sketch map showing the gestation model of the No. 2 Piliqinghe landslide.

- (1) The disaster process of the No. 2 Piliqinghe landslide was as follows: fluvial scouring of the slope toe leading to the local sliding of the leading edge → snowmelt infiltration resulting in the creep sliding and tension cracking of the slope surface → overall sliding of the slope.

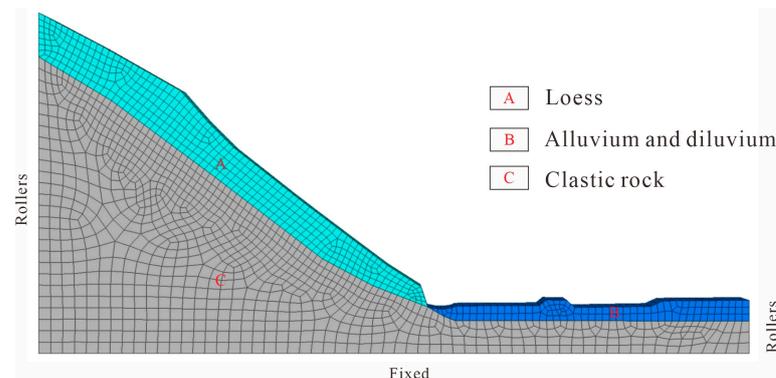
Figure 14. A numerical simulation model of the landslide profile.

According to the field investigation data and the model generalization, three different types of rock–soil material were considered in the calculation, namely, loess, alluvium and diluvium, and bedrock. The physico-mechanical parameters of these types of rock–soil and water table level refer to the results of Zhu et al. [32], with the specific parameters listed in Table 2.

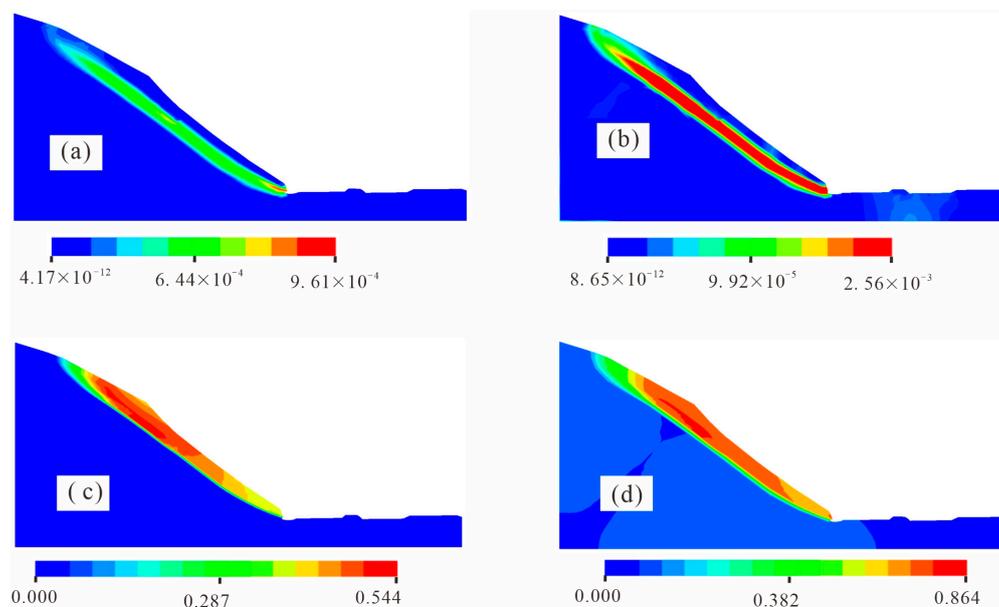
The numerical simulation results for dry and wet season are shown in Figure 15. In the dry season, the plastic shear zone of the slope was distributed at the front of the slope (Figure 15a), and the overall slope stability factor was calculated to be 1.243, indicating that the slope was stable. The shear strain was large at the front of the slope, with a maximum value of 9.61×10^{-4} , which could be a potential failure surface of the slope toe. Figure 15c shows the contours of the displacement in the landslide, with a maximum value of 0.544 m in the dry season.

Figure 15. Modeling results for dry and wet season: (a) contours of the shear strain for the dry season; (b) contours of the shear strain for wet season; (c) contours of the displacement for the dry season; (d) contours of the displacement for the wet season.

In the rainy season, the slope was in the limit equilibrium state, with a calculated stability factor of 0.981. The plastic shear strain, with a maximum value of 2.56×10^{-3} , was distributed along the sliding zone (Figure 15b), and the trailing edge of the landslide was located at the crack position in the upper part of the slope. In addition, the displacement contours indicate that the maximum displacement in the slope was 0.864 m (Figure 15d). In fact, the cracks at the trailing edge of the Piliqinghe landslide formed a channel for the infiltration of snowmelt and rainfall, resulting in the softening of the soil in the trailing edge of the slope and thus extending the sliding from the back to the middle of the slope. The fluvial erosion and softening of the slope toe also caused the soil of the slope toe to slide. The two factors had an important influence on the progressive failure of the Piliqinghe landslide.

- (3) The stability and the underlying deformation and failure mechanism of the No. 2 Piliqinghe landslide were investigated using the finite difference strength reduction method. The results showed the following. In the dry season, the slope had a stability factor of 1.254, indicating that it was stable. The shear strain at the front of the slope was large, with a maximum value of 3.59×10^{-4} , and the maximum displacement in the slope was 0.304 m. In the rainy season, the slope was in the limit equilibrium state, and the stability factor was calculated to be 0.985. The plastic shear strain, which had a maximum value of 9.29×10^{-4} , was distributed along the sliding zone, and the trailing edge of the landslide was consistent with the crack position in the upper part of the slope. The maximum displacement in the slope was 0.636 m. Therefore, regarding the prevention of loess landslide disasters in the Ili region, the results suggest that cracks in the trailing edge of the slope have an extremely important influence on the landslide and that additionally, instability in the middle and back parts of the landslide has a strong impact on the stability of the whole slope and should be avoided. These findings can be used as a reference for the analysis of the disaster mechanism and movement characteristics of similar loess landslides and provide further theoretical support for disaster prevention and mitigation.
