Article

Soil Reinforcement with Geocells and Vegetation for Ecological Mitigation of Shallow Slope Failure

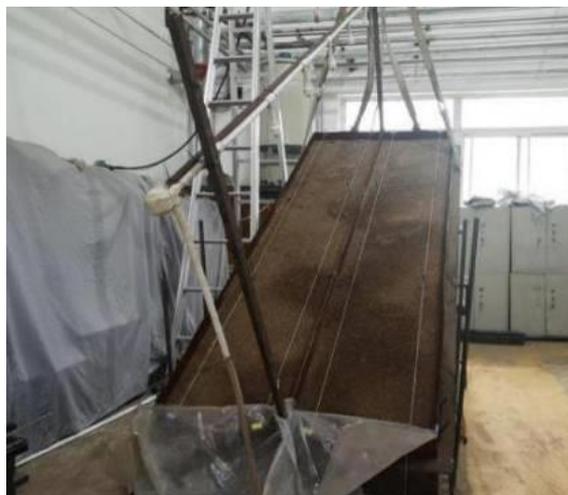
**Figure 1.** The constructed physical model at a slope ratio of 1:1.5.

The physical models in Group A contained the bare soil with no extra reinforcement. For the geocell and straw reinforced slopes, the geocells were placed on the compacted soil layer at the bottom, and were infilled with the mixture of soil and straw. The infilled soil was properly compacted until the designed height was reached. The rear side of the rig can be lifted to adjust the slope steepness. The finished model is shown in Figure 1.

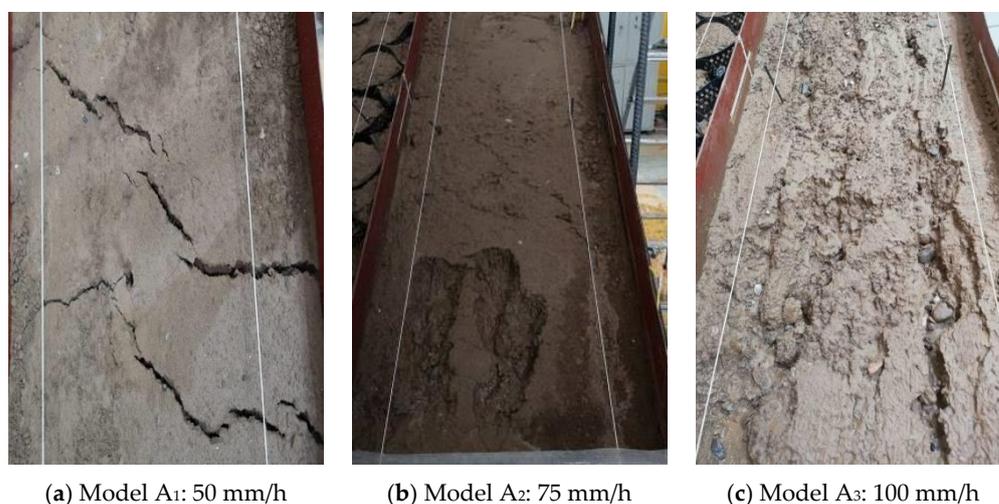
Figure 2 shows the failure characteristics of the bare slopes under different rainfall intensities after 30 min of rainfall. A number of cracks were observed on the bare slope in Model A₁ at the rainfall intensity of 50 mm/h (Figure 2a). However, the inverse impact of the raindrop to the slope was not significant, and the slope surface still remained smooth and flat. By contrast, an increase in the rainfall intensity contributed to the soil degradation in Models A₂ and A₃. Under the rainfall intensity of 75 mm/h, the soil erosion was insignificant at the top section of the slope, but the soil deterioration was clearly observed at the bottom (Figure 2b). As the rainfall intensity increased to 100 mm/h, rill erosion was found over the majority part of the slope surface (Figure 2c).

Figure 2. Failure characteristics of the bare slopes after the rainfall.

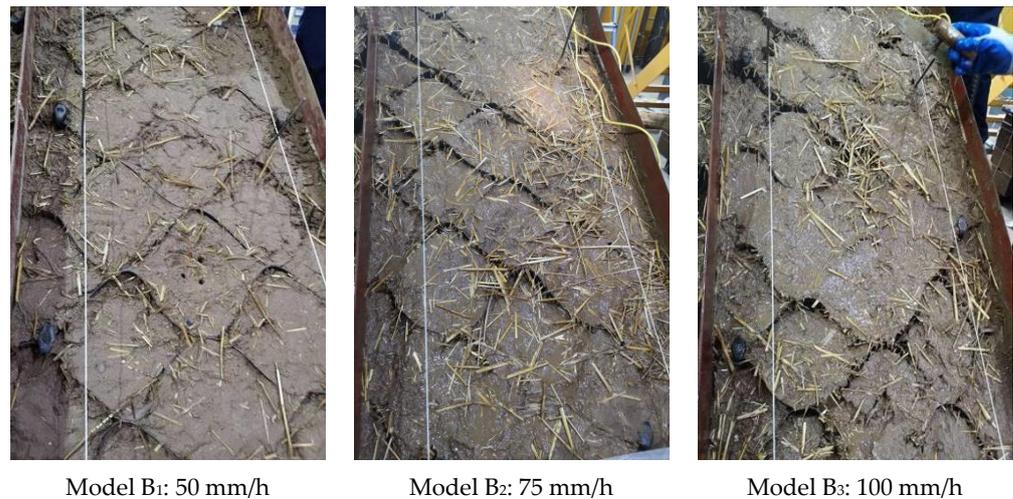
The stability and surface erosion of the geocell reinforced slopes were better off as compared with the bare slope. Figure 3 shows the final appearance of the small geocell-reinforced slopes under the three rainfall intensities. The overall integrity of the geocell-reinforced slopes was maintained. No cracks or any gully and rill erosion were observed on the slope surfaces reinforced by geocells. The geocell structures played an important role in improving the slope stability by holding the soil in place. On the other hand, the soil degradation increased with the rainfall intensity, which was observed from the depth of the re-appeared geocell section.

Figure 3. Failure characteristics of the small geocell-reinforced slopes after the rainfall.

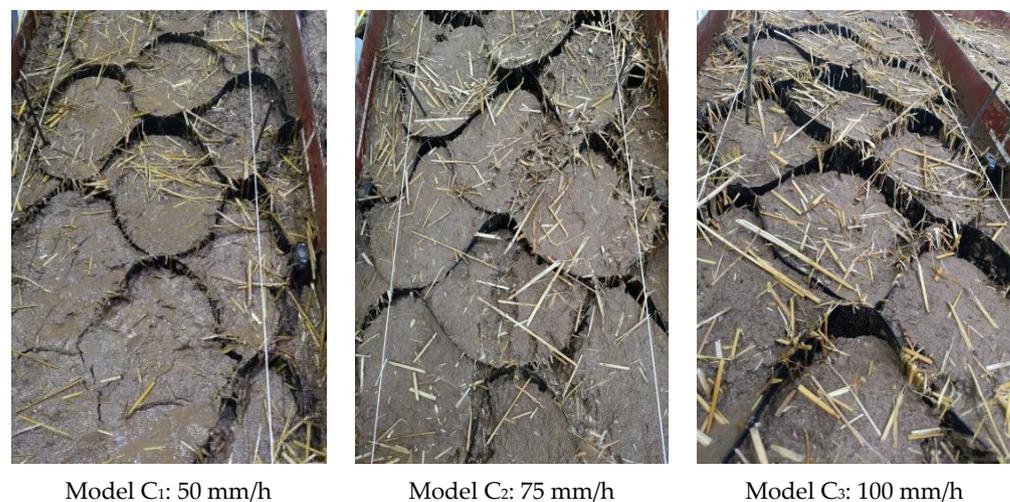
The large geocell-reinforced slopes after 30 min of rainfall are shown in Figure 4. Again, the rainfall reduced the slope stability significantly, and an increase in the rainfall intensity resulted in more soil deterioration. The soil erosion and the stability of slopes were also compared to those reinforced with small geocells in Figure 3. It was noted that, in Figure 4, a larger depth of the re-appeared geocell sections was observed, indicating an increased amount of soil erosion. Hence, the small geocells outperformed the large geocells in terms of the soil erosion control.

Figure 4. Failure characteristics of the large geocell-reinforced slopes after the rainfall.

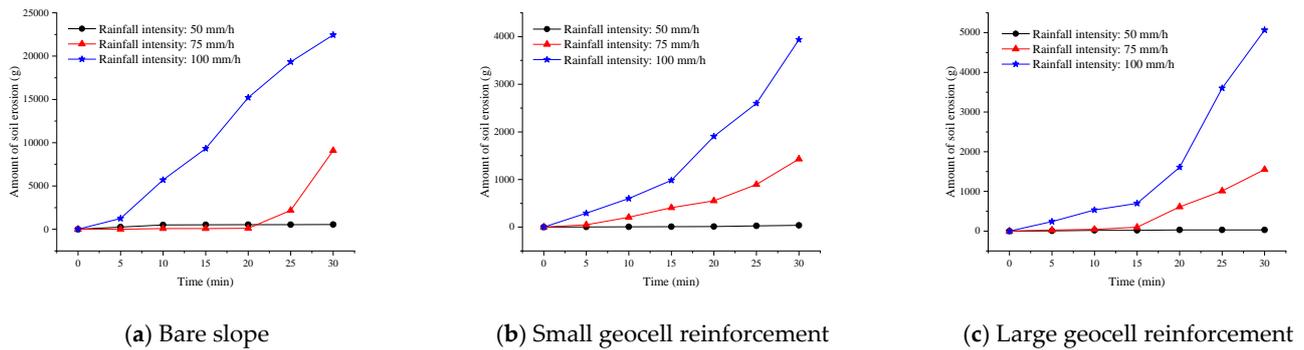
Figure 5 shows the growth of soil erosion with the rainfall process for different slopes. The amount of soil erosion was almost unnoticeable under the rainfall intensity of 50 mm/h. However, the soil erosion increased with the rainfall intensity at an even faster rate. The bare slope saw 550 g of soil erosion at the end of the 50 mm/h rainfall, which was significantly raised to about 9000 g and 22,000 g at the rainfall intensities of 75 mm/h and 100 mm/h, respectively (Figure 5a). The soil erosion was decreased when the slope was reinforced with the small geocells and the wheat straw. The amounts of soil erosion for the three slopes were observed as 40 g, 1400 g, and 3900 g at the cease of the rainfall. The large geocells also decreased the soil erosion; the amounts of soil erosion were 30 g, 1500 g and 5000 g under the three rainfall intensities. However, the small geocell-reinforced models showed less soil erosion; therefore, the small geocells outperformed the large ones.

Figure 5. Amount of soil erosion for different reinforced slopes under the three rainfall intensities.

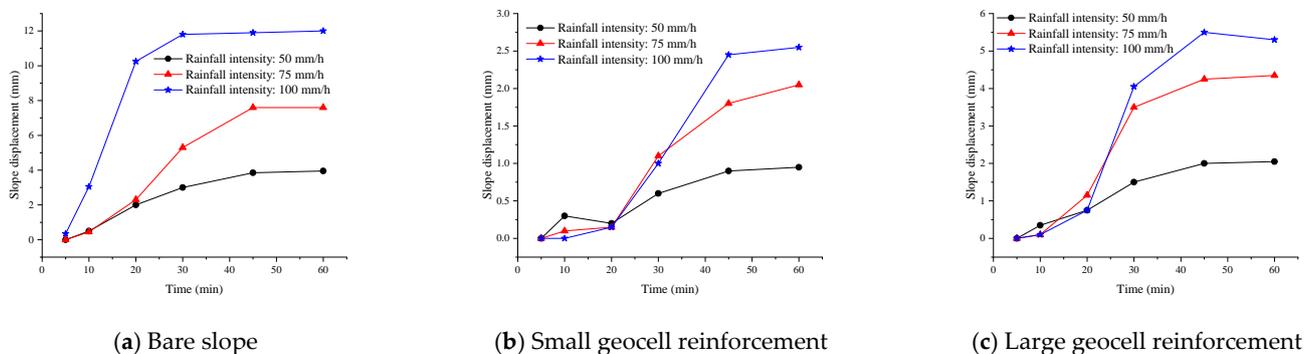
The displacement at the top section of the slope was recorded during the test until 30 min after the rainfall (see Figure 6). The slope displacement increased at the first 30 min as the rainfall continued. The increase in slope displacement slowed down and started to stabilize after the rainfall ceased. The increase in the rainfall intensity increased the slope displacement. For the bare slope, the final slope displacement grew from 4 mm to 7.6 mm and 12 mm as the rainfall intensity increased (Figure 6a). The geocells improved the slope stability with decreased slope displacement. Particularly, the slope displacement was better controlled with the small geocells. This was seen from the fact that, after the rainfall ceased for 30 min, the small geocell-reinforced slopes found the displacement stabilizing at 1 mm, 2 mm, and 2.6 mm under the three rainfall intensities, respectively (Figure 6b). By comparison, the slope displacement with the large geocells stood at 2 mm, 4.4 mm, and 5.3 mm (Figure 6c).

Figure 6. Amount of soil erosion for different reinforced slopes under the three rainfall intensities.

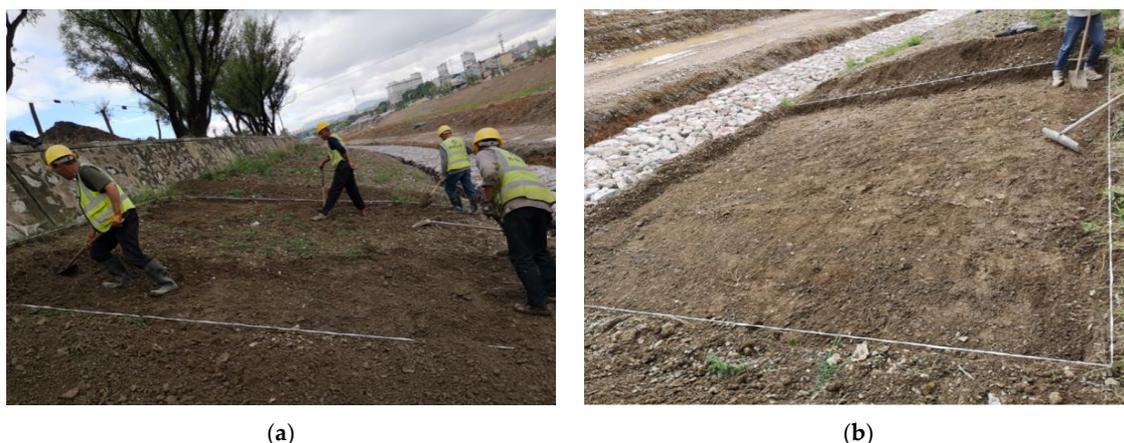
The first step for the slope stabilization with geocells and vegetation was the site preparation. An area of 10 m × 10 m was first selected on the subgrade at the studied area (Figure 7a). The selected area was then properly prepared by removing all the debris, rocks, sticks, weeds, vegetation and gullies before installing the geocell structures (Figure 7b). Voids or channels were filled so that uncontrolled water flow was not allowed under the geocells. The surface was properly leveled and compacted to ensure a smooth and fine graded slope surface. The finished slope after preparation is shown in Figure 7b.

Figure 7. Site preparation: (a) slope preparation; (b) the slope after preparation.

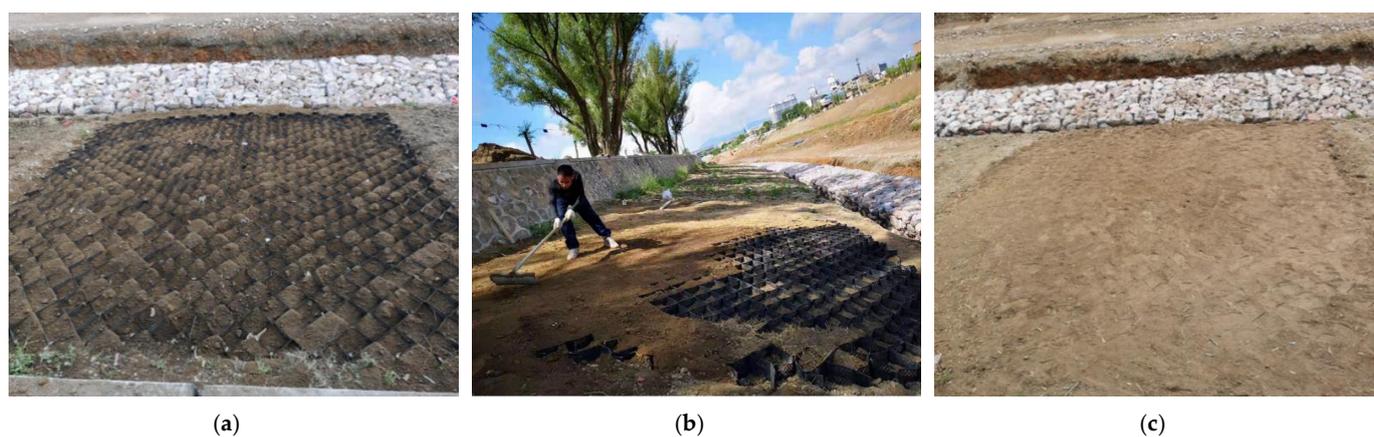
The next step was the installation of the geocells over the slope and infilling. The geocell was held in place at the crest of the slope with anchors, and fully expanded down the slope and secured at the toe of the slope (Figure 8a). The geocells were opened to a fixed width using separator bars and fixed to the ground using U-shaped nails at a proper interval. A full contact between the cell and the slope surface was properly maintained. After the geocell sections were secured on the prepared surface, infills were placed into the cells. The infills for this study were the local topsoil with appropriate nutrients. The bottom 10 cm of infill placed into the cells was the sufficient bare soil extracted from the neighbouring site (Figure 8a), while the top 10 cm infill was the mixture of the bare soil and wheat straws. Infilling was performed from the crest to the toe (Figure 8b). The topsoil was spread uniformly and evenly over the entire surface. The soil materials were overfilled 25 mm and compacted to the designed height. Excess soil was scraped off from the surface. The treated slope surface is shown in Figure 8c.

Figure 8. Infilling of the top soil: (a) bottom 10 cm of bare soil; (b) infilling from the crest to the toe; (c) the finished slope after treatment.

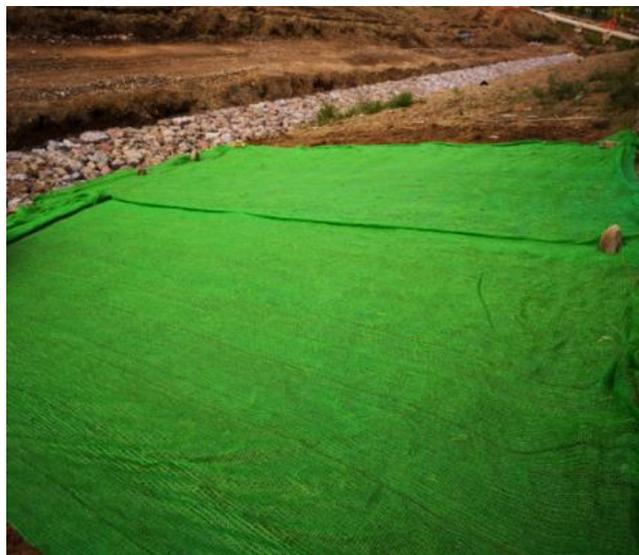
over the entire surface on 18 July 2019. Once infilled with all the soil materials, an erosion control blanket was used to cover the treated slope face (Figure 9).

Figure 9. Slope surface covered with blanket after seeding.

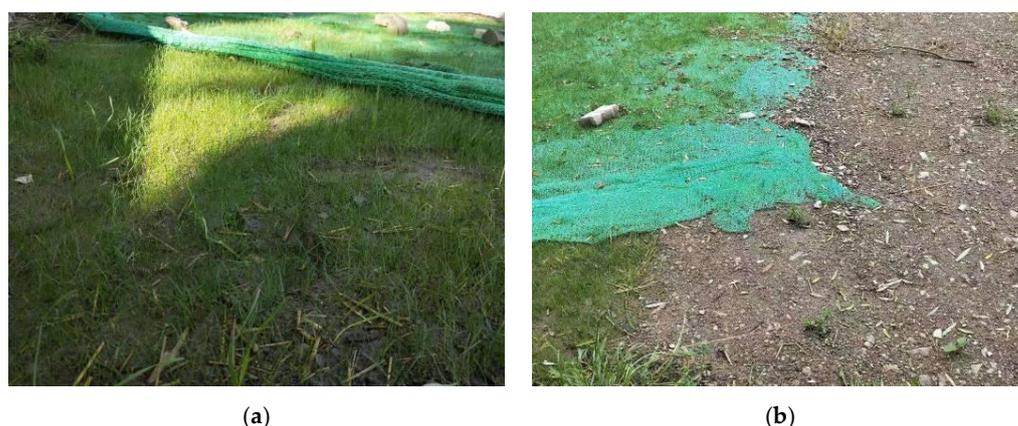
The vegetation growth 13 days after seeding is shown in Figure 10. The fast-growing vegetation was well developed beneath the erosion control blanket on the geocell- and wheat straw-treated slope (Figure 10a). The slope was covered with the vegetation over the entire slope surface within the selected area. This was compared to the neighboring untreated bare slope with only few plants on the sandy ground (Figure 10b). As compared with the treated slope soil in the studied area, the sandy soil on the bare slope was unable to provide sufficient and proper nutrients for the vegetation growth. The poor water conditions on the bare slope were also unfavorable to the growth of new vegetation. Vegetation can hardly be planted on the bare slope unless properly treated.

Figure 10. Vegetation growth at the 13rd day after seeding: (a) vegetation growth within the selected area; (b) comparison of the vegetation growth on the treated and bare slopes.

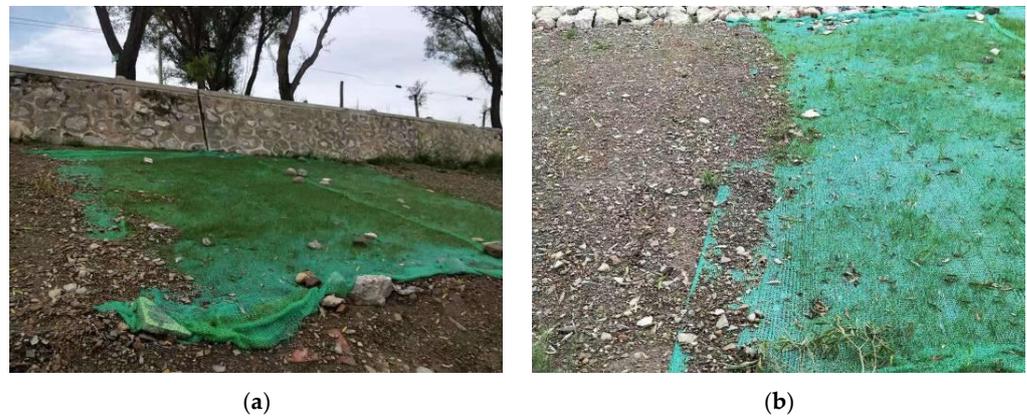
A rainstorm event occurred at the studied site on 4 August 2019, the 17th day after seeding. The slope condition after the impact of the rainstorm is shown in Figure 11. The vegetation was observed on most of the area above the erosion control blanket (Figure 11a). The treated slope in the selected area was neat and clean, with only limited rock and wood debris found at the edge of the selected site, which might be shifted from the neighboring

untreated area by the rainwater. This indicates that the slope in the area covered with the erosion control blanket was barely influenced by the rainstorm. By contrast, no protection against erosion was provided to the neighboring untreated slope. As a result, the bare slope saw a large amount of rock debris scoured around by the rainwater (Figure 11).

Figure 11. The condition of the slope under the impact of the rainfall on the 17th day after seeding. (a) vegetation observed above the blanket; (b) comparison of conditions of the treated and bare slopes.

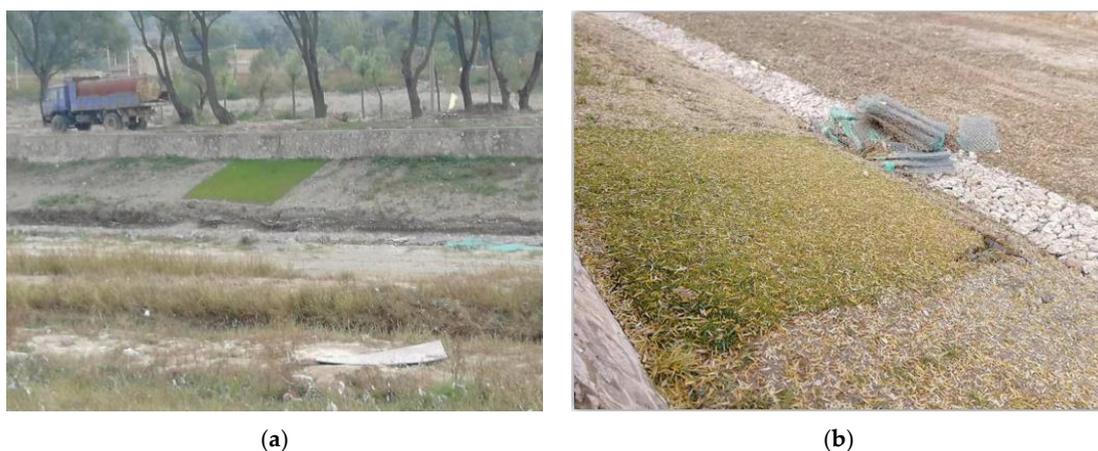
The establishment of the vegetation after 75 days and 120 days of seeding is shown in Figure 12a,b respectively. A picture of the vegetation was taken from the other side of the river on 1 October 2019 (Figure 12a). It was observed that the vegetation was well developed on the selected slope surface, in strike contrast to the neighboring untreated slope area with only few plants observed. The new vegetation provided protection against the surface erosion. Four months after seeding, another visit was paid to the studied site on 15 November 2019. The grass in the studied area turned brown in the winter time (Figure 12b). As compared with the bare slope, however, the vegetation cover still protected the slope against the wind, rain and snow. The root system of the vegetation and the geocell structures also provided strength to the soil by holding it in place.

Figure 12. Establishment of vegetation after (a) 75 days and (b) 120 days.
