# Stability Assessment of Coastal Cliffs Incorporating Laser Scanning Technology and a Numerical Analysis

**Abstract:** We investigated the cliff coast in Jastrzebia Gora, Poland. The measurements that were taken between 2014 and 2018 by applying terrestrial, mobile, and airborne laser scanning describe a huge geometric modification involving dislocations in a 2.5 m range. Differential maps and a volumetric change analysis made it possible to identify the most deformed cliff's location. Part of the monitoring of coastal change involved the measurement of a cliff sector in order to determine the soil mass flow down the slope. A full geometric image of the cliff was complemented by a stability assessment that incorporated numerical methods. The analysis showed that the stability coefficients, assuming a particular soil strata layout and geotechnical parameters, are unsafely close to the limit value. Moreover, the numerical computations, which were performed under simplifying assumptions, were not able to capture a multitude of other random factors that may have an impact on the soil mass stability. Thus, displacements of both reinforced soil and gabions were detected that are intend

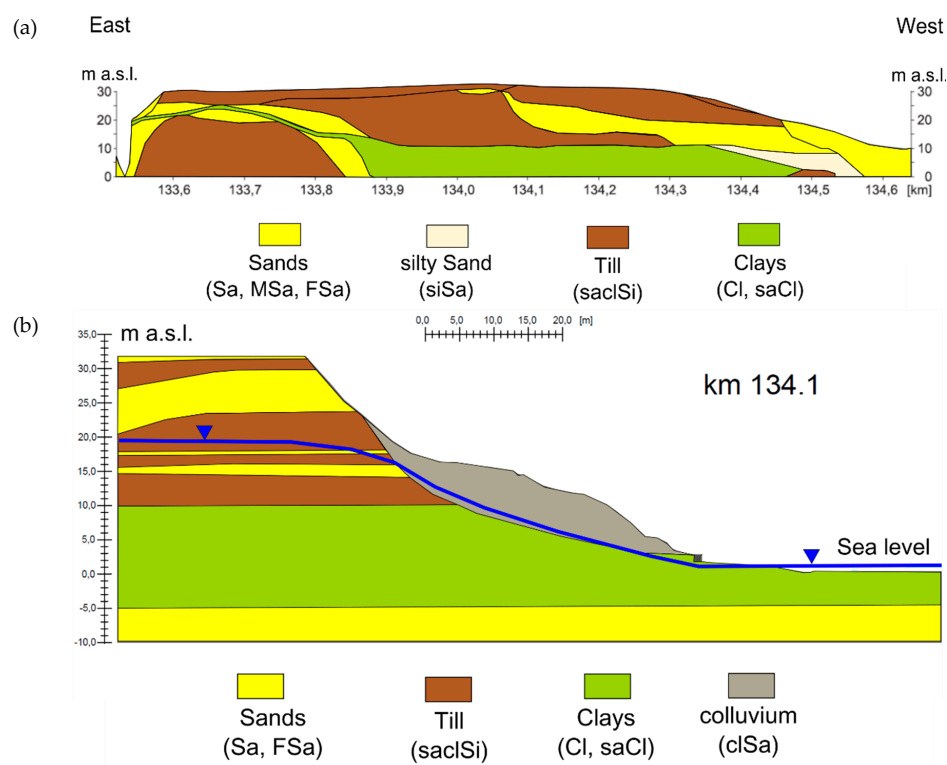
**Figure 2.** (a) Longitudinal (b) and transverse geological cross-sections of the cliff (based on [48]).

Abrasion has caused the cliff's base to relocate due to sea activity; however, another landslide trigger is the geological structure. In the case of Jastrzebia Gora, an impact is made by a clay layer in the bottom part of the cliff. Drilling in the investigated area uncovered a clay stratum that reaches 10 m above sea level. The upper strata are made of different gravelly clays, sandy and silty clays, and

Figure 2a,b show longitudinal and transverse geological cross-sections of the cliff, respectively.

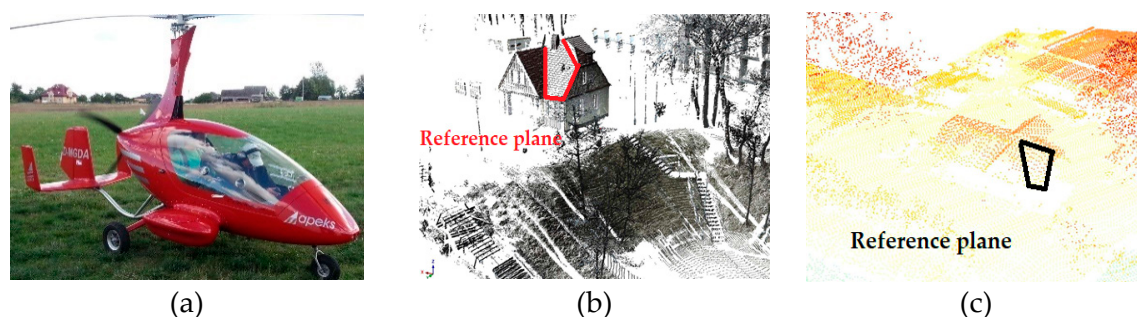
**Figure 3.** (a) The airborne system; (b) the reference planes at a laser view from the Terrestrial Laser System; (c) the reference planes at a laser view from the Airborne Laser System. The Airborne Laser-Scanning measurements were referenced to the EPSG:2177 ETRS89/Poland CS2000 zone 6 coordinate system.

For airborne laser scanning, we used a Riegl VQ-580 laser scanner (Manufacturer: Riegl GmbH, Horn, Austria). According to the Riegl VQ-580's specifications, the scanner's precision and accuracy are equal to 25 mm. The measurement accuracy was assumed to be the same. In practice, the accuracy thresholds were found to differ, which was addressed in further work stages. The errors in the scanner's position were complemented by the accuracy of the Inertial Measurement Unit/Global Navigation Satellite System (IMU/GNSS) system [20]. We designed and performed an experimental flight over the investigated area. Figure 3 shows the airborne system (a gyrocopter with a laser scanner attached to it), the reference planes that were registered with the help of the terrestrial laser-scanning system, and the same planes measured with the help of the airborne laser-scanning system. The designed flight lines along the coast were complemented by additional ones along the return route due to the low coverage between the flight rows. The air-scanning data were collected twice (in 2014 and in 2017). The missions aimed to obtain a sufficient point density (10 points/m<sup>2</sup>).

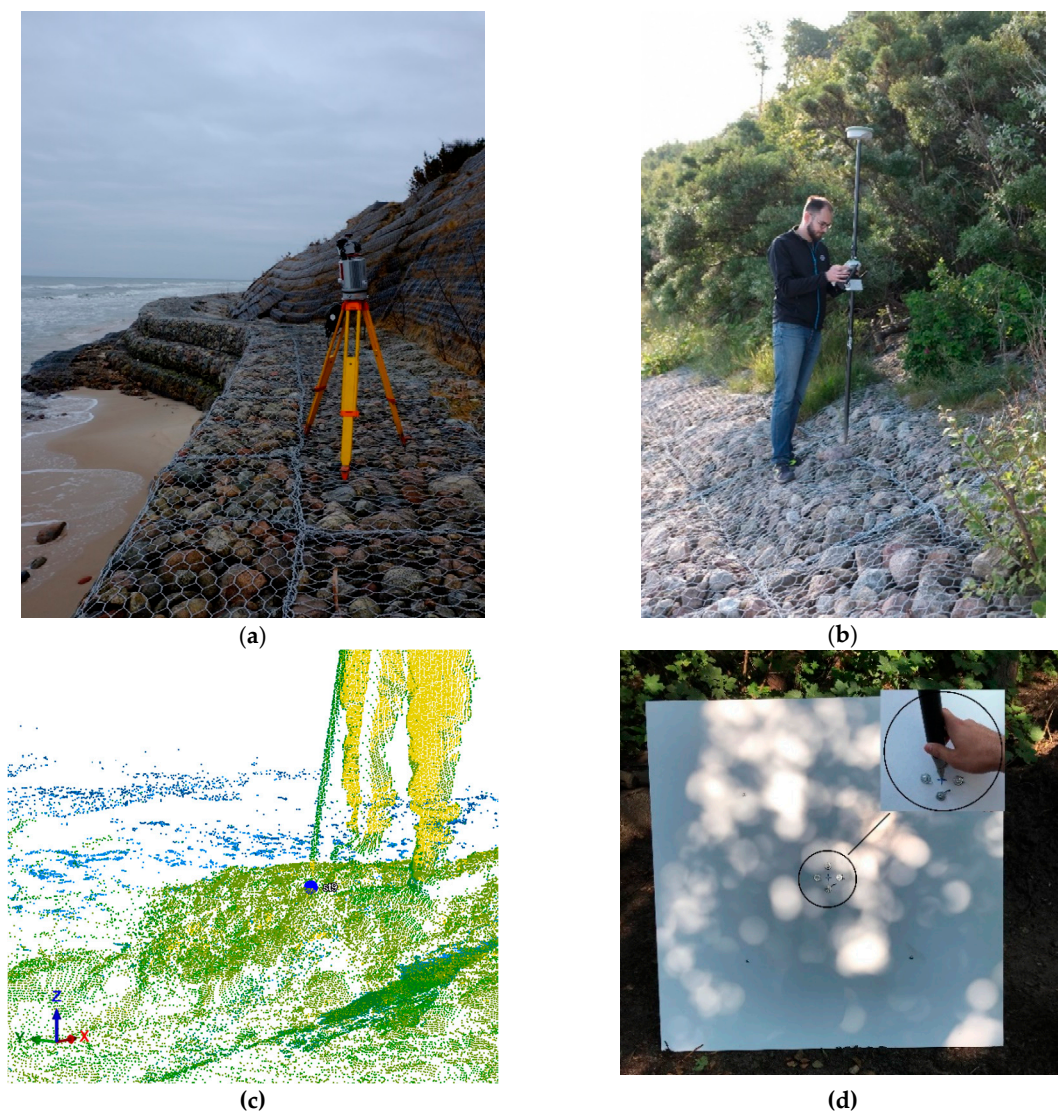
**Figure 4.** (a) The laser scanner working on the investigated object; (b) the Global Navigation Satellite System (GNSS) receiver; (c) the point cloud with the marked bottom of the pole; and (d) the materialized tie point z with a marked sighting cross on which we put a pole.

For terrestrial laser scanning, we used a Riegl VZ-400 laser scanner (Manufacturer: Riegl GmbH, Horn, Austria). This scanner allows for the remote acquisition of 3D data at high speed (122,000 pulses per second) and uses an infrared laser beam and a fast scanning mechanism. Compared to other instruments of this type, the Riegl device is a compact and lightweight measurement unit that can be installed in any orientation and does not require levelling. Note that the meteorological conditions, e.g., rain and snow, have a substantial impact on the device's measurement quality [19]. Figure 4 shows photos of the scanner's coverage of measurement courses in the Jastrzebia Gora region. The views are as follows: (a) a view of the scanner alone on the investigated object; (b) measurement of characteristic points using the GNSS technique in order to align 3D data that were referred to the EPSG:2177 coordinate system due to various measurement cycles; (c) the marked bottom of the pole on a point cloud, which represents a measured point in the EPSG:2177 coordinate system; (d) a materialized point that we deployed on an object of interest in order to unambiguously identify the reference points on scans. The size of this point is approximately  $1\text{ m} \times 1\text{ m}$ , and it has a sighting cross marked on the inside, on which we put a pole.

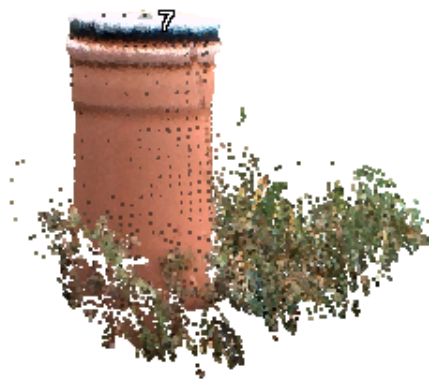
**Figure 5.** A representation of a measured object in the local coordinate system below the lower hummus layer.

In order to study the exact pattern of a landslide's behaviour and assess its threat to nearby infrastructure, we performed an experiment to measure the stabilized points at the top of the cliff under the hummus layer (Figure 5) in the local coordinate system. In this instance, we decided to change our assumption that the data were aligned with the EPSG:2177 coordinate system due to the fact that, locally, we were able to obtain greater accuracy. For this particular case, we used a Leica P30 Laser Scanner (Manufacturer: Leica Geosystems AG—Part of Hexagon). We used this instrument because it is possible to level it. This provided us with a simple orientation of the local system in such a way that the Y axis extended towards the sea, the Z axis extended upwards, and the X axis extended to the left according to the rule of the right hand. Figure 6 shows the location of the measurement points together with the orientation of the local coordinate system on an orthophotomap.

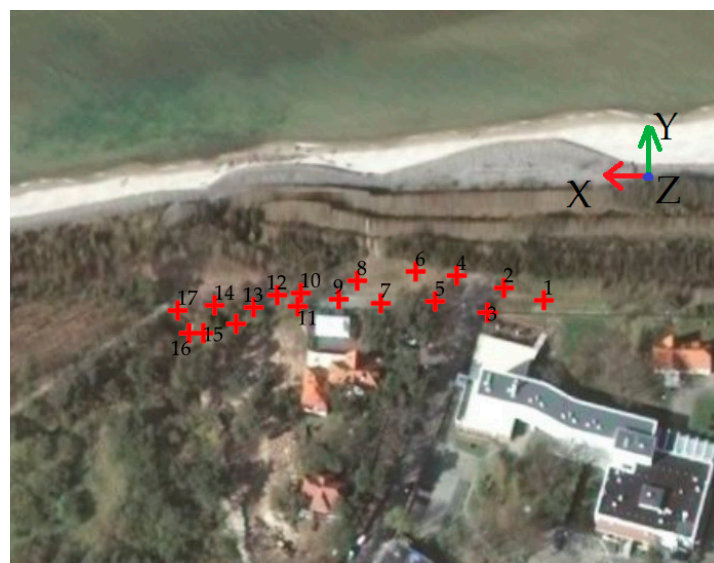
**Figure 6.** Locations of the measurement points.

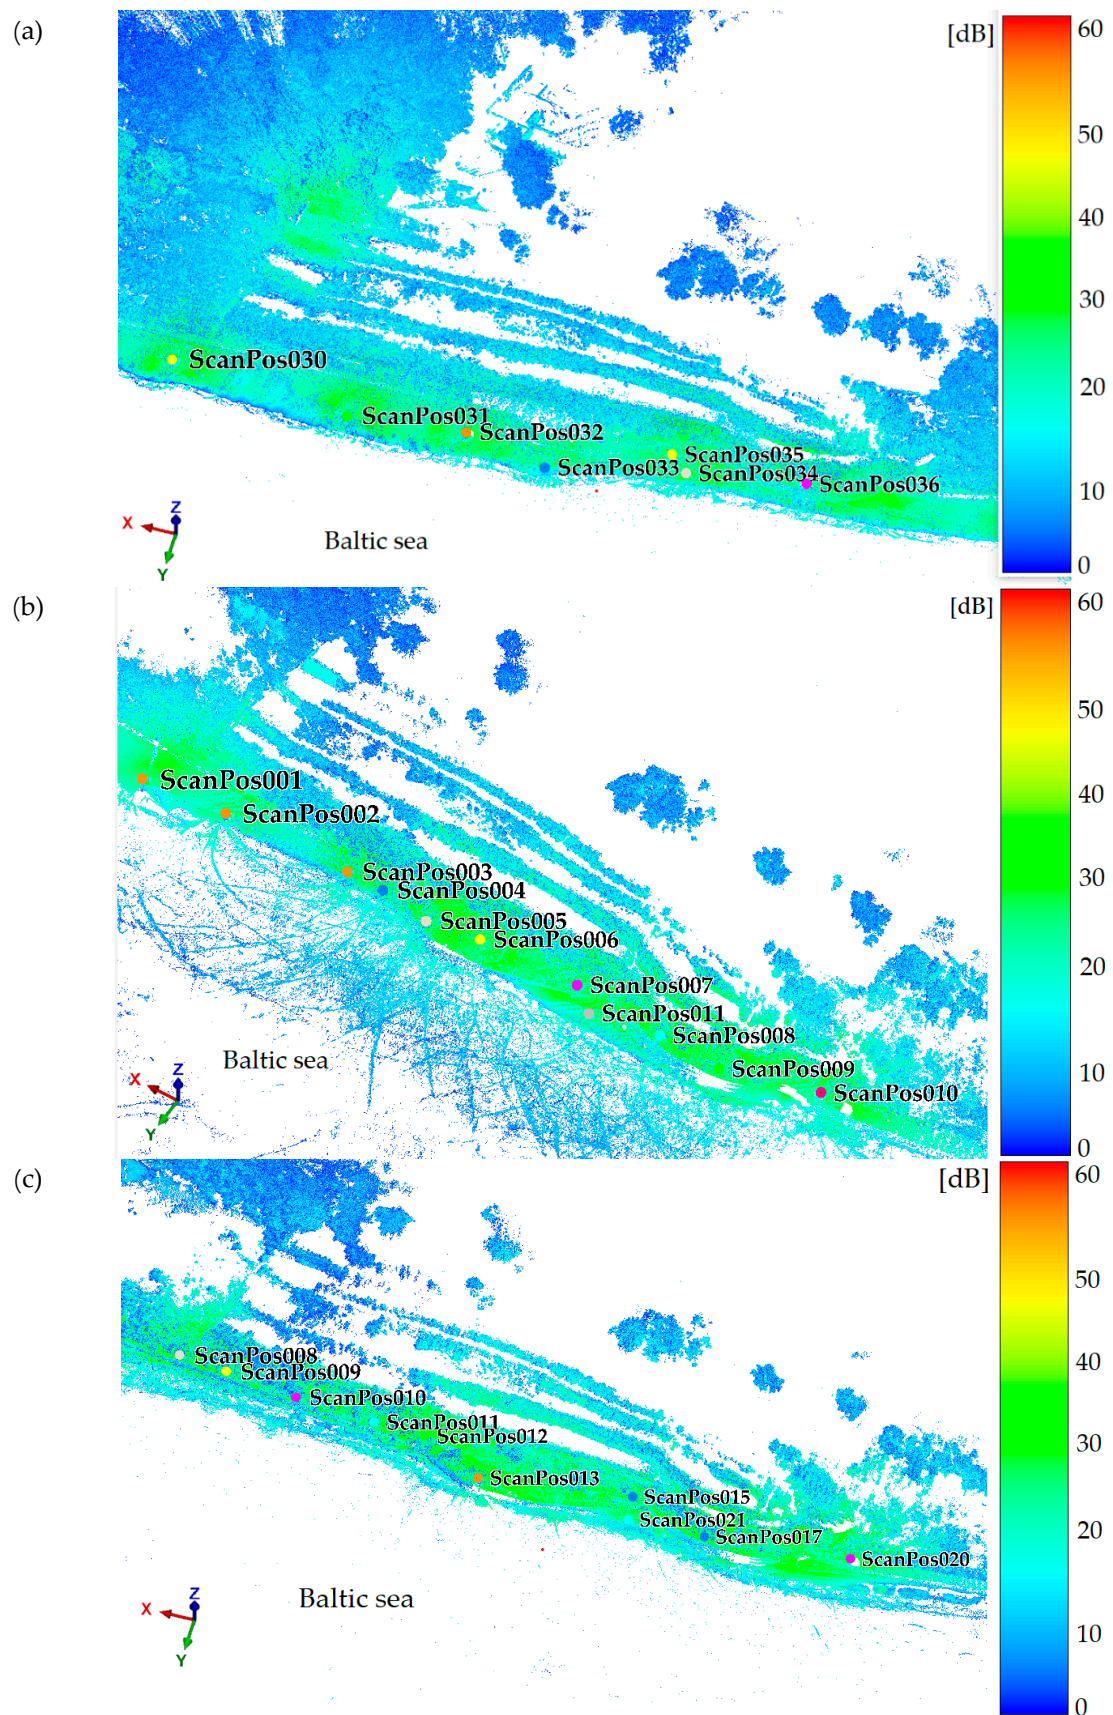
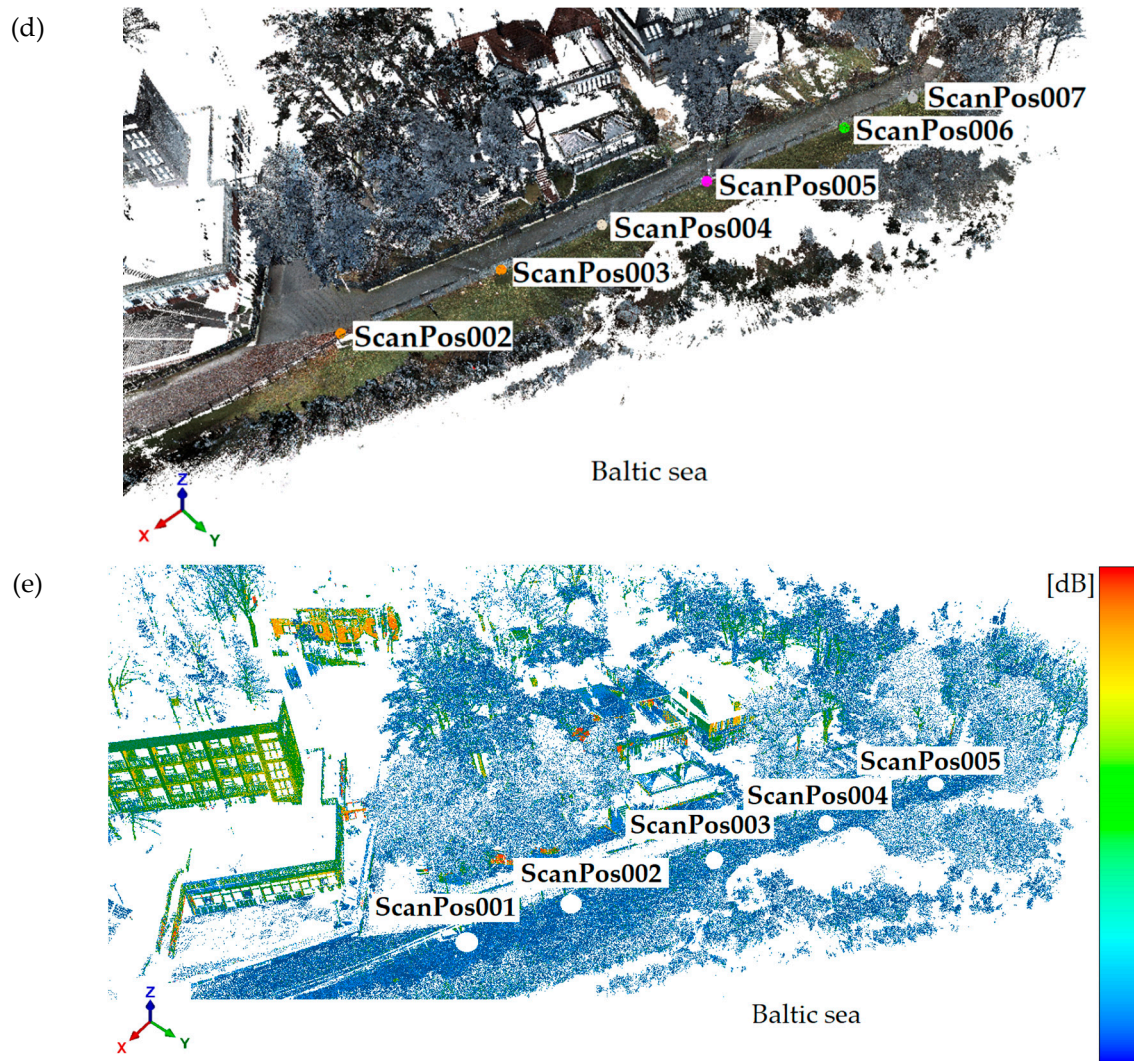
**Figure 8.** The scanner locations for the (a) February 2015, (b) March 2017, (c) July 2017, (d) November 2018, and (e) March 2018 measurement missions.

Figure 8 presents the location of the scan positions for each of the February 2015, March 2017, and July 2017 measurement missions and the deployment of positions in the local system in November 2017 and March 2018. The point density for each measurement mission was equal 4200 pts/m<sup>2</sup>. In Figure 8a–c,e respectively, colours are presented as a function of light reflection amplitude, while Figure 8d shows the fragment of the upper part of the cliff in RGB (Red-Green-Blue) colours.

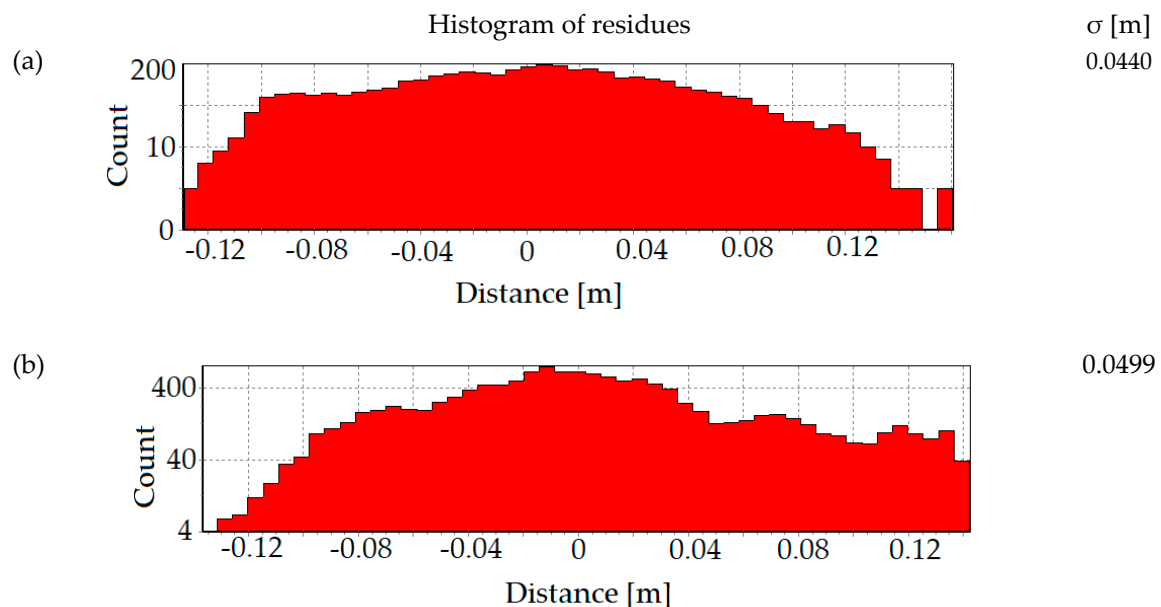
**Figure 12.** A histogram of the data alignment residues for (a) 2014 and (b) 2017.

Based on the results obtained from the alignment of laser strips with each other as shown in Figure 12, the standard deviation values for these values (for the 2014 flight,  $\sigma = 0.044$  m; for the 2017 flight,  $\sigma = 0.0499$  m) and the irregularities that are visible in the trajectory shown in Figure 11, we assumed that the accuracy of one model varied at the level of  $3\sigma$ , which is 0.132 m for the flight from 2014 and 0.149 m for the flight from 2017. These values mean that the summed accuracy of the comparative model will be in the range of 20–30 cm. The presented residues show the differences in distance between the tie points measured by surveying methods and in the case of automatic extraction described in Section 2.4.1.

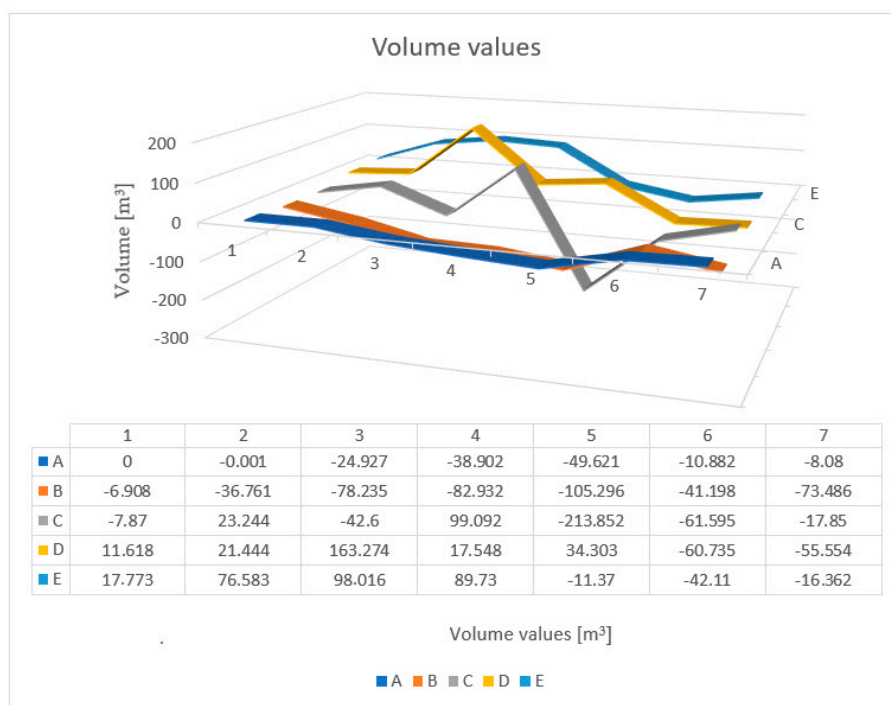
**Figure 18.** The volumes at each mesh square according to Figure 15 (b).

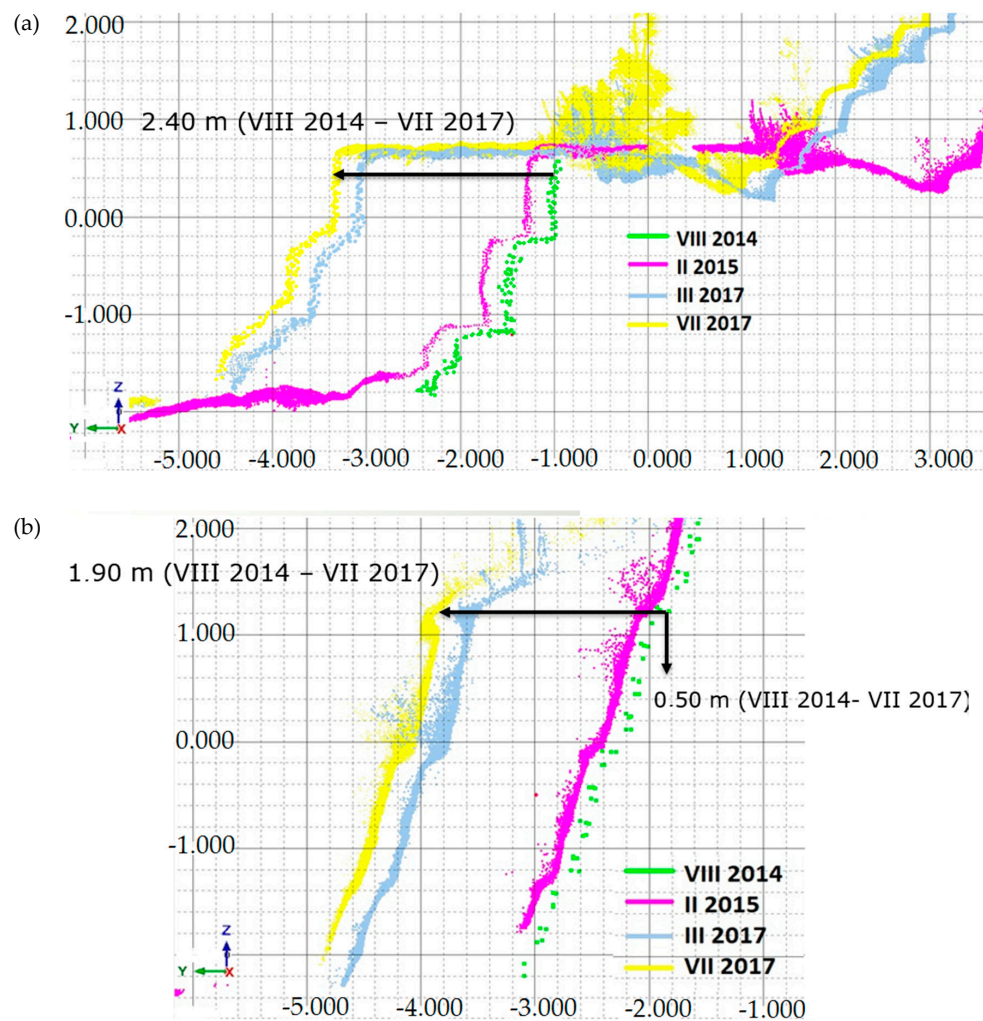
**Figure 20.** The results of the geometric analysis of a section in the form of a displacement graph: (a) gabion structure and (b) reinforced subsoil.

from a geometric analysis of the gabion structure and the reinforced soil are shown in Figure 20a,b, respectively. We marked the month and year of the measurement and linked them to relevant colours.

It can be observed that the gabion reinforcement's movement was horizontal (Figure 20a), and the value of the soil's movement reached 2.4 m over 3 years. This is a substantial deformation of the cliff's base, which has an influence on its higher parts. Another part of the cliff, which is constructed from soil reinforced with geosynthetics (Figure 20b), showed a smaller displacement (1.9 m) in the direction of the sea, but also displayed a substantial settlement (vertical displacement) of about 0.5 m over 3 years.

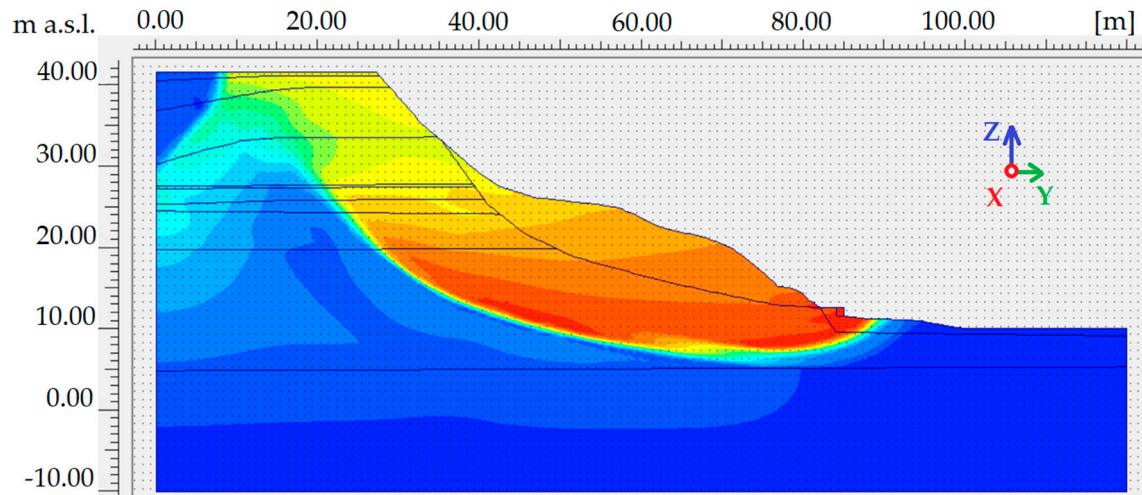
**Figure 21.** The global failure mechanism: calculations for the actual groundwater table (dimensions in meters) (source: Reference [48]). Blue colour: no displacement, red: maximum displacement.

cohesion). The analysis showed that, for the initial case (no elevation in the water table), the most sensitive parameters were the friction angle and the cohesion in the bottom layer (the clay from which the cliff is built). This is logical, as this scenario triggers a path that leads to the cliff's destruction (see Figure 21).

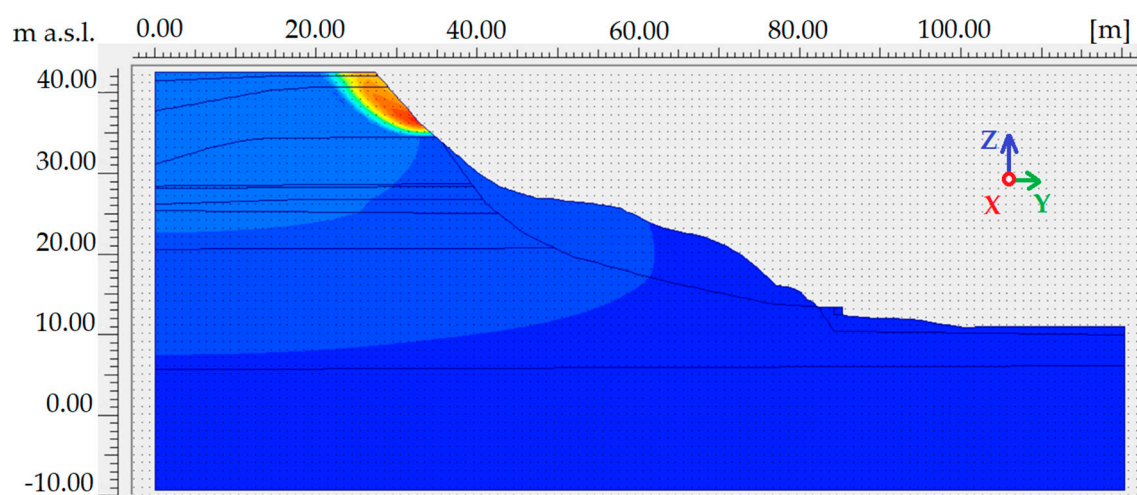
**Figure 22.** The local failure mechanism: calculations for the groundwater table elevated by 0.9 m. (source: Reference [48]). Blue colour: no displacement, red: maximum displacement.

It is worth emphasizing that the cohesion is not constant for a given soil—it reduces with increasing water content. In complicated geological conditions, even a thin layer of sand interbedding the clays can deliver a substantial amount of water into the clay layer and reduce cohesion. It is also interesting to note, that slight water table elevation from +0.8 m to +0.9 m causes failure path transformation from a global (Figure 21) to local one (Figure 22). In this case, the most sensitive parameters are the cohesions of both layers building local slip surface: till and clayley sand, followed by friction angle of both layers. The resulting interpretation is similar to the previous case: The change of geotechnical parameters caused e.g., by a substantial water content increase, can result in a sudden landslide.
