The Application of UAV for the Analysis of Geological Hazard in Krk Island, Croatia, Mediterranean Sea

Citation: Ružić, I.; Benac, Č.; Jovančević, S.D.; Radišić, M. The Application of UAV for the Analysis of Geological Hazard in Krk Island, Croatia, Mediterranean Sea. *Remote Sens.* **2021**, *13*, 1790. <https://doi.org/10.3390/rs13091790>

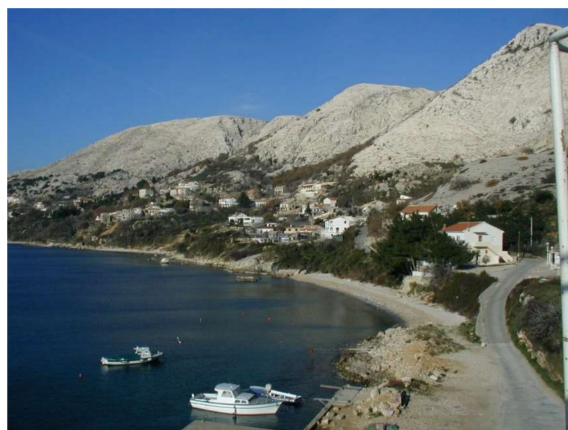
Due to tourist development in recent decades, the settlement of Stara Baška had expanded without sufficient infrastructure development. Some houses were built on potential landslide area (Figure 2). Inadequate drainage has increased the water table and

thus the landslide risk. However, these structures increase wave reflection, coastal process and groundwater table.

Figure 2. The coastal area near the settlement of Stara Baška.

The narrow gravel beaches (Figure 2) along the major part of the studied coast cannot form a winter profile and absorb wave energy during the storm surges. In this situation, waves cross the beaches and erode the base of the coastal slopes. The consequences are landslides, cliff erosion and the movement of sliding bodies. These processes will be exacerbated by the expected sea level rise and more frequent storm surges (Acqua Alta) in the Kvarner area [34]. The important data on the geological structure and geomorphological processes of the study area were obtained 2020 thanks to the application of modern remote sensing methods.

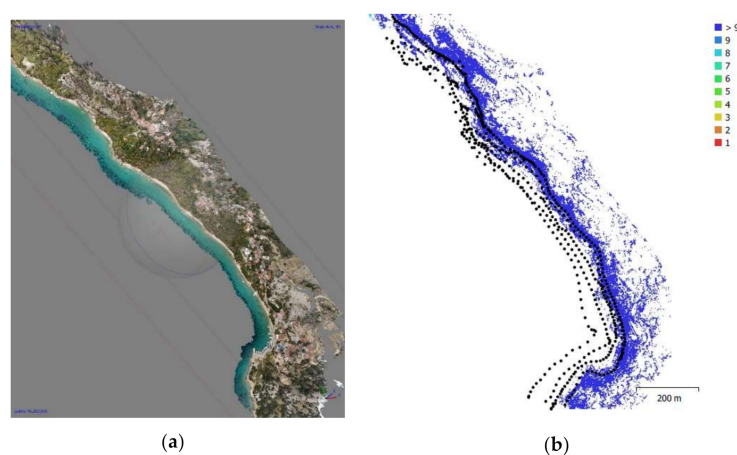
Figure 3. Agisoft Metashape Processing Report: (a) Investigated area 3D Point cloud, (b) camera locations and number of image overlaps.

The 3D point cloud (Figure 3a) was generated using the SfM-MVS photogrammetry technique [39,40]. The photo sets were processed using SfM-MVS software Agisoft Metashape Professional, v1.7.1.

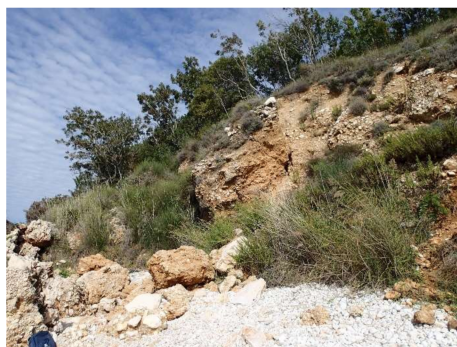
Figure 6. Cliff formed in talus breccia.

The talus breccia has a pronounced horizontal stratification and the joints are not visible. The horizontal layers consist of limestone fragments/clasts ranging in size from a few millimeters to blocks larger than 50 cm. Fragments ranging in size from 1 cm to 4 cm predominate. The matrix is a reddish silty sandy cement (20–50% silt and clay) with varying degrees of calcification. The estimated GSI of the talus breccia is 25–35 (Figures 5C and 6).

The narrow coastal zone is mainly covered by well-rounded gravel and pebbles, which form the beach bodies. Rocky blocks are also present, formed from talus breccias. The cliffs formed from talus breccias have an average height of 8 m to 20 m. A varying degree of calcification has a great influence on the erodibility and some strength parameters of the breccia, and thus on marine erosion. Cliff wave-cut notches are formed as a result of toe erosion. The geometry of the toes plays a significant role in the stability of the cliff [33]. The uppermost layer in the subsurface is completely weathered and has soil-like features (Figures 5C and 6).

A significant increase in the rate of erosion will also occur in coastal sections formed in talus breccia, although they are more resistant to coastal erosion than those formed in flysch. The hydraulic action of waves and corrosion plays a significant role in cliff retreat. The main cause of cliff instabilities formed in talus breccia is the occurrence of strong waves and the formation of wave-cut notches. The hydraulic action occurs when the waves compress the air in the cracks of the rock undercut and the cliff face. This exerts pressure on the surrounding rock, and can gradually erode and remove fragments of breccia. Secondary causes include weathering and erosion of the matrix of reddish silt and sand. The acids present in seawater cause corrosion or dissolution of the matrix in breccia, weakening the bonds between the grains. Abrasion or corrosion occurs when waves break on cliff faces and slowly erode them. The resistance of marine erosion depends greatly on the degree of calcification. The slump of the cliff's slope can occur where notches are cut several meters inward into the base of the cliff slope [33] (Figures 4, 6 and 9).

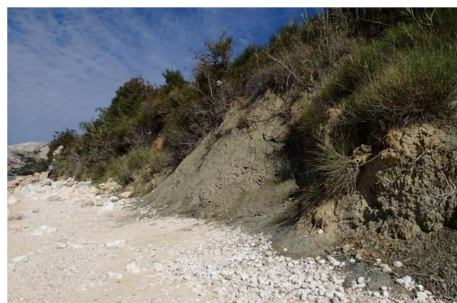
Figure 7. Cliff formed in a weathered flysch rock mass.

The cliffs formed in the flysch rock reach a height of up to 15 m (Figure 5B,D). The recent erosion process is visible (Figure 7). However, the eroded material does not remain on the beaches but is carried away by the sea currents in the form of a suspension.

The Palaeogene flysch in the studied coastal zone consists mainly of relatively soft siltstones and marls. During neotectonic and recent tectonic movements, this rock mass was repeatedly disturbed and fractured [35]. For this reason, the flysch rock mass is very sensitive to near-surface mechanical and chemical weathering. As the degree of weathering increases, the bulk density and the possibility of moisture absorption increases, while the hardness of the rock mass decreases. The destructive effect of waves is more pronounced at this weakened rock mass [58] (Figure 7).

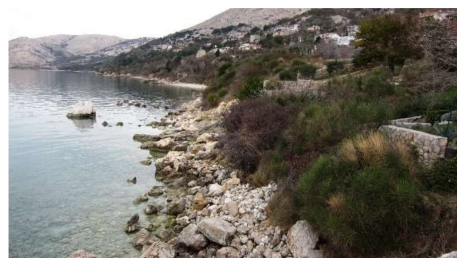
Figure 8. Landslide toe before the building of retaining wall.

One major and two minor landslides are in the phase of creeping (Figures 4 and 5B). The toes of the landslides are exposed to wave attack (Figure 8).

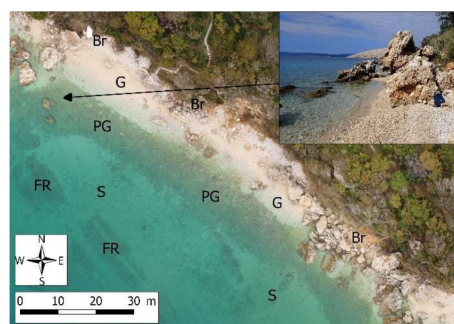
Figure 9. The beach and cliff formed in talus breccia (near cross-section C, Figure 4): Br—talus breccia, G—fine to coarse gravel, PG—pebbles and coarse gravel, S—sand, FR—flysch rock.

Coarse-grained sediments eroded from the talus breccia around cross-section C (Figures 4 and 5C) are accumulated on the beach body. Large fallen blocks provide an obstacle to waves. The beach body is relatively narrow and has a low thickness, so the total sediment input is very important for coastal resistance. The granulometric composition of the individual beaches varies widely. Round grains of fine to medium gravel predominate at some sites, while coarse gravel and pebbles are found at others. Angular and subangular pebbles and blocks are below MSL. The layer of sandy sediment is very thin and crops of flysch rock are visible on the seabed (Figure 9).

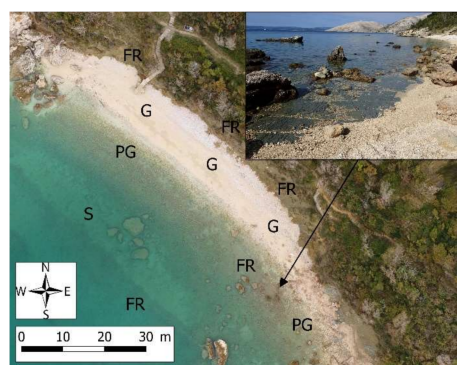
Figure 10. The beach and cliff formed in flysch rock (near cross-section D, Figure 4): FR—Flysch rock, G—Fine to coarse gravel, PG—Pebbles and coarse gravel, S—Sand.

Narrow beaches near cross-sections B and D are formed in front of cliffs composed of flysch rock mass (Figures 4 and 5B,D). The sand layer here is very thin and flysch outcrops are visible on the seabed. The granulometric composition of the beach at this site is also patchy and the small thickness of its body may lead to flysch rocks being visible onshore

in some places (Figure 10). However, large blocks that present an obstacle to waves are relatively rare on these beaches.

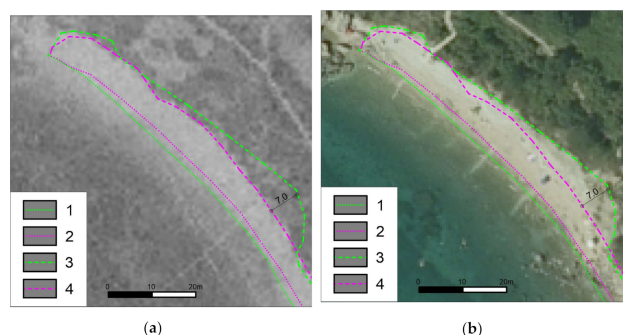
Figure 12. Ortho photo map (from 1966 (a) and 2014 (b)) showing considerable coastal changes from 1966 to 2014: 1—coastline 2004; 2—coastline 1966; 3—cliff line 2004; 4—cliff line 1966.

Figure 12 shows a significant retreat of the cliff formed in the flysch between 1966 and 2014. The estimate of cliff retreat is very rough due to the (in)accuracy of the maps. The changes are visible on a 50-year scale, but according to the same State Geodetic Administration web service, the coastal changes between 2011 and 2018 are not visible, which would not be the case if there were regular UAV or LIDAR surveys. These precise surveys allow monitoring of coastal slides, cliff recession and even block movements [56,57].

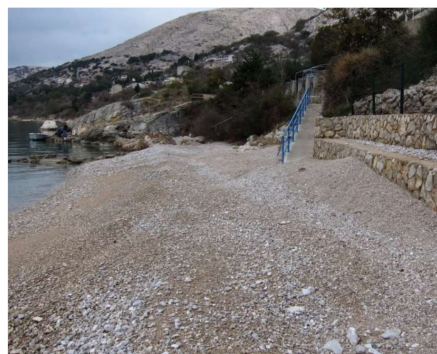
Figure 14. Winter beach profile formation after extreme tide 1.27 m CVD on 29 October 2018.

The beach foreshore and backshore are very narrow and have low thickness in most of the study area (Figure 4). Therefore, they cannot absorb the energy of the waves and coastal erosion occurs [59]. The only wider beach is located in the southeastern part of the study area (Figures 1, 2 and 4). During storm surges, intense onshore sediment movement occurs, resulting in the formation of the beach's winter profile that protects the shoreline from erosion (Figure 14).

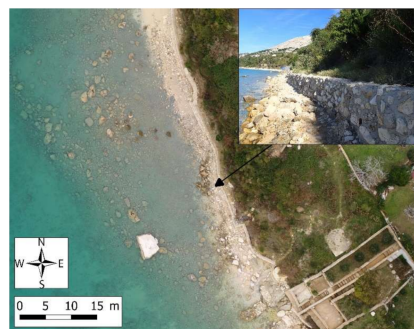
Figure 15. Improvised retaining wall near the landslide toe.

Landslides are in the creeping phase and damage (open joint cracks) is visible on adjacent houses [60]. The improvised coastal wall, constructed in 2019, cannot stop the movements of the landslide body (Figure 15).

Although it can protect the base of the embankment from further erosion, the wall does not meet the quality standards of coastal structures. The wall has no drainage system, resulting in a local rise in the water table due to wave overtopping and surface and subsurface runoff. If the wall were to collapse due to wave action, the vulnerability of this section of the coast would increase significantly.
