Anticipating the Collapse of Urban Infrastructure: A Methodology Based on Earth Observation and MT-InSAR

Ignacio Rodríguez-Antuñaño , Joaquín Martínez-Sánchez, Manuel Cabaleiro and Belén Riveiro *

Keywords: satellite monitoring; collapse; Line 12 of the Mexico City Metro; Capriogliola bridge; Font Nova urbanization (Peñíscola); Champlain Towers South (Miami)

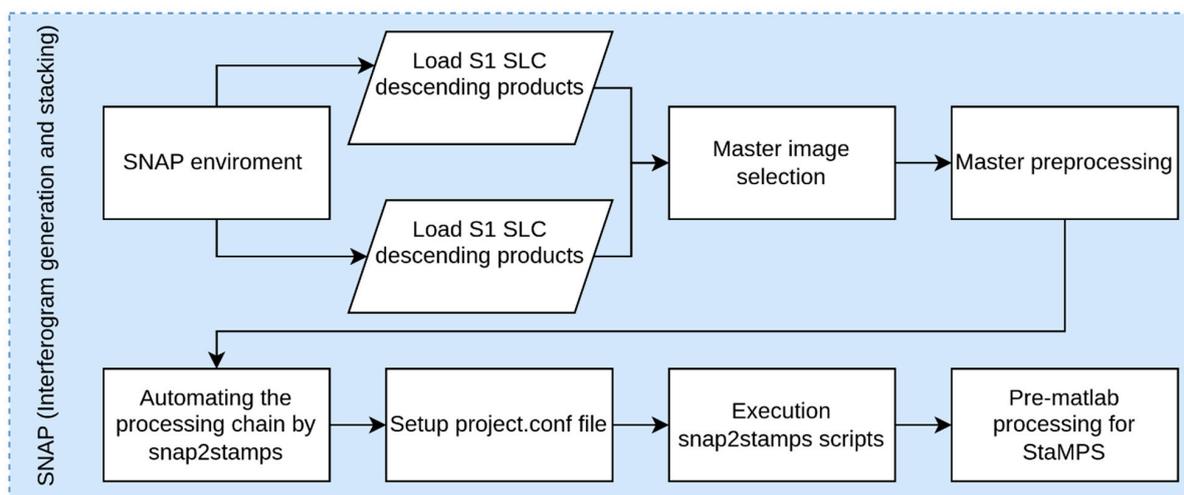
Figure 2. Workflow for the interferogram generation using Sentinel-1 images.

Our methodology consists of dividing the processing by year, and therefore, the workflow for interferogram generation and stacking is depicted in Figure 2. Here, the first step consists of selecting the master image (in SLC format) for each year of the analysis. The master image will collate the rest of the images for each annual analysis in order to detect and monitor changes by comparison between the master image and other images at time t . This analysis is performed using the free ESA program of SNAP [27]. The analysis continues by using the snap2stamps tool [28], which supports the automation of the processing chain for interferograms and is compatible with StaMPS.

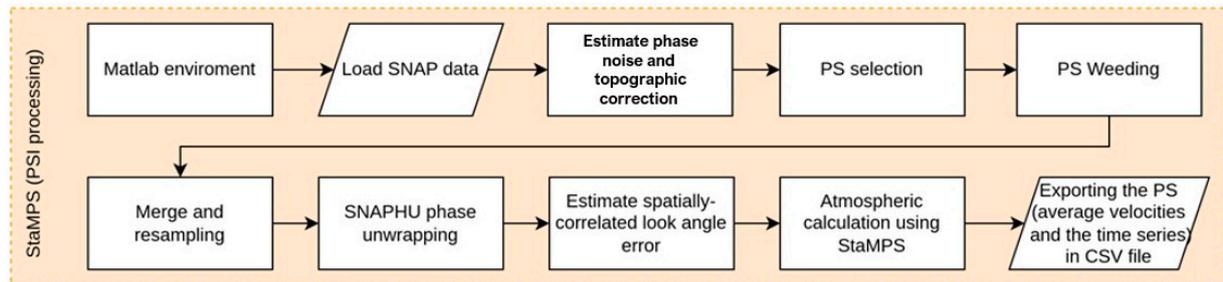
Figure 3. Workflow for PS extraction.

This analysis using StaMPS is implemented within MATLAB following the workflow depicted in Figure 3. This MATLAB code consists of sequential instructions or steps (commands) to obtain the PSs and the corresponding deformation map of the study area. Therefore, the sequence involves loading the data obtained from SNAP into the MATLAB environment to calculate temporal coherence by estimating the phase noise and the spatially uncorrelated DEM error (to remove the topographic phase component and geocode the results, we used the SRTM 1-arcsec DEM with 30 m resolution); thus, a first selection of PSs can be made so that those considered noisy can be eliminated. Then, the data are resampled

to drop pixel errors and merged to perform phase unwrapping. Finally, the results are filtered to remove the spatially correlated look angle errors and the noise from atmospheric disturbances. The correct PSs can then be exported with their velocity and time series trend.

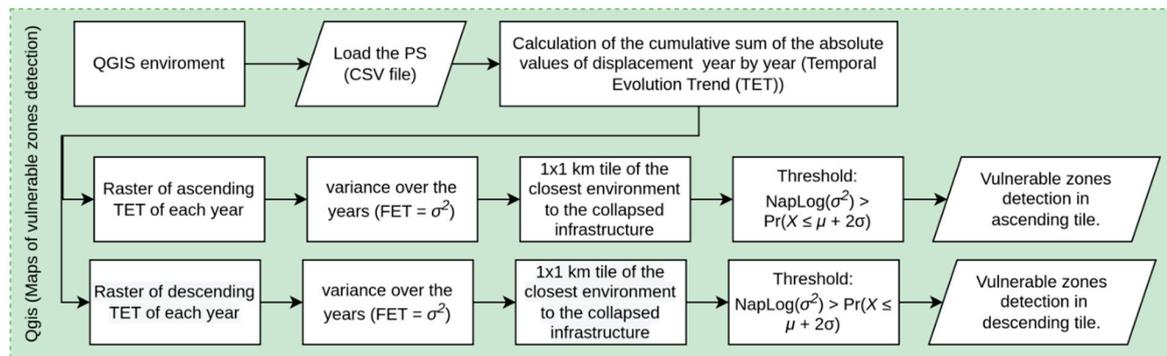
Figure 4. Workflow of the third step for each year of the analysis of Sentinel-1 images to detect areas potentially at risk of dangerous collapse.

To proceed with the analysis, QGIS software was used according to the workflow presented in Figure 4. The first step is obtaining the TET for each point (PS) of the years analyzed. As the product obtained in the previous phase consists of a series of point clouds for each year and orbit, a common grid is defined in order to rasterize the data with a pixel size of 20 m. The choice of 20 m pixels is taken as the minimum resolution, and is obtained from the maximum resolution of Sentinel-1 images.

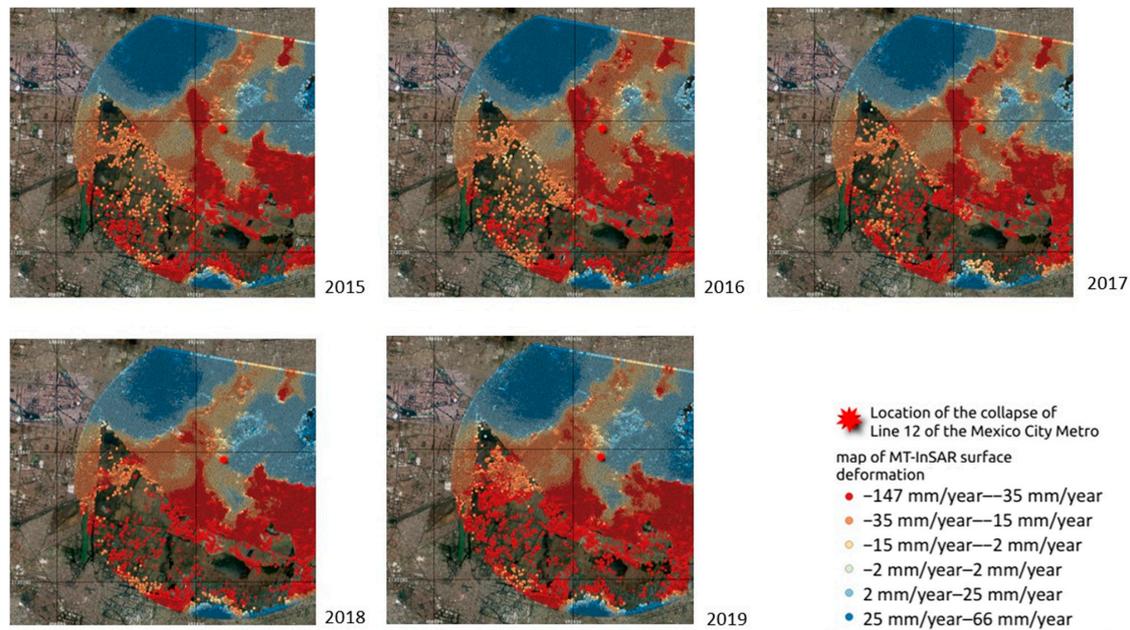
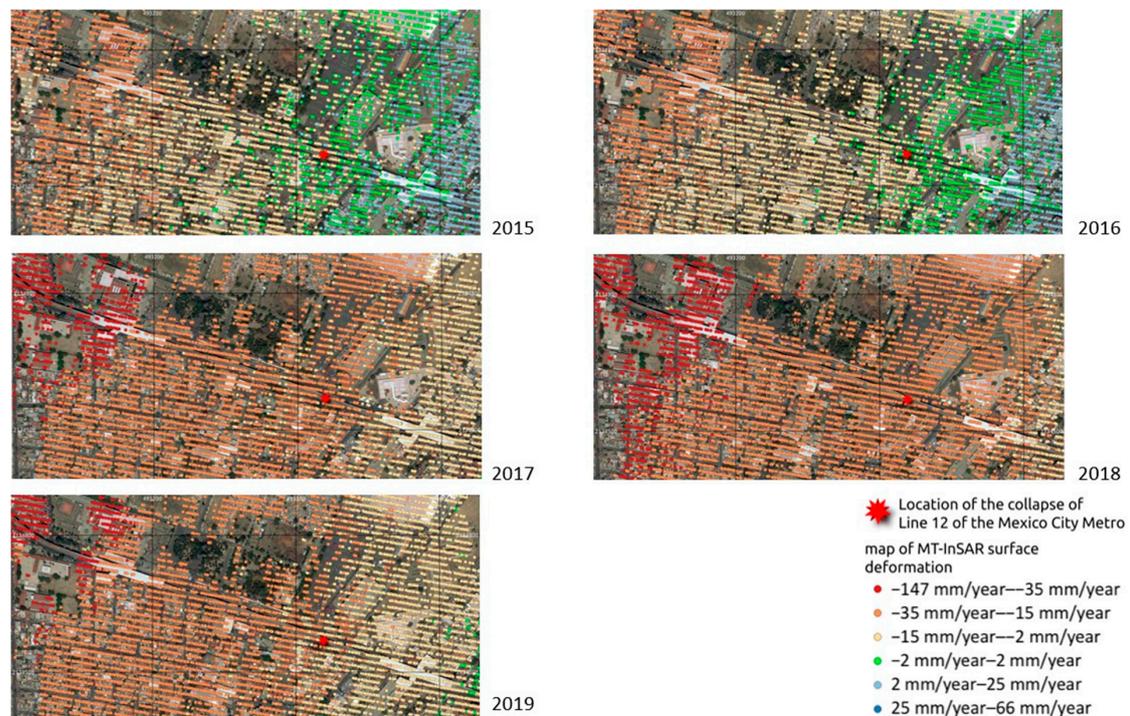
Figure 5. (a) Map of MT-InSAR surface deformation (2015–2020) in descending images of the entire study area. (b) Detailed map of MT-InSAR surface deformation (2015–2020) in descending images in the specific infrastructure where the accident occurred on 3 May 2021 on Line 12 of the Mexico City Metro.

study (Line 12 of the Mexico City Metro) in Figure 5. Therefore, this new methodology is proposed through the FET map for each year (2015 to 2020). As mentioned in Section 2.3, the variance of the FET value for the same pixel over the years of analysis was calculated for both ascending images (in Figure 6) and descending images (in Figure 7).

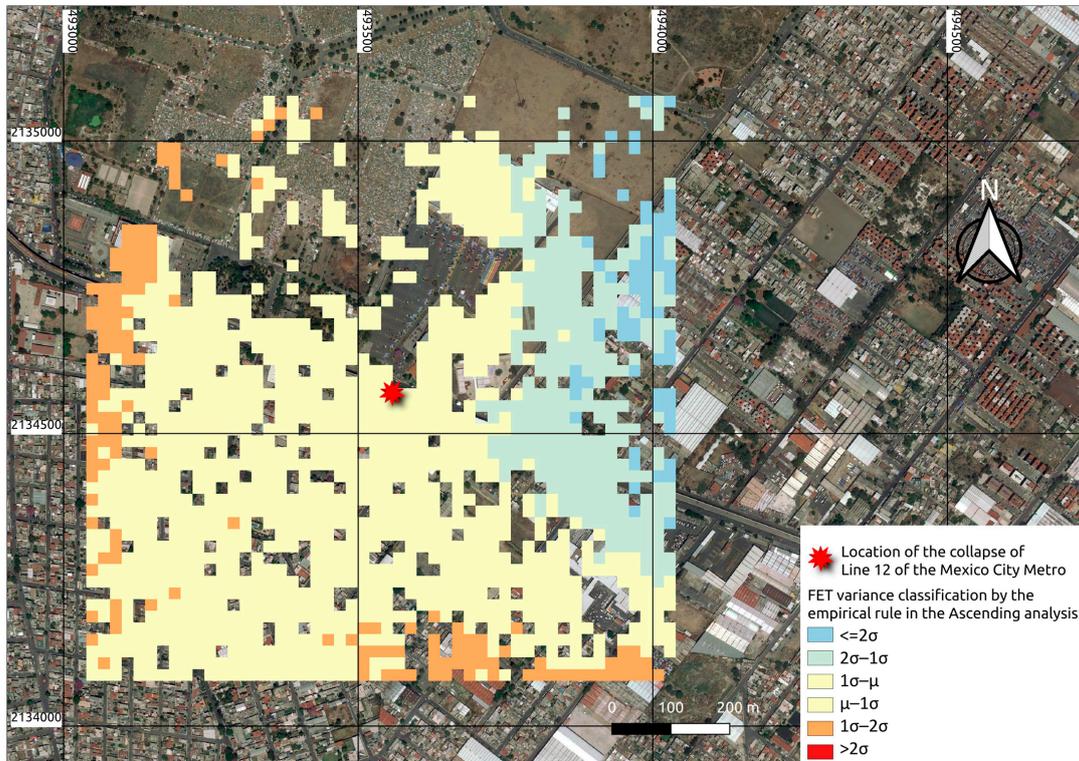
Figure 8. Variance obtained of the FET value for each pixel over the years of the analysis (2015–2020) in the 1×1 km tile in ascending images.

The points of infrastructure collapse were located and are marked with a red point in Figures 8 and 9. The depicted variance in the 1 sq-km surrounding area provides an

indication of vulnerability, both for descending and ascending images. The values for this indicator are logarithmically transformed and filtered in the 2σ interval.

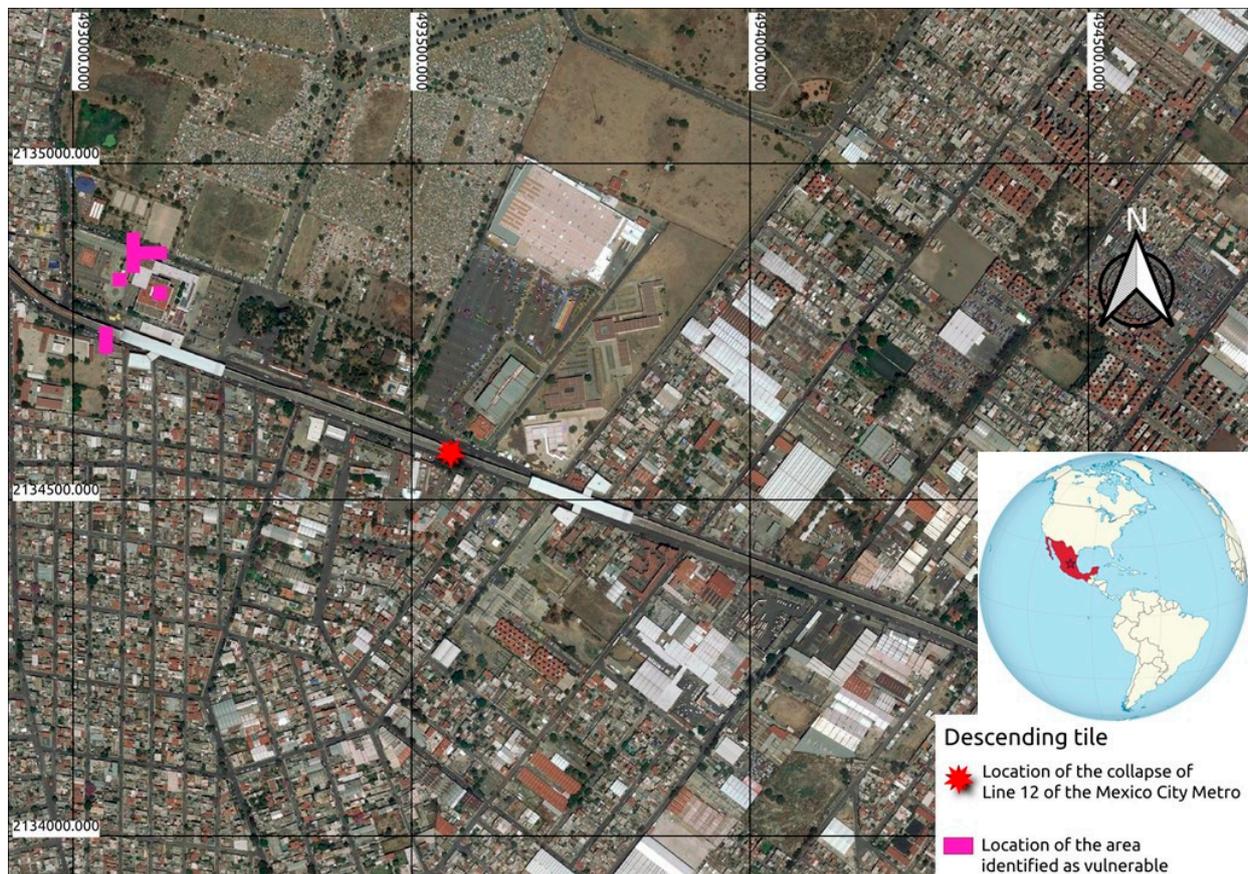
Figure 10 shows that, in the descending case, the vulnerable zone, represented in magenta pixels, corresponds with one of the girders supporting the overpass that carries Line 12 of the Mexico City Metro near the Tezonco station. The vulnerable zone is defined as those pixels whose variance of FET exceeds the mean (μ) by 2 times the variance (σ) of the set of pixels of the tile.

Figure 10. The vulnerable zone, which concurs geographically with a girder that supported the overpass carrying Line 12 of the Mexico City Metro and that collapsed.

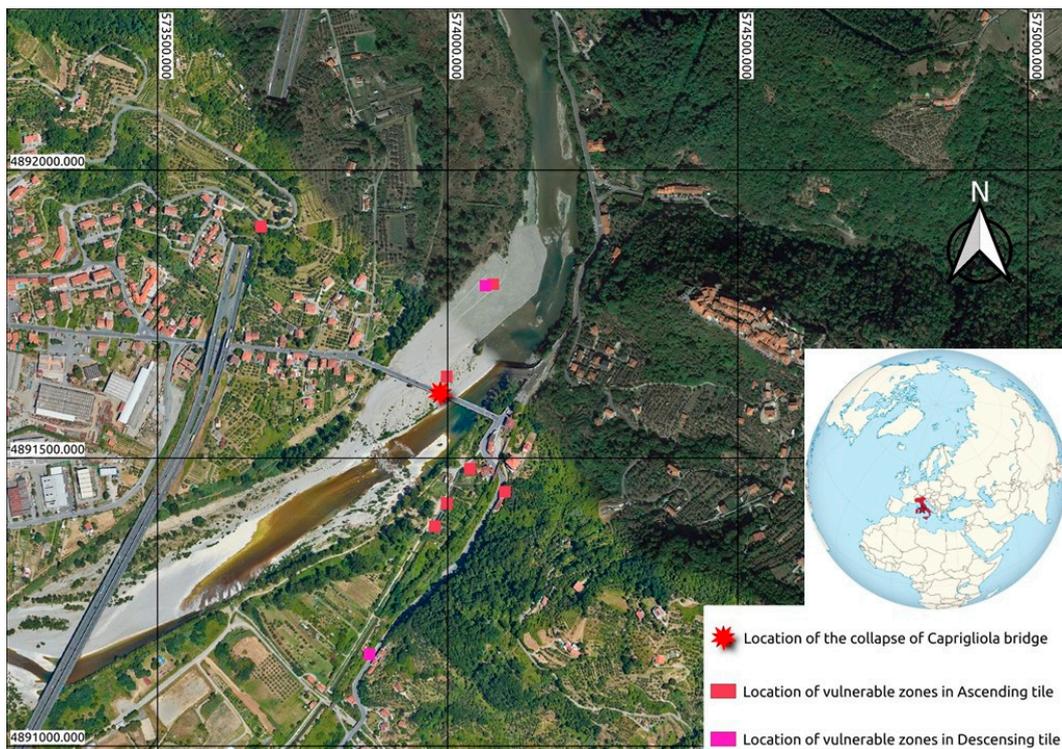
For the second case study, which is focused on the Caprigliola bridge, the variance of the FET map from 2016 to 2019 is obtained for both ascending and descending images. The analysis of the 1×1 km tile around the collapse location shows three vulnerable zones for the map with ascending images and two vulnerable zones for the map with descending images, as shown in Figure 11. In this case, only one of the areas is in close proximity to the collapsed bridge, showing the capability of the methodology to identify vulnerable zones, albeit only using ascending images.

Figure 11. The vulnerable zone geographically concurs with the streambed of the Caprioliola bridge, which collapsed.

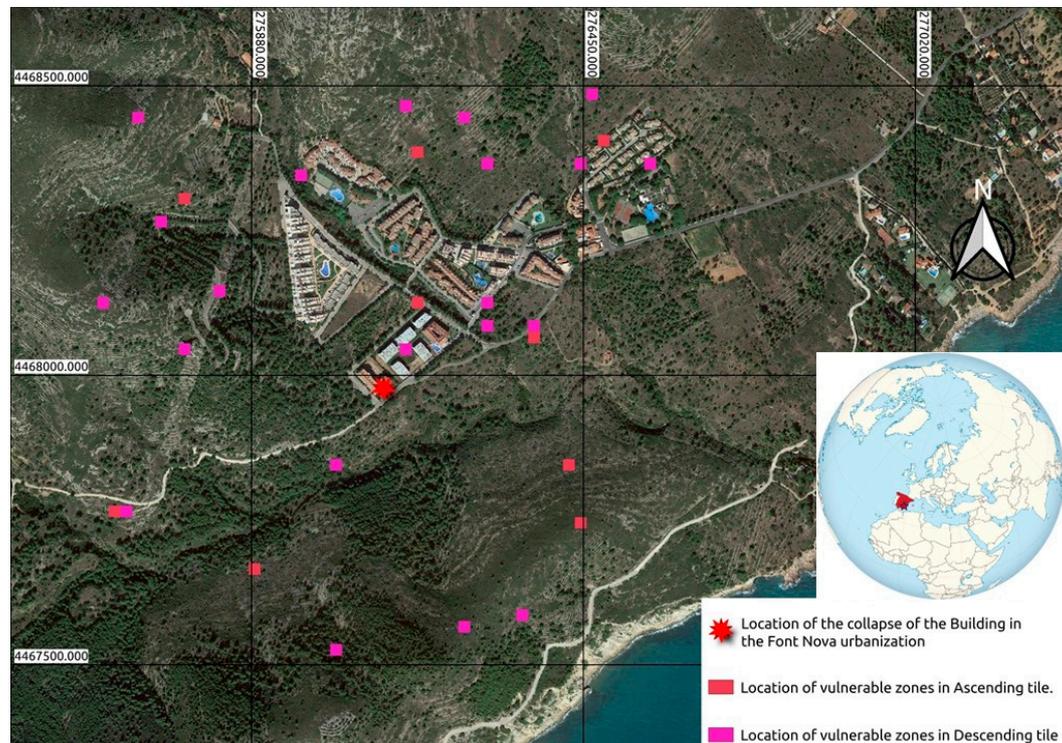
For the third case study, due to a time gap in the available images, only the images from the same time intervals in both ascending and descending images were used, which limited the analysis to the years 2015–2016 and 2019–2021. The variance in the tile was logarithmically transformed and filtered using the criterion of $\Pr(X \leq \mu + 2\sigma)$, resulting in the identification of seven vulnerable zones in the ascending image map and eleven vulnerable zones in the descending image map, as shown in Figure 12.

Figure 12. The vulnerable zone is geographically situated in the environment of the building, which collapsed, of the Font Nova urbanization.

In this case, only one of the identified areas is located close to the building where the collapse occurred. Despite the distance of approximately 65 m between the detected area and the building, it is still considered to belong to the building's environment based

on the resolution of Sentinel-1. Although there are more potential risk areas in this case study compared to the others, only five of them are located in built environments, with the others being false alarms caused by vegetation. The results were achieved only in the descending images.

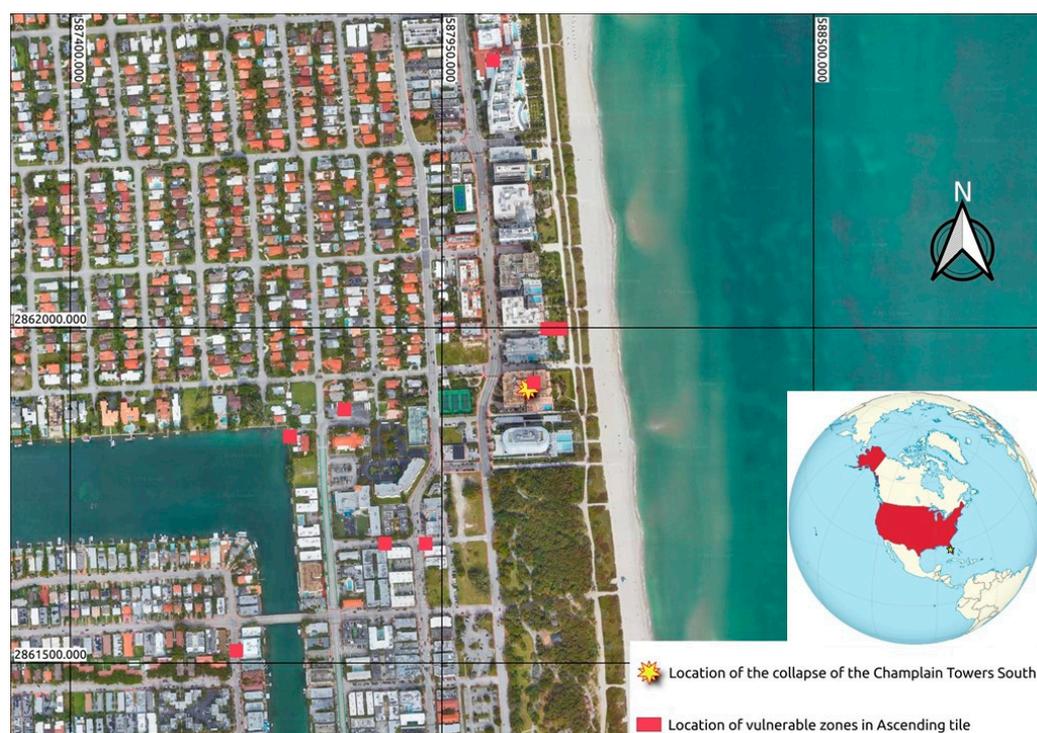
In the final case study, which focuses on the collapse of Champlain Towers South, the variance of the FET map is obtained for the years 2017 to 2021, using only ascending images since they are the only images available for download. The results show six vulnerable zones in the map with ascending images, as shown in Figure 13. Of the six areas identified, only one coincides geographically with the collapse of the building, providing evidence that the methodology is effective in detecting vulnerable areas.

Figure 13. The vulnerable zone geographically concurs with the Champlain Towers South building, which partially collapsed.

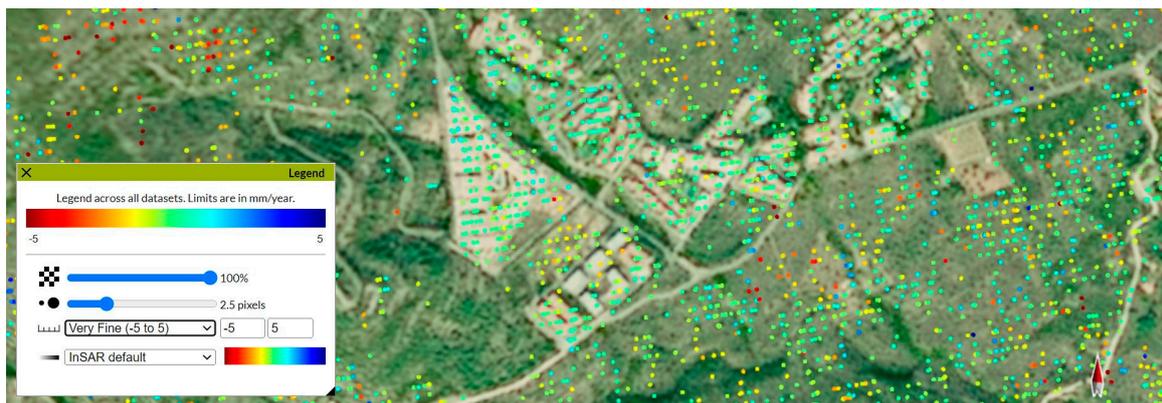
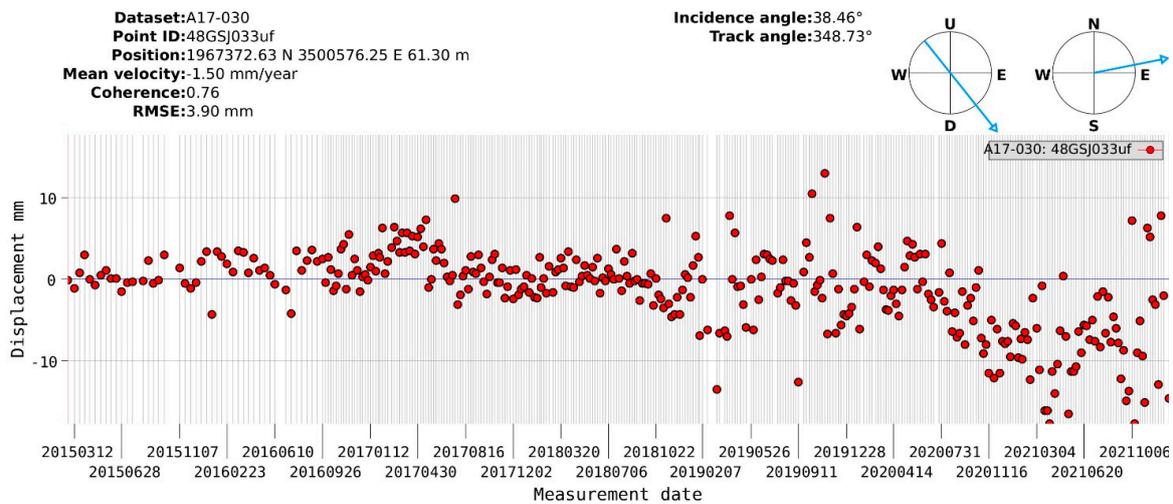
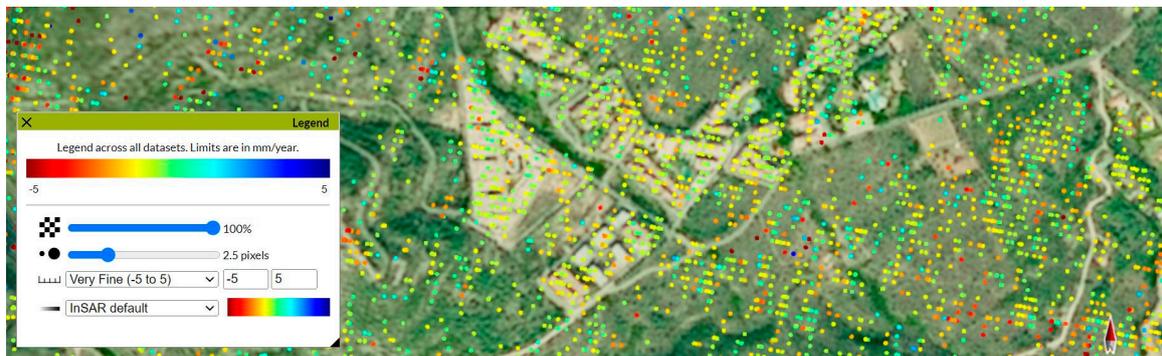
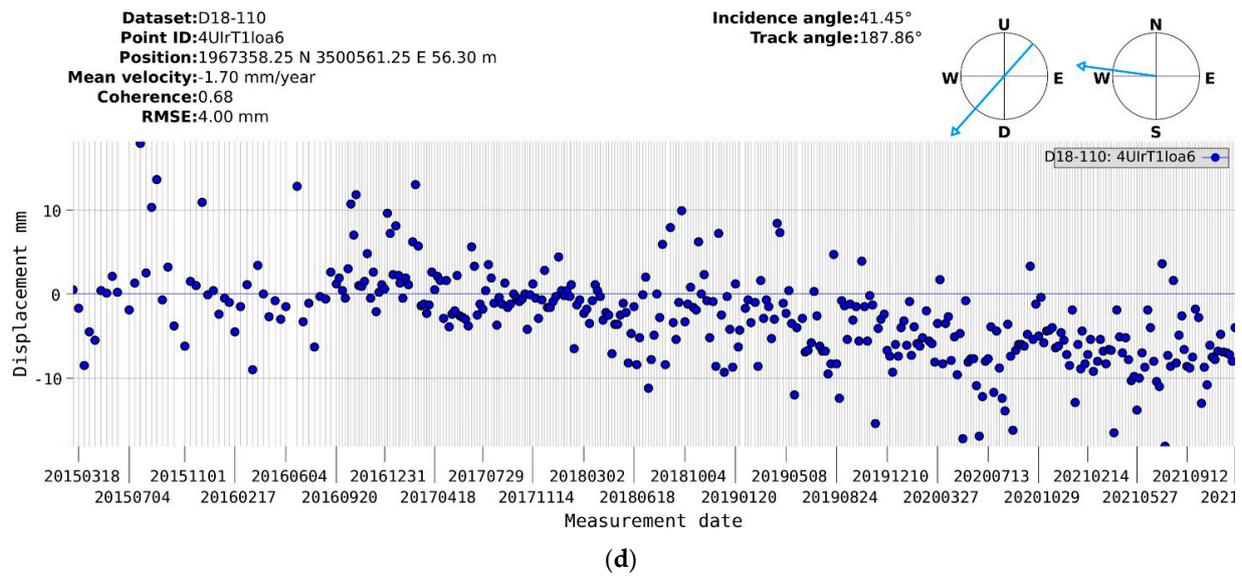
We use the European Ground Motion Service (EGMS), which provides accurate and consistent information on natural and anthropogenic ground motion with millimeter precision [38], to compare our results of vulnerable zones in the European case studies. In the case study of the building in the Font Nova urbanization (Peñíscola), Figure 14 shows the difficulty of the early detection of infrastructure at risk in isolation due to the high variability of ground motion values. If we take the most extreme value, which coincides with the building that collapsed, we can see that it had an average ground motion velocity of -1.5 mm/year in ascending images and -1.7 in descending images; in fact, the trend graph presents an almost stable picture before the collapse on 25 August 2021, which suggests it is practically impossible to anticipate risks.

Figure 14. (a) Ground motion in the ascending track from EGMS [38] in the area of the building collapse in the Font Nova urbanization (Peñíscola). (b) Deformation time series in the ascending track of the point with the highest value of ground motion located in the building collapse. (c) Ground motion in the descending track from EGMS in the area of the Font Nova urbanization. (d) Deformation time series in the descending track of the point with the highest value of ground motion located in the building collapse.

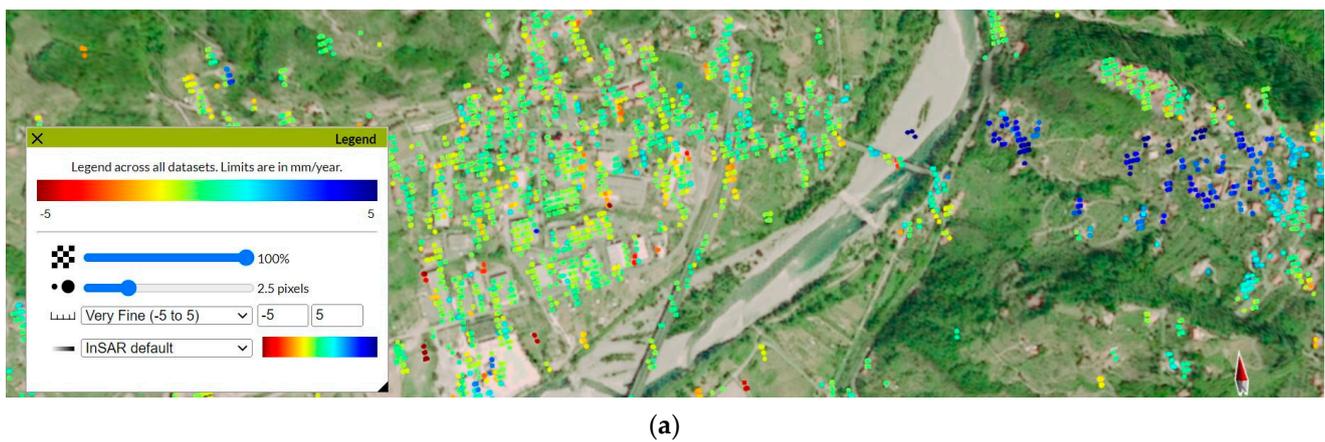
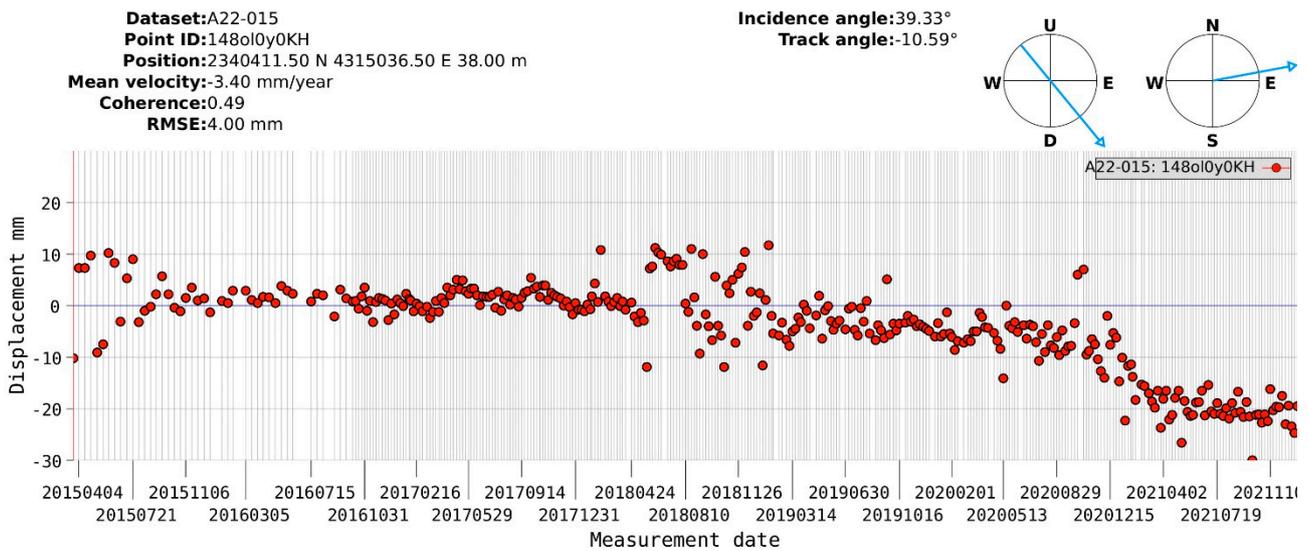
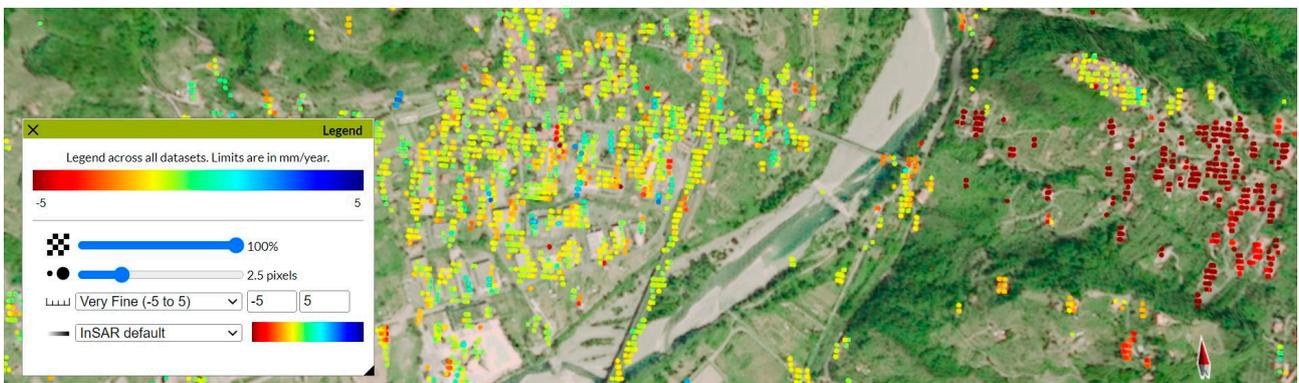
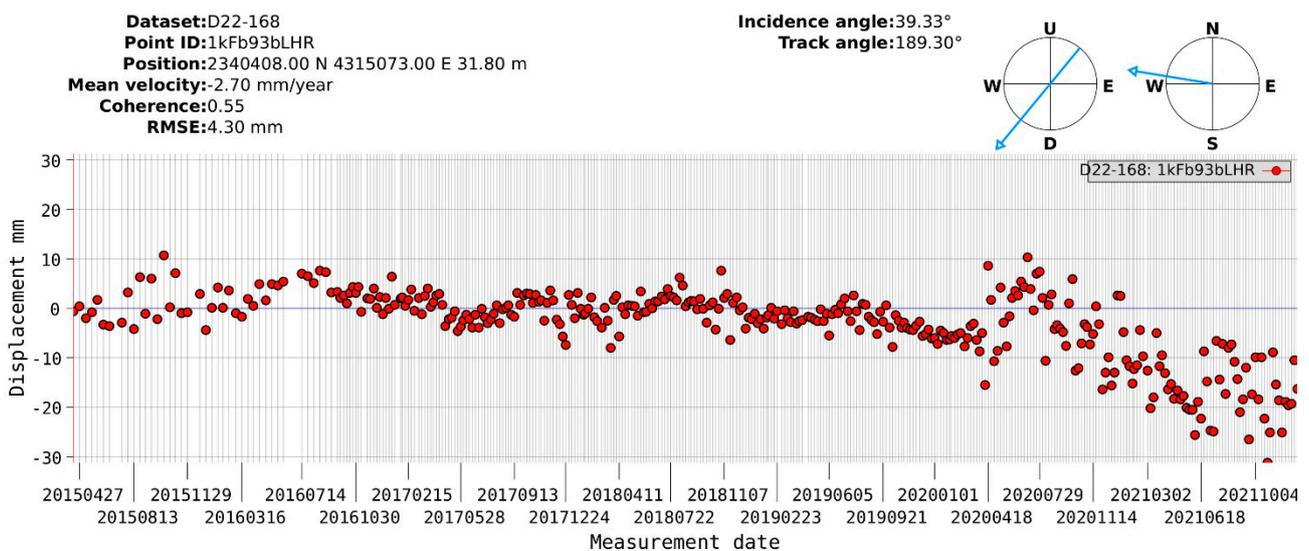
In the case study of the Caprigliola bridge in Figure 15, the average ground motion velocity is -3.4 mm/year in ascending images and -2.7 in descending images. However, the trend graph shows stability before the collapse on 8 April 2020, and the trend graph changed only after the date of collapse, indicating the difficulty of anticipating the risks with this monitoring service.

Figure 15. (a) Ground motion in the ascending track from EGMS [38] in the area of the Capriogliola bridge collapse. (b) Deformation time series in the ascending track of the point with the highest value of ground motion located at the bridge collapse. (c) Ground motion in the descending track from EGMS around the Capriogliola bridge collapse. (d) Deformation time series in the descending track of the point with the highest value of ground motion located at the bridge collapse.
