Article

# RC Columns Strengthened with Novel CFRP Systems: An Experimental Study

**Abstract:** This paper presents an experimental study undertaken to investigate the seismic behavior of full scale square (300 mm × 300 mm) reinforced concrete (RC) columns strengthened with novel systems employing carbon fiber-reinforced polymers (CFRP) wraps. Experimental tests were carried out by subjecting specimens to a constant axial load and a cyclically reversed horizontal force applied in displacement control. Results have allowed for investigating the influence of the used strengthening systems on the specimens' performance in terms of flexural strength and ductility as well as on the exhibited failure modes. The effectiveness of the studied techniques is also evaluated by comparing the performance of tested specimens with that of companion columns strengthened with alternative CFRP systems investigated in a previous experimental campaign.

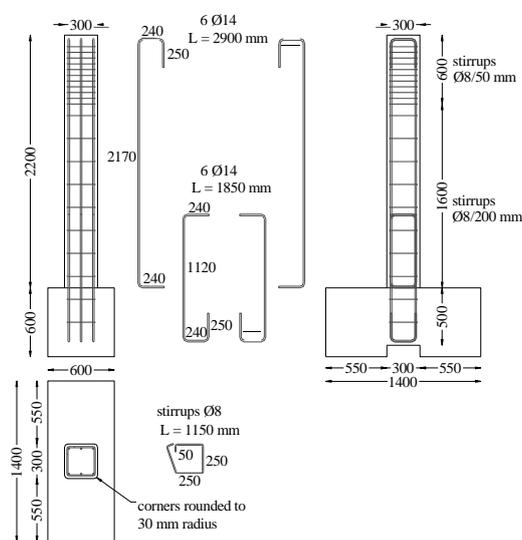
In addition, the steel reinforcement details were arranged without any particular care for seismic considerations. Figure 1 illustrates the configurations of the longitudinal and transverse deformed steel reinforcement adopted for the specimens which are the same already considered in the previous experimental campaign [12]. As shown, the longitudinal reinforcement, made of steel grade “B450C” [14], consisted of six 14 mm diameter rebars having a lap splice length at the column-base joint equal to about 40 bar diameters ( $\approx 600$  mm), as frequently used in Italy; a clear concrete cover of 27 mm was considered at the both sides of the cross section. Tensile tests were performed on small samples to characterize the yield ( $f_{sy}$ ) and the ultimate strength ( $f_{su}$ ) of the steel longitudinal rebars and the corresponding strains ( $\epsilon_{sy}$  and  $\epsilon_{su}$ ); from these tests the following average values were found:  $f_{sy} = 490$  MPa and  $\epsilon_{sy} = 0.23\%$ ;  $f_{su} = 619$  MPa and  $\epsilon_{su} = 11.78\%$ .

The transverse reinforcement, made of the same steel grade as for longitudinal rebars, consisted of 8 mm diameter steel stirrups; 200 mm spaced and closed with 90° hooks at both ends.

Figure 1. Details of RC specimens.

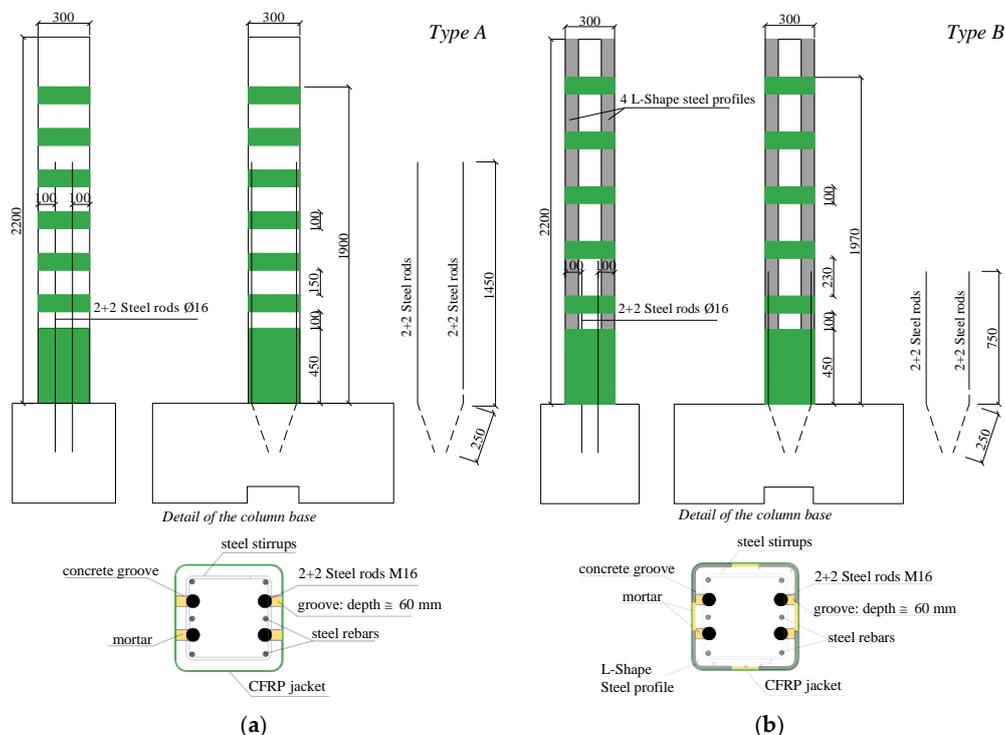
Figure 2 shows the two strengthening layouts investigated in the experimental campaign which were designed in collaboration with Italian company “Interbau Srl” [15].

The system “type A” (Figure 2a) entailed the use of four (2 + 2) M16 threaded steel rods (tensile strength  $\approx 635$  MPa), which were placed with mortar inside grooves cut into the concrete. These rods integrating the pre-existing longitudinal steel reinforcement (3 + 3 $\phi$ 14), crossed the column for a height of about 1450 mm and were anchored with epoxy resin into the concrete foundation for a length of about 250 mm. Then, the column strengthening was completed by a passive confinement obtained with unidirectional CFRP layers. In particular, starting from the column base, the first portion of the member (of about 450–500 mm) was continuously wrapped by using one or two CFRP plies, while the remaining part was strengthened employing a single layer of 150 mm spaced strips, each having a width of 100 mm; the overlap length between layers in the transverse direction was about 300 mm. It is highlighted that the layout of the CFRP confinement was the same already used in the previous experimental campaign [12], and the length of the region with continuous wrapping was based on previous theoretical estimates performed on the development of the plastic hinge zone. In addition, the choice of using two CFRP plies for the continuous wrapping was always based on considerations drawn by experimental tests previously performed by the authors; indeed,

Figure 2. Strengthening layouts: “type A” (a); “type B” (b).

The system “type B” (Figure 2b), instead, also entailed the use of longitudinal cold bent steel profiles along the member corners before applying the external wrapping made of two CFRP layers; they were four 80 mm  $\times$  80 mm  $\times$  6 mm equal leg angles made of structural steel S235. The angles were glued to the concrete substrate by an epoxy adhesive and were properly manufactured in order to have a rounded corner with a radius of about 30 mm. After placing the angles and before manufacturing the FRP jacket, a 6 mm layer of epoxy mortar was applied on each column side, in order to fill the gap between the profiles (see the detail in Figure 2b).

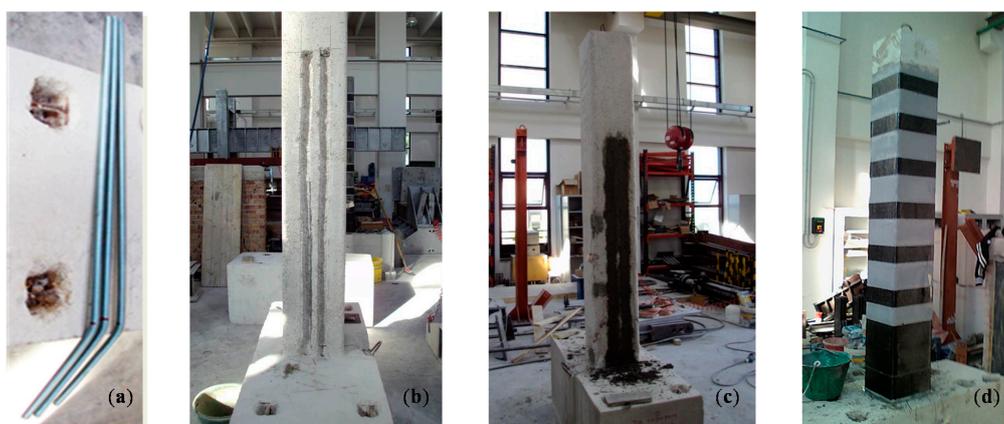
Figures 3 and 4 show some details about the strengthening procedures used for the considered layouts “type A” and “type B”, respectively. In particular, Figure 3a illustrates the shape of the threaded rods used for internally reinforcing the RC columns, pre-bent at one end in order to be inserted into the concrete foundation; Figure 3b,c show the status of the column after: (a) cutting the

outer portion of the concrete surface; and (b) filling the grooves and covering the threaded rod with mortar. Finally, Figure 3d depicts the column at the end of the strengthening procedure "type A".

Figure 3. Strengthening procedure: layout "type A".

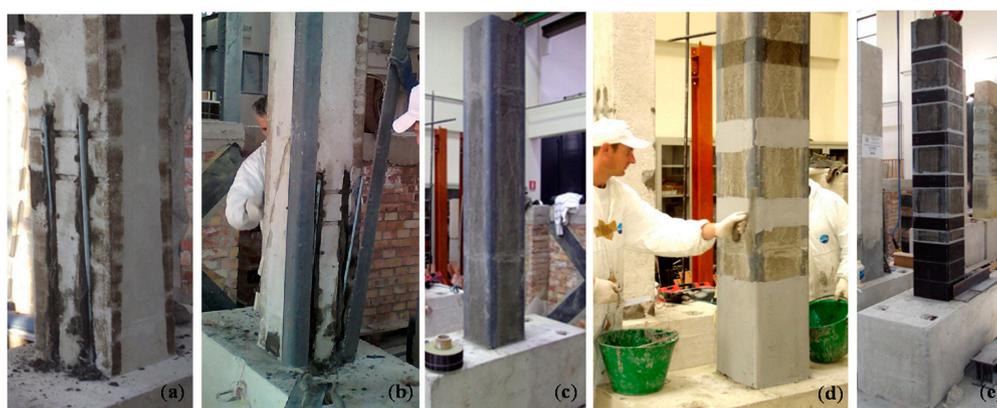
Figure 4. Strengthening procedure: layout "type B".

Regarding the strengthening procedure "type B", Figure 4a,b illustrate the placing of the steel rods inside the concrete grooves, the filling with mortar and the arrangement of the steel angles at the columns corners; Figure 4c,d show, respectively, the subsequent operations dealing with the application of a 6 mm mortar layer on the column and the CFRP external confinement. Finally, Figure 4e depicts the column at the completion of the strengthening procedure "type B".

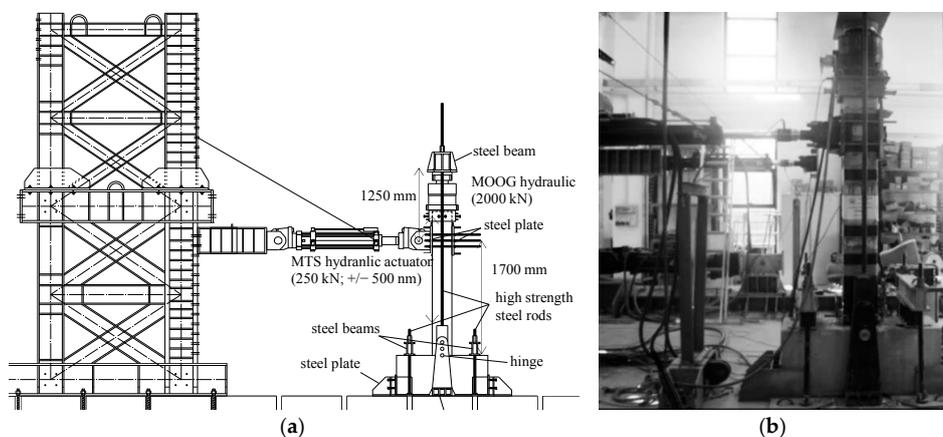
The test set-up, as shown in Figure 5, is very similar to that already used in the previous experimental campaigns; therefore, specific details, omitted for the sake of brevity, can be found in [12].

Tests were carried out by subjecting the specimens to combined axial and lateral loads. The specimens were restrained to the lab's floor by means of a steel system which consisted of: (a) two transverse beams placed on the RC foundation and fixed to the floor by means of four high strength thread rods that were properly pre-tensioned in order to avoid any stub rotation; and (b) two stiff steel plates fixed onto the ground and placed orthogonally to the load direction at the bottom of the stub in order to prevent any horizontal movement.

The axial load ( $N$ ) was applied before the horizontal one by pre-tensioning a pair of 40 mm diameter high strength steel rods with a 2000 kN MOOG hydraulic actuator: this actuator, placed

Figure 5. Test set-up.

The horizontal action, instead, was cyclically applied in displacement control by using a 250 kN MTS hydraulic actuator, mounted at 1700 mm from the column base and fixed to a reaction steel frame. An increment of the imposed horizontal displacement every three cycles was considered in order to evaluate the strength and stiffness degradation at repeated lateral load reversals. In particular, after initial cycles performed at 1, 2, 4, and 6 mm, the displacement amplitude was given as fraction of the estimated top yield displacement of the column,  $\Delta_y$  ( $\approx 20$  mm for columns tested under  $\nu = 0.40$  and  $\approx 17$  mm for the column tested under  $\nu = 0.14$ ). Two different displacement rates were considered during the tests: 0.1 mm/s before the achievement of  $\Delta_y$  and 1 mm/s after  $\Delta_y$ .

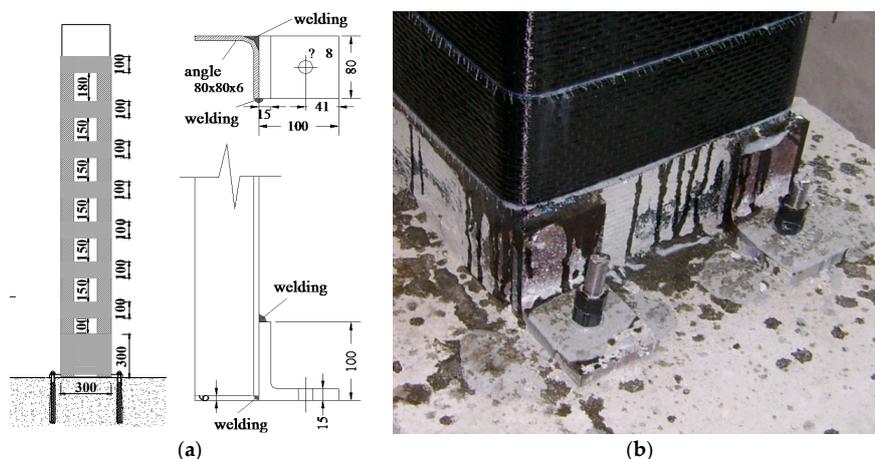
With the aim to better compare the effectiveness of the considered strengthening techniques, Table 1 also reports data and results of three tests performed in the previous experimental campaign, namely C9-D, C15-D-A1 and C24-D-A1 [12], for which the maximum displacements reported herein were computed at 85% conventional collapse (not available for the test C9-D). These specimens had the same geometry and steel reinforcement configurations of those used for the new test members. Except for the specimen C9-D, that was unstrengthened and used herein as control specimen for the only test performed under  $\nu = 0.14$  (i.e., test C5N-B), the other members were strengthened using a system “type A1” (see Figure 6a,b). As mentioned earlier, such a system is characterized by the combined use of CFRP confinement and steel profiles placed at the column’s corners and connected to the foundation by using an L-shape steel system. The layout of FRP confinement and the arrangement of steel profiles are the same of those in Figure 2b, whereas details on the anchorage system of such profiles, illustrated in Figure 6b, can be found in [12].

Figure 6. Strengthening systems “type A1” (a); details of steel profile’s anchorage system (b).

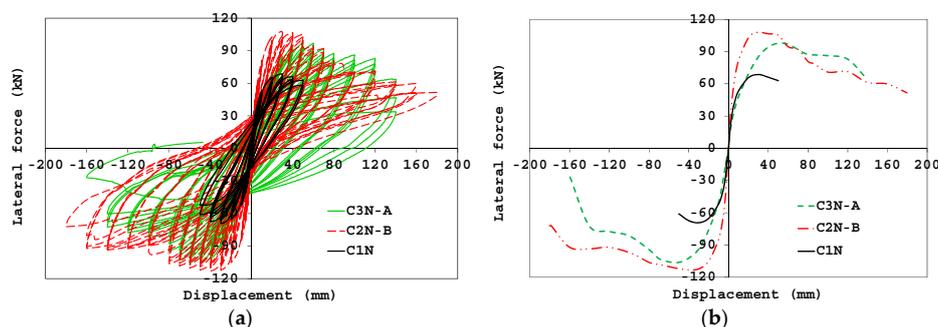
Figures 7 and 8 show the lateral force ( $F$ )–displacement ( $\Delta$ ) hysteretic curves and the corresponding  $F$ – $\Delta$  envelopes for some tested specimens. In particular, in Figure 7a the cyclic response of the control specimen (C1N) is compared with the performance of two members strengthened with the FRP systems “type B” and “type A” (samples C2N-B and C3N-A, respectively).

Figure 7.  $F$ – $\Delta$  hysteresis curves (a) and envelopes (b): columns C1N, C2N-B and C3N-A.

As expected, the reference column experienced a rapid degrading behavior in the post-peak phase and achieved the collapse under low values of the imposed displacement. Disregarding the type of strengthening system, the specimens C2N-B and C3N-A have exhibited significant increases of strength over the control specimen (about 60% and 48%, respectively). The improvement of the column’s confinement through the use of steel profiles avoided the rupture of the FRP wrapping and delayed the crushing of concrete; indeed, after achieving the conventional collapse, the sample C2N-B showed a less degrading behavior with respect to the sample C3N-A and was capable of still undergoing significant lateral displacements. It is highlighted that the failure of two additional steel rods (on the same column’s side), due to a slight slippage combined to a fatigue phenomenon, was observed for the specimen C2N-B at imposed displacements of 90 and 120 mm (corresponding to lateral loads in the post-peak phase equal to about 78 and 70 kN, respectively).

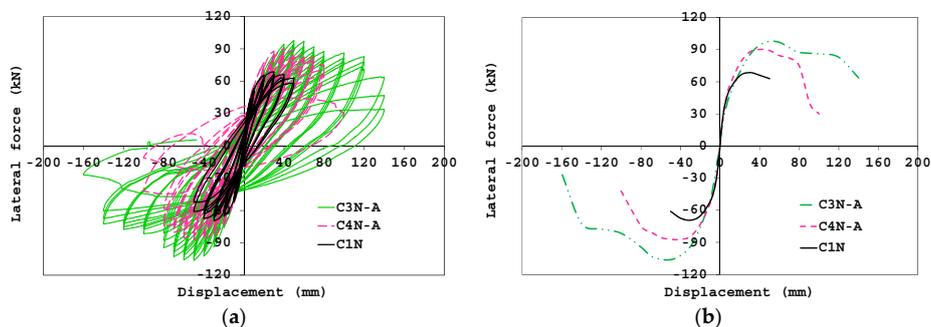
Figure 8.  $F$ – $\Delta$  hysteresis curves (a) and envelopes (b): columns C1N, C3N-A and C4N-A.

Figure 8a,b shows the dependence of the cyclic response on the number of FRP layers employed for the continuous wrapping at column base; the  $F$ – $\Delta$  comparisons clearly highlight the beneficial role of using a double layer of CFRP layers in improving the deformation capacity of specimens.

In particular, it is observed that the lateral displacement exhibited by the specimen C3N-A at the conventional collapse is about 30% over that measured for the counterpart confined with a single FRP layer; an increase of flexural strength equal to about 15% is also computed.

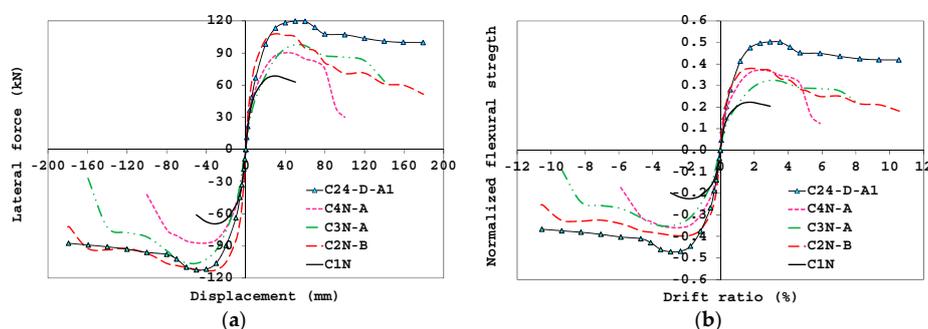
Figure 9a shows the  $F-\Delta$  monotonic envelopes of test specimens subjected to  $\nu = 0.40$  which are also compared with the curve of the column C24-D-A1 [12]. Furthermore, in order to by-pass the dependence of the response on the concrete strength value, in Figure 9b the experimental results have been represented in terms of normalized flexural strength–drift ratio ( $\mu-\delta$ ) curves.  $\mu$  and  $\delta$  are given by:

Figure 9.  $F-\Delta$  envelopes (a) and  $\mu-\delta$  envelopes (b) under  $\nu = 0.40$ .

From the experimental  $F-\Delta$  comparisons it is noted that the strengthening system “type A1” provides increases of flexural strength and ductility slightly greater than those obtained through the layout “type B”; conversely, as mentioned earlier, this beneficial effect is offset by the need of time consuming and labor-intensive operations to provide a proper installation of the anchor system of steel profiles; on site, such installation is even more difficult when the anchoring of column’s steel profiles is made into a beam member rather than a concrete foundation. In addition, the strength increase progressively reduces with the occurrence of the slipping of the steel connector linking the profile’s anchor system to the concrete foundation, as shown in Figure 10 [12]; therefore, the performance provided by the use of a system “type A1” strongly depends on the proper design of the steel profile’s anchoring to the concrete beam/foundation.

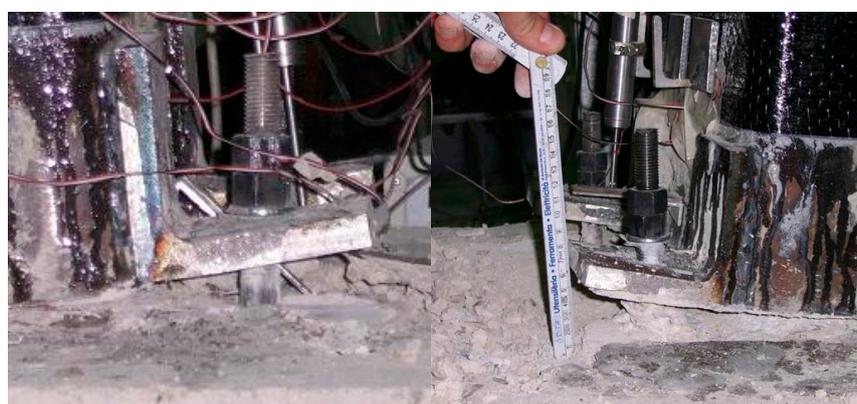
Figure 10. Pull-out of the steel connector from the concrete foundation.

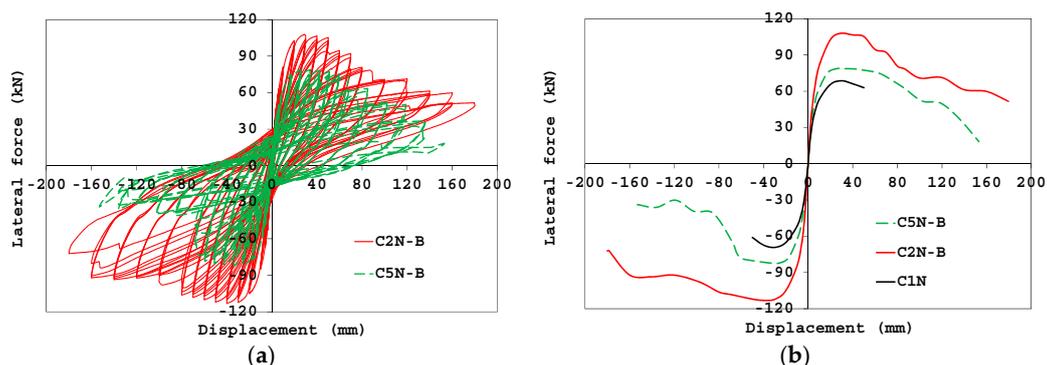
Figure 11 allows for investigating the influence of the axial load level  $\nu$  on the experimental response of specimens strengthened with the system “type B”. For this purpose, Figure 11a shows the comparison between the  $F-\Delta$  cyclic curve of column C2N-B and that of the specimen C5N-B, subjected to  $\nu$  equal to 0.40 and 0.14, respectively; Figure 11b, instead, depicts the corresponding  $F-\Delta$  envelopes, with the addition of the curve related to the reference specimen C1N, available for  $\nu = 0.40$ .

As expected, the presence of a higher axial load approximately produces a 37% strength increase, thus confirming the beneficial effect of the CFRP confinement for significant values of the acting axial load.

Figure 11.  $F-\Delta$  hysteresis curves (a) and envelopes (b): columns C2N-B ( $\nu = 0.40$ ) and C5N-B ( $\nu = 0.14$ ).

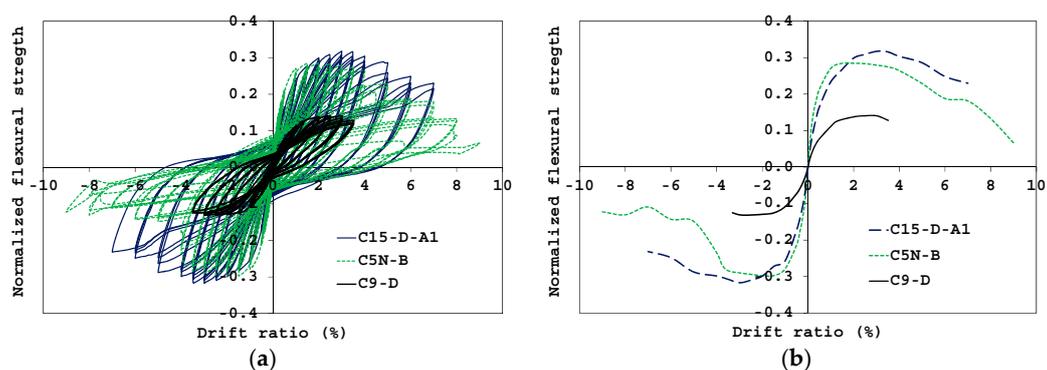
Furthermore, to better examine the performance of the specimen C5N-B subjected to a low value of the axial load, in Figure 12a,b the cyclic response and the corresponding envelope curve are compared with those of the control (unstrengthened) member C9-D and the strengthened column C15-D-A1, tested in the previous experimental campaign [12]. It is worth highlighting that, for a better comparison of the experimental behaviors, both graphs have been represented in normalized terms  $\mu-\delta$ .

Figure 12. Normalized cyclic (a) and envelope (b)  $F-\delta$  curves for specimens subjected to  $\nu = 0.14$ .

The plots allow for verifying the beneficial effects of the studied strengthening technique even in presence of low axial load. On average, the flexural strength of the sample C5N-B is about twice that characterizing the control member and only 10% lower than the strength shown by the counterpart C15-D-A1. However, the specimen C5N-B exhibited an abrupt strength degradation in the post-peak phase caused by the rupture of the additional rods arranged in the column, first of which occurred at a displacement of about 70 mm.

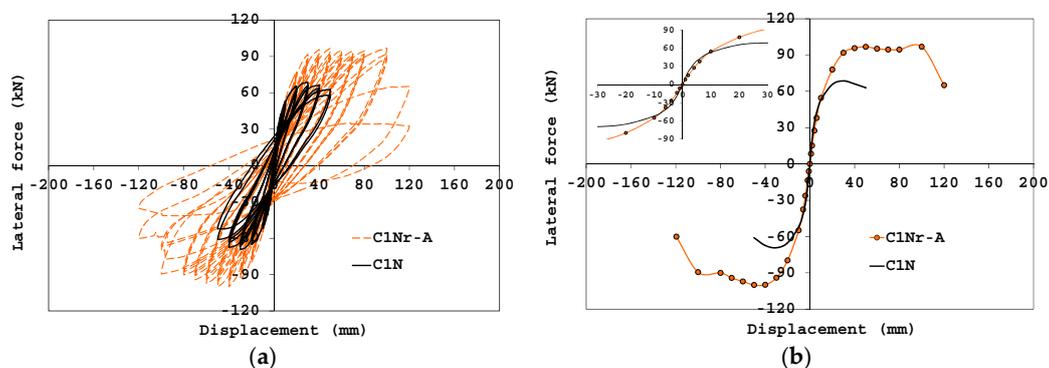
Finally, in Figure 13, the performance of the unstrengthened specimen C1N is compared with that of the repaired one C1Nr-A. The plots allow for verifying the effectiveness of the system “type A”

as a repairing technique of damaged columns; as shown, indeed, the application of this system is not only capable of restoring the performance of the original specimen, but also of improving the experimental response in terms of both flexural strength and deformation capacity. By looking at the plot in Figure 13b, it is observed that, except for the reduced initial stiffness (as shown in the  $F-\Delta$  enlargement), the member C1Nr-A exhibited an increase of strength and ductility over the counterpart C1N of about 43% and 84%, respectively.

Figure 13.  $F-\Delta$  hysteresis curves (a) and envelopes (b): columns C1N and C1Nr-A.

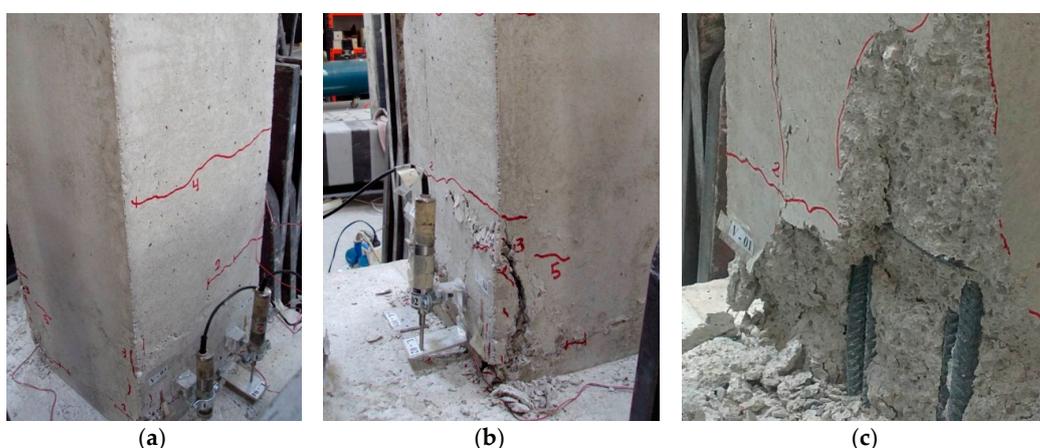
Figures 14–16 show the crack pattern and failure mode exhibited by test specimens. In particular, as already observed in the previous experimental campaign [12], the unstrengthened member C1N experienced cracking phenomena and significant damages concentrated in the first 500 mm from the column base (Figure 14). A flexural crack first developed at the column–foundation interface at a displacement value of 20 mm; the width of this crack did not significantly increase during the test since the specimen rapidly achieved the collapse. Other flexural cracks evenly distributed along the member at a distance of about 200 mm, which approximately corresponds to the stirrups spacing (Figure 14a). Lacking adequate confinement, the specimen was rapidly involved by the development of vertical cracks due to the incipient buckling of steel rebars (Figure 14b). Relevant signs of damage and concrete spalling occurred in the first 200 mm from the column base at an imposed displacement of 40 mm (Figure 14c); the test was stopped soon to avoid severe damage of the member since it had to be repaired and re-tested.

Figure 14. Crack pattern: control specimen C1N.

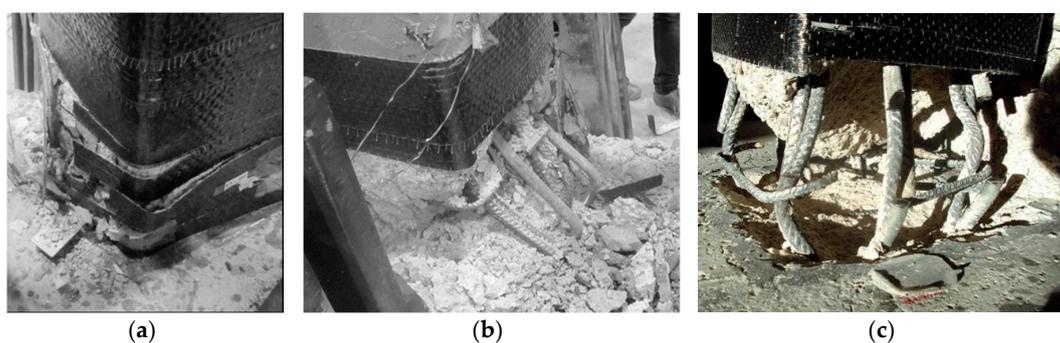
Disregarding the type of strengthening system, the presence of a FRP jacket has contributed to: inhibit the crack opening; delay the buckling of longitudinal rebars. Figure 15a,b illustrate the damage exhibited by strengthened specimens C4N-A, C3N-A and C1Nr-A. As expected, the use of a single FRP layer for the external confinement (test C4N-A) strongly penalized the performance of the column since a first rupture of the sheet prematurely occurred in the first 100 mm from the base (see Figure 15a taken at a displacement of 50 mm). After the FRP system failure, the column rapidly achieved the collapse with the buckling of steel rebars and of the additional rods, stirrups opening and crushing of concrete (Figure 15b). The cyclic behavior of the strengthened specimen significantly improved by doubling the number of FRP layers (test C3N-A); in this case, the FRP rupture occurred in the first 50 mm from the column base only at a displacement value of 120 mm. Figure 15c shows the status of damage at the column base at the end of the test: fracture and buckling of some rebars and rods and stirrups opening were observed.

Figure 15. Damage of specimens strengthened with the system “type A”.

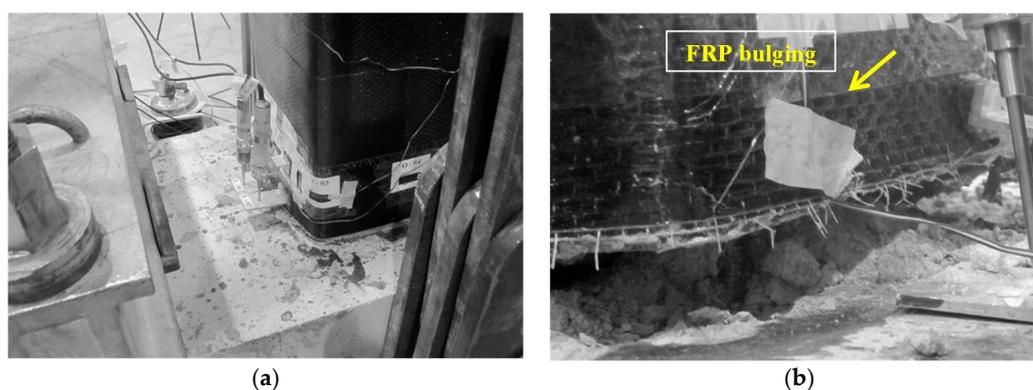
The presence of longitudinal steel profiles (system “type B”) has further inhibited the damage and crack propagation. Independently on the applied axial load  $\nu$  (0.14 or 0.40) the arrangement of steel profiles avoided the FRP rupture at the base even for high values of the imposed displacement, as shown in Figure 16a. Approaching the end of the test, the FRP exhibited only a bulging in the first 50 mm from the base, whereas inside the wrap the concrete column was severely damaged (Figure 16b). Specimens C5N-B and C2N-B have both experienced the rupture of additional steel rods at column–foundation interface.

Figure 16. Damage of specimens strengthened with the system “type B”.

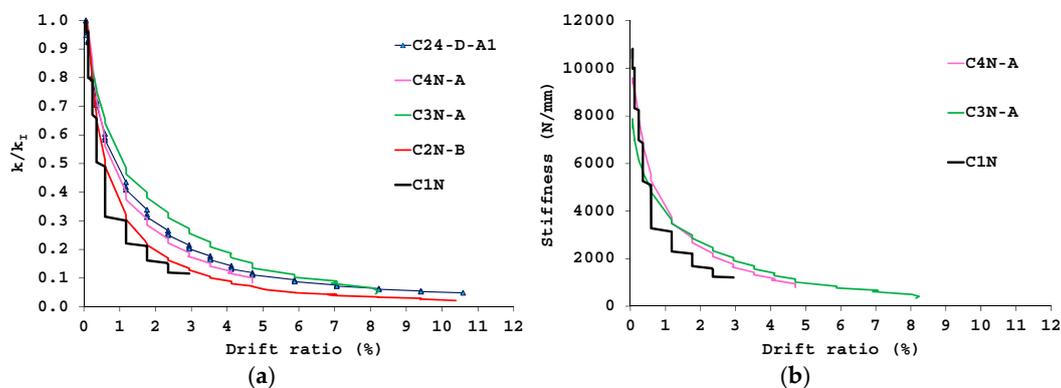
Figure 17a depicts the relationship between the normalized stiffness  $k/k_1$  and the drift ratio for all the specimens subjected to the higher axial load ( $\nu = 0.40$ ). As expected, lacking the external confinement, the unstrengthened column C1N experienced a more rapid strength degradation with respect to the other specimens. Conversely, it seems that the column C3N-A, although not provided with longitudinal steel profiles, exhibited a strength degradation lower than the counterparts C2N-B and C24-D-A1. This result can be motivated by observing Figure 17b showing that the specimen C3N-A was characterized by an initial stiffness already reduced and significantly lower than that of the control specimen C1N; this evidence might have affected the corresponding strength degradation making it lower than the effective one. However, from Figure 17b it can be observed that also the column C4N-A showed an initial stiffness lower than the unstrengthened specimen. For both columns C3N-A and C4N-A, this reduced initial stiffness can be partly motivated in the installation procedure of the system “type A” which, by requiring the cutting of concrete grooves for introducing the additional steel rods, inevitably induces a pre-damage of the specimens; probably, this pre-damage is not relevant in the case of the specimen C2N-B where the presence of steel angles in some way does not affect the initial stiffness.

**Figure 17.** Stiffness degradation (a) and stiffness-drift ratio relationship (b) specimens subjected to  $\nu = 0.40$ .

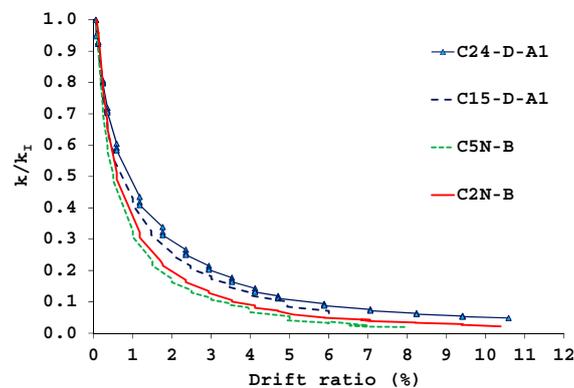
In Figure 18 the stiffness degradation of columns strengthened with the system: “type B” is compared with that exhibited by the counterparts previously strengthened with the alternative system employing steel profiles at the columns corners (*i.e.*, systems “type A1”). As shown, regardless of the axial load level, the specimens C15-D-A1 ( $\nu = 0.14$ ) and C24-D-A1 ( $\nu = 0.40$ ) exhibited a lower stiffness degradation with respect to the corresponding members C5N-B ( $\nu = 0.14$ ) and C2N-B ( $\nu = 0.40$ ); this result implies that the introduction of internal steel rods in addition to steel profiles and CFRP confinement was less effective than the use of a more complex system like the type A1 one.

Figure 18. Stiffness degradation: specimens strengthened with the systems “type B” and “type A1”.

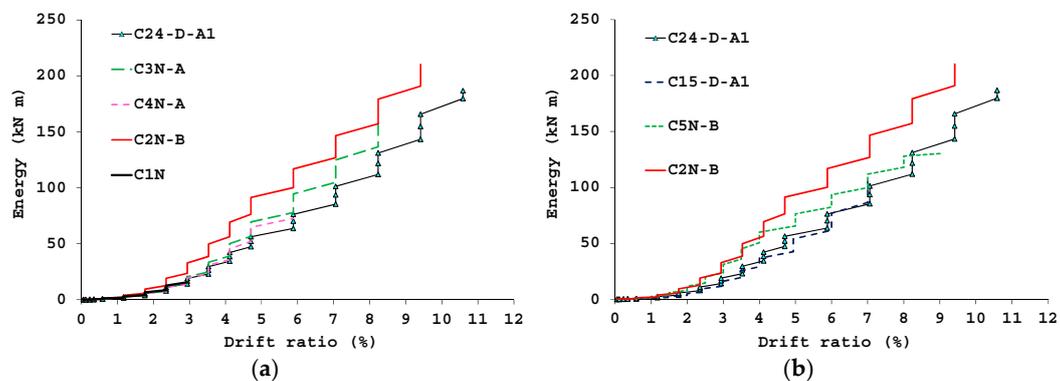
Finally, Figure 19 depicts the relationships between the cumulative dissipated energy ( $E$ ) and the imposed drift ratio. This energy parameter was calculated from the area under the lateral load-displacement response enclosed within one complete cycle up to the achievement of the conventional collapse for each specimen. In particular, the plot in Figure 19a refers to all the

specimens subjected to the higher axial load ( $\nu = 0.40$ ), whereas that in Figure 19b allows for a comparison between systems “type B” and “type A1”.

Figure 19. Energy dissipation: specimens subjected to  $\nu = 0.40$  (a) and comparison between systems “type B” and “type A1” (b).

As already highlighted in [12], from Figure 19a it is observed that the CFRP system produces a significant increase of the cumulative dissipated energy; however, in comparison with the unconfined member C1N, there is no remarkable improvement of the dissipated energy at a given displacement cycle (except for the specimen C2N-B). In the case of the strengthening system “type A”, it is noted that doubling the number of the FRP layers (from one to two) produced only a small increase of the energy performance (compare test C4N-A and C3N-A). Furthermore, disregarding the presence of steel profiles at column corners, the plot in Figure 19a shows that, in terms of dissipated energy, the CFRP strengthening systems “type A” and “type B” are more effective than the previous solution “type A1”, whose width of the hysteresis cycles is strongly affected by the performance of steel profile’s anchoring to the concrete beam/foundation. This experimental evidence is also confirmed by observing the plot in Figure 19b where, regardless of the applied axial load level, the energy dissipated by columns strengthened with the system “type B” is significantly greater than that computed for the counterparts C15-D-A1 and C24-D-A1.

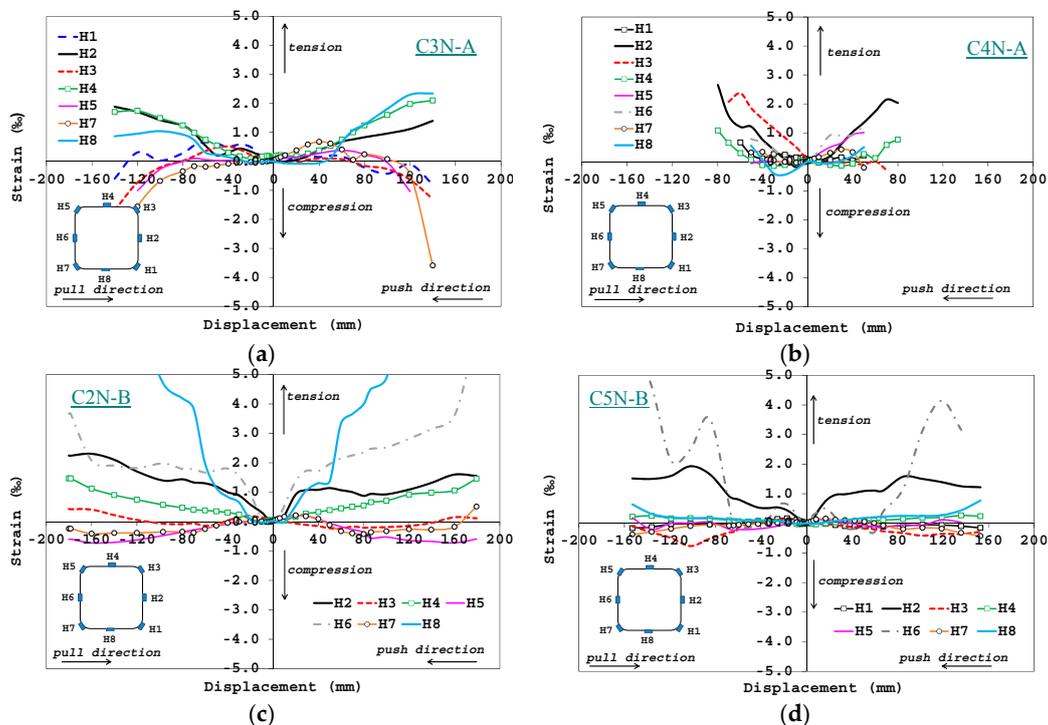
Figure 20 shows for the strengthened members the envelopes of the FRP transverse strains ( $\epsilon_h$ ) plotted under both positive (push) and negative (pull) directions of the imposed displacement  $\Delta$ ; such plots allow for obtaining a qualitative trend of the strains achieved by the FRP jacket. In particular, the strain diagrams refer to the maximum values recorded at the first of the three cycles performed at each level of the imposed displacement, up to the end of the test (when the measures were available); negative and positive values of  $\epsilon_h$  indicate compressive and tensile strains of the FRP jacket, respectively.

Observing the plots in Figure 20, it is highlighted that, disregarding the type of strengthening system, the maximum tensile strains never attained the ultimate FRP strain value indicated by the supplier ( $\epsilon_{f,u} = 8\%$ ); in particular, except for measures provided some strain gauges, the higher strains were below the 2%–2.4‰ threshold (which is only 1/4–1/3 of  $\epsilon_{f,u}$ ).

By comparing the plots in Figure 20a,b it is observed that, at a given level of the imposed displacement, the tensile strains recorded in the case of the test C4N-A were generally higher than those measured by doubling the number of layers for the continuous FRP jacket (test C3N-A), with maximum values recorded by the strain gauge H2.

The FRP strains typically increase in the case of the strengthening system “type B” (see test C2N-B in Figure 20c), where the values recorded by strain gauges H6 and H8 are well over the 2‰ threshold. Conversely, reduced values were, on average, recorded for the specimen C5N-B (Figure 20d) where a reduced efficacy of the FRP jacket is obtained under lower axial load levels ( $\nu = 0.14$ ).

Figure 20. FRP strains: tests C3N-A (a); C4N-A (b); C2N-B (c); and C5N-B (d).

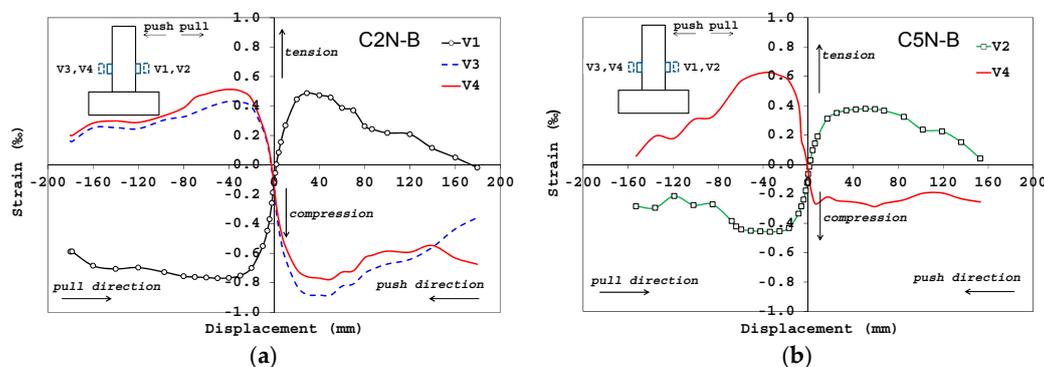
Finally, by focusing on the strengthening system “type B”, Figure 21 shows the envelopes of the longitudinal strains ( $\epsilon_v$ ) recorded by the couples of strain gauges V1, V2 and V3, V4 placed on the L-shape steel profiles (the measures were not always available); negative and positive values of  $\epsilon_v$

indicate compressive and tensile strains in the profiles, respectively. A rather symmetric response of the strains in the push and pull directions is observed from the plots, with maximum values recorded under the higher axial load (test C2N-B in Figure 21a); however, it is highlighted that such strains were always below 0.9‰, thus implying that the use of steel profiles mainly contributes to improving the external confinement of the columns rather than significantly increasing their flexural strength.

Figure 21. Strains on the L-shape steel profiles: tests C2N-B (a) and C5N-B (b).
