# Stability Analysis of Cofferdam with Double-Wall Steel Sheet Piles under Wave Action from Storm Surges

**Abstract:** Double-wall steel sheet piles (DSSPs) are widely used in large-span cofferdams for docks due to their good performance against wave action during storm surges. This paper describes a study of the dynamic behavior of a DSSP cofferdam under wave action through flume tests and a numerical simulation that combined computational fluid dynamics (CFD) and the finite element method. The influences of the water level and wave height on the DSSP cofferdam were investigated experimentally and numerically. Tall waves in shallow water broke upon and impacted the seaside pile with large dynamic wave pressure, dramatically increasing the stress and displacement of the seaside pile. The overlap of the traveling and reflected waves increased the excess pore water pressure near the seaside pile due to taller overlapped waves and higher wave frequency. The DSSP cofferdam failed under the combined actions of the dynamic wave pressure and erosion of the landside seabed. The leakage and overflow of the breaking waves resulted in significant erosion of the landside seabed and greatly we

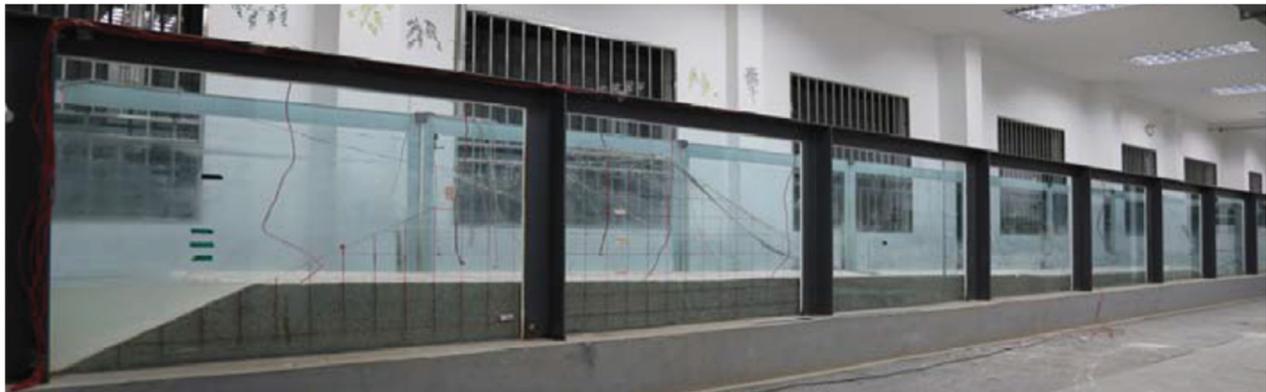
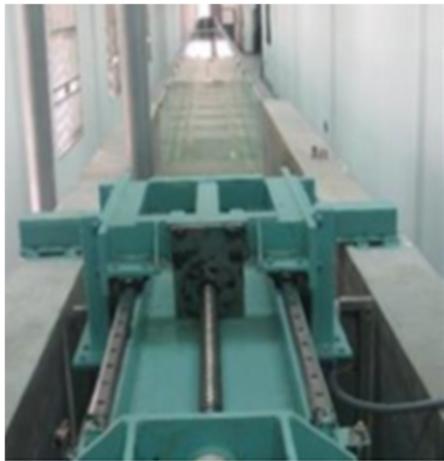
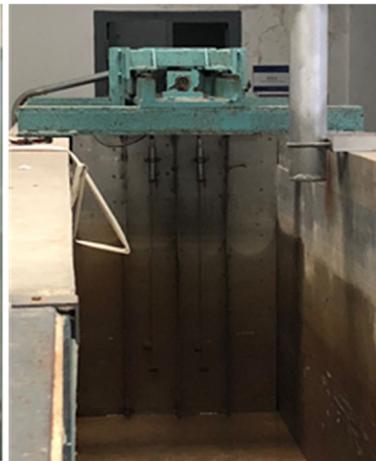
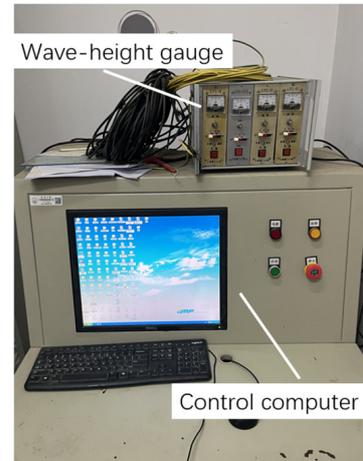
**Figure 1.** Test setup: (a) the test flume; (b) wave-generating machine; (c) wave-generating board; (d) control computer and data collection system.

transparent glass on both sides for making observations. The wave-generating system was located at the head of the wave flume, as shown in Figure 1b. Water waves were generated by pushing the steel board (Figure 1c) back and forth. The wave generator could simulate regular waves, elliptical cosine waves, solitary waves, and superimposed breaking waves. The range for wave heights was 0.02–0.3 m. The generated wave period was in the range of 0.5–5 s. The wave-generating machine, manufactured by Siemens in Munich, Germany, was controlled by a dual-core 2.6 GHz compatible computer (Figure 1d). The wave height was monitored and validated by a wave height sensor and data collection system (Figure 1d). Vertical energy dissipation nets were arranged at both sides of the flume to reduce the reflection effect.

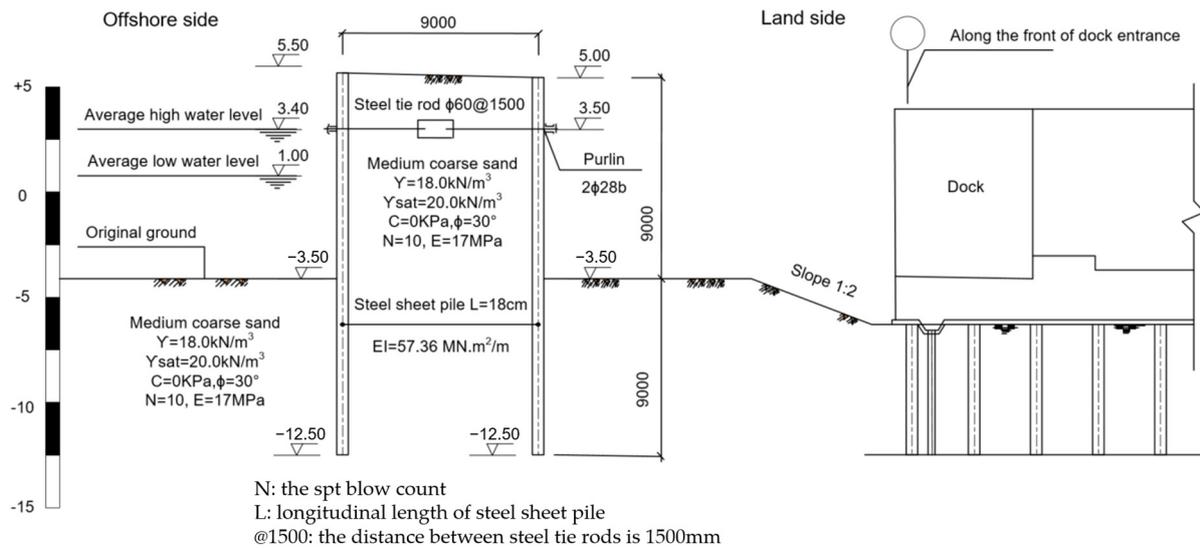
**Figure 2.** The cross-section of the cofferdam at the Changxing dock.

The test was modeled after the cofferdam at the Changxing dock, as shown Figure 2. The cofferdam was built with double rows of steel sheet piles on both sides. The height of the steel sheet pile was 18 m, which was 9 m above the seabed. The two rows of piles were connected with steel tie rods on the top, and the space between the two rows of piles was filled with medium-coarse sand to maintain the entire structure.

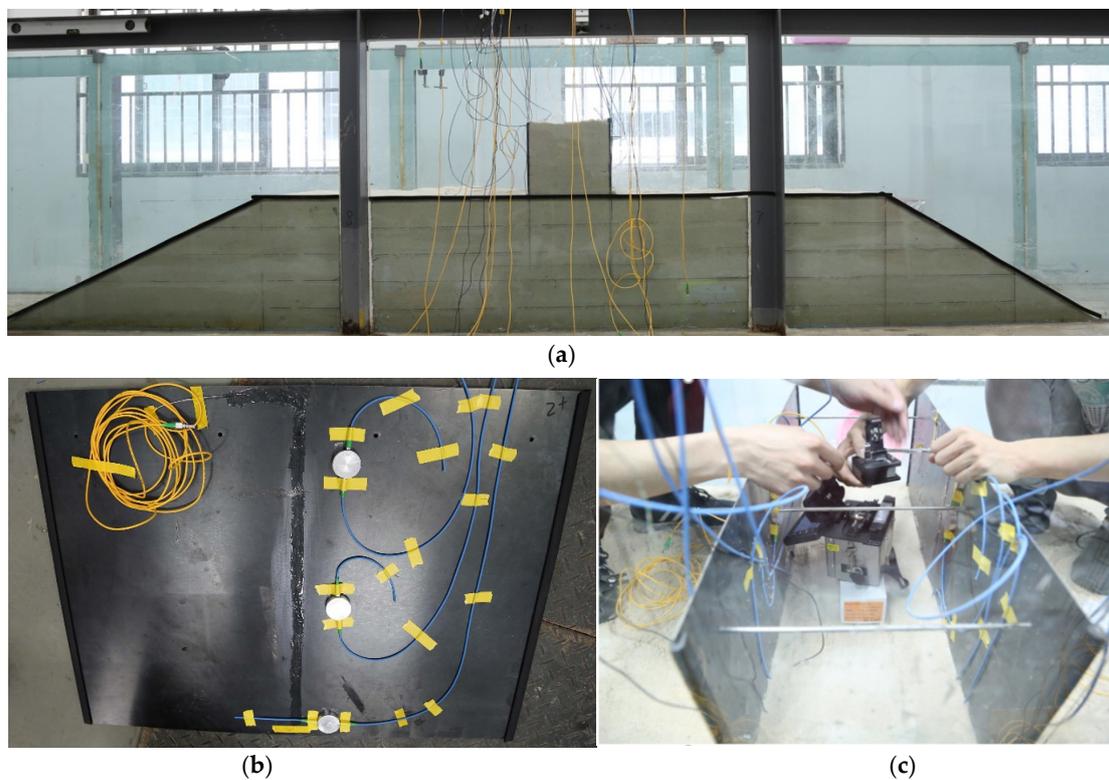
**Figure 3.** The model cofferdam with double-wall steel sheet piles: (a) the cofferdam model; (b) the steel sheet pile with monitoring sensors; (c) two steel sheet piles connected with four tie rods.

The model cofferdam was built with a geometric similarity ratio of 1:30, as shown in Figures 3 and 4. The similarity ratios of time and density were 1:5.48 and 1:1, respectively. The other similarity ratios can be derived accordingly. The seabed was in the shape of a trapezoid with a height of 50 cm, top width of 230 cm, and a bottom width of 403.2 cm. Positioned centrally on this seabed, the model featured two rows of steel sheet piles, each 60 cm high, surpassing the seabed by 30 cm. These rows were bridged by four steel tie rods spaced 22 cm apart, with pile thickness and tie rod diameter set at 1.5 mm and 5.2 mm, aligning with the established similarity ratio. The inter-pile space and seabed utilized 0.35 mm quartz sand as fill material, with sand properties detailed in Table 1.

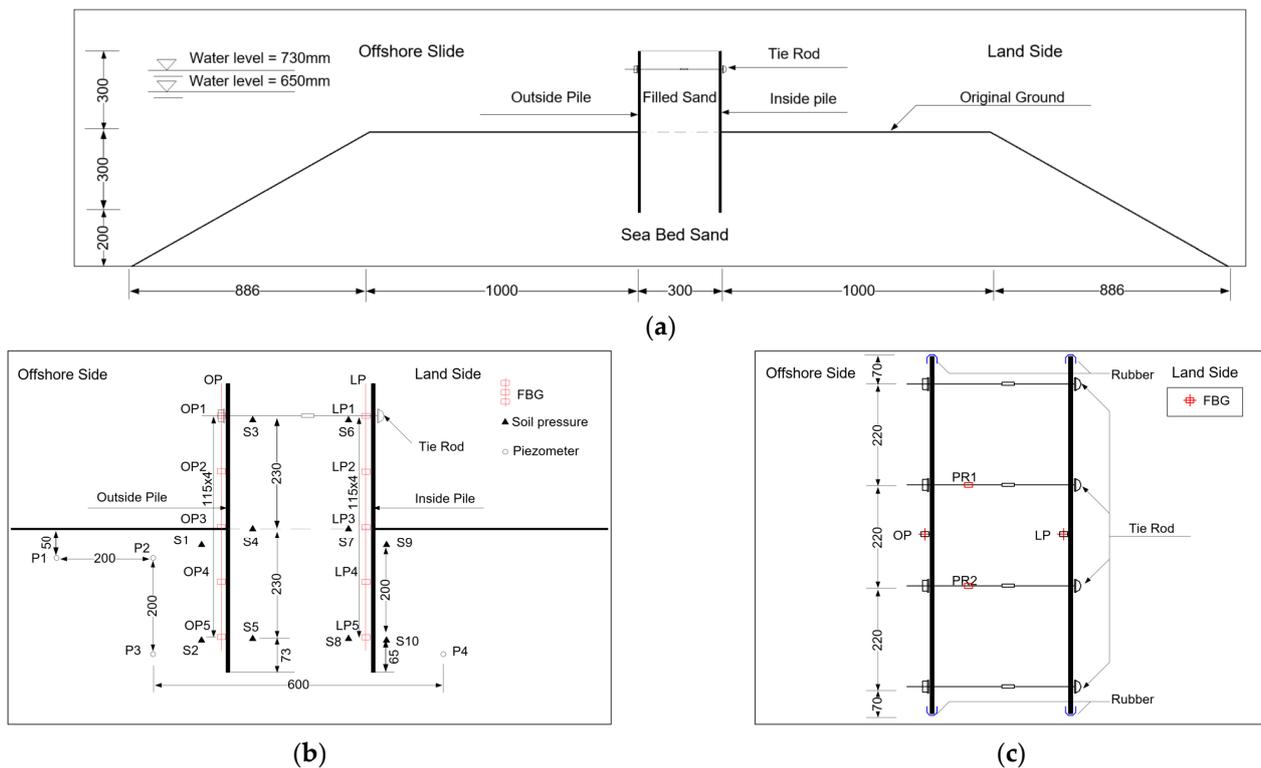
**Figure 4.** Experimental setup and measurement system layout: (a) full side view; (b) side view; (c) top view.

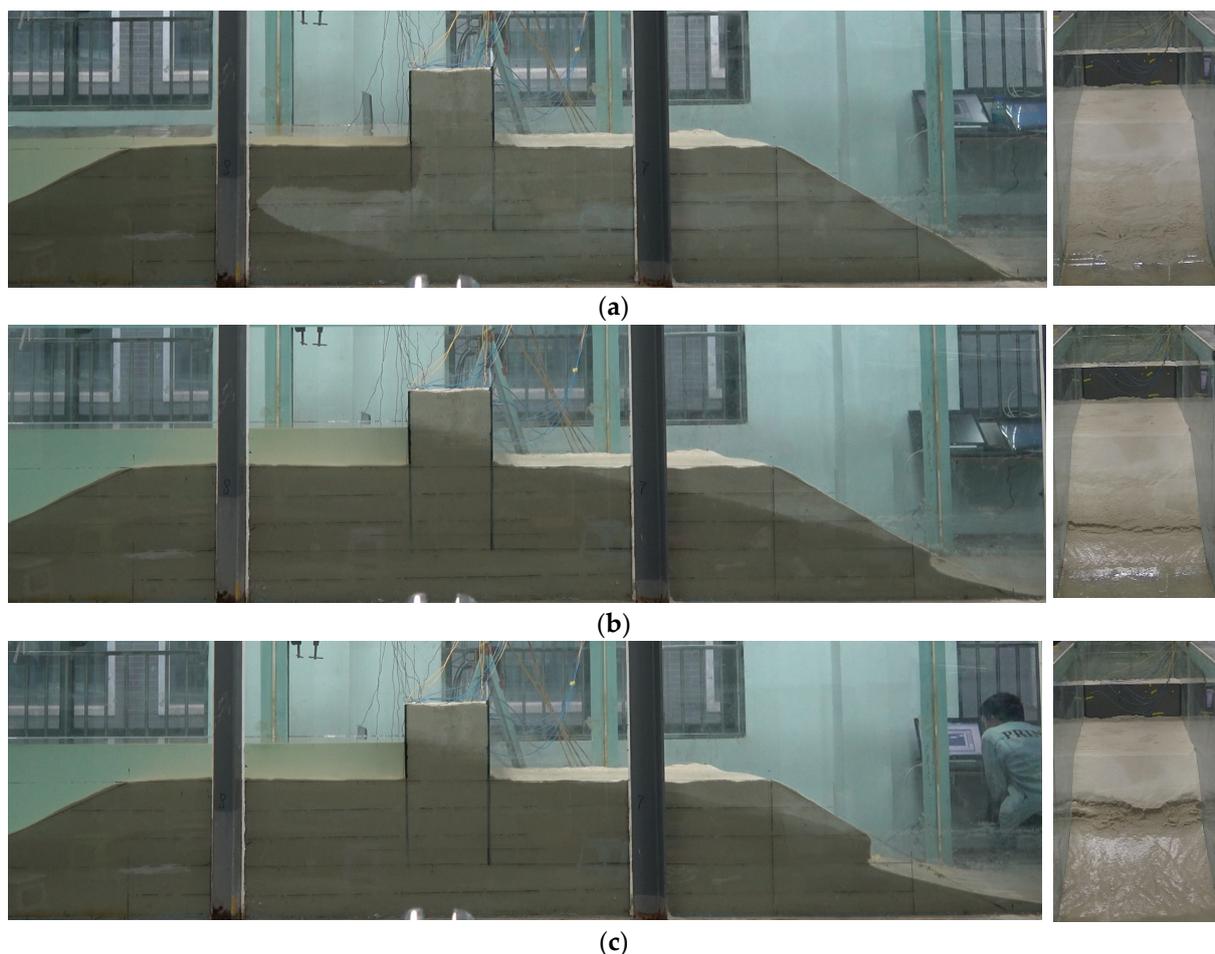
**Figure 6.** Snapshot of the pre-wave stage: (a) at 11’06’’; (b) at 29’04’’; (c) at 43’33’’. Note: the left photos show the side view, and the right photos show the seaward view from the landside.

The moment of starting to add water was set as time 0 s. Water infiltrated the seabed from the upstream slope, and the phreatic line in the seabed rose accordingly. Upon the water level surpassing the seabed’s apex, infiltration ensued atop the seabed, accelerating as it converged with the pre-existing phreatic line originating from the upstream slope, thereby intensifying the rate of seepage (refer to Figure 6 at 11’06’’). The pace of seepage decelerated once the phreatic line ascended to the base of the seaside pile. It took more than 8 min for the phreatic line to arrive at the toe of the landside slope. The phreatic line rose steadily, and water seeped out of the downstream slope.

18'04" in Figure 5), making the downstream slope gentler. Combined with the deposition at the adjacent downstream area of the slope toe, a new stable downstream slope with an angle of 15° formed (see 43'33" in Figure 6), which was much smaller than the original slope angle of 30°. The loss of soil was mainly caused by three factors: the weakening of the shear strength due to saturation, seepage force, and gravitational force.

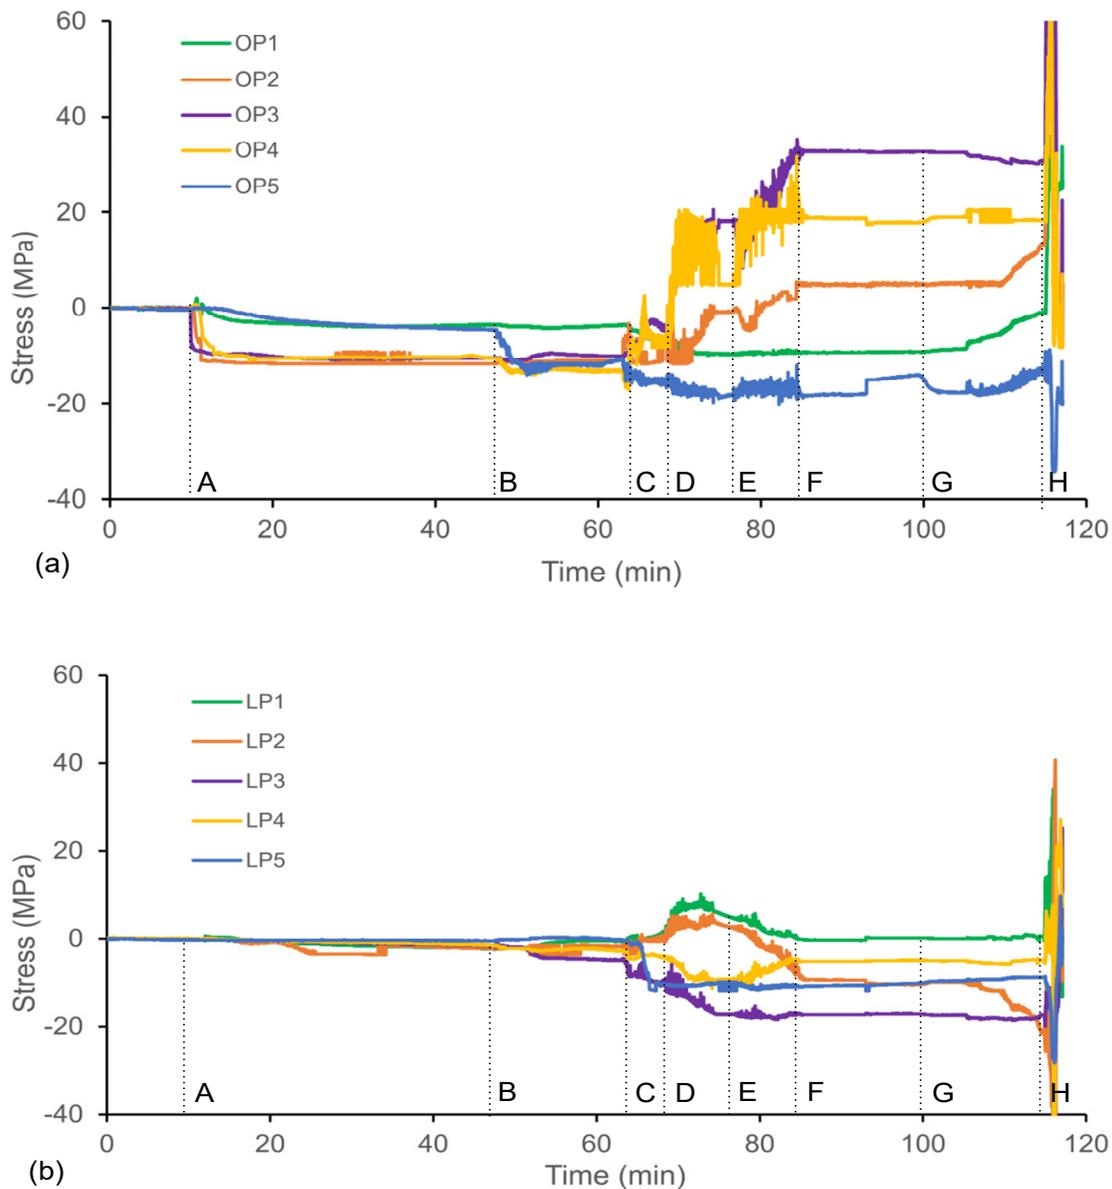
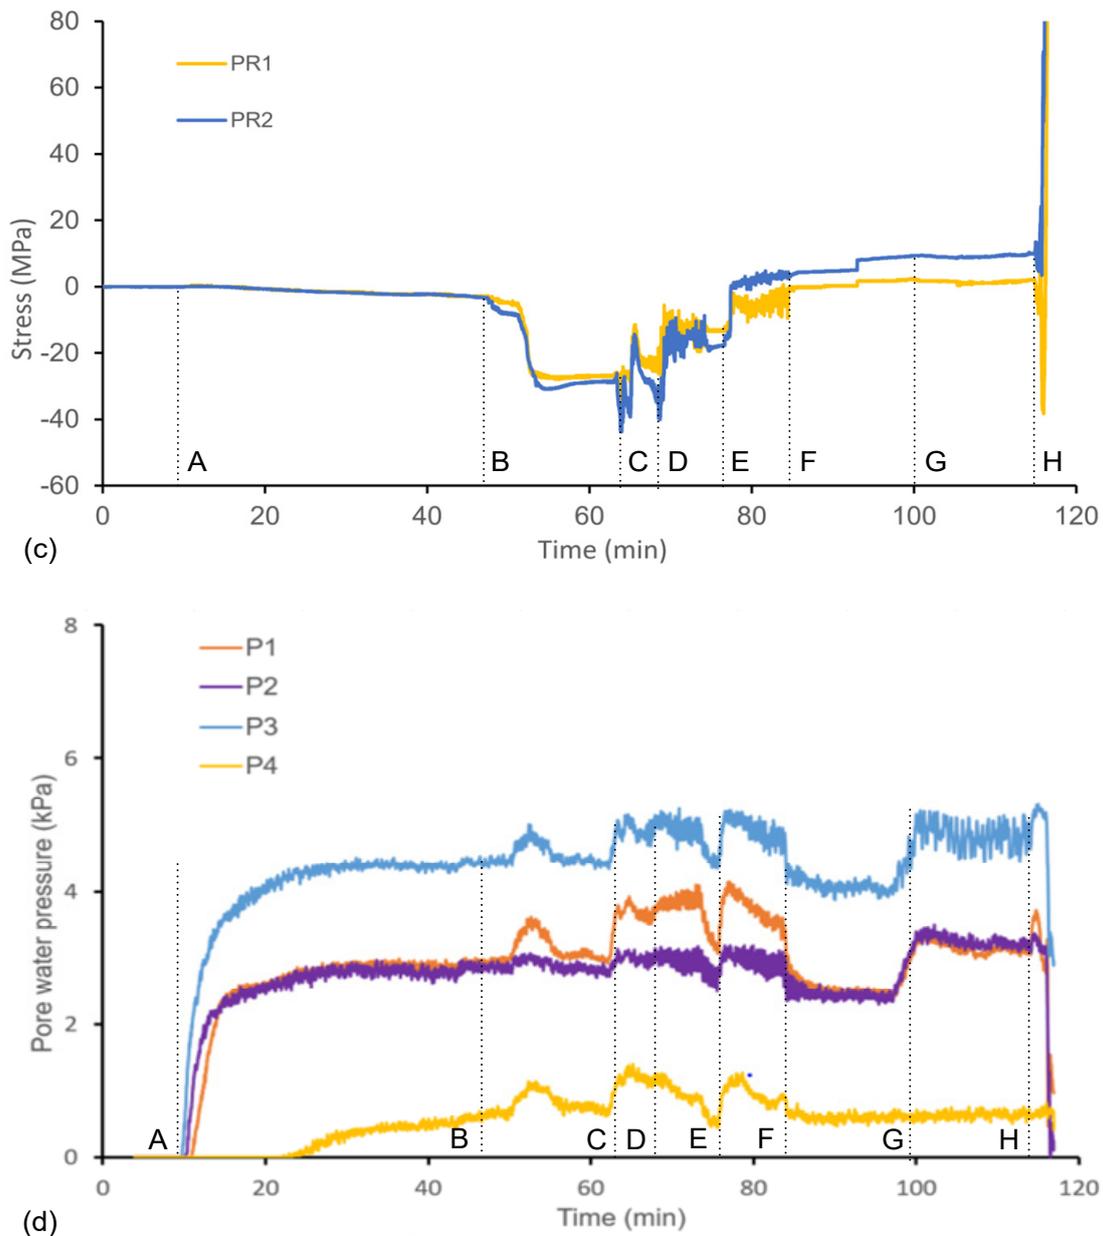
**Figure 7.** Stresses of the steel sheet piles and the tie rods based on results from fiber optic sensors and pore water pressure: (a) offshore side pile, (b) landside pile, (c) tie rod, (d) the pore water pressure (the positions of the monitor points are shown as OP, LP, PR, and P in Figure 4). Note: Point 0 was the moment of starting to add water at 0 s; Point A was the moment when the water level reached 50 cm (the top of the seabed) at 10 min; Point B was the moment when the wave (wave height = 4 cm) was generated at 47 min (water level = 65 cm); Point C was the moment when the wave (wave height = 8 cm) was generated at 63 min (water level = 65 cm); Point D was the moment when the wave started to break at 69 min; Point E was the moment when the wave (wave height = 12 cm) was generated at 77 min (water level = 65 cm); Point F was the moment when the 12 cm high wave ended at 85 min; Point G was the moment when the wave (wave height = 4 cm) was generated at 100 min (water level = 73 cm); Point H was the moment when the wave (wave height = 8 cm) was generated at 115 min (water level = 73 cm).

Figure 7 shows the stresses on both sheet piles (OP1–OP5 and LP1–LP5) and the two middle tie rods (PR1–PR2) measured by the optic fiber sensors and the pore water pressure (P1–P4). In the figure, '+' represents tensile stress and '-' represents compressive stress. The stresses of OP2, OP3, and OP4 decreased at Point A when water arrived at the seabed. The infiltration from the seabed caused the pore water pressure to increase rapidly (Figure 7d), leading to decrease in the stresses of OP2, OP3, and OP4. However, OP1 and OP5 did not change much because they were not in the area influenced by water pressure. The stresses on the landside pile did not change much because the sand infill between the two piles supported the major forces. The stresses on the tie rods decreased slightly after Point A because of the deformation of the seaside pile.

Under the action of the dynamic water pressure, the stress of OP5 in the seaside pile decreased rapidly, as shown in Figure 7a. The stress of OP4 decreased slightly, but the stress of OP3 increased, which denoted the inflection point of the seaside pile located between OP3 and OP4. The stress of the landside pile did not change obviously, except at LP3. Point LP3, which was located closest to the seabed (3 cm above), supported the largest force compared to the other four points, as shown in Figure 7b. The stress of the tie rods decreased sharply after 50 min because the landward deformation of the pile decreased the pre-tension (Figure 7c).

The stresses of OP1 and OP5 in the seaside pile decreased from the start of Stage 2 (Point C) due to the lasting deformation caused by the larger wave (Figure 7a). The stresses of OP2, OP3, and OP4 underwent two phases: fluctuating phase (from Point C to Point D, or from 63 min to 68 min) and rapidly increasing phase (from Point D to Point E, or from 68 min to 78 min). In the first phase, the seabed near the seaside pile was generally flat, and the water was deep enough to make the wave become a standing wave (as shown in Figure 7a,b). However, after Point D (68 min), the deposition close to the pile made the water much shallower. Thus, the wave became a breaking wave instead of a standing wave. The dynamic wave pressure was much larger than that before Point D, leading to larger deformation and stress of the pile.

The pore water pressure increased at the start of Stage 3 (Point E in Figure 7d) due to the action of the breaking wave and then decreased gradually due to dissipation of the pore water pressure. The pore water pressure of P1 decreased at the fastest rate because of the reduction in the water level due to wave overflow and leakage.

The pore water pressure before wave generation (the period between Points F and G in Figure 7) was less than that in the former stages because of water lost due to overflow and leakage. Water was supplemented to the level of 73 cm, and the wave with a 4 cm height was generated. The pore water pressure at P1, P2, and P3 increased with the water level and fluctuated during wave action. However, the water pressure at P4 did not change because of the steady water level in the landside seabed caused by overflow and leakage.

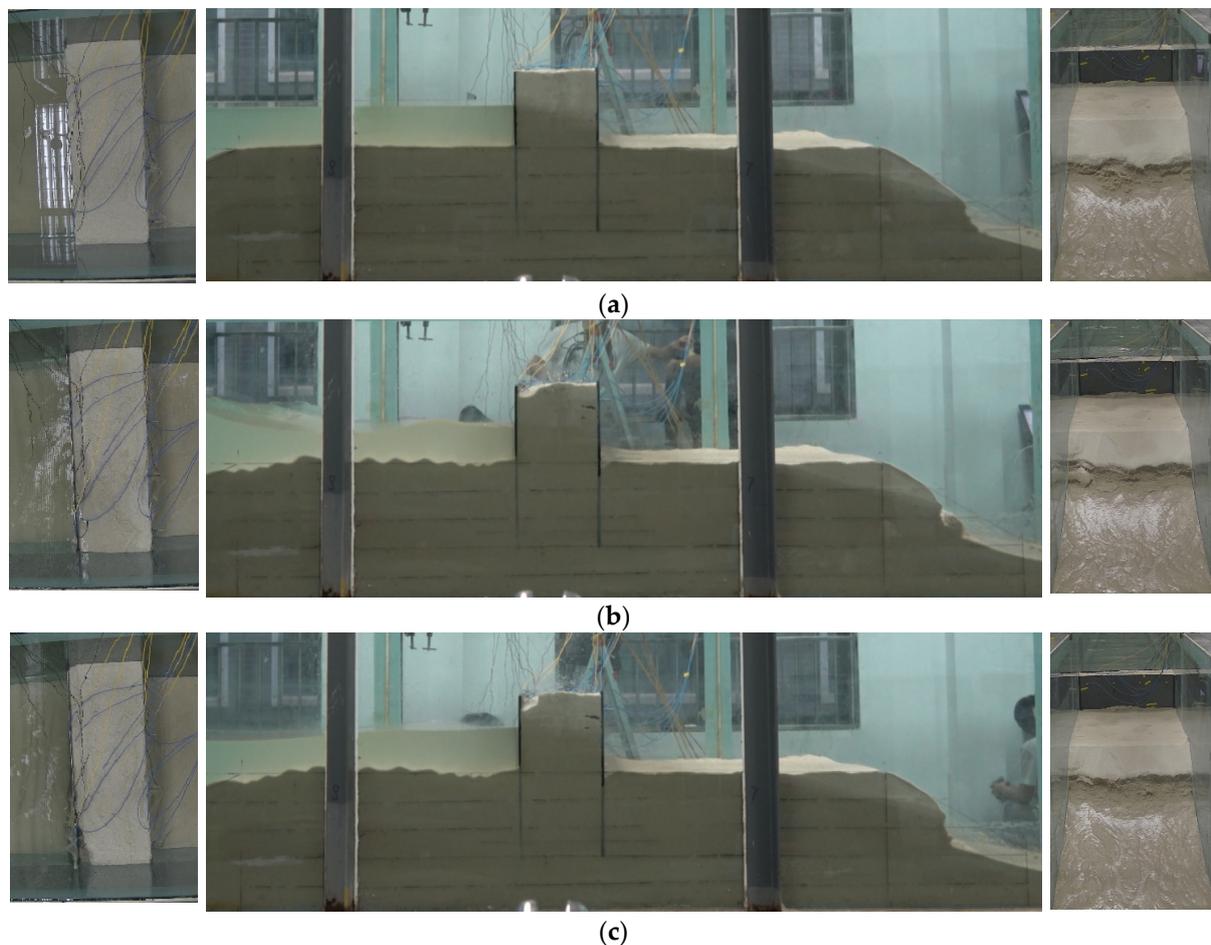
**Figure 8.** Snapshot of Stage 1 with water depth of 65 cm and wave height of 4 cm: (a) at 47'16"; (b) at 55'20"; (c) at 61'45". Note: the left photos show the top view, the middle photos show the side view, and the right photos show the seaward view from landside.

Stage 1 with a water level of 65 cm and wave height of 4 cm started at 47'16" (Figure 8). The wave did not break due to a relatively large water depth of 15 cm. The seabed exhibited fluctuations on the offshore side, which slowly moved toward the cofferdam. Overtopping occurred casually on the top of the cofferdam due to the overlapping of the traveling and reflecting waves, incurring a small groove on the top of the cofferdam near the offshore side pile. The slope on the landside underwent gradual erosion and local sliding due to the dynamic wave that caused the phreatic line to rise (see 55'20" in Figure 8b). Stage 1 ended at 61'45". Generally, the wave in Stage 1 did not cause an obvious impact on either the cofferdam or the foundation.

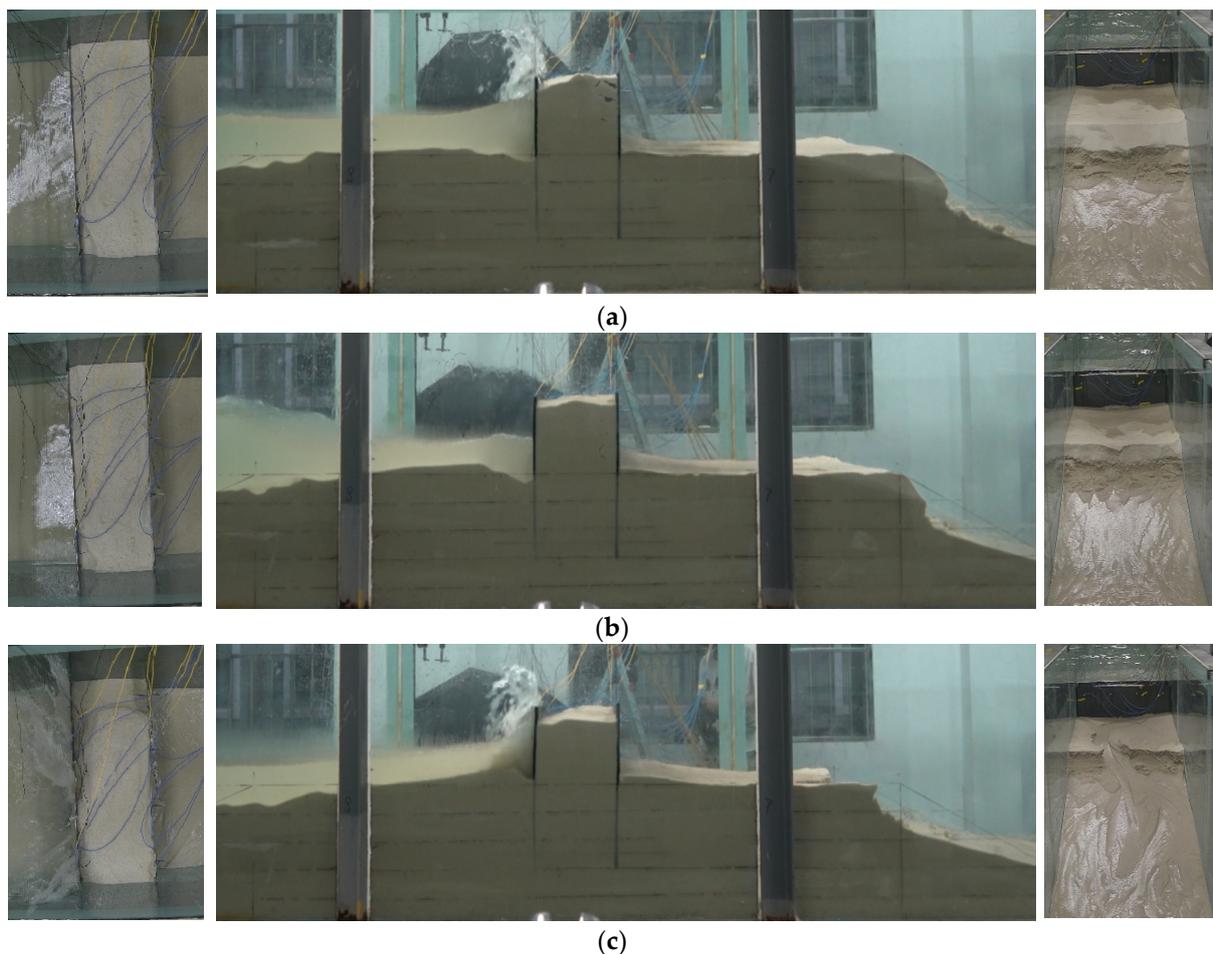
**Figure 9.** Snapshot of Stage 2 with water depth of 65 cm and wave height of 8 cm: (a) at 64'36"; (b) at 68'25"; (c) at 73'08". Note: the left photos show the top view, the middle photos show the side view, and the right photos show the seaward view from the landside.

Stage 2 (water level of 65 cm and wave height of 8 cm) started at 63'. The higher wave moved the seabed soils forward and gradually formed a gentle slope. The elevation of the seabed adjacent to the pile rose, making the waves climb higher with larger overtopping volume. In addition, the suction caused by the reflected wave produced a pit beneath the pile (see 68'25" in Figure 9). The pit decreased due to the continuing transportation of sand from the seaside. A bulge formed 10 cm from the pile, making the water depth here (i.e., 9 cm) much shallower. The wave broke in the shallow water region and caused large dynamic pressure toward the steel sheet pile, deforming the pile periodically toward the landside. The overtopping wave became larger and enlarged the groove on the top of the cofferdam. Moreover, the overtopping wave reached and eroded the landside seabed, forming a trench inside it. The erosion and the rising of the phreatic line made the downstream slope slide at the shoulder (see 73'08" in Figure 9).

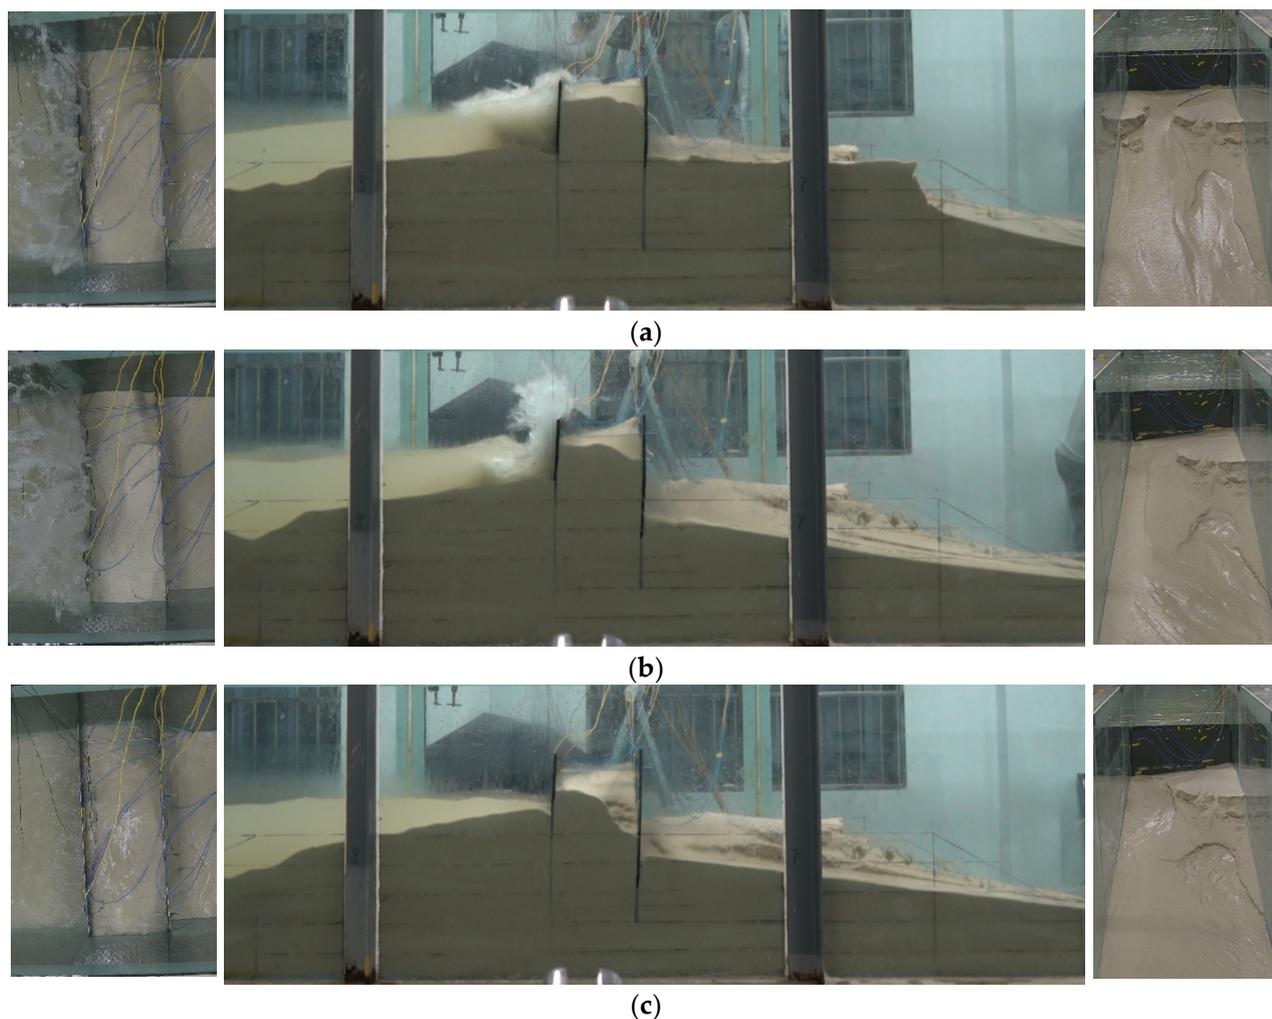
**Figure 10.** Snapshot of Stage 3 with water depth of 65 cm and wave height of 12 cm: (a) at 77'58"; (b) 81'51"; (c) 84'54". Note: the left photos denote the top view, the middle photos show the side view, and the right photos show the seaward view from the landside.

Stage 3 (water level of 65 cm and wave height of 12 cm) started at 77'25". The highly energetic wave caused more serious erosion on the seabed on the offshore side and deposition on the seabed adjacent to the pile (see Figure 10a,b). A stable slope formed on the offshore side of the seabed with a maximal elevation of 60 cm adjacent to the pile, making the water level rather shallow at 5 cm (see Figure 10c). The dynamic pressure caused by the breaking wave was weakened by the friction action between the water wave and the seabed slope.

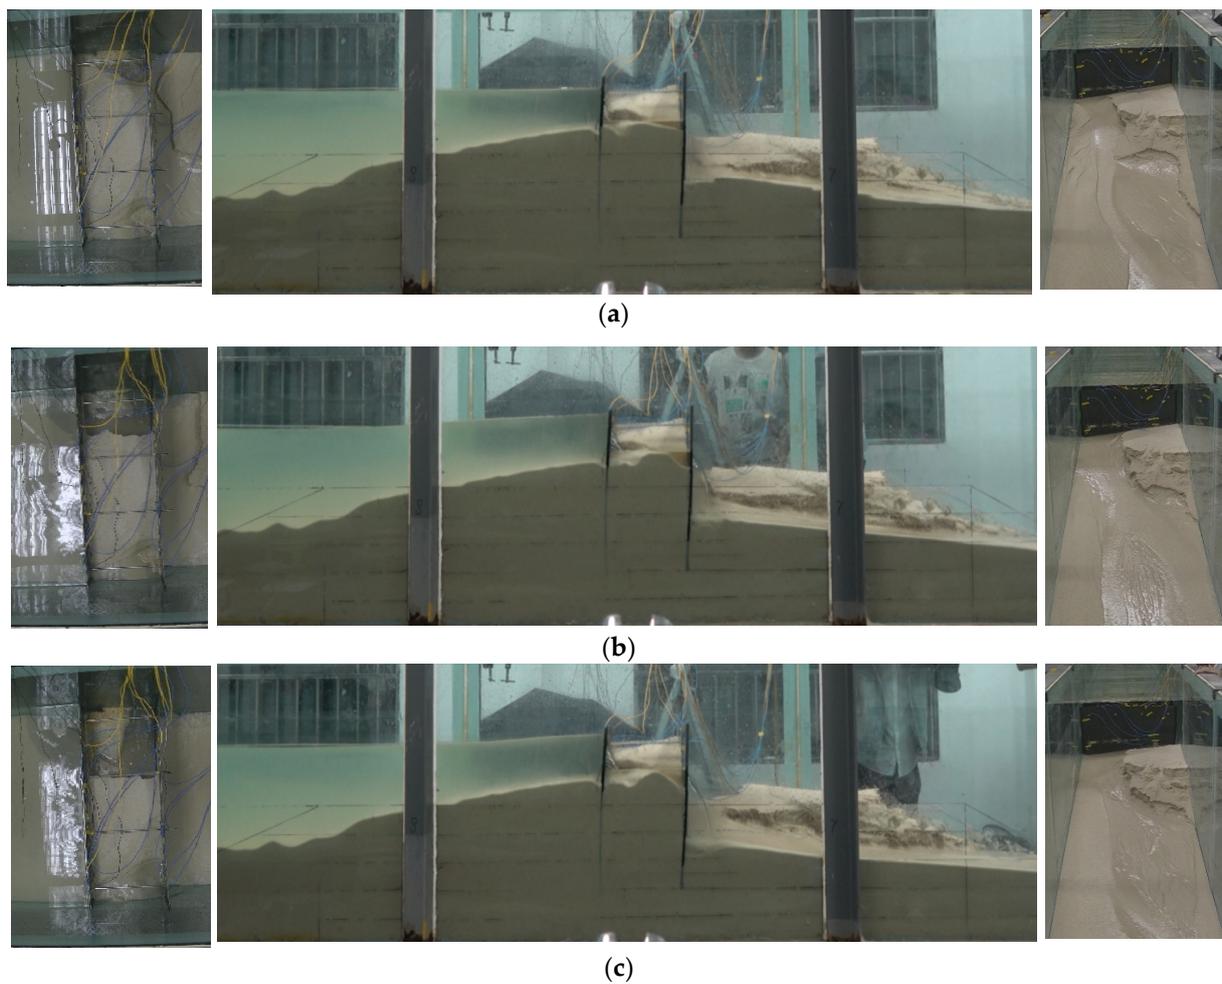
**Figure 11.** Snapshot of Stage 4 with water depth of 73 cm and wave height of 4 cm: (a) at 100'44''; (b) at 106'20''; (c) at 112'37''. Note: the left photos show the top view, the middle photos show the side view, and the right photos show the seaward view from the landside.

The water level increased to 73 cm in Stage 4. The wave with a height of 4 cm was produced at 100'00". The wave action had no impact on the offshore side seabed and the deformation of the two steel sheet piles. The wave leakage eroded the sand between the two piles and widened and deepened the trench on the landside. The cofferdam deformed gradually toward the landside during the erosion of soil on the landside (Figure 11).

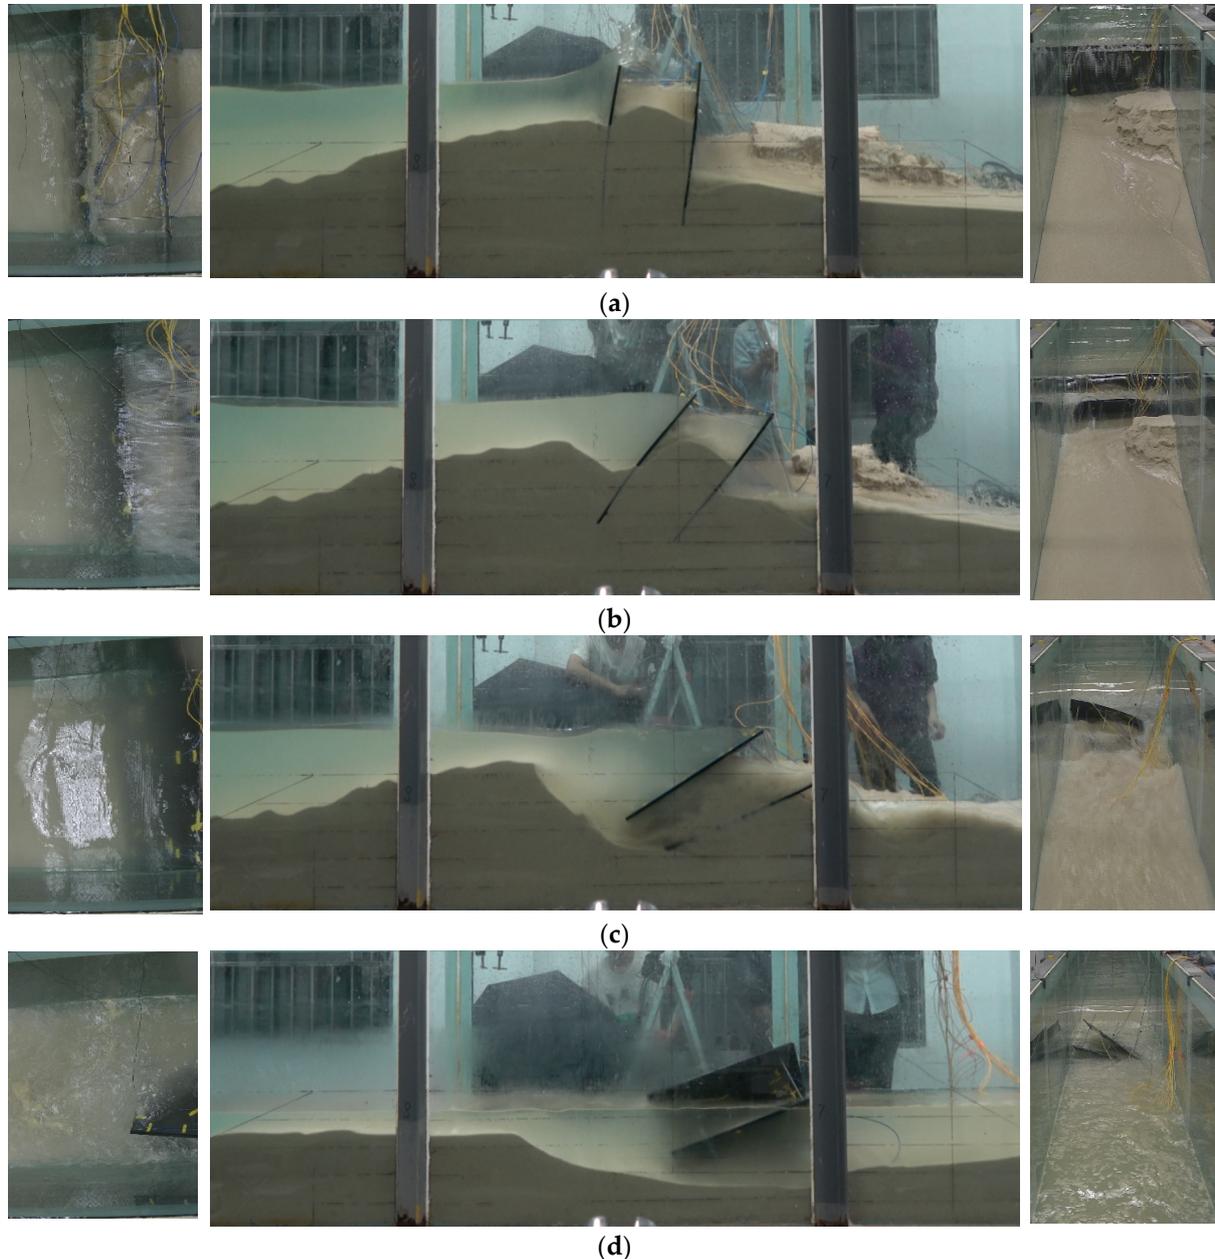
**Figure 12.** Snapshot of Stage 5 with water depth of 73 cm and wave height of 8 cm: (a) at 115'03"; (b) at 115'58"; (c) at 116'54"; (d) at 117'05". Note: the left photos show the top view, the middle photos show the side view, and the right photos show the seaward view from the landside.

Stage 5 started at 114'45'' when the wave height increased to 8 cm. The dynamic wave pressure pushed the cofferdam to deform significantly (see 115'03'' in Figure 12). The deformation was mainly due to the continuing action of wave pressure and erosion of sand at the toe of the landside pile. The cofferdam tilted and rotated, causing more water to overflow the crest and leak through the gap between the piles and the glass wall (see 115'58'' in Figure 12). The tilting of the offshore side pile caused the formation of an adjacent pit and obvious erosion. The erosion then washed out the foot of the piles.

Despite the failure of the cofferdam, as shown at 115'58'' in Figure 12, the seabed on the offshore side maintained a height of 53 cm. The residual sand on the landside supported the steel sheet pile structure and maintained a water level of 65 cm, which showed that the DSSP could significantly delay the failure of the cofferdam and provide more time for warning and evacuation. The sand beneath the pile structure was then washed away, and the pile structure fell down. After that, the seabed on the offshore side was completely eroded.

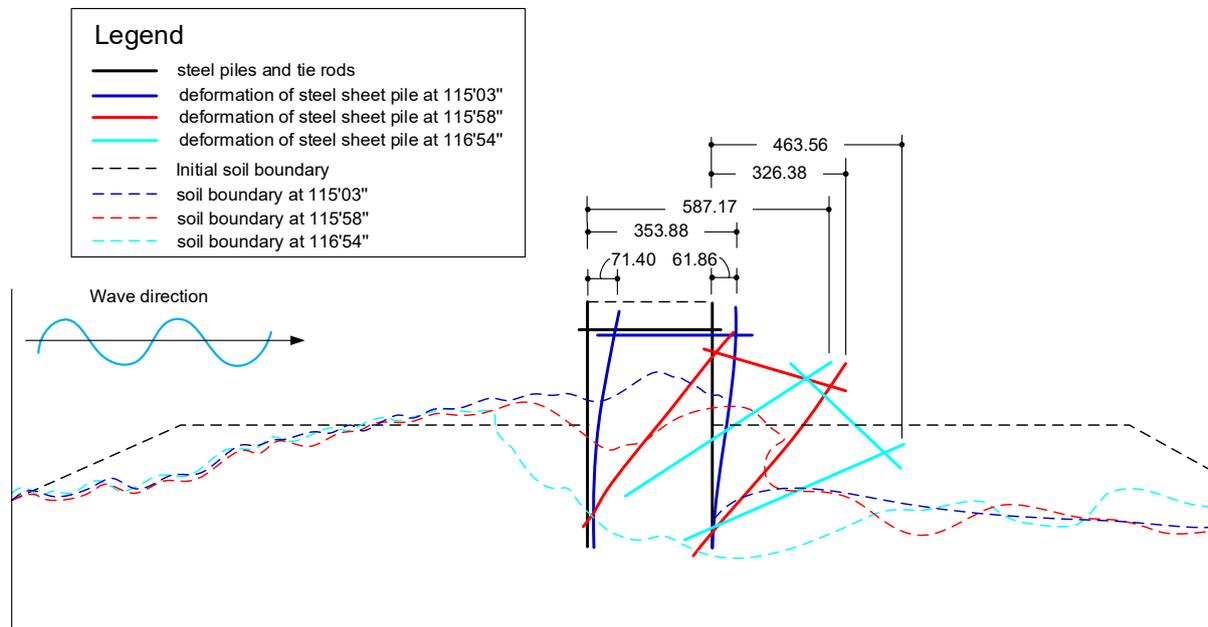
**Figure 13.** The failure process of the DSSP cofferdam in Stage 5. Note: the black lines are the steel sheet piles and tie rod, and the dotted lines are the soil envelope of the seabed and the sand infill before wave generation.

Figure 13 shows the deformation of the DSSP cofferdam and seabed during failure. The seaside seabed underwent erosion in the seaward half and deposition in the landward half, as shown in the left part of Figure 13. In particular, deposition close to the seaside pile made the wave break with large dynamic pressure. The sand infill was eroded due to the large leakage through the gap between the pile and glass wall, which resulted from deformation caused by the impact of waves. The soil in the landside seabed was eroded

first by leakage when the water level was smaller (65 mm) and then by overflow when the water level (73 cm) and wave height (8 mm) were larger.

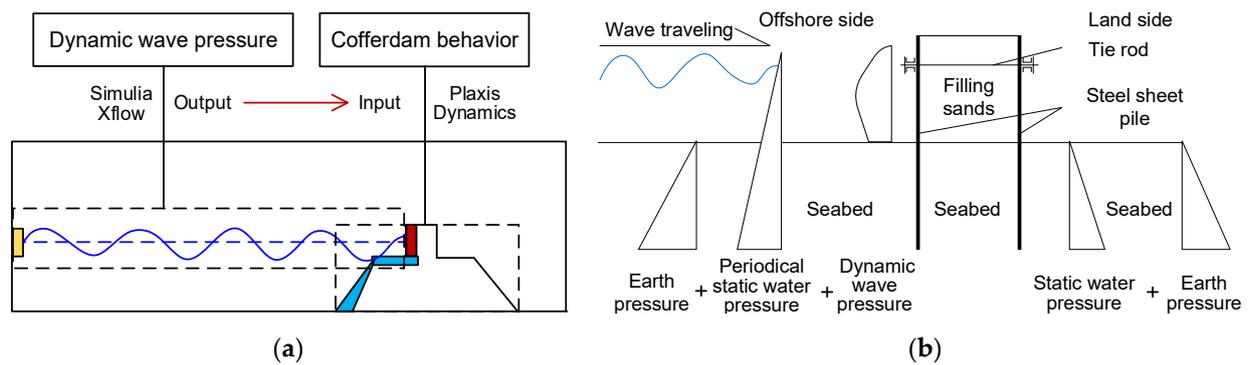
**Figure 14.** Force analysis of the DSSP cofferdam under wave action: (a) force components; (b) simulation.

The dynamic behavior of the DSSP cofferdam in the presence of waves was simulated by the combination of computational fluid dynamics (Simulia Xflow, or Xflow for short, version2020) and finite element software (Plaxis Dynamic, version2020), as shown in Figure 14a. The forces on a DSSP cofferdam in the coastal zone are shown in Figure 14b. The offshore side of the cofferdam was subjected to earth pressure, periodic static water pressure, and dynamic wave pressure, and the landside of the cofferdam was subjected to earth pressure and hydrostatic pressure. The hydraulic and hydrodynamic parameters (i.e., periodic static water pressure and dynamic wave pressure), which were obtained by simulating the wave generation, traveling, and action on the steel sheet pile via Simulia Xflow, were extracted and applied in the Plaxis Dynamic software to simulate the dynamic behavior of the cofferdam. Soil erosion was simulated by removing the corresponding finite element mesh in the cofferdam model.

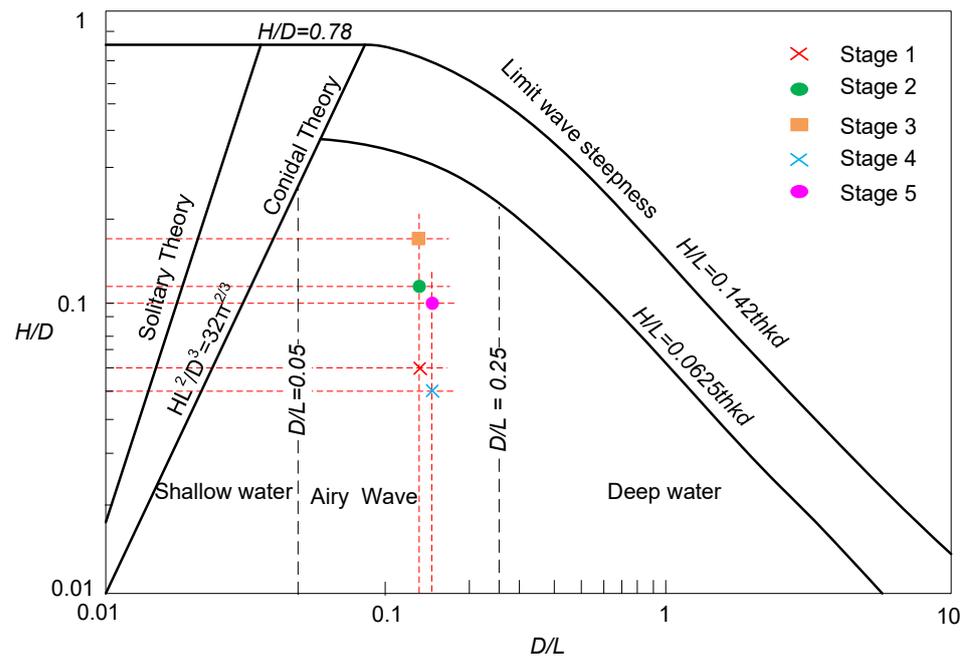
Figure 15. The wave conditions of the five stages in the Kolmar diagram.

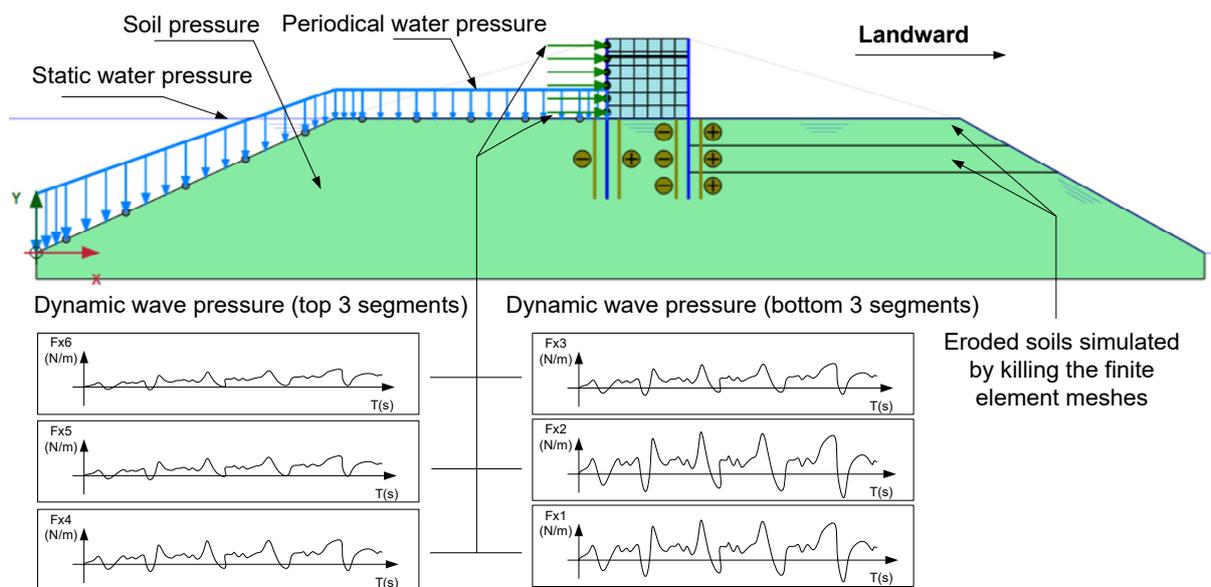
Figure 16. Numerical model of the cofferdam flume tests under wave action. Note: the seaside pile was separated into six segments of 5 cm each, and the dynamic wave pressure was added to each segment.

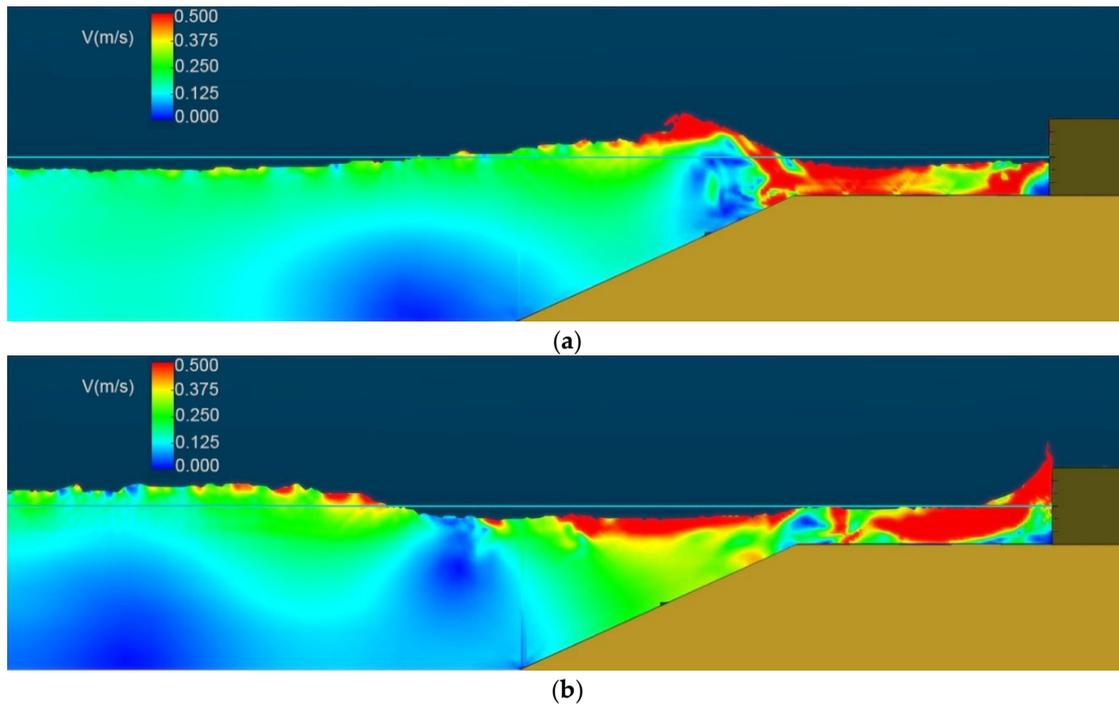
**Figure 17.** Snapshot of the velocity distribution of the wave in Stage 3 with water depth of 65 cm and wave height of 12 cm: (a) with a trough on the seaside pile; (b) with crest on the seaside pile.

Figure 17 shows a snapshot of the velocity distribution of the waves in Stage 3 (with water depth of 65 cm and wave height of 12 cm) via Xflow. When the wave trough arrived at the pile position, the water level and dynamic pressure were the lowest (Figure 17a). When the wave crest arrived at the pile position, the water level and dynamic pressure were the highest (Figure 17b). The dynamic wave pressure could be even larger if the breaking wave was taller or in shallower water.
