# Stability Analysis of Cofferdam with Double-Wall Steel Sheet Piles under Wave Action from Storm Surges

**Abstract:** Double-wall steel sheet piles (DSSPs) are widely used in large-span cofferdams for docks due to their good performance against wave action during storm surges. This paper describes a study of the dynamic behavior of a DSSP cofferdam under wave action through flume tests and a numerical simulation that combined computational fluid dynamics (CFD) and the finite element method. The influences of the water level and wave height on the DSSP cofferdam were investigated experimentally and numerically. Tall waves in shallow water broke upon and impacted the seaside pile with large dynamic wave pressure, dramatically increasing the stress and displacement of the seaside pile. The overlap of the traveling and reflected waves increased the excess pore water pressure near the seaside pile due to taller overlapped waves and higher wave frequency. The DSSP cofferdam failed under the combined actions of the dynamic wave pressure and erosion of the landside seabed. The leakage and overflow of the breaking waves resulted in significant erosion of the landside seabed and greatly we

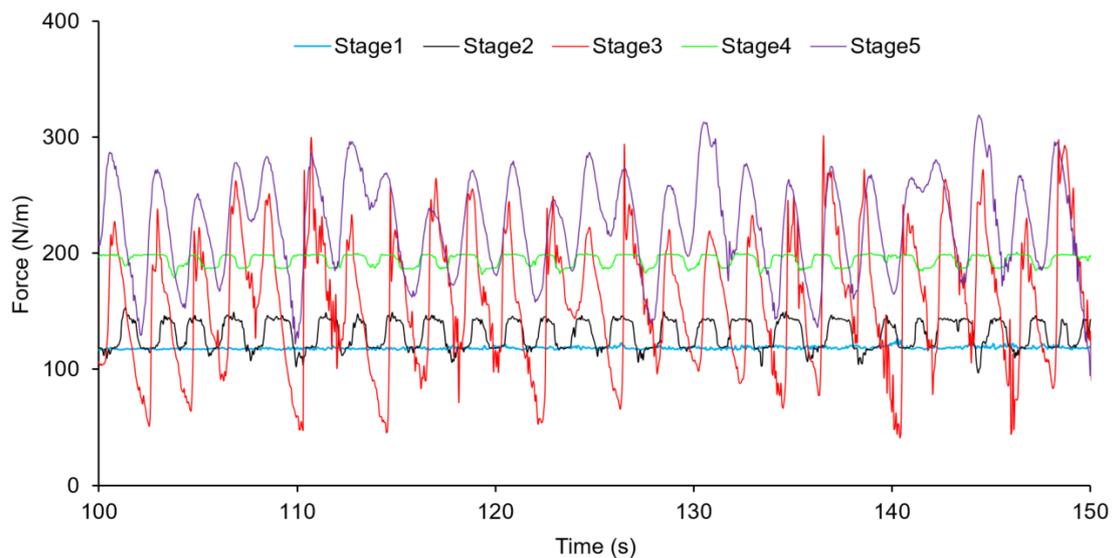
**Figure 18.** Part of the time records of the wave force in the five stages.

Figure 18 shows the calculated wave dynamic pressure at the bottom segment of the offshore side pile in the five stages. In Stage 1 with water level of 65 cm, the 4 cm high waves did not produce obvious dynamic pressure on the pile. A slight increase in the dynamic pressure amplitude was observed in Stage 2 with 8 cm high waves. However, the increase in the dynamic pressure amplitude in the stage with 12 cm high waves was significant because of the wave breaking and the overlap between the traveling and reflected waves. In Stage 4, the static water pressure increased because of the higher water level of 73 cm, while the dynamic pressure amplitude was not very large. In Stage 5, despite a large increase due to the overlap between the traveling and reflected waves, the dynamic pressure amplitude was not as large as that in Stage 3. The reason is that the wave in Stage 5 did not break due to the large wave depth above the seabed.

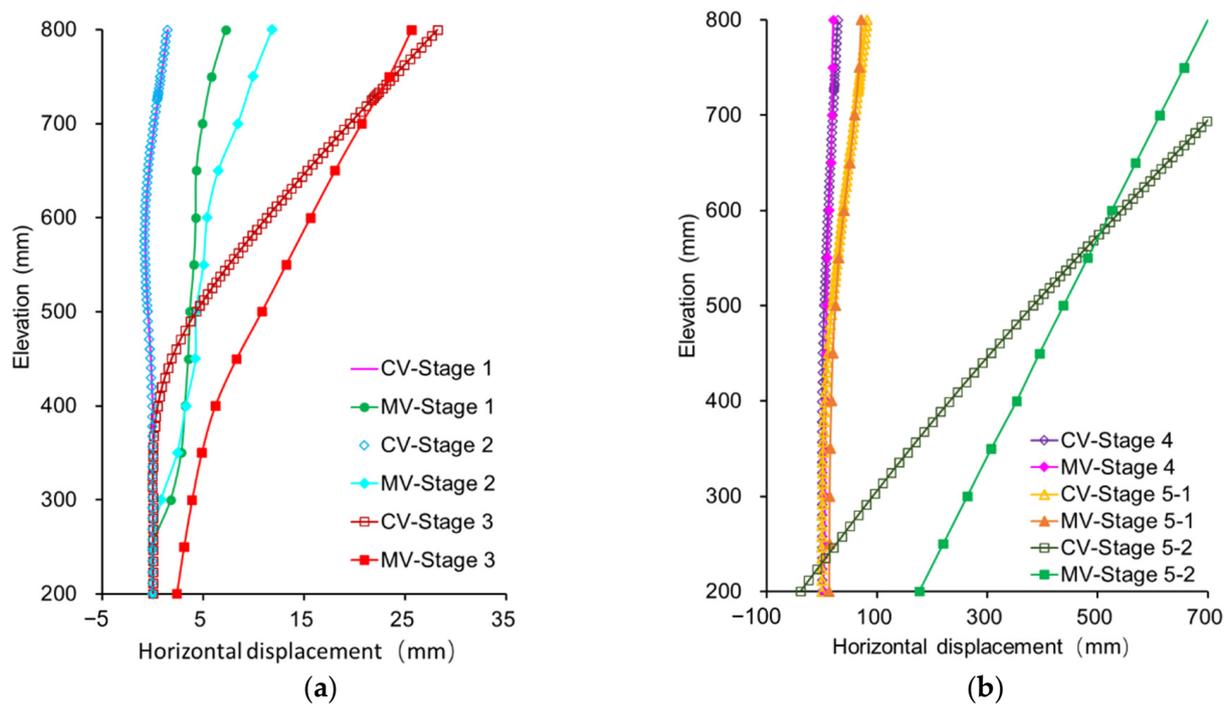
**Figure 19.** The horizontal displacement of the seaside pile: (a) with water depth of 65 cm, (b) with water depth of 73 cm. Note: CV = calculated value, MV = measured value. Stage 5 was divided into two sub-stages by considering the soil erosion: Stage 5-1 (with erosion depth of 4 cm) and Stage 5-2 (with erosion depth of 8 cm), as shown in Figure 18.

Figure 19 shows the calculated and measured horizontal displacement (HP) of the seaside pile in the five stages. In Stage 1, the dynamic wave pushed the top of the seaside pile landward, but the sand infill restricted the displacement and produced a slight seaward bulge, which was observed in both the calculated and measured HPs. The landside pile was pushed landward by the sand infill but restricted by the tie rods. Thus, there was also a slightly landward bulge in the landside pile (Figure 20). The difference in the HPs between Stages 1 and 2 was not very large due to the constraint of the sand infill. However, the HPs in both the seaside and landside piles largely increased in Stage 3 due to the taller breaking wave and erosions of the soil in the landside seabed and between the two piles. The largest calculated HPs were 28.2 mm in the seaside pile (vs. 25.7 mm in the measured HP) and 24.4 mm in the landside pile (vs. 16.6 mm in the measured HP).

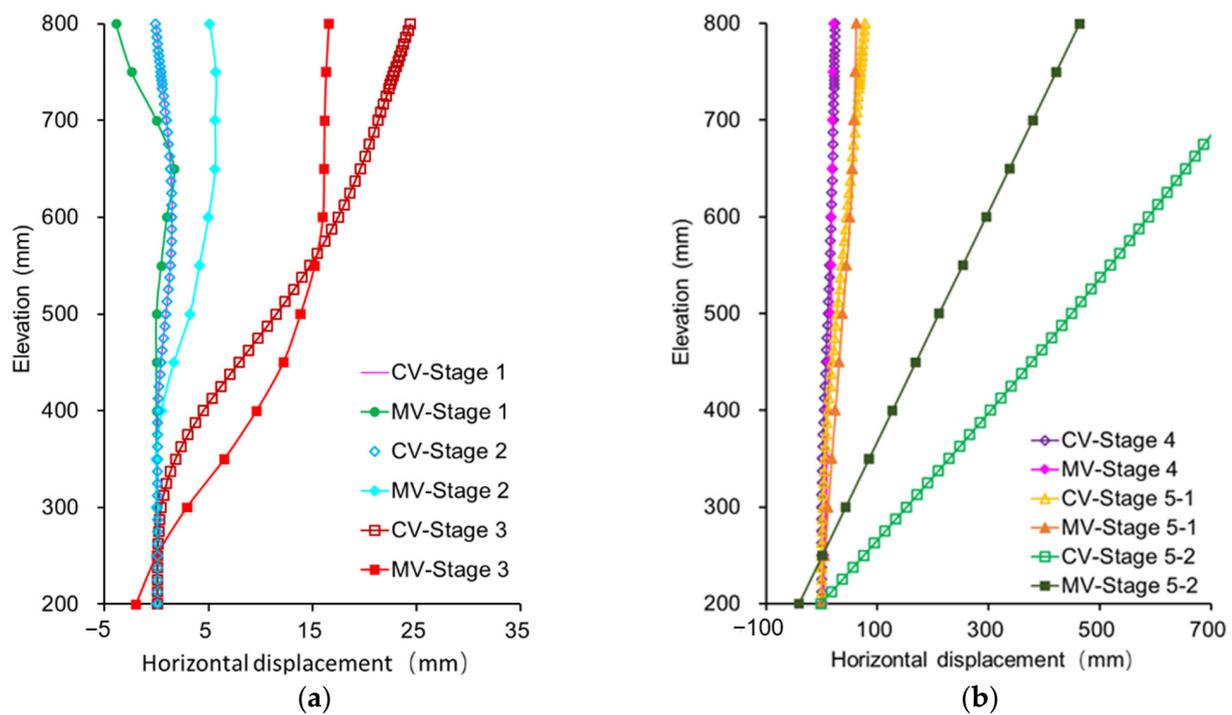
**Figure 20.** The horizontal displacement of the landside pile: (a) with water depth of 65 cm, (b) with water depth of 73 cm. Note: CV = calculated value, MV = measured value.

In Stage 4, despite the higher water level of 73 cm, the HPs in both the seaside and landside piles did not change obviously due to the relatively small dynamic water wave. In Stage 5-1 with 8 cm high waves, the HPs of the seaside and landside piles increased to 82 mm (vs. 71.4 mm in the measured HP) and 78.1 mm (vs. 61.9 mm in the measured HP). In Stage 5-2, further soil erosion in the landside seabed greatly decreased the insertion depth of the landside pile, leading to failure of the DSSP cofferdam. The HPs of both the seaside and landside piles became very large, with 877 mm (vs. 694 mm in the measured HP) and 675 mm (vs. 464 mm in the measured HP), respectively.

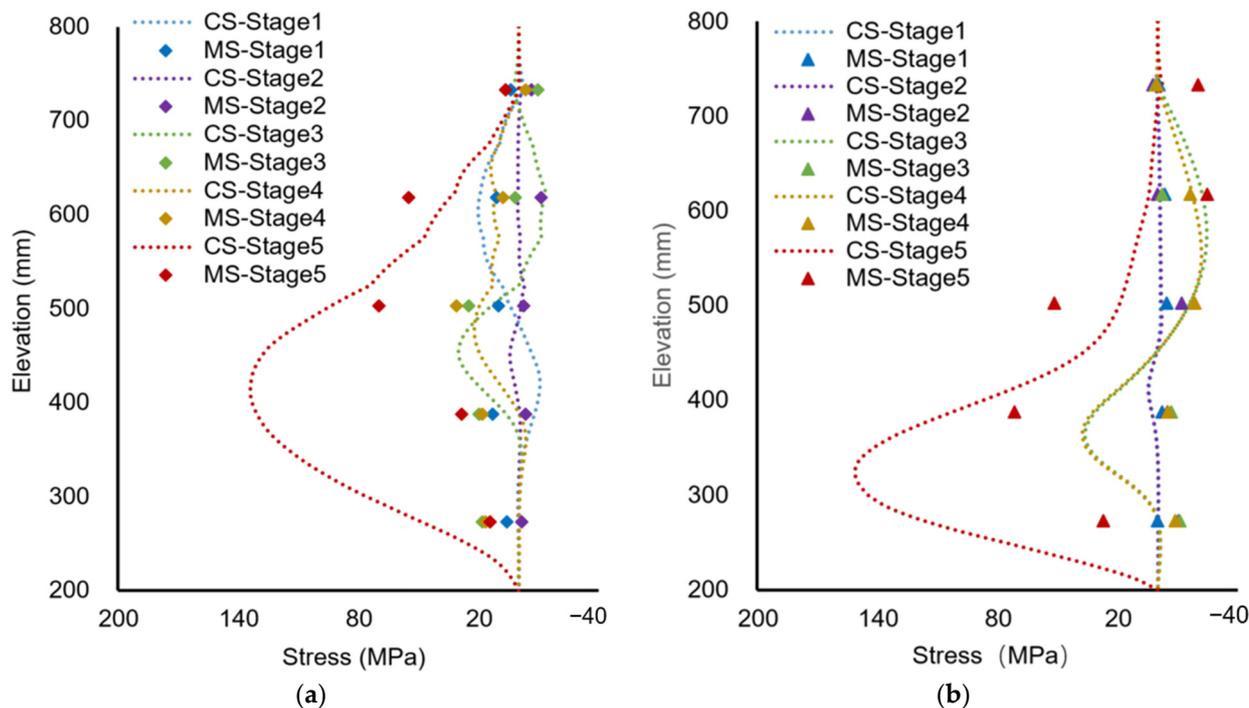
**Figure 21.** The measured and calculated stresses at the end of the five stages: (a) seaside pile, (b) landside pile. Note: CS = calculated stress, MS = measured stress.

Both the tests and the numerical simulation showed that three external influence factors affected the HPs and stresses: static water pressure, dynamic wave impact, and soil erosion in the landside seabed. Static water pressure was the least significant factor, as the DSSP cofferdam as a whole had good stability and resistance to deformation. The dynamic wave impact, especially when the wave broke, had a larger influence on the DSSP, which forced the sheet pile to bend. However, the HPs and stresses on the two piles were still limited if no erosion occurred in the landside seabed or sand infill. Soil erosion led to the large HP and stresses and failure of the DSSP cofferdam. Therefore, reinforcement of the soil in the landside and sand infill to prevent erosion is of critical importance.

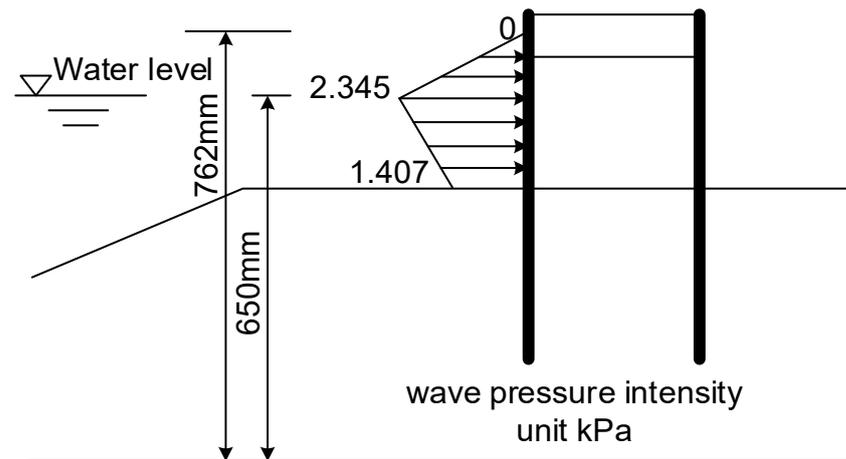
**Figure 22.** The input of the static method. Note: the input of the cyclic load method was set as a cosine wave on the basis of this figure.

Stage 3 was taken as an example to compare the two methods with the present method (PM). Figure 22 shows the inputs for the static method according to the Code of Hydrology for Harbour and Waterway [25]. The input of the cyclic load method was set as a cosine wave on the basis of Figure 22.

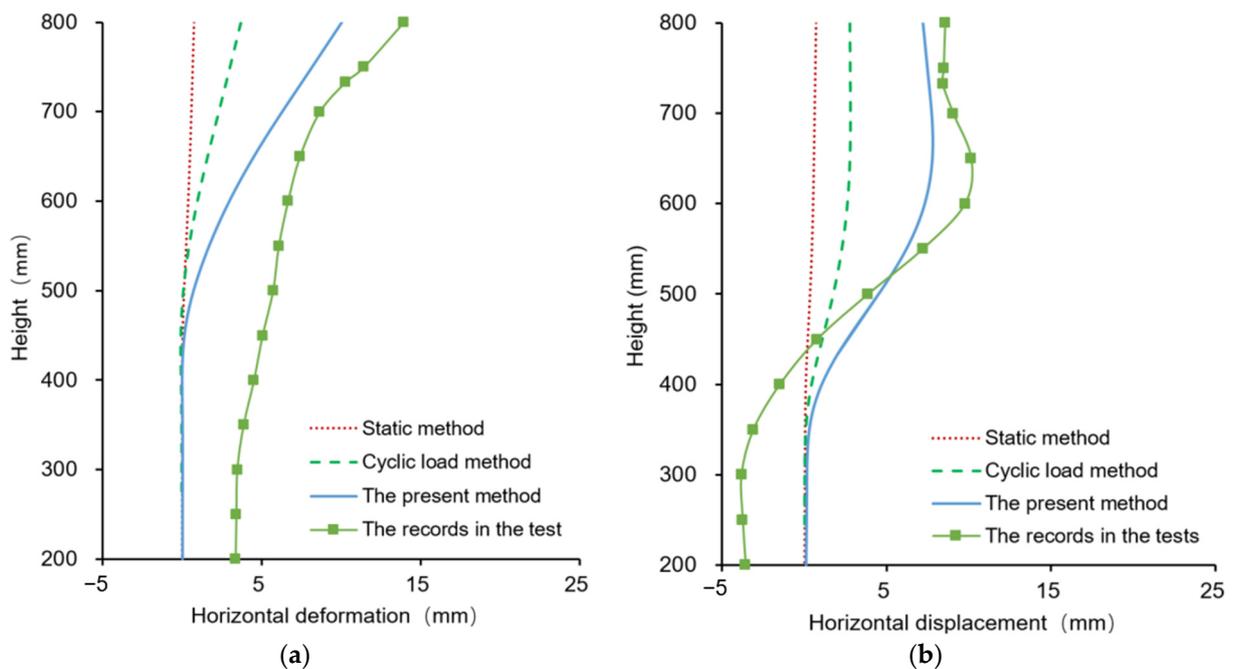
**Figure 23.** Horizontal deformation of the steel sheet piles in Stage 3 before erosion in the landside seabed: (a) the seaside pile; (b) the landside pile.

Figure 23 shows the calculated HP of the two steel sheet piles in Stage 3 before erosion in the landside seabed. The displacements with the static method were relatively small in both seaside and landside piles. The displacements with the cyclic load method were larger than those of the static method. The reason is that the dynamic load caused plastic deformation in the soils, which restricted the recovery of both piles. The HPs calculated via both the static method and cyclic load method were much smaller than the records in the test, as the large dynamic wave pressure caused by breaking waves was not properly simulated. In contrast, the HP calculated via the present method was much closer to the records because it considered the breaking waves. Despite this, there was still some difference between the calculated and measured HPs, especially in the foot of the piles. In the test, there was plastic deformation of 3–4 mm in both piles because of the tilt caused by the sand infill, which cannot be simulated by the finite element method with an ideal elastic–plastic constitutive equation.

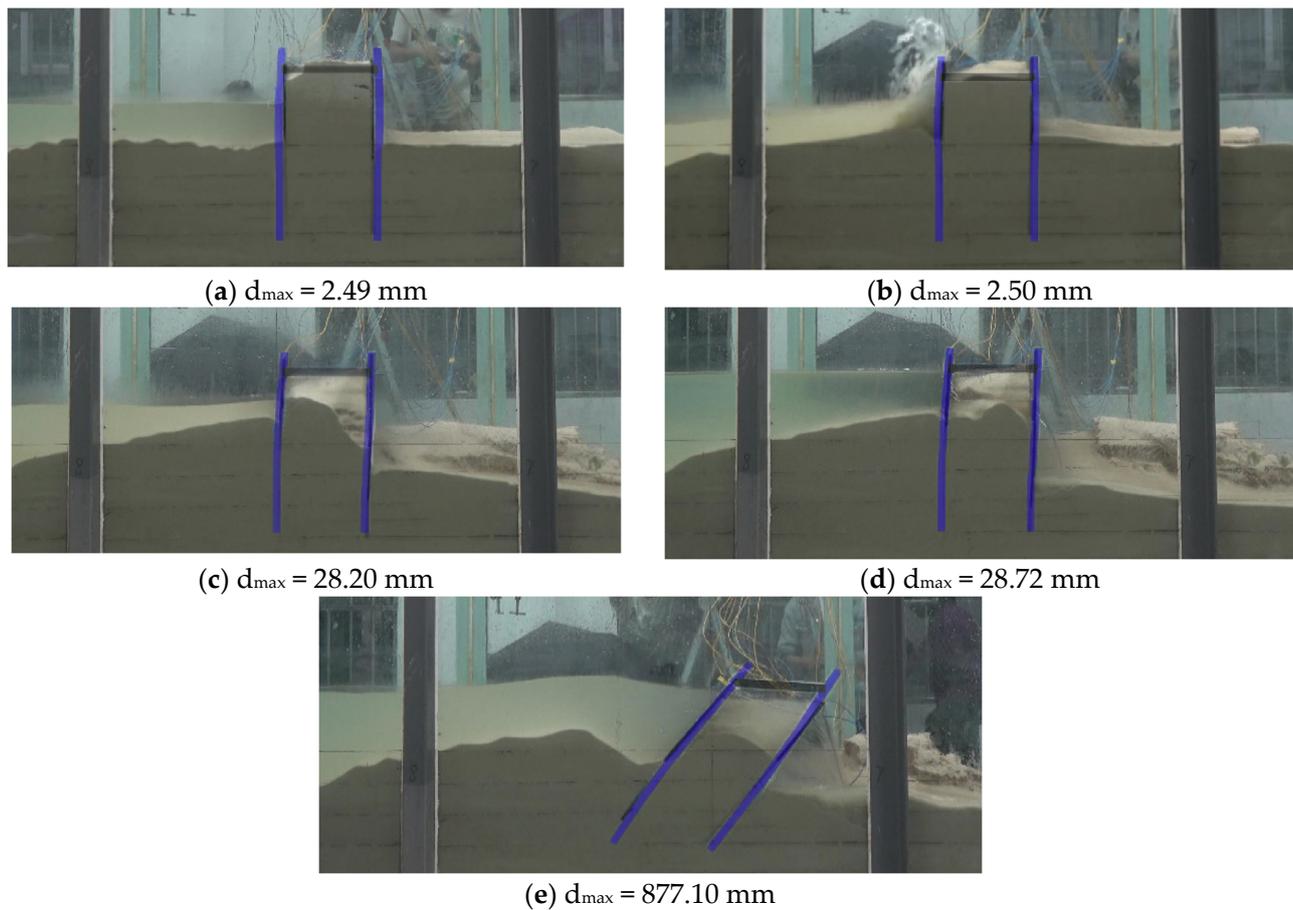
**Figure 24.** The deformation of the DSSP cofferdam and the seabed during the failure process: (a) at the end of Stage 1; (b) at the end of Stage 2; (c) at the end of Stage 3; (d) at the end of Stage 4; (e) failure at Stage 5. Note, the figures are the snapshots of the model tests, the blue line represents the deformed double row steel sheet piles, and the black line is the rigid tie rod in the simulation results for comparison.

Figure 24 shows the results of the simulation of the deformation of the DSSP cofferdam in the five stages as well as the corresponding snapshots in the tests. The soil erosion was modeled by removing the element meshes. Generally, the calculated results agreed well with the test values. It is found from the comparison analysis between numerical simulation and laboratory tests that the DSSP deformation dramatically increased when the landside soils were eroded by the leakage between the piles and glass wall and the overflow. The large wave ( $H = 8$  cm) then pushed the cofferdam tilted with large displacement. The results emphasized the importance of sheet pile waterproofing, wave overflow prevention, and soil erosion on the landside as well as the top of the cofferdam.

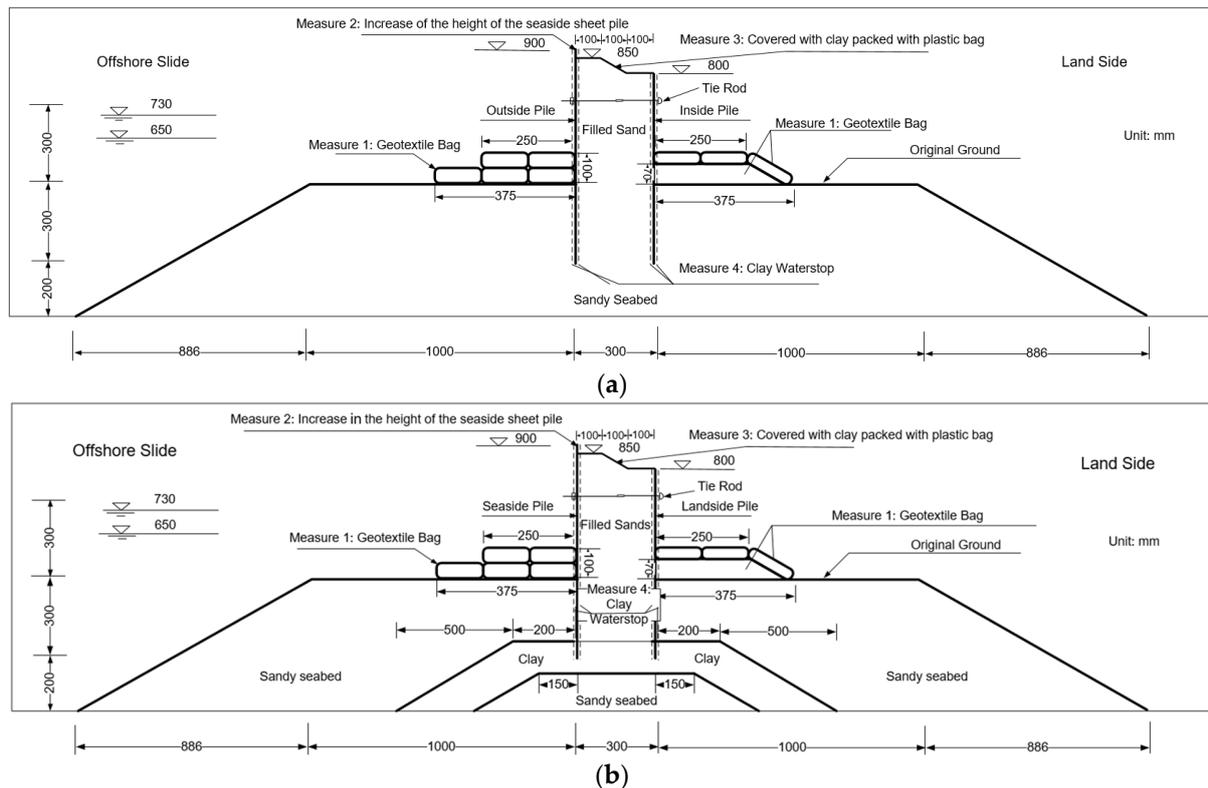
**Figure 25.** Layout of the DSSP cofferdam with reinforced measures in different seabeds: (a) with sandy seabed foundation; (b) with clay interlayer seabed foundation.

In order to prevent the DSSP cofferdam from continuous failures of deformation–leakage–erosion–tilting, four reinforced measures were taken in sandy and clay interlay seabed foundations, as shown in Figure 25.

- (1) The seabeds close to both seaside and landside sheet piles were covered with geotextile bags filled with coarse sands to prevent soil erosion.
- (2) The height of the seaside sheet pile was increased 10 cm to reduce wave overflow.
- (3) The top of the cofferdam between the two piles was covered with clay packed with plastic bags to prevent soil erosion and water infiltration.
- (4) The junctions between the sheet piles and the glass walls were covered with clay for waterproofing.

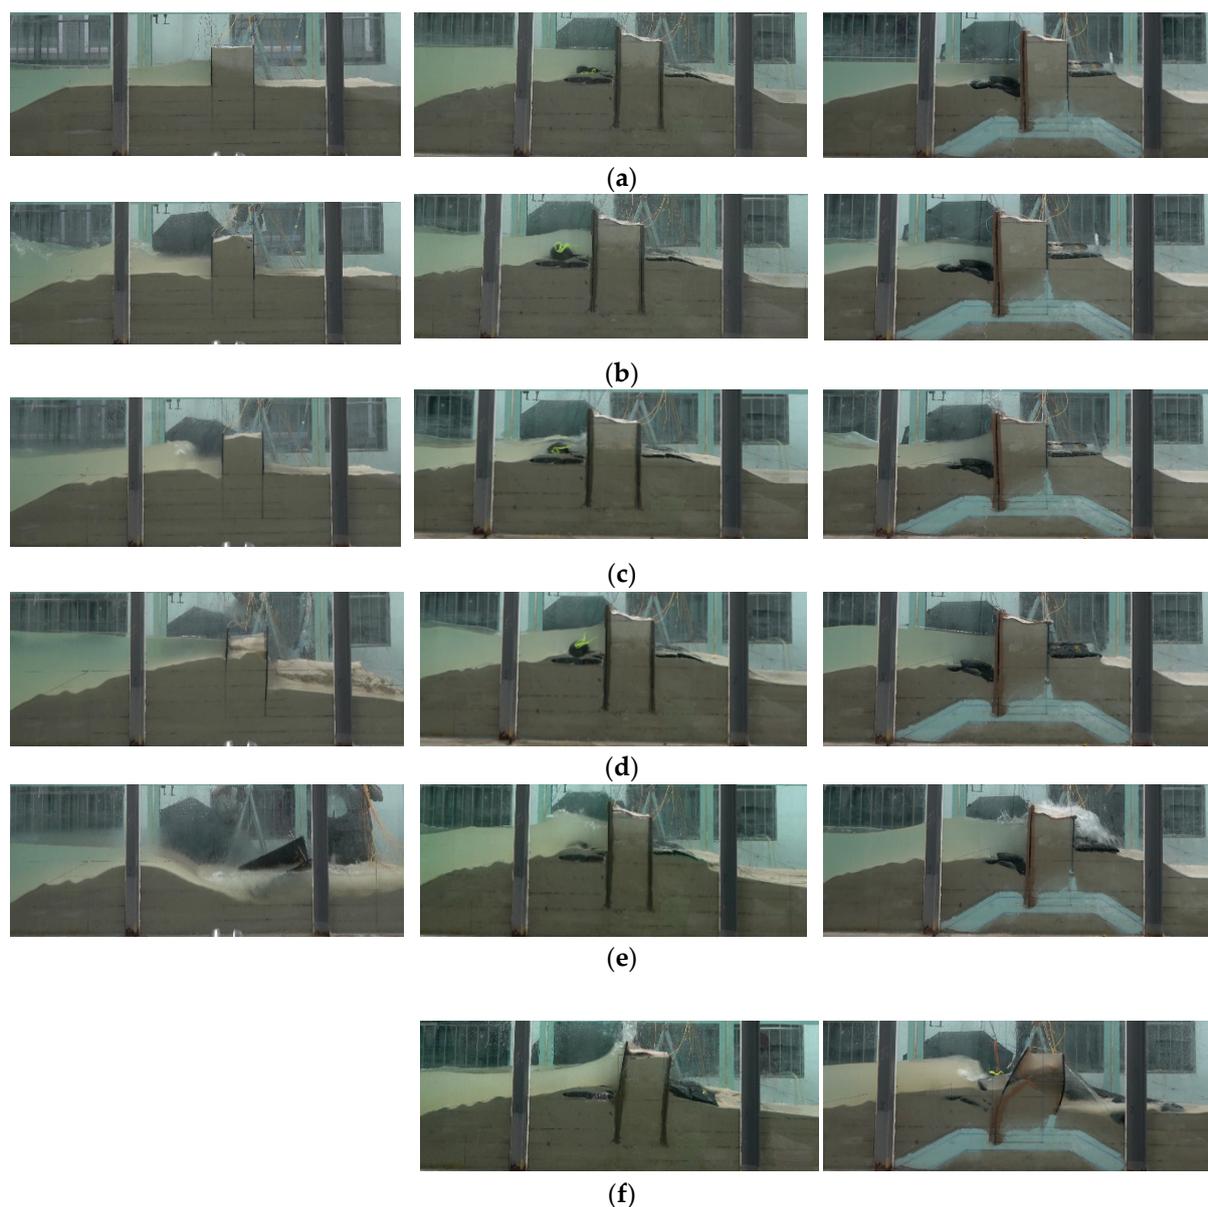
**Figure 26.** Snapshots of the DSSP cofferdams with reinforced measurement in different seabeds: (a) Stage 0; (b) at end of Stage 1 ( $D = 65$  cm,  $H = 4$  cm); (c) at end of Stage 2 ( $D = 65$  cm,  $H = 8$  cm); (d) at end of Stage 4 ( $D = 73$  cm,  $H = 4$  cm); (e) at end of Stage 5 ( $D = 73$  cm,  $H = 8$  cm); (f) at end of Stage 6 ( $D = 73$  cm,  $H = 12$  cm). Note: the figures on the left denote the test in sandy seabed without reinforced measures (Test 1); the figures in the middle denote the test in sandy seabed with reinforced measures (Test 2); and the figures on the right denote the test in clay interlayer seabed with reinforced measures (Test 3). The cofferdam in Test 1 failed at Stage 5 so there was no snapshot at Stage 6.

The effects of the reinforced measures were great as shown in the middle of Figure 26. The wave overflow was strongly mitigated by the higher landside steel pile. The leakage between the piles and the glass wall was very small because of the clay waterproofing. The upper part of the sands between two sheet piles remained dry. The soil erosions on the seabed of both seaside and landside were successfully controlled by the geotextile bag filled with coarse sands. Finally, the cofferdam did not fail at Stage 5 with water level of 73 cm and wave height of 8 cm. Moreover, the cofferdam successfully endured much larger waves with the height of 12 cm at Stage 6 as shown in the middle of Figure 26e, despite relatively large deformation.

When there is a clay interlayer seabed beneath the cofferdam and the pile end is inserted into a clay layer, the situation would be different, as shown in the right figures in Figure 26. The seaside pile sunk down into the soft clay layer, reducing the height of that pile. The textile bag close to the pile also sunk down. The cofferdam worked well when either the water level or the wave height was not very large. However, the wave overflow became very large when the water level and the wave height rose to 73 cm and 12 cm, respectively. The seabed soils as well as the textile bag were washed away. The landside pile tilted landward. With the constraint of the tie rods pulled by the seaside pile, the landside pile bent but stood up. Compared to Test 2 with a sandy seabed, the DSSP cofferdam in the clay interlayer seabed should have a higher wave wall due to large settlement cause by the soft clay.
