## Article

# Soft Roof Failure Mechanism and Supporting Method for Gob-Side Entry Retaining

**Keywords:** gob-side entry retaining; unloading loose; bolt installation angle; extrusion strengthening

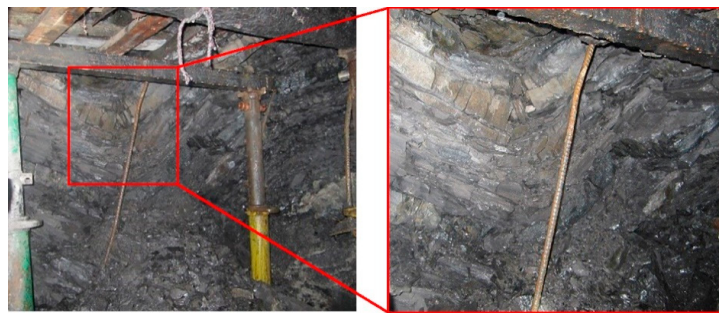
Field observations found that there were a large number of cracks in the vertical direction of roof near the end of the working face, so the roof caving occurred generally within a height range of 1.5 to 2 m, as shown in Figure 3.

**Figure 3.** Caving roof near the working face end.

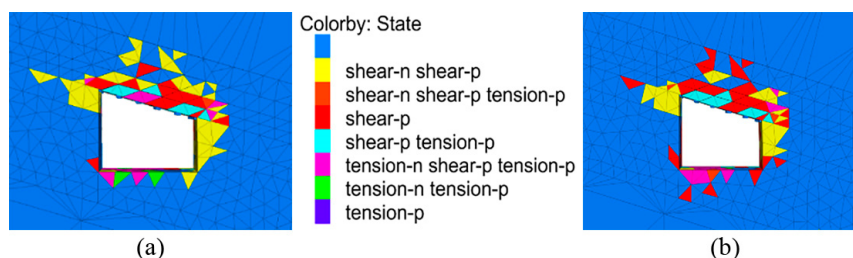
Figure 9. Plastic zone of surrounding rock: (a) Plastic zone before disturbance; (b) Plastic zone after disturbance.

Figure 9a,b show the plastic distribution zone before and after the dynamic disturbance of the gateway surrounding rock mass, respectively. The stress wave had countless reflections and refractions on the roof crack surface according to the stress wave propagation theory, and the tensile stress would cause changes to the roof rock mass stress state and result in a combination of shear failure on existing joints/weakness horizons, an extension of critically oriented joints and propagation of new fractures through previously intact rock so that the integrity of the roof became poor, the plastic zone expanding into the higher strata, and the ultimate widespread destruction of the roof rock mass [7]. At the same time, the two gateway sides and floor rock mass also produced plastic damage under the stress wave action, but had small extended failure zones.
