# Fatigue Crack Growth in Welded S355 Samples Subjected to Bending Loading

**Abstract:** The paper presents a result of experimental tests of welded S355 samples subjected to bending loading. In order to analyze how the fillet joints' shape and the load ratio affect the crack growth, we selected two kinds of the fillet shape: concave and convex, and load ratios, namely  $R = -1$ . Samples with stress concentrators in form of the two-sided fillet welded joint were tested. The test results were compared to experiments conducted on welds samples with and without heat treatment.

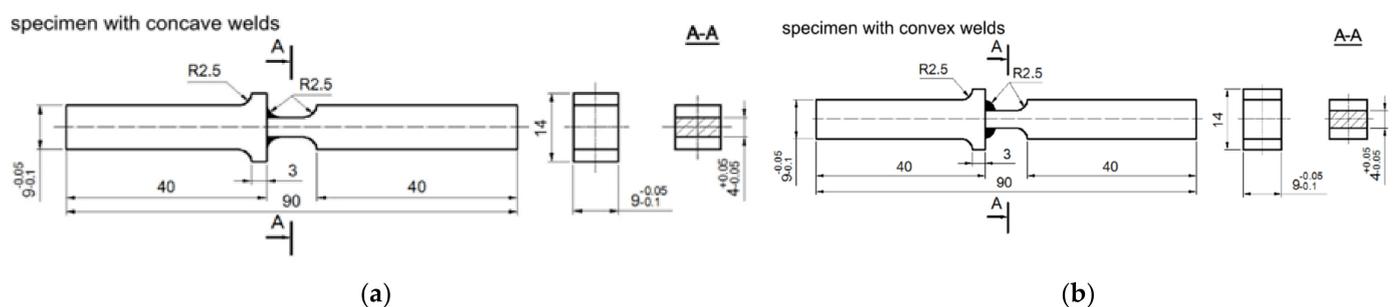
**Figure 1.** Geometries of specimen: (a) with concave welds, (b) with convex welds, (dimensions in mm).

The experimental tests were carried out on samples welded without heat treatment and on samples after two different heat treatments. The first heat treatment was performed by subjecting the samples to annealing at the temperature of 630 °C for 2 h. However, the second heat treatment consisted of normalizing annealing at the temperature of 940 °C for 1.1 h [8–15]. Geometries of the tested samples are presented in Figure 1.

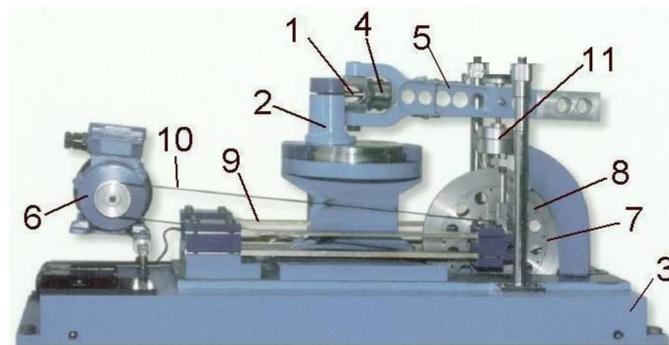
**Figure 2.** MZGS-100 machine, where: 1—specimen, 2—rotational head with a holder, 3—bed, 4—holder, 5—lever, 6—motor, 7—rotating disk, 8—unbalanced mass, 9—flat springs, 10—driving belt, 11—hydraulic connector.

Metallographic tests were performed with the use of an optical microscope OLYMPUS IX70 (Olympus Corporation, Japan). The test to fatigue crack growth under cyclic bending were performed in the laboratory of the Department of Mechanics and Machine Design at Opole University of Technology on the fatigue test stand MZGS-100 [15,16] (Figures 2 and 3). The tests were conducted under amplitude of total force moment control with the loading frequency 28.4 Hz. The scope included fatigue tests under low-cycle fatigue (LCF) and high-cycle fatigue (HCF) conditions. The samples restrained on one side were loaded with a constant amplitude of moments with the value  $Ma = 9.2 \text{ N}\cdot\text{m}$  and the load ratio  $R = -1$ . The theoretical stress concentration factor, estimated with use of the model [17], in the solid specimen with concave weld under bending was  $K_t = 1.38$  while it was 1.56 for the convex weld configuration.

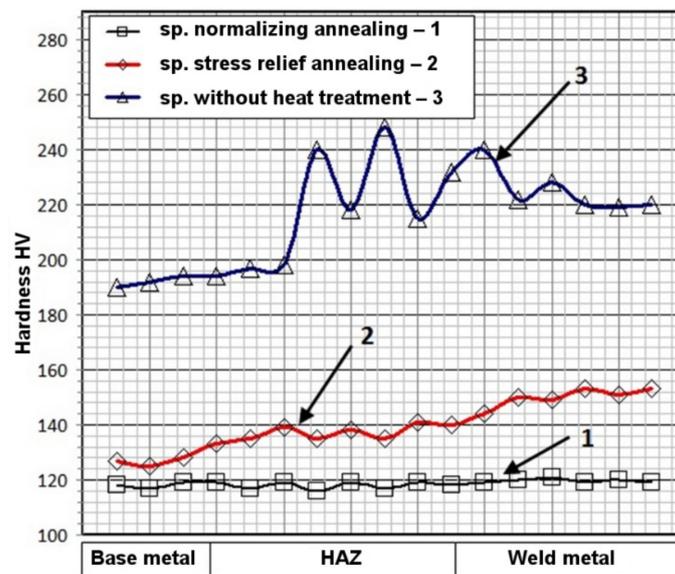
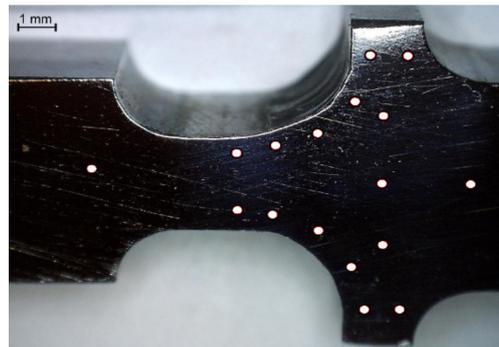
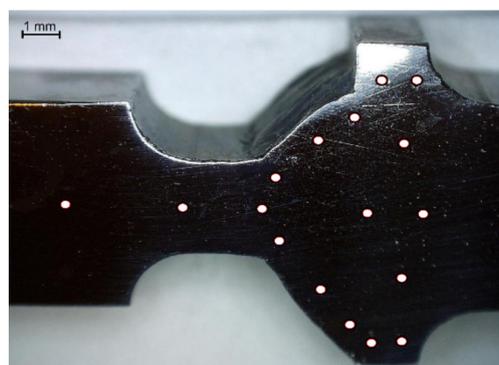
**Figure 4.** Hardness values including the location of the measurement in the samples, (a) hardness diagram; (b) place of measurement in strokes with concave welds; (c) place of measurement in strokes with convex welds. HAZ: heat-affected zone.

Selected solid and welded samples were subjected to hardness tests using the Vickers  $HV_{0.1}$  method, in accordance with the EN ISO 9015-1 standard. The results of hardness measurements of welded specimens without heat treatment (HT) and after HT are shown in Figure 4 for the averaged results of samples with concave and convex welds. For the native material of the specimens, the hardness values remained at the level of (188–189  $HV_{0.1}$ ). However, for specimens welded without HT, the hardness values changed significantly depending on the place of measurement. For the base material, the hardness remained the same (188–189  $HV_{0.1}$ ). While in the heat-affected zone (HAZ) large fluctuations in hardness were observed (194–248  $HV_{0.1}$ ). Then, moving to the work piece, the measured values decreased and stabilized (230–220  $HV_{0.1}$ ). In the specimens subjected to relief annealing (temperature 630 °C and time 2 h), the measured hardness and their variability were lower compared to the hardness of the specimens without HT. However, in the specimens subjected to normalizing annealing (temperature 940 °C and time 1.1 h), the hardness and their fluctuations reached the lowest values, compared to all tested specimens.

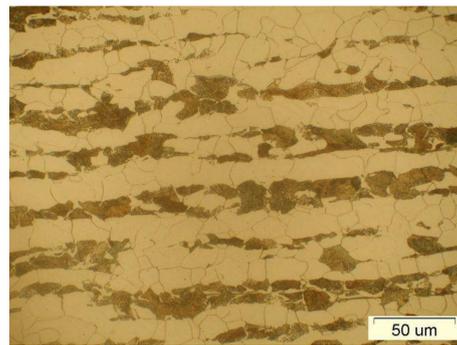
**Figure 5.** Steel structure base metal.

The metallographic tests of the base material confirmed the ferritic–pearlitic microstructure with a band pattern (base—Figure 5). The base material was characterized by ferrite grains with a diameter of 5 to 40  $\mu\text{m}$  and similar grain sizes of pearlite with a diameter of 5 to 45  $\mu\text{m}$ .

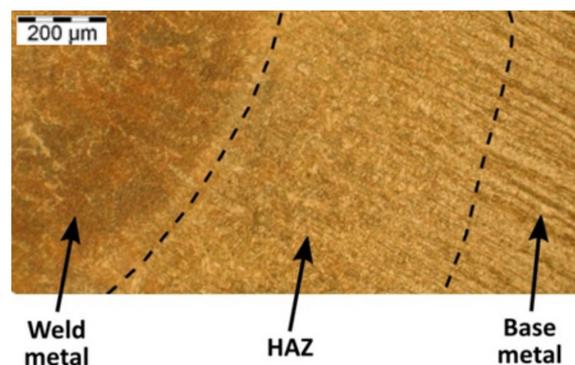
**Figure 6.** Three regions of samples welded without heat treatment: the base material, heat-affected zone (HAZ) and the weld region.

Figure 6 shows the zoning image observed in the test specimens without HT (Base metal, HAZ, Weld metal). The base material has the typical ferritic–pearlitic microstructure of the material used. In the heat-affected zone, microstructures can be distinguished: partially recrystallized, fine grained normalized zone, lower bainite zone, upper bainite and martensite structure. On the other hand, the microstructure of the weld was dendritic with grains in the Widmanstätten system.

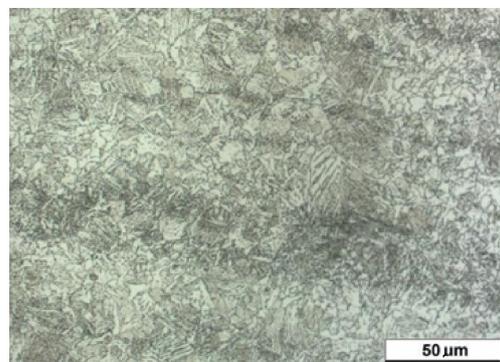
**Figure 7.** Microstructure of the welded specimen after relief annealing (500× magnification), bainite and sorbite structure.

The microstructure of the material of the welded specimen subjected to relief annealing is shown in Figure 7. In the heat-affected zone there is a coarse-grained structure of bainite and sorbite.

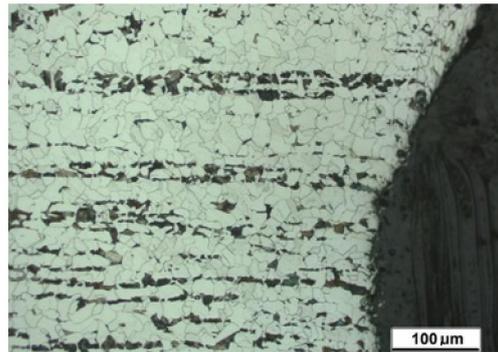
**Figure 8.** Microstructure of the welded specimen after normalizing annealing, ferrite with a small amount of pearlite.

The microstructure of the material of the welded specimen subjected to normalizing annealing is shown in Figure 8. In the case of normalizing annealing in the weld and HAZ, a coarse-grained ferrite structure with a small amount of pearlite was formed.

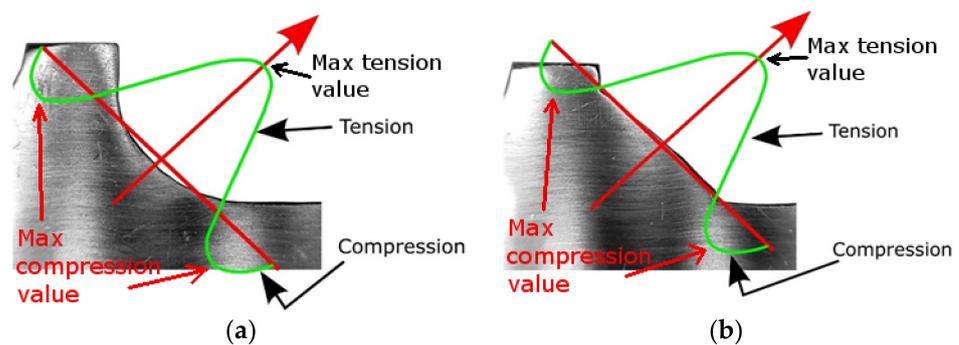
**Figure 9.** The distribution of residual stresses in the tested T-joints with fillet welds, where: (a) samples with concave welds, (b) samples with convex welds.

Additional stresses appear in the material of welded specimens as a result of uneven solidification of welds and the occurring structural changes. Residual stresses (RS) do not depend on the action of external forces. Tensile stresses occur in the weld face zone, and compressive stresses in the HAZ zone. Measurements were made using the strain gauge and trepan method in accordance with the standard (ASTM E837-08). The stress distribution in the tested specimens is shown in Figure 9. The tensile stress values reached their maximum values up to 280 MPa in the center of the welds for joints without HT. On the other hand, the compressive stresses in the HAZ regions. These stresses can cause deformation of the workpiece. The distribution of stresses and their values in samples with convex and concave welds was similar.

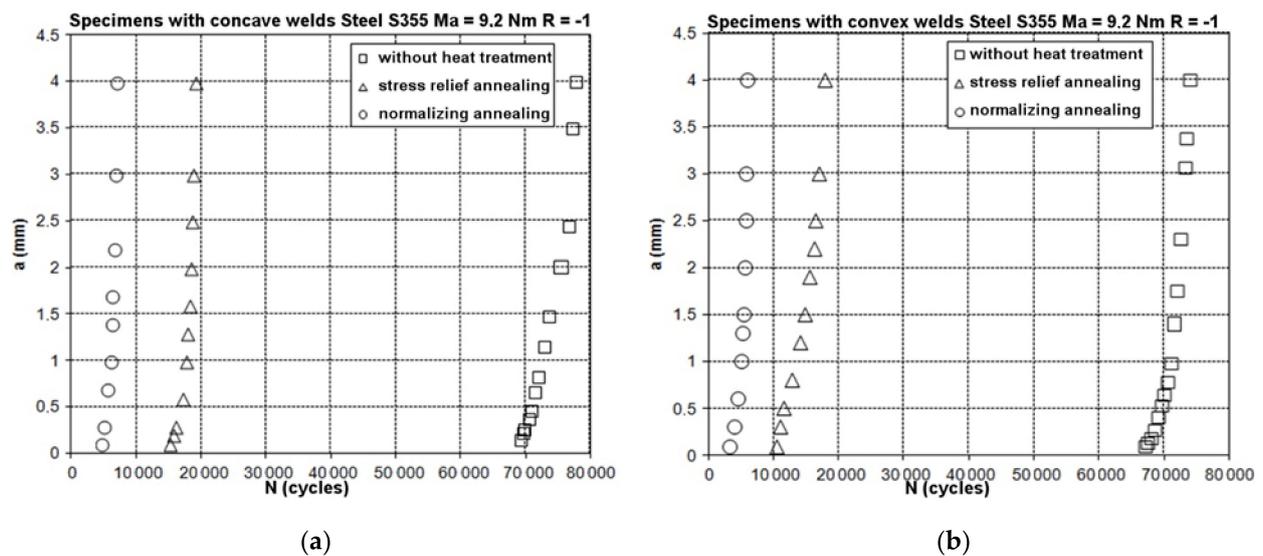
**Figure 10.** Fatigue crack length vs. number of cycles under bending for specimens with: (a) concave welds, (b) convex welds.

Figure 10 shows the fatigue crack lengths “a” as a function of the number of cycles “N” for the tested samples, the values of which were closest to the average of the five tested samples. The scatter of the results ranged from 2 to 3%. From Figure 10a, the lowest fatigue life for the specimen after normalizing and concave welds can be seen. Crack initiation (0.10 mm) was at 4700 cycles. The further development of the crack was rather quick and the specimens failed at 7000 cycles. In the specimens subjected to relief annealing, the initiation of fatigue cracks occurred at the number of cycles of 15,100 cycles, and the failure of the specimens occurred at the number of cycles of 19,000. The specimens without heat treatment showed the highest fatigue life, in which the crack initiation took place at the number of cycles of 69,000, and their failure at the number of cycles of 77,500.

Figure 10b shows the results of fatigue tests for specimens with convex welds, where it can also be seen that in this case the lowest fatigue life was shown by the specimens after normalizing annealing. Crack initiation (0.10 mm) was at 3200 cycles. Further growth of cracks occurred at a rapid pace and the specimens failed at 5900 cycles. In the samples subjected to relief annealing, the initiation of fatigue cracks took place at the number of cycles of 10,500 cycles, and the failure of the specimens occurred at the number of cycles of 18,000. Samples without heat treatment, as in the case of specimens with concave welds, showed the highest fatigue life, where the crack initiation took place at the number of cycles of 67,000, and their failure at the number of cycles of 74,000.

The differences in the fatigue life of the tested specimens with concave and convex welds are significant. In the case of specimens with concave welds, the decrease in fatigue life of relief annealed specimens was 75%, and for specimens annealed normalizing it was 90% compared to specimens without heat treatment. As in the case of specimens with concave welds, a 76% decrease in fatigue life of relief annealed specimens was observed for samples with convex welds, and 92% for specimens with normalizing annealing compared to specimens without heat treatment. When comparing the durability of samples with concave and convex weld faces, for the same specimen states (without heat treatment and after heat treatment), it can be seen that for specimens with concave welds, the durability was always higher compared to specimens with convex welds. The decrease in fatigue life of specimens with convex welds without heat treatment and relief annealing was 6%, and for specimens with normalizing annealing, it was 15% in comparison to specimens with concave welds. According to the authors, the significant drops in fatigue life in the specimens subjected to heat treatment were caused by structural changes taking place in the tested material. On the other hand, the higher durability of specimens with concave welds compared to specimens with convex welds was due to the occurrence of sharp notches in specimens with convex welds, which gave rise to cracks.

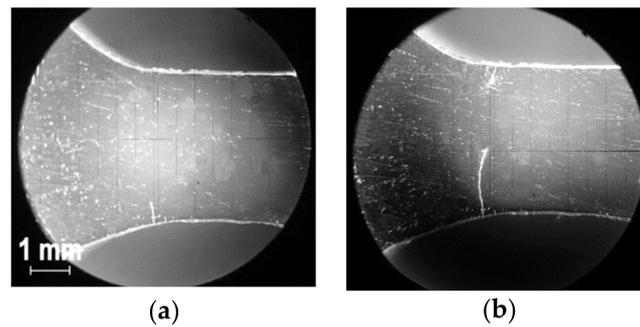
**Figure 11.** Selected stages of crack development in a specimen with concave welds in bending without HT (heat treatment), where: (a) crack initiation; (b) crack initiation and propagation.

Exemplary fatigue crack path is shown in Figure 11 for a specimen with concave welds (without HT) and in Figure 12 for a specimen with convex welds under bending (without HT). During experimental tests, the crack initiation occurred on one side of the sample, most often on the upper surface and less often on the lower surface. A single crack propagated to a certain value, after which a crack also appeared on the other side of the sample.

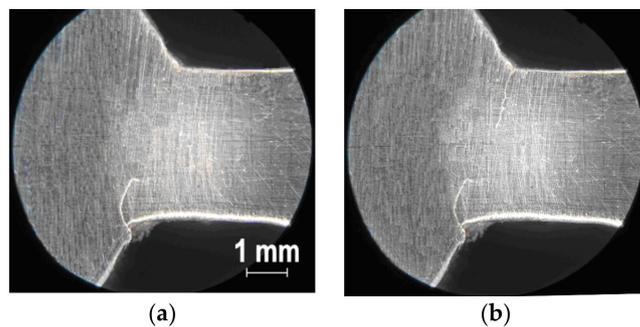
**Figure 12.** Selected stages of crack development in a specimen with convex welds in bending without HT, where: (a) crack initiation; (b) crack initiation and propagation.

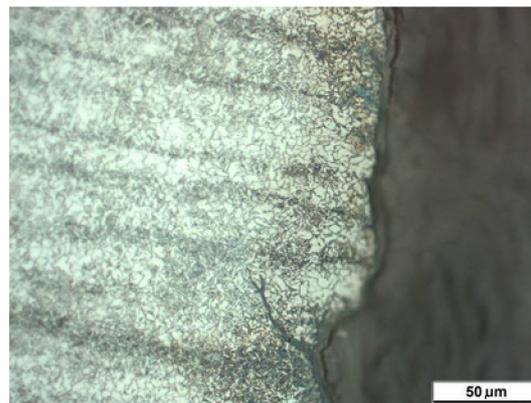
**Figure 13.** Development of secondary cracks.

Figure 13 shows a damaged specimen after relief annealing. The main fracture is located outside the weld and the original HAZ in the area of the sample with a spheroidite structure, strip enriched with fine-grained cementite (carbides). From the main fracture, numerous lateral fractures initiated in areas rich in carbide precipitates developed.

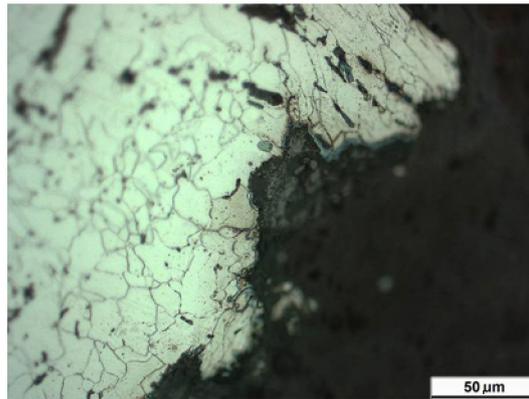
**Figure 14.** Damaged welded sample after normalizing.

A sample welded after normalizing annealing is shown in Figure 14. The main crack propagation took place outside the weld in a homogeneous structure of the ferritic-pearlitic zone of the HAZ. There are also side cracks propagating along the grain boundaries. Within the scrap, mixed cracking is observed: brittle and plastic with areas of high plastic deformation.
