Seismic Experimental Assessment of Remote Terminal Unit System with Friction Pendulum under Triaxial Shake Table Tests

Citation: Kim, S.-W.; Jeon, B.-G.; Yun, D.-W.; Jung, W.-Y.; Ju, B.-S. Seismic Experimental Assessment of Remote Terminal Unit System with Friction Pendulum under Triaxial Shake Table Tests. *Metals* **2021**, *11*, 1428. <https://doi.org/10.3390/met11091428>

Keywords: electrical cabinet; triaxial shake table; friction pendulum; seismic isolated device

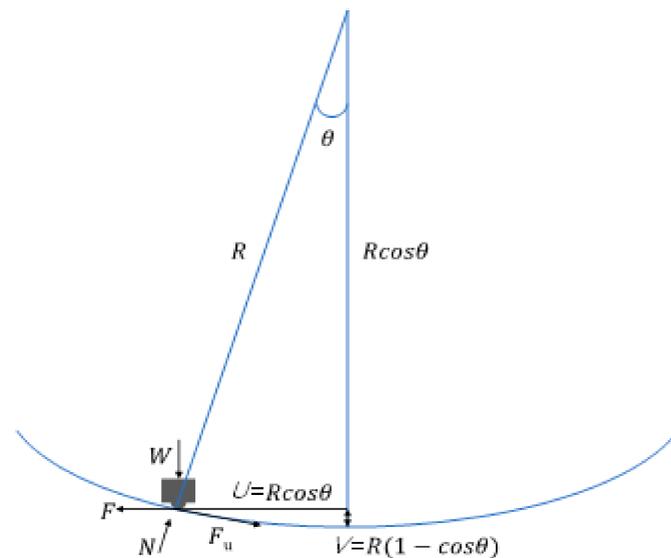
Figure 1. Typical principle of a friction pendulum system.

The FPS, a seismic isolator of the friction series, is a device that can determine the natural frequency of the target structure by using the characteristics of the pendulum. As shown in Figure 1, it moves like a pendulum along a horizontal direction on a curved surface to show the effect of seismic isolation based on the dissipation of seismic energy. The horizontal direction force (F) of the FPS can be expressed as

where W , R , U , μ , and \dot{u} represent the vertical load from the upper structure, radius of curvature of the curved surface, horizontal displacement, surface friction coefficient, and velocity, respectively. The natural period of the FPS can be determined by R , regardless of the upper structure mass, according to Equation (2).

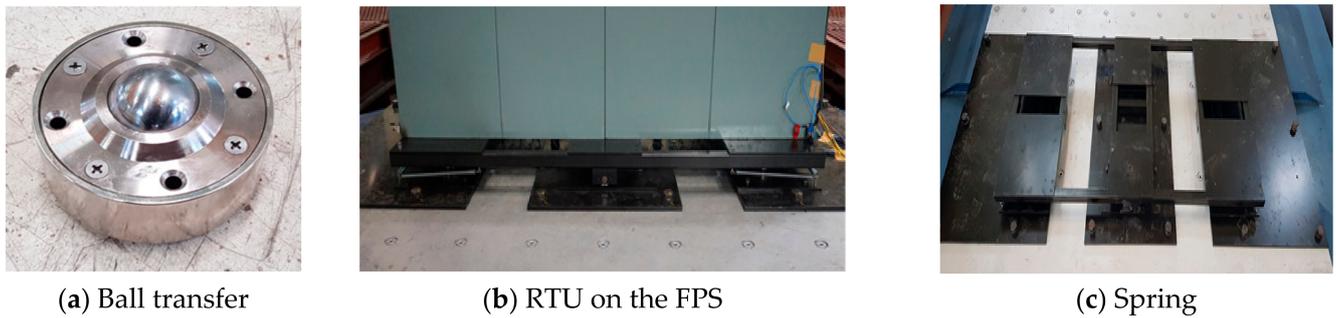
Figure 2. Non-overtourn seismic isolator on the shaking table.

The existing FPS can cause a separation of the ball and impact due to uplift induced by vertical vibration, and can cause overturning of the cabinet equipment due to unstable conditions. The seismic isolator, used as a type of FPS in this study, is a non-overturn seismic isolator manufactured by Power&Tech Co., Ltd, Seongnam-si, Korea. To prevent the separation of the ball, a ball transfer, as shown in Figure 2a, was installed, and the spring connecting the upper and lower plates of the seismic isolator system ensures horizontal and vertical restoring forces, as shown in Figure 2b. Figure 2c illustrates the system with a spring as a type of FPS.

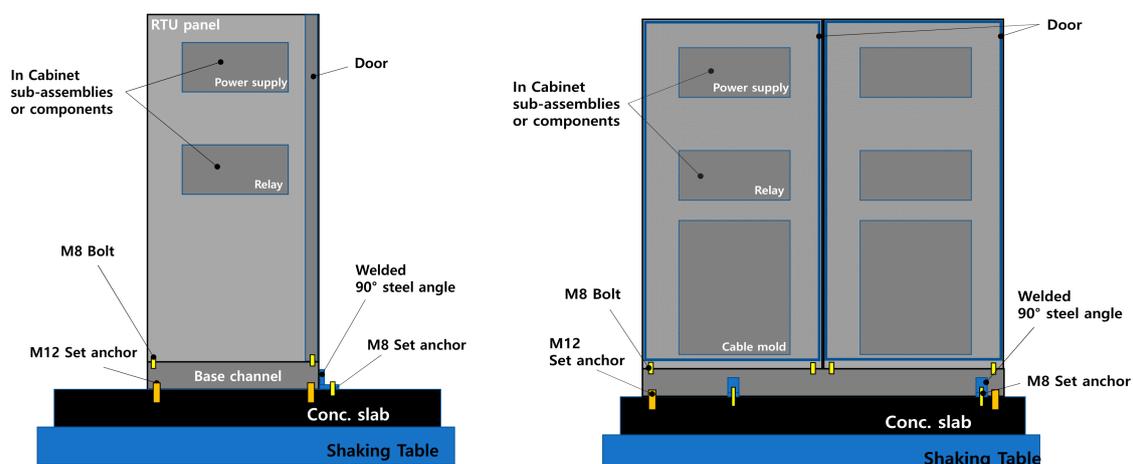
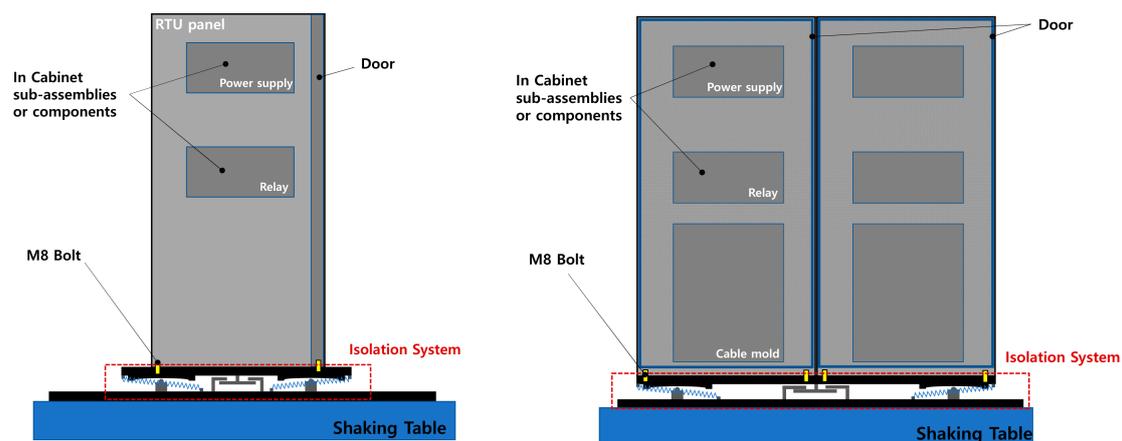
(a) Case 1: RTU panel on concrete slab

(b) Case 2: Base-isolated RTU panel

Figure 3. Description of the RTU systems on the shaking table.

Next, a triaxial shake table test corresponding to the conditions listed in Table 2 was conducted. Case 1 was applied to illustrate the on-site installation conditions of the RTU system. After fixing the enclosure of the grouped RTU panel to one base channel, as shown in Figure 3a, the RTU system was installed using a set anchor on the concrete foundation fixed to the shaking table. The RTU panel was connected to the base channel using eight M8 bolts. Both ends of the base channel were fixed to the concrete foundation with two M12 set anchors, and two L-shaped angles in front of the RTU panel were connected to the base channel by welding. Next, it was fixed to the concrete with each M8 set anchor. For Case 2, as described in Figure 3b, the RTU was fastened to the top plate of the seismic isolator using eight M8 bolts, and then the seismically isolated device was coupled with M30 bolts on the shaking table. In addition, the design properties in terms of M8 and M12 set anchors listed in the Table 3, and the tensile resistance force of M30 set anchors as a high strength bolt was 403 kN.

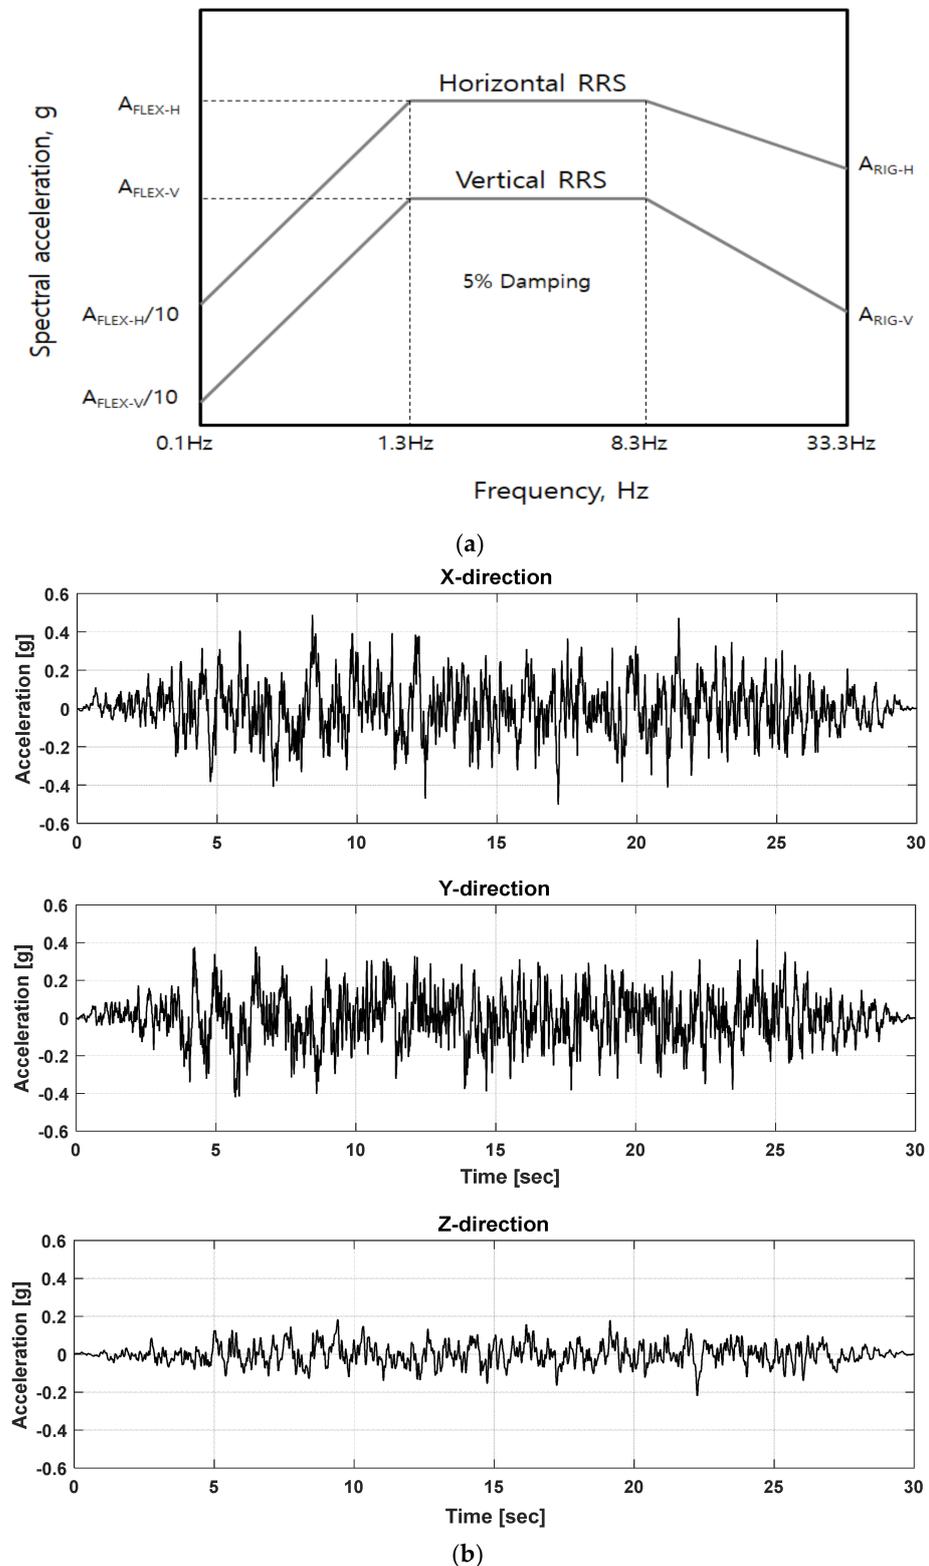
Figure 4. Input motion (a) RRS based on ICC—ES AC 156, (b) acceleration time histories.

performed until structural or functional damage occurred. Figure 4a demonstrates the RRS based on ICC-ES AC 156 considering the floor level response of the structural system, and Figure 4b shows the time histories of each direction of EQ1. Table 4 lists the parameters used to generate the RRS.

The acceleration time history was implemented using a trapezoidal envelope function in accordance with ASCE 4-98 [33], and the correlation of each axial direction (x , y , z) was examined. The coefficient of correlation function at xy , xz , and yz planes was set as 0.3 or less, based on ASCE 4-98 and IEEE Std. 344 [34]. The duration of the acceleration time history with respect to the artificial ground motion was 30 s and, in this case, the duration of the strong ground motion was 20 s. Furthermore, with this acceleration, the magnitude of the acceleration increased for the first 5 s, and then the strong ground motion continued for 20 s. Subsequently, the magnitude of acceleration decreased during the last 5 s.

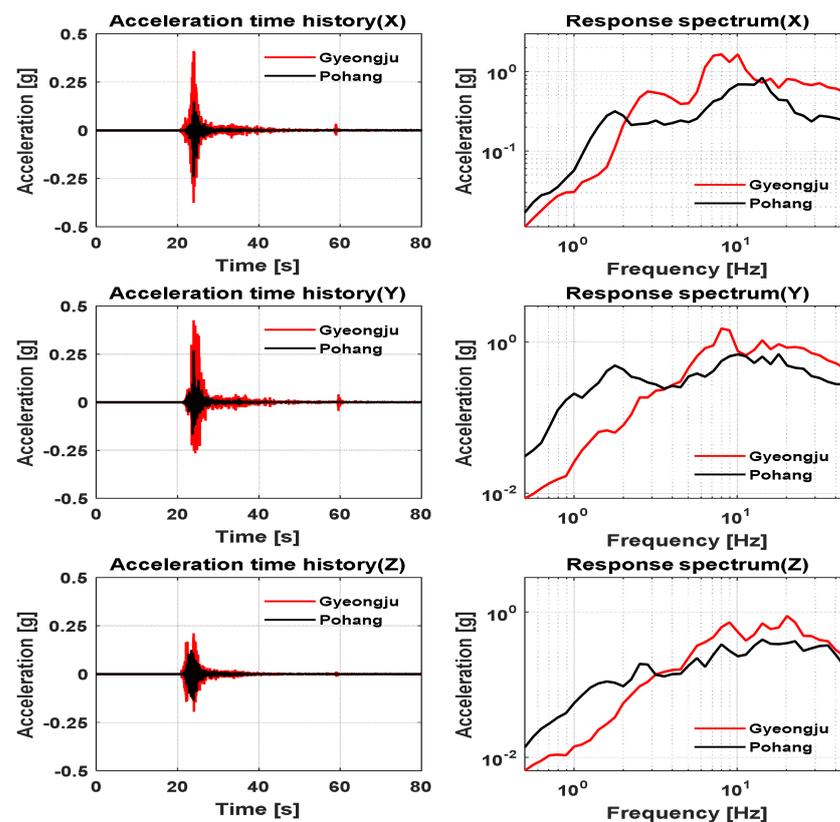
Figure 5. Acceleration time histories and response spectra for Gyeongju (USN) and Pohang (PHA2) earthquakes.

In this study, among historical earthquakes in Korea, the Gyeongju and Pohang earthquakes, which caused significant damage, were selected as input ground motions to conduct the shaking table test. The peak ground acceleration (PGA) of the Gyeongju earthquake (USN) and Pohang earthquake (PHA2) was 0.43 g and 0.27 g, respectively. In addition, each ground motion exhibited different frequency components. Overall, the spectral acceleration of the Pohang earthquake was greater than that of the Gyeongju earthquake in the low-frequency range (below 2 Hz). However, the Gyeongju earthquake showed greater spectral acceleration than the Pohang earthquake in the high-frequency range (over 10 Hz). Figure 5 demonstrates the acceleration time history and response spectra for Gyeongju and Pohang.

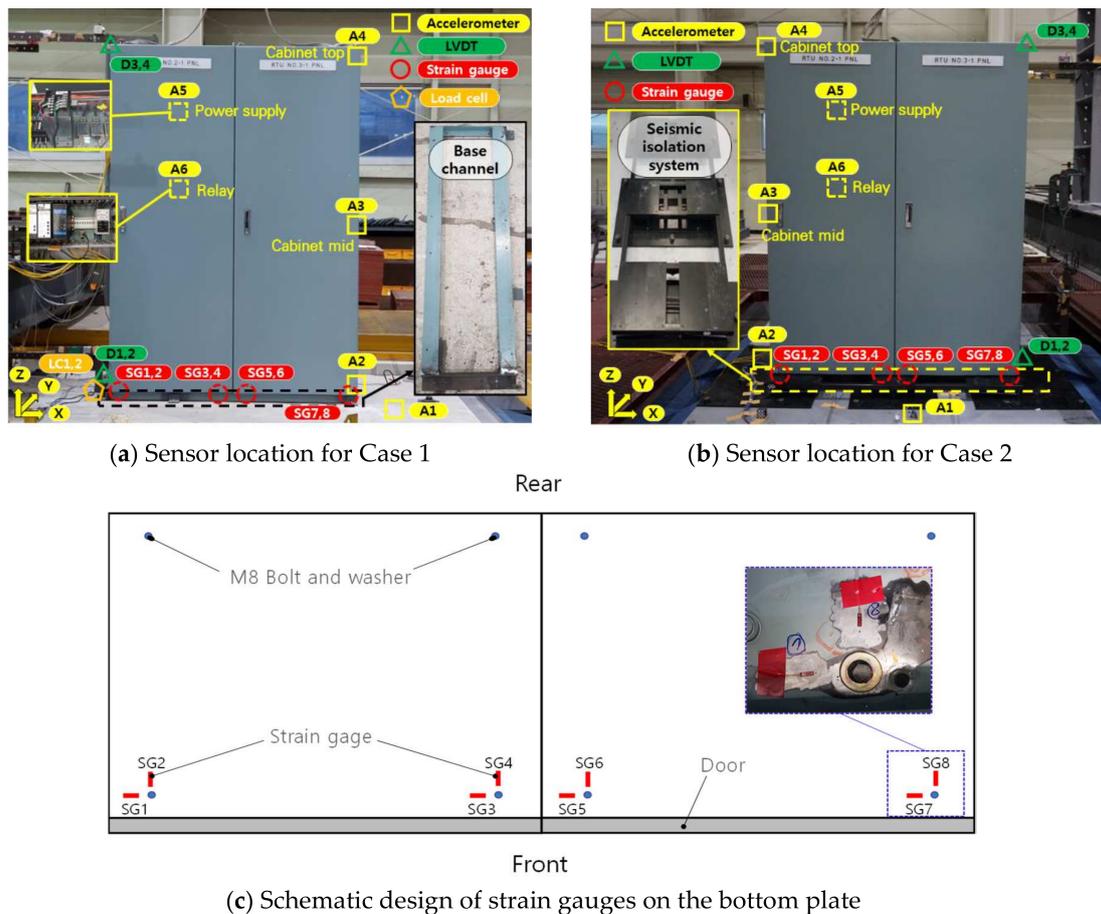
Figure 6. Sensor locations for the cabinet.

In this experimental test, the acceleration response was measured by installing three-axis accelerometers (A2–A6) around the bottom, center, and top of the RTU panel, and the response was obtained around the power supply and relay of the internal main parts of the RTU. Next, to achieve a reliable test response, a three-axis accelerometer (A1) was placed at the bottom of the shaking table. A strain gauge was installed in the horizontal direction, perpendicular to the position 20 mm away from the center of the bolt (SG 1–SG 8). This is because, due to the excessive external force, there is a risk of local deformation at the bottom plate of 2-mm thickness around the bolt connecting the RTU panel and base channel. The strain gauge was set up around the four connecting bolts at the front, as shown in Figure 6, and the displacement sensors were installed at the top and bottom to measure the relative displacement of the RTU panel caused by the seismic input motion. For Case 1, only a load cell was installed to measure the pull-out force of the post-installed anchor connected to the concrete slab and lower channel. Before, during, and after the test, the electrical signal of the main circuit was measured using an AC/DC transducer to monitor the functionality. Figure 6a,b illustrate the location of the sensors according to cases 1 and 2, respectively, and Figure 6c shows the schematic design of the stain gauges.

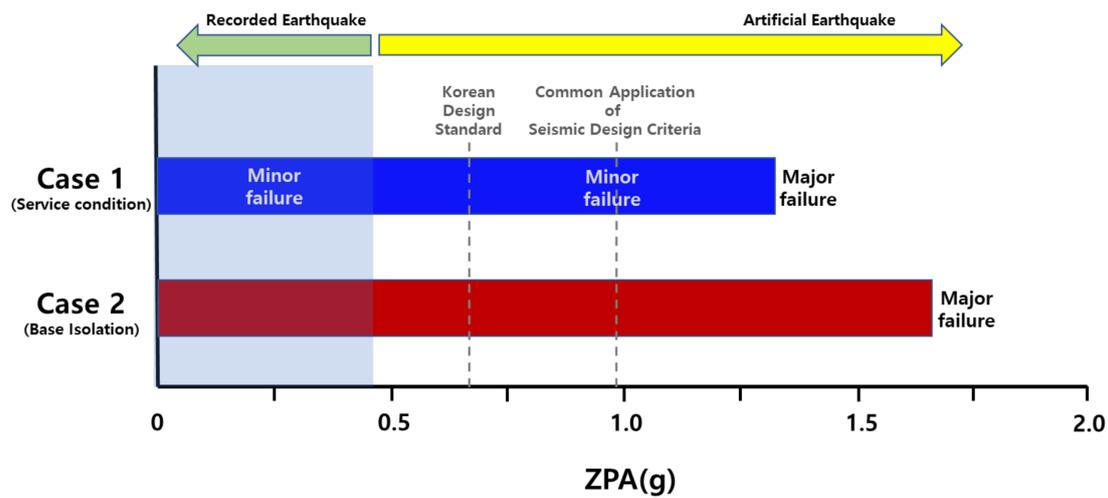
Figure 7. Visual inspection modes.

After the shaking table tests, the power was turned on–off–on to confirm the functionality of the RTU system, and then a visual inspection was conducted to examine the parts for drop-off, deformation, and loosening of bolts. Figure 7 and Table 8 present the visual inspection results. For Case 1, the cable mold was disconnected during the Pohang earthquake, but there was no damage by visual inspection during the Gyeongju and Pohang earthquakes for Case 2. In the case of the seismic simulation test by an artificial earthquake, the cable mold was also uncoupled during Test 6 (EQ #2), and the fixed door device was damaged in Test 7 (EQ #3). Therefore, the door was opened during the test, and the test was terminated. After the shaking table tests, a cup-like deformation occurred around the bolt connection area of the lower plate at the RTU panel, and the M8 anchor set was also damaged, as shown in Figure 8.

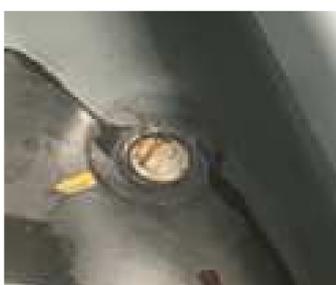
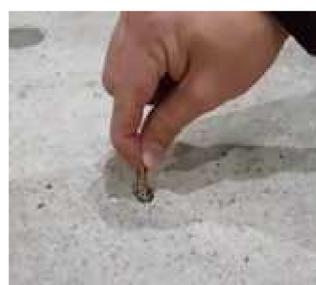
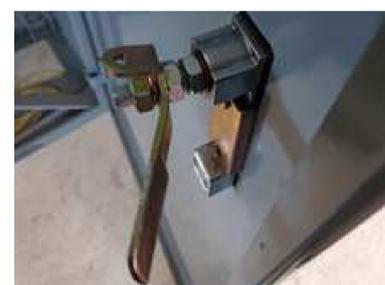
(a) Cup-like deformation

(b) M8 anchor set failure

(c) Door-lock failure

Figure 8. Failure of the RTU system due to EQ #3 for Case 1.

Furthermore, in the RTU panel fixed to the concrete foundation with a set anchor, cup-like deformation occurred around the bolt of the lower plate due to strong ground motion. Moreover, the relative displacement between the top and bottom of the RTU panel significantly increased owing to the seismic load acting in the left and right directions. The impact generated by the lift RTU panel colliding with the lower channel made the internal equipment respond, and the panel enclosure was capable of having a significant impact. However, the application of the seismic isolator can effectively protect the RTU panel from the impact and amplification of seismic forces. In particular, in this study, the non-overturn seismic isolator installed to achieve additional seismic resilience contained a spring that generated a certain level of restraining force in the vertical direction, effectively dealing with the amplification of the seismic force, although a friction pendulum type of the seismic isolator was applied in the horizontal direction. However, it showed that the test was conducted for a recorded earthquake with a PGA of 0.43 g or less and an artificial earthquake with a vertical component of 27% of a horizontal earthquake.

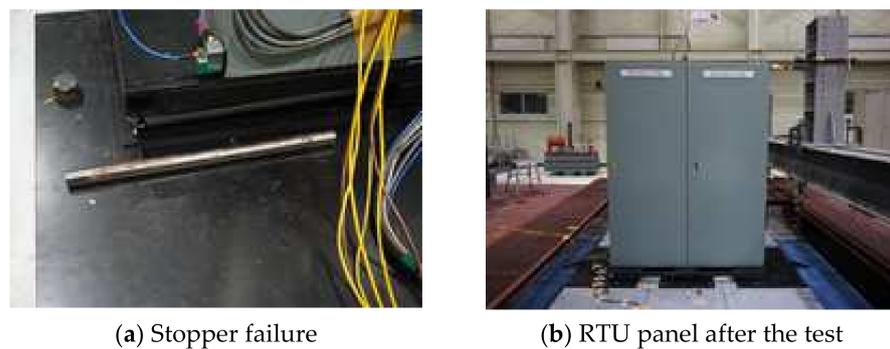
Figure 9. Failure of the RTU system due to EQ #4 (test 8) for Case 2.

The RTU system with the seismically isolated device, however, remained functional and operational during and after the EQ #3 (test 7) loading condition for Case 2. There was also no structural damage during EQ #4 (test 8), but the test was stopped because the fall prevention stopper of the seismic isolator was split, as illustrated in Figure 9. The fall prevention stopper was damaged by the impact generated by the friction pendulum, exceeding the allowable displacement caused by the seismic ground motion. Therefore, the allowable displacement of the slider plate of the friction pendulum system could be adjusted to sufficiently respond to the strong ground motion. Accordingly, we assumed that the uncertainty with respect to other structural damage in the RTU system could be reduced by concentrating the damage mode to the seismic isolators. Notably, the integrity of the electric circuit was maintained until all the seismic simulation tests were completed.

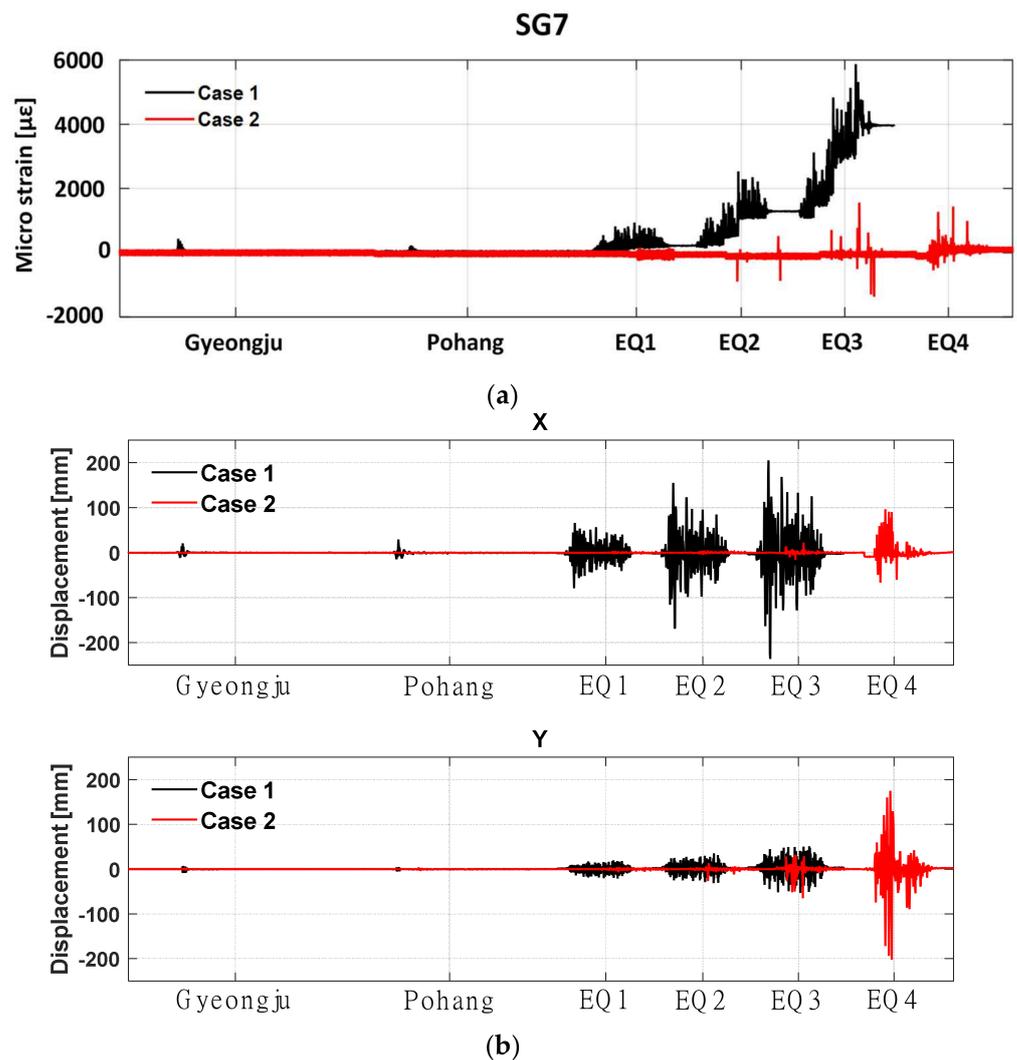
Figure 10. Response of strain and relative displacement of the RTU: (a) strain response and (b) displacement response.

Figure 10a compares the strain response measured at the same location of the lower plate of the RTU panel for cases 1 and 2, and the relative displacement of the upper and lower parts of the RTU panel is described in Figure 10b. Specifically, the strain response of SG7 with relatively significant differences observed in the strain gauge around the fixing bolt, located on the lower plate of the RTU panel, was shown according to the test excitation sequence (Figure 10a). The black and red lines indicate responses of cases 1 and

2, respectively. In all seismic simulation tests, the strain response of Case 1 was significantly greater than that of Case 2. In addition, for Case 1, permanent strain occurred at EQ #1, and the value of 0.002 for the maximum strain response was exceeded at EQ #2. Finally, the permanent strain of 0.00396 occurred in EQ #3. However, for Case 2, the permanent strain of the system without the damage to the seismic isolator was less than 0.0001 up to EQ #3, and the permanent deformation was not as high as 0.00027 or less when the seismic isolator was damaged during the EQ #4 test. Therefore, when a seismic isolator was installed, the structural damage caused by the earthquake was concentrated on it, and the upper device was safely protected. The results of the shaking table test indicate that the deformation of the lower panel in the RTU can be effectively mitigated by the installation of the seismic isolator, with over 99% maximum reduction rate. Table 9 lists the permanent deformation with respect to EQ #3 and #4; herein, SG 1 and SG 8 were excluded due to the damage during the test.

Table 10 and Figure 10b show the unidirectional maximum relative displacements in the left–right (X) and front–back (Y) directions for the top and bottom of the RTU panel. The relative displacement was compared up to EQ #3, in accordance with the results obtained from the experimental tests. In Figure 10b, in terms of the relative displacement time history responses, a signal capable of causing an impact was measured in all the tests of Case 1, wherein the base channel is fixed to a concrete slab with a post-installed anchor. In particular, Figure 10b depicts that the permanent deformation in Figure 10a occurs when a large instantaneous displacement with a short duration is generated by an impact.

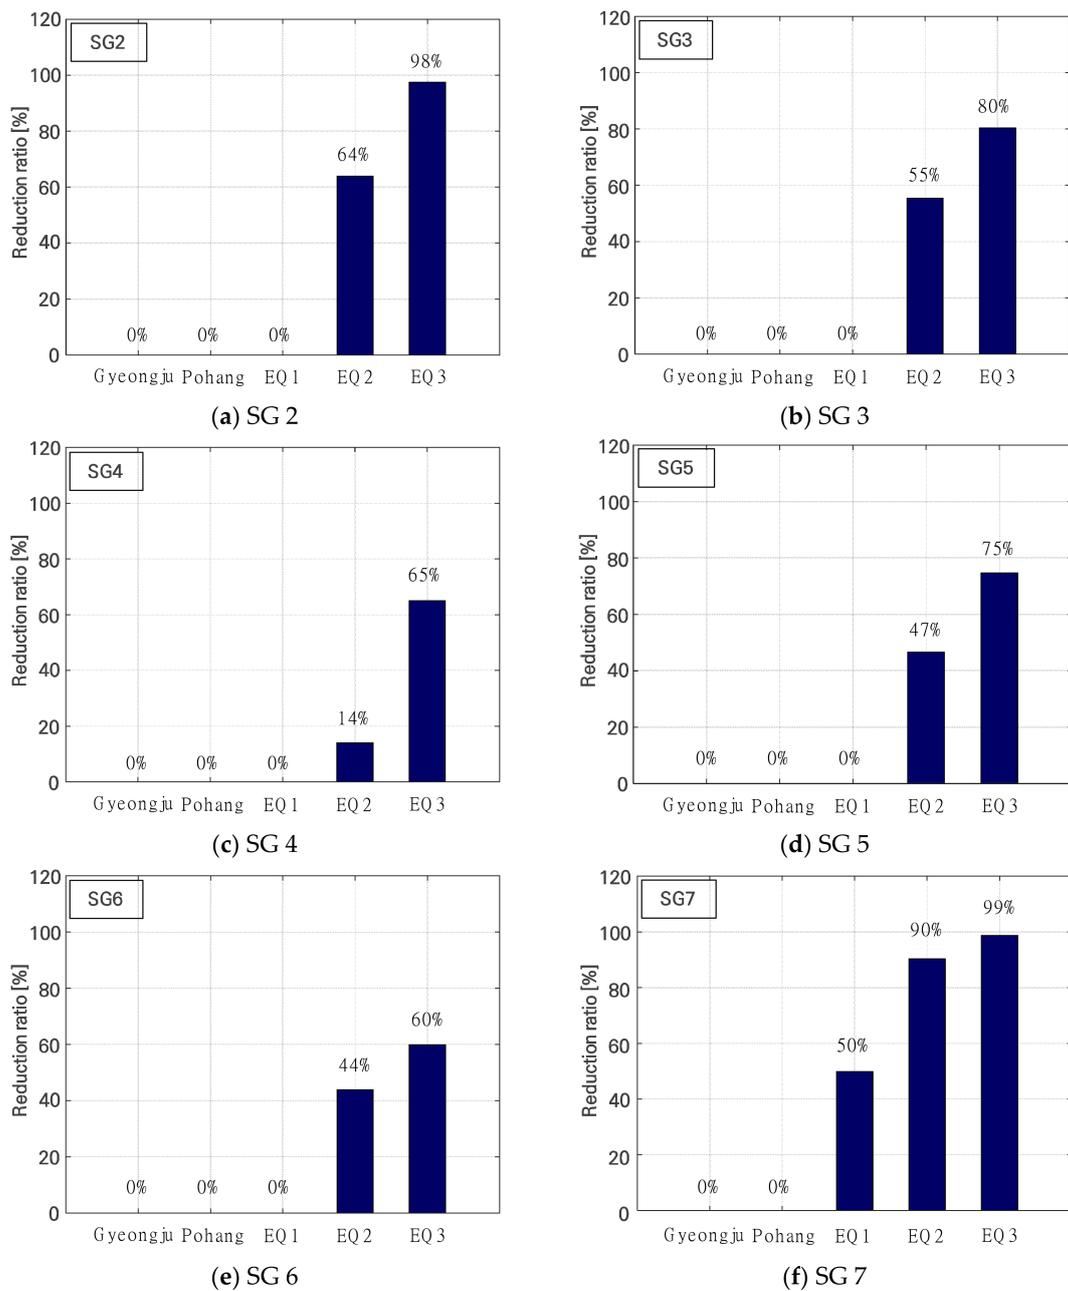
Figure 11. Permanent strain ratios (Case 2/Case 1).

Next, the magnitude of the strain was reduced by up to 90% and 99% in EQ #2 and #3, respectively, as shown in Figure 11, with respect to the permanent strain ratio (Case 2/Case 1). Specifically, the reduction in the strain response was significantly higher in SG 2 and SG 7, which were the strain gauges installed to measure the strain around the bolts, located at both ends of the lower panel of the RTU panel. Therefore, the end of the panel was lifted from shaking due to strong ground motion. This must be controlled because the uplifted cabinet system can cause a strong impact between the lower channel and cabinet. Finally, in this test, the effect of reducing the strain of the cabinet with the seismic isolator was up to 99%, in comparison to the case without the seismic isolator.

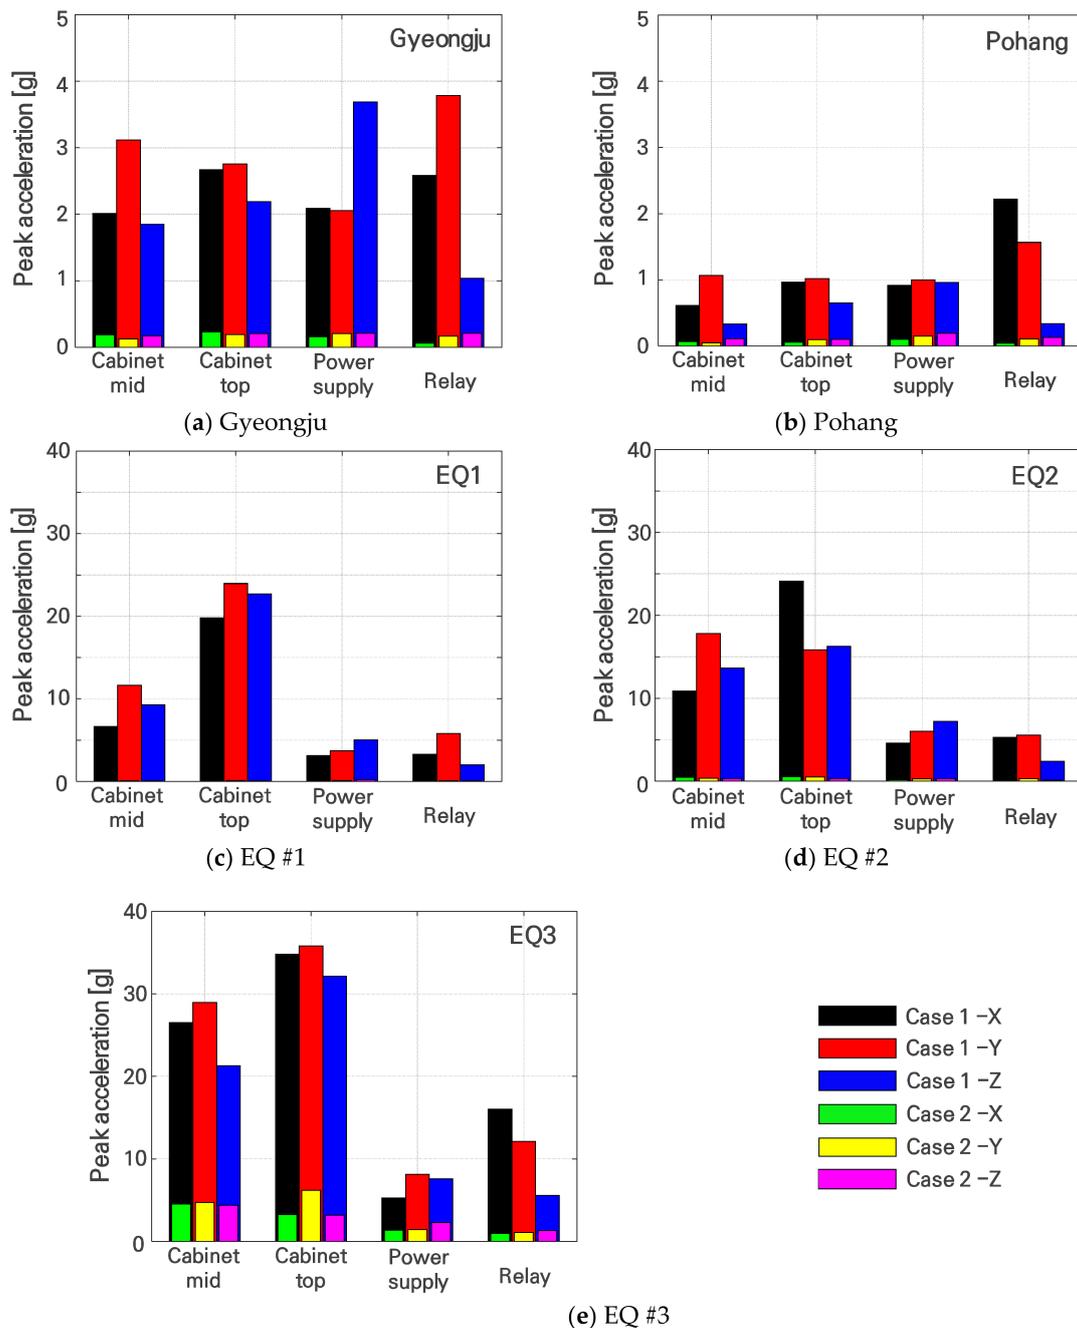
Figure 12. Comparison of peak acceleration responses.

To evaluate the effect of the seismic motion reduction by the seismic isolator, the peak acceleration responses of both the cases were compared, as shown in Figure 12. Figure 12a,b show the peak accelerations related to both the recorded earthquakes. In addition, the peak accelerations corresponding to the artificial earthquakes are illustrated in Figure 12c–e. For Case 1, wherein the base channel is fixed to the concrete foundation with post-installed anchors, in the case of the Gyeongju earthquake (Figure 12a), the peak acceleration response of the internal component power supply and relay was greater than that of the other locations. In particular, the peak acceleration response was 3.78 g, which is the largest in the relay. In addition, for the case of the Pohang earthquake (Figure 12b), the peak acceleration response was 2.22 g at the relay. In the case of the artificial earthquake in Figure 12c–e, the peak acceleration responses were also measured at the top of the panel's enclosure, which were 23.96 g, 24.14 g, and 35.81 g for EQ #1, #2, and #3, respectively. The peak acceleration response measured by the internal power supply and relay was also greater than 5 g for Case 1. In Case 2 of the RTU panel installed with non-overturn seismic isolator, however, the peak acceleration response in the Gyeongju earthquake, Pohang earthquake, and EQ #1 was approximately 0.2 g; the peak acceleration response up to EQ #2, the seismic design level, was less than 0.5 g. Even in EQ #3, the magnitude of the peak acceleration response was quite small compared to Case 1. Figure 13 showed the reduction ratio of the peak acceleration response of Case 1 and Case 2 by Equation (12). Here, a_{max} is peak acceleration of each case. Except for EQ #3, the peak acceleration response of Case 2 in the horizontal direction was at least 85.3%, and up to 99.6% smaller than that of Case 1. In the vertical direction, except for the Pohang earthquake and EQ #3, the peak accelerations measured in Case 2 were approximately 79.7%–99.7% less than those of Case 1. Therefore, the non-overturn seismic isolator applied in this study can effectively control the vibration amplification of the structures during triaxial simultaneous input ground motions. The peak acceleration ratio in the vertical direction, however, was less than that in the horizontal direction.

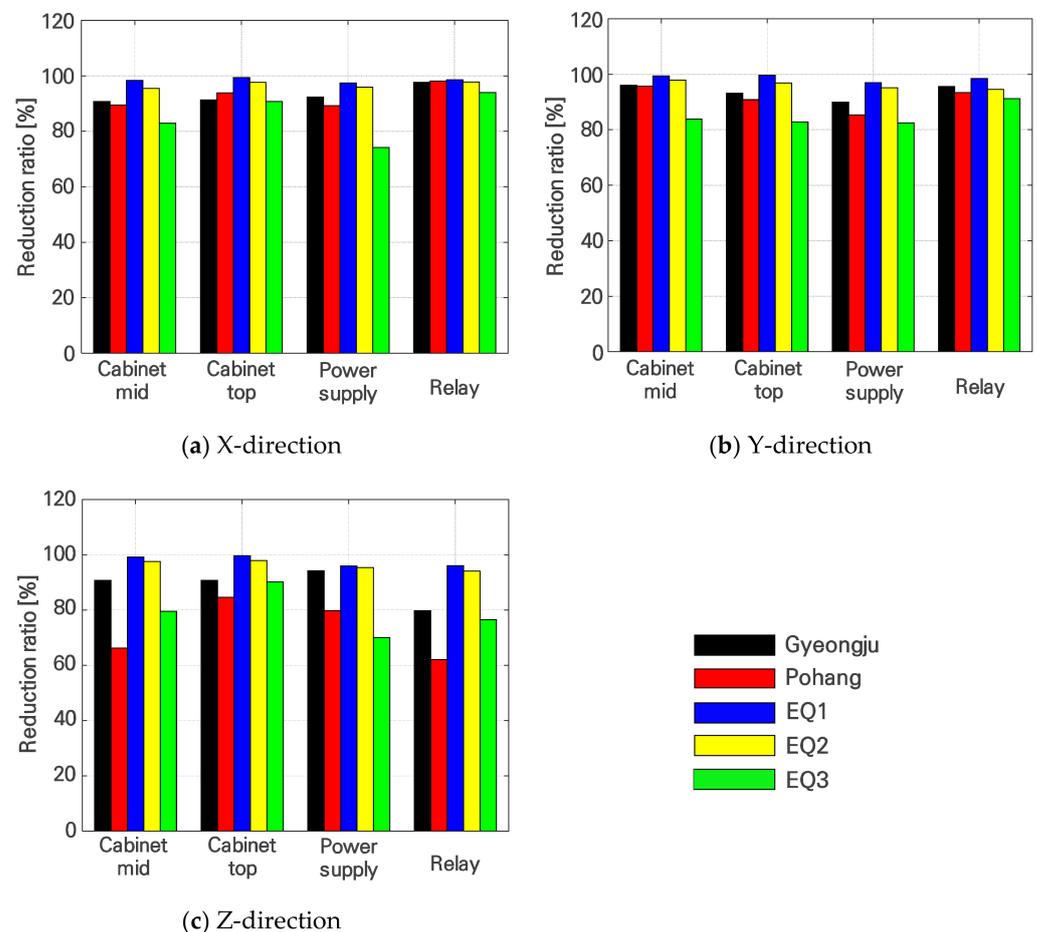
Figure 13. Ratio of peak accelerations (Case 2/Case 1).

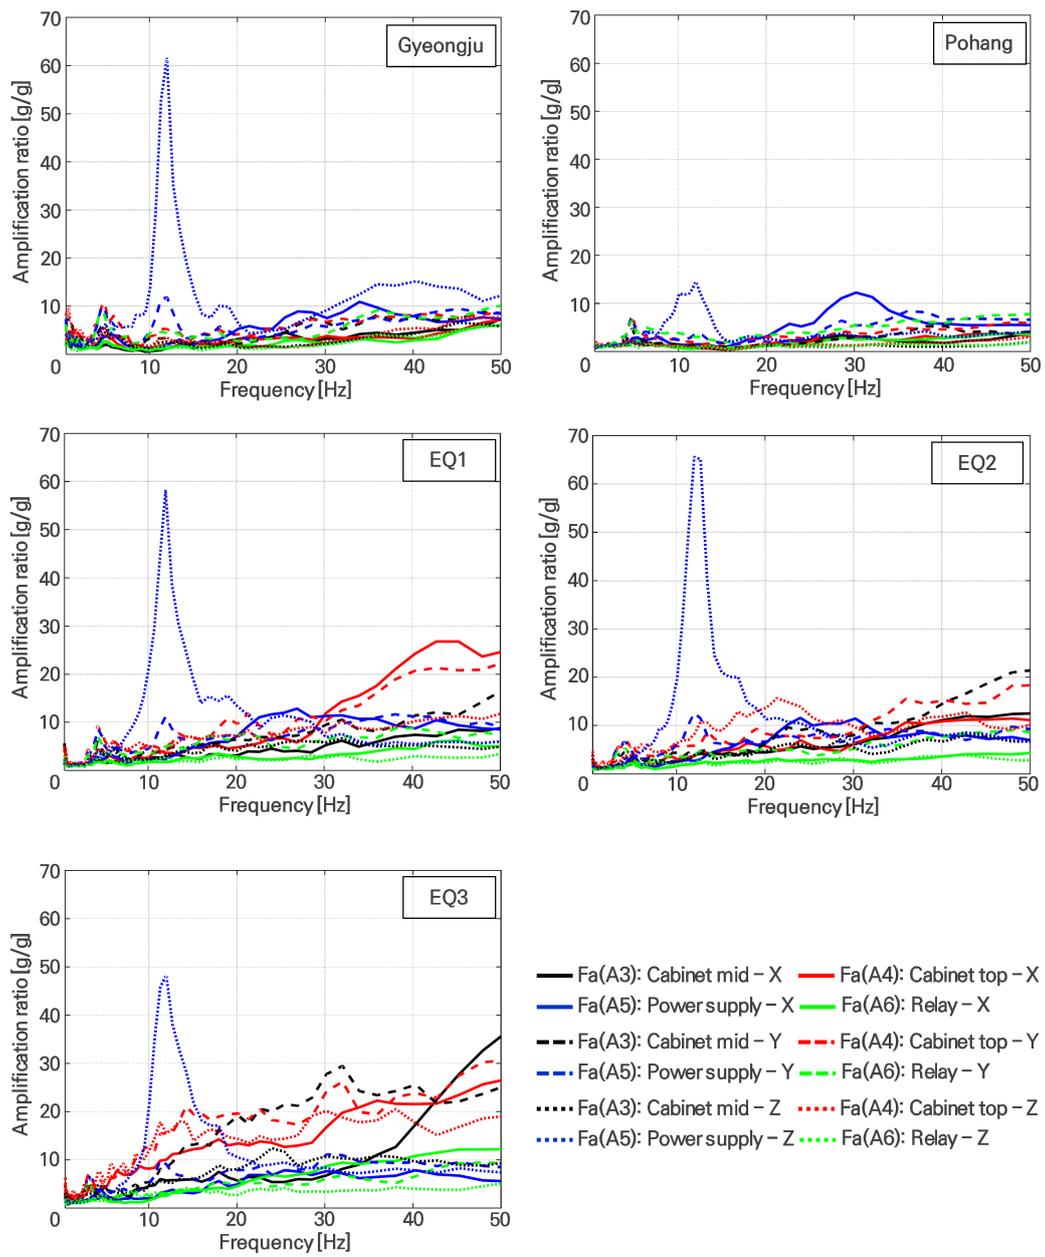
Figure 14. F_a values for Case 1.

Figures 14 and 15 demonstrate $F_a(i)$ for each measurement location for case 1, and 2, respectively. In both cases, the amplification in the vertical direction of the power supply was the largest; in addition, F_a of the power supply for Case 1 was 65. However, for Case 2, the amplification ratio was efficiently controlled to 6 or less. For Case 1, in all earthquakes, excluding the Pohang earthquake, F_a tended to increase rapidly in the frequency region above 30 Hz. The amplification ratio of the response may appear large in the high-frequency region owing to the vibration of the device, thumping of the door, and the impact caused by uplifting [12]. In addition, for Case 2, the peak F_a value up to the EQ #2 test was maintained to less than 1 in both the horizontal and vertical directions. In the EQ #3 test, F_a increased from the RTU panel’s enclosure toward the high-frequency range. Notably, the ball and slider plate collided with the allowable limit displacement of the seismic isolator. Compared with Case 1, the value for Case 2 was less than 1/7. Table 11

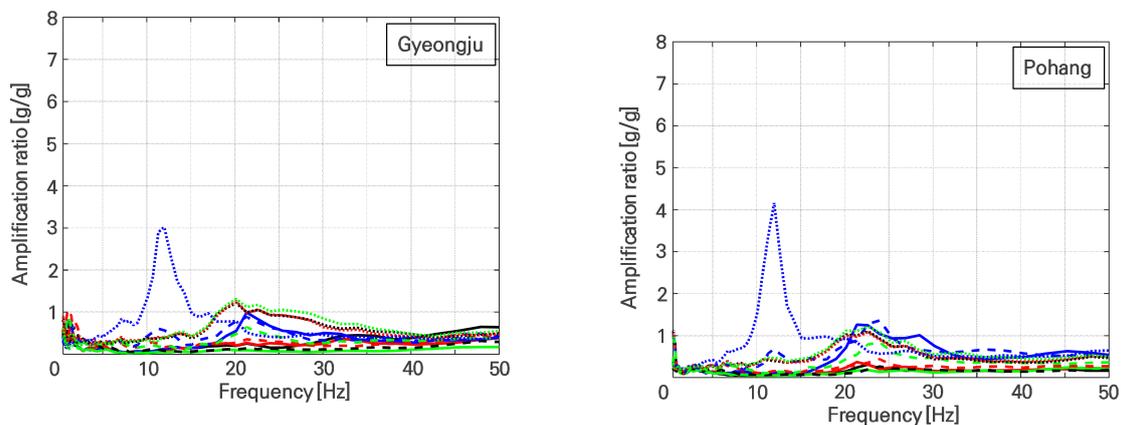
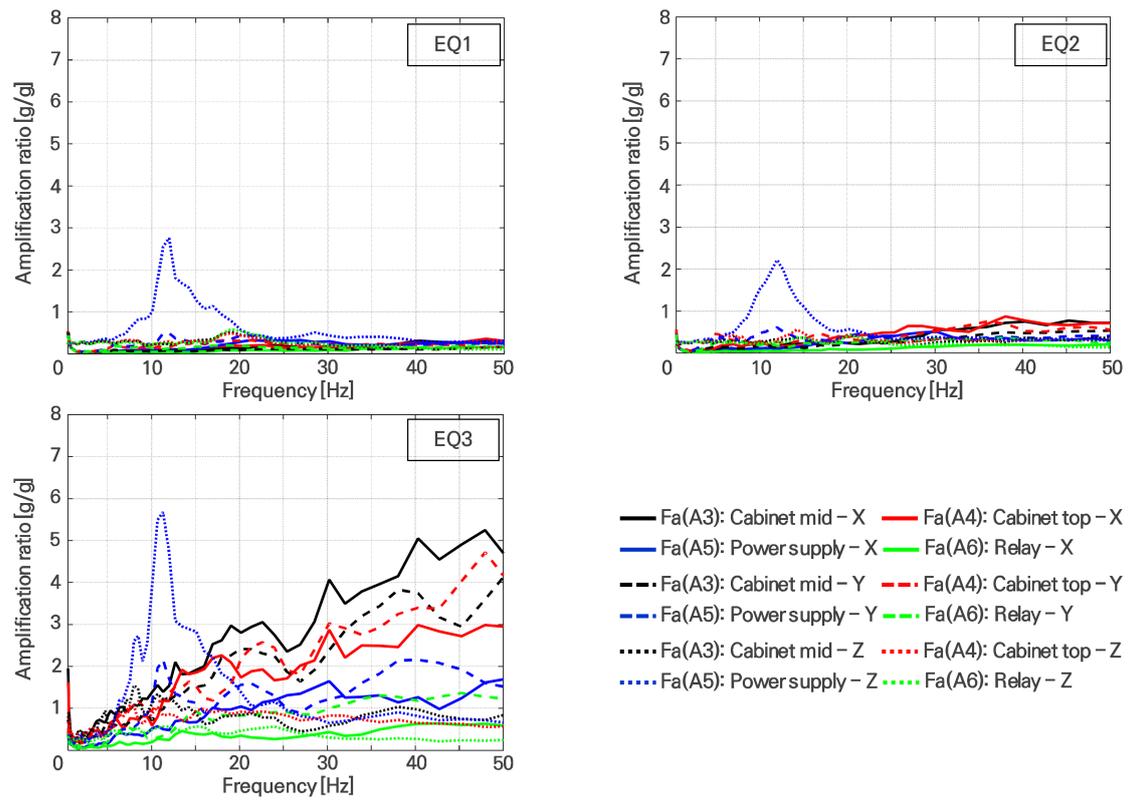
Figure 15. F_a values for Case 2.

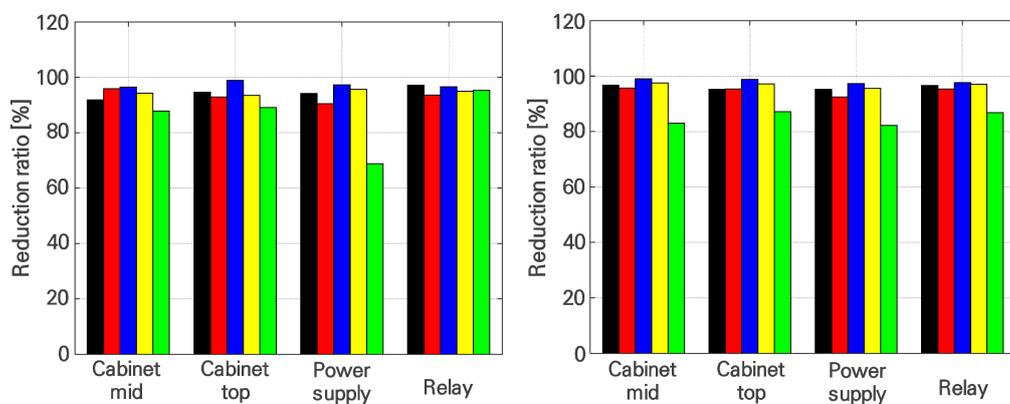
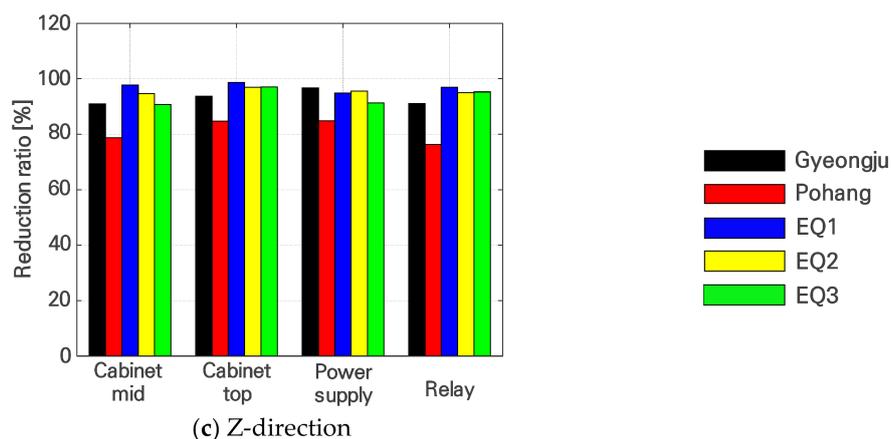
(a) X-direction

(b) Y-direction

Figure 16. Ratio of F_a values (Case 2/Case 1).
