# Structural Analysis of Five Historical Minarets in Bitlis (Turkey)

**Citation:** Işık, E.; Harirchian, E.; Arkan, E.; Avcil, F.; Günay, M. Structural Analysis of Five Historical Minarets in Bitlis (Turkey). *Buildings* **2022**, *12*, 159. <https://doi.org/10.3390/buildings12020159>

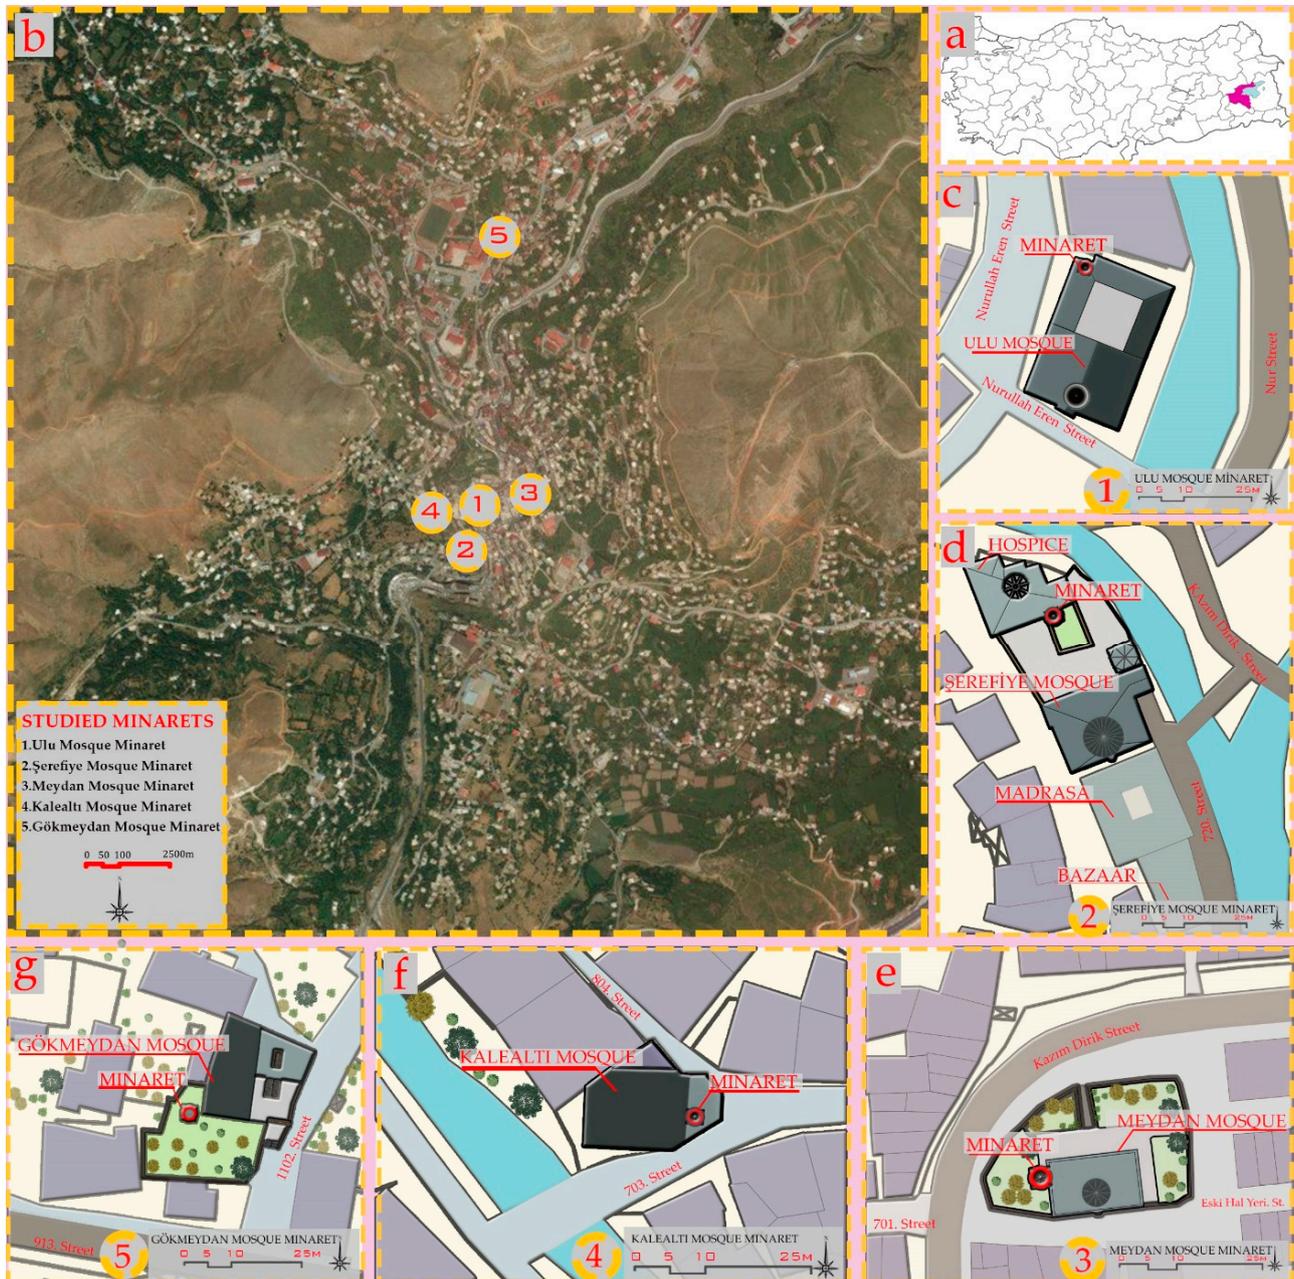
**Figure 1.** (a) The location of the Bitlis city in Turkey. (b) The location of Five Minarets in Bitlis city. (c) The site plan of the Ulu Mosque and its minaret. (d) The site plan of the Şerefiye Külliye and its minaret. (e) The site plan of the Meydan Mosque and its minaret. (f) The site plan of the Kalealtı Mosque and its minaret. (g) Plan of Gökmeşdan Mosque and Minaret.

This study is important in that it is the first study on the structural analysis of Five Minarets, which is one of the important cultural and historical advertising structures of Bitlis city. The most well known is the minaret of the Ulu Mosque of Five Minarets. This minaret was built after the mosque. The Ulu Mosque, to which the minaret belongs, is one of the oldest mosques in Bitlis. In addition to the Ulu Mosque in Bitlis, the Şerefiye Külliye, Dört Sandık Gökmeydan, Ayn'el Barit (Soğuk Pınar), Sultaniye, Meydan, Kızıl Mescit, Seyit İbrahim, Alemdar, Hacı Begiye, Kureyşi, and Memi Dede mosques are important historical places of worship of the city. The minarets, which are the subject of the song "Five Minarets in Bitlis", belong to the Ulu Mosque, Şerefiye Mosque, Meydan, and Gökmeydan mosques. It is estimated that the fifth minaret belonged to one of the Hatuniye, Kalealtı, or Kadiri mosques, and when it was destroyed, a new one was built in its place. The positions of Five Minarets are shown in Figure 1 and visuals are shown in Figure 2.

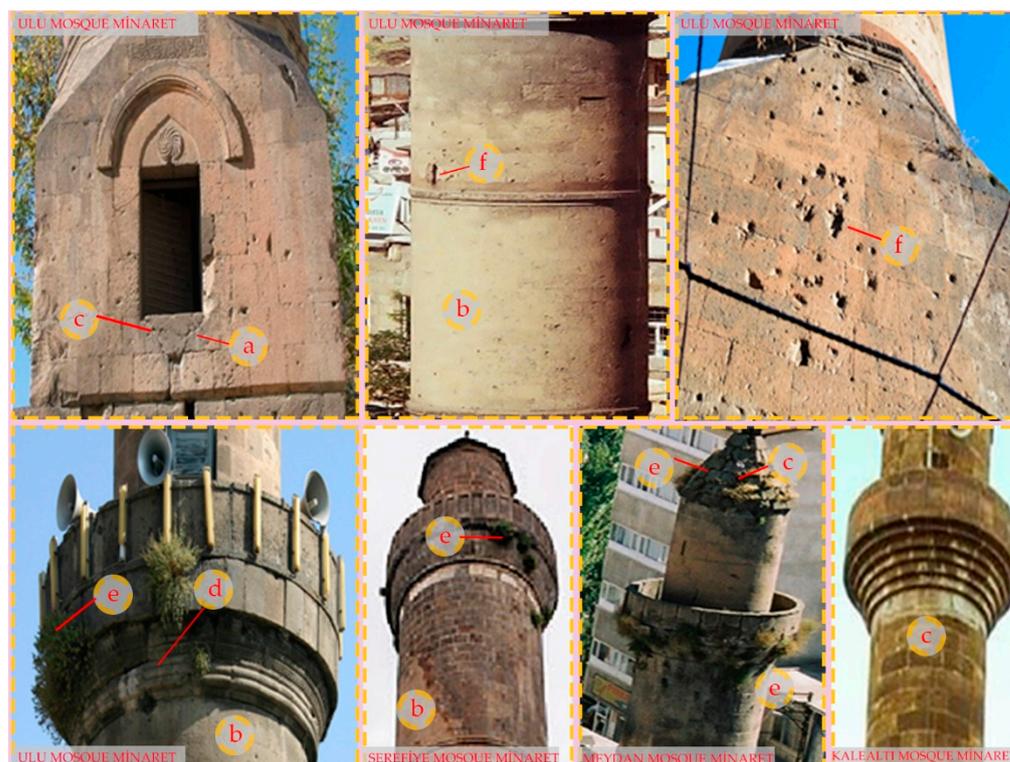
**Figure 4.** Damages observed in Five Minarets: a. high temperature difference; b. discoloration and color change; c. water effects; d. rupture damage; e. vegetation and f. bullet traces.

current state of the building as well as to provide information about the damage and deformations that occur in the structure. Minarets have survived to the present day with protection and interventions by the relevant public institutions and organizations. However, partial damage occurred due to the high-temperature differences in the city and excessive precipitation. Bitlis Stone, with its local name, was used in all of the minarets. The stones obtained from the quarries in Bitlis were used in minarets after being subjected to the cutting process. One of the general features of Bitlis stone is discoloration and color change over time with the effects of natural conditions. Discoloration and color change were partially observed in almost all minarets studied. The Bitlis city, where the minarets are located, is one of the city centers with the highest snowfall in Turkey. Some of the minarets, which were examined due to excessive precipitation, have calcifications in places due to water effects. Some of the stones used in the building have occasional rupture and damage. It has been observed that there are almost no consolidation effects over time since the soil properties are good in the investigated structures. Although vegetative formations were noticeable in different parts of the minarets, they did not cause great damage to the minarets. It is seen that maintenance and restoration were conducted over time in all Five Minarets. Conducting such maintenance and restoration over time is an important step towards prolonging the life of the buildings and preserving the originality of the buildings. In addition, the bullet traces of the occupation forces during the years of occupation are also clearly visible. Neither random renovation nor restoration were made to the buildings. The images of the damages and deformations observed in Five Minarets are shown in Figure 4.

In the Bitlis stones, which formed the minarets under the influence of natural conditions, partial mass loss, rupture, and wear were observed over time. It has been surveyed that the vegetative cell formations formed on the minarets over time damaged the stones and the joining elements that formed the minaret. In some minarets, traces of moisture were observed, partly due to the harmful effects of water and the stone's characteristics. Many lead traces are still clearly observed on the minaret of the Ulu Mosque. Authorized institutions are proceeding to fix these damages and protect the structure from further damage in the future. Therefore, it was not possible to make a comparison between the damage conditions on the minarets and the results obtained.

Bitlis stone, which is used in all of the minarets, is weak strength and has high porosity ratio, as well as the high-temperature difference in the city, the high and long-term snowfall causes fragmentation and partial rupture of these stones. In a city where the winter season is long, the freezing–thawing factor is one of the important reasons for decreasing the strength of the stone. Therefore, Bitlis stone, which is the main structural element of minarets, may lose its mechanical properties over time and affect its strength. In order to solve this problem, institutions/organizations related to minarets should observe the minarets structurally and ensure that the necessary engineering interventions are made in a timely. In this respect, the relevant public institutions and organizations have preserved the originality of the minarets by carrying out the necessary works and procedures. The continuity of such works and transactions is very important in order to transfer the minarets to the next generations.

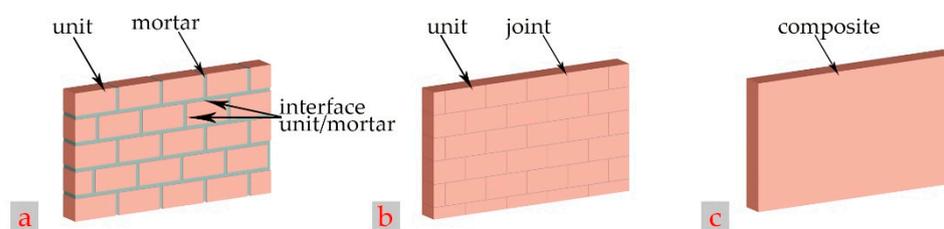
**Figure 5.** Modelling methods of masonry: (a) detailed micro modelling; (b) simplified micro modelling; and (c) Macro modelling.

Modelling of masonry walls is extremely important in the evaluation and design of historical and modern masonry structures. Masonry walls can be modelled using three different modelling techniques such as detailed micro-modelling, simplified micro-modelling, and macro-modelling. These models can be seen in Figure 5.

In detailed micro-modelling, the mechanical properties of the masonry unit and the mortar forming the masonry wall are taken separately. In this approach, it is assumed that cracks will occur at the interfaces between the masonry unit and the mortar. In simplified micro-modelling, mass densification was made at each connection point consisting of a mortar and two masonry unit–mortar interfaces, and it was accepted that cracks that could occur in masonry could occur at the mean interface line, assuming the average interface. Findings differ slightly from detailed micro-modelling, as the Poisson ratio of the mortar is not taken into account here. However, this difference is so small that it can be neglected [53–55].

The macro modeling technique is one of the masonry structural modeling techniques and is widely used. While performing this type of modeling, analyses are carried out without making any distinction between the binding material (mortar, etc.) used in the building and the structural elements. In this modelling, the masonry unit and the properties of the mortar are homogenized and considered as a masonry composite material. The mechanical properties of this model are the values obtained as a result of the homogenization process. Macro modelling is more convenient in practice because it requires less memory and time. However, with macro modelling, stress distributions in masonry units and mortar can be obtained accurately [55–58]. In this respect, structural masonry elements are considered composites, and an equivalent material model is used for all minarets models. Structural analyses were carried out for the Five Minarets in Bitlis using this macro-modeling technique. The mortar and Bitlis stone used in the minarets were considered as a single material. The sign criterion for the stress components of the elements used in the finite element model of the structure is shown in Figure 6, in accordance with the assumptions stipulated by the software [59] in which numerical modeling is made.

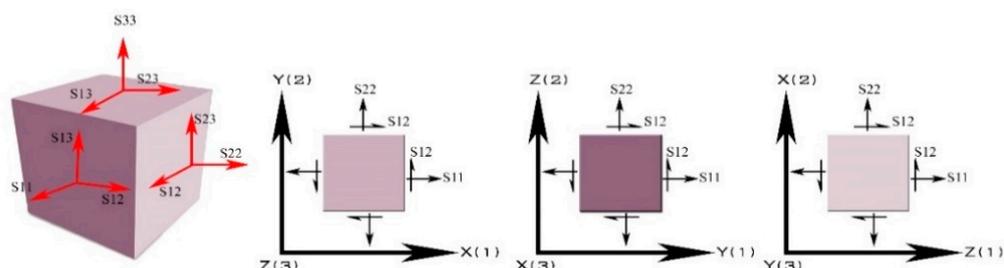
**Figure 6.** The sign criterion for the stress components.

As stated in Figure 6,  $S_{11}$  is vertical stress in (x) direction,  $S_{22}$  is vertical stress in (y) direction,  $S_{33}$  is vertical stress in (z) direction, and  $S_{12} = S_{21}$  constitute shear stresses in the x-y plane. With TBEC-2018, which was updated in 2018 and entered into force on 1 January 2019, the biggest change was the use of site-specific design spectra. Turkey Earthquake Maps Interactive Web Application has been developed to calculate design spectra and site-specific earthquake parameters. With the help of this application, horizontal and vertical design spectra can be obtained as well as earthquake parameters belonging to any desired geographical location. By using the coordinate values obtained for each minaret, design spectra and earthquake parameters were obtained with the help of this application. While obtaining these values, the design ground motion level DD-2 was chosen as the earthquake ground motion level. From the ground survey reports received from the relevant institutions, the ZB soil class was taken into account for all five minarets as the local soil class. As it can be seen from Table 3, the design spectra were obtained close to each other since the seismic parameters for the minarets are close to each other. The horizontal and vertical spectra obtained for the Ulu Mosque Minaret are shown in Figure 7 as an example. In these curves, the horizontal axis represents period values, while the vertical axes represent the horizontal and vertical elastic design spectral accelerations, respectively.

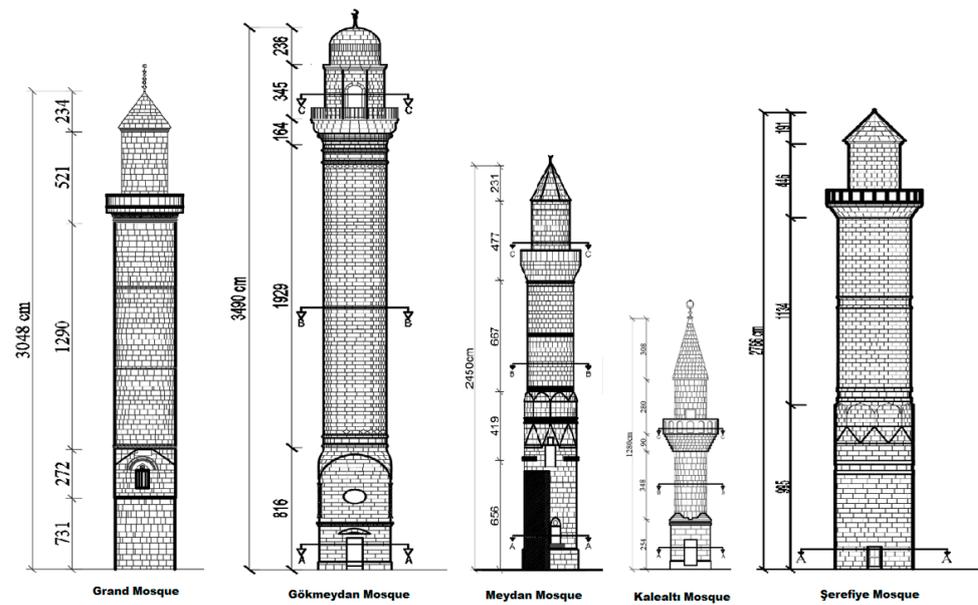
Figure 8. Dimensions of Five Minarets.

While the dimensions of Five Minarets are shown in Figure 8, the three-dimensional models obtained from the software program are shown in Figure 9.

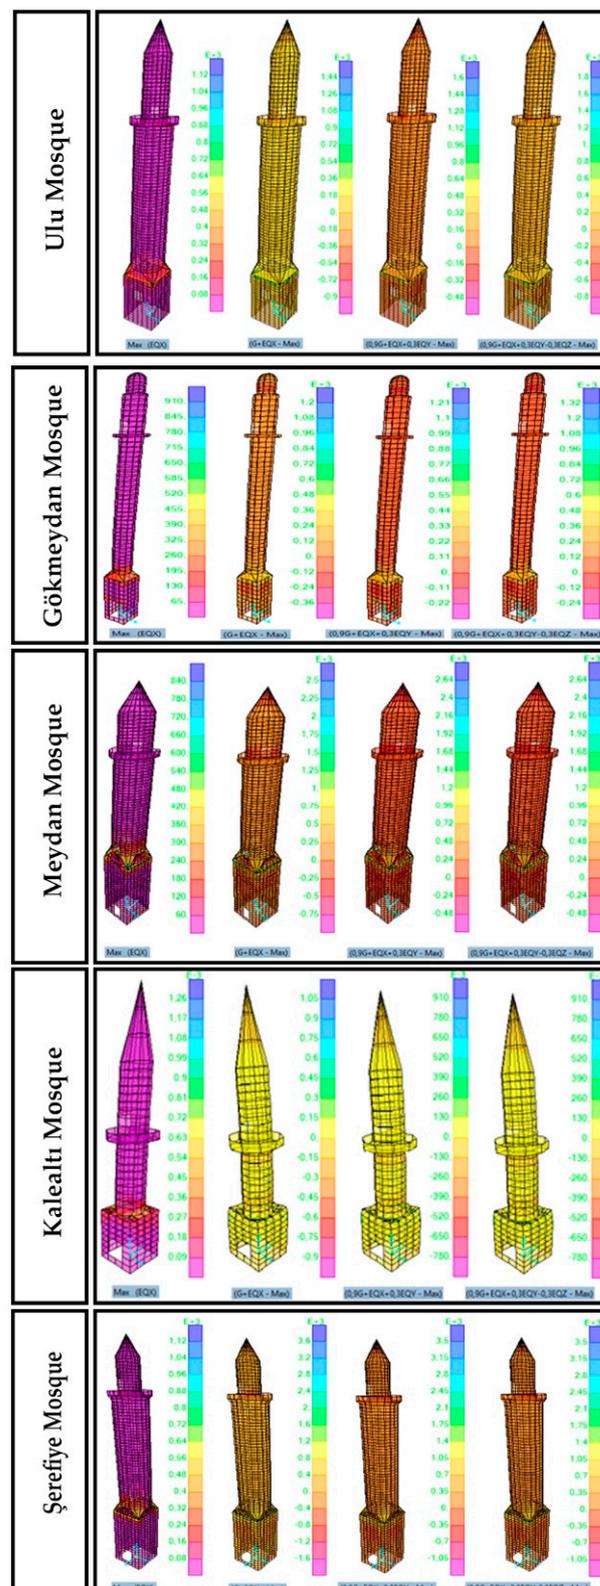
Figure 10. The maximum stress for Five Minarets (S11).

The dead-load, live-load, and earthquake-load are taken into account for stress calculations. The software program according to material properties made dead load calculations. Horizontal and vertical elastic design spectra obtained from Turkey Earthquake Hazard Maps Interactive Web Applications were used as design spectra. For the earthquake load, load definition was made in three directions as EQ<sub>x</sub>, EQ<sub>y</sub>, and EQ<sub>z</sub>. Structural analyses were performed for different load combinations by using these values. The load combinations envisaged in the TBEC-2018, which is currently used in Turkey, have been taken into account. Load combinations have been selected in accordance with the definition under the title of Combining Earthquake Effect with other Effects in TBEC-2018. Load combinations are defined by the constant load effect, live load effect, earthquake effects defined in perpendicular directions, and the vertical earthquake effect together with the load coefficients. The stress diagrams for S11 (vertical stress in the x-direction) obtained from different load combinations are shown in Figure 10.

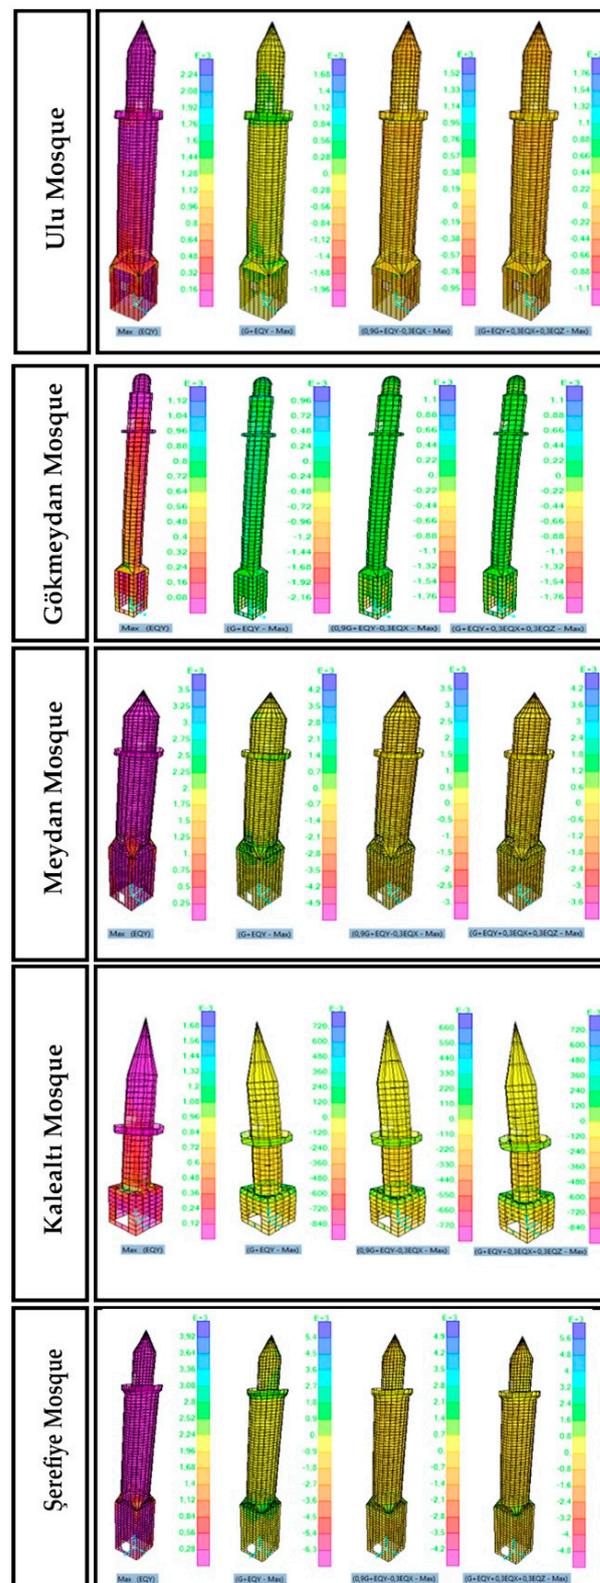
Figure 11. The maximum stress for Five Minarets (S22).

The maximum stress diagrams for the vertical stress in the y-direction (S22) obtained from different load combinations are shown in Figure 11.

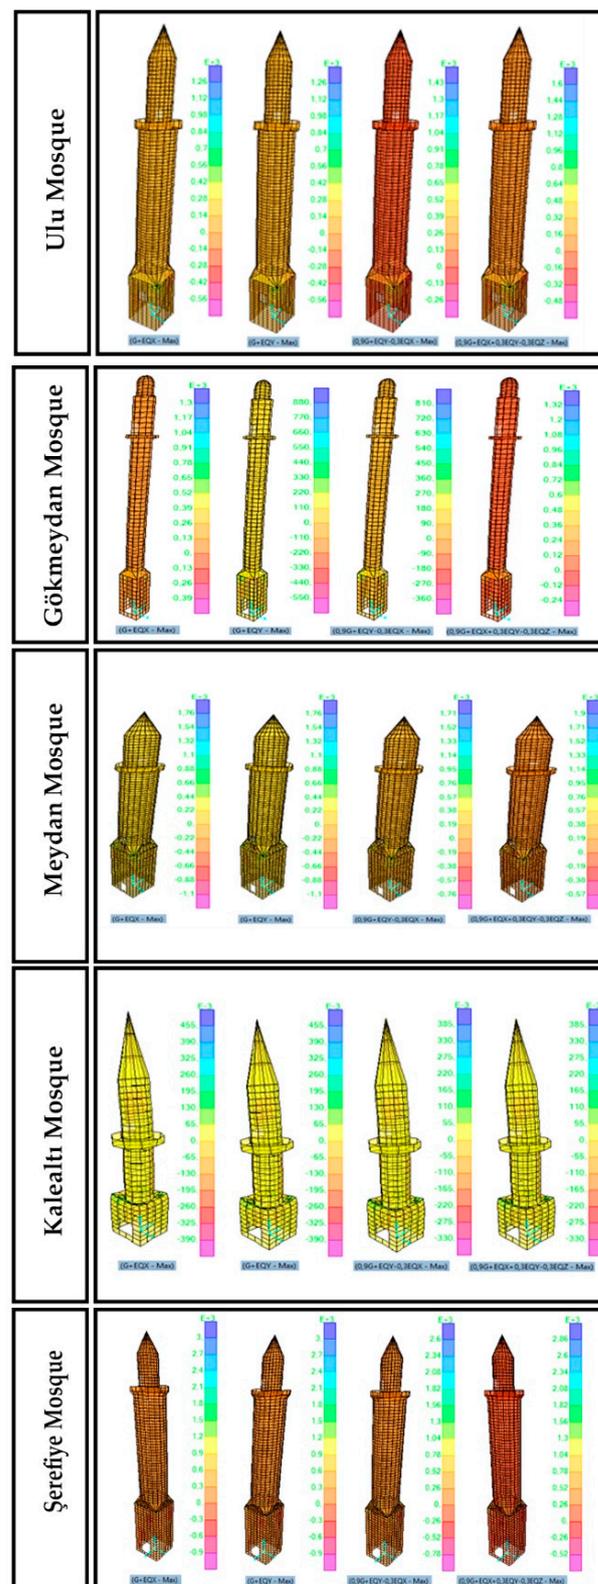
Figure 12. Maximum shear stress for Five Minarets (S12).

The diagrams of shear stress in the x-y directions (S12) for five minarets under different load combinations are shown in Figure 12.
