# Constructing Hospitals for Functionality after Earthquakes: Saves Lives and Costs!

**Abstract:** Applications of the American Seismic Isolator Standard “SIS” are summarized. The SIS is the only construction standard that specifies design criteria for retaining the functionality of hospitals after earthquakes. The SIS specifies limits for in-structure accelerations and deformations. Earthquake data shows that the SIS limits are the maximum that can be tolerated and retain the functionality of hospitals after earthquakes. The Adana and Elazig hospital complexes retained 100% functionality after the severe earthquakes that occurred in Turkey in 2023 and 2020. These earthquakes resulted in 55,000 fatalities and 236 health care facilities losing functionality. Since the 1989 California earthquake, 18 structures with SIS isolators have retained 100% functionality after major earthquakes that caused over 800,000 deaths, and over 700,000 structures to be demolished. The functionality of these SIS structures saved many lives by enabling post-earthquake emergency services. Since 1985, SIS isolators have been implemented in over 40 million square meters of important buildings, bridges, and

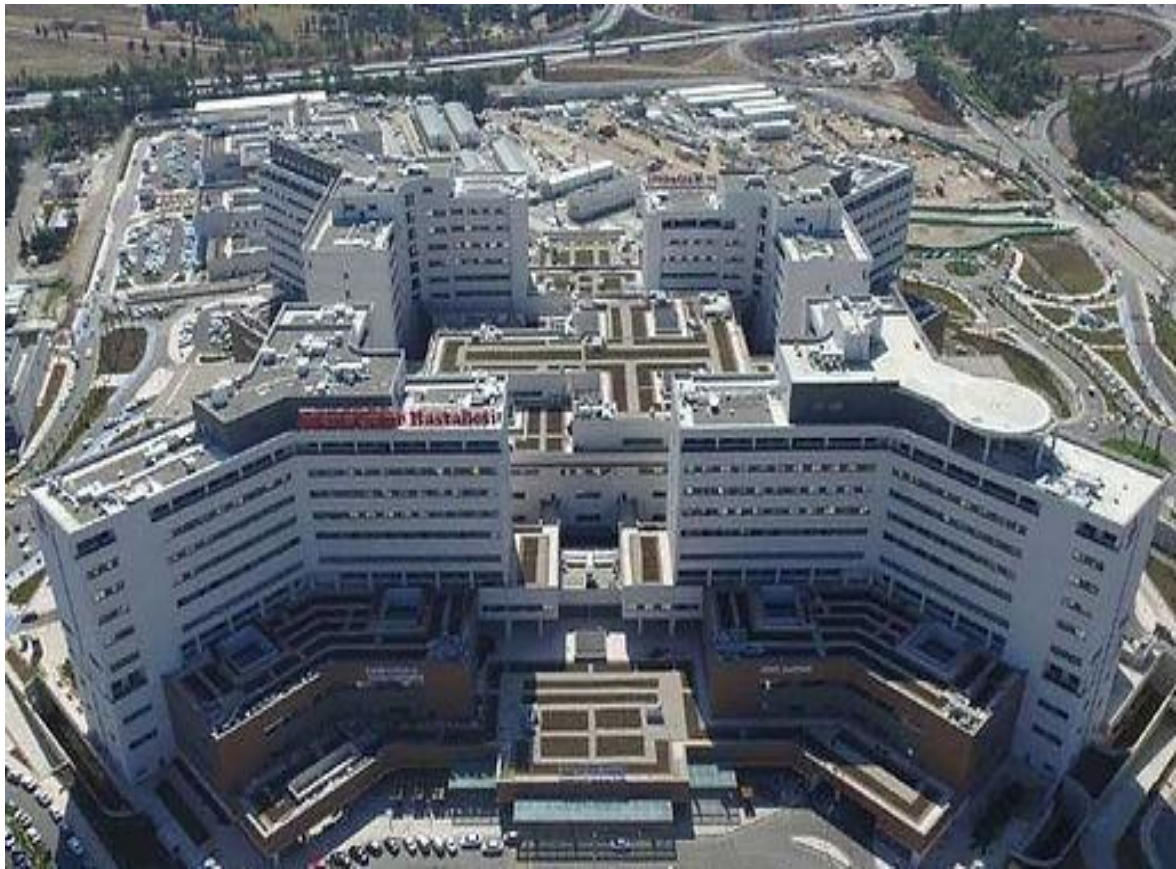
**Figure 1.** Adana Hospital Complex, Turkey, 100% Functional after 2023 Turkey Earthquakes.

The Adana hospital Complex (Figure 1) as in the disaster region of Turkey’s 2023 magnitude 7.8 earthquake and 49 aftershocks of magnitudes 5.0 to 7.5. The 8 g earthquake force demands were 20 times greater than the seismic design loads specified by the building code. There were: 55,000 fatalities; 236 inoperable health care facilities; 35,000 collapses; and 220,000 buildings demolished [4].

Yet, Adana's 550,000 square meters of hospital buildings retained 100% functionality, thereby saving many lives by caring for over 10,000 earthquake injured persons. This was the second time hospitals were 100% functional after such strong earthquake shaking.

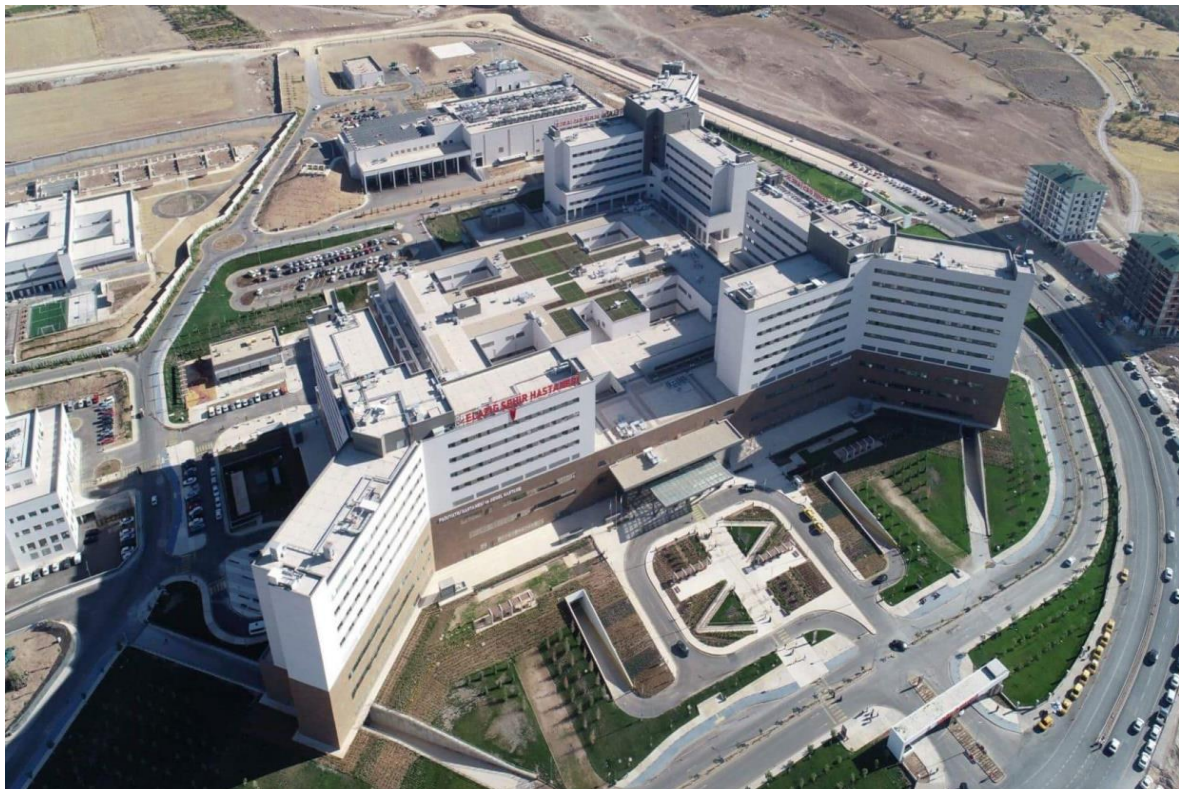
**Figure 2.** Elazığ Hospital Complex, Turkey, 100% Functional after 2020 Earthquakes.

The Elazig Hospital Complex (Figure 2) were the closest hospital buildings to the epicenter of Turkey's 2020 magnitude 6.7 Elazig earthquake. The Elazig hospitals maintained 100% functionality, saving many lives by caring for over 1000 earthquake injured persons. The Elazig earthquake caused 87 other multi-story buildings to collapse, and over 5000 buildings to lose functionality, of which 1287 were later demolished [20]. The Elazig hospitals were the first to be completely functional after experiencing such strong earthquake shaking.

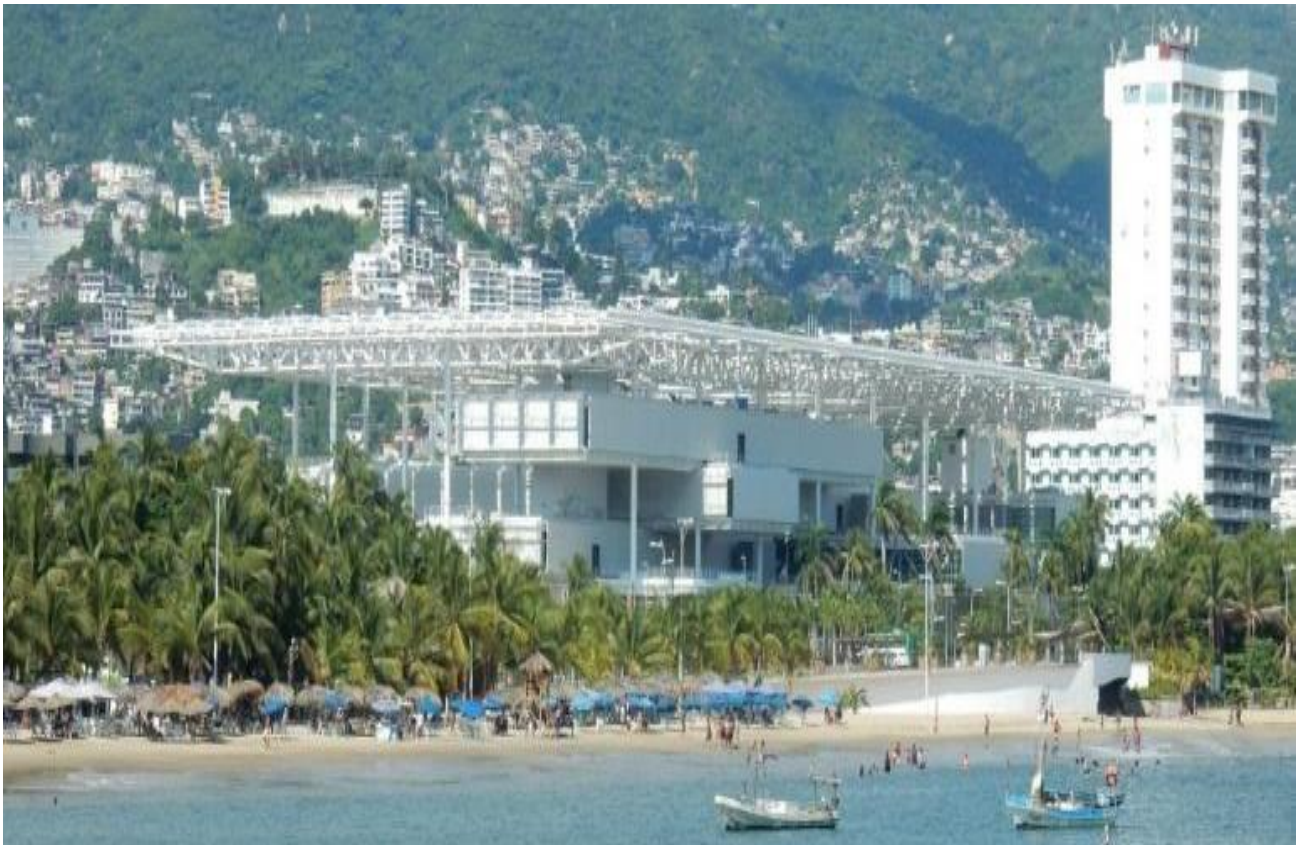
**Figure 3.** Acapulco Emergency Response Center, 100% Functional after 2021 Earthquakes.

**34 Years of Earthquake Proven Functionality in 18 Essential Structures:** The Acapulco Emergency Response Center (Figure 3) was 9 km from the epicenter of Acapulco's 2021 magnitude 7.1 earthquake. It remained 100% functional during and after the earthquake. The soft bay muds resulted in ground accelerations of 0.54 g, and structure base shear demands of 1.1 g. The seismic force demands on the Acapulco Emergency Response Center were 10 times the seismic design loads specified by the building code for collapse avoidance. The emergency response center was able to respond to all calls for emergency assistance without interruption [2]. This was the first time an emergency response center suffered no damage to architectural components and communications equipment after very strong earthquake shaking. The 100% functionality of Acapulco Emergency Response Center saved many lives.

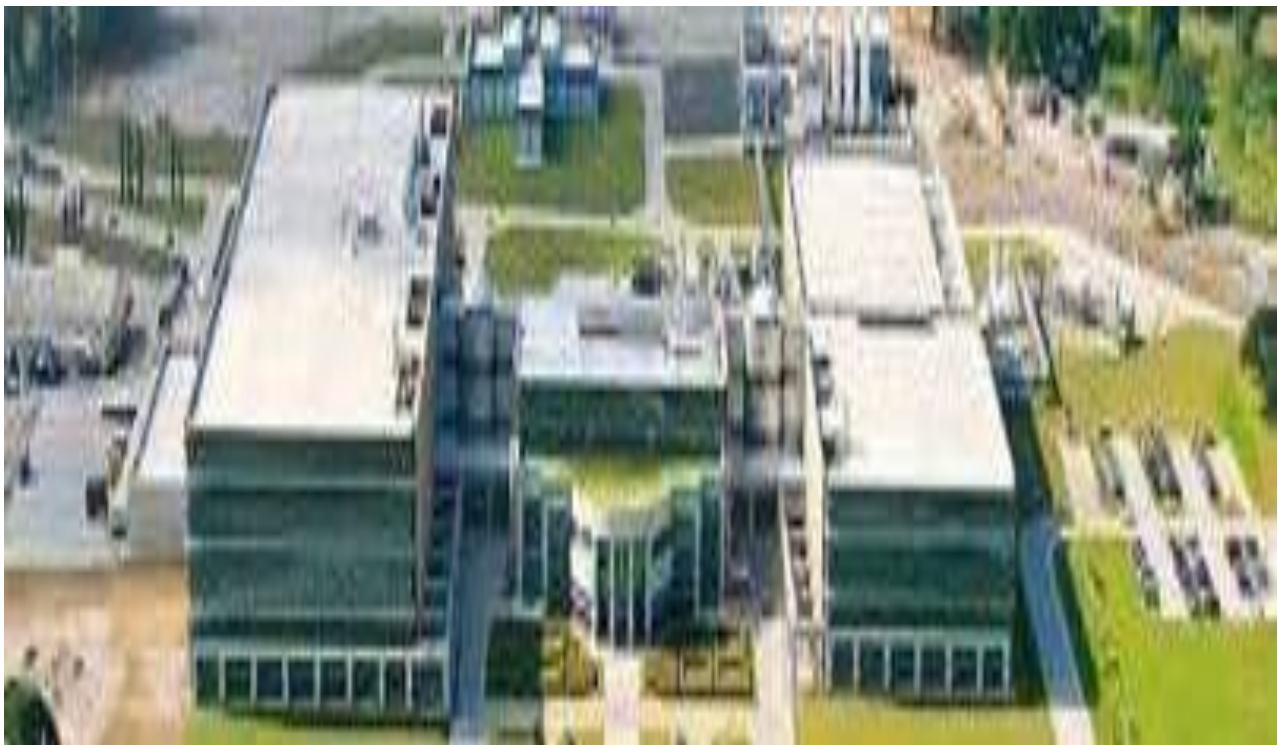
**Figure 4.** Texas Instruments, Medical Instruments Factory, Philippines, 100% Functional.

Texas Instruments' (Figure 4) Philippines Plant has fragile manufacturing equipment that produce microprocessors used in medical devices. The facility's manufacturing equipment remained completely functional after the 2019 magnitude 6.1 earthquake [21]. The nearby airport and other buildings were forced to close because of earthquake shaking damage. Several older buildings in the area collapsed.

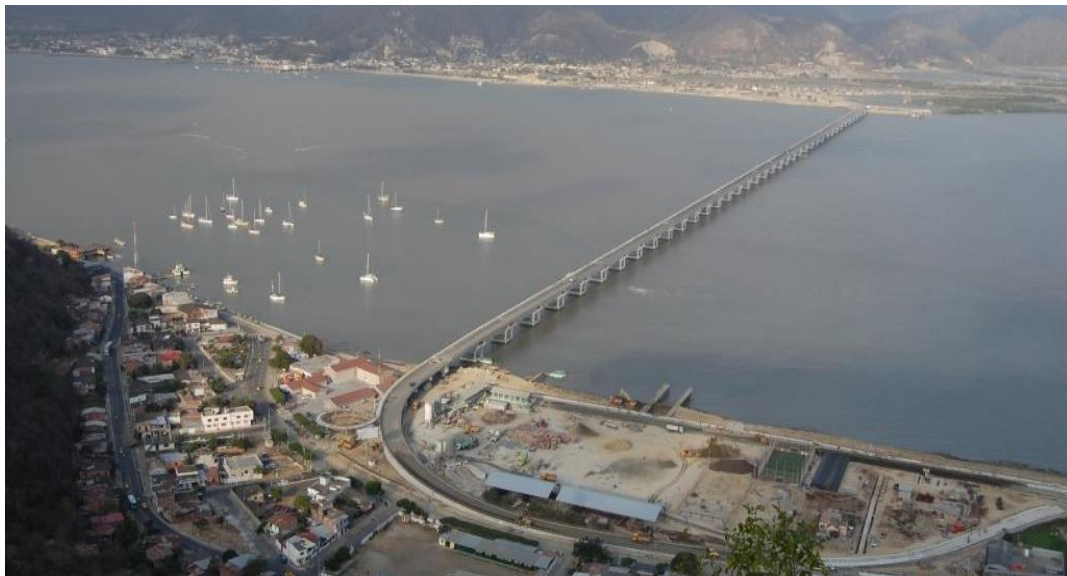
**Figure 5.** Bahia Bridge Ecuador, 100% Functional after 2016 Earthquakes.

Ecuador's 2016 magnitude 7.8 earthquake fault ruptured directly under the Bahia Bridge (Figure 5). The 3 g seismic force demands were 20 times the seismic design loads specified by the code. Yet, this bridge remained 100% functional. In the 24 h after the earthquake, 15,000 vehicles crossed the Bahia Bridge to evacuate thousands of injured persons from the destroyed city [22]. The SIS seismic isolators reduced the seismic design loads on the pile foundations by 80%, thereby reducing initial construction costs by 5%, and also avoiding damage from an extreme earthquake. Three other bridges with SIS pendulum isolators were within Ecuador's 2016 fault rupture area, and also remained 100% functional.

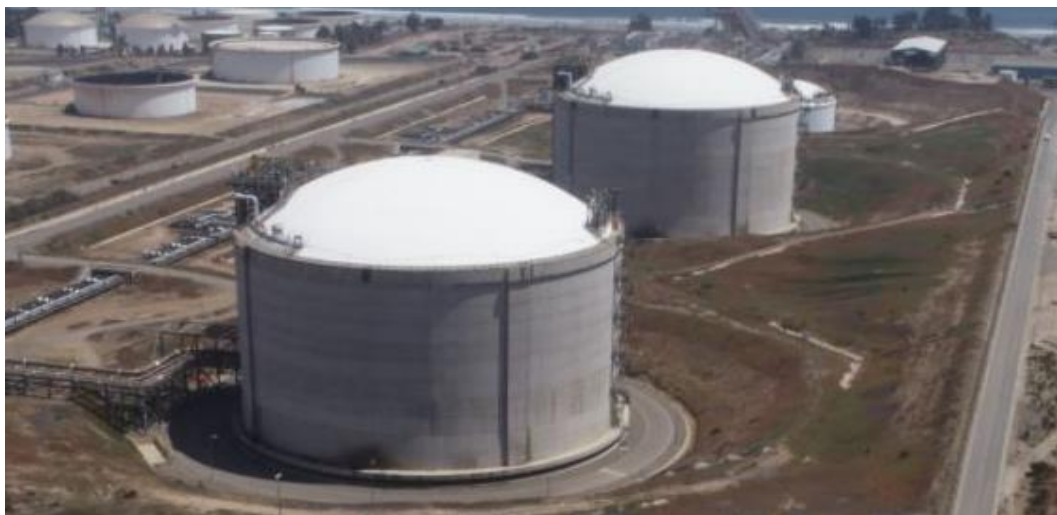
**Figure 6.** LNG Tanks, Chile, 100% Functional after 2010 M8.8 Earthquake.

Two large concrete Liquid Natural Gas tanks were completely functional after Chile's 2010 Magnitude 8.8 Earthquake, and a Magnitude 7.1 aftershock with the epicenter 3 km from the tanks (Figure 6). These tanks are critical for Chile to produce electric power. In Mexico, two large concrete Liquid Natural Gas tanks were completely functional after the 2022 magnitude 7.6 earthquake (Figure 7). These concrete LNG tanks were protected by SIS isolators. The storage of hazardous materials is incompatible with the ductile structures specified by the building codes. The leaking of billions of liters of liquid natural gas from the concrete tanks would cause a fire, explosion, and major public catastrophe.

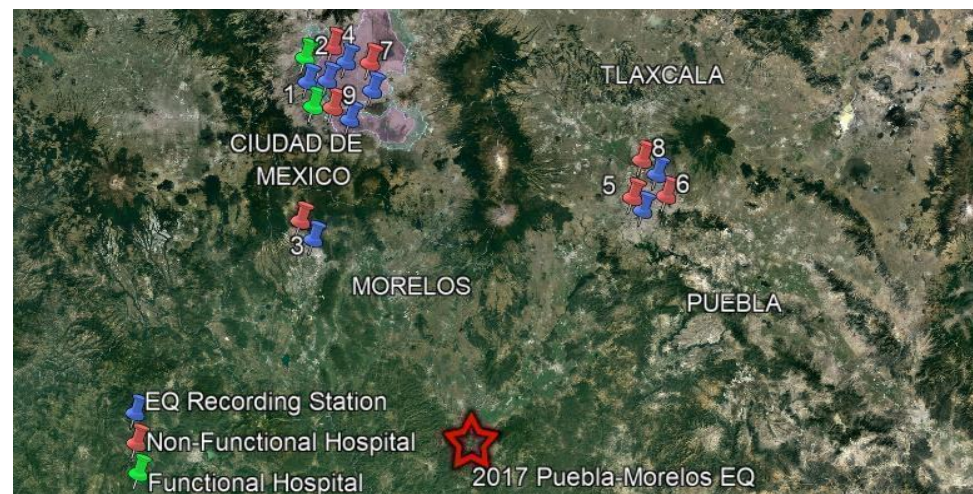
**Figure 10.** 7 hospitals that lost functionality, and 2 hospitals that retained functionality, plus 8 earthquake ground motion recording stations.

These SIS functionality criteria were checked against the functionality performance of 9 hospitals that experienced Mexico's 2017 magnitude 7.1 earthquake [2] (Figure 10). Earthquake ground motion records were available near these 9 hospitals. Of the 9 hospitals, 7 lost functionality, and 2 retained functionality. The earthquake shaking for the 2 hospitals that retained functionality were significantly less severe than those for the 7 hospitals that lost functionality. 2 hospitals that retained functionality were over 100 km from the epicenter, constructed on shallow stiff soil sites. 3 hospitals that lost functionality were over 100 km from the epicenter, but were on deep soft soil sites. 4 hospitals that lost functionality were closer than 100 km from the epicenter, and were on rock or firm soil sites.

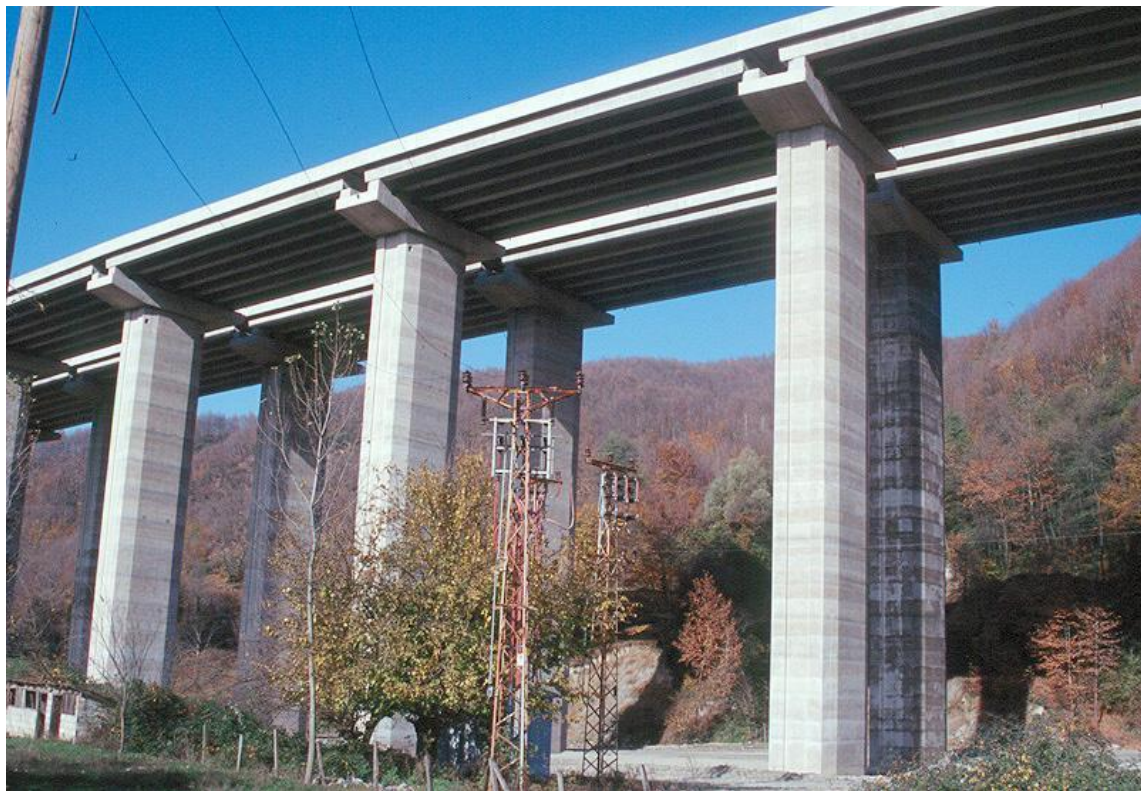
**Figure 13.** Failed Trans-European Motorway Isolation System.

Failed Trans-European Motorway, Turkey (Figure 13). The European seismic isolators and supplemental dampers suffered collapse during a magnitude 7 earthquake. Earthquake damage repair costs were equal to 100% of the original construction costs. All 2500 components of the European isolation system were removed and replaced with SIS compliant pendulum isolators. The SIS pendulum isolators had 4 times the displacement capacity and shear strength, yet cost less to buy than the original price of the European isolation system.

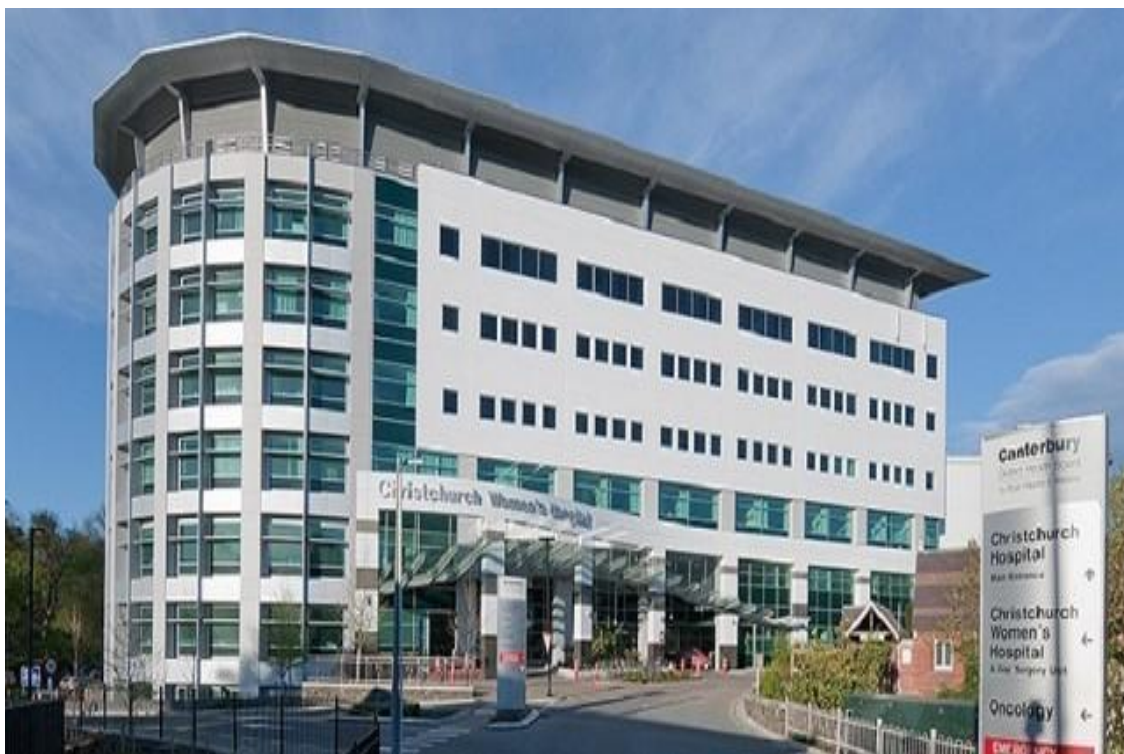
**Figure 14.** Christchurch Women's Hospital with Failed Rubber Isolators.

Christchurch Womens's Hospital, New Zealand, with failed rubber seismic isolators (Figure 14). Canterbury University reported that the rubber isolators did not displace during 2 magnitude 6 earthquakes, and that the "structure responded as if it was fixed base". Fletcher Construction Company was paid to repair the earthquake damage, which took 4 years. Fletcher reported the repair costs exceeded 30% of the building replacement cost.

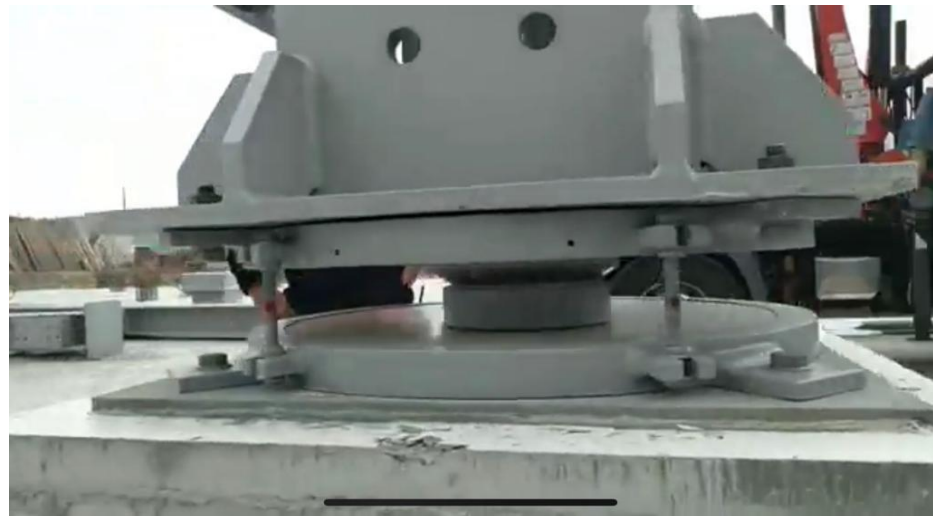
**Figure 15.** Dangerous EN15129 essentially flat isolator installed in a hospital in Ecuador.

To retain facility functionality, and isolator and structure stability, and it is necessary to specify the American Seismic Isolator Standard "SIS" as the product standard for all isolators. The SIS establishes the long term reliability of the isolator materials, properties, design capacities, factors of safety, and isolator design load limits. ASCE 7 and AASHTO specify the minimum seismic design loads, and do not specify functionality design criteria. The ASCE7, AASHTO, and the Eurocode specify design criteria for avoiding the collapse of isolated structures. The SIS establishes the additional seismic design criteria needed to avoid facility damage, and maintaining functionality. It is the structural product standards that specify the factors of safety required for structural member strength capacities. Despite the Eurocode intention to avoid structure collapse, EN15129 isolators implemented under the Eurocode have resulted in the highest collapse hazards of any new structures constructed during the past 20 years. The SIS requires an isolator shear strength factor of safety of 3.0, which is needed to comply with ASCE 7 and AASHTO Target Reliability for Structural Stability [11,33]. The EN15129 shear strength factor of safety is 1.0, which is no factor of safety. EN15129 isolators are dangerous! (Figures 15 and 16).

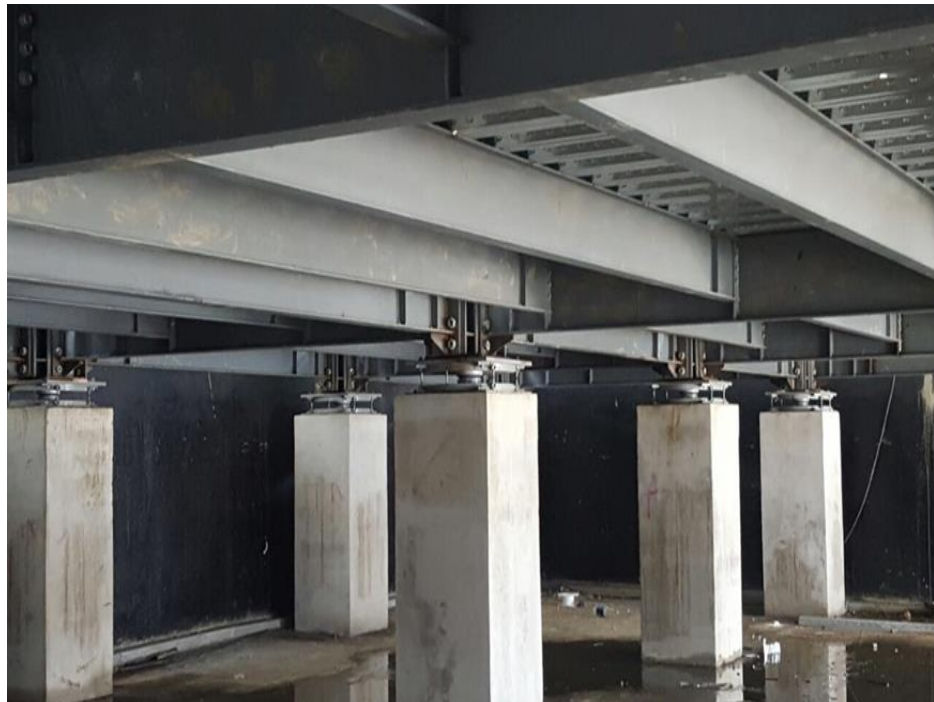
**Figure 16.** Dangerous EN15129 isolators installed on columns in a hospital in Ecuador.

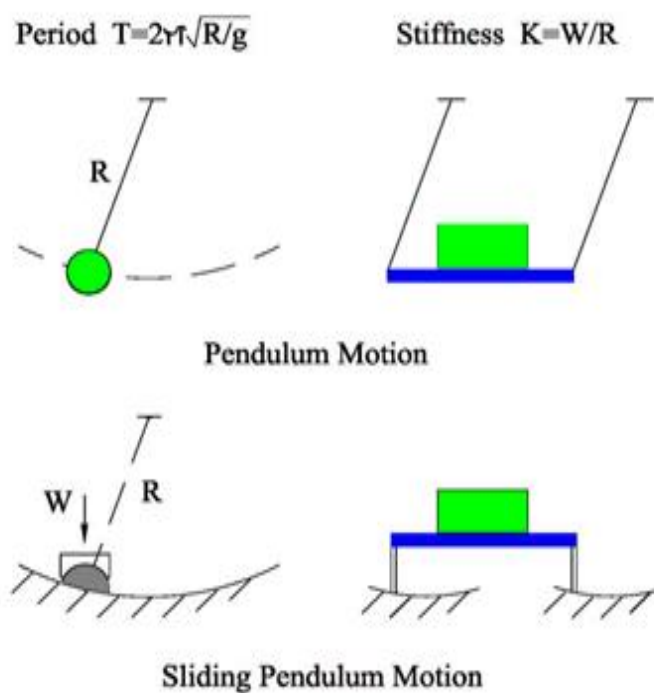
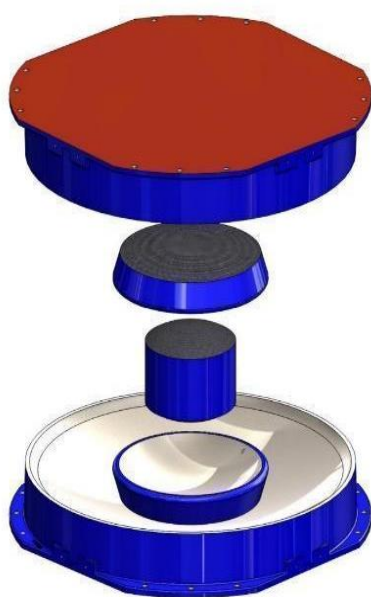
Figure 17. Triple Pendulum Isolators.

Triple Pendulum Isolators (Figure 17) were developed to limit in-structure accelerations and deformations to comply with the SIS Functionality Design Criteria. Triple Pendulum Isolators use 4 concave spherical surfaces to absorb the earthquake displacements. Each Triple Pendulum Isolator has 3 independent pendulum mechanisms. The 3 pendulum mechanisms are optimized to minimize: construction costs; earthquake damage; and collapse risks. The first pendulum typically has a friction of less than 0.5%, and a pendulum period less than 2 s, which filters out the high accelerations associated with high frequency earthquake ground motions. The first pendulum protects facility contents and equipment, and architectural components from acceleration related damage. The second pendulum's period and friction are selected to reduce structure deformations as needed to protect architectural components from deformation related damage. The third pendulum's period and friction are selected to protect the structure from damage from the Design Earthquake.

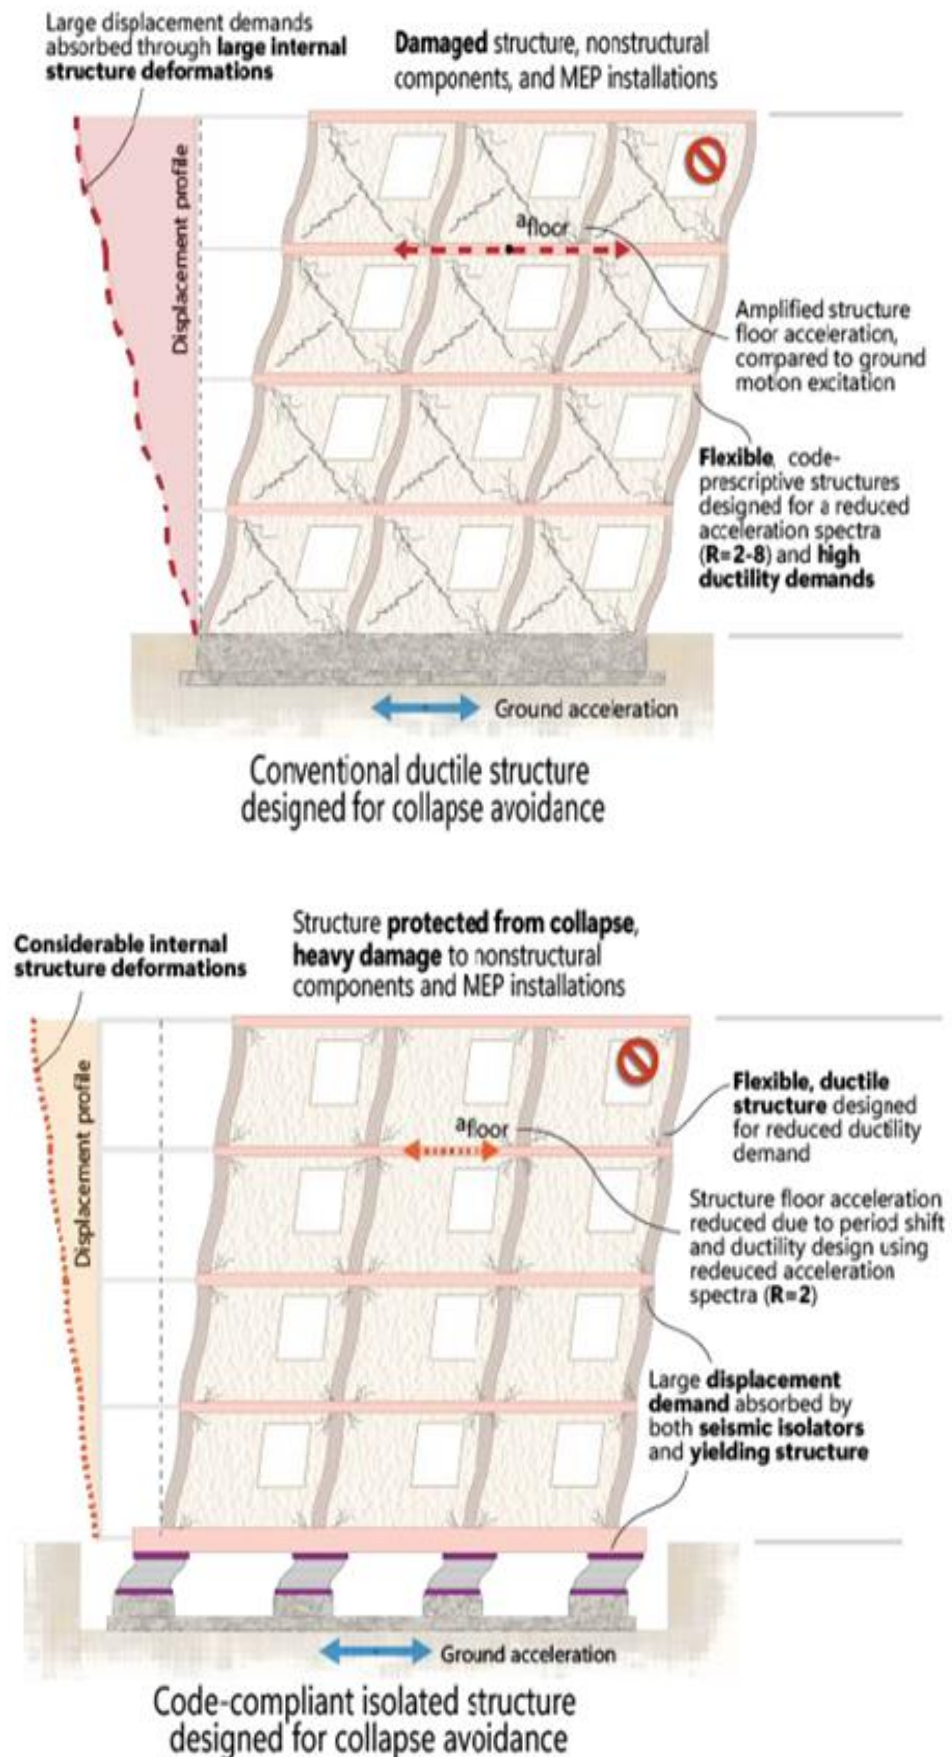
Figure 18. Code-designed structures designed for collapse avoidance.

The safety retainer rings in SIS isolators protect the structure from collapse for earthquakes stronger than the code Maximum Considered Earthquake. How SIS isolators protect against earthquake damage is illustrated in Figures 18–22.

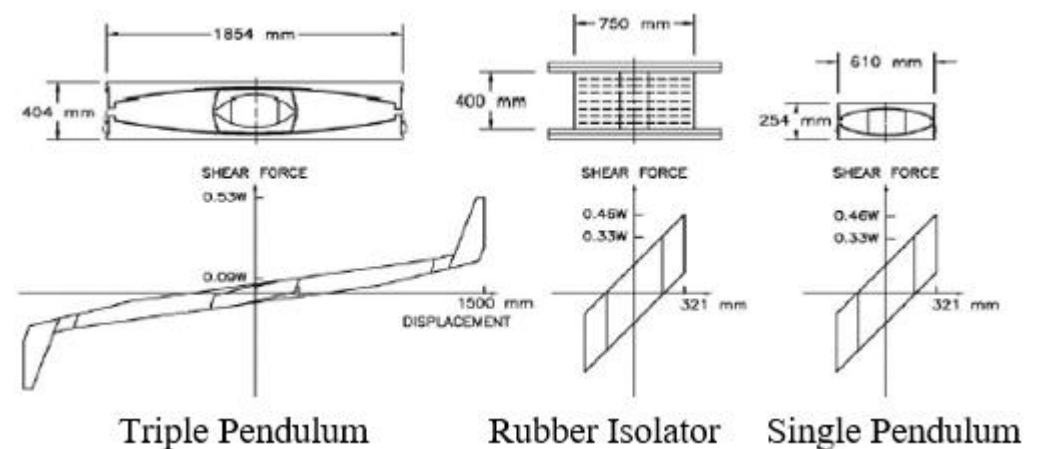
Figure 20. Seismic isolator sizes and force loops.

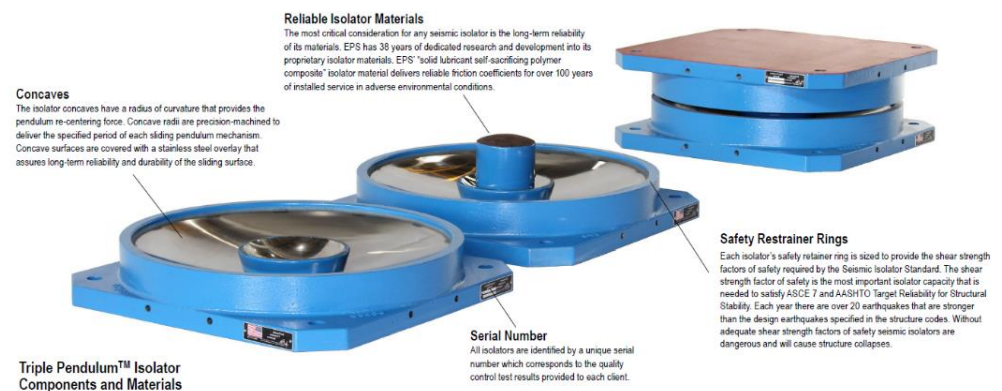
Figure 21. Triple pendulum isolator.

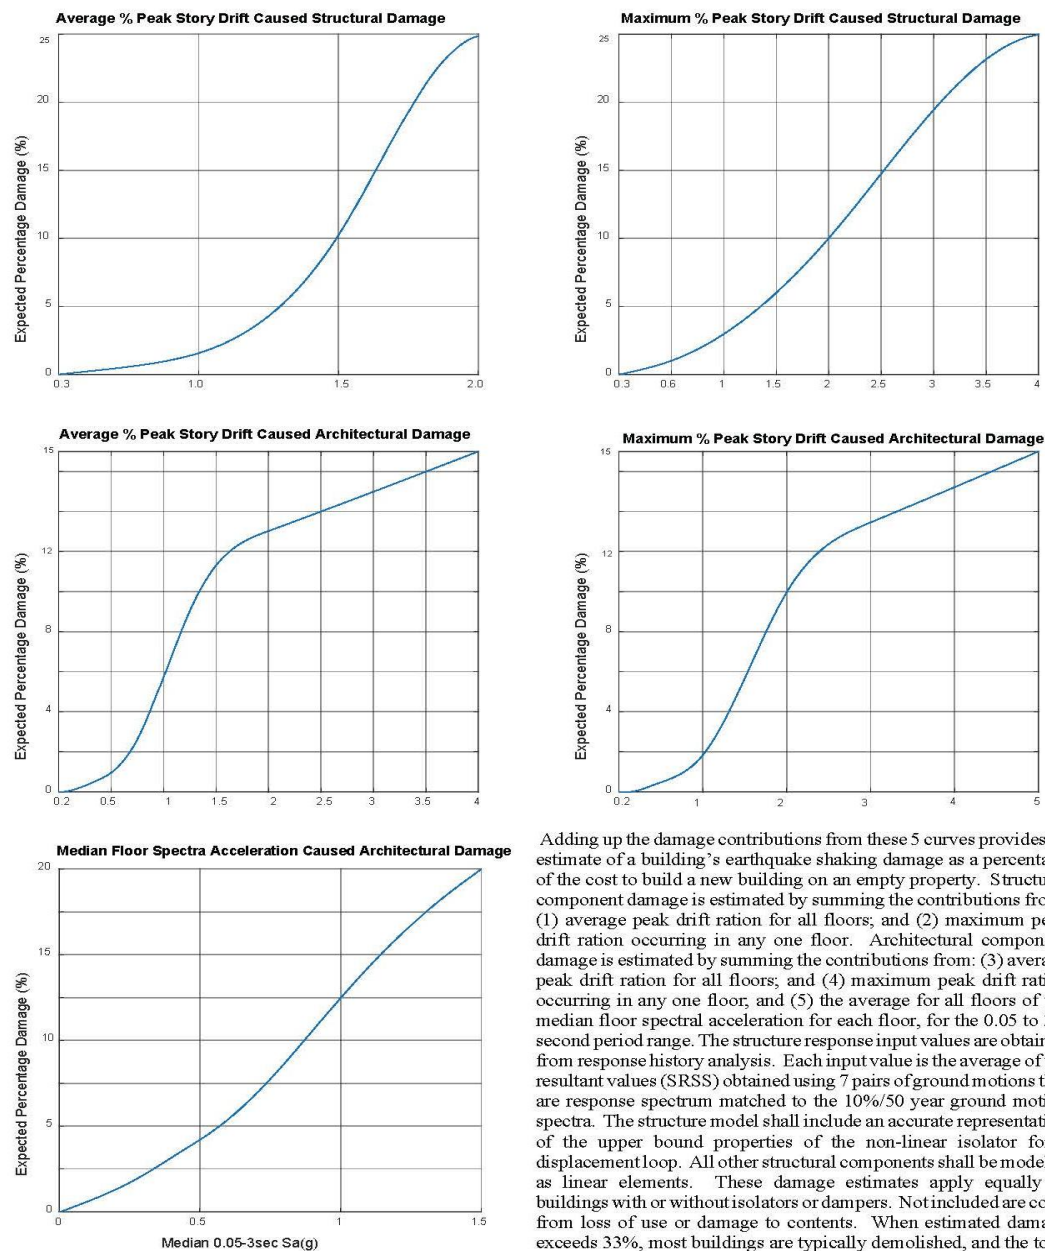
Adding up the damage contributions from these 5 curves provides an estimate of a building's earthquake shaking damage as a percentage of the cost to build a new building on an empty property. Structural component damage is estimated by summing the contributions from: (1) average peak drift ration for all floors; and (2) maximum peak drift ration occurring in any one floor. Architectural component damage is estimated by summing the contributions from: (3) average peak drift ration for all floors; and (4) maximum peak drift ration occurring in any one floor; and (5) the average for all floors of the median floor spectral acceleration for each floor, for the 0.05 to 3.0 second period range. The structure response input values are obtained from response history analysis. Each input value is the average of the resultant values (SRSS) obtained using 7 pairs of ground motions that are response spectrum matched to the 10%/50 year ground motion spectra. The structure model shall include an accurate representation of the upper bound properties of the non-linear isolator force displacement loop. All other structural components shall be modeled as linear elements. These damage estimates apply equally to buildings with or without isolators or dampers. Not included are costs from loss of use or damage to contents. When estimated damage exceeds 33%, most buildings are typically demolished, and the total economic loss is 200% of the building replacement costs.

Building damage estimate from earthquake shaking . When estimated damage is less than 2%, the buildings can typically function at maximum capacity.

**Figure 22.** SIS Building damage estimate curves.

For the SIS example applications presented herein, once the isolator properties were selected for compliance with the SIS functionality criteria, then estimates of building damage were obtained using the Building Damage Estimate Curves in the SIS. For all applications, the calculated seismic damage was less than 2% of the facility replacement costs.

From the SIS Damage Estimate Curves, it is observed that earthquake damage increases with increases in structure deformations and increases in in-structure accelerations. The in-structure acceleration parameter that correlates best with damage is the median floor spectra acceleration. The floor spectra for each floor is calculated to quantify the seismic demand on the architectural components and contents. The median floor spectra acceleration for each floor is then calculated, with half the spectra points lying above the median value, and half lying below the median value.
