# The Effect of ECC Materials on Seismic Performance of Beam—Column Subassemblies with Slabs

**Abstract:** The main objective of this investigation was to study the influence of an Engineered Cementitious Composite (ECC) on the seismic performances of beam–column–slab subassemblies. Tests and simulations were conducted on several models. The bearing capacity of the ECC model was 15% higher than that of the RC member, the deformability increased by 19%, and the energy dissipation capability increased by 34%. The use of an ECC in the slab could reduce the contribution of the reinforced bars in the slab to the flexural strength of the beam. At a drift of 2%, the range of the yielding bars in the slab of the RC models was 5*h* to 6*h*. However, the yield range of reinforcement in the slab of the ECC models was nearly 3*h*. As a result, the ECC subassemblies were prone to reach a “strong column and weak beam” yield mechanism.

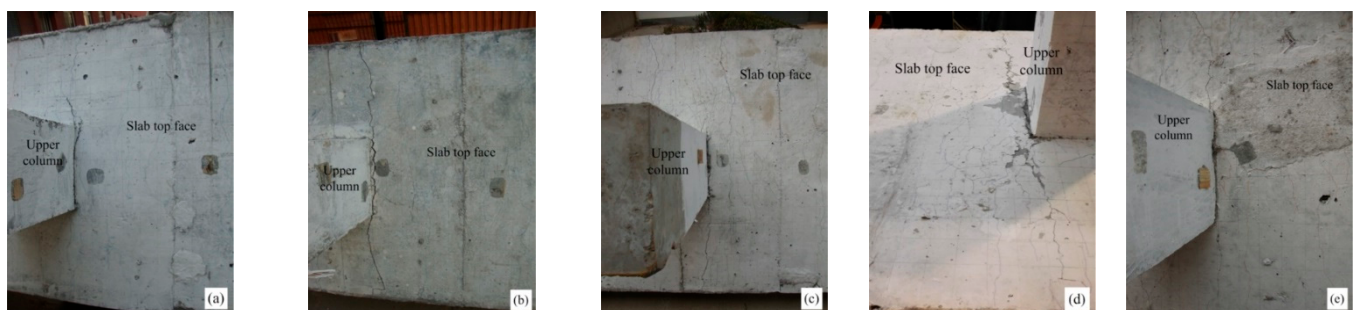
**Figure 4.** Final failure pattern of slabs: (a) FBCS-2; (b) FBCS-3; (c) FBCS-4; (d) FBCS-5; (e) RBCS-1.

All the ECC specimens maintained better integrity at a 6% drift. Figure 3 shows the final failure patterns of the five subassemblies, and Figure 4 shows the cracking state of the slab surface. The ECC subassemblies showed better integrity than the RC subassembly, and were prone to the “strong column–weak beam” yielding mechanism.

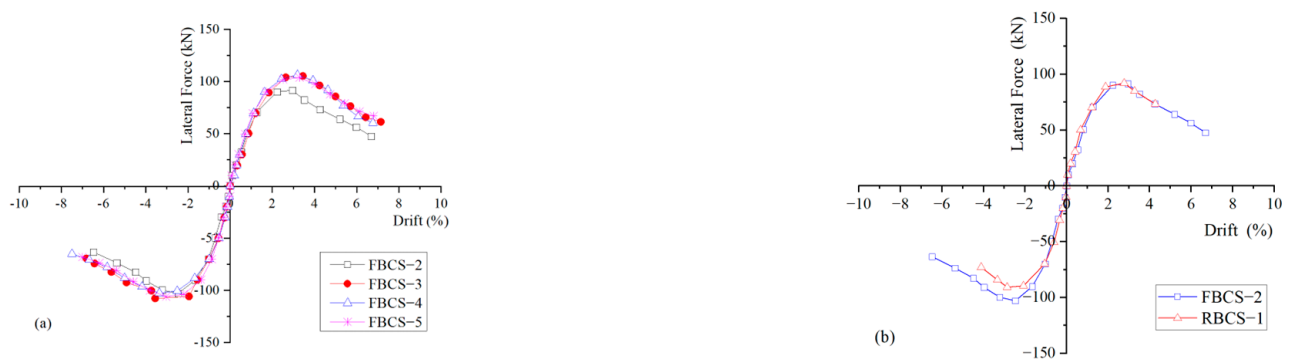
**Figure 6.** Skeleton curves: (a) comparison between ECC specimens; (b) comparison between RC and ECC specimens.

Figure 5 shows the hysteretic curves of the five subassemblies, and Figure 6 shows the skeleton curves. The maximum loads at each level for the five specimens are listed in Table 3.
