Research on Pathology Information Management of Educational Architectural Heritage Based on Digital Technology: The Case of James Jackson Gymnasium

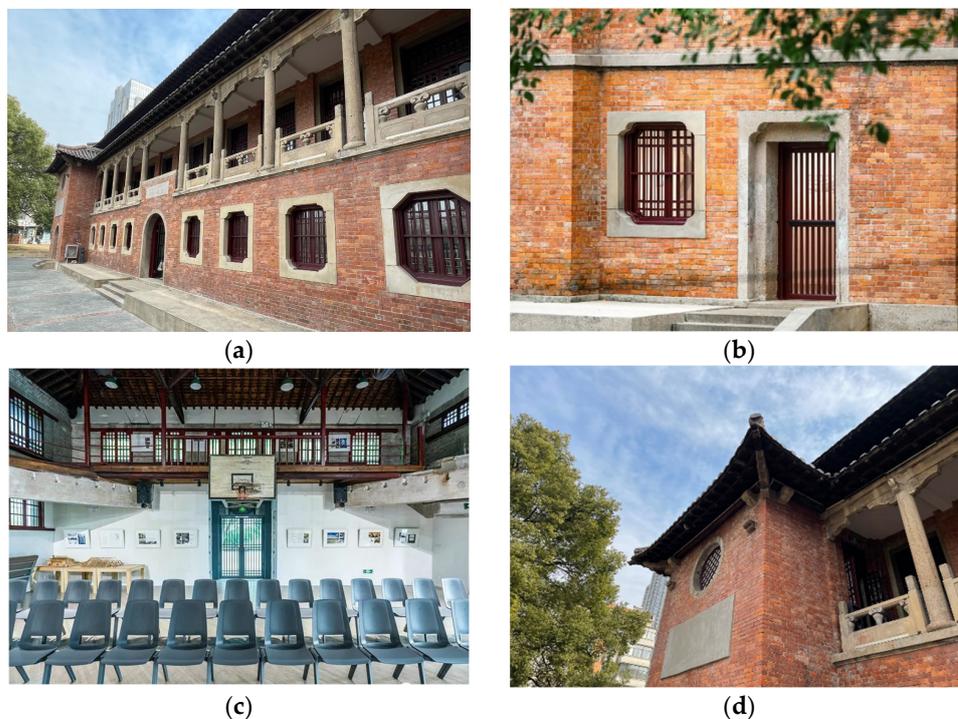
Figure 5. Detailed components (source: author). (a) Main facade of building. (b) Building exterior wall. (c) Building indoor, second floor. (d) Building eaves and corridors.

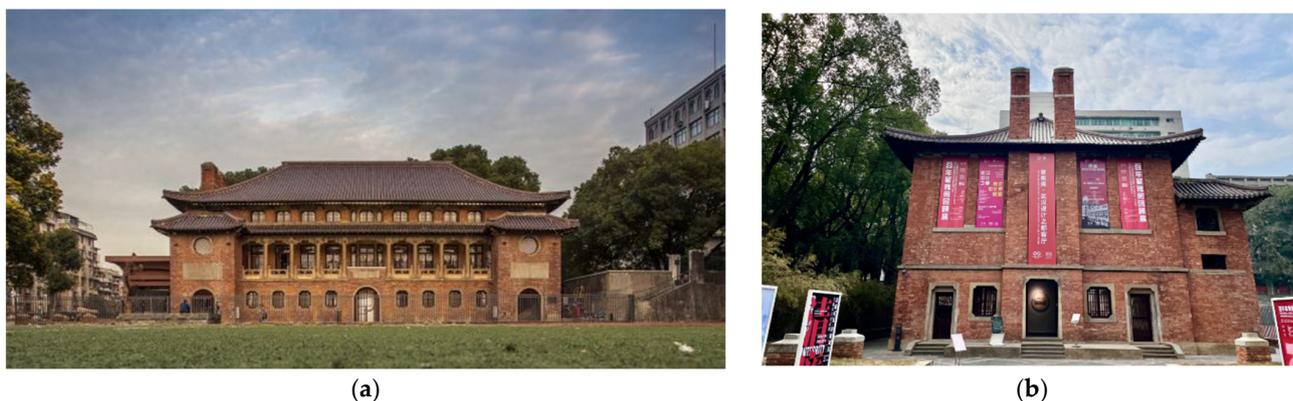
Figure 6. James Jackson Gymnasium's current situation (source: author). (a) Current status of the main facade of the building. (b) Current status of the north facade of the building.

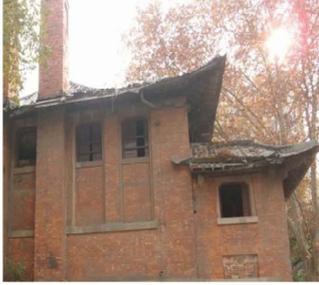
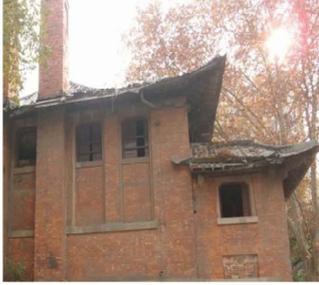
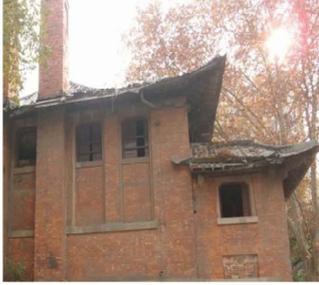
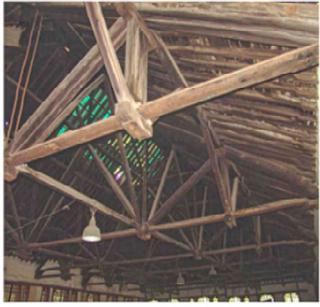
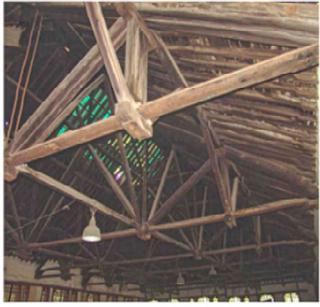
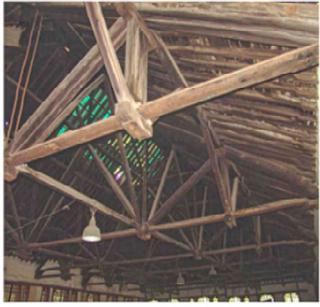
It can be seen from Figure 13 that the brick walls, wooden roof trusses, columns, and other structural components of the building are seriously damaged, and the monitoring and protection of these important parts should be strengthened.

<table><tr> <th>Raster Image</th> <th>Pathology description</th> </tr><tr> <td></td> <td>Tiles falling off</td> </tr><tr> <td></td> <td>Grass on the roof</td> </tr></table>

<table><tr> <th>Raster Image</th> <th>Pathology description</th> </tr><tr> <td></td> <td>Components are cracked</td> </tr><tr> <td></td> <td>Components rot</td> </tr></table>

Figure 13. Integrated diagram of James Jackson Gymnasium pathology information (source: author). (a) Roof tiles component pathologies. (b) Wooden roof truss component pathologies. (c) Door and window component pathologies. (d) Wall components pathologies.

First, by attaching the pathology location, pathology size, pathology photos, pathology text records, etc., to the three-dimensional model, we comprehensively displayed the damage, cracking, weathering, and other pathology states of the building components. Then, we classified the pathologies and recorded the time of the pathology in the “shared parameters”. Finally, an integrated map of historical building pathology information was generated to realize real-time monitoring of the historical building pathology. For example: the roof of James Jackson Gymnasium is covered with grass and the tiles are damaged (Figure 13a), the wood roof trusses are rotten and cracked (Figure 13b), the stone window sills are weathered (Figure 13c), and the platform base and wall are corroded (Figure 13d). In this way, we built a three-dimensional model of the pathology information of different parts of the historical building in the Revit 2020 software according to the timeline to realize the visualization of the pathology information of the historical building.

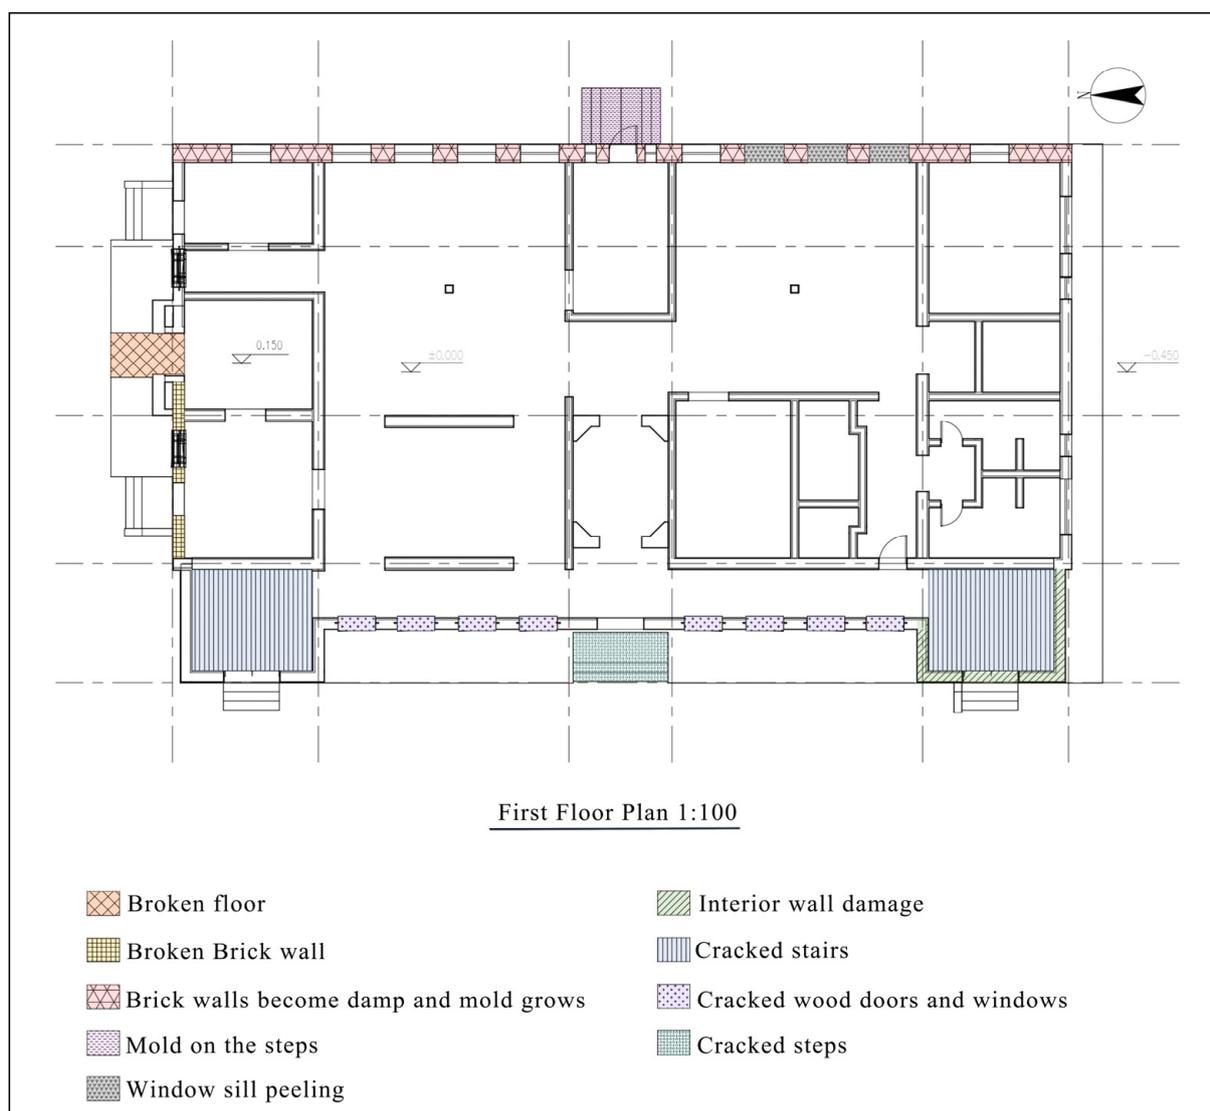
Figure 14. Visualization of building pathology areas (source: author).

In order to more clearly understand the location and details of historical building pathologies, we distinguish the areas where the pathologies occur to realize regional visualization of BIM pathologies [55]. We use the “Room Separation” function in the BIM model to divide specific pathology areas and add descriptions and pathology photos according to the pathology status, using different colors or patterns to differentiate between different areas and causes of pathology, as shown in Figure 14, which shows the locations of various pathologies on the first floor of the James Jackson Gymnasium. Through this plan, we can understand the entire pathology status of historical buildings, facilitate quick identification of the specific location of the pathology, and monitor the development trend
