Article

Experimental Investigation of the Explosion Effects on Reinforced Concrete Slabs with Fibers

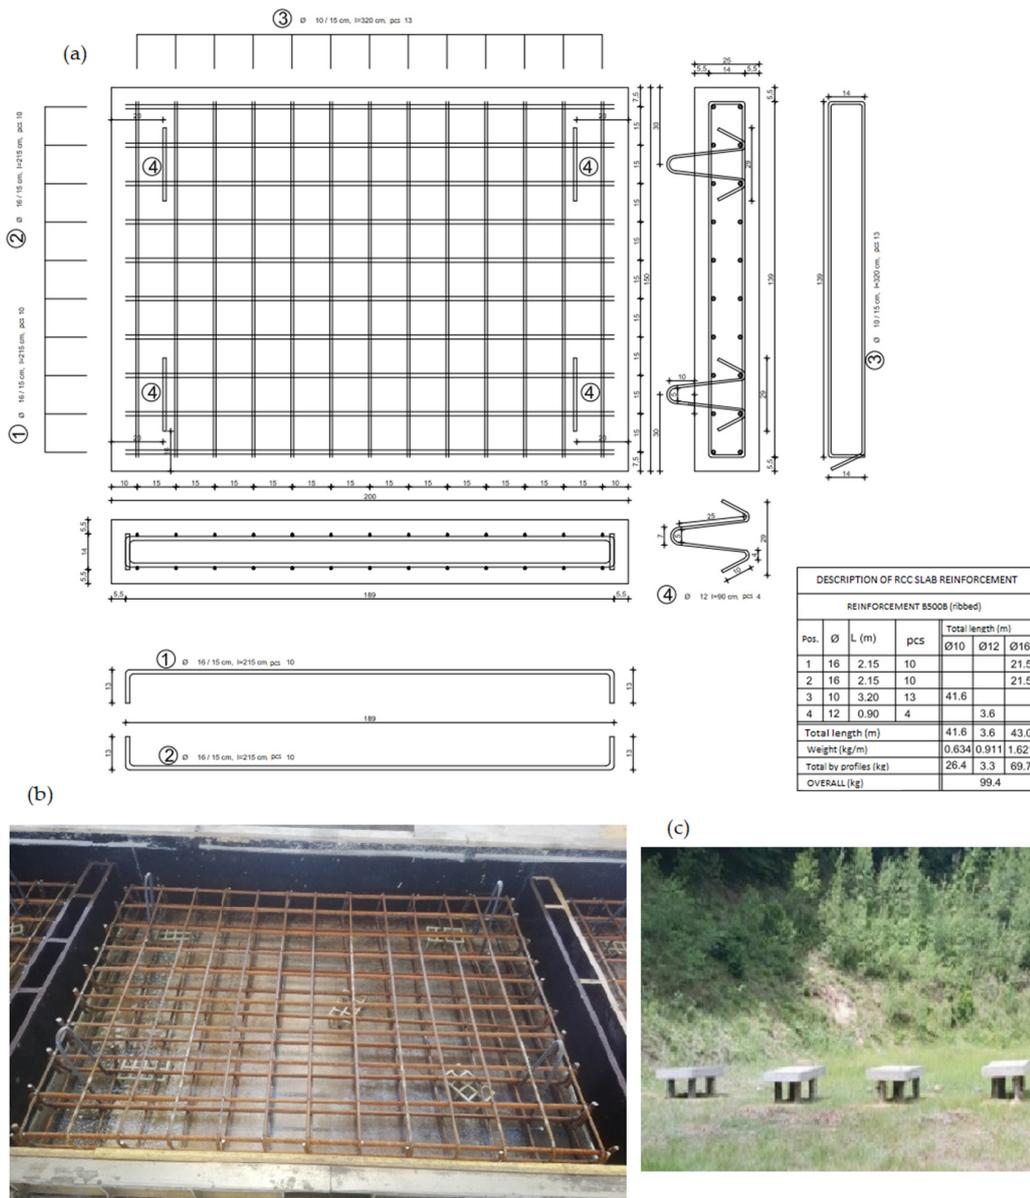
Figure 1. (a) Reinforcement drawing of RC slab specimens, (b) specimen with reinforcement before concreting, and (c) six specimens of RC slabs placed in the Cerovac military training area.

The thickness of the concrete specimens and the type and arrangement of the embedded reinforcement correspond to RC slabs commonly used for bridges. However, the length and width dimensions are modified to meet the transportation requirements of the Cerovac military training area.

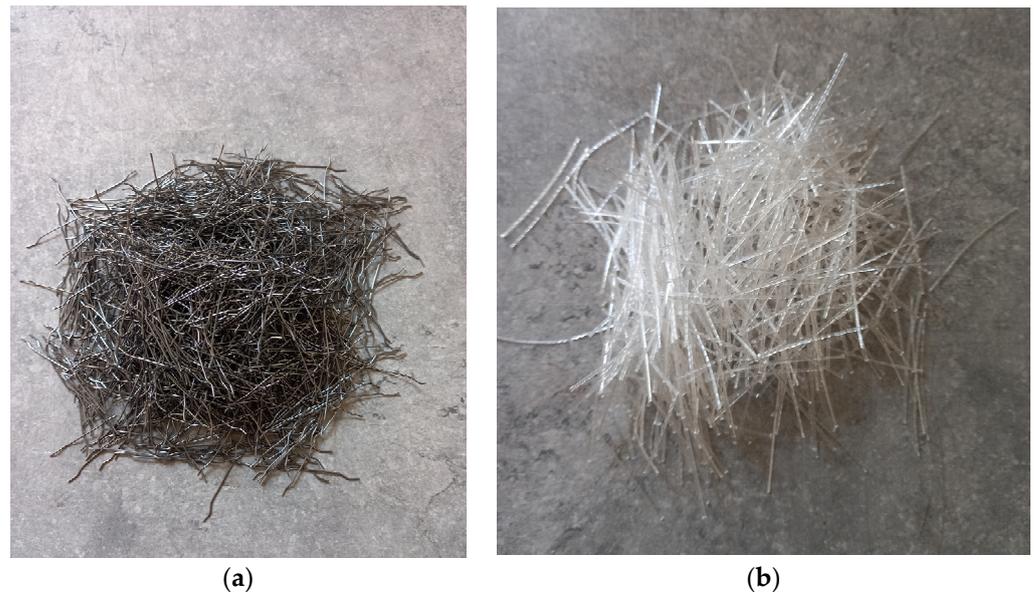
**Figure 2.** Fibers used in reinforced concrete slab specimens: (a) steel fibers and (b) polypropylene fibers.**Table 3.** Concrete mixtures for the RC slab specimens with lower (RCS1, RCS3, and RCS5) and higher (RCS2, RCS4, and RCS6) concrete classes.

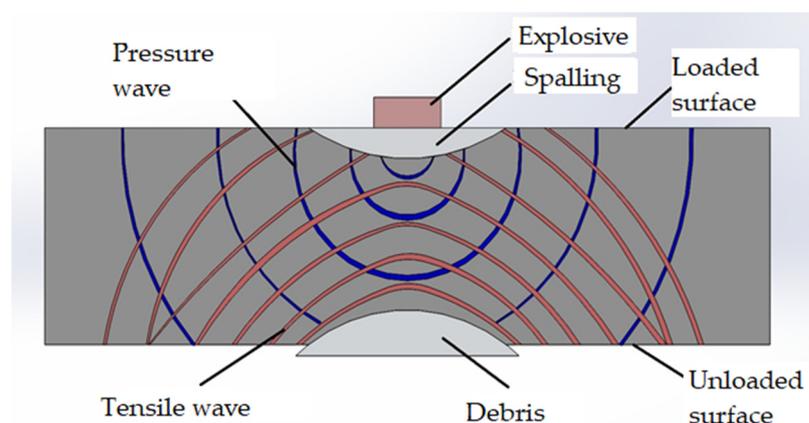
Figure 3. Scheme of contact detonation.

and shear stress, which are often very destructive to the structure. As shown in Figure 3, a strong pressure wave is initially generated in the vicinity of the explosive charge [28]. This wave exceeds the compressive strength of the concrete and causes its crushing. The pressure wave continues to propagate through the concrete structure and finally reaches the lower unloaded surface. From there, it is reflected as a tensile stress wave, which poses a greater risk to concrete structures due to the significantly lower tensile strength of concrete compared to its compressive strength.

When the amplitude of the tensile stress wave exceeds the concrete's tensile strength, the concrete structure starts to crush, expelling fragments as flying debris from its lower or unloaded side. This flying debris poses a serious threat to people and equipment in the vicinity of the structure [28,41].

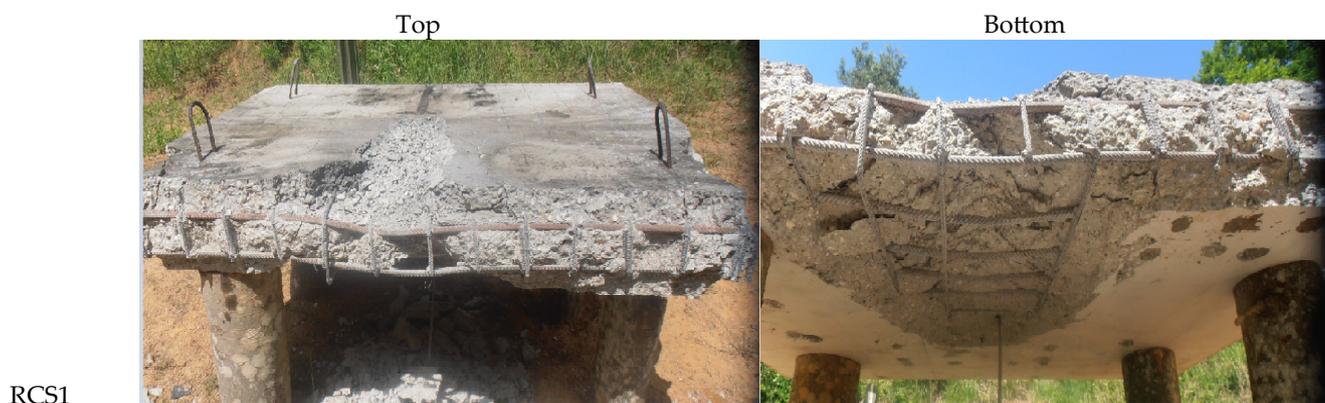
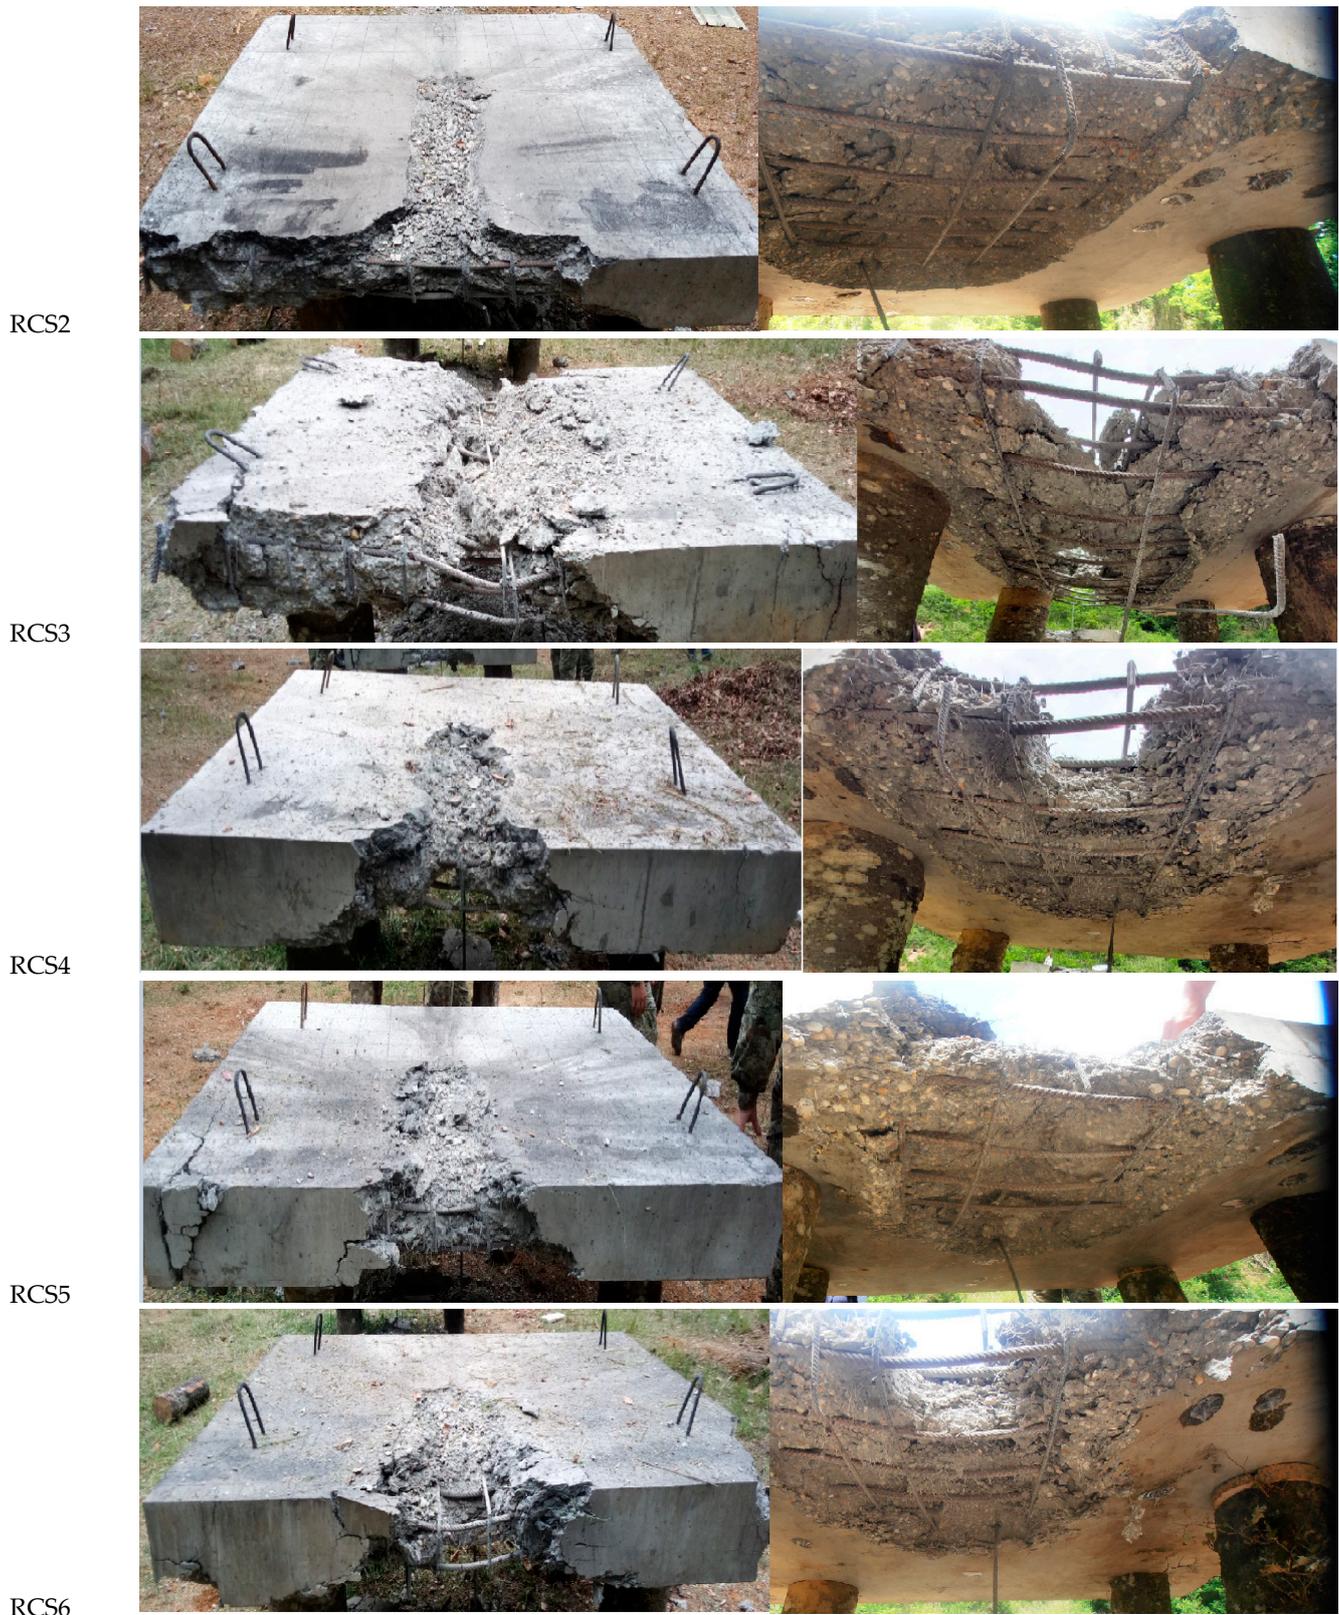
Figure 4. RC slab samples (RCS1-6) after explosive action: upper (left) and lower (right) surfaces.

The damaged surface of the concrete, that is, the surface of the spalled and punctured concrete, is evaluated by visual inspection and measurement (Figures 4 and 5; Table 5). These methods applied to the RC slab specimens demonstrate high accuracy and reliability for the following reasons: before the explosion, a reinforcing mesh was drawn on the top and bottom of the slab at 15 × 15 cm intervals, which facilitated the accuracy of the measurement of surface damage, while the size of the slab specimens and their placement at a height of 1 m above the ground enabled precise measurements from above and below.

When analyzing the results of the RC slab samples, it is found that all the RC slab samples show major surface damage on the bottom side due to the explosion. This is a consequence of the lower tensile strength of the concrete compared to its compressive strength and the principle of the impact of contact detonation (Table 5; Figures 3–5).

In the first part of the analysis, samples RCS1, RCS2, RCS4, RCS5, and RCS6 are considered because they contain a similar amount of explosive. The impacts of the compressive strength, presence, and type of fibers on the damage caused by the blasting effect are investigated. The analysis of the results of these samples shows that the highest surface damage occurs in samples RCS1 and RCS2, namely in slabs without fibers. It is obvious that the area of punctured concrete (8–10%) is significantly larger in these samples compared to the samples with fibers (2–4%). The surface area of the spalled concrete on the top side of all five samples is approximately the same. However, when comparing the surface area of the spalled concrete on the bottom side, it is noticeable that the results are similar for the samples without fibers and the samples with steel fibers (22–29% of spalled surface), and that they are larger compared to the samples with polypropylene fibers (18% of spalled surface). The FRC slabs (RCS4, RCS5, and RCS6) show significantly less surface damage. For the slab with steel fibers, the area of the punctured concrete is significantly smaller compared to the slabs with polypropylene fibers. However, the area of spalled concrete on the lower surface of the sample with steel fibers is significantly larger (Table 5; Figures 4 and 5).

When considering the influence of the concrete class, i.e., the characteristic compressive strength, it is not possible to clearly determine how the compressive strength affects the resulting damage to the concrete. In other words, no significant differences are found in the spalled or punctured surface between the samples with different characteristic concrete compressive strengths (Table 5; Figures 4 and 5).

In the second part of the analysis, samples with steel fibers but with different amounts of explosives used, RCS3 and RCS4, are compared. As expected, the greatest destruction occurs in the sample with a larger amount of explosive (RCS3). A comparison between the damaged areas of RCS3 and RCS4 reveals that, for RCS3, the area of destruction is 167% larger on the top surface, while it is 110% larger on the bottom surface. For sample RCS3, the spalled area is 60% larger on both the top and bottom surfaces than for sample RCS4. The surface area of the punctured concrete in sample RCS3 is approximately 807% larger. It is crucial to emphasize that significant puncture of concrete occurs on the lateral sides

(edge of slabs) of sample RCS3, while no such puncture is observed on the lateral sides in sample RCS4 (Table 5; Figures 4 and 5).

In view of the fact that RCS3 uses about three times the amount of explosives compared to RCS4, the ratio of the damaged surfaces of the two plates is analyzed. It is found that the damaged surface on the upper side of RCS3 is about three times as large as that of RCS4 ($r = \text{ARCS3, damaged} / \text{ARCS4, damaged} = 2.7$) and the damaged surface on the bottom side is about twice as large ($r = \text{ARCS3, damaged} / \text{ARCS4, damaged} = 2.1$). In other words, the damaged top surface of sample RCS3 is about three times as large as the amount of explosive activated on it (Table 5; Figures 4 and 5).

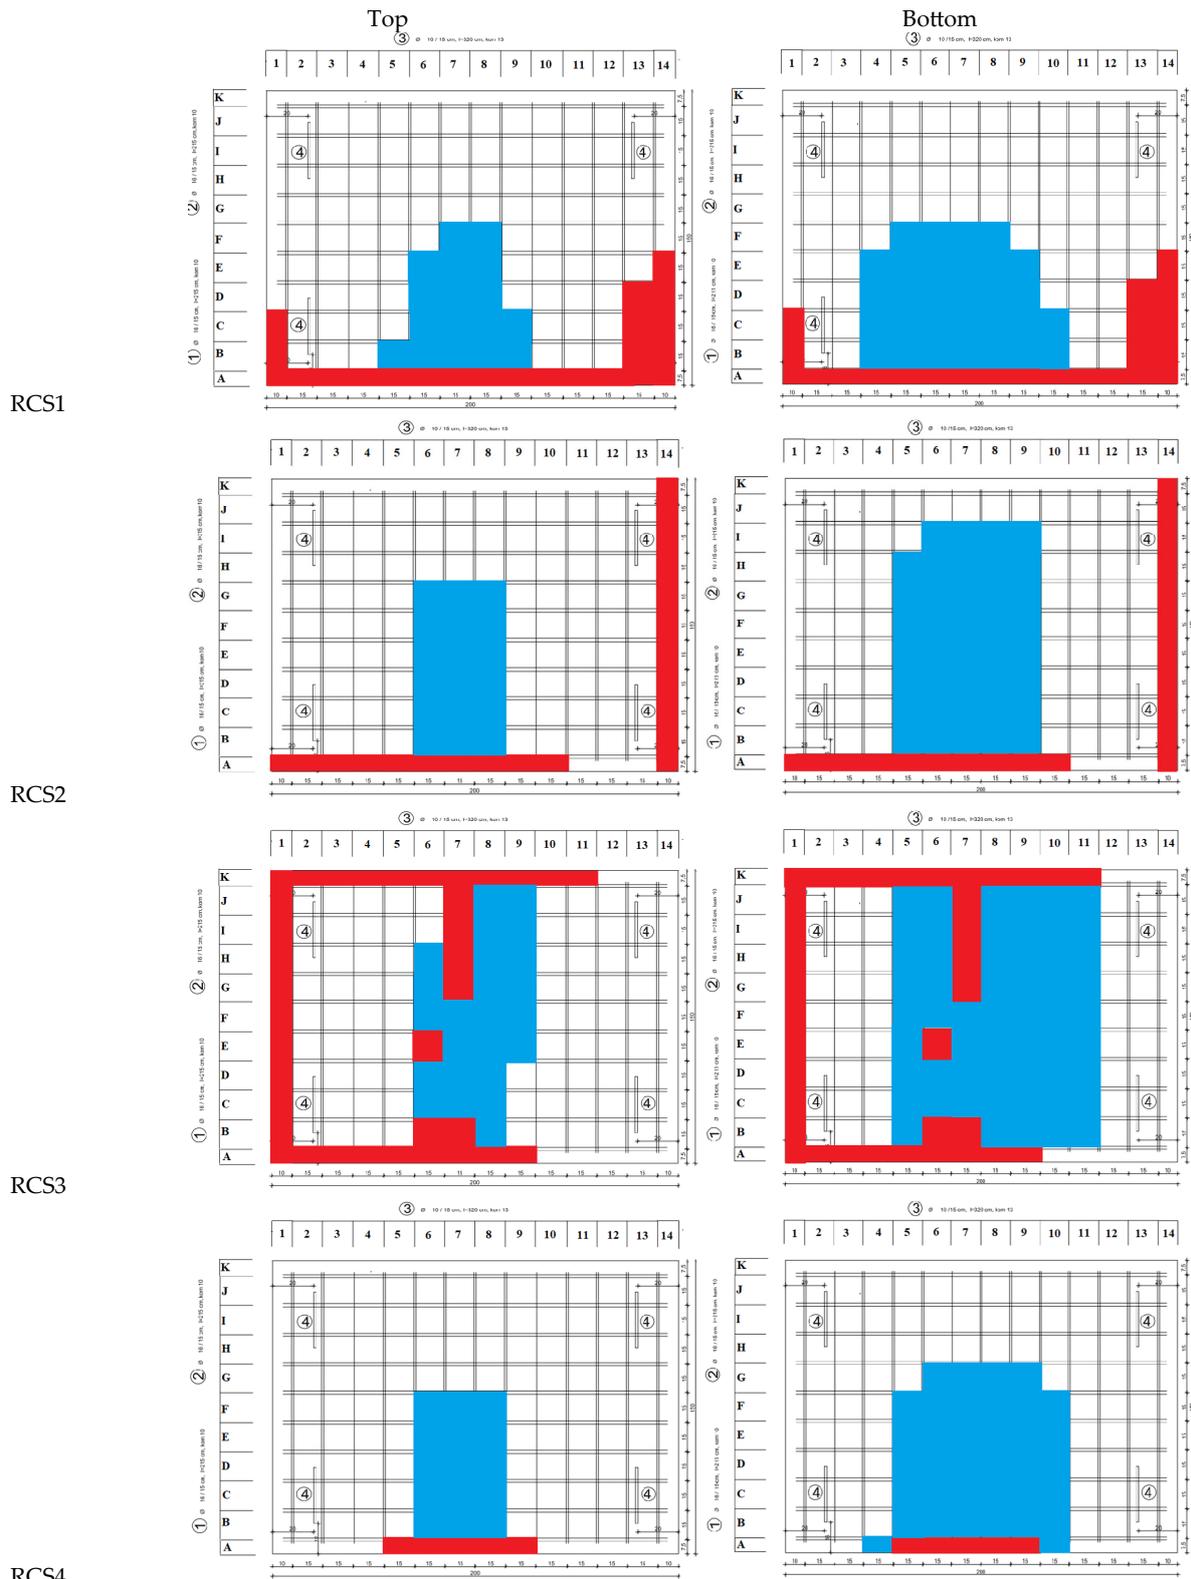
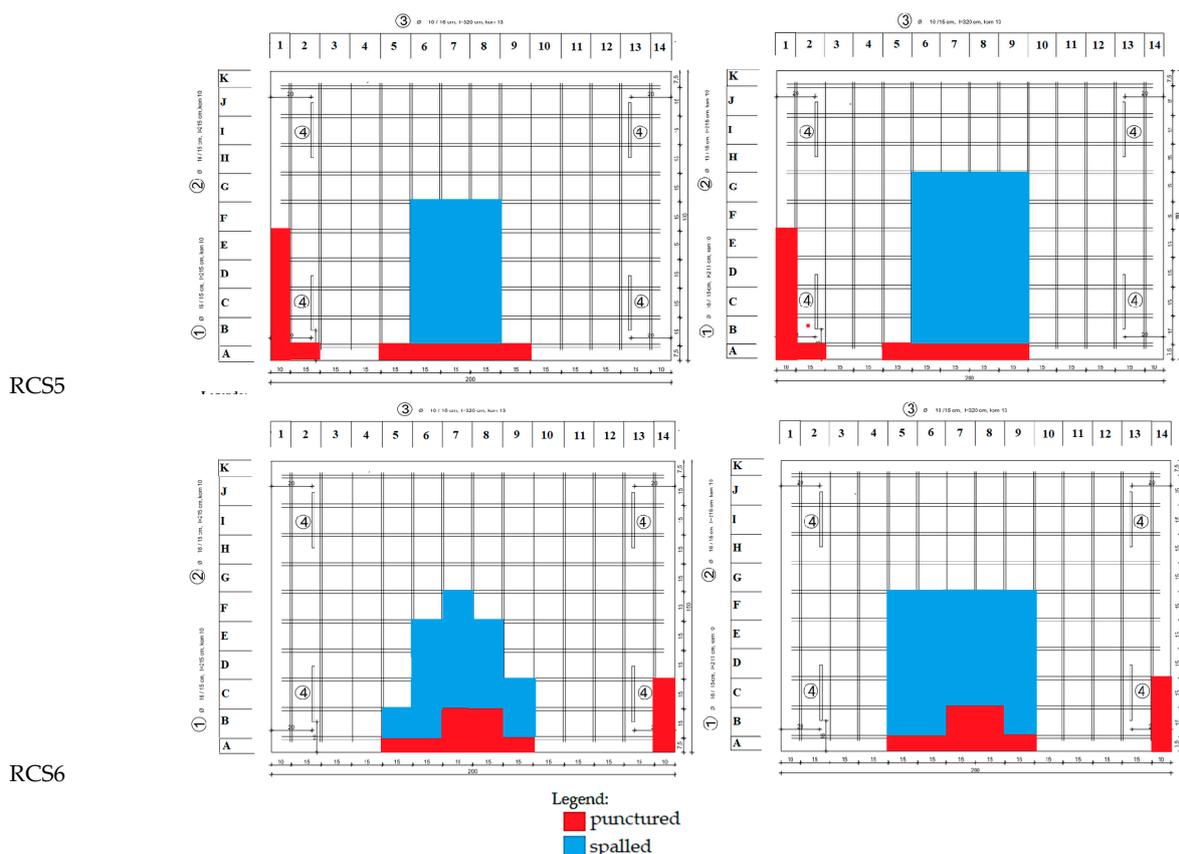
Figure 5. Punctured and spalled surfaces on specimens of RC slabs on the upper (left) and lower (right) surfaces after explosive action.

A spalled surface implies the destruction of the concrete cover up to the reinforcement level or in some places even a few centimeters deeper than the reinforcement. A punctured surface is the destruction of concrete over the entire thickness of the RC slab, usually on the slab edges.

After analyzing the results, it is found that the samples without fibers (RCS1 and RCS2) show the most severe concrete puncture on the side surfaces as a result of the explosive effect. The samples with polypropylene fibers (RCS5 and RCS6) have a lesser extent of concrete puncture on the side faces. Notably, in the case of the sample with steel fibers (RCS4), there is no puncture of the concrete at the edge of the slab (Figure 5).

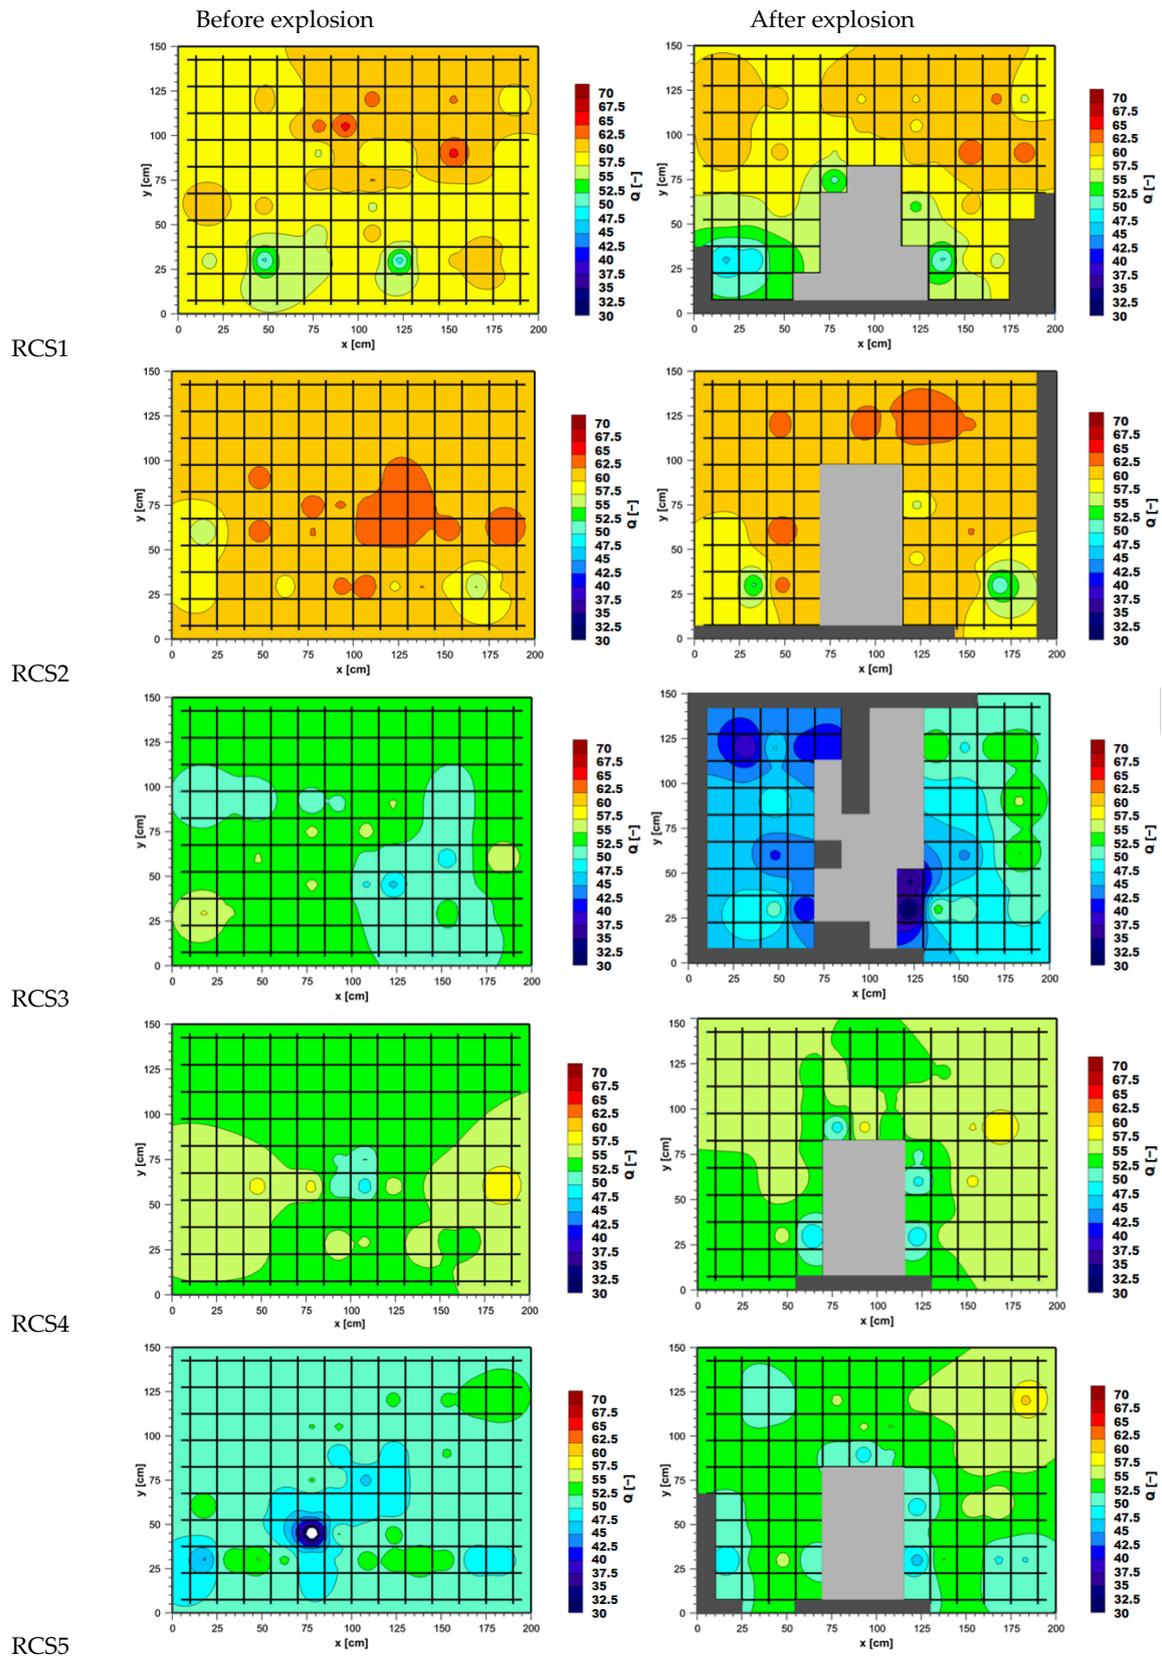
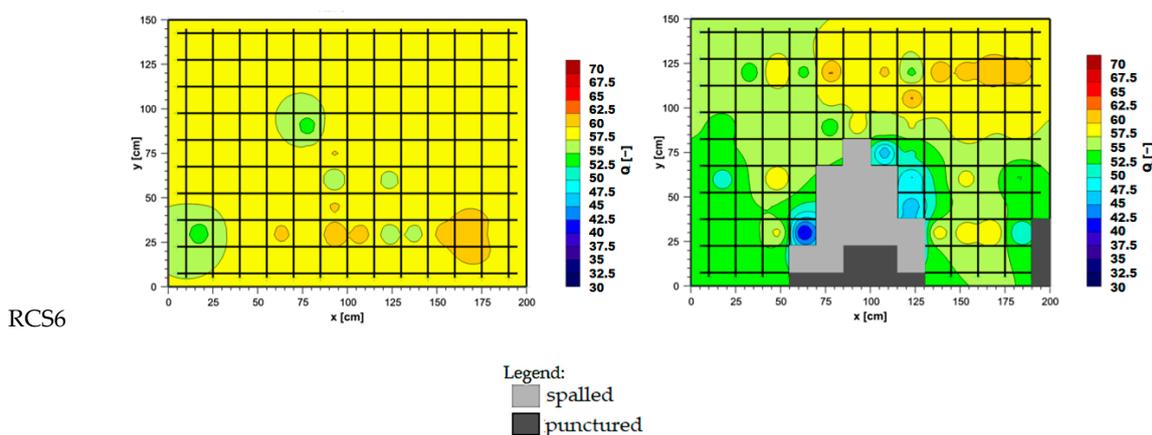
Figure 6. The rebound values Q measured before (left) and after (right) the explosion on the top of each RC slab specimen.

The rebound value, Q , is measured before and after the explosion on the top of each RC slab specimen. Q is measured before and after the explosion at the same predefined 52 measurement spots with ten impacts per spot for each RC slab specimen. At the place where the explosives are placed, six measurements are additionally carried out before the explosion to confirm the uniformity of quality. After the explosion, this part is damaged, so the tests could not be repeated at these spots. The results of testing the Q value before and after the explosion for each RC slab specimen are shown graphically in Figure 6. The mean Q value and the standard deviation of the Q value before and after the explosion are calculated for each RC slab specimen (Table 6). In addition, the ratio of the mean Q value after and before the explosion (r_Q) and the ratio of the standard deviations of the Q value after and before the explosion ($r_{\delta Q}$) are calculated according to the following expression:

By analyzing the RC slab specimens exposed to a conventional amount of explosives (RCS1, RCS2, RCS4, RCS5, and RCS6), it is clear that the most significant reduction in Q value due to explosives exposure is observed in specimen RCS6, with an r_Q value of 0.95. Conversely, the strongest Q value increase occurs in RCS5, where the calculated r_Q value reaches 1.05. The highest r_{6Q} value is measured for specimen RCS6 at 2.75. This means that the explosion effect on this specimen led to the greatest development of cracks and damage to the concrete, resulting in uneven strength and quality. In contrast, the lowest r_{6Q} value is 0.63 and is observed in the RCS5 specimen. This result indicates that, as a result of the explosive action on sample RCS5, there is a uniformization of the strength and quality of the concrete, which deviates from the expectations and the results of measurements on other samples. Therefore, it can be concluded that a gross error occurred. However, when looking at the values of Q before and after the explosion, there is not a significant difference in the values (Figure 6; Table 6).

When examining the area where the explosion affected the Q value, it is found that this zone is relatively uniform in size for all specimens. The sharpest drop in Q value is primarily concentrated along the entire abscissa axis (the longer side of a slab) and extends up to approximately 110 cm along the ordinate axis (the shorter side of the board). Beyond this point along the ordinate axis, the Q value remains mostly unchanged, apart from occasional local increases in the observed value (Figure 6).

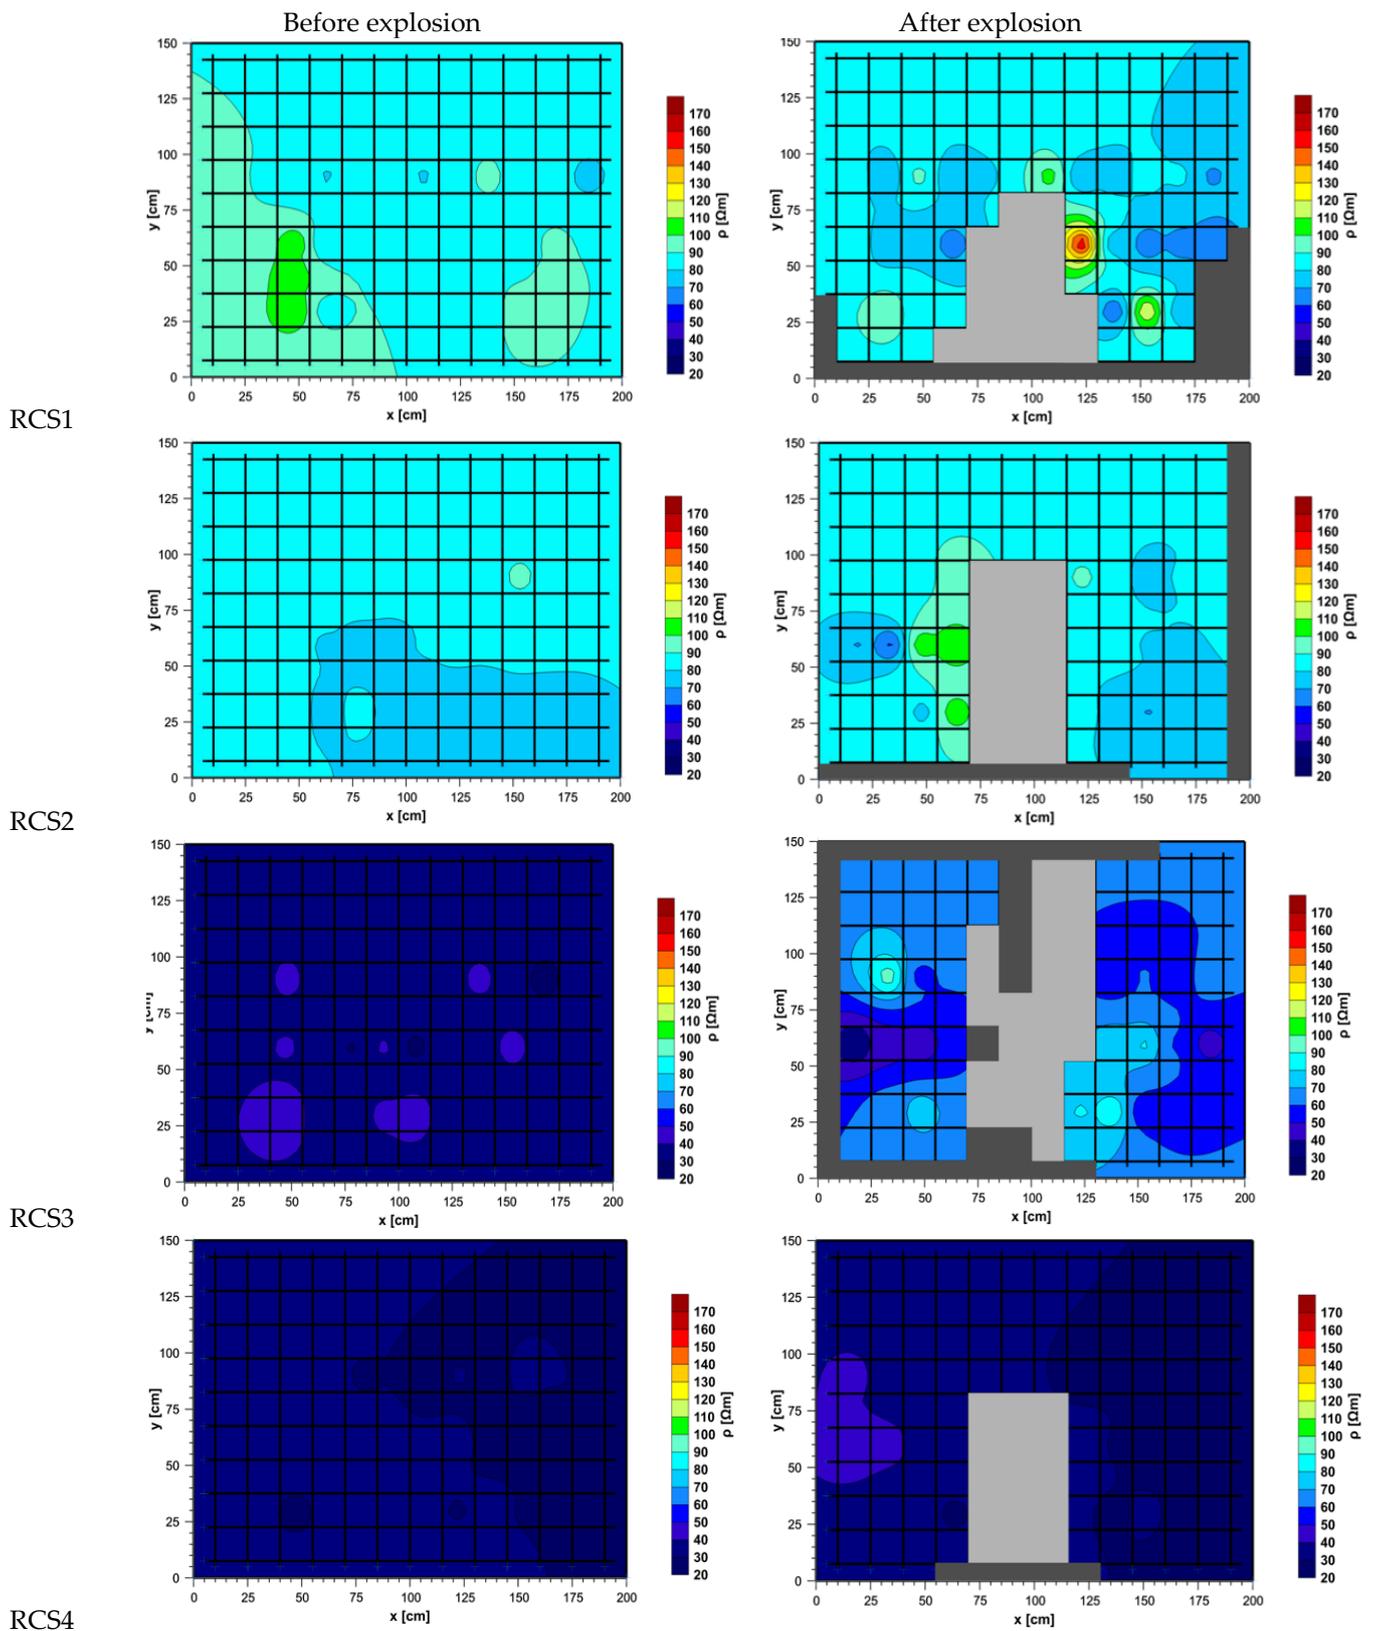
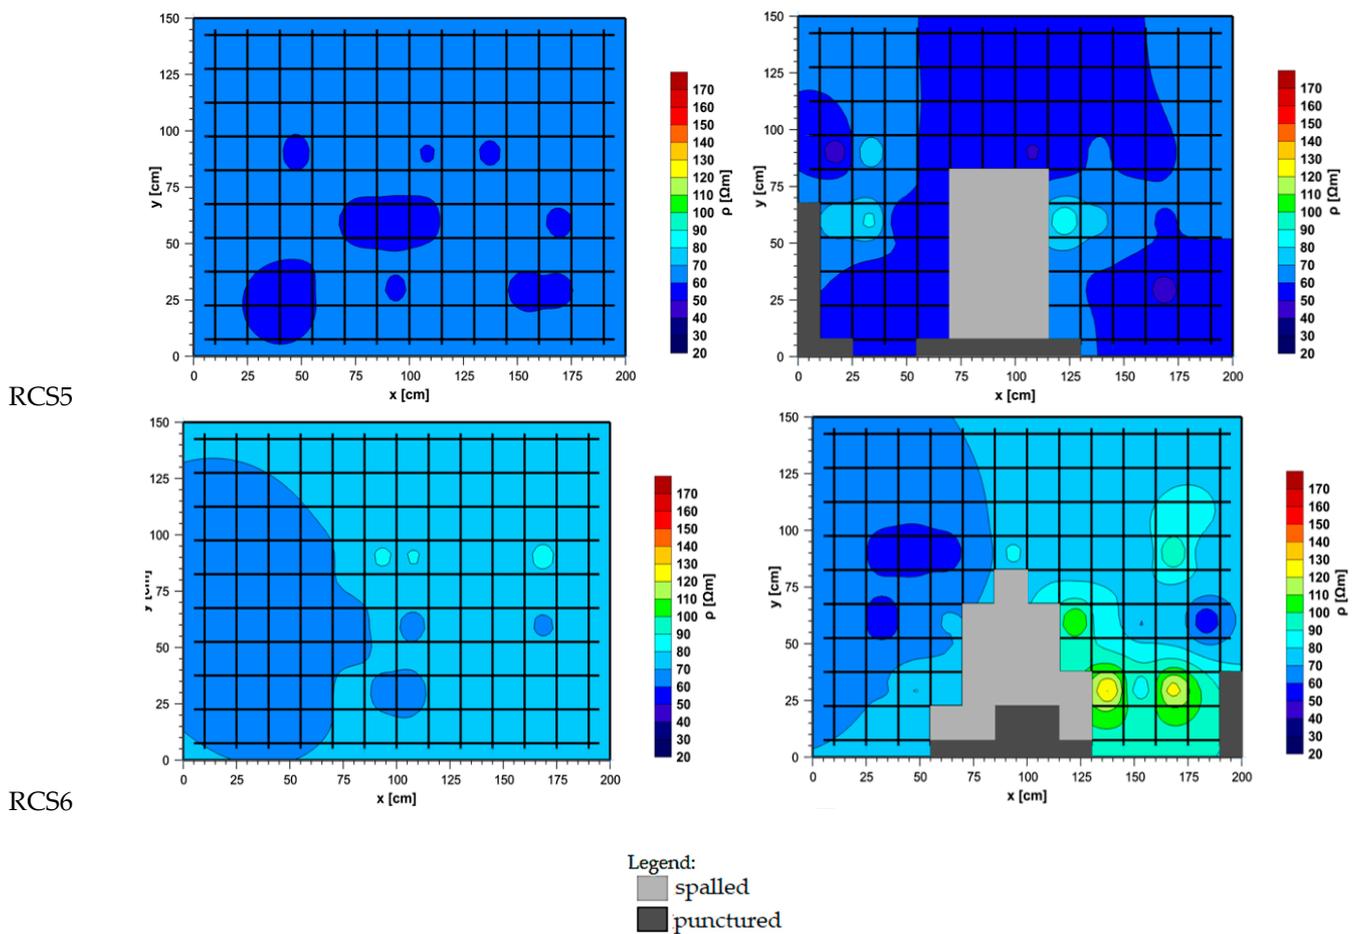
Figure 7. Electrical resistivity of the reinforced concrete slabs before (**left**) and after (**right**) explosive action.

Test specimen RCS5 exhibits the highest $r_{\delta\rho}$ value of 4.48, signifying considerable internal damage and the formation of numerous cracks resulting from explosive action. Consequently, this leads to a reduction in the compactness of the concrete structure. In contrast, the lowest $r_{\delta\rho}$ value of 1.69 is recorded for RCS4 (Figure 7; Table 6).

Upon comparing the zones affected by explosive action on RC slab specimens, it is observed that the most extensive zone is identified in specimens RCS5 and RCS6. The zones of influence are slightly smaller in other specimens (RCS1, RCS2, and RCS4). Beyond approximately 120.00 cm along the ordinate axis, notable fluctuations in the ρ value are absent (Figure 7; Table 6).

It is worth noting that it rained before the explosion, which led to an increase in the humidity of the specimens and a subsequent decrease in concrete resistivity. During the tests after the explosion, the moisture of the specimens was significantly lower, which led to an increase in the electrical resistivity of the concrete. For the above reasons, the results of the electrical resistivity test cannot be considered fully authoritative for assessing the internal damage caused by the explosion. Instead, they must be compared with the results of other NDT methods carried out.

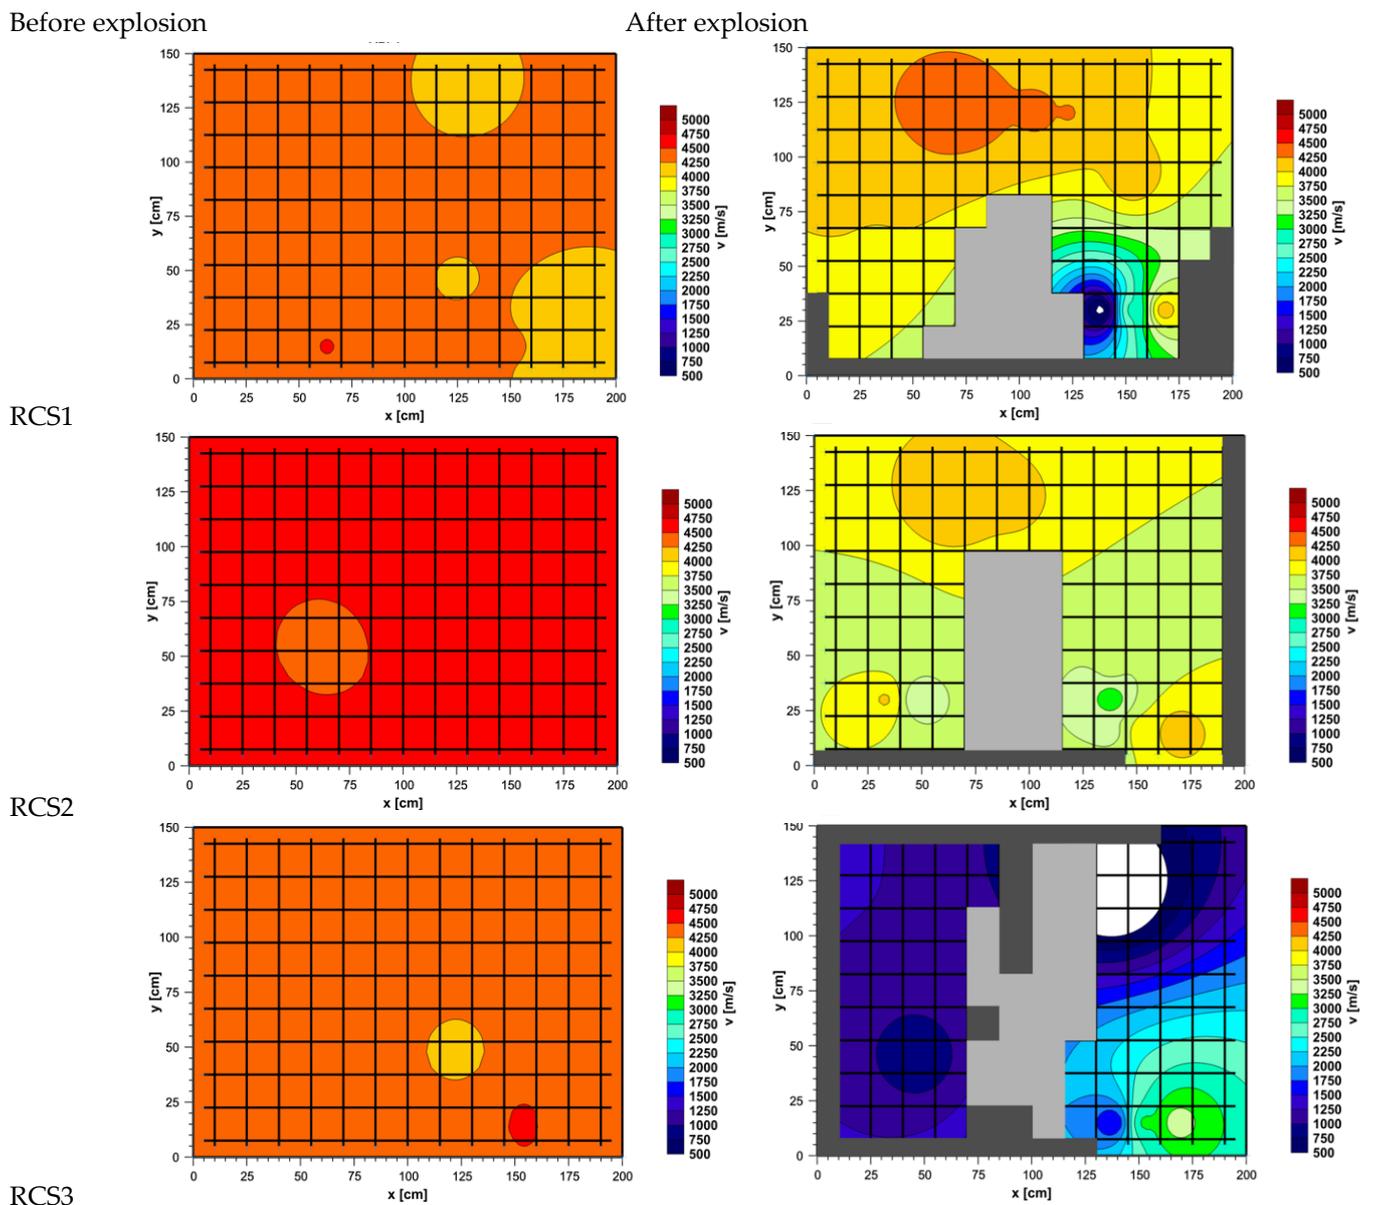
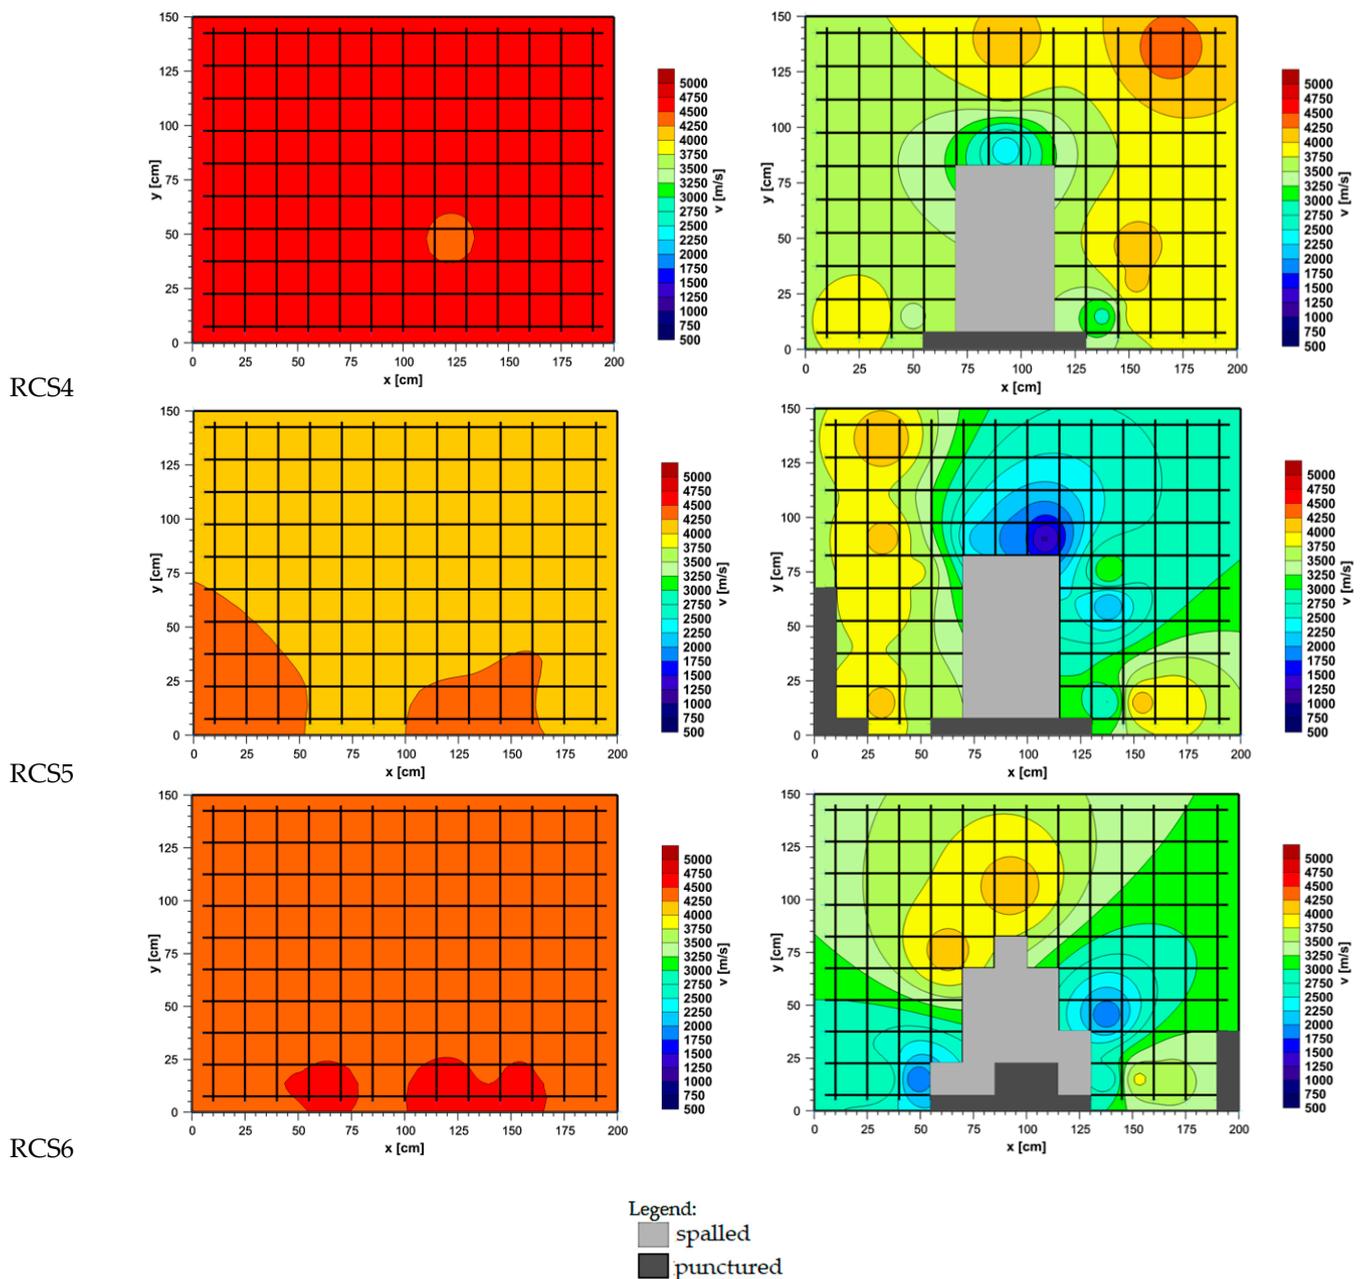
Figure 8. Velocity of the ultrasonic wave through the concrete in specimens of reinforced concrete slabs before (**left**) and after (**right**) explosive action.

The velocity of the ultrasonic wave, v , is measured before and after the explosion through the RC slab thickness of 25 cm. The velocity of the ultrasonic wave is measured at 44 predefined measurement spots with three tests per spot for each RC slab specimen. At the place where the explosive is placed, an additional six measurements are conducted before the explosion to confirm the uniformity of quality. As expected, the upper or lower surfaces of this part were damaged after the explosion, so the tests could not be repeated at these six spots.

According to the criteria listed in Table 4, the most significant deterioration in concrete quality, which transitioned from good to poor, is observed in the RCS5 specimen. Approximately 1.16 m² (39%) of the surface shows poor concrete quality. In contrast, the RCS2 specimen shows no areas where the concrete quality decreased from good to poor (Figure 8; Table 6).

The most extensive area of deterioration in concrete quality from good to medium is found in the RCS4 specimen. More specifically, approximately 2.11 m² (70%) of the surface has a medium concrete quality after the explosive impact. In contrast, the smallest area showing a medium level of deterioration due to the impact of the explosives is found in the RCS1 sample. Here, the concrete of medium quality covers around 0.97 m² (32%) after the explosion (Figure 8).

least impact of the explosive are found in the RCS5 and RCS6 specimens. These specimens exhibit good concrete quality over approximately 0.10 m² (3%) of the surface (Figure 8).
