Article

Digital Twin Research on Masonry–Timber Architectural Heritage Pathology Cracks Using 3D Laser Scanning and Deep Learning Model

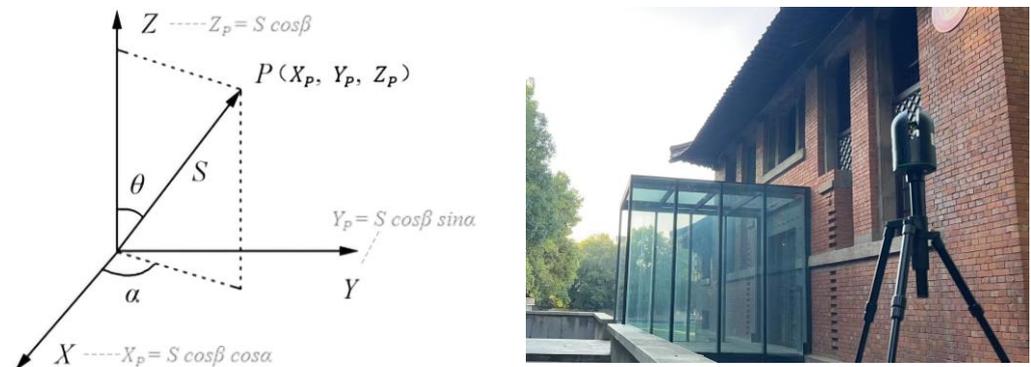
Figure 2. Calculation principle of 3D laser scanner target point imaging (left); James Jackson Gymnasium was surveyed using a 3D laser scanner on site (right).

Three-dimensional laser scanning is an automated, non-contact, high-precision stereo scanning technology (Figure 2). It serves as an extremely efficient method for acquiring initial data in architectural heritage studies, with three-dimensional scanning stations

This study uses the Leica BLK 360 G1 3D laser scanner, laser wavelength 830 nm; scanning range 0.6–60 m; ranging accuracy 4 mm @ 10 m/7 mm @ 20 m; point cloud accuracy 6 mm @ 10 m/8 mm @ 20 m. Using WFD waveform digitization technology and HDR image technology, three-dimensional space point cloud information and 360° panoramic images can be quickly obtained within 3 min.

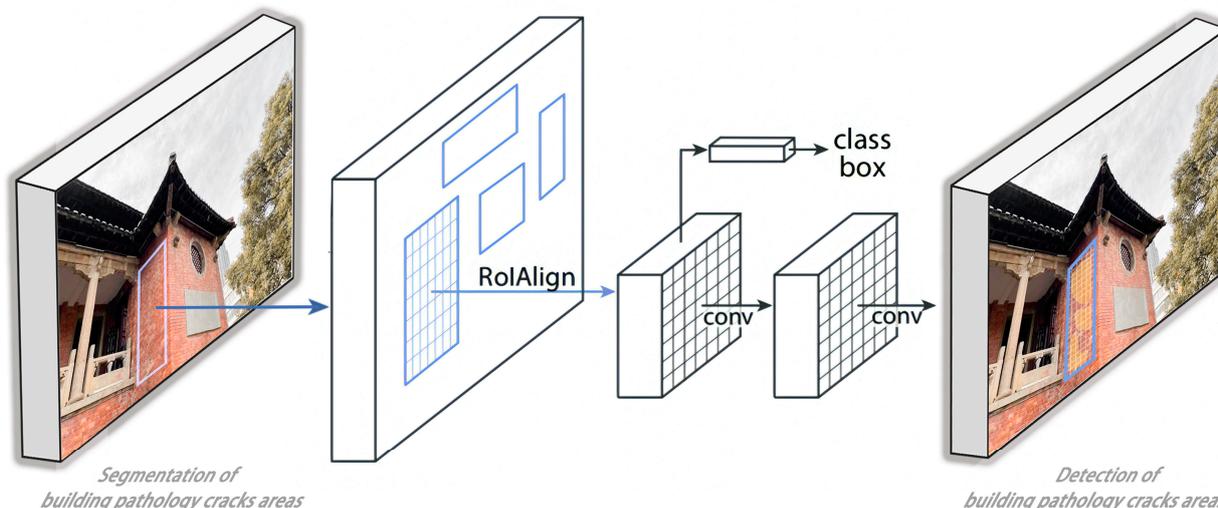
Figure 3. The principle of Mask R-CNN pathology crack detection model to achieve target detection in two-dimensional images.

ning the image. In the second stage, classification results and bounding boxes are obtained based on the candidate regions. Additionally, a segmentation branch is incorporated into the original Faster RCNN model to produce mask results, thus decoupling the relationship between mask and category prediction (Figure 3).

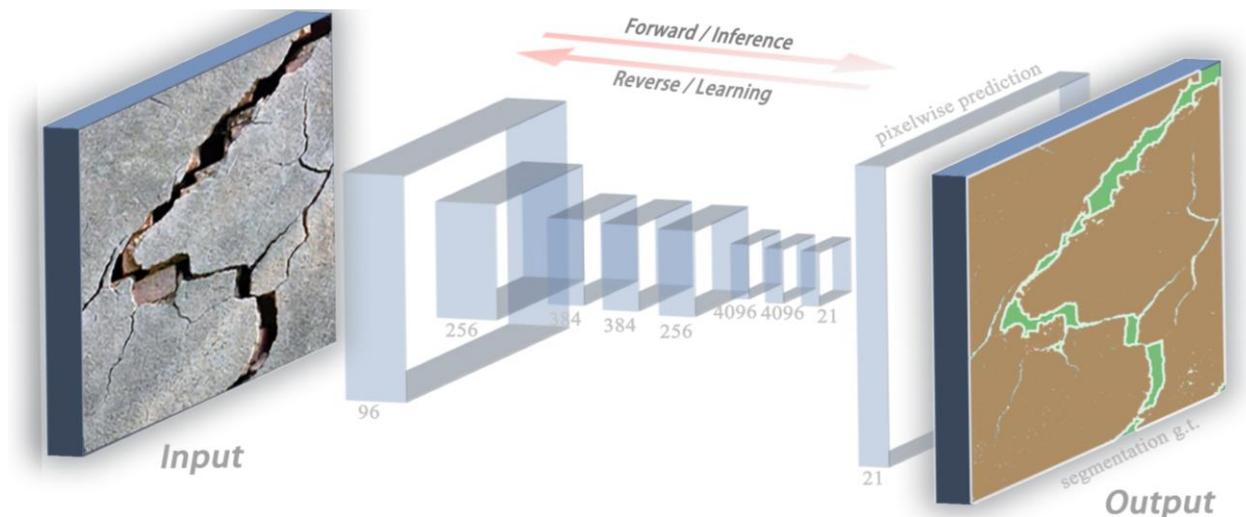
Figure 4. FCN pathology crack identification and computational model generation principle. The numbers below each convolutional layer represent the number of images stacked in each layer. For example, 256 means that the layer is composed of $256 \times 256 \times 256$ images stacked.

FCN (Fully Convolutional Neural Network) is an enhanced form of convolutional neural network (CNN) that transforms the fully connected layer found in traditional CNNs into a convolutional layer. This modification allows the network to process input images of various sizes and generate classification maps that match the original input size [31,32]. The FCN network architecture consists of convolutional layers, pooling layers, and upsampling layers. Convolutional and pooling layers are responsible for extracting features, while the upsampling layer restores the feature map to the original input image resolution for precise pixel-level classification. This capability makes the FCN model ideal for tasks involving pixel-level image interpretation [33], such as image segmentation, target detection, and scene parsing [34] (Figure 4).

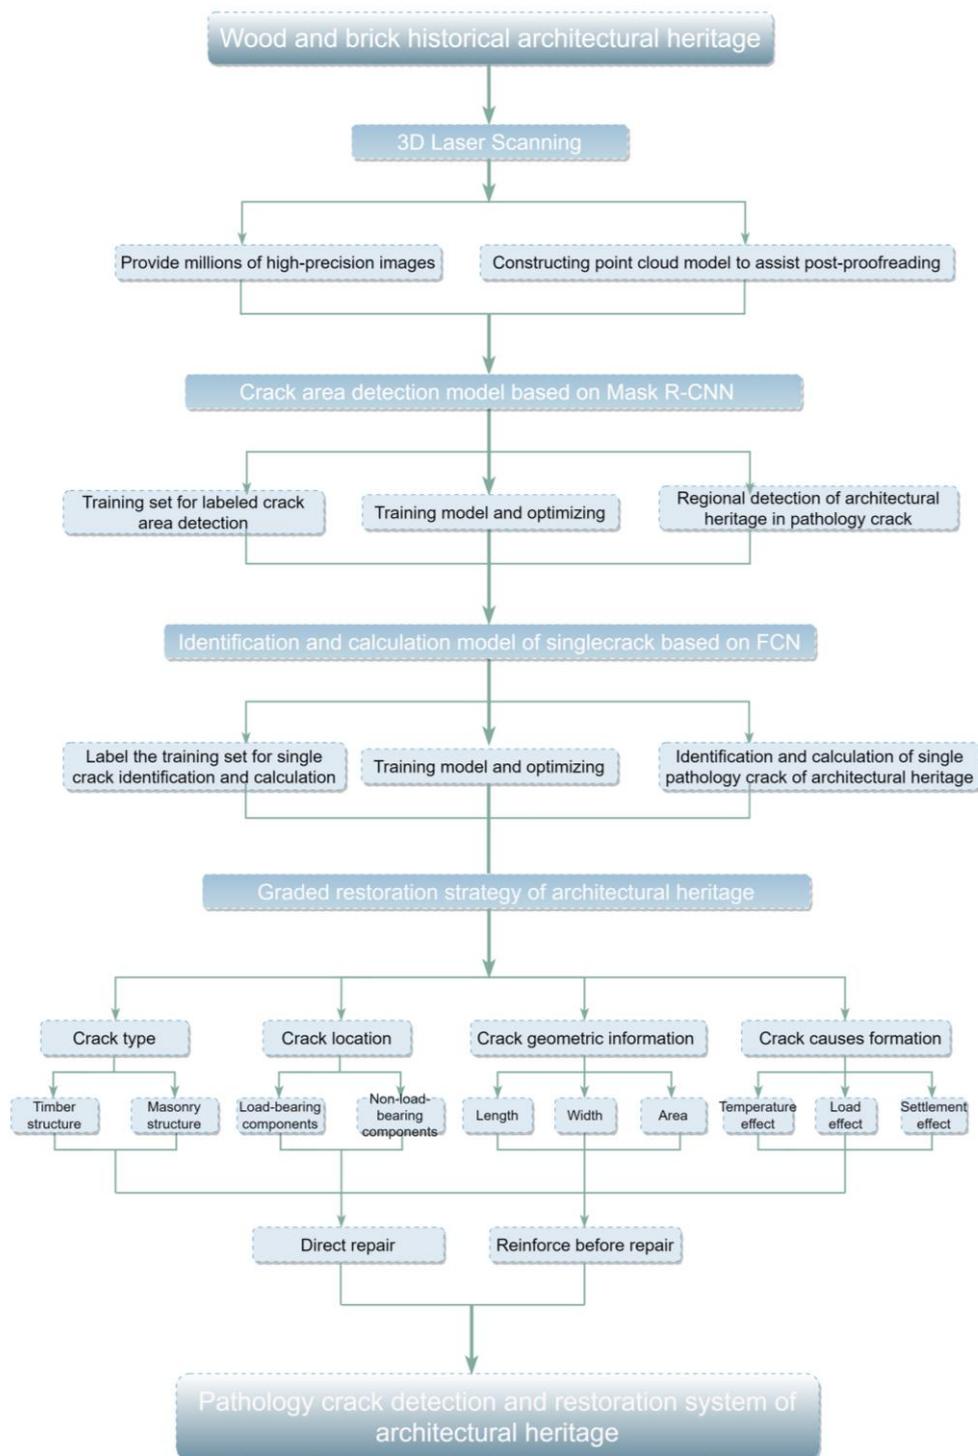
Figure 5. Research framework.

Finally, using James Jackson Gymnasium in Wuhan as a case study, the architectural geometry information was captured using 3D laser scanning. This enabled the detection of pathology crack areas, as well as the identification and calculation of individual cracks. Subsequently, a targeted hierarchical restoration strategy was developed based on the identification results. The methodology presented in this study is illustrated in Figure 5.

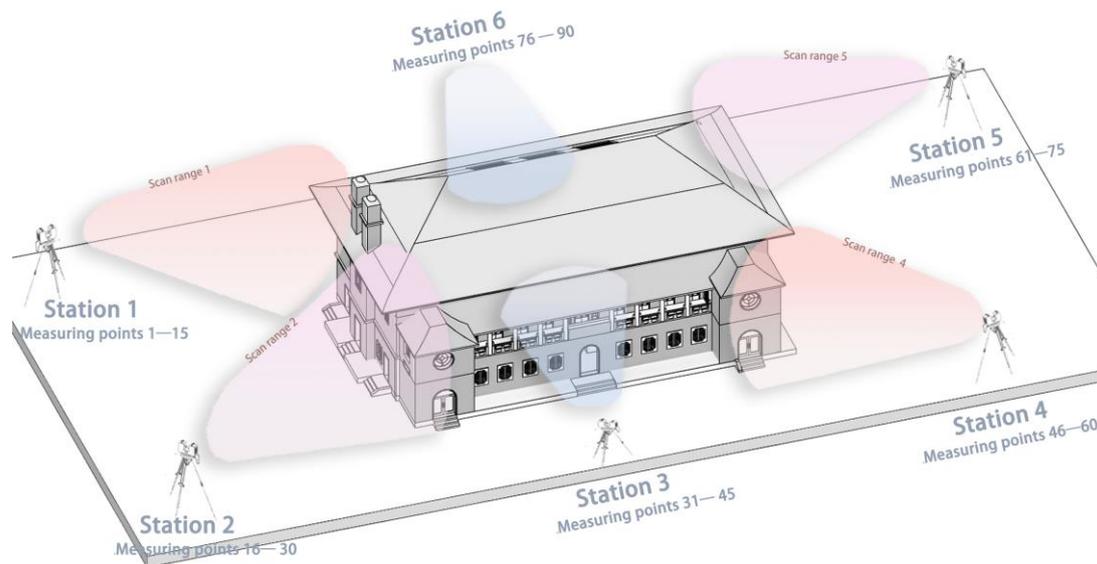
Figure 6. Schematic diagram of James Jackson Gymnasium station and point layout in 3D laser scanning.

According to measurements, the architectural heritage James Jackson Gymnasium has dimensions of 30,854 m in the north–south direction, 17,452 m in the east–west direction, a height of 13,950 m, and a circumference of 96,612 m. The perimeter of the gymnasium is divided into six equidistant stations, spaced 16 m apart, with each station containing 15 measuring points [35], resulting in a total of 90 measuring points (Figure 6). This division allows for high-precision 3D laser scanning to be conducted on the entirety of James Jackson Gymnasium [35,36].

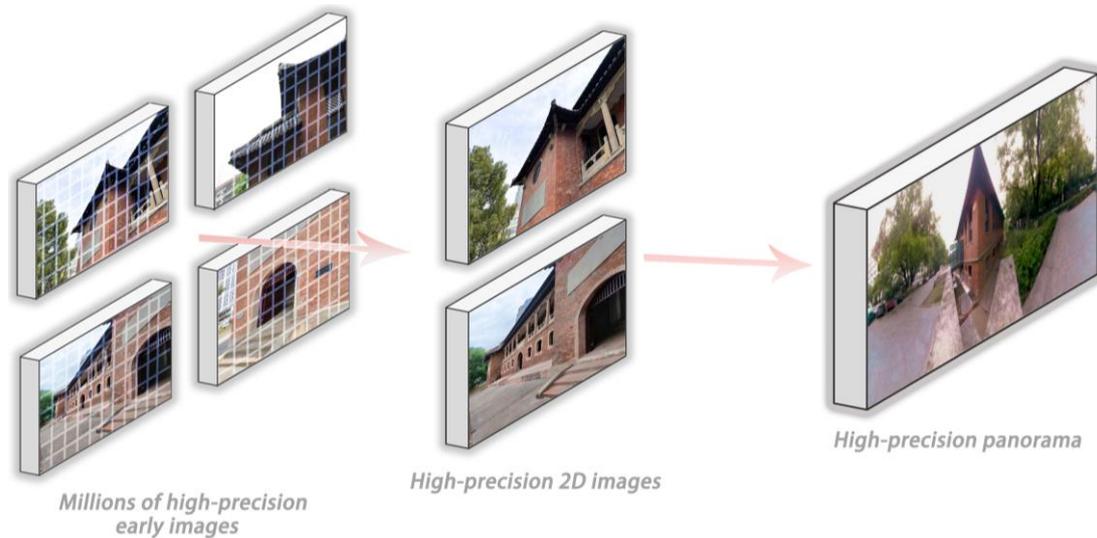
Figure 7. Principle of obtaining millions of high-precision image data of 3D laser scanner by using James Jackson Gymnasium.

Through high-precision and omni-directional 3D laser field scanning, millions of image data points of James Jackson Gymnasium were captured, resulting in the creation of highly accurate real 2D images through integration of the 3D laser scanner [38–40]. Further, the real panorama of James Jackson Gymnasium (Figure 7) was produced by computer-aided splicing of features such as targets as reference points. A total of 282 high-precision two-dimensional images of James Jackson Gymnasium were generated during scanning, with 270 effective two-dimensional images obtained, accounting for factors such as weather, angle, and equipment limitations. These detailed and high-precision real image data of James Jackson Gymnasium serve as valuable support for future identification and study of structural issues.

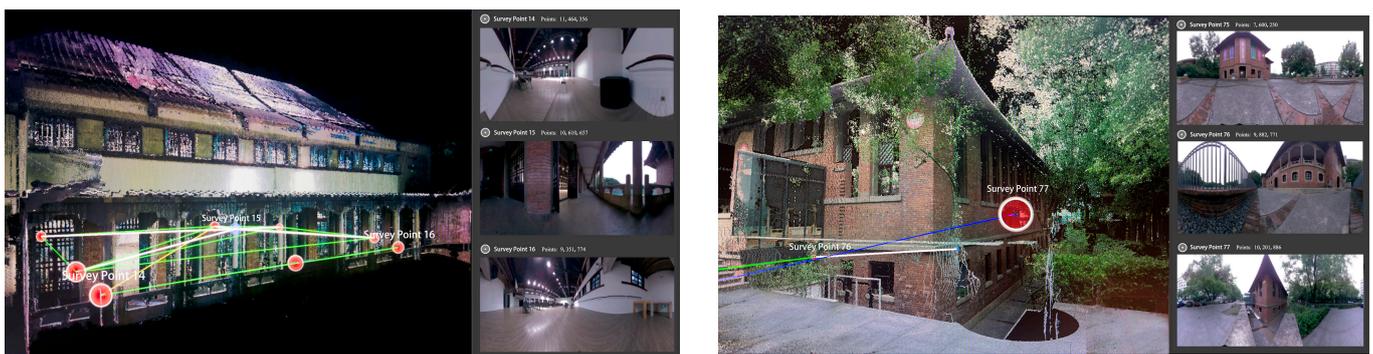
Figure 8. James Jackson Gymnasium point cloud data model at spliced measuring station 1 (measuring points 1–15) and the scanning panorama corresponding to each measuring point, and the right text part is the total number of point cloud data points contained in the measuring point (left); the scanning panorama corresponding to each measuring point of James Jackson Gymnasium point cloud data model at spliced measuring station 6 (measuring points 76–90), and the right text part is the total number of point cloud data points contained in the measuring point (right).

During the James Jackson Gymnasium 3D laser scanning, six stations were set up, each consisting of 15 measuring points, totaling 90 measuring points. The measuring points accumulated a total of 986,258,832 point cloud data points, with an average of 10,600,000 point cloud data points per measuring point (Figure 8). Furthermore, the scanned scattered point cloud data from the 90 measuring points were integrated with the same characteristics as the target using a computer, resulting in a complete cluster of 90 point cloud data. Subsequently, the adjacent point cloud data clusters were stitched together [41] to form a comprehensive point cloud data model [42,43], aiding in the calibration of pathology cracks in the later stages. Additionally, based on the assembled point cloud data model, the external and internal building components of James Jackson Gymnasium were inventoried.

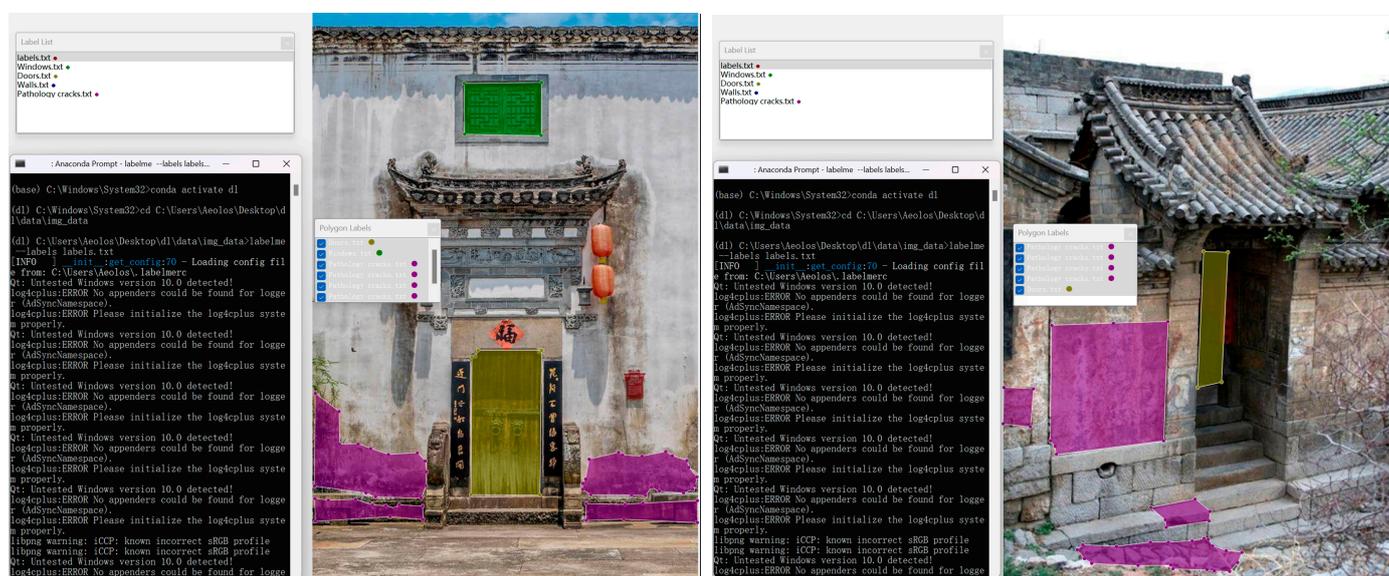
Figure 9. Architectural heritage pathology cracks training dataset. In order to enhance recognition accuracy, annotated images are predefined and displayed within a white box. Green signifies the window category, yellow signifies another category, purple signifies architectural heritage pathology cracks, and the portion within the black box represents the running code.

Finally, after the installation is completed, enter “`labelme`” at the terminal to start `labelme`. The labeled image (Figure 9) will serve as input data for the neural network, providing guidance for deep learning algorithms to classify various components such as cracks, doors, windows, and other architectural elements in heritage structures. In the initial image screening process, selection of masonry–timber structure architectural heritages from different countries and regions occurred to enhance the relevance of the subsequent training model for recognizing cracks in such structures. Subsequently, a total of 500 valid images were labeled as the training dataset for detecting pathology cracks in such structures of masonry–timber structures of architectural heritage [44].

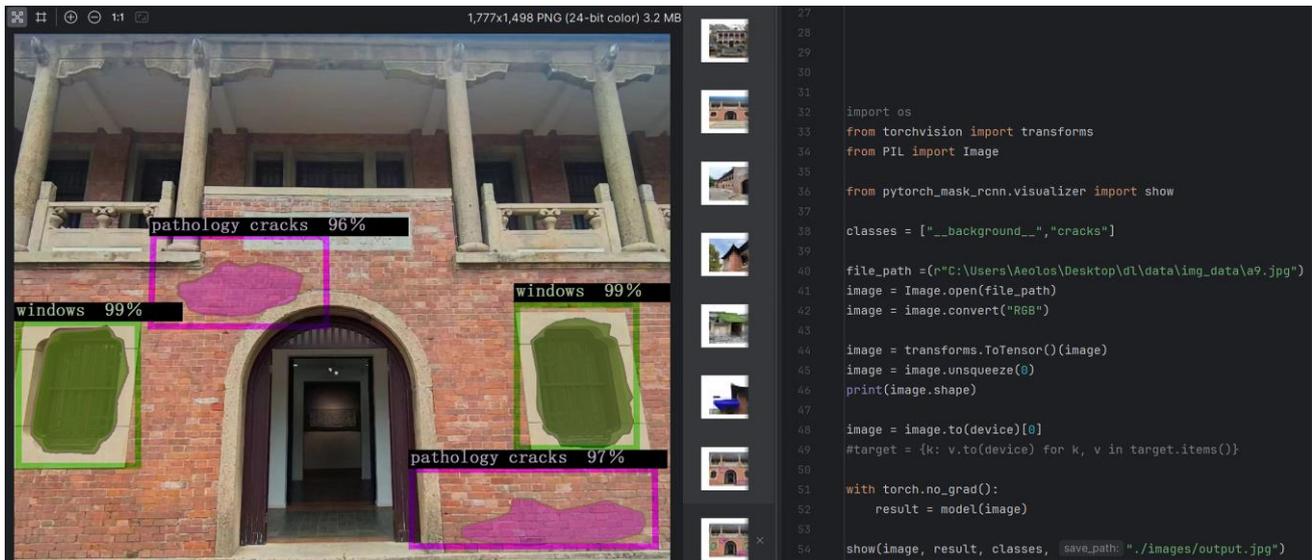
Figure 10. Operation interface and result display of a pathology crack area detection model based on the Mask R-CNN deep learning algorithm. Green marks indicate windows, while purple marks indicate building pathology cracks (left). The black box on the right side represents the running code (right).

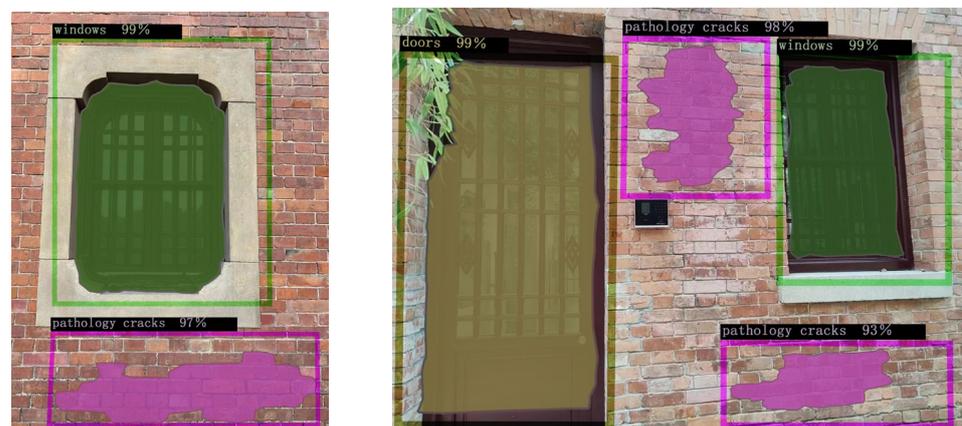
Figure 11. Based on Mask R-CNN crack area detection model, the James Jackson Gymnasium area detection results of pathology cracks are displayed. Green is marked as window class, yellow is marked as category, and purple is marked as architectural heritage pathology cracks.

Subsequently, 270 high-precision two-dimensional images acquired through 3D laser scanning were inputted into the crack detection model based on the Mask R-CNN deep learning model for crack detection (Figure 10). A total of 408 crack areas were identified, out of which 253 were found to be duplicate crack areas, resulting in the detection of 155 effective pathology crack areas (Figure 11).

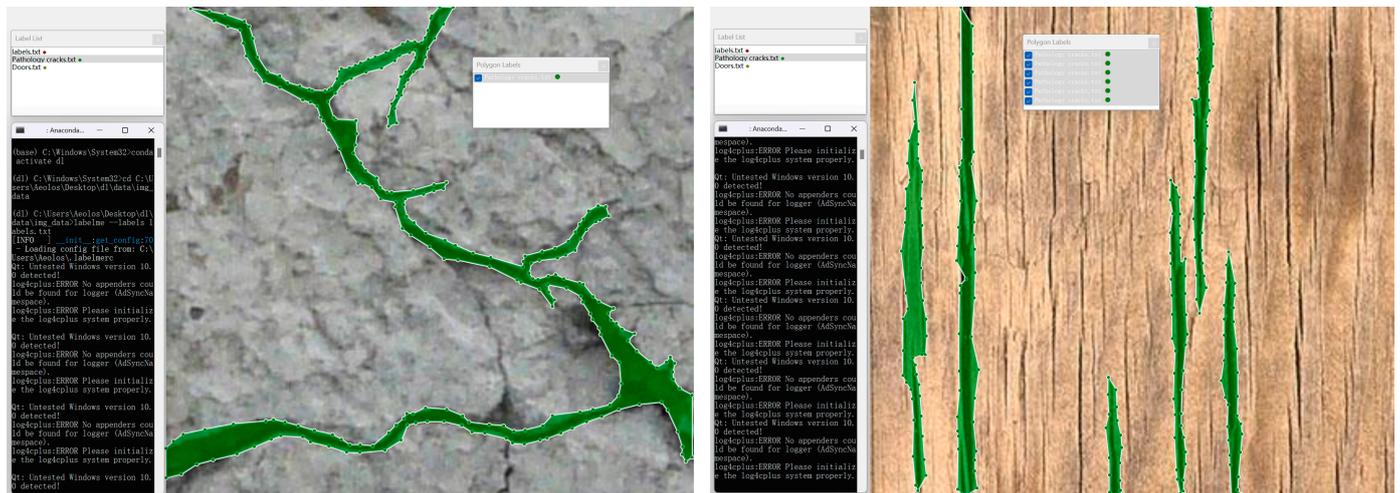
Figure 12. Training set for identifying and quantifying pathology cracks in architectural heritage. The image on the left displays pathology cracks in masonry structure (**left**), while the image on the right shows annotated pathology cracks in timber structure (**right**). To enhance recognition accuracy, the annotation image is predefined and displayed within a white box, with the black box containing the running code.

start labelme. In order to ensure the accuracy of the dataset and later crack calculation, the pixel size of all the labeled images is 300 pixels, with an error of 50 pixels [48]. Through the multi-point labeled crack image (Figure 12), the label as deep learning supervision is inputted into the neural network [49]. In order to improve the range and accuracy of model recognition, we expanded the selection of crack types in the labeling process and marked 510 pathology crack sheets of masonry structure and 490 pathology crack sheets of timber structure, totaling 1000 sheets (Figure 12).

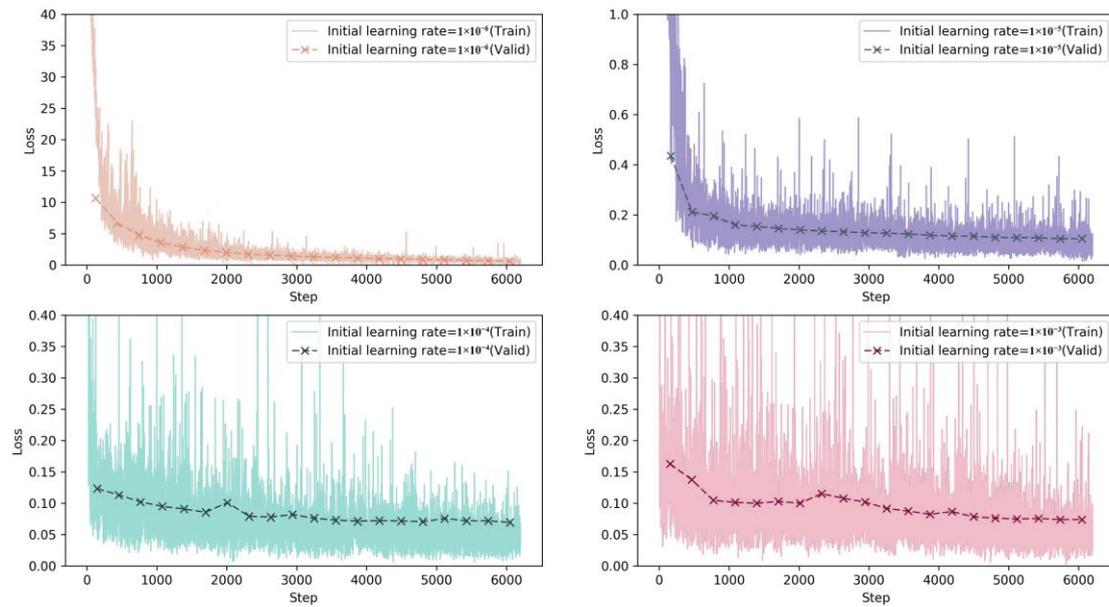
Figure 13. The influence of different initial learning rates in the training process of pathology crack recognition and calculation model of architectural heritage. The horizontal axis in the figure represents the training iteration (step), while the vertical axis represents the loss value. In each subgraph, the solid line represents the training loss, and the dotted line marked with 'x' represents the loss verification.

In the training process of a single pathology crack identification and calculation model for architectural heritage, we aimed to enhance the accuracy of the model and minimize losses by setting four initial learning rates (Figure 13). Through comparison, we observed that, when the initial learning rate is 1×10^{-6} , the model's convergence speed is excessively slow. Conversely, with an initial learning rate of 1×10^{-5} , the loss value drops rapidly and exhibits poor stability. For an initial learning rate of 1×10^{-4} , the loss value decreases steadily, although the overall decline is gradual and reaches a stable point early on. This provides sufficient momentum for the model to facilitate quick learning. Finally, at an initial learning rate of 1×10^{-3} , the loss value experiences significant fluctuation and demonstrates signs of overfitting [50]. In conclusion, we selected 1×10^{-4} as the optimal initial learning rate (Figure 14).

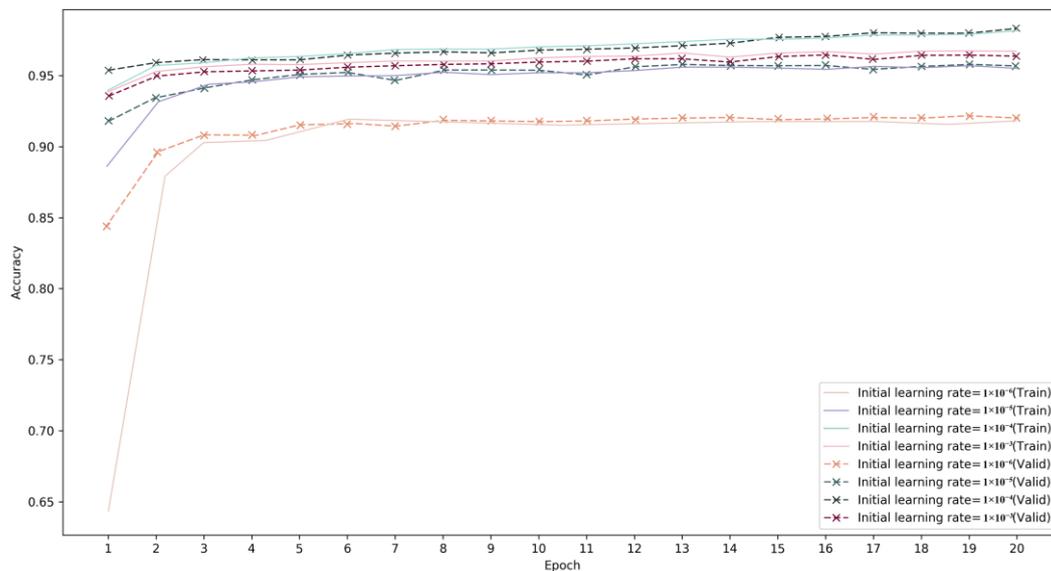
Figure 14. In the training process of pathology crack recognition and calculation model of architectural heritage, the training accuracy and verification accuracy change with the training period (epoch) under different initial learning rates. The horizontal axis in the figure represents the training period, while the vertical axis represents the training accuracy and verification accuracy of the model.

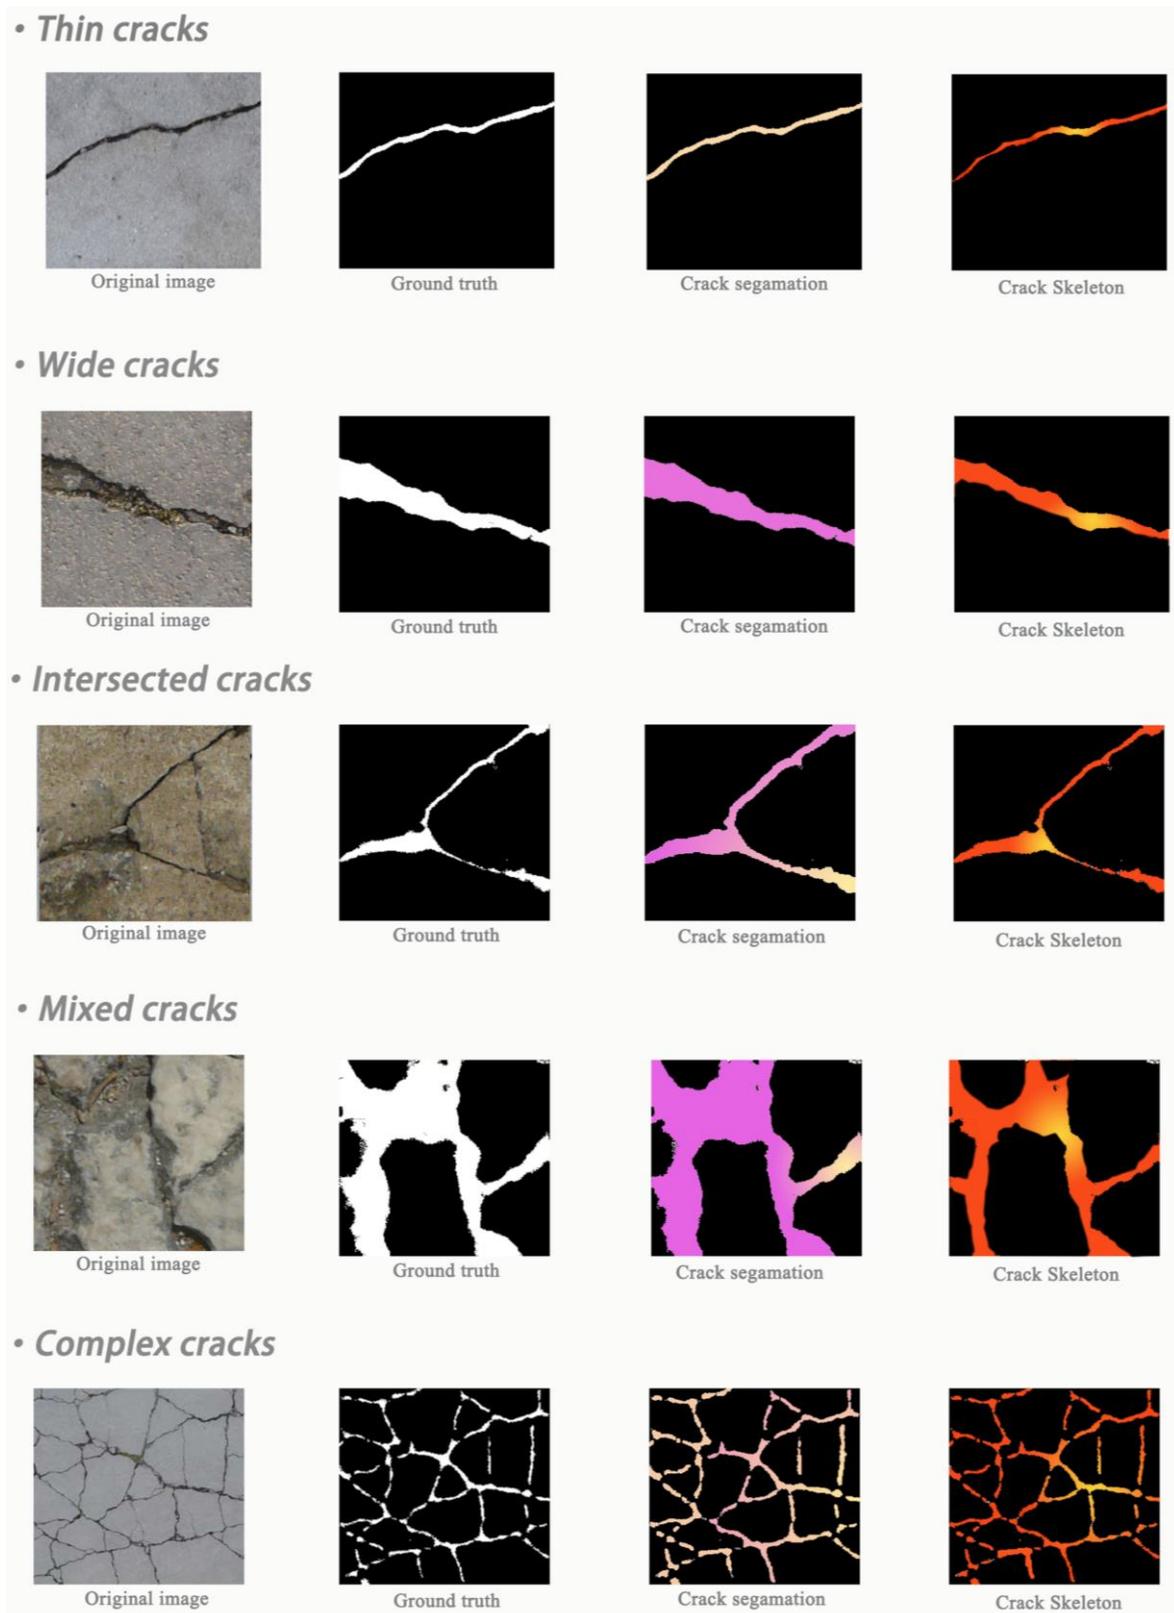
Figure 15. Process demonstration of a pathology crack segmentation model based on the FCN deep learning algorithm. The division of cracks is indicated by a gradient from purple to light yellow based on area size. The extraction of fracture structure assigns the yellow part as the center point of the fracture, the orange part as the edge of the fracture, and the remaining parts decrease in intensity relative to their distance from the center point.

In order to enhance the accuracy of the single-crack identification and calculation model based on FCN, image segmentation and crack extraction functions were incorporated prior to model identification and calculation [51]. Initially, the cracks were categorized into five types for computer recognition: (1) thin cracks; (2) wide cracks; (3) intersected cracks; (4) mixed cracks; (5) complex cracks (Figure 15). Next, the pathology crack and its surrounding area were segmented based on image gray levels. Subsequently, the pathology crack was divided by color according to its area. Finally, the center point of the pathology crack was determined and the structure of the pathology crack was extracted.

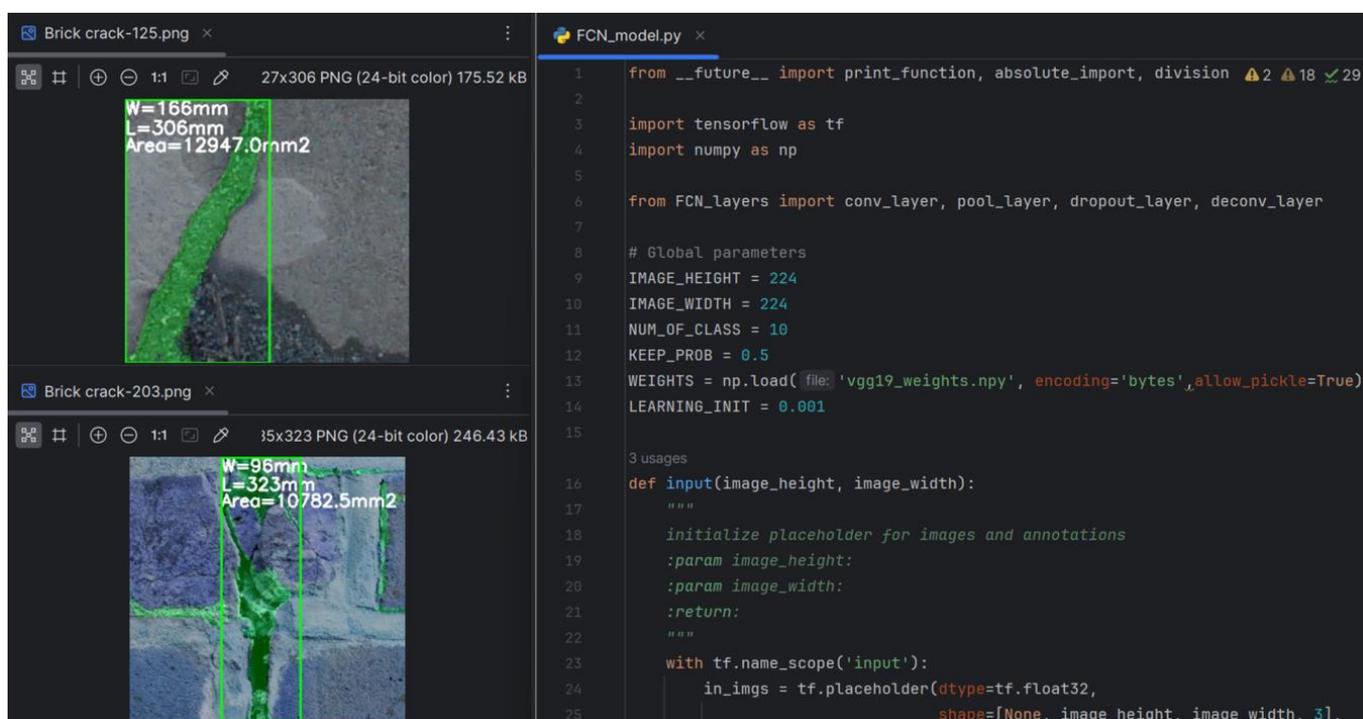
Figure 16. Operation interface and result display of pathology crack area detection model based on FCN deep learning algorithm. The selected area in the green box on the left side is the pathology crack part recognized by the model, and the white text part is the calculation result of pathology crack geometric information after recognition (W: width, L: length Area: path crack area); The black box on the right side is the running code.

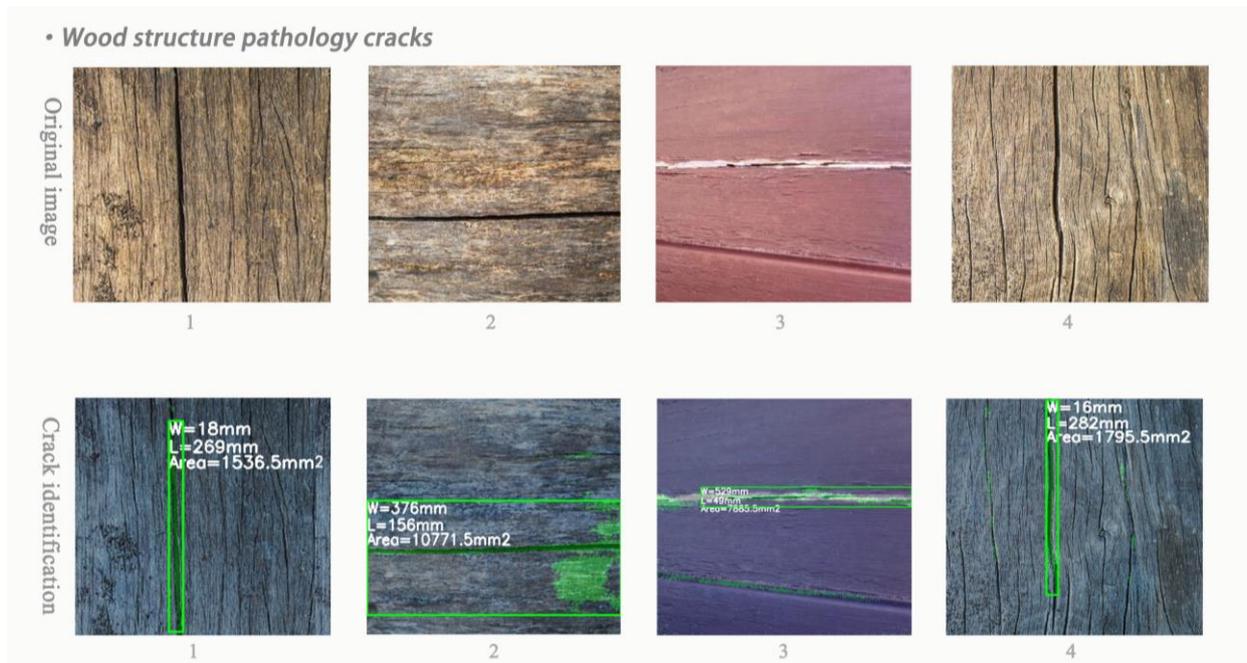
Figure 17. James Jackson Gymnasium recognition and calculation results display of pathology crack timber structure based on FCN deep learning model. The selected area in the green box is the pathology crack part recognized by the model, and the white text part is the calculation result of pathology crack geometric information (W: width, L: length, Area: path crack area) after recognition.

According to the 155 pathology crack areas detected in James Jackson Gymnasium using the Mask R-CNN pathology crack area detection model, the fractures within these areas were further examined using the FCN-based pathology crack identification and calculation model [52]. The resulting separation of fractures was then individually identified and calculated (Figure 16). Since James Jackson Gymnasium is a masonry–timber building, cracks were classified and identified within both timber structures (Figure 17) and masonry structures (Figure 18).

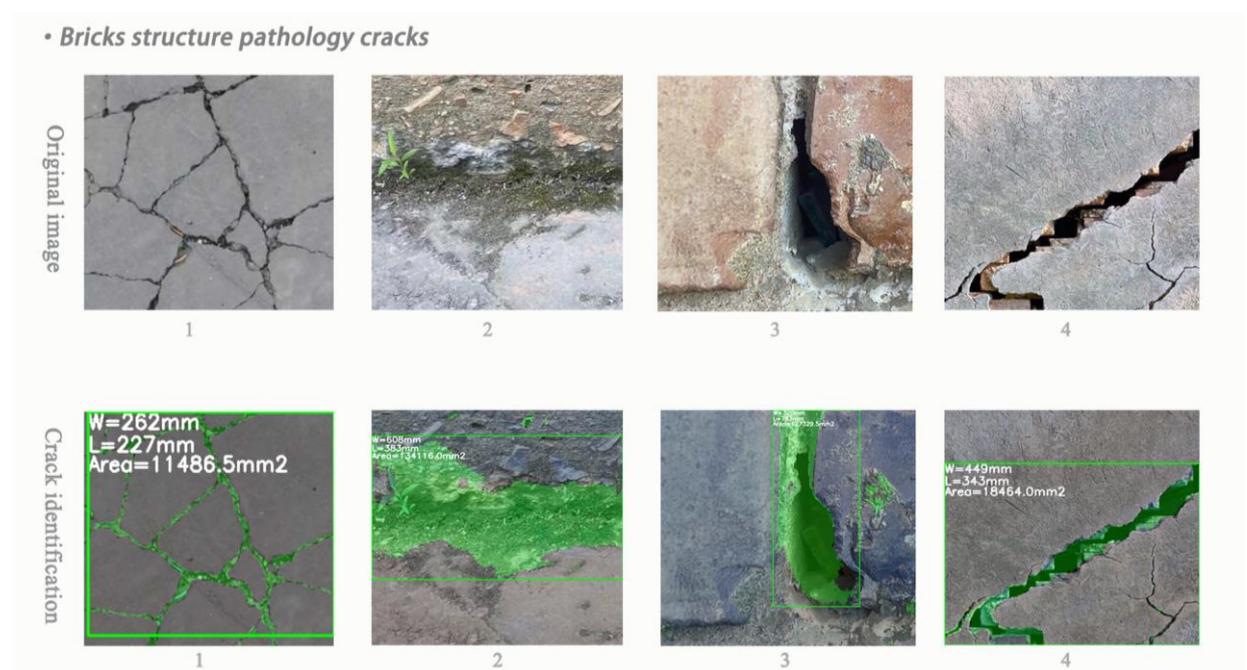
Figure 18. James Jackson Gymnasium recognition and calculation results display of pathology crack masonry structure based on FCN deep learning model. Among them, the green box selected area is the pathology crack part recognized by the model, and the white character part is the calculation result of pathology crack geometric information after recognition.
