An Updated Perspective of the Impact of the 1940 Vrancea Earthquake on Design and Construction Practices in Romania

Florin Pavel

Department of Reinforced Concrete Structures, Technical University of Civil Engineering Bucharest, Bd. Lacul Tei, 122-124, Sector 2, 020396 Bucharest, Romania; florin.pavel@utcb.ro

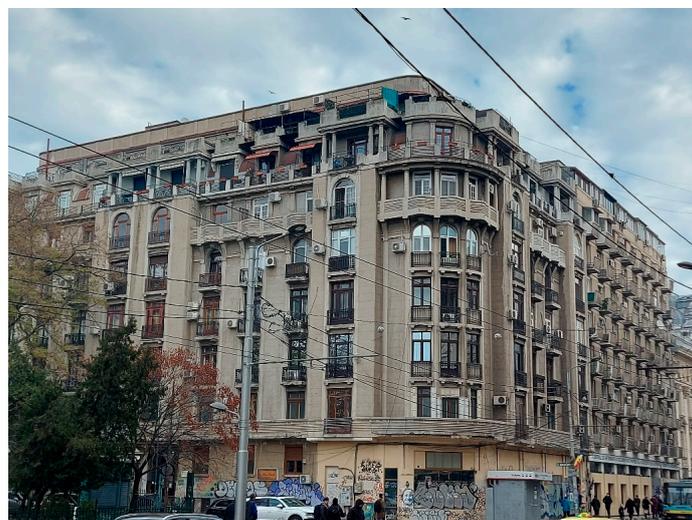
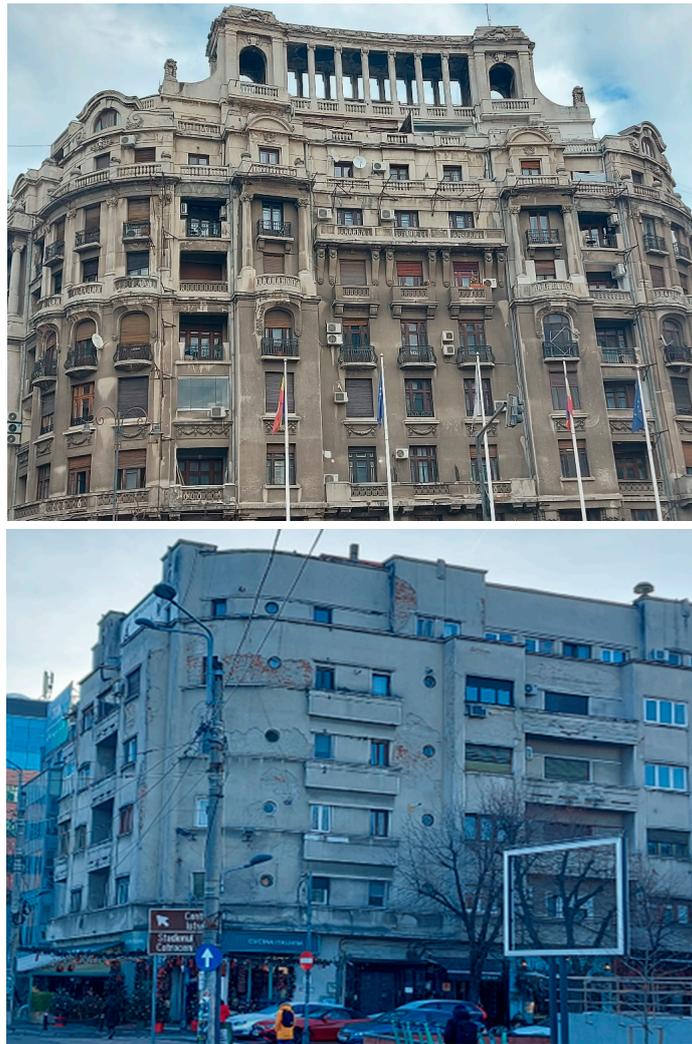
Figure 1. Typical high-rise structural typologies used before 1940 for residential buildings in Bucharest.

Examples of the above-mentioned typical structural typologies located in Bucharest are given in Figure 1. It can be observed that their current states from the point of view of maintenance and current repair works are not adequate at all. Figure 2 shows the typical structural layout of a high-rise reinforced concrete building that was constructed before 1940 in Bucharest [28]. Other examples of typical low-rise structures located in Bucharest are shown in Figure 3.

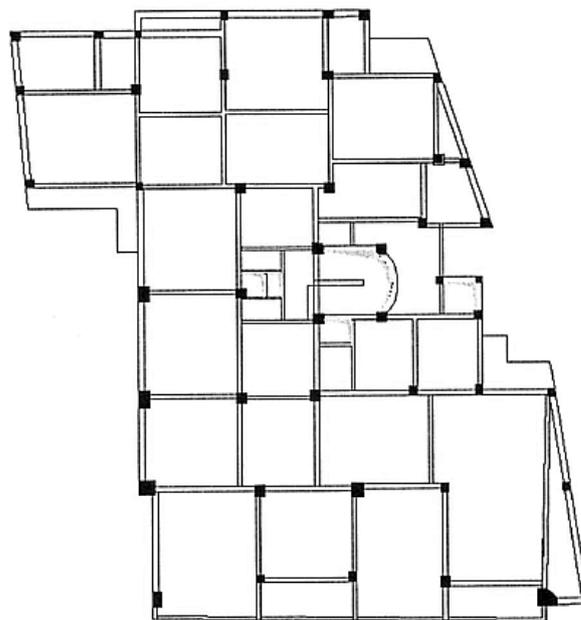
Figure 2. Typical layout of high-rise reinforced concrete structure built before 1940 in Bucharest [28].

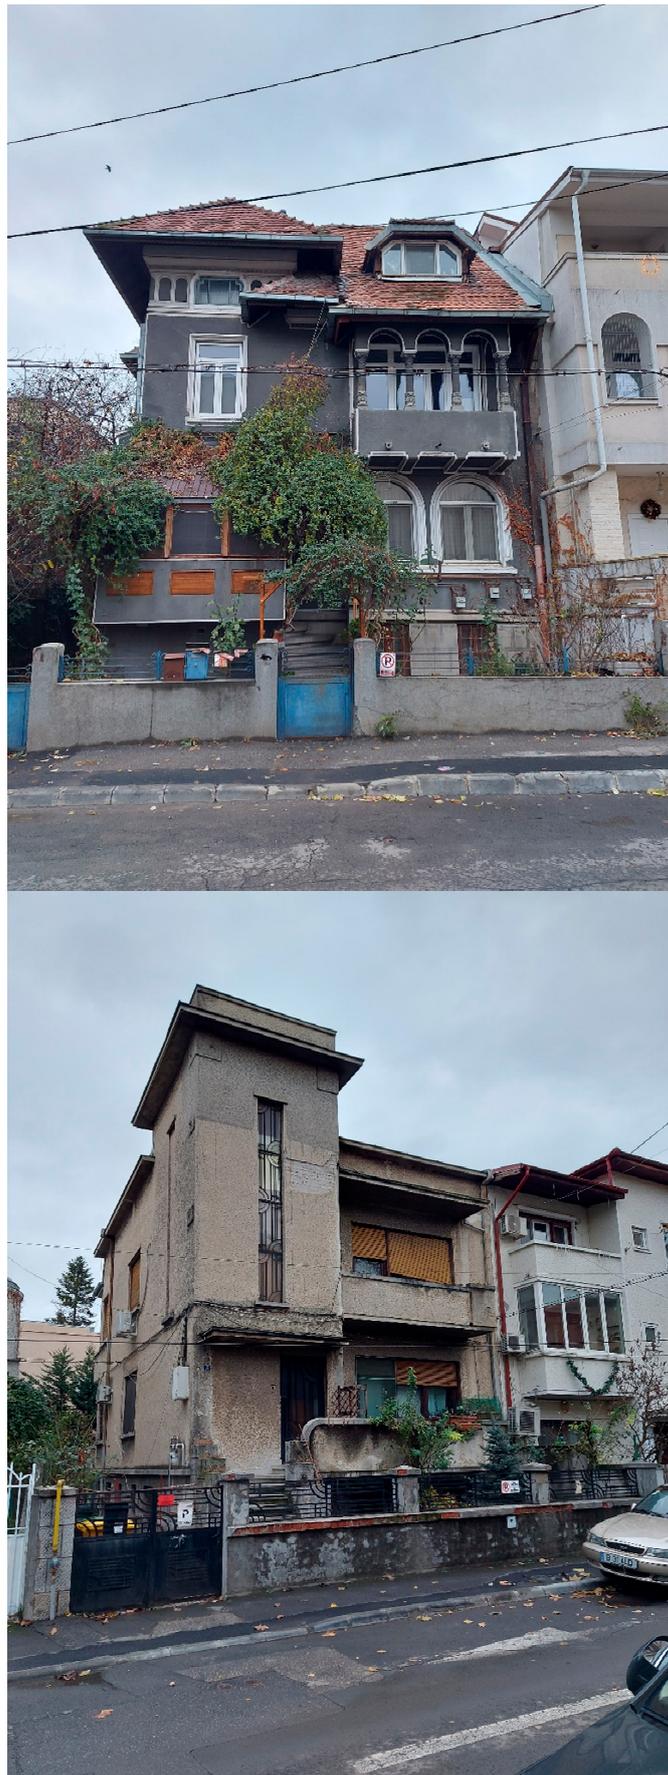
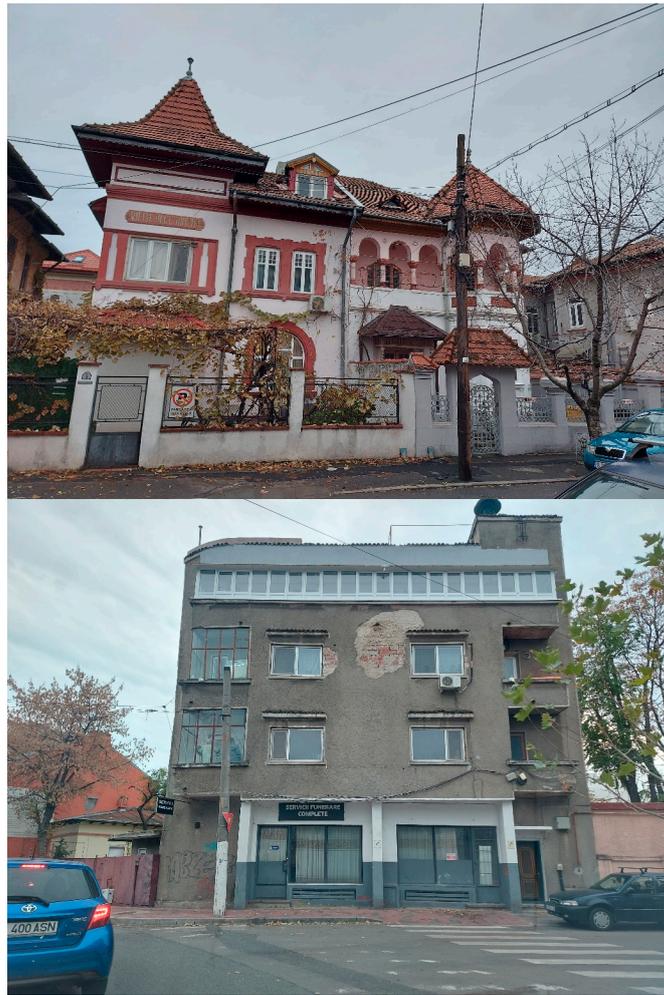
Figure 3. Typical low-rise structural typologies used before 1940 for residential buildings in Bucharest.

Figure 3 illustrates some common structural typologies for low-rise buildings with unreinforced masonry structures that were built before 1940.

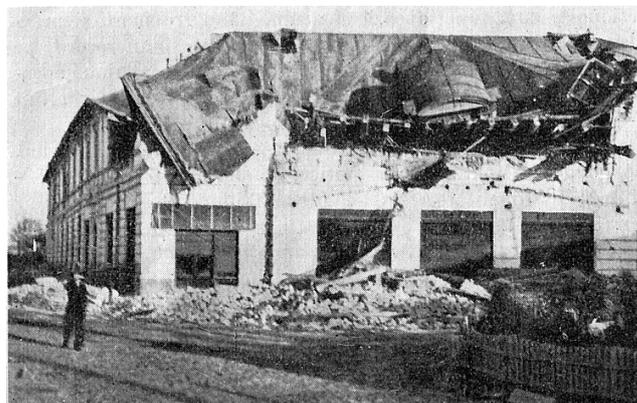
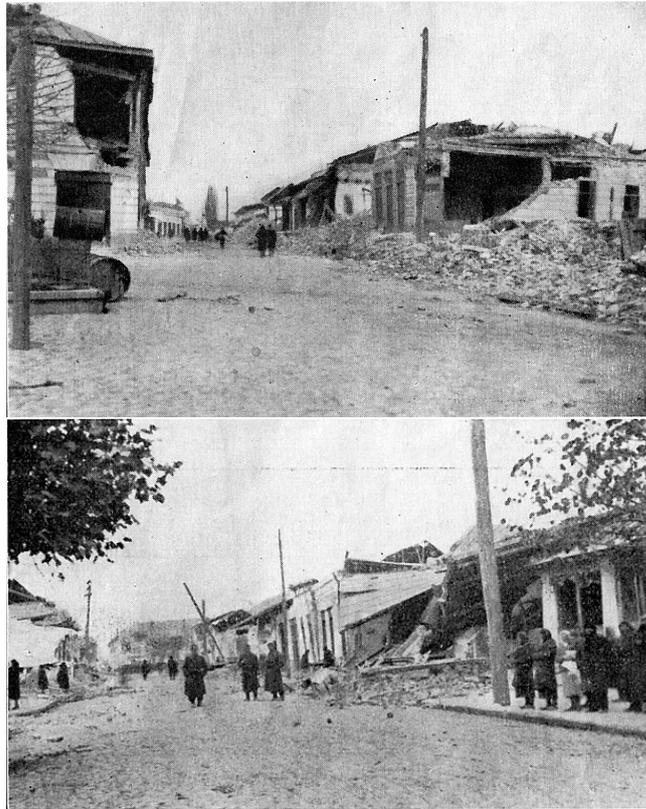
Figure 4. Typical damage of unreinforced masonry buildings in Panciu [21].

Some photos showing the damage in various publications from the time of the event highlight both the effects and the common structural typologies described previously. Figure 4 shows the damage sustained by unreinforced masonry buildings located in Panciu (near the earthquake epicentre), where 338 buildings sustained heavy damage or collapsed [29].

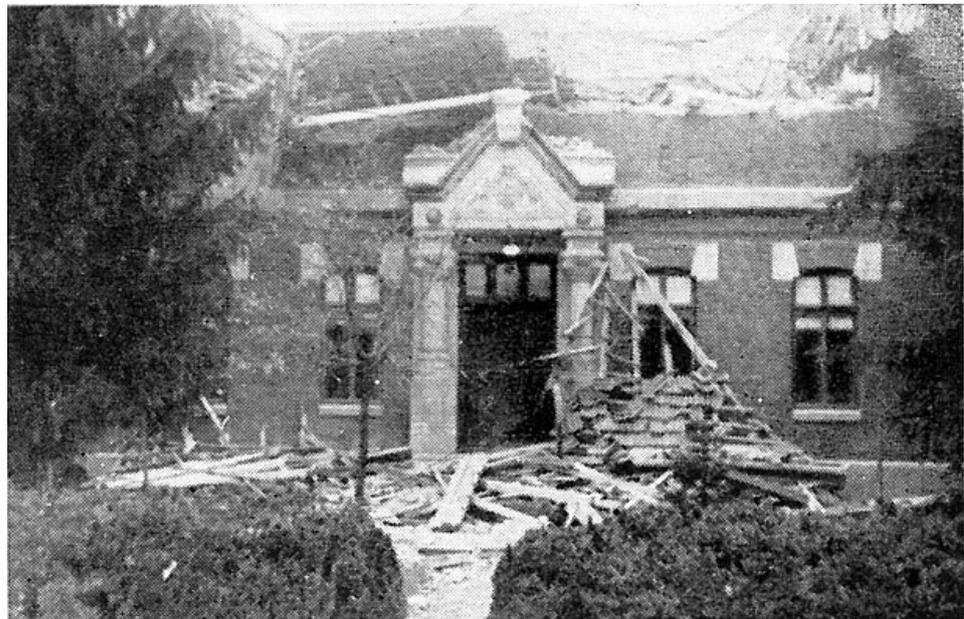
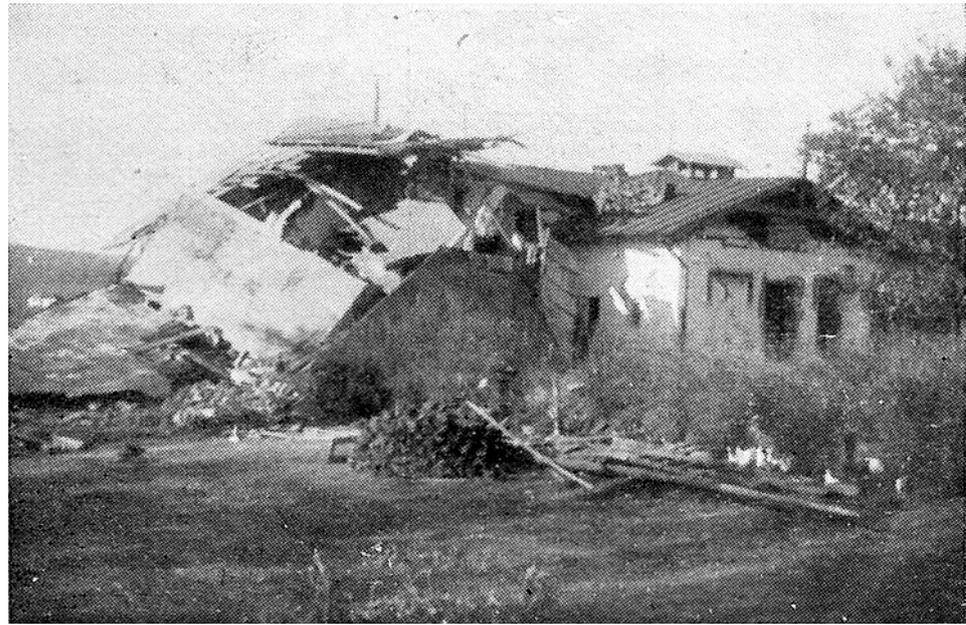
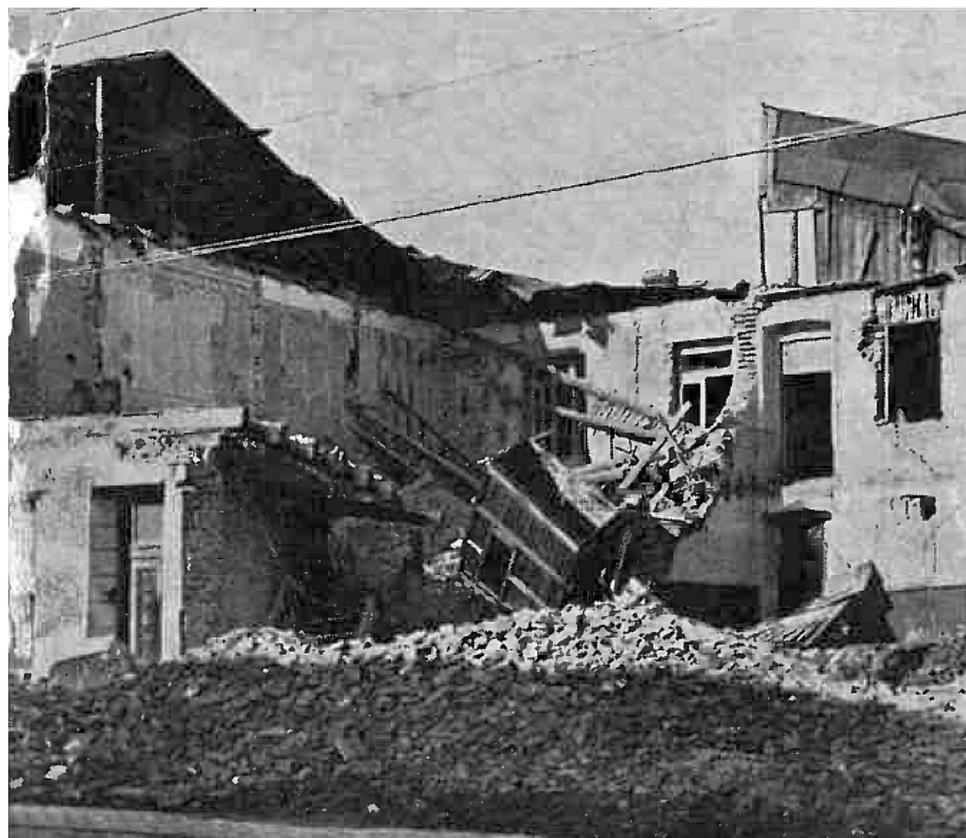
Figure 5. Typical damage of unreinforced masonry structures located in (a) Focsani [25], (b) Tecuci [25] and (c) Galati [30].

Figure 5 displays other failures of similar unreinforced masonry structures in other areas located near the epicentre of the earthquake (Focsani, Tecuci and Galati) [25,30].

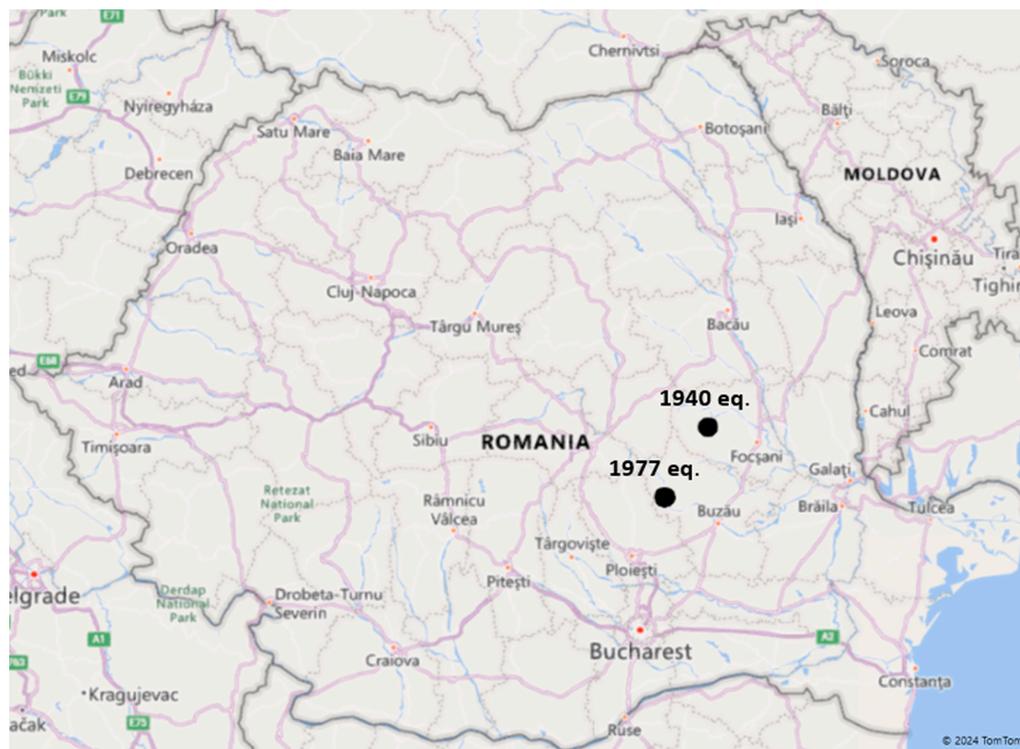
Figure 6. The epicentre locations of the two Vrancea intermediate-depth earthquakes in 1940 and 1977.

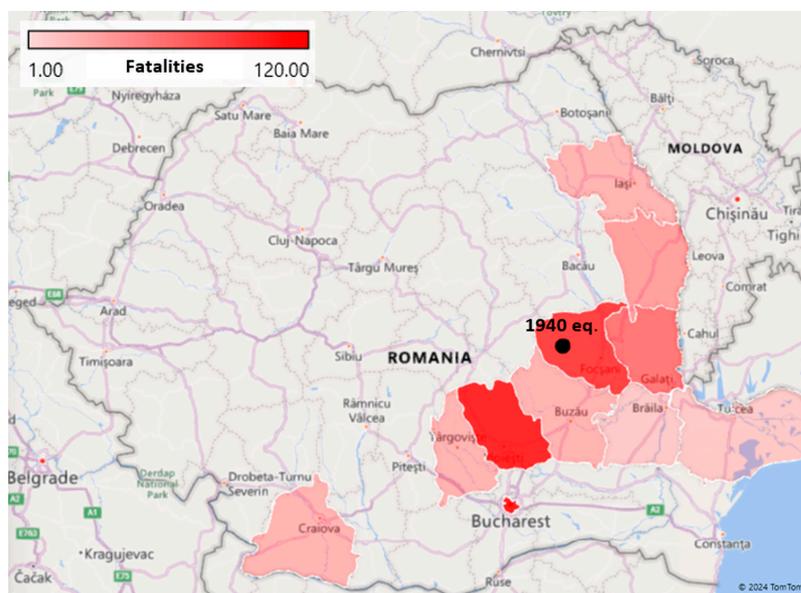
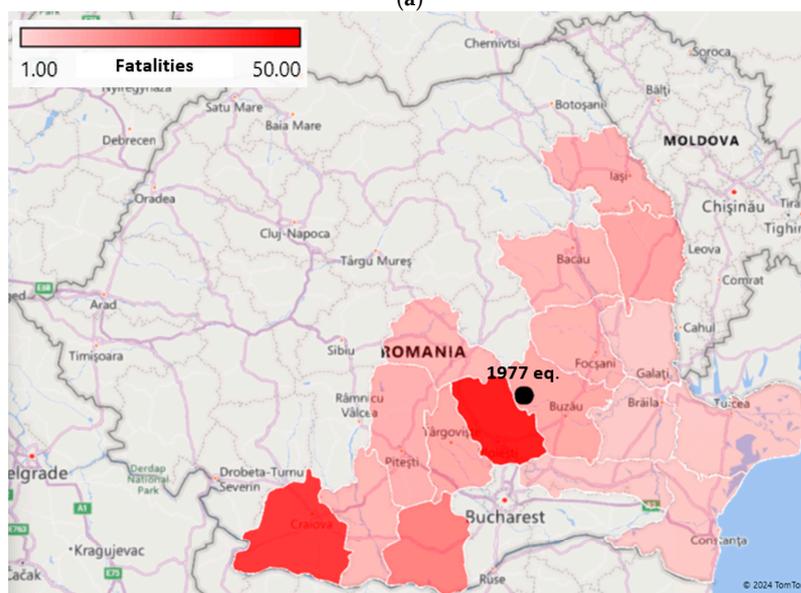
Figure 7. Fatalities evaluated for the (a) Vrancea 1940 earthquake and (b) Vrancea 1977 earthquake.

Based on the available literature (mainly journal articles from *Universul* and *Curentul*), in this study, the estimated numbers of fatalities and injuries for the 1940 event are 423 and 1456, respectively. Figures 7 and 8 show a comparison performed at county level of the fatalities and injuries caused by the two seismic events. In total, fatalities and/or injuries during one or both the 1940 and 1977 earthquakes were identified in 19 counties. In the case of the injured people as a result of the 1977 earthquake, about 12% were unaccounted for in terms of their location. The representation for the 1977 event does not include Bucharest since 90% of the deaths and 70% of the injuries were located here.

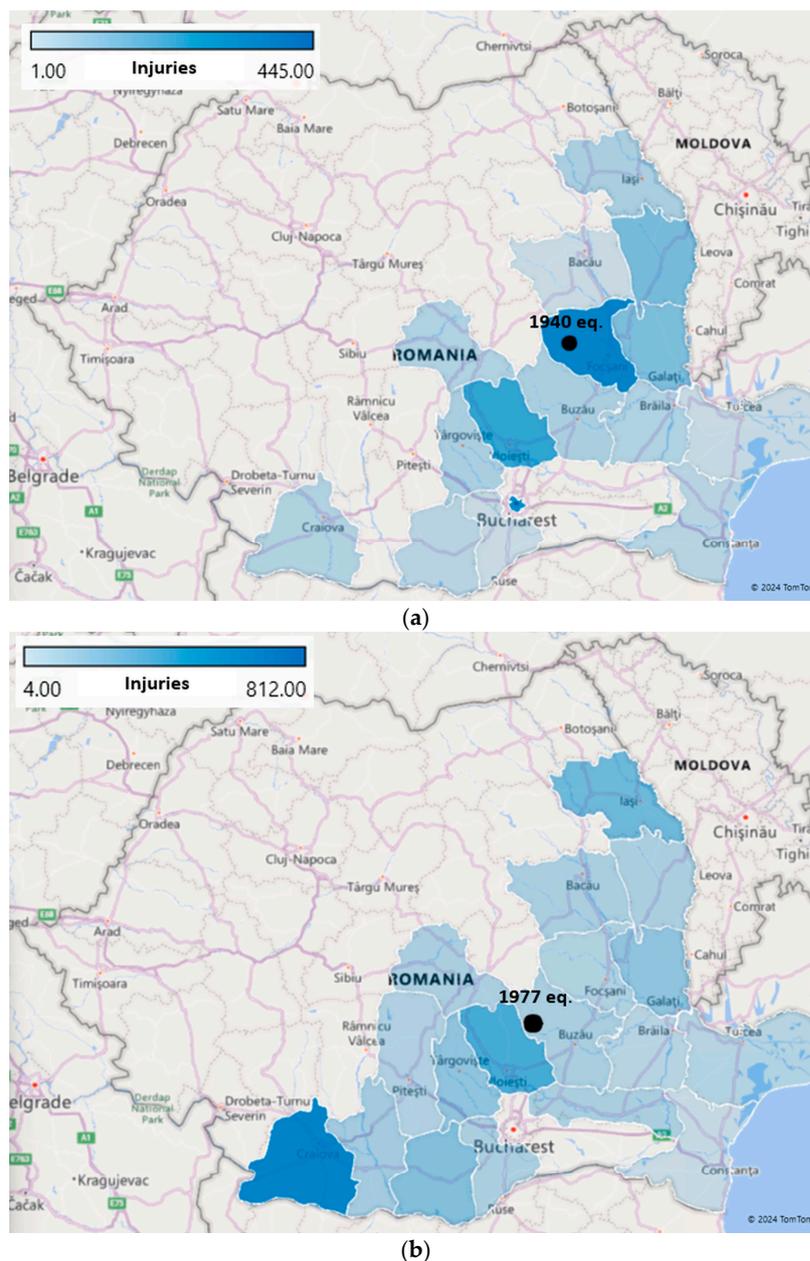
Figure 8. Injuries evaluated for the (a) Vrancea 1940 earthquake and (b) Vrancea 1977 earthquake.

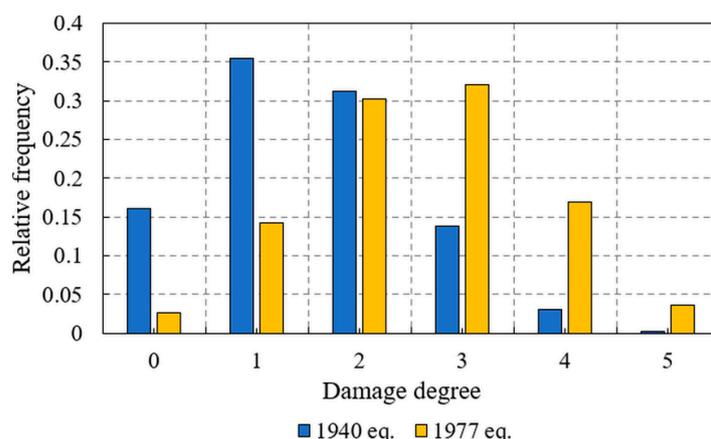
Figure 9. A comparison of the empirical damage probability histograms for medium- and high-rise RC buildings in Bucharest that were constructed before 1940 regarding the 1940 and 1977 Vrancea earthquakes.

The mean damage degree for the entire dataset is 1.53 (assuming a macroseismic intensity level of VII–VIII), while the resulting values of the vulnerability parameters are $V = 0.75$ and $Q = 2.30$. A comparison of the binomial probability mass functions for the 1940 and 1977 earthquakes (assuming a macroseismic intensity level of VIII–IX) is shown in Figure 9 for the dataset of medium- and high-rise buildings constructed before 1940. It can be seen that the proportion of buildings with low or medium damage degrees is significantly larger in the case of the 1940 earthquake. The reasons for the larger damage degrees observed during the subsequent 1977 event can be the larger ground motion intensity in Bucharest coupled with the previous 1940 earthquake damage.

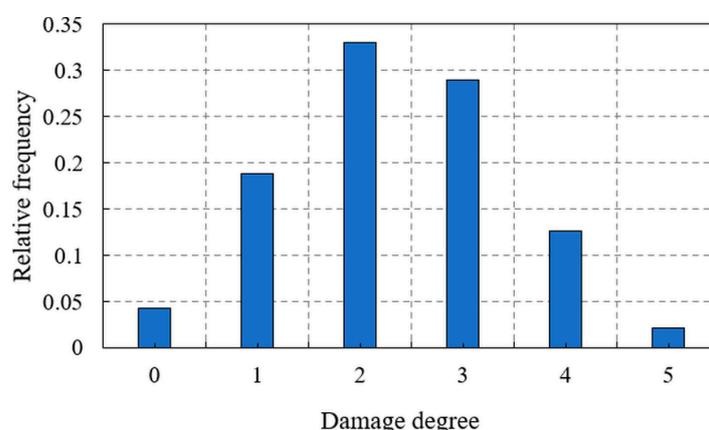
Figure 10. Empirical damage probability histograms for the unreinforced masonry structures in Barlad regarding the 1940 earthquake.

The sample of masonry buildings with flexible floors for which the damage data are available consists of about 1200 buildings [57]. The data shown in the paper by Mandrescu [57] highlight a much larger percentage of damaged buildings that were observed for the structures with more than one storey in height. The mean damage degree for the entire dataset is 2.33 (assuming a macroseismic intensity level of VIII), while the resulting values of the vulnerability parameters are $V = 0.79$ and $Q = 2.30$, which are practically identical with the previous results obtained for Bucharest. This observation highlights the similarity in terms of the seismic vulnerability of unreinforced masonry structures constructed before 1940 irrespective of their location (Barlad or Bucharest). The empirical damage probability histograms for unreinforced masonry buildings located in Barlad for the 1940 earthquake are shown in Figure 10.

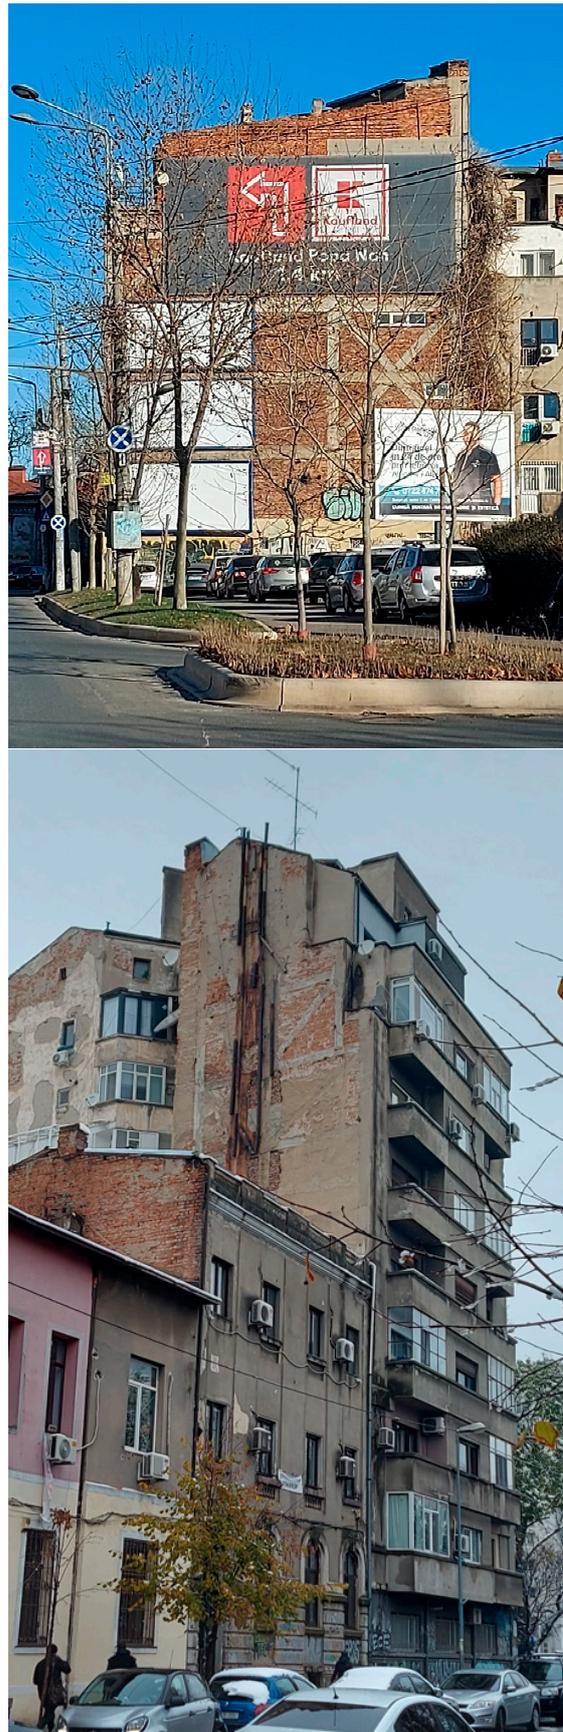
Figure 11. Examples of buildings with RC-braced frame structures that were constructed after the Vrancea 1940 earthquake.

An interesting consequence of the 1940 event is the use of braced reinforced concrete frames as structural systems for some residential buildings that were constructed in the aftermath of the event. Some examples of such structures still existing in Bucharest today are shown in Figure 11.

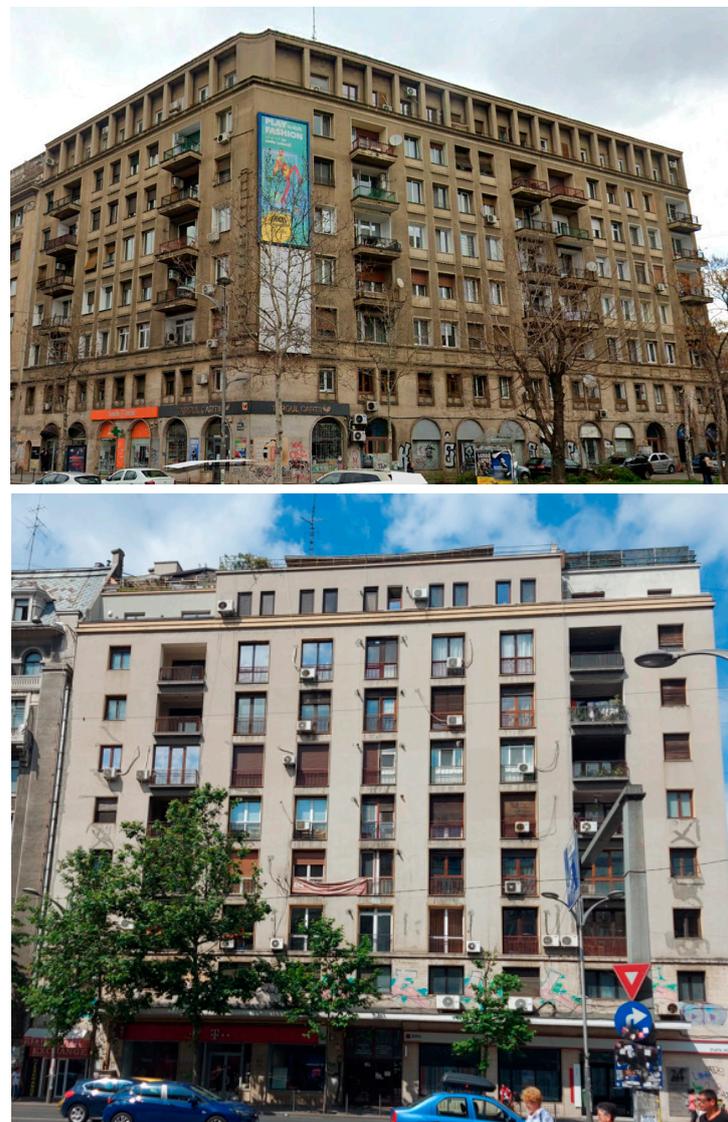
Figure 12. Examples of buildings with RC frame structures that were constructed after the Vrancea 1940 earthquake.

And a final and critical observation was that the structural layout should not depend on various architectural criteria [67] with more emphasis on the structure itself. This aspect led to an improved generation of residential buildings with a reinforced concrete frame structure being constructed in Bucharest until the introduction of the P13-63 code [68] and which performed well during the 1977 earthquake (better than some of the frames built in the 1970s). Some examples of such buildings are shown in Figure 12.
