Article

Field Testing of an Acoustic Method for Locating Air Leakages in Building Envelopes [†]

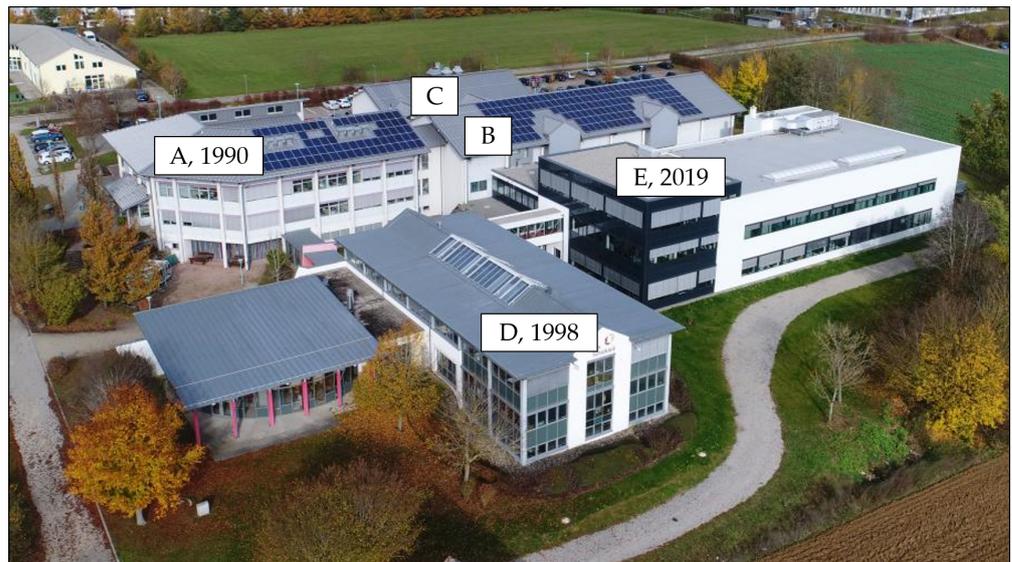
Figure 1. The building complex with labels and the approximate year of the most recent modification (photo: adapted with permission from Hahn-Schickard).

Schwenningen, Germany. This site comprises five distinct buildings, each serving different functions and constructed at various times, thus offering a diverse test environment. For the purposes of this study, our focus was narrowed to the office buildings, designated as parts A, D, and E. These buildings were selected based on their construction or renovation years—approximately 1990, 1998, and 2019, respectively—providing a range of ages and construction styles for analysis. At the forefront of the measurement campaign, the staff working in Building D had often commented on draughts in the building. Building B is utilized for clean rooms, whereas Building C accommodates a cogeneration unit. An aerial photograph (refer to Figure 1) provides a visual representation of the site, including the labelling of the individual building parts, thereby offering a comprehensive overview of the measurement context.

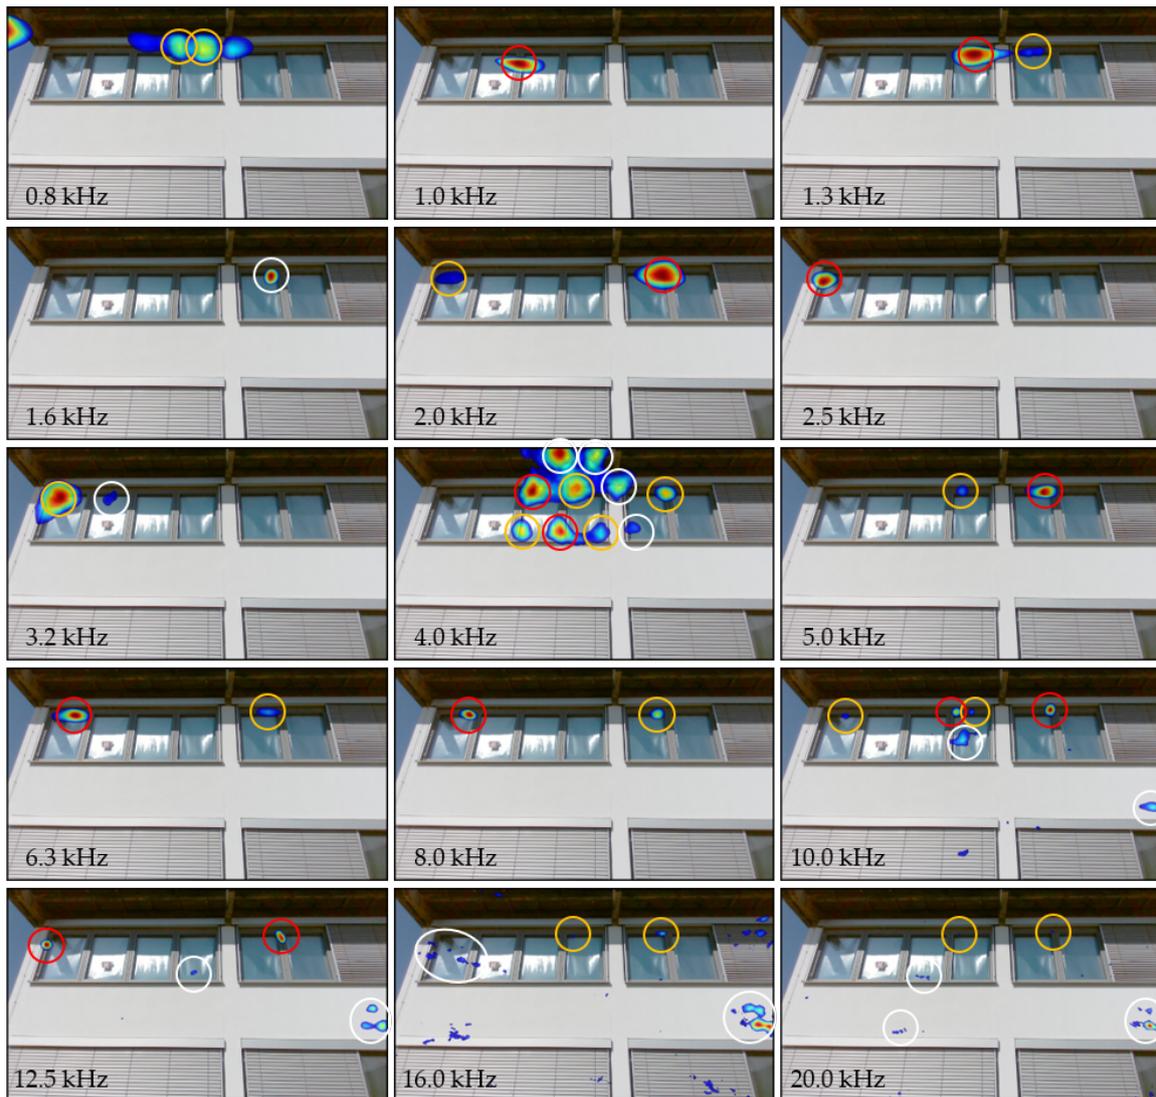
Figure 3. Representation of the evaluation of sound peaks using the example of Room 206 (east side) in Building D. The colors of circles align with the color code presented in Table 1.

Not every sound peak is necessarily indicative of a leak; they can also be caused by sound reflections or structure-borne noise, such as vibration, which can cause locally high sound levels. The sound peak on the pane from the fourth window from the left in the 10 kHz frequency band in Figure 3 is clearly at an implausible location for a leak and is more likely caused by the vibration of the pane.

Nevertheless, in many instances, visual inspection at the location of the sound peaks confirmed credible causes of air leakage. In some rooms, a blower door and smoke stick were used to definitively confirm a leakage at the location of a sound peak.

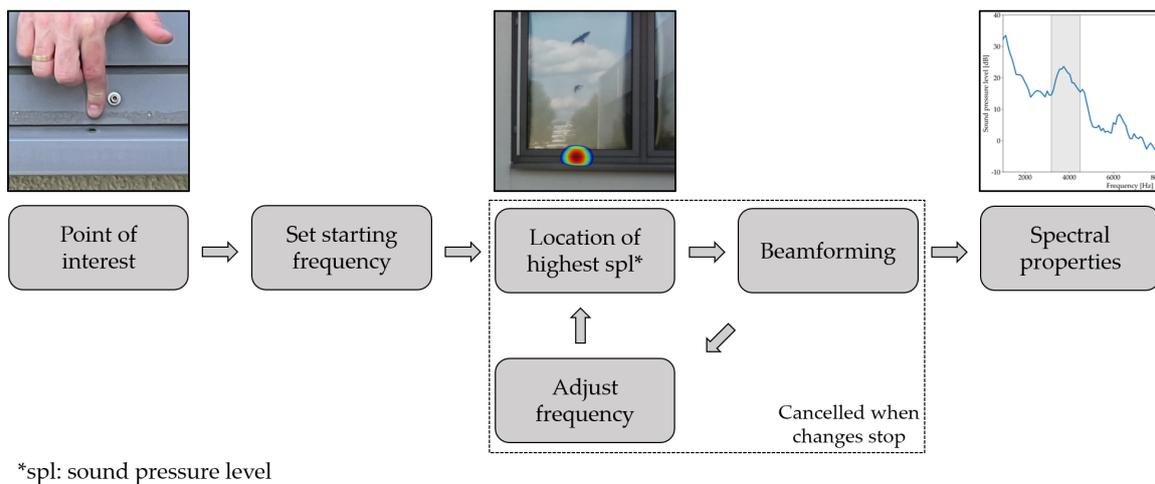
Figure 4. Schematic representation of the iteration process for the determination of the spectral properties of a point of interest.

In order to obtain the spectral characteristics of a point of interest (e.g., a potential leak) within the acoustic image, an iterative process is required. The first step is to analyze the sound pressure level across the entire recorded image. This involves examining individual frequency ranges, usually in one-third octave band intervals. After the frequency range has been found in which the sound pressure level at the location of a point of interest is the highest or can be best distinguished from the rest, the beamforming method is used to obtain its spectrum. The next step is to adjust the examined frequency range so that the peak sound pressure level of this point falls exactly within the limits of the frequency. With the new frequency range, the location of the highest sound pressure level may also change. If this happens, the beamforming method is applied to the new point. The resulting spectrum will then be looked at once again, and the frequency limits will be adjusted accordingly. This iterative process is stopped whenever the point with the highest sound pressure level changes by less than 5 pixels as a result of the frequency range adjustment; otherwise, the process will get caught in an infinite loop. The whole process is graphically illustrated in Figure 4.

In this section, the spectral properties of the first three leakages shown in Section 3.1 are presented. We utilize the beamforming algorithm, as detailed previously in Section 2.5 and demonstrated in Figure 4, to extract the sound spectra at specific points.

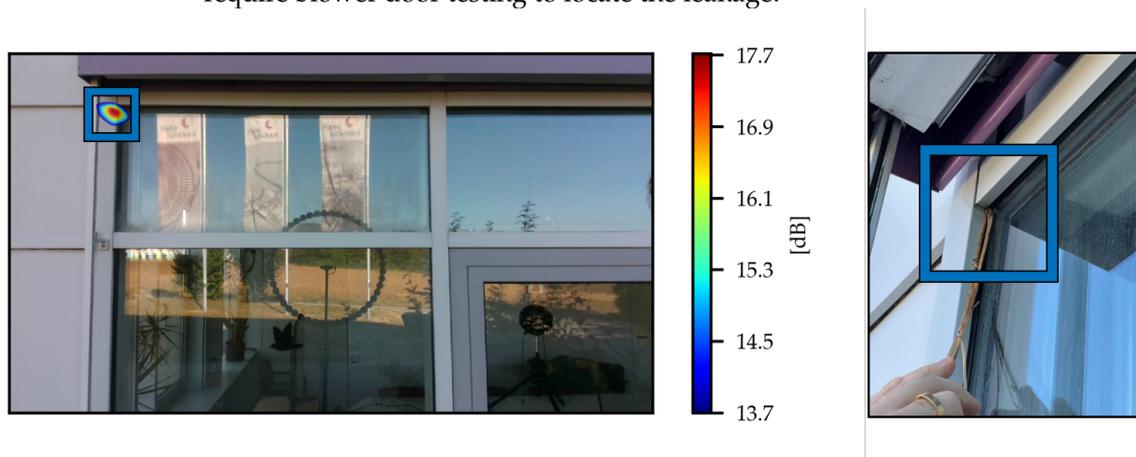
Figure 5. Room A-101. Photograph superimposed with the sound pressure level within the frequency range of 4.9 kHz to 6.4 kHz (left). Twig-sized hole in the window panel seal (right).

The first example shows a substantial leakage in the cladding seal at the top of a window, as shown in Figure 5. The seal was severely damaged, facilitating mold growth within the cavity of the insulated glass, allowing a twig to penetrate several centimeters deep into the cladding. This example demonstrates the strengths of the beamforming method, as the leak, which caused significant damage to the building, was quickly and accurately detected by the acoustic camera and, unlike conventional methods, did not require blower door testing to locate the leakage.

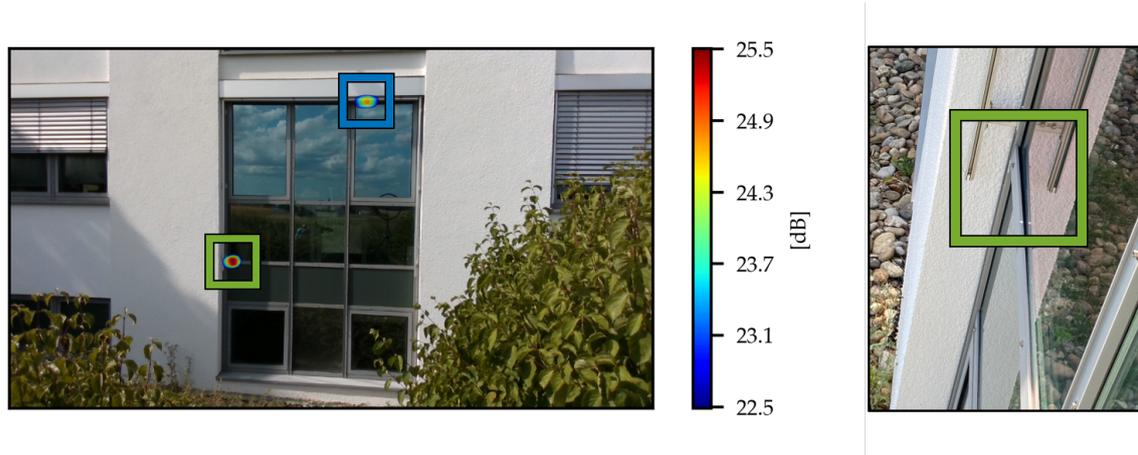
Figure 6. Room D-107. Photograph superimposed with the sound pressure level within the frequency range of 4.2 kHz to 8.2 kHz (left). Potential leakage due to protruding paneling and window seal (right).

Figure 6 shows a second example of detected leaks located on a large window front. The more prominent one (in green), located in the center left of the front, was caused by a protruding window panel and the seal underneath it.

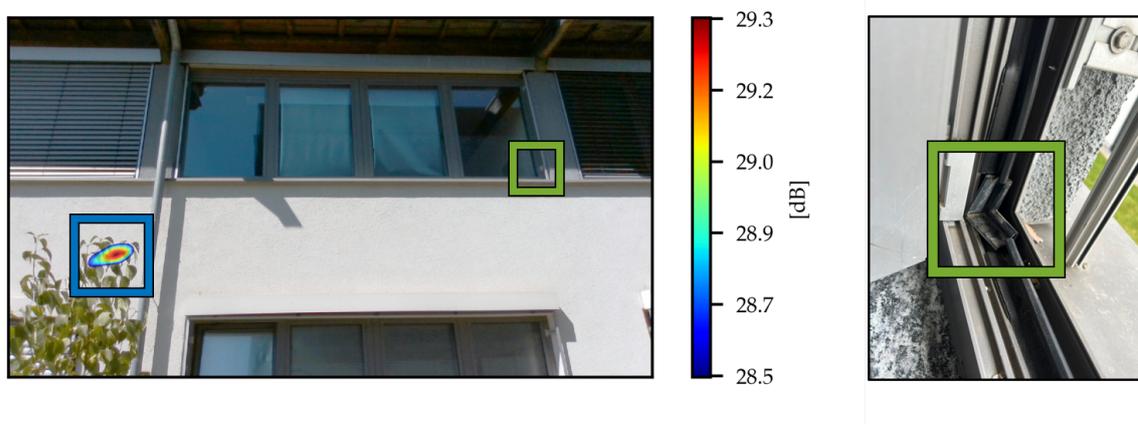
Figure 7. Room D-203. Photograph superimposed with the sound pressure level within the frequency range of 2.6 kHz to 5.2 kHz (left). Fractured seal in the corner of the window (right).

The third example shown in Figure 7 illustrates a notable challenge associated with the acoustic measurement method. Although visual inspection suggested the presence of several potential leaks, including a broken window seal on the examined façade (in green), these were not detectable in any of the frequency ranges examined. However, these suspected leaks were not confirmed through alternative verification methods either. Instead, the method was sensitive to other sources of sound, notably the rustling of leaves (in blue), which represent the point of highest sound pressure level over a wide bandwidth.

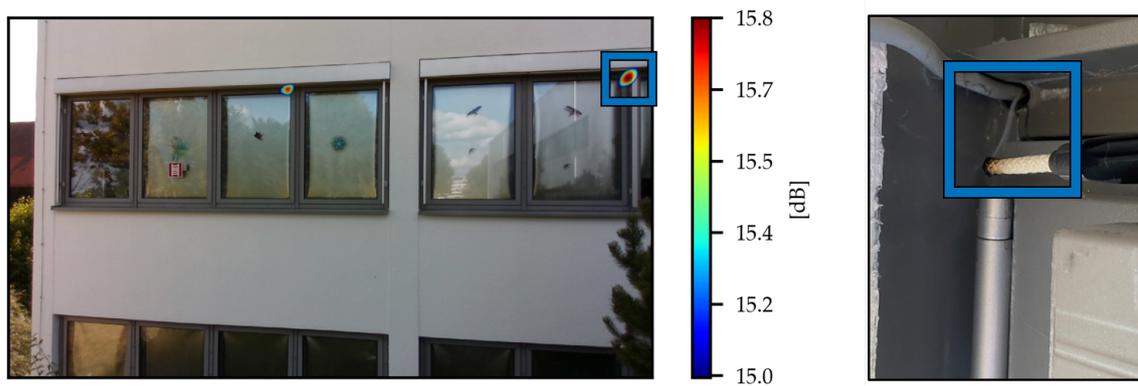
Figure 8. Room D-106. Photograph superimposed with the sound pressure level within the frequency range of 6.6 kHz to 8.2 kHz (left). On the right: Leaky cable entry (leak confirmed with smoke sticks and blower door) (right).

In Figures 8 and 9, two additional points of interest were identified as leaks using visual inspection. In the first case, the leakage is an improperly sealed cable penetration caused by a shutter cable. By using blower door testing and a smoke stick, it was verified that this penetration was an air leak. In the case of Figure 9, the presence of mold at the top corner of the window seal was a clear indication of a leak.

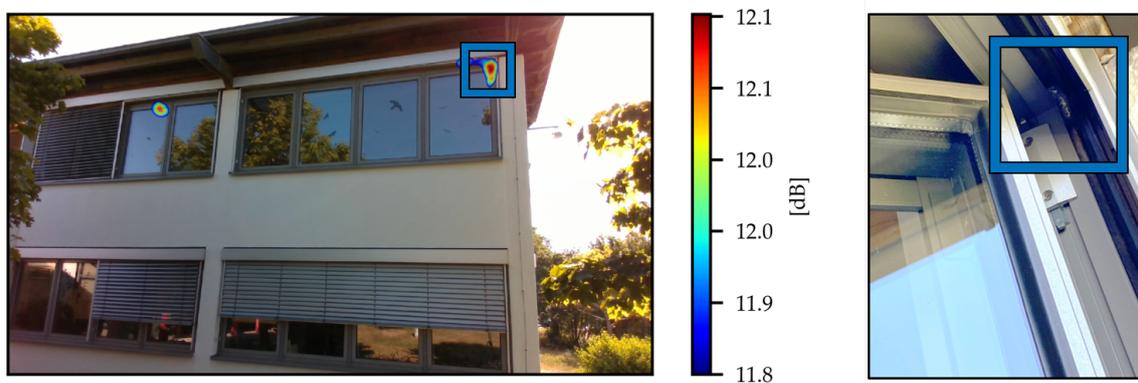
Figure 9. Room D-208. Photograph superimposed with the sound pressure level within the frequency range of 6.4 kHz to 9.5 kHz (left). Mold growth on window seal (right).

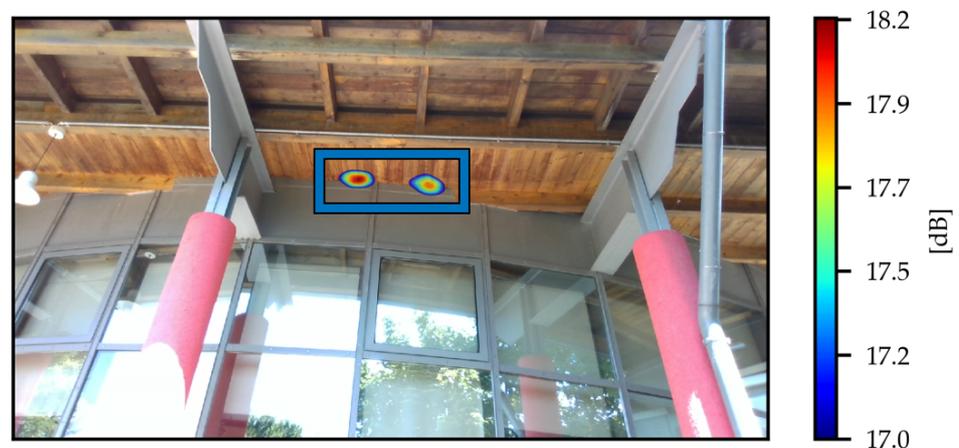
Figure 10. Room D-112. Photograph superimposed with the sound pressure level within the frequency range of 5.6 kHz to 7.1 kHz.

The final example, shown in Figure 10, is the acoustic recording of a wall–roof junction. This area could not be actively investigated due to difficult accessibility, but this junction is often listed in the literature [35,36] as a potential leakage hazard.

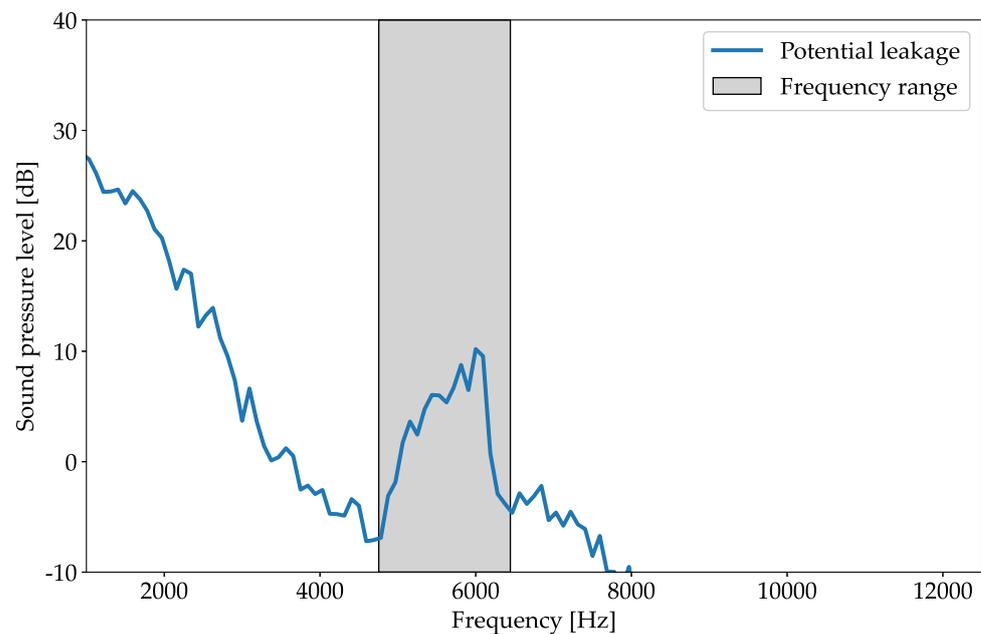
Figure 11. Spectral characteristics of a twig-sized hole in a window panel seal (see Figure 5). The marked peak is in the frequency range between 4.9 kHz and 6.4 kHz.

In Figures 11–13, the sound pressure level is plotted over a frequency spectrum ranging from 1 kHz to 12.5 kHz. The color of each plot matches the color of the annotations made on the related photographs, providing a visual correlation between the acoustic data and the physical locations of interest. Specifically, the frequency ranges highlighted in grey correspond to those used in the visual overlays presented in Figures 5–7. For example, in Figure 12, which corresponds to Figure 6, “Potential leakage 1” (P1) represents the sound pressure level curve of the blue mark situated at the top right of the window front. Similarly, the spectrum of “Potential leakage 2” (P2) corresponds to the green mark in the image and the close-up shown in the right section of Figure 6.

Figure 11 shows the sound pressure level curve at the specific location where a hole, roughly the size of a twig, can be found in the seal of a window panel. Notably, the curve shows a steep increase in the sound pressure level in the range from 4.2 kHz to 6.0 kHz, with a total increase of over 10 dB. Such an increase in sound pressure level enables the identification of the potential leak in the spectrum. This detection is confined to the specified frequency range; beyond these parameters, the area in question does not demonstrate any notable deviations from the overall acoustic landscape.

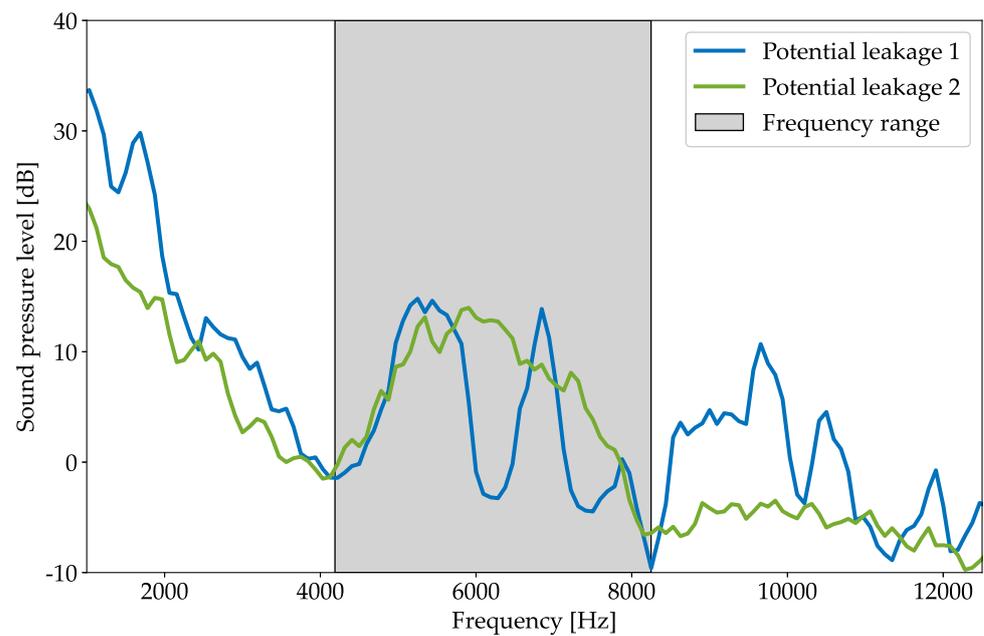
Figure 12. Spectral characteristics of two different leakages within a window front (see Figure 6). The marked peaks are in the frequency range between 4.2 kHz and 8.2 kHz.

only approximately encompass the peak limits of P12. These two potential leaks can be traced back to different origins. While P11 results from a failure in the actual window seal, P12 is caused by the protruding paneling of the window front. A comparative analysis of the curves within the selected frequency range shows divergent behaviors. P11 shows the presence of three sharp maxima and P12 of only one broad maximum, which may offer valuable clues about the type or severity of the leakage. Though a comprehensive exploration has yet to be conducted, these variations in spectral patterns suggest the potential of using spectral shapes as indicators of different types of leakages.

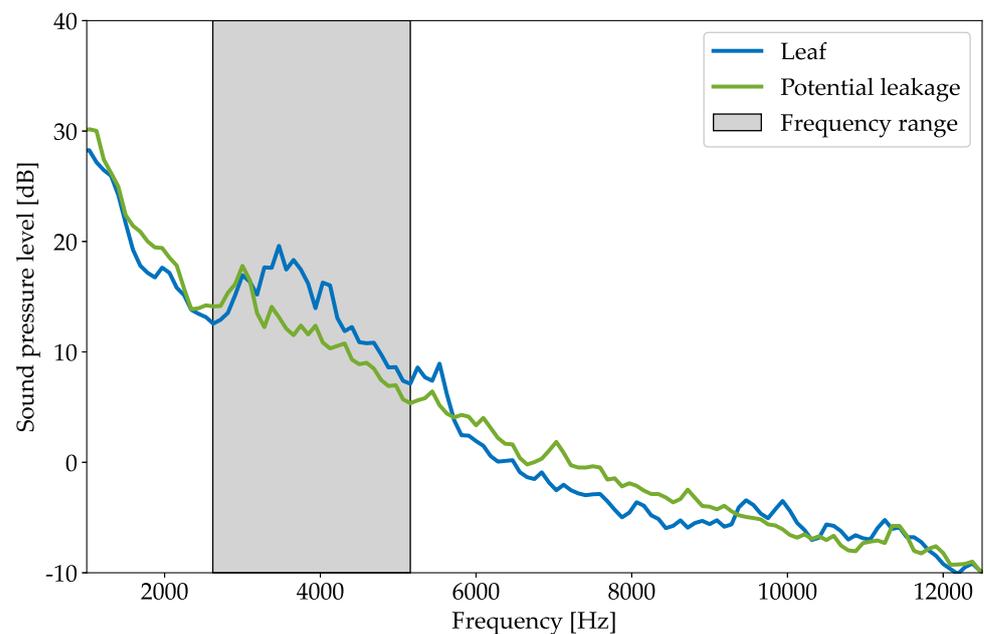
Figure 13. Spectral characteristics of a leaf rustling in the wind and a fractured window seal (see Figure 7). The marked peaks are in the frequency range between 2.6 kHz and 5.2 kHz.

Figure 13 highlights the challenges associated with the acoustic method. In this example, two sound pressure level curves are shown. However, only one corresponds to a potential leak through a fractured window seal, whereas the other curve originates from the ambient noise of leaves rustling in the wind. This disturbing noise reveals two major problems: first, ambient noise in a recorded image can obscure the acoustic signature of potential leaks, complicating their detection. Second, a peak in the blue curve can be observed at roughly 3.5 kHz, which is similar to those associated with actual leakages. Although the peak's prominence is reduced compared to previous findings, it should be noted that such acoustic behavior may not be solely a characteristic of leak-induced signals. Consequently, further investigation is essential to refine the acoustic method's accuracy and reliability, particularly in environments with significant background noise.
