Sensitivity Analysis of Modal Parameters of an RC Joint Subject to Progressive Damage under Cyclic Loads

Amedeo Gregori, Lorenzo Bizzarri *

Abstract: This paper presents the results of an experimental study that focused on the gradual modification of the modal parameters of reinforced concrete beam–column frames subjected to progressive damage under cyclic loading. As is commonly found in structures of the 1970s, the specimen was characterized by the absence of specific shear reinforcement in the nodal panel. The frame modal parameters were investigated using the ambient vibrations test (AVT) as a modal identification technique. In particular, quasi-static cyclic tests with increasing amplitudes were performed on the reinforced concrete frame specimen and the modal parameters were assessed at various stages of frame degradation. By establishing a correlation between the changes in the modal parameters and the mechanical indicators of the structural damage in the frame, this study aimed to determine whether the ambient vibration tests could offer meaningful insights for evaluating the structural health of this type of structural component. As a result of the damage that occurred i

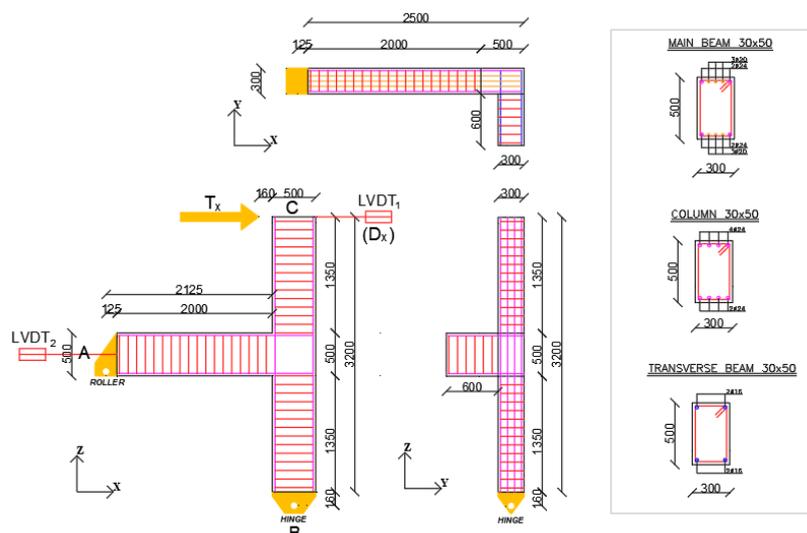
Figure 1. Various views of the specimen with details about the geometry and reinforcement.

Figure 1 also illustrates the geometric dimensions and reinforcement details of the specimen. Both the beam and the column were characterized by a cross-sectional area of $300 \times 500 \text{ mm}^2$, with the column's overall height measuring 3200 mm and the beam's total length spanning 2500 mm. Additionally, a transverse beam with a cross-sectional area of $300 \times 500 \text{ mm}^2$ and extending 600 mm from the column face was included. This transverse beam was introduced to more accurately replicate the geometry of reinforced concrete frames found at the corner of common existing buildings to consider the influence of a beam orthogonal to the frame.

The column's reinforcement consisted of $4\phi 24$ mm steel ribbed bars set longitudinally along both of the shorter sides of the section. With reference to the beam, $2\phi 24$ mm plus $3\phi 20$ mm ribbed bars were adopted as longitudinal reinforcement (on both of the short sides of the section). The reinforcement of the short beam orthogonal to the frame consisted of a single $\phi 16$ mm longitudinal reinforced ribbed bar at each of the four corners. Transverse

reinforcement for the column and the beam included 10 mm diameter stirrups placed at intervals of 100 mm. The stirrups were deliberately excluded from the joint space to reduce its strength, and thus, induce shear failure in the joint before attaining the yield in both the beam and column branch during the simulated seismic loads.

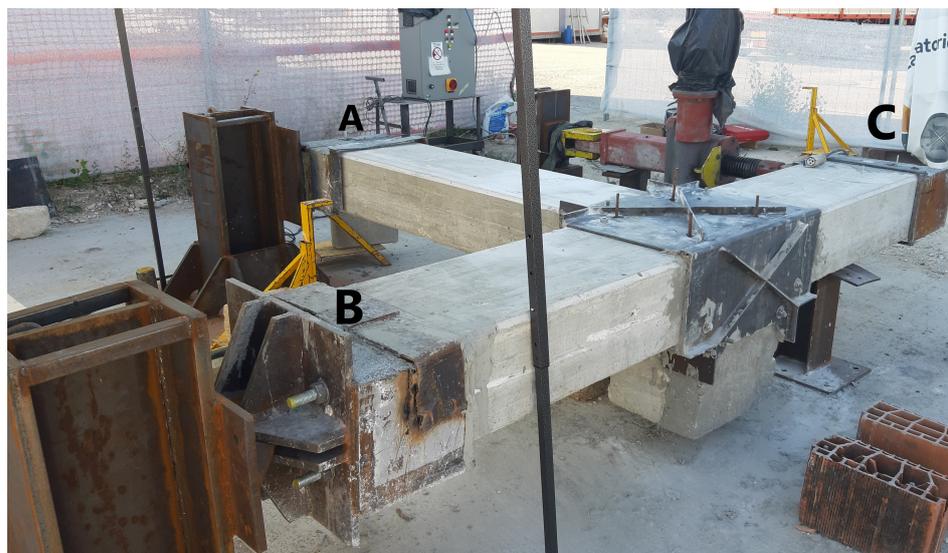
Figure 2. Testing assembly.

Two linear variable displacement transducers (LVDTs) were used to measure the main displacement of the frame under loads. They were placed with one at the top end “C” of the column (Figure 1) and one aligned with the main beam axis at the left end “A” of the beam (Figure 1). To operate the cyclic loading in the displacement-controlled procedure, an electrically driven actuator measuring 500 kN in capacity was applied at end “C” of the column; meanwhile, a 500 kN capacity load cell was used to record the force resisted by the structure.

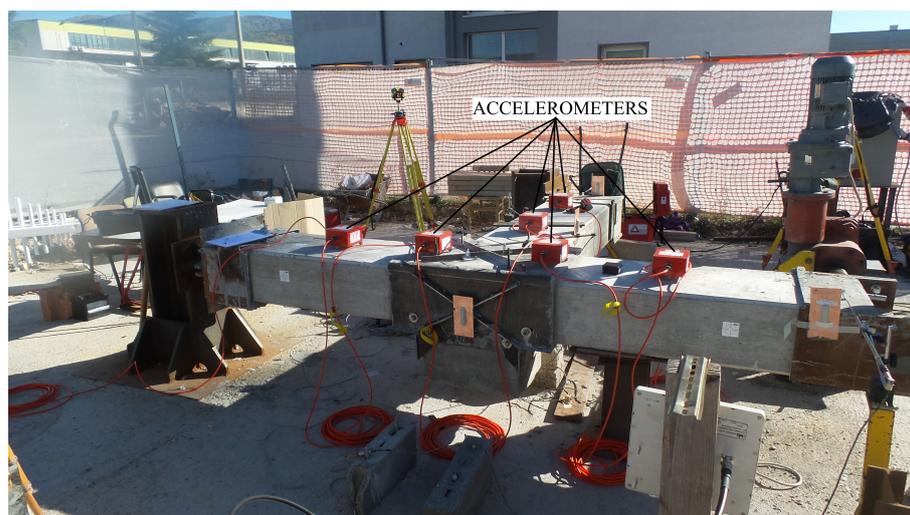
Figure 3. Experimental layout with a view of the measuring devices.

More details about the experimental setup are provided in Figure 3. In particular, a total of six force balance accelerometers are shown. Their strategic placement was decided to capture the dynamic behavior of the specimen through the ambient vibration test (AVT), with the aim to achieve a thorough evaluation of the damage progression within the specimen.

In particular, the digital array accelerometric measurement chain comprised SL06 converters and FB SA10 accelerometers produced by Sara Electronic Instruments (Italy). The accelerometer had a dynamic range higher than 165 dB from 0.1 Hz to 200 Hz, with a 1 g full scale. On the other hand, the dynamic range of the digital converter was 144 dB such that the sensitivity was limited by the converter, not by the noise of the accelerometer,

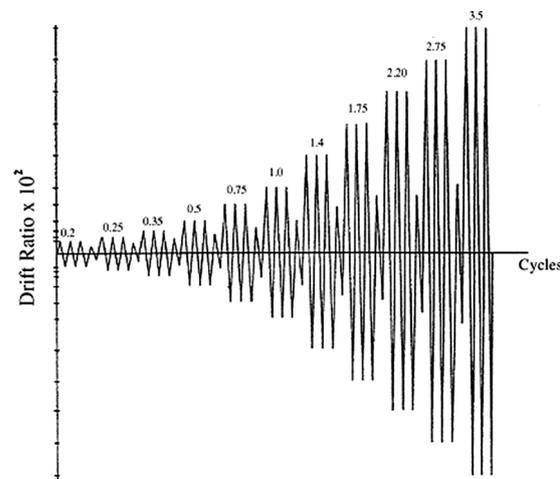
Figure 4. Ideal standard test protocol ACI 374.1 (2005).

To comprehensively analyze the mechanical behavior and the modal parameter changes of the RC frame, the experimental investigation in this study encompassed various activities. In particular, a quasi-static cyclic loading procedure was executed on the RC frame. Specifically, to replicate a seismic action, a sequence of increasing-amplitude, quasi-static cyclic displacements D was applied at the upper free end “C” of the column. The adopted loading sequence shown in Figure 4 consisted of several sets of displacements aiming to produce progressive damage on frame elements. Each set comprised three fully reversed identical cycles. No axial load was applied to the column in direction “CB”, thus reducing any positive influence on the shear capacity of the joint [34].

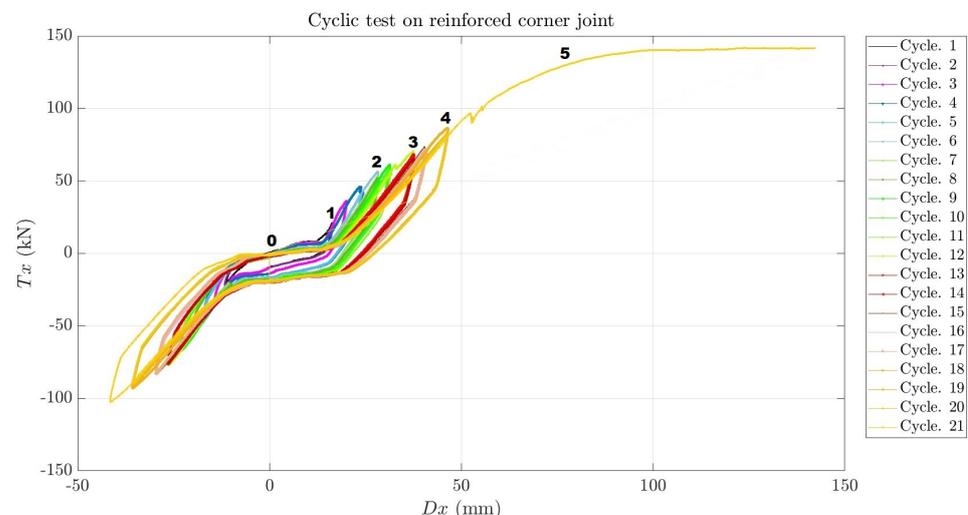
Figure 5. Experimental data of forces and displacements recorded during the cyclic loading. Numeration of the AVT measurements.

The resulting hysteresis cycles obtained from the test are depicted in Figure 5 in terms of the shear force T resisted by the frame with respect of the imposed displacement D . In the same graph, some of the hysteresis cycles are numbered to later compare the experimental results with those obtained from the numerical analysis (see Section 5).

At the end of the specific set of cycles (those numbered in Figure 5), and thus, at various stages of the frame progressive damage, ambient vibration tests (AVTs) were performed before restarting with subsequent groups of cycles. In particular, Figure 6a depicts the quasi-static test setup configuration, showcasing the positioning of the loading point, of the constraints applied to the RC frame, and of the 6 accelerometers. Ambient vibration tests (AVTs) were conducted using a “hammer” to activate vibrations in the frame.

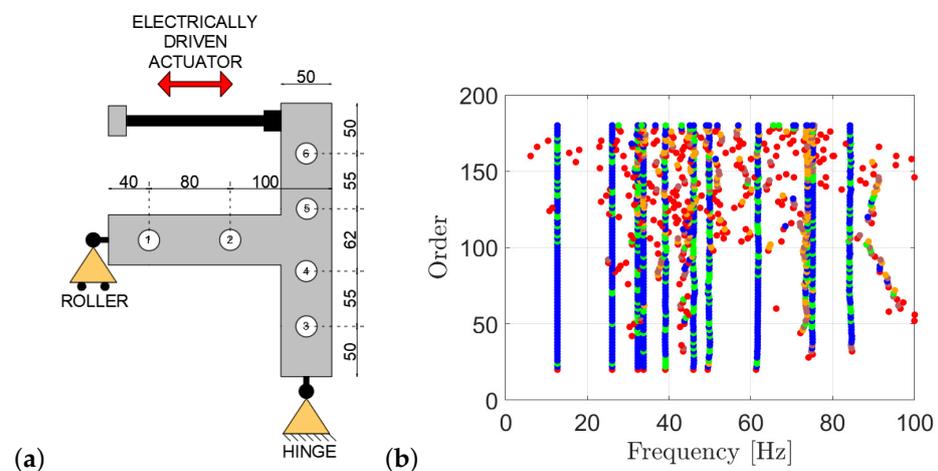
Figure 6. (a) AVT experimental setup; (b) stabilization diagram referring to stage 0 (undamaged stage of the specimen).

Later, data collected from both the quasi-static and the ambient vibration tests underwent processing using the stochastic subspace identification covariance-driven (SSI-cov) from [35]. Widely acknowledged for its effectiveness in extracting modal parameters from measured data, this algorithm was implemented using the open-source software PyOMA [36].

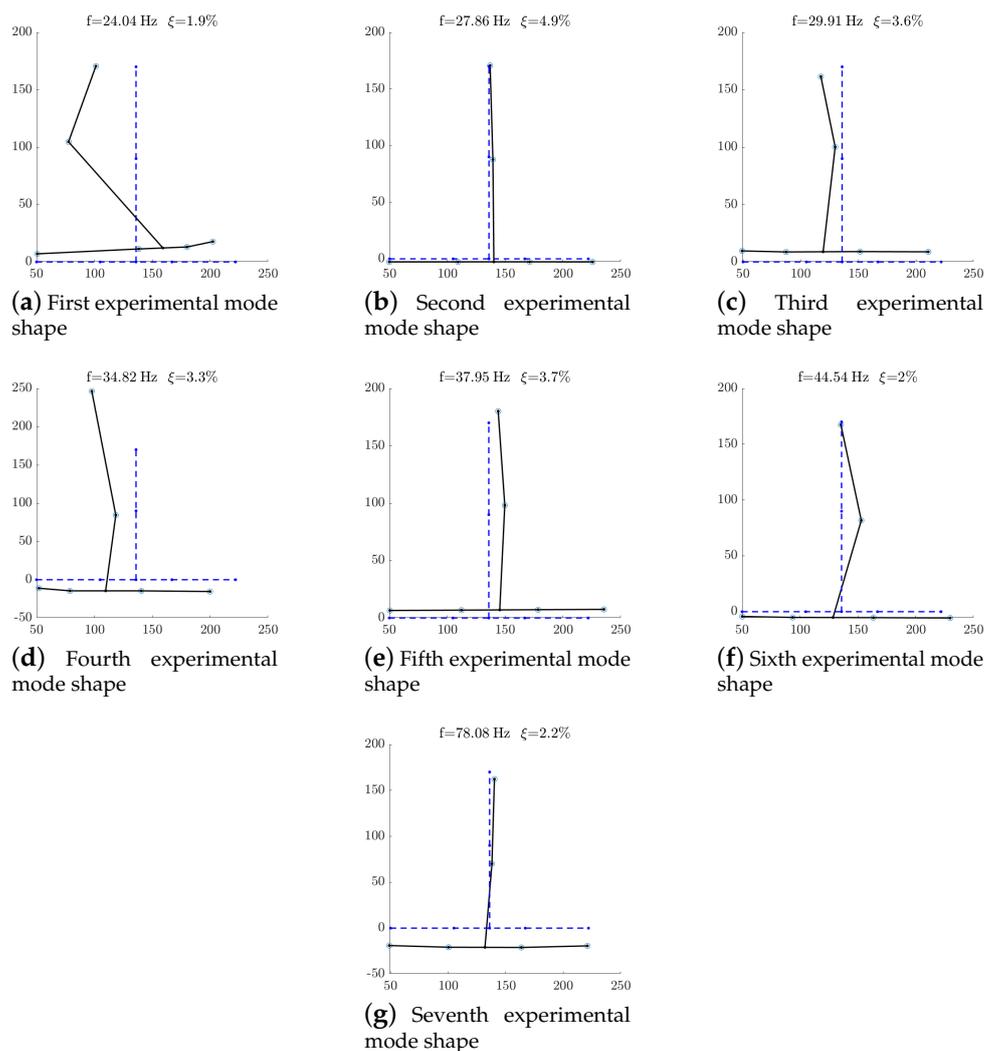
Figure 7. Two-dimensional representation of the first seven experimental mode shapes corresponding to the undamaged stage of the specimen.

In Figure 7, only the positions of the six accelerometers are illustrated (not the entire frame's geometry). The first mode, which was distinguished by a reference frequency of 24.04 Hz, showcased the most pronounced distortion of the joint.

The first mode, as seen in Figure 7, had the most pronounced distortion of the joint, and this is precisely why it was singled out among the various other modes; it was chosen to investigate a relationship between alterations in the frame's dynamic response and the accumulation of structural damage during the cyclic loading of the frame.

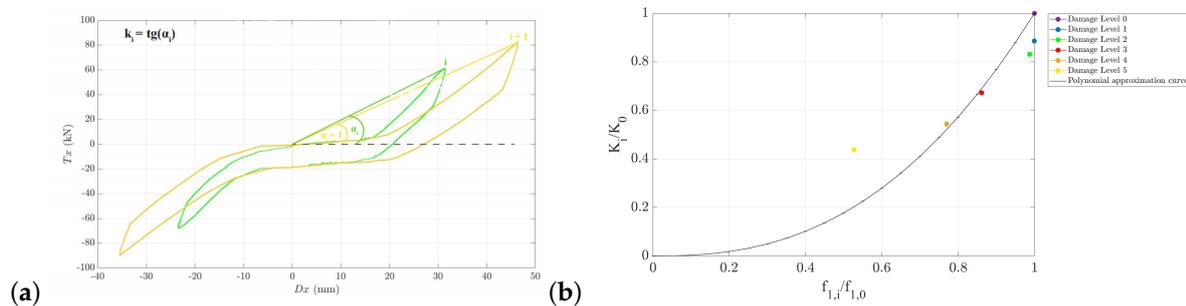
Figure 8. (a) Graphical meaning of the stiffness factor $K = \tan(\alpha_i)$; (b) relationship between the decay in stiffness K_i/K_0 and the variation in the first modal frequency $f_{1,i}/f_{1,0}$.

formed by the line connecting the curve's peak with the origin of the axes with respect to the x-axis. This graphical representation is demonstrated in Figure 8a.

According to this assumption, the graph in Figure 8b highlights a relationship between the residual stiffness K_i at the damage stage i , which was normalized with respect to the undamaged level K_0 (as obtained from the experimental cyclic load test), and the residual frequency $f_{1,i}$ of the first mode at stage i (measured using the ambient vibration test), which was normalized with reference to the undamaged stage frequency $f_{1,0}$. The polynomial approximation, expressed by the equation

Actually, the graph depicted in Figure 8b illustrates how the system's progressive damage due to cyclic displacements resulted in a gradual reduction in both the frame stiffness and its first natural frequency.

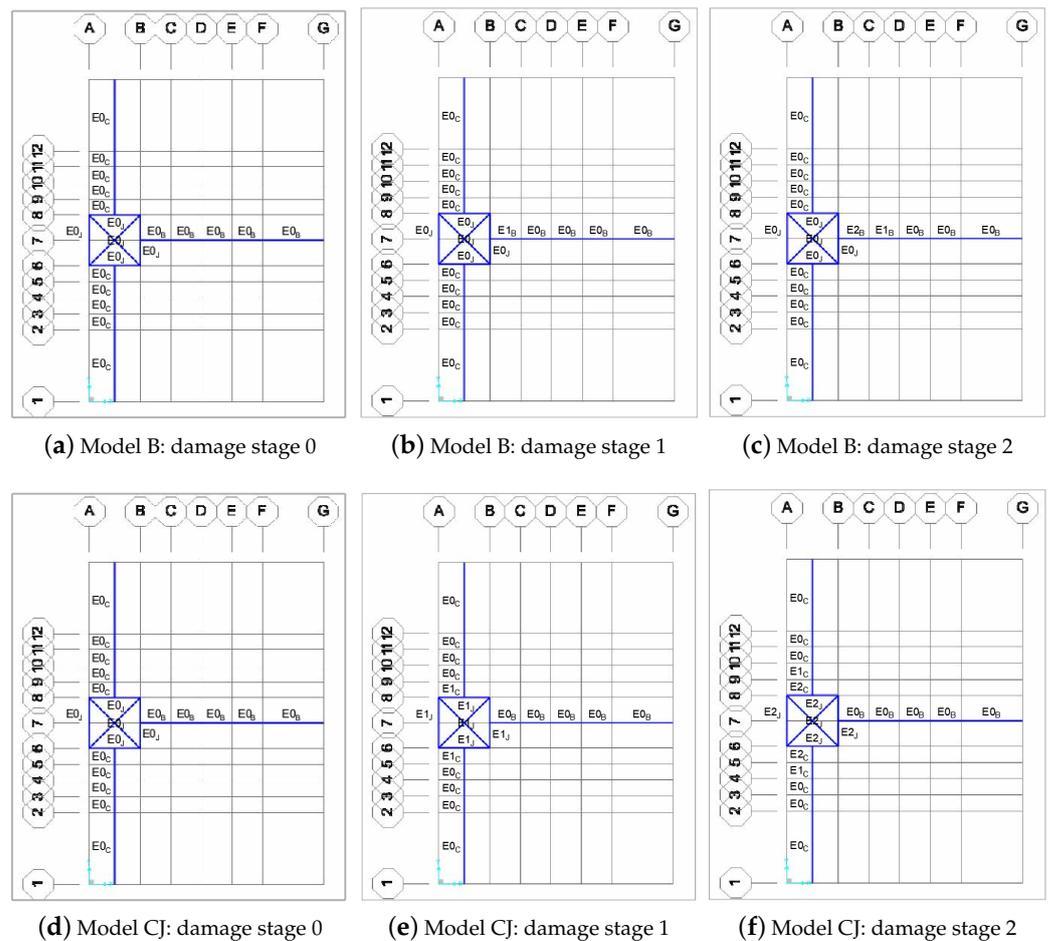
Figure 9. (a–c) Stages of the progressive damage considered in model “B”: only the main beam was affected by the progressive damage; (d–f) stages of the progressive damage considered in model “CJ”: both the column and the joint were affected by the progressive damage.

For example, schemes (a), (b), and (c) of Figure 9 show how the models from B0 to B2 were made. In particular, model B0 was equal to models J0, C0, CJ0, BJ0, BC, and BCJ0 since they all corresponded to damage stage 0, in which the whole system was undamaged. Then, model B1 was thought to represent structural damage starting in the beam and near the joint, and thus, E_1 was assigned to segment "BC", where bending moment M and shear forces T were higher for the beam; the other beam's segments ("CD", "DE", "EF", "FG") were considered undamaged and E_0 was assumed for them. Therefore, in the FEM B2, a higher beam damage was modeled by assigning a more reduced value E_2 to segment "BC" (near the joint), assigning E_1 to the subsequent segment "CD", and assuming the rest of the beam was undamaged with $E = E_0$ (Figure 9c). In so doing, the beam presented progressively more important damage near the joint and gradually less damage as the distance from the joint increased. This was until case B5, where the damage near the joint was assumed to be at the maximum level (E_5 was assigned to the segment "BC") and the minimum damage was at the final segment of the beam (with E_1 assigned to segment "FG"). Moving from segment "BC" (near to the joint) to segment "FG" (at the end of the beam), progressively decreasing values of E were assigned. Similar assignments were undertaken for all the models listed above, and FEM referred to damage stages 0, 1, and 2 of model CJ are shown as examples in Figure 9d, e, and f, respectively.

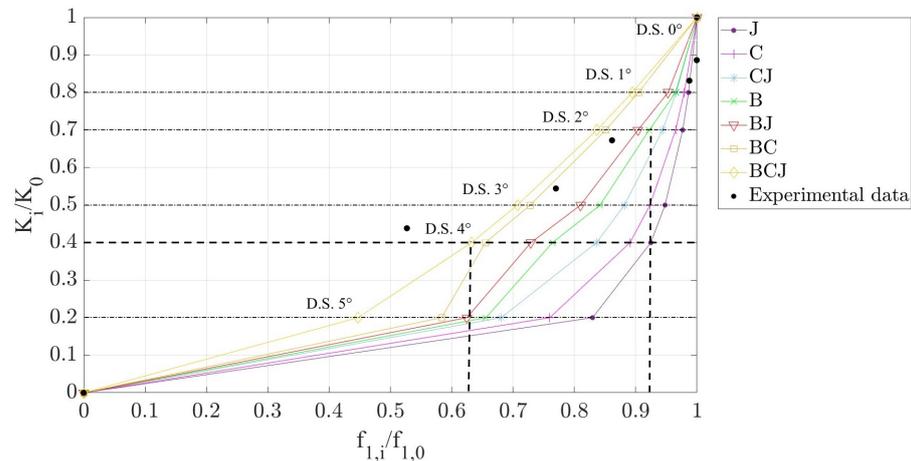
Figure 10. Relationship between residual stiffness (K_i/K_0) and residual frequency ($f_{1,i}/f_{1,0}$) resulting from the analysis of the FEMs (six damage levels for each of the seven models) and comparison with the numerical models.

All the curves depicted in Figure 10 highlight a nonlinear decay of the first natural frequency of the system as a result of the increasing structural damage suffered by the frame. The results define a range of minimum and maximum values within which the natural frequency of the system could vary when the distribution of stiffness across the frame components also changed. For example, in Figure 10, it is shown that a reduction to 40% of

the original stiffness of the structure ($K_i/K_0 = 0.4$) could result from a variety of different damage distributions (from damage model J to damage model BCJ), also highlighting that different residual natural frequencies (ranging from 62% to 92% of the value corresponding to the undamaged stage) may correspond to the same structural health condition for the structure (here represented by a residual stiffness fixed to 40% of the initial one). The graph also shows that a given frequency reduction (for example, $f_{1,i}/f_{1,0} = 0.92$) could result from a high-damage stage in the joint (damage stage 4), as well as from a lower damage stage in the beam (damage stage 2) instead.

The curves in Figure 10 also highlight that, among all cases, the damage in the beam had the most significant influence on the frame frequency, while damage in the joint had less impact. Consequently, it can be asserted that employing natural frequency monitoring to evaluate whether the beam–column joint is undergoing cracking may be less effective than actually expected. Conversely, frequency monitoring may be very sensitive in detecting the structural health of a beam, namely, the element predominantly influenced the variation in the system's natural frequencies. Because during the experimental test, cracks were noticed in the joint (primarily), as well as in the beam and in the column, experimental variation in the natural frequency resulted from different damage processes all took place at the same time.

In fact, for lower damage levels, when the system's stiffness remained considerable, the experimental values remained close to the model J curve, which was the joint where the frame part was actually damaged first. In other words, this similarity between the first experimental data and the model J scenario was consistent with expectations, whereas in the first part of the experiment, structural damage took place in the joint.

As the damage intensified, the experimental values correctly shifted toward models BC and BCJ, where damage in the beam was modeled. Actually, due to the specific test setup, the beam experienced a higher bending moment M and shear forces T compared with the column, although these elements were both characterized by equivalent strength.

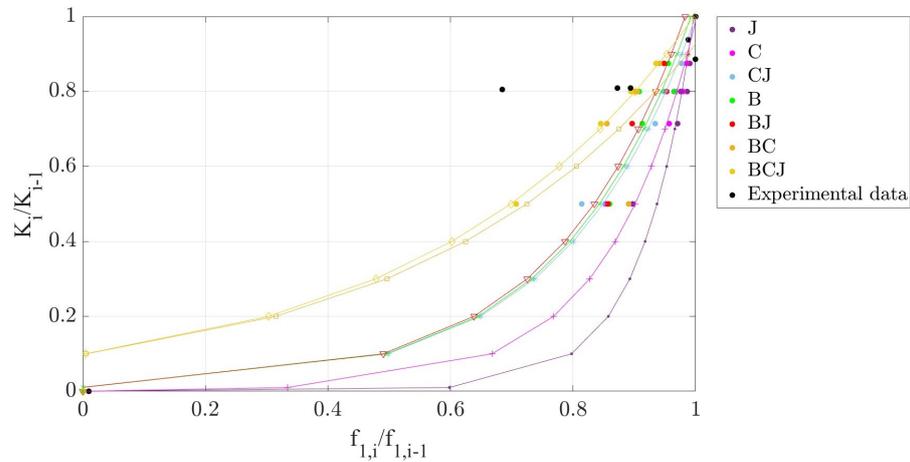
Figure 11. Relationship between calculated residual normalized stiffness values K_i/K_{i-1} and calculated residual normalized frequency values $f_{1,i}/f_{1,i-1}$: exponential approximation curves.

In accordance with these considerations resulting from numerical simulations carried out in this study, one may assume the damage stage $i-1$ to be the reference in comparison with damage stage i . In so doing, residual values of the stiffness K_i and of the first natural frequency f_i were normalized with respect of their values at the previous steps K_{i-1} and $f_{1,i-1}$, respectively, and are plotted in Figure 11.

The graph in Figure 11 also shows the data related to the experimental damage history. Since, as noted above, there is no biunivocal correlation between the AVT measurements and damage stages, and the same happened between changes in the stiffness and the type of damage, the graph in Figure 11 shows that only by intersecting information about frequency changes and changes in stiffness, it was possible to determine the type and level of damage that affected the structure. In other words, it is recommended to contemporarily measure changes in natural frequencies with AVT techniques and changes in structural stiffness with static load tests, and to repeat this procedure during the life of the structure to understand whether its damage grows according to diffuse or localized damage models. For example, the experimental data in the graph of Figure 11 show that during the cyclic tests, the damage occurred in a diffuse way and was not localized only in the joint, as might have been expected from the test design (in fact, the experimental damage was close to the BCJ curve and not to the J curve).

In so doing, curves already plotted in the previous Figure 10 were recalculated to attempt to search for a mathematical correlation between the residual structural stiffness values and the residual values of the first natural frequency of the system.

As can be seen from Figure 11, comparing K_i with the stiffness values K_{i-1} calculated at the previous damage level, a difference in frequency decay was made explicit for each of the seven models considered to describe the progressive damage in different parts of the frame: again, the natural frequency of the whole frame primarily depended on the health condition (damage level) of the beam and less on the joint health condition.
