The “Sant’Angelo in Criptis” Cave Church in Santeramo in Colle (Apulia, South Italy): A Multidisciplinary Study for the Evaluation of Conservation State and Stability Assessment

Abstract: Sant’Angelo in Criptis (Santeramo in Puglia, South Italy) is a karst cave located in the Alta Murgia National Park (aspiring geopark), presently degraded, but with signs of intense past visiting activity for worship, as testified by the beautiful wall paintings and the large number of inscriptions and engravings on the cave walls. With the aim to permit the desirable restoration and the following fruition of this ancient geo-cultural heritage, a multidisciplinary investigation of the cave was carried out in this study. The 3D cave model permitted a detailed map of the area and highlighted that the cave vault, although very regular, somewhere presents chimneys that develop upwards, indicating areas where the rock thickness is now very small. The stability analysis indicates that presently, the cave does not show remarkable signs of instability, but block failures, toppling and roof collapse are possible. Archaeometry investigations confirmed the past importance of this holy site, as testified by t

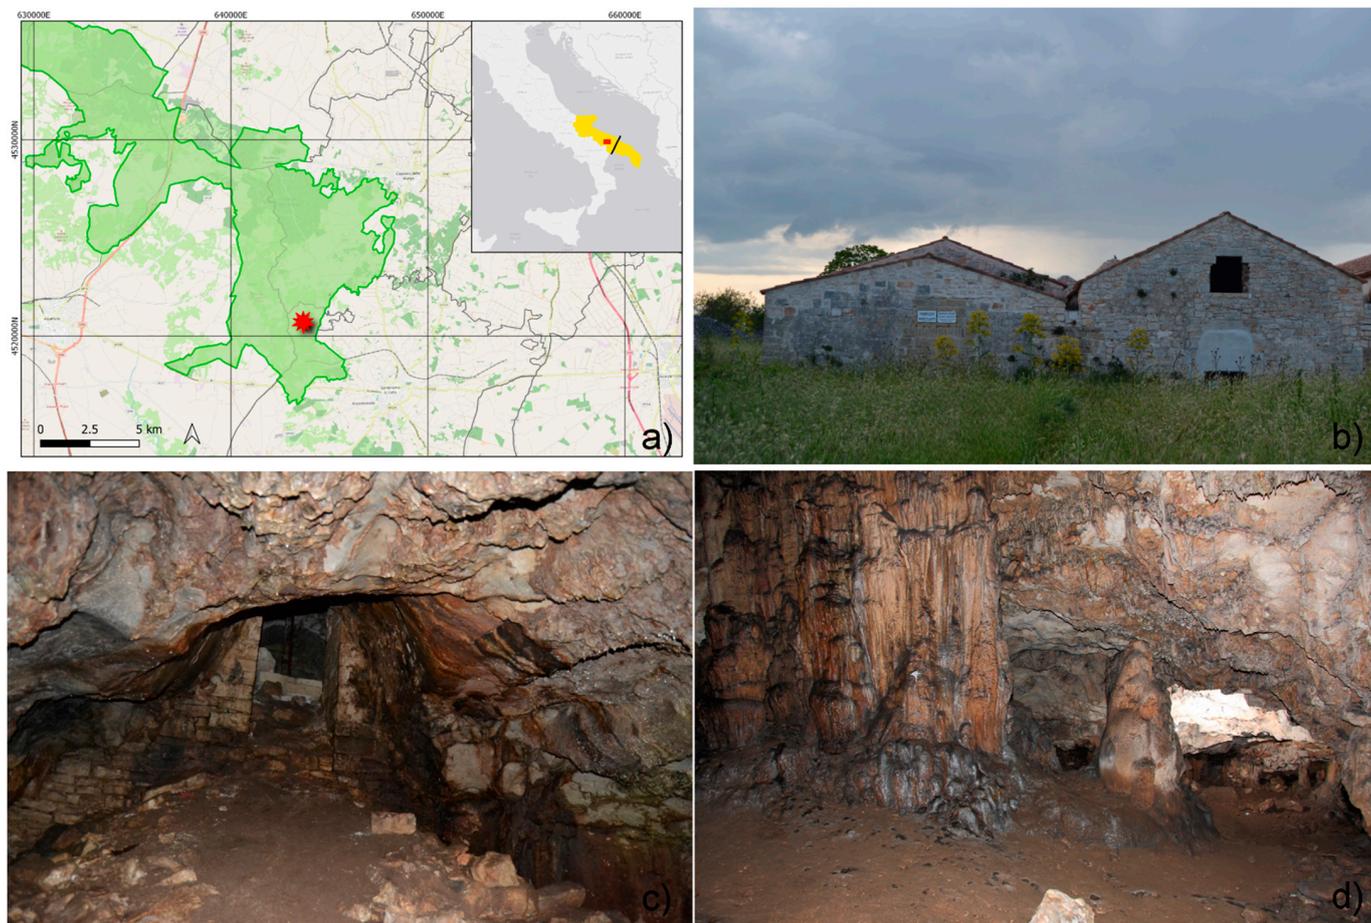
Figure 1. (a) Localization of the study site (red star) just inside the Alta Murgia National Park (green), the black line is the cross-section in Figure 3. (b) The front of the ancient buildings built over the cave. (c) The entrance view from the cave inside, delimited by rock walls of the ancient church foundations. (d) View of the central cave corridor with massive columns.

It is a suggestive natural karst cavity, which is part of a wider and more complex structure, locally known as “Iazzo Sant’Angelo” (Figure 1), consisting of three adjacent buildings (Figure 1b) that cover the entrance of the cave (Figure 1c) and overlap the northern end of the cave itself.

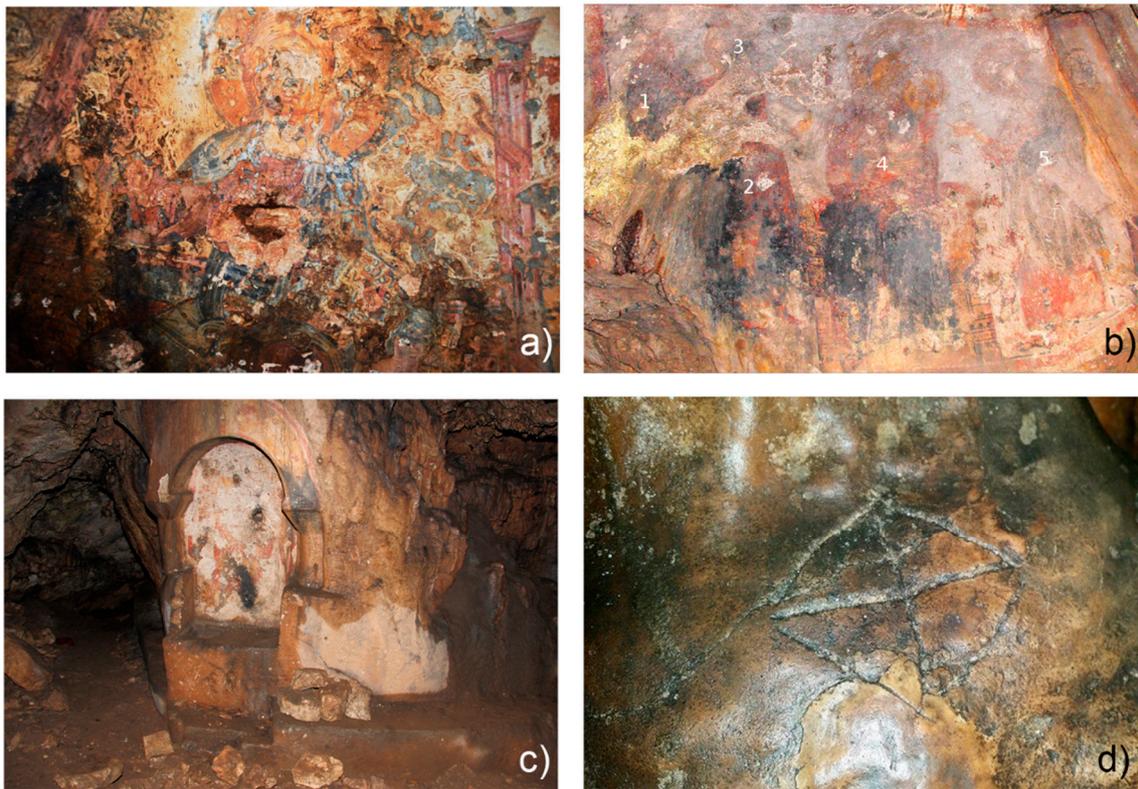
Figure 2. Wall paintings and ancient graffiti in the Sant'Angelo crypt. In detail: (a) the “Descent of the Holy Spirit and Christ Pantocrator” painting, (b) the “The Virgin and the Child flanked by the St. John and the St. Michael” painting (1. St. Michael’s wings, 2. St. Michael’s body, 3. St. Michael’s face, 4. Virgin and Child, 5. St. John), (c) the niche containing the “St. Michael the Archangel slaying the dragon” painting and (d) a cross incised in the crypt wall by pilgrims.

The site was initially used as a church and later as a manor farm. In 1939, Archeological Superintendence for Puglia declared the considerable historical interest of the site and subjected it to protection constraints. The cave represents the core of the historical structure, being characterized by a beautiful underground karst landscape (stalactites, stalagmites, columns delimiting unique niches carved into the rock), in which fine, stratified wall paintings enrich both the cave walls and niches (Figure 2a–c).

In addition to paintings, cave walls collect engravings and graffiti signs (Figure 2d) from different time periods, indicating the sacredness of the place, which was an important religious pilgrimage destination since early Christian periods and even before. As a matter of fact, it is likely that the cavity was originally devoted to the pre-classical “cult of water”, and later converted to Christianity and finally entitled, in the early Middle age, to St. Michael the Archangel [16].

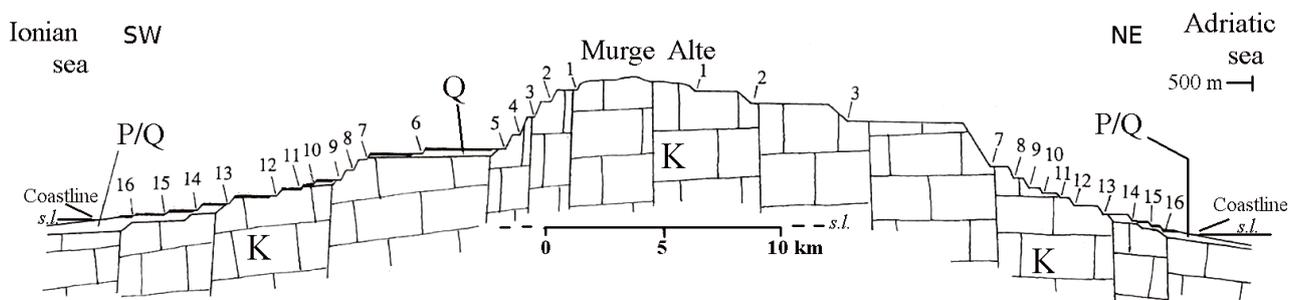
Figure 3. A cross-section of the Apulia foreland near the study area highlights the stepped structure of the Murgia plateau. Location in Figure 1. Legend: (1–16): uplifted shorelines (middle–late Pleistocene), P–Q: Bradanic trough cycle (late Pliocene–early Pleistocene), K: Apulia foreland carbonates (Cretaceous). Modified from [30].

Overall, the Murgia relief has a monocline structure, with a SW dip (Figure 3). A slight bending is believed to be due to an intraplate compressive phase of the Cretaceous period, with axes roughly WNW to ESE [32].

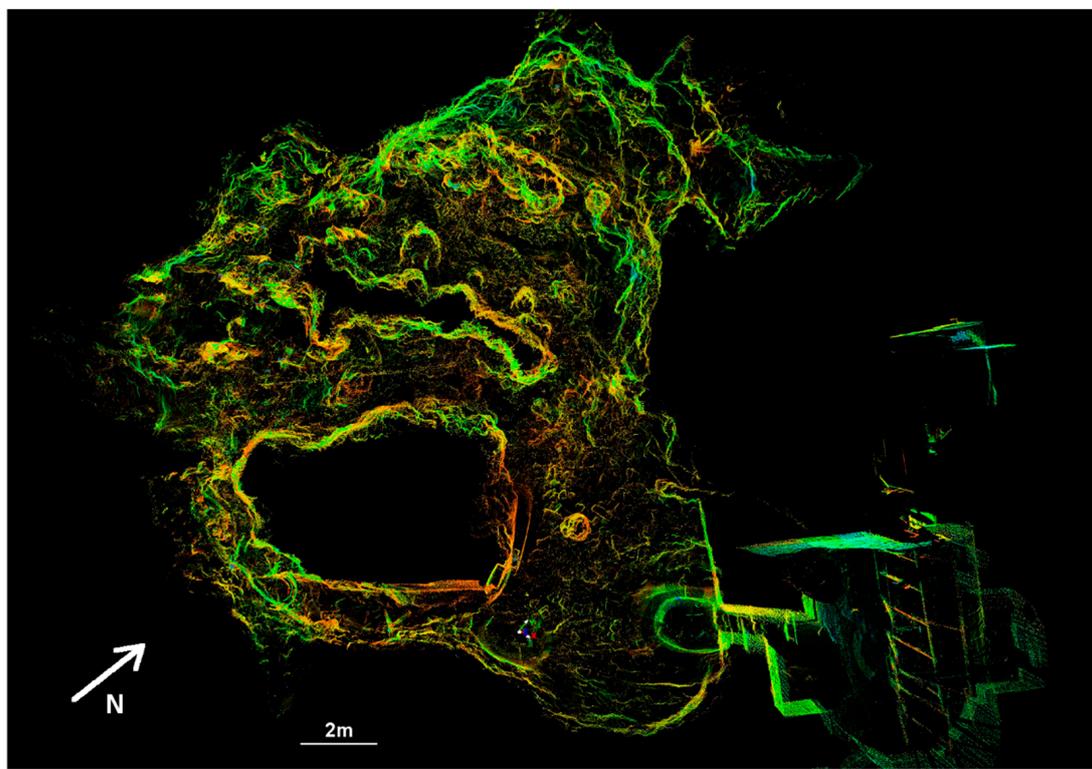
Figure 4. The cave point cloud from the above point of view: the black areas inside the cave profile show the unscanned portions that represent the columnar structures.

leading back to the starting point, and then carrying on in the building until arriving on the outside, on the countryside plan over the cave (Figure 4).

The subdivision is due to massive columnar structures (Figure 4), formed over a long time, that serve as a support for the vault but also testify to the concentration of dripping percolation along at least three main directions parallel to each other and related to bands of structural weakness. The walkable area of the cave is about 190 m², considering the areas high enough to allow human passage and excluding inaccessible areas where stalactites, walls, columns and collapsed material are present. It is also possible to estimate the volume of the void of the cave at about 510 m³, excluding the concretions and the detrital fan.

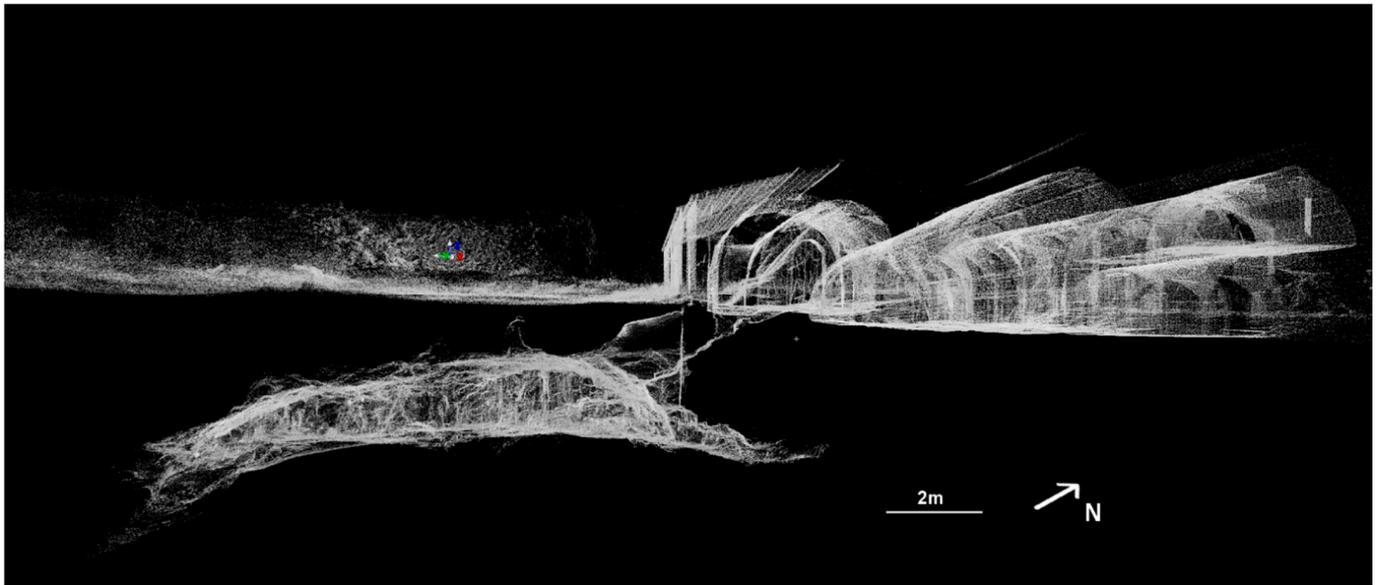
Figure 5. The 3D model of the complex structure of Iazzo Sant'Angelo showing the connection between the cave and the buildings and the rock thickness over the cavity. It is evident that a chimney rises up toward the ground level.

The Sant'Angelo cave is very close to the surface, and its entrance has been modified by man and inserted into the structure of the adjacent building (Figures 4 and 5). The entrance leads directly to the main corridor, from which all the others depart. Due to the abundance of both chemical and clastic deposits, the bedrock is hardly visible in the cave (Figure 1c,d). The speleothems, whose size ranges from recent cannulae to imposing columnar complexes that join the vault and floor as irregular "pillars" (Figures 1d and 4), are due to a sequence of deposition events. According to the current model of speleothems' evolution, the largest complexes originated from stalactite–stalagmite pairs that, thanks to the concurrence of intense water supplies and a sufficiently long time, first joined vertically and finally fused horizontally. The main coarse clastic deposit (boulders) is correlated with the upward migration of the ceiling, in vadose conditions, due to the progressive detachments of slabs, and this sediment is the base of the current walking surface, as well as (apparently) of the largest speleothems. In general, and in particular also in some caves of the Murge, the survey of speleothems and joints allows to identify both the structural factors that in the past have geometrically driven the speleogenesis, and any deformation in progress due to instability or tectonics [51]. Although the limestone rock mass is rich in joints, in this cave, there is only a limited area (in the NW wall) that shows recent fractures affecting the calcite coating.

It is expected, as it is evident in the topography, that the current morphological evolution of the cavity and its processes are no longer supported by an active hydrogeological basin tributary, nor by water flow through its passages. On the surface, one can find only a limited feeding rock mass, corresponding with the slightly depressed area above the cave, hypothetically a small doline (Figure 5).

state. Small signs of spalling mechanisms from the roof are restricted to the sector in which the cave vault is higher (Figure 5), but shear failures were not recorded.

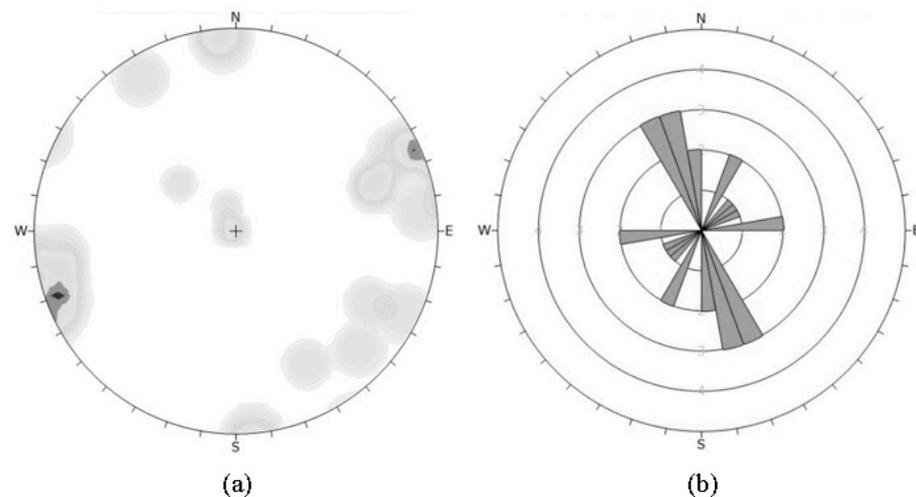
Figure 6. (a) Pole density plot—lower hemisphere, Schmidt equal area stereographic projection. (b) Rose diagram showing direction and count (total number) for the discontinuities measured (fractures and bedding planes).

In particular, bedding planes show a generalized E–W orientation, ranging from horizontal to 15 degrees SSE-dipping. The main discontinuities exhibit the typical NW–SE and NE–SW orientations, while E–W and N–S orientations are subordinate. Each of them dips more than 60 degrees, except for an extensive closed fracture of 130/40 (dip direction/dip). The rebound hardness index of the rock mass was determined using a spring-driven steel hammer (the Schmidt hammer) for estimating the uniaxial compressive strength (UCS) and the tangential Young’s modulus (E_t) of intact rock bridges and discontinuity walls. A standard L-type hammer, with 0.735 Nm impact energy, was used for the in situ measurements [52]. The UCS and E_t values were obtained using the equations proposed by Sachpazis [53], because they refer to carbonate rock masses such as those found in the study site. For the rock bridges, UCS and E_t vary respectively from 61.18 to 104.08 MPa, with mean 74.05 MPa, and from 27.38 to 43.47 GPa, with mean 32.21 GPa. For the discontinuity walls, UCS and E_t vary respectively from 18.28 to 61.18, with mean 35.44 MPa, and from 11.29 to 27.38 GPa, with mean 17.72 GPa. According to the GSI classification system, a Geological Strength Index falling in the range 60–70 was assigned to the rock masses cropped out in the study site. With regard to the RMR1989 system, the rating index was 61.

Four main discontinuity sets were identified on the rock mass, generally associated with the tectonic evolution of the study area. Details on the attitudes and relative weights of the sets identified from the integrated approach are summarized in Figure 6.

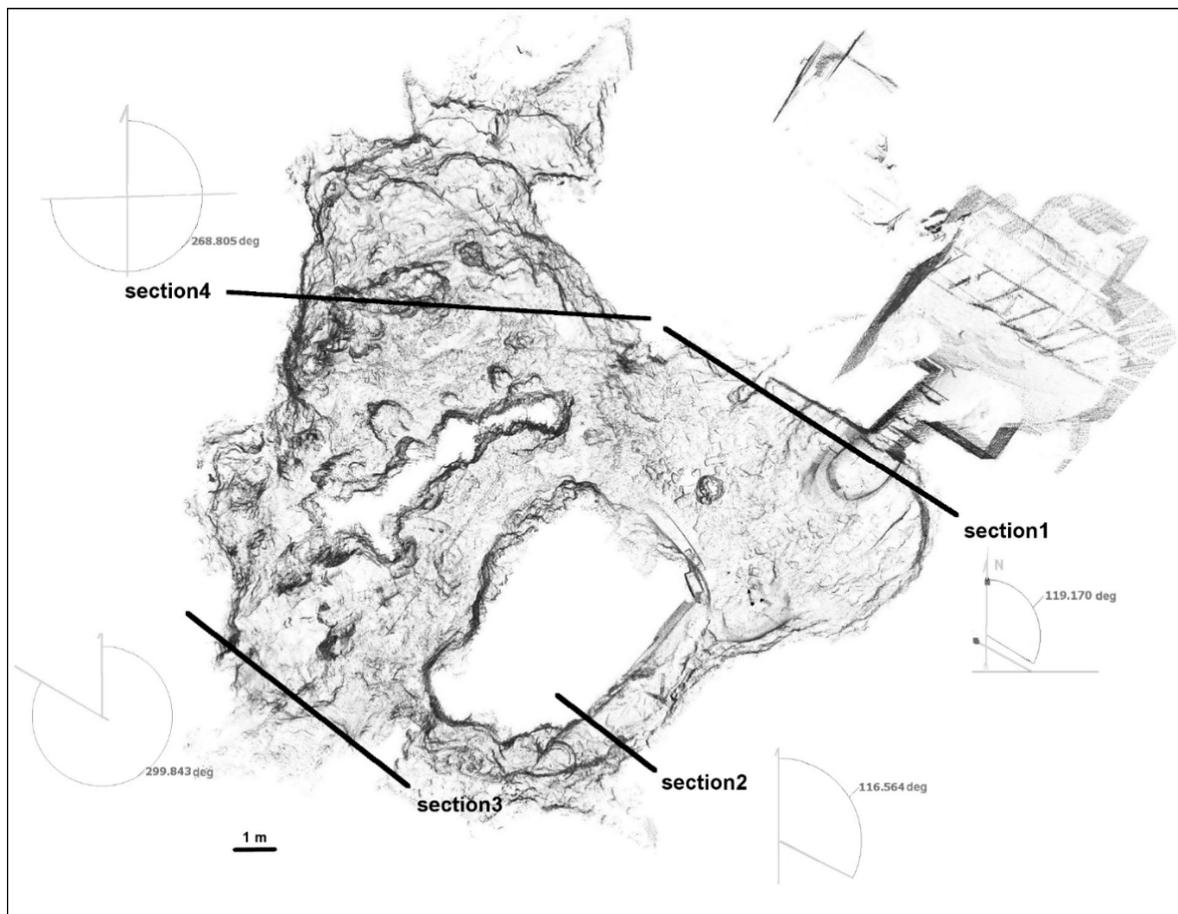
Figure 7. Section traces used for the kinematic analysis of the cave stability depicted on the 3D model, here shown as a map from the top view.

Kinematic analysis was carried out by means of graphical approaches for detecting geometrically possible instability mechanisms [54–56]. The Rocscience’s Dips 7.0 and Unwedge software were used to perform kinematic analysis of the cave stability for four different sections inside the cave (Figure 7). The potential for planar sliding, wedge sliding, flexural toppling and direct toppling failure modes was evaluated assuming full persistence for the discontinuity sets measured.

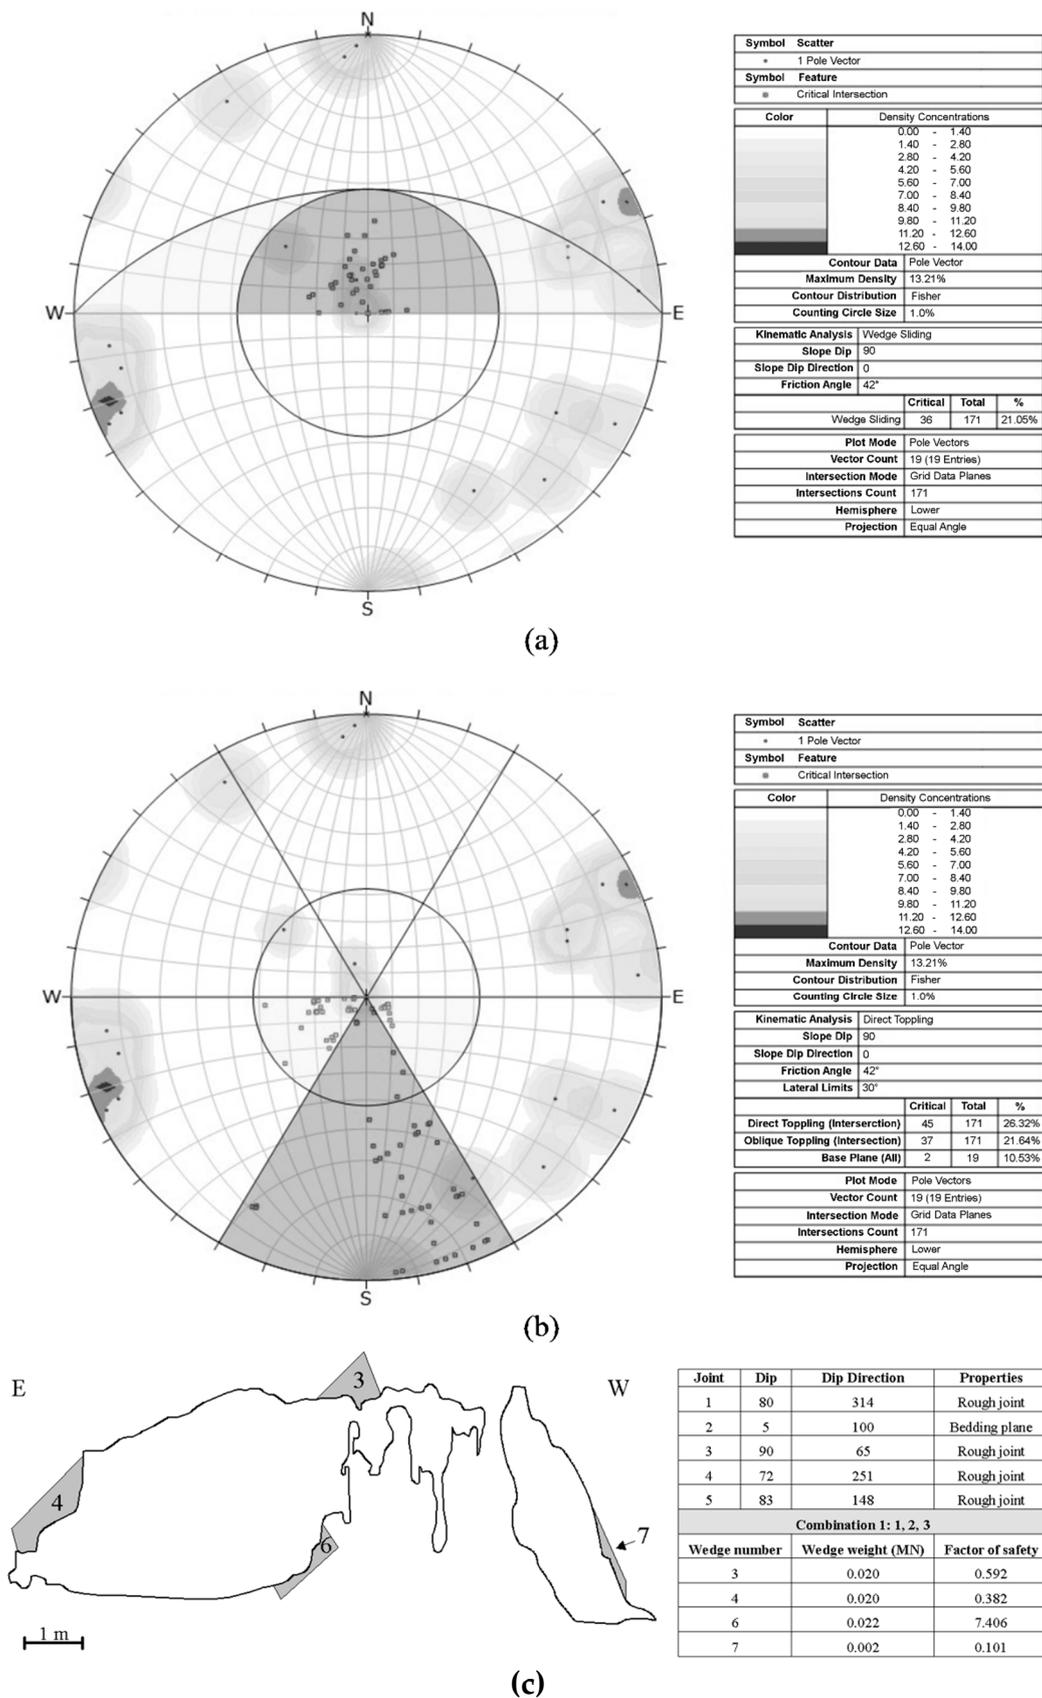
For each section, deterministic analysis and factor of safety were carried out on about 80 combinations of the 4 joint sets measured. The design seismic coefficient used in the pseudo-static stability analysis was 0.1. Potential failure modes were identified, most of which are attributable to wedge sliding and block toppling from the cave sidewalls and falling from the roof (roof collapse). According to Palmström [57], the sections considered potential unstable rock blocks exhibit polyhedral shape and volumes generally less than 1 m³ and only occasionally between 2 and 4 m³. Figure 8 shows, by way of example, some results obtained for section 4.

Figure 8. Examples of potential instability analysis of the rock masses of the Sant'Angelo in Criptis Cave along the section 4. (a) kinematic analysis of wedge and (b) direct toppling failures using stereographic projections; (c) deterministic analysis for the joint combination 1, using the Unwedge program, based on Goodman-Shi key block theory.

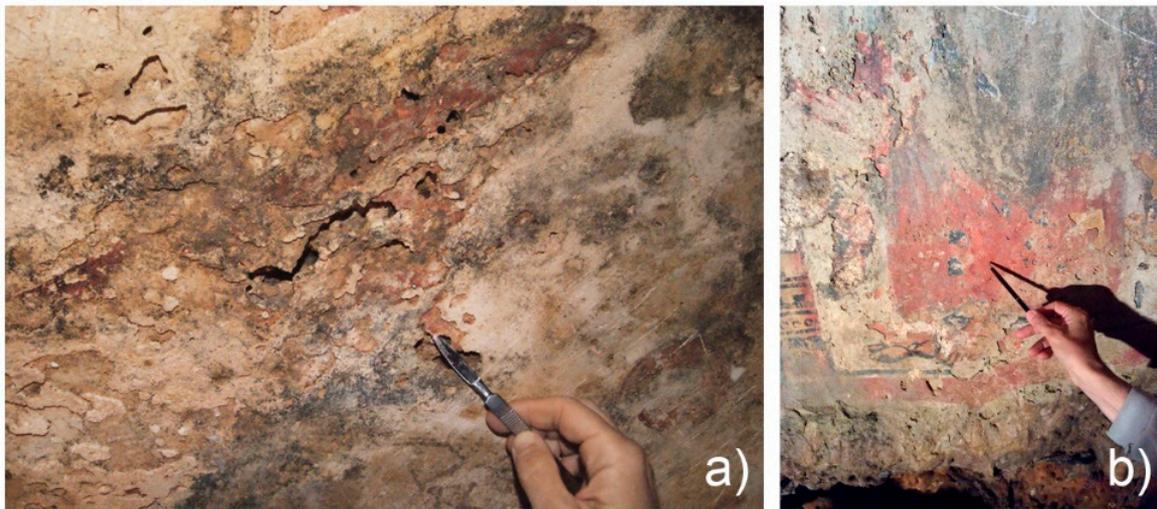
After the in situ observation, all the paintings (Figure 2) in the Sant'Angelo crypt appeared seriously damaged due to both environmental and anthropic causes. Some scenes were fragmentary, lacking cohesion or detached, owing to clear problems of dampness, but in some cases, i.e., in the case of the “St. Michael the Archangel slaying the dragon” painting, the main scenes were lacking due to the removal of the pictorial film for vandalism, so only the preparatory mortar layer and the frame of the original painting is preserved (Figure 2c). The “Descent of the Holy Spirit and Christ Pantocrator” painting appeared affected by large and numerous losses, mainly in correspondence to the most recent pictorial layer (Figure 2a), highlighting the older underlying pictorial layer. Instead, the painting “The Virgin and the Child flanked by the St. John and the St. Michael” showed an almost complete superficial pictorial layer, but it appeared covered by a dark deposit, making difficult the reading of the depicted subject (Figure 2b). There was also a clear presence of plants, fungi and molds, and the decorations were affected by craquelure, losses of the paint layers and deposition of secondary surface deposits, which influenced the rendering of chromatic features and the depicted scene (Figure 9).

Figure 9. Degradation effects on the surface of wall paintings in the Sant'Angelo crypt: (a) losses and calcite deposits on the surface of “Descent of the Holy Spirit and Christ Pantocrator” painting; (b) dark deposit on the surface of “The Virgin and the Child flanked by the St. John and the St. Michael” painting.

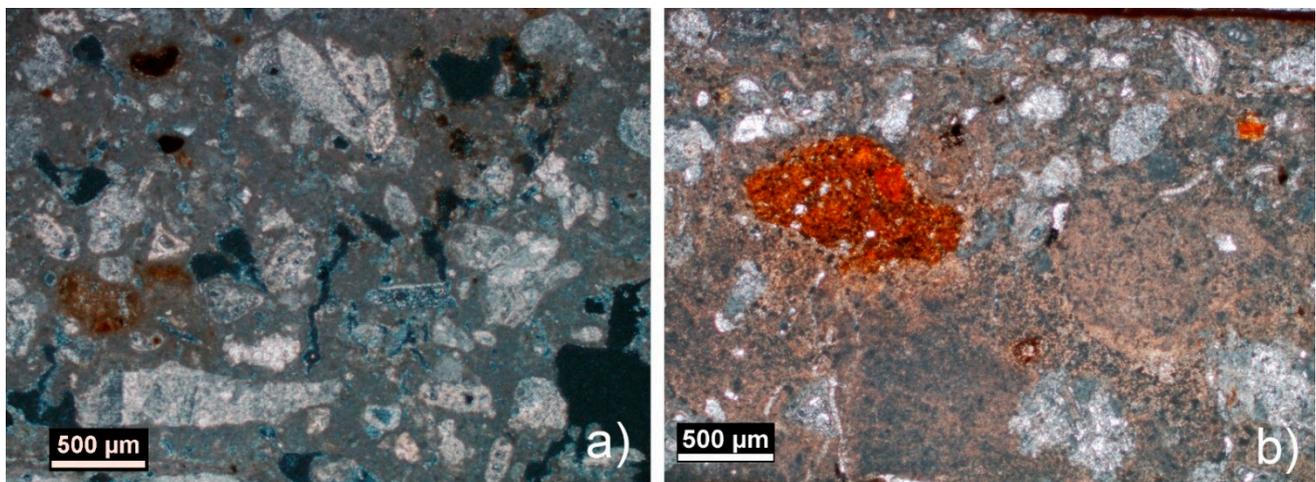
The laboratory investigation of painted fragments showed the occurrence of one single, variable thick, preparatory plaster layer beneath each pictorial cycle. The analysis by TL-OM highlighted a plaster composed by cryptocrystalline calcite binder and an aggregate mainly composed by carbonate rock fragments and minor quartz and feldspars (Figure 10a). Lime lumps (non-hydrated CaO) are also present in addition to cocchiopesto fragments which testify to the hydraulic character of the plasters (Figure 10b).

Figure 10. Transmitted-light optical microscope microphotographs in thin sections showing: (a) the preparatory mortar composed by cryptocrystalline calcite binder and the aggregate consisting of carbonate rock fragments and minor quartz and feldspars, and (b) lime lumps and cocchiopesto fragments to increase the hydraulic properties of preparatory mortars.

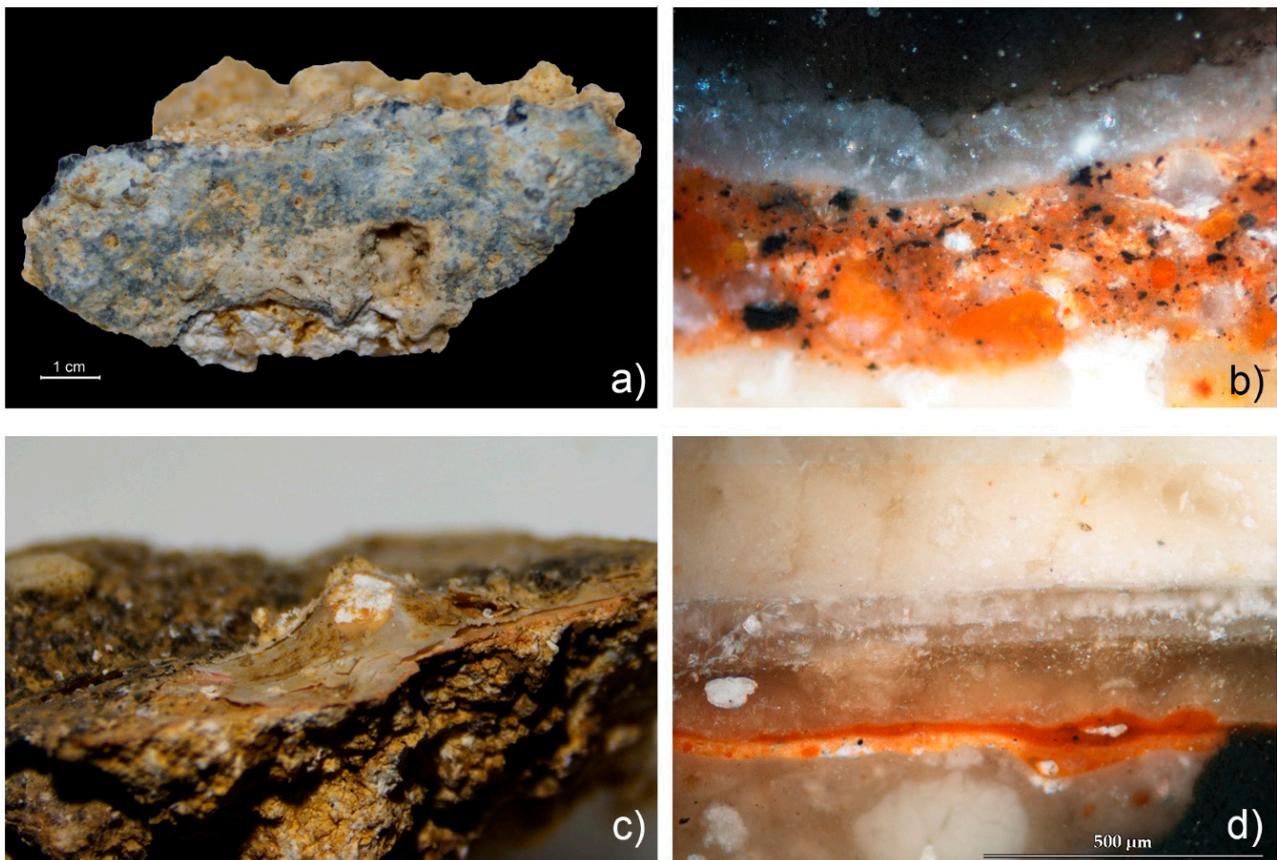
Figure 11. (a) Paint fragment with a thick brown–yellowish crust. (b) RL-OM microphotograph of a paint fragment in the cross-section showing a red pictorial layer composed by an admixture of red ochre and carbon pigments overlaid by a single calcite incrustation layer. (c) Paint fragment showing multilayer lamellar crusts on the surface of the pictorial layer. (d) RL-OM microphotograph of a paint fragment in the cross-section showing a red pictorial layer overlaid by several calcite incrustation layers.

On the surface of the latest pictorial layer, all the samples showed one or more differently thick incrustation coats composed of secondary products related to the physical decay and chemical alteration phenomena linked to the karst activities inside the cave and to the effects of typical environmental degradation (Figure 11). With the naked eye and under a stereomicroscope, these surface deposits generally appeared as compact brown to yellowish crusts, covering the pictorial layers without producing any chemical alteration and physical disaggregation on their constituting materials (Figure 11a).

In some cases, encrustation layers were observed on the surface of each pictorial cycle, while in other cases, only a single surface layer of encrustation was observed. The crusts appeared white, opaque and extremely compact under RL-OM (Figure 11b). Sometimes, however, a less compact surface crust layer showing lamellar morphology was detected (Figure 11c). In detail, sample CR11 from the wall painting of “Descent of the Holy Spirit and Christ Pantocrator” showed a secondary crust formed by the overlapping of three layers very similar to each other in terms of color, transparency and hardness, and showing vertical and beige–yellowish fractures (Figure 11d).

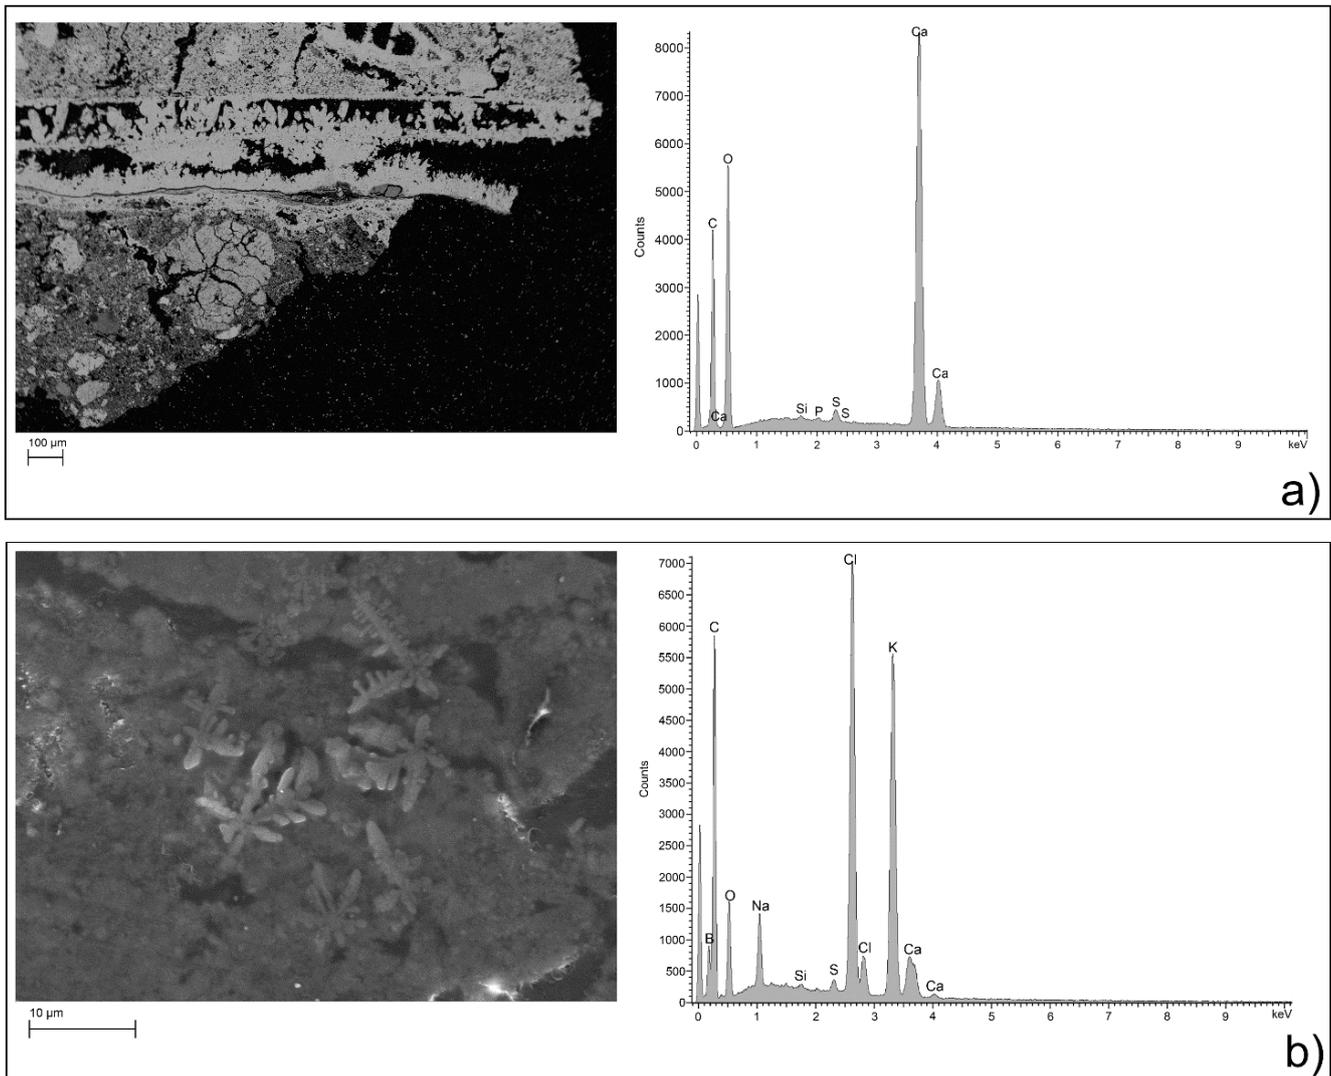
The chemical analyses performed by SEM-EDS revealed, in all the investigated samples, the presence of a surface encrustation composed almost exclusively by calcium and oxygen, attributable to calcite (Figure 12a), in addition to minor chlorine, potassium, sodium, phosphorus and sulfur, which can be related to common soluble salts, namely sulphates, phosphates and chlorides.

Figure 12. (a) SEM-BSD (back-scattered detector) image (left) of a thick surface encrustation composed almost exclusively by calcium and oxygen (EDS graph on the right). (b) SEM-BSD image (left) showing the presence of secondary phases in the preparatory plaster layers composed by chlorine, potassium, sodium and sulfur (EDS graph on the right).

Contrary to the pictorial layers, the preparatory plasters underlying the paintings showed more significant chemical and physical degradation effects. They generally appeared powdery and incoherent under OM, whereas SEM-EDS chemical analyses disclosed the presence of relatively high quantities of chlorine, sulfur, phosphate, sodium and potassium, suggesting a more significant formation (if compared to the pictorial layers and encrustations) of common soluble salts, mainly composed by potassium chloride (Figure 12b).

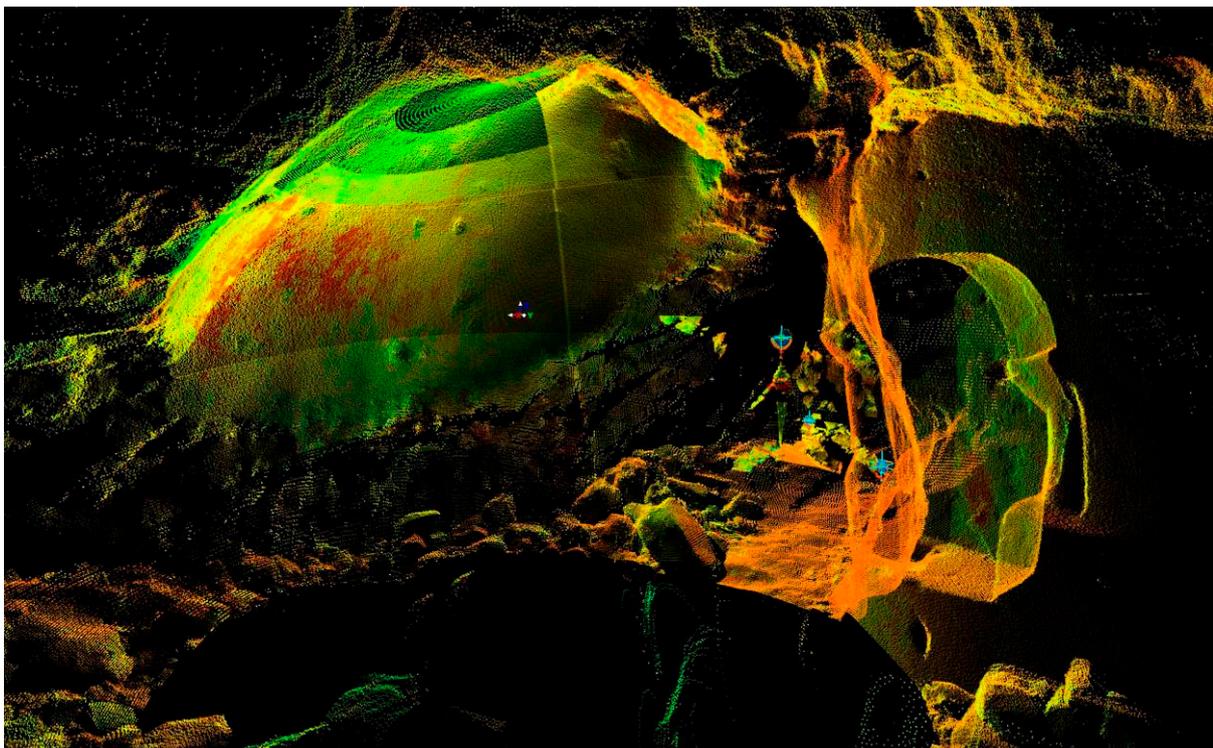
Figure 13. The 3D model of the biggest room close to the entrance: the altar is visible on the right while the ceiling with paintings is visible on the left.

The 3D cave model, derived from TLS, greatly improved the old cave plan with more accurate measurements of the length of the walkways, of the heights of the vaults, of the surfaces and of the relation with the ground level. The cave is not very deep and has close relations with the countryside above, as evidenced by the intense dripping and the presence of many roots, especially near the entrance. The rooms closest to the entrance are those richest in cultural evidence due to the presence of paintings, of the altar and of a lot of graffiti, and this is the area where the visitors stay longer to admire the heritage contained in the cave (Figure 13).
