Failure Mechanism of a Rainfall-Triggered Landslide in Clay Slopes

Abstract: In December 2013, a portion of a large and deep ancient landslide on the southern slope of the Montescaglioso town (Basilicata, Southern Italy) was abruptly reactivated, as a consequence of exceptional rainfall events, causing relevant damages to structures and infrastructures. The sliding surface is supposed to be located within a thick deposit of Pleistocene stiff clays overlain by dislocated blocks of calcarenites and cemented conglomerates. This paper discusses the research carried out to investigate the failure mechanism that occurred during the landslide event and the factors that controlled the reactivation. To this purpose, geological and geomorphological analyses were first proposed, followed by a back-analysis of the landslide process, performed via limit equilibrium calculations implementing time-dependent pore water pressure distributions derived from transient seepage finite element analyses. Furthermore, the overall landslide mechanism was investigated through a three-dimensional finite element analysis, built using the monitoring campaign carried out in the post-failure stage and calibrated

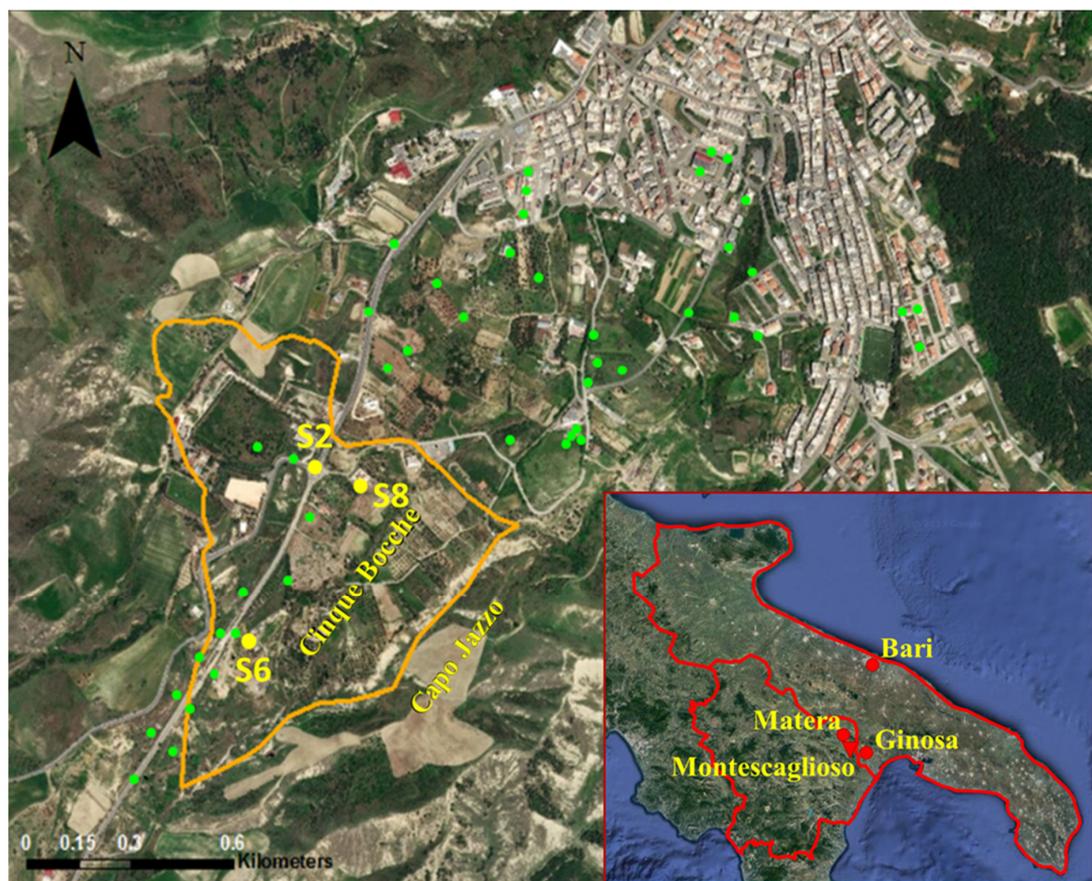
Figure 1. Aerial view of the Montescaglioso area (location in the inset) and its SW hillslope, with the landslide area in orange and locations of the Cinque Bocche and Capo Jazzo streams. In green are the locations of the boreholes performed throughout the area during several campaigns, and in yellow are the locations of the boreholes drilled after the landslide event and equipped with inclinometers (S2, S6, S8).

Between October 2013 and the beginning of December 2013, the area around the Montescaglioso town (Matera province, Southern Italy) (Figure 1) was hit by two severe rainfall events. The first (5–8 October, cumulative rainfall was 246 mm, and mean rainfall intensity was 3.6 mm/h) affected a large area between Apulia and Basilicata, causing several landslides and floods, four casualties, and huge economic damages. Two months later, another rainfall event (30 November–3 December, cumulative rainfall was 151.6 mm, and duration was 56 h), hit the same area and triggered a large earth-slide on December 3 along the southern hillslope of the town [11,14]. Taking into account the pluviometric regime of the area, characterized yearly by a value of 570 mm, this second event corresponds to 27% of the average annual rainfall and 81% of the maximum monthly rainfall.

The Montescaglioso village is located at the top of a hill, at about 350 m a.s.l., in the final reach of the Bradano river alluvial plain. The hill is bounded by steep slopes that are affected by the widespread development of landslides of different typologies, showing a variable state of [9,14,23], indicating that the area is highly prone to mass movements. The landslide area is located just below the urban area and the cemetery, between the Cinque Bocche and Fosso di Capo Jazzo streams (Figure 1).

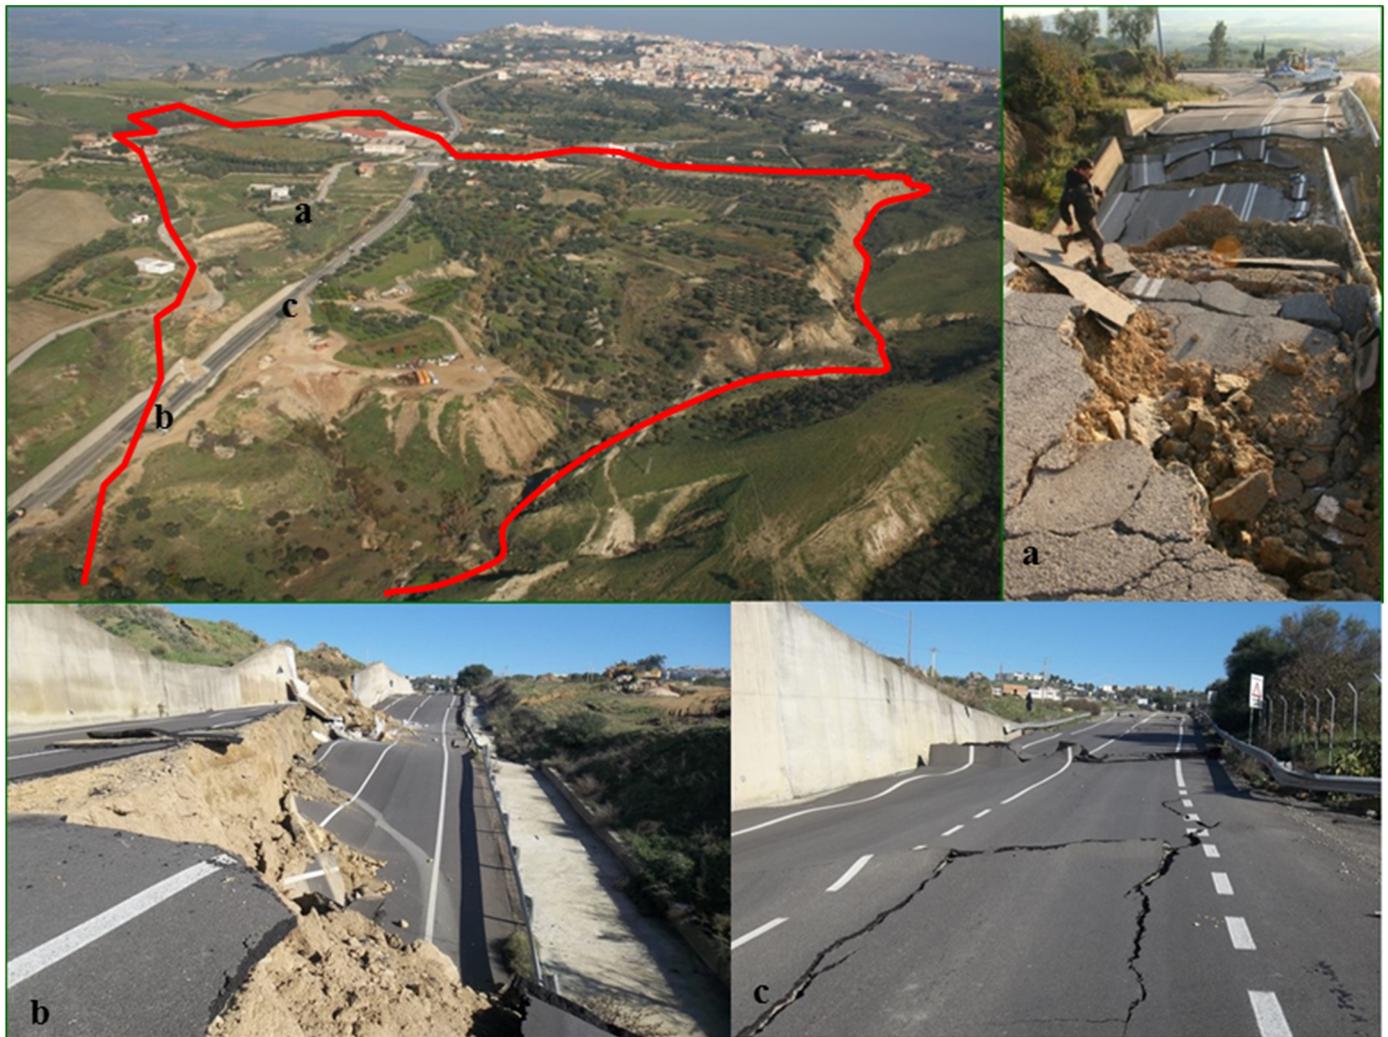
Figure 2. Aerial view of the landslide area and some of the most relevant damage to the infrastructures in the affected area. Labels (a, b, c) indicate the location of the pictures in the aerial view.

The landslide initiation and evolution were reconstructed based on the information collected from direct witnesses: it started at ca. 13.00 CET on 3 December, quickly exhausting its most intense phase and immediately causing the destruction of a 500 m stretch of the freeway connecting Montescaglioso to Province Road SP175 (Figure 2).

Later on, the movement involved the lower-left flank of the landslide, resulting in the formation of a swarm of scarps and counterscarps (Figure 2), several tens of meters in length, and creating a series of trenches with a maximum depth of seven to eight meters [11,23]. The whole surface of the landslide area (about $5 \times 10^5 \text{ m}^2$) directly affected some private houses and warehouses, which were subjected to rigid body translation for few meters downslope and tilting, while a grocery store located in the crown area collapsed (Figure 3). Luckily, no direct damage to people was recorded, despite the rapid activation of the landslide, since the evolution and the consequent deformation of the buildings were relatively slow, allowing the inhabitants to avoid fatal consequences.

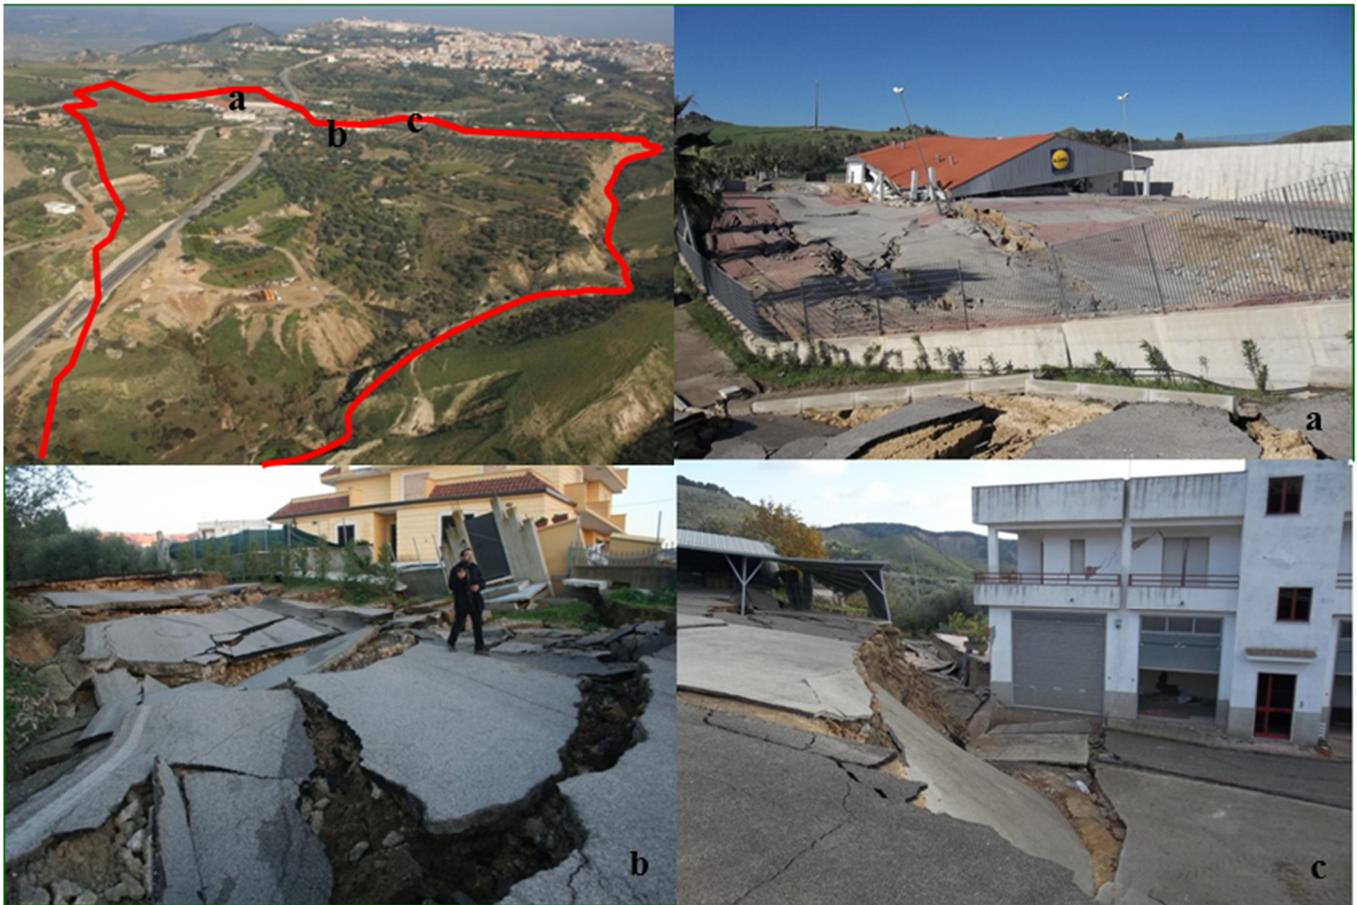
Figure 3. Aerial view of the landslide area and the main effects on buildings. Labels (a, b, c) indicate the location of the pictures in the aerial view.

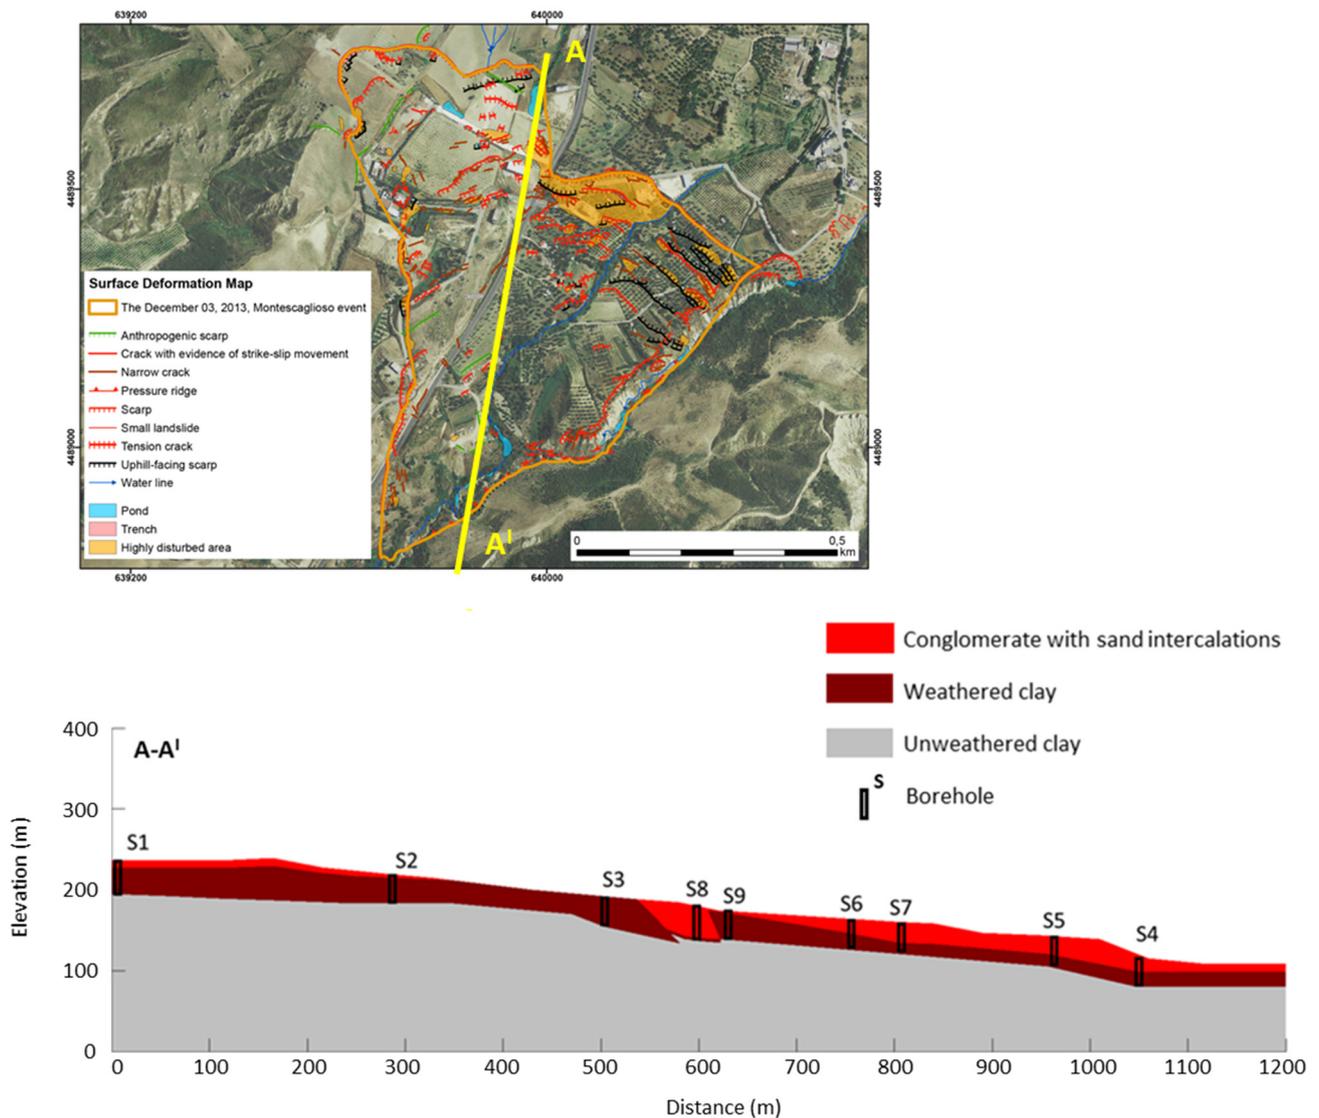
Figure 4. Geological longitudinal cross-section of the landslide area. In the sketch, the geomorphological map (modified from [11]) and the section trace are shown.

The geological setting is characterized by sediments of the Bradanic Trough, which represents the foredeep where the Apulian foreland subsidies under the Southern Apennines [15]. The Lower–Middle Pleistocene sediments [17,24] are represented by a regressive sequence, locally covered along the slope interested by the 2013 landslide by fluvial conglomerates. In detail, Sub-Apennine Clays crop out in the area, delimited at the top by the Montemarano sands and the Irsina conglomerates [25–30]. The overall sequence of clays, sands, and conglomerate crops out at the upper hillslope, while the clays are interbedded by sandy/arenaceous layers in the middle lower portion [23]. Along the slope, where erosion processes are widespread, chaotic large blocks related to ancient gravitational phenomena are common [15]. The general structural setting of the area is characterized by tectonic lineaments with NW-SE and SW-NE orientations, which play a fundamental role in the development of the fluvial network at the regional scale. Based on borehole stratigraphies, a geological longitudinal section was reconstructed (Figure 4), and a fault system was recognized in the crown area.

The stratigraphic scheme adopted for the calculation was assumed according to the geological longitudinal section shown in Figure 4. Figure 5 shows the finite element mesh adopted for the seepage analysis. The geometry of the sliding surface was assumed to be in accordance with in situ geomorphological evidence [11], as well as with borehole and inclinometer data. In particular, the assumed sliding surface delimits a roto-translational landslide body, with the scarp approximately at an elevation of 200 m a.s.l. and the depth of the failure surface increasing downslope (between 10 and 20 m from g.l. in the upper part of the landslide to 50 m depth just above the toe). The location of the landslide toe was assumed according to the geomorphological evidence. It turns out that most of the landslide surface (namely its middle and lower portions) involves the clay substratum, with only limited parts (in the scarp area and at the toe) passing through the conglomerates.

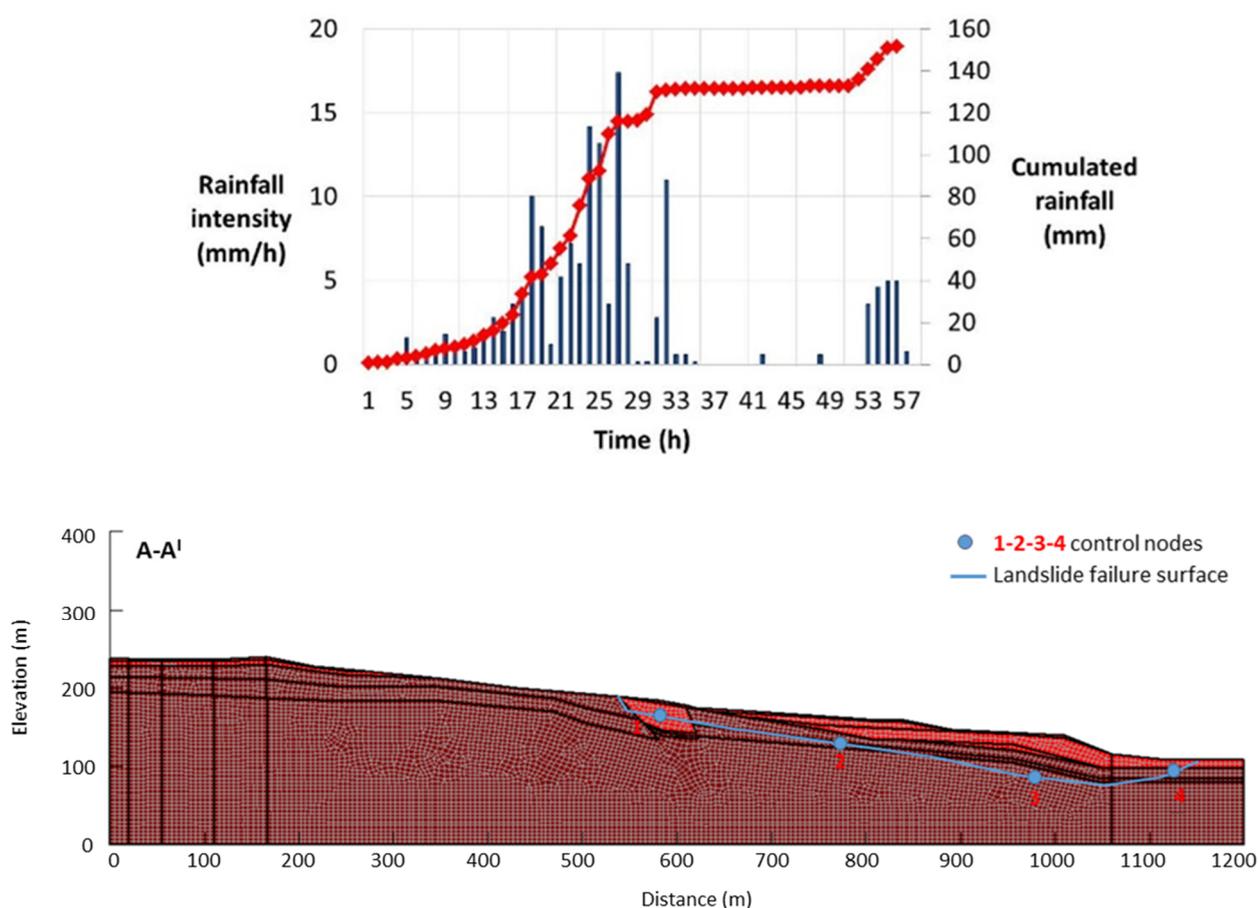
Figure 5. Above, the plot of the rainfall intensity with time during the event that triggered the 2013 Montescaglioso landslide. Below, the seepage domain adopted for the SEEP/W transient analysis: discretization mesh and boundary conditions. The failure surface of the landslide is also reported, along with the location of the control nodes (1–4) used to follow the variation of the pore water pressures with time (see text for further details).

In the seepage analysis, a slope steady-state groundwater regime, representative of the ordinary hydraulic conditions in the slope, consistent with a water table at depth of about 10 m from the ground surface (Figure 5), was assumed to be the initial pore water pressure

distribution. This is in accordance with the available well and open-pipe piezometer data. Then, a transient seepage analysis was simulated by assuming the event rainfall history as boundary condition along the slope surface, as shown in Figure 5. The permeability saturated coefficients of the different strata were prescribed according to the literature data available for the Sub-Apennine Clays [33,34]. In particular, the coefficient of permeability, k_{sat} , for the lower unweathered grey was assumed to be equal to 4×10^{-8} m/s, whereas it was set at equal to slightly larger values for the upper layers in order to account for the weathering effects and the higher sand component (Table 1). As concerns the partially saturated soils above the water table, a coefficient of permeability constant with suction was assumed for the upstream layers' soils, whereas a variation of the unsaturated coefficient of permeability with suction was taken into account for the other layers. For the latter, the variation of the volumetric water content with suction (soil–water characteristic curve) was estimated based on the grain size curve, according to the method suggested by Arya and Paris [38]; the law of variation of the unsaturated hydraulic conductivity with respect to suction was defined following Green and Corey [39].

An impervious boundary was assigned at the bottom of the mesh, whereas the actual rainfall intensity of the event, as reported in the sketch in Figure 5, was prescribed along the slope profile. A constant total head was assumed along both right and left boundaries of the seepage domain: in particular, at the right boundary, the value of the hydraulic head was set equal to the elevation of the water course at the toe of the slope, whereas it was imposed at 15 m depth below the ground level along the left boundary to comply with in situ measurements.

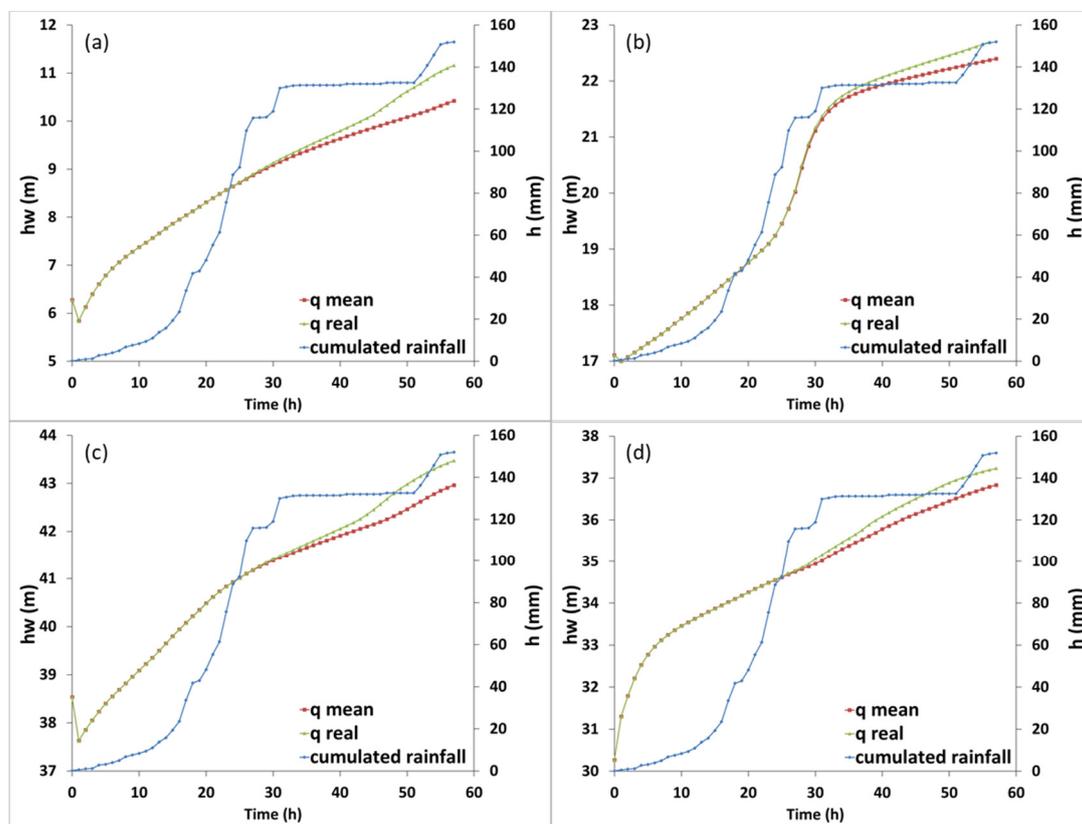
Figure 6. Variation with time of the cumulated rainfall and pore water pressure resulting from the seepage analysis for Nodes 1 (a), 2 (b), 3 (c), and 4 (d). Node locations are shown in Figure 5.

The results of the transient seepage analysis are reported in Figure 6 in terms of the variations of piezometric head calculated against time for four nodes of the mesh along the sliding surface (see points 1–4 in Figure 5), along with the variation of the cumulated rainfall with time.

The plots show that, in the first stage of rainfall infiltration (the first ten hours), the piezometric head values in the shallower nodes located within the conglomerates (Nos. 1 and 4) increase with rates higher than the nodes located at depth in the clay substratum (Nos. 2 and 3). Later on, Nodes 1 and 4 tend toward a steady increase of piezometric heads, whereas Node 2 is characterized by a larger increase of piezometric heads as an effect of the significant rainfall height cumulated during the 15–30 h time interval. The effect of such strong rainfall intensity in this latter time interval is also observed for all nodes in terms of a slightly delayed increase of piezometric heads calculated in the following hours. The overall variations of piezometric heads are in the order of 5–7 m, reaching the maximum value of 7 m at the toe of the slope (Node 4). In the same plots, the curves of piezometric heads obtained by assuming a constant average intensity for the whole rainfall time duration are reported for comparison. A slight difference is observed only in the last stage of the rainfall term.

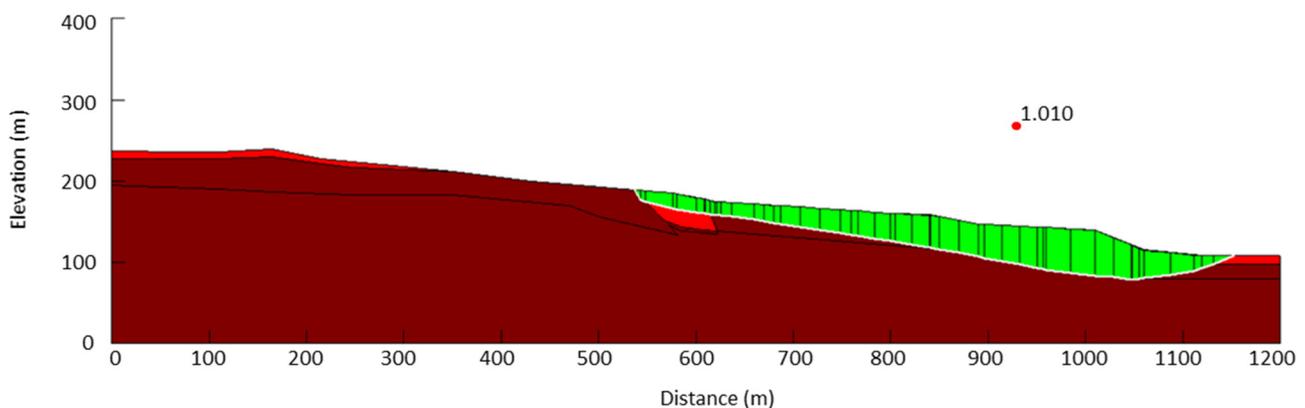
Figure 7. Safety factor obtained in the LE analysis after 56 h from the beginning of the rainfall event.

The pore water pressure distributions obtained from the transient seepage analyses were then implemented in a time-dependent limit equilibrium analysis to assess the variation of the stability conditions of the landslide body during the event (Figure 7).

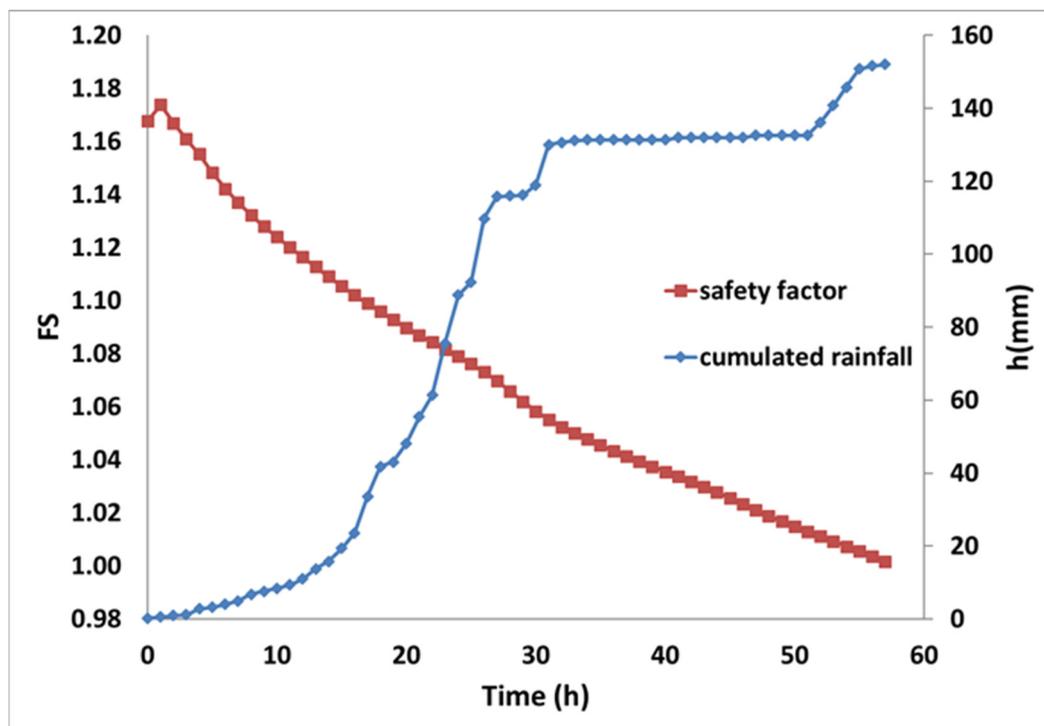
Figure 8. Variation of the safety factor for the assumed landslide body, along with the cumulated rainfall data recorded during the event.

These results can provide a reasonable explanation for the landslide triggering, taking into account the permeability values for the soil materials assumed in the seepage analysis. Therefore, in this study, no effect of preferential seepage flows, water filling of tension cracks, or rear scarps in the crown area, as well as the potential effect of the rupture of the pipeline passing across the landslide body, was accounted for.

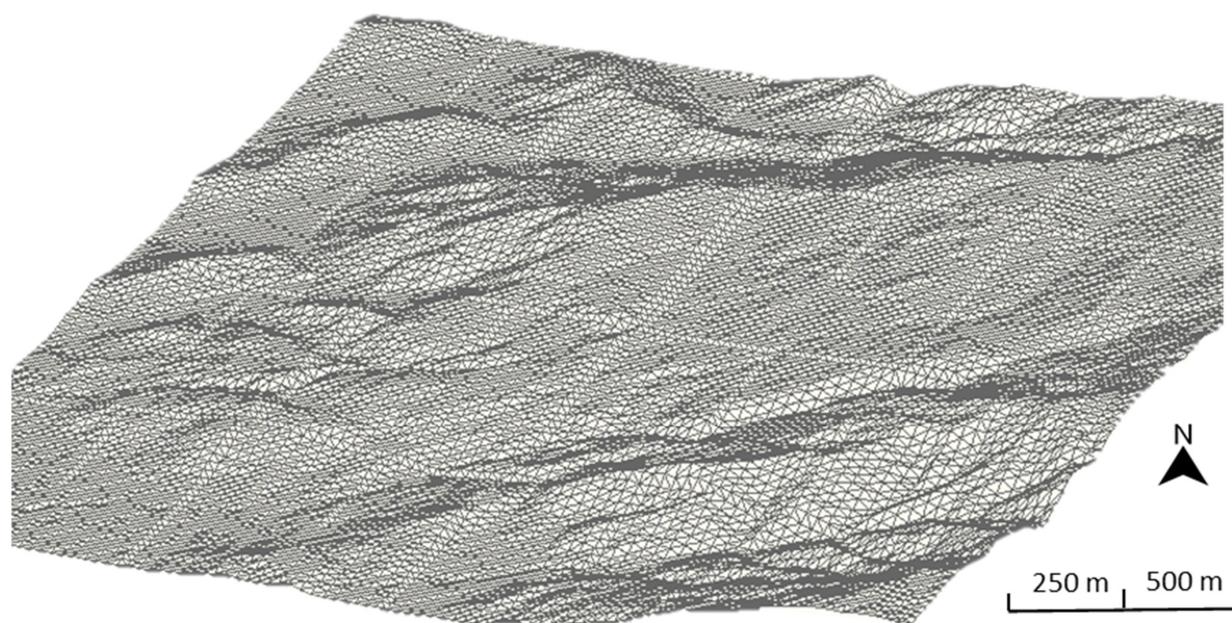
**Figure 9.** DEM adopted for the construction of the 3D FEM model.

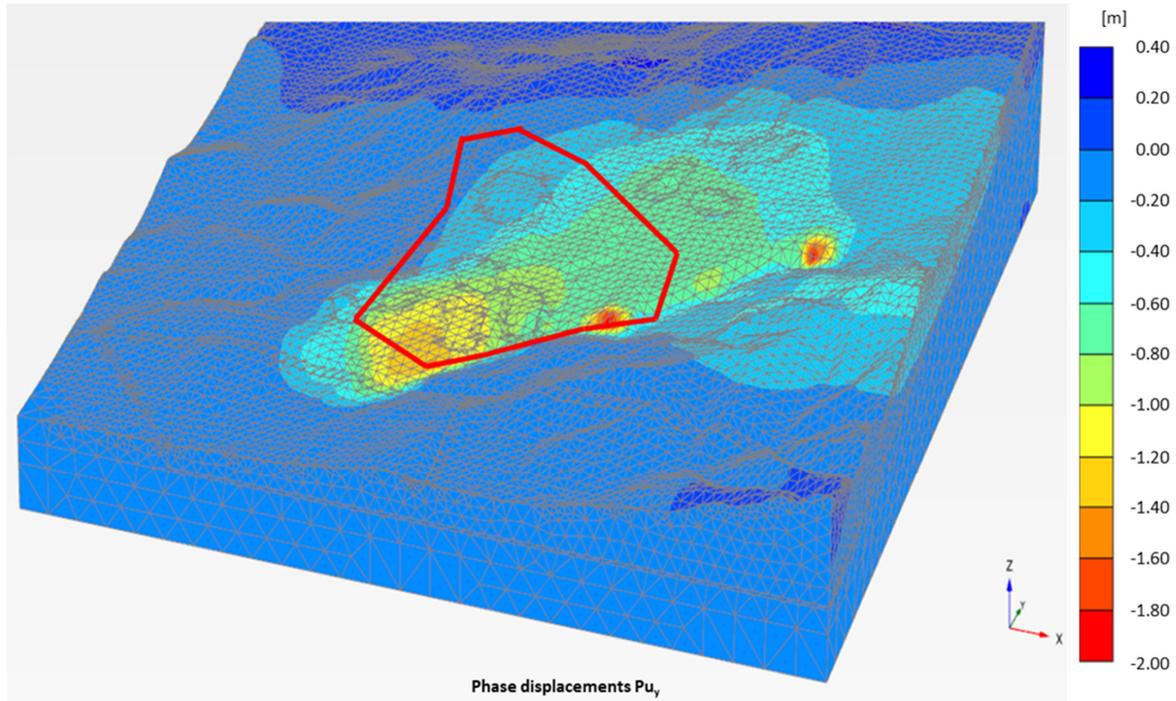
Figure 10. Y-direction displacement contours.

displacement field is shown in Figure 10 in terms of the contours of horizontal displacement component along the y-axis and indicates that the largest horizontal displacement components are oriented along the y-axis and concentrate in the lower portion of the slope (orange and yellow zones), with values progressively lower in the upper slope.

This is in good agreement with the observed in situ failure mechanism and, in particular, with the direction of the larger horizontal displacement (N–S direction), as well as with the retrogressive evolution of the landslide process, as reconstructed by means of remote sensing and interferometry techniques [13–17,23]. Figure 11 reports the in situ vertical and horizontal displacement maps to highlight one of the aforementioned displacement fields, as reconstructed by Amanti et al. [23].

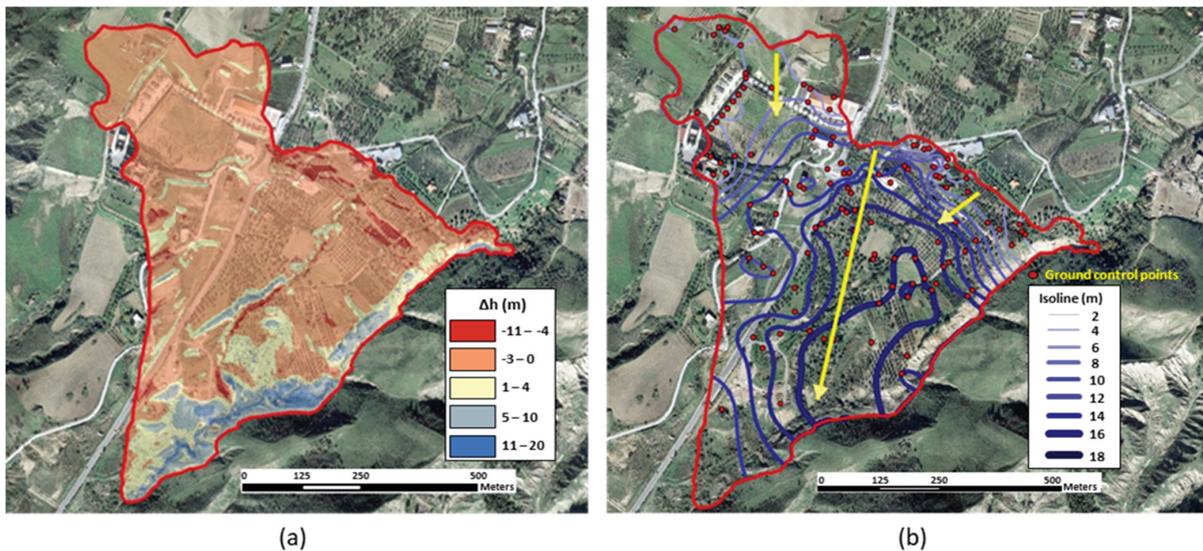
Figure 11. (a) Vertical and (b) horizontal displacement maps reconstructed by comparing pre- and post-event orthophoto and LIDAR surveys (modified from [23]).

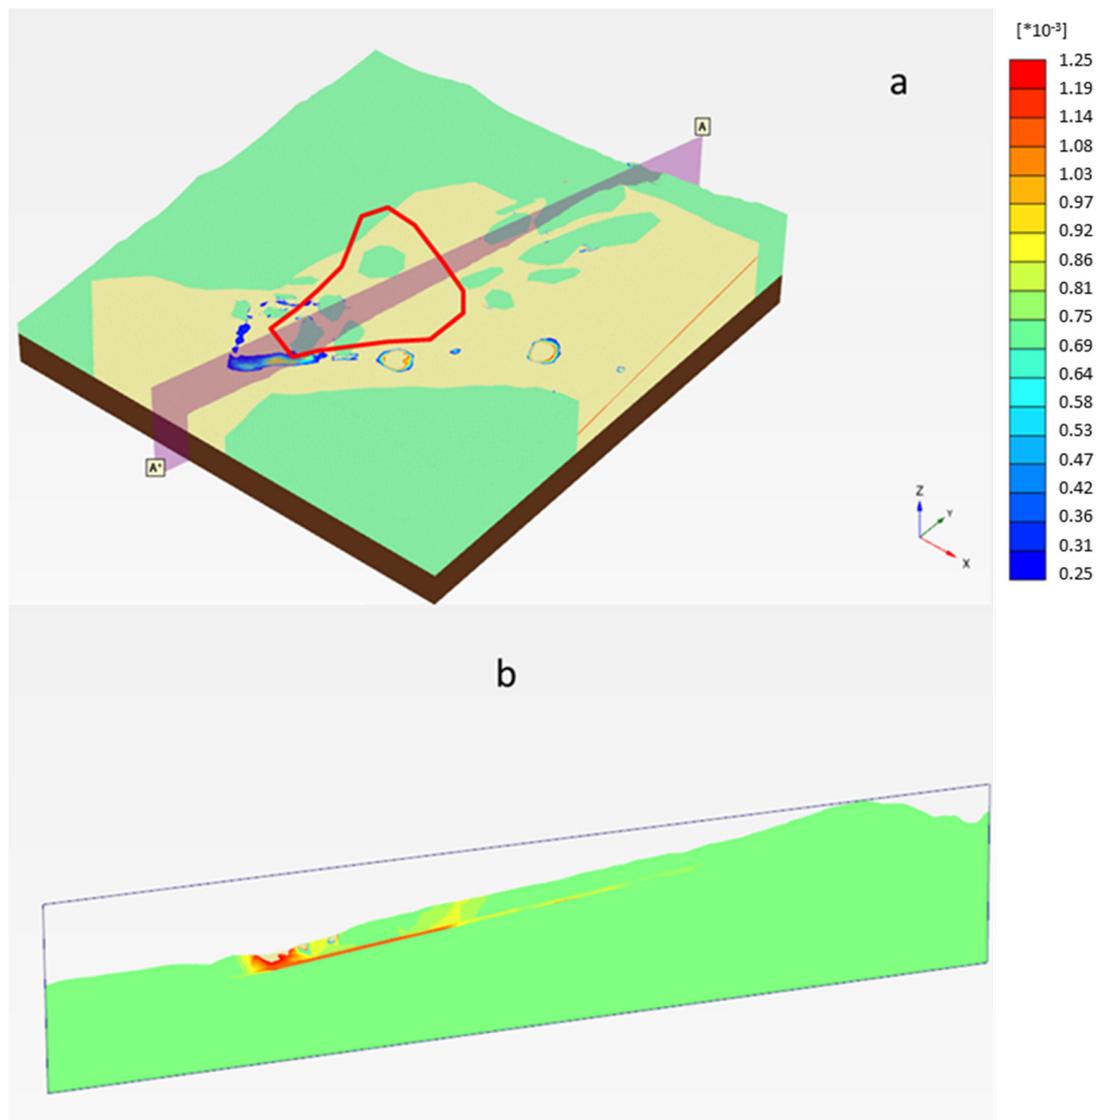
Figure 12. Contours of the deviatoric strains calculated (a) and the cross-section of the landslide area (b).

Actually, a significant uplift of the stream bed was measured in situ after the landslide reactivation, along with settlements of the ground surface in the uppermost sectors of the landslide area [14,15,17,23]. A longitudinal section of the deviatoric strain activated at failure can be seen in Figure 12. This shear straining is concentrated along the pre-imposed shear band and connects with the toe of the slope and the landslide crown through new shear zones, crossing areas not affected by previous straining.

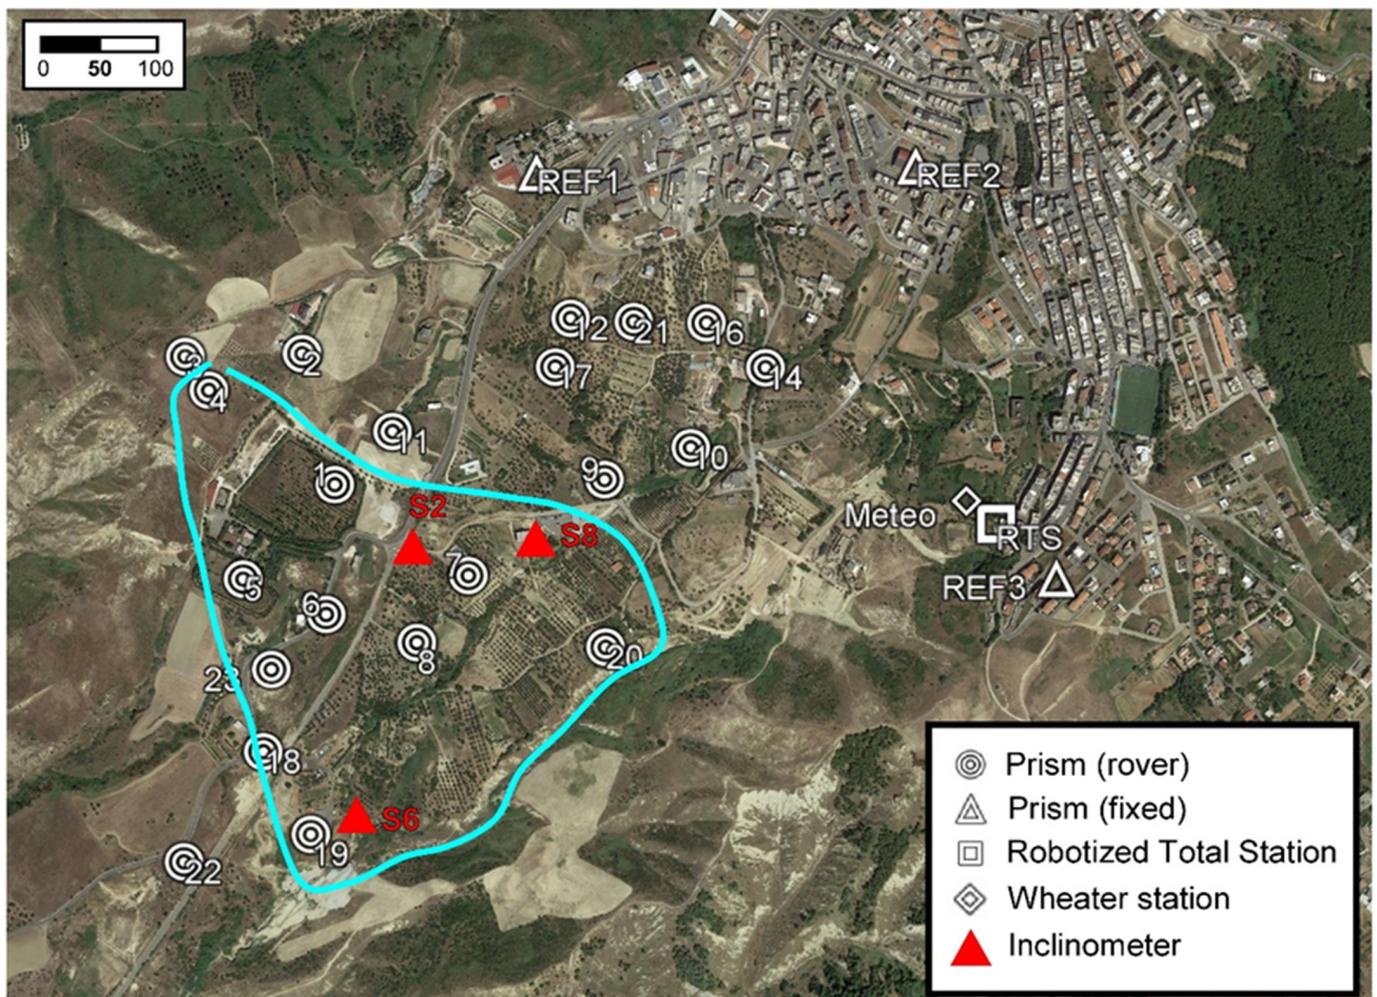
Figure 13. Aerial view of the landslide area with the location of the topographic targets (white circles 1–23), the Robotized Total Station (RTS white square), and the inclinometers (S2, S6, S8 red triangles). The landslide limit is shown in the pale blue color. The fixed point is shown with white triangles (REF1, REF2, and REF3).

A topographic network consisting of a Robotized Total Station (RTS) and optical targets was installed to monitor the area of interest in the 2013 landslide, as well as to identify urban areas potentially affected by retrogressive landslide activities (Figure 13).

The RTS was set on a private terrace southeast of the town, with a view over the whole landslide and the lower part of Montescaglioso. In order to ensure the maximum measurement effectiveness, three fixed points (REF1, REF2, and REF3) were also installed in stable areas (cemetery, municipal auditorium, and sector behind the total station), so that accuracy of 1 cm in the planimetric and altimetric components was reached. The measured cumulated displacements are close to zero throughout the monitored area, even in the portion where large displacements occurred in 2013 (Figures 13 and 14).

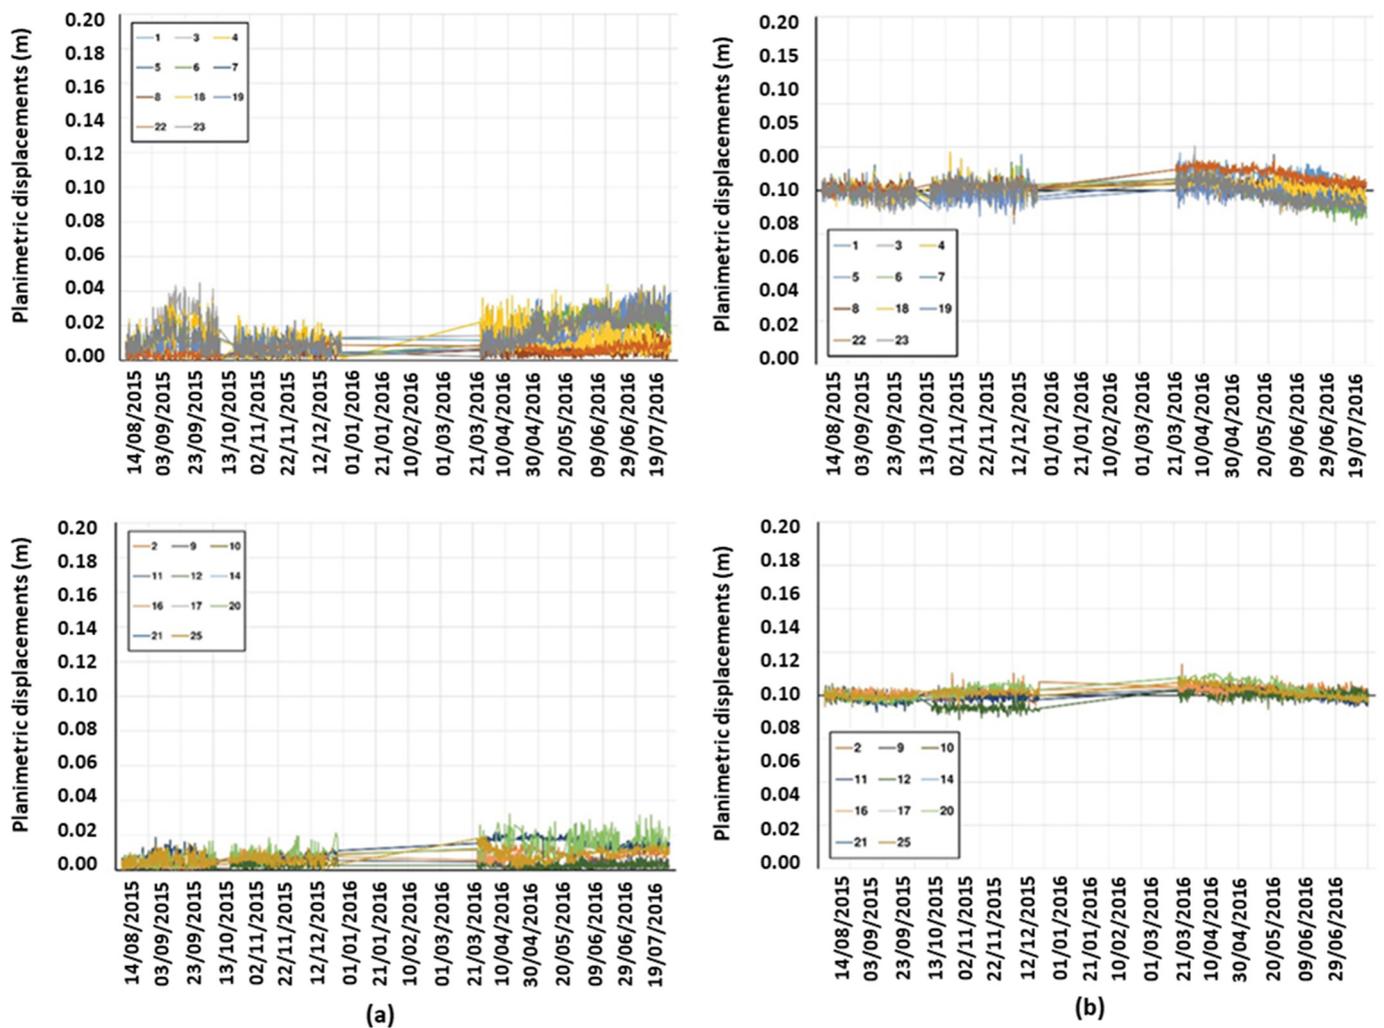
Figure 14. Post-failure RTS displacement monitoring data for the landslide area (upper graphs) and the upslope area (lower graphs): (a) horizontal component and (b) vertical component.

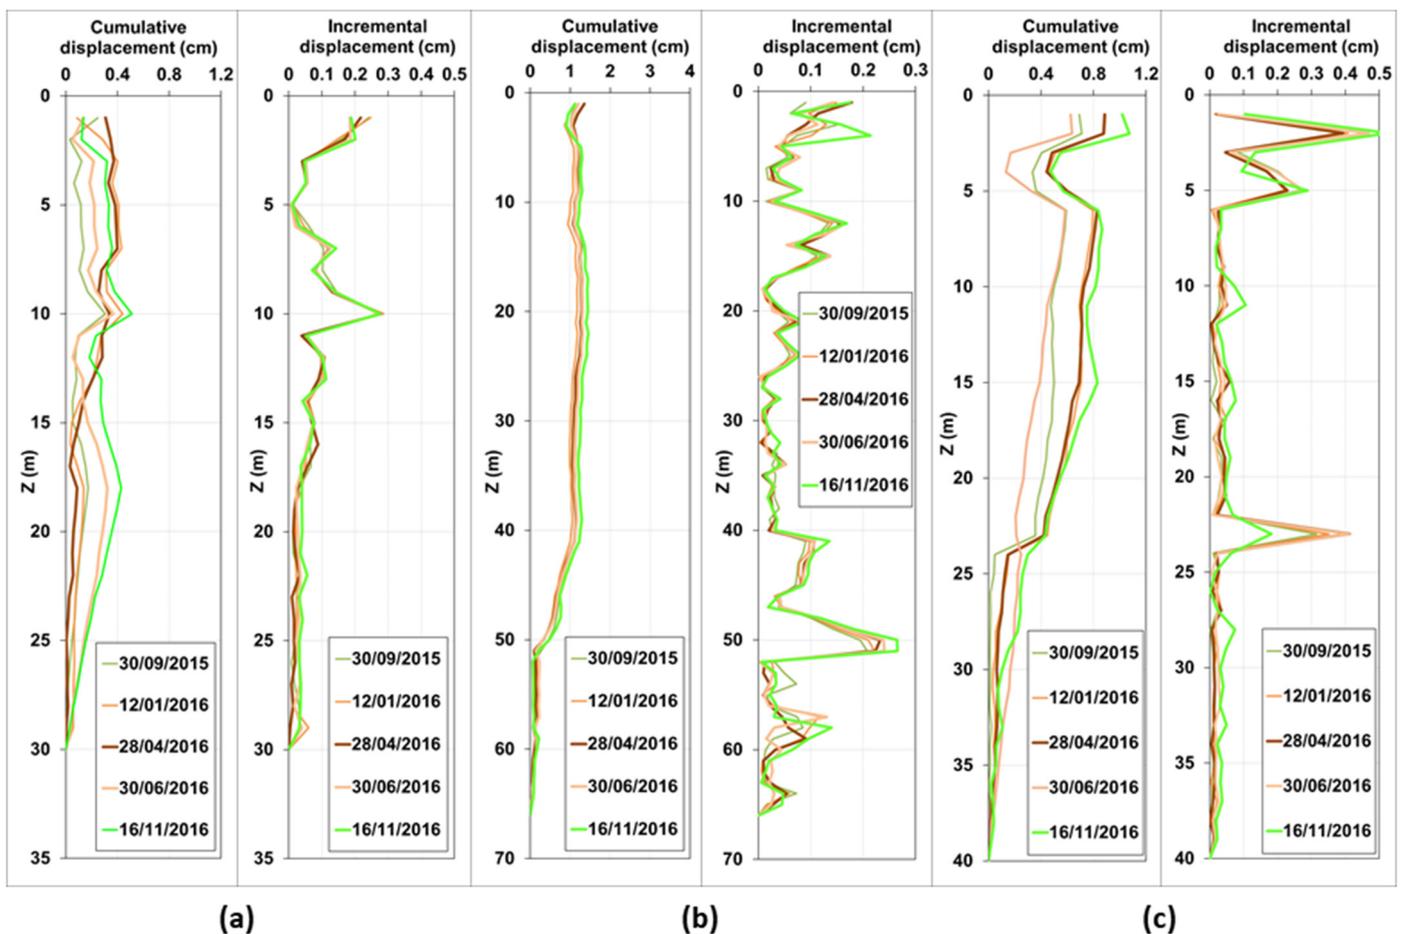
Figure 15. Post-failure inclinometer profiles for three boreholes in the landslide area: (a) S2, (b) S6, and (c) S8 (see Figures 1, 4 and 13 for location).

A post-failure inclinometer monitoring was also carried out within S2, S6, and S8 boreholes (Figure 1). The readings (Figure 15) indicate cumulated displacements that are generally below the accuracy level recognized for such instruments, also with a trend that does not suggest an evolution towards instability. Nonetheless, the inclinometer profiles show some clear bending at specific depths (51 m at S6, and 23 m at S8) that could correspond to the depth of the weakness zone or the shear band.
