Historical Monitoring of Shoreline Changes in the Cua Dai Estuary, Central Vietnam Using Multi-Temporal Remote Sensing Data

Abstract: Cua Dai is one of the major estuarine areas in Central Vietnam that plays a significant role in local maritime transport, fisheries, and tourism activities. This paper presents a study that monitored the shoreline dynamics of the Cua Dai estuary over a period of 50 years (1964–2014) by using field survey data, geographic information systems techniques, and multi-temporal satellite remote sensing images (ALOS-AVNIR2 and Landsat imageries). The assessment of shoreline changes was divided into three phases: 1964–1980, 1981–2000, and 2001–2014. The results revealed that over the last 50 years, shoreline changes dramatically occurred between 1964 and 1980. The general trends of erosion and accretion at the Cua Dai estuary show that the river mouth moved towards the south due to the erosion of shorelines in the north and the river bank in the south of the Cua Dai estuary. The study outcomes can provide essential information for planning, zoning, and sustainable development activities of the coastal zones in the context of climate change.

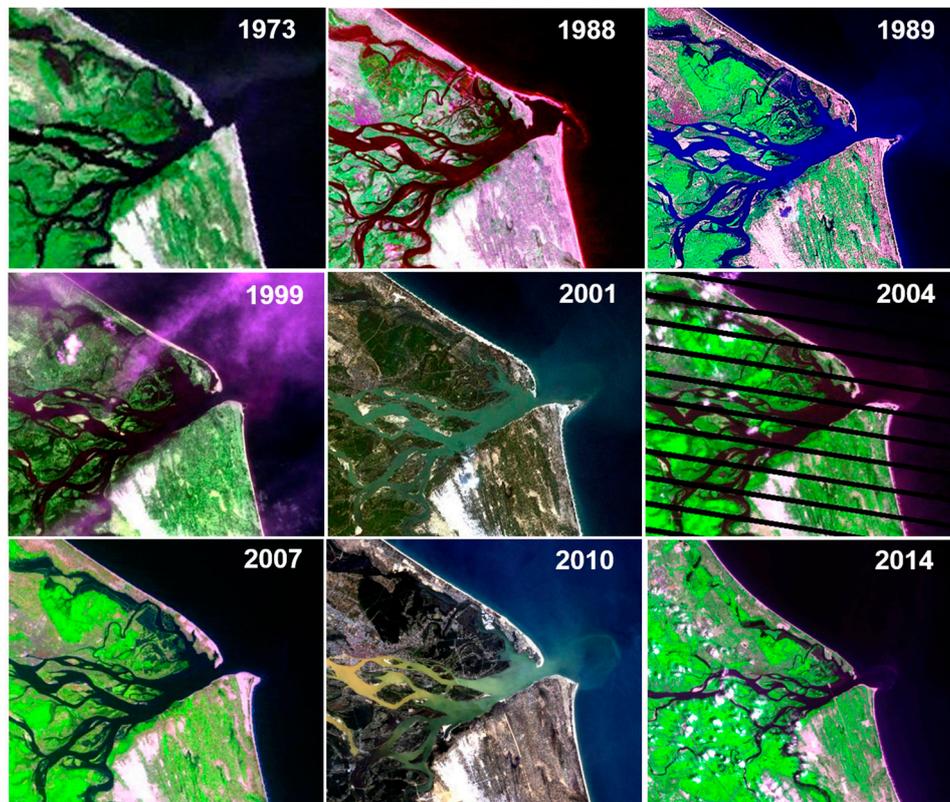
Figure 2. Characteristics of the Cua Dai estuary morphology from multi-temporal and spatial satellite images in the selected years.

The temporal remote sensing satellite data including Landsat TM 5, Landsat 7 ETM+, Landsat 8 OLI and ALOS-AVNIR 2 have been employed for shoreline change assessment. The detailed information for the satellite images is presented in Table 1. The characteristics of the Cua Dai estuary morphology from multi-temporal and spatial satellite images in the selected years are illustrated in Figure 2.

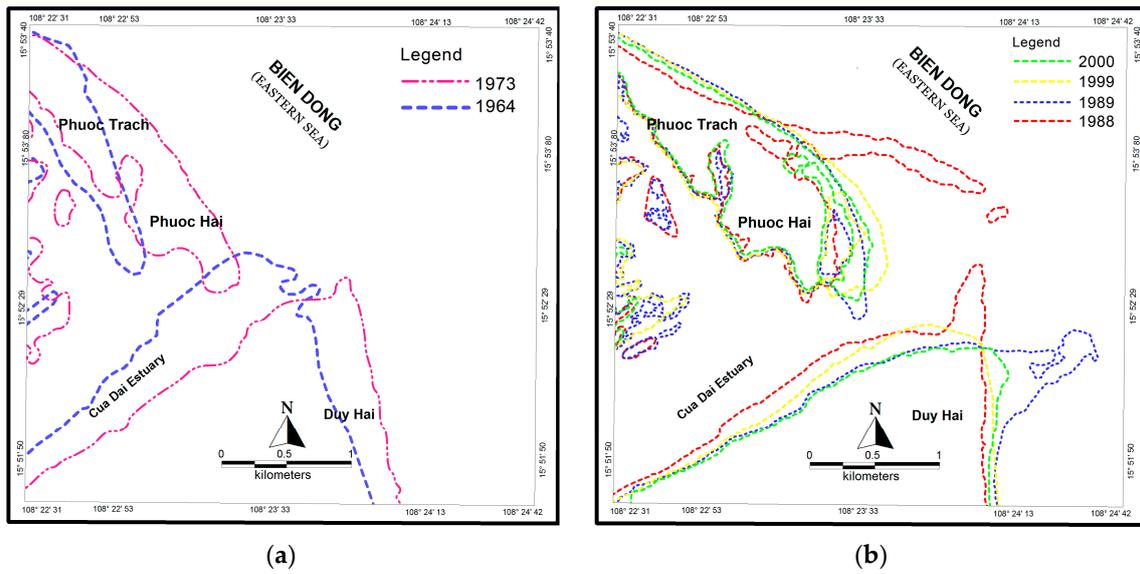
Figure 3. The historical shoreline morphological changes of the Cua Dai estuary (a) between 1964 and 1973; and (b) between 1988 and 2000 are shown in different line patterns and colors.

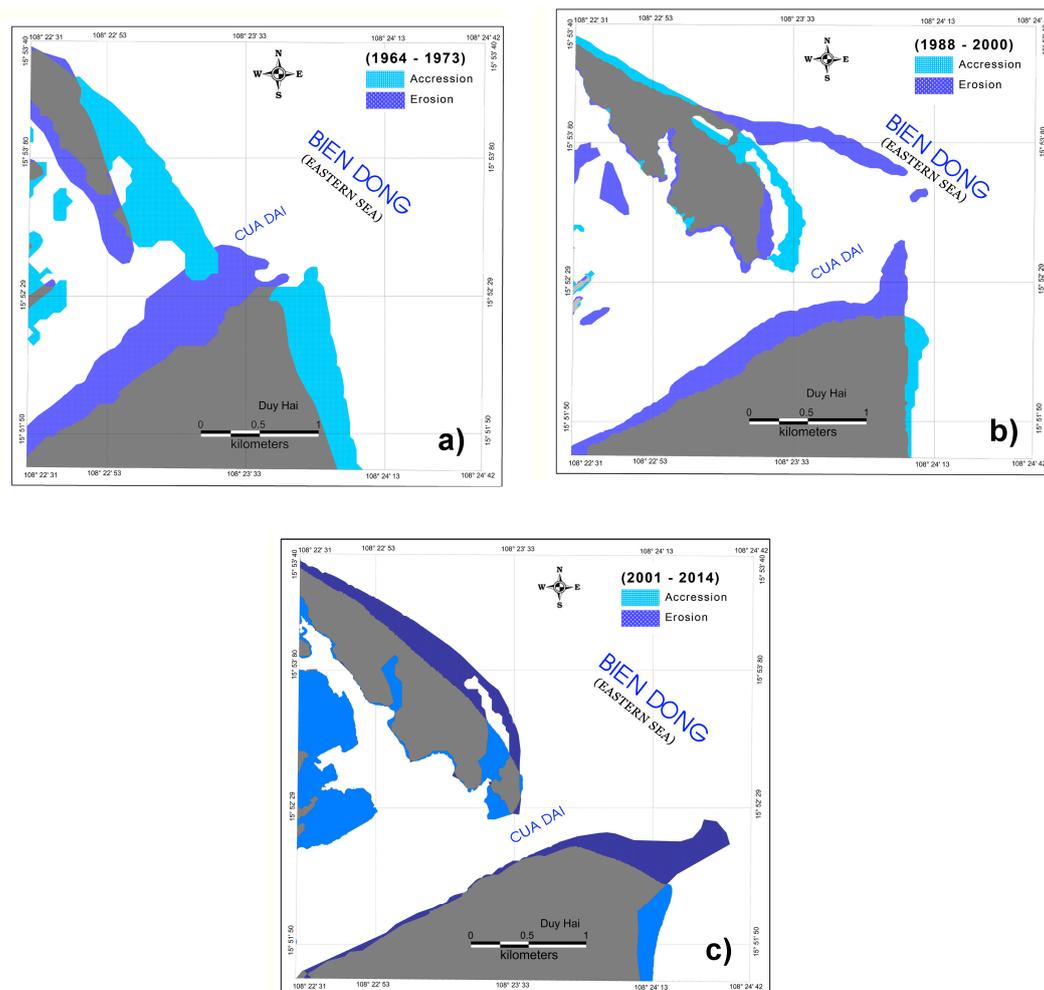
Figure 4. The post-class change detection during the periods of (a) 1964–1973; (b) 1988–2000; and (c) 2001–2014 in the Cua Dai estuary.

In the south of the Cua Dai estuary, the shift from the northern river mouth to the southern side was relatively large. On the south bank of the Cua Dai estuary, the shoreline increased by 250 to 390 m in 1973 compared with the 1965 shorelines. The largest position in the seaside shifted by about 510 m (Figure 3a). Meanwhile, the banks of the adjacent shoreline areas in the Duy Hai commune accreted and shifted the Cua Dai toward the beach side. The shoreline area bordering the Bien Dong (Eastern Sea) extended in 1973 to approximately 290–370 m, as compared to the shoreline in 1964 (Figure 4a).

From 1988 to 2000, the sand bar established in 1988 in the north of the Cua Dai estuary had been removed, and a newly formed peninsula was found on the eastern side. There were no significant changes in estuary morphology during this period. In 1988, the early moon-like shape had eroded; and accretion occurred inside the estuary. In the southern side of the Cua Dai, the movement of the estuary showed definite erosion at the riverside (in the northwest direction) of approximately 220 to 240 m, which enlarged the estuary area by about 520 m. The accretion occurred on the eastern side of the estuary towards the Bien Dong Sea, with a length of between 90 and 110 m, and up to 210 m in some areas (Figure 4b).

In the southern side of the Cua Dai estuary, the movements of the estuary and shoreline were different when compared with the previous periods. For instance, the greatest erosion occurred on the northeast shoreline, while accretion happened mainly on the eastern shoreline. Between 2001 and 2002, the southern side of the Cua Dai cape had about 430–480 m of land eroded. The accretion trend was similar to that of the previous phases, with accretion continuously occurring on the eastern side of the estuary, which formed a large sand bar. During the period from 2001 to 2010, this area accreted approximately 170–210 m (Figure 4c).

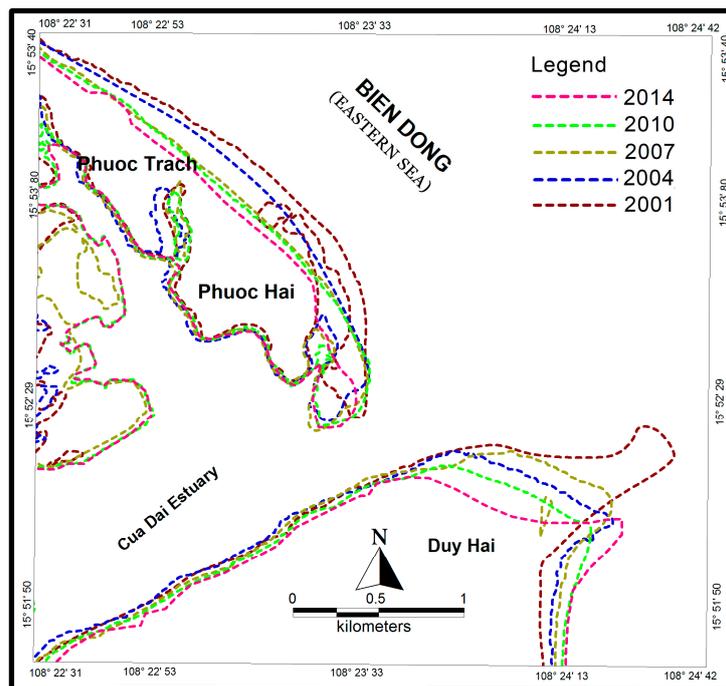
Figure 5. The historical shoreline morphological changes of the Cua Dai estuary between 2001 and 2014.

The analysis results revealed that the shoreline experienced significant fluctuation during the 13 years of this phase. However, the Cua Dai estuary had little movement in the southern direction in comparison with the periods of 1964–1980 and 1981–2000. The movement of the shoreline on the eastern side encountered a significant fluctuation during this period. In the northern side of the estuary, the submerged early moon-like shape eroded. The erosion at the seaside tended to move into the landside, resulting in the loss of the land area in the north of the Cua Dai peninsula (Figure 5).

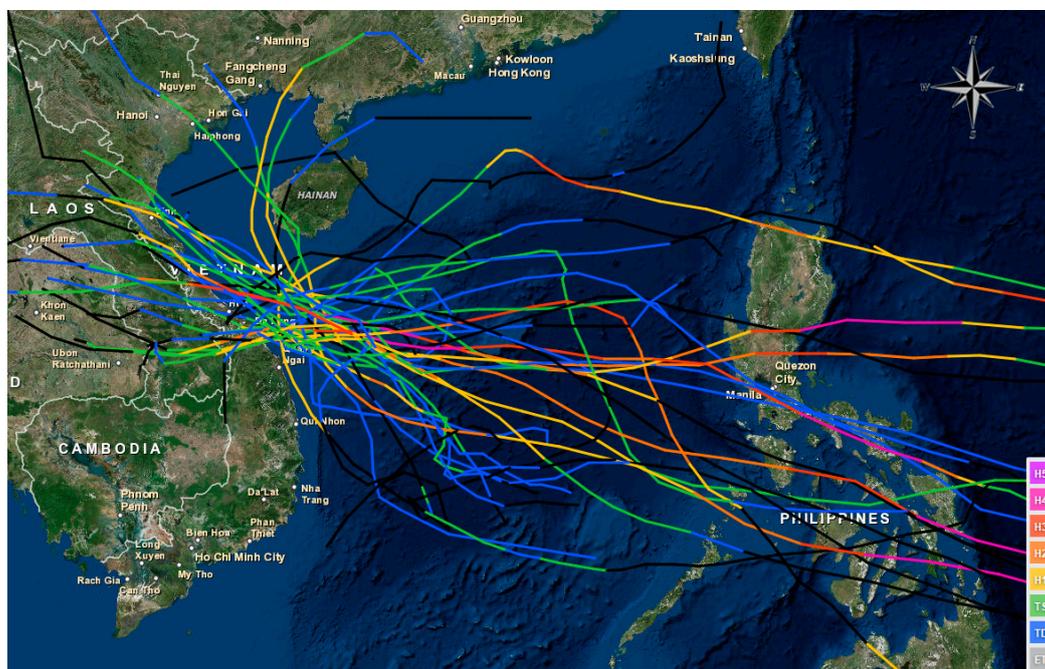
Figure 6. Historical typhoon tracked off the Cua Dai estuary, Central Vietnam during the period from 1964 to 2013 (Imagery source <http://coast.noaa.gov/hurricanes/>).

Besides the effect of typhoons, the movement of water levels also affects this area. The vulnerability of the shoreline is steadily increasing, and could be considered one of the main causes of shoreline erosion. The rising sea levels due to the monsoon usually occur along the central coast in general, and particularly along the Quang Nam coast. The sea level rise during the monsoon is usually about 30–40 cm high, but often exists for an extended period, usually one week or longer. According to the historical data, around two to four tropical storms annually hit the mainland in the coastal areas of Quang Nam. Storm tracking data from 1964 to 2014 showed 35 typhoons, and tropical depressions made shoreline changes and landfall on the coast from Thua Thien Hue to Quang Nam [26]. The deadly typhoon Xangsane hit Da Nang on October 1, 2006, with strong winds at the 12–14 level in the Quang Nam province. At the Ai Nghia (Dai Loc) hydrological station ($15^{\circ}53' \text{ N}$ – $108^{\circ}07' \text{ E}$) on the Ai Nghia River, the flood peak reached 10.77 m; and the Giao Thuy River's flood peak was 9.75 m, higher than those in 1999 and 2007. Over the course of the history of the Hoi An River, the water level once rose over 3 m, approximately 1.3 m above the third alert level (Figure 6).

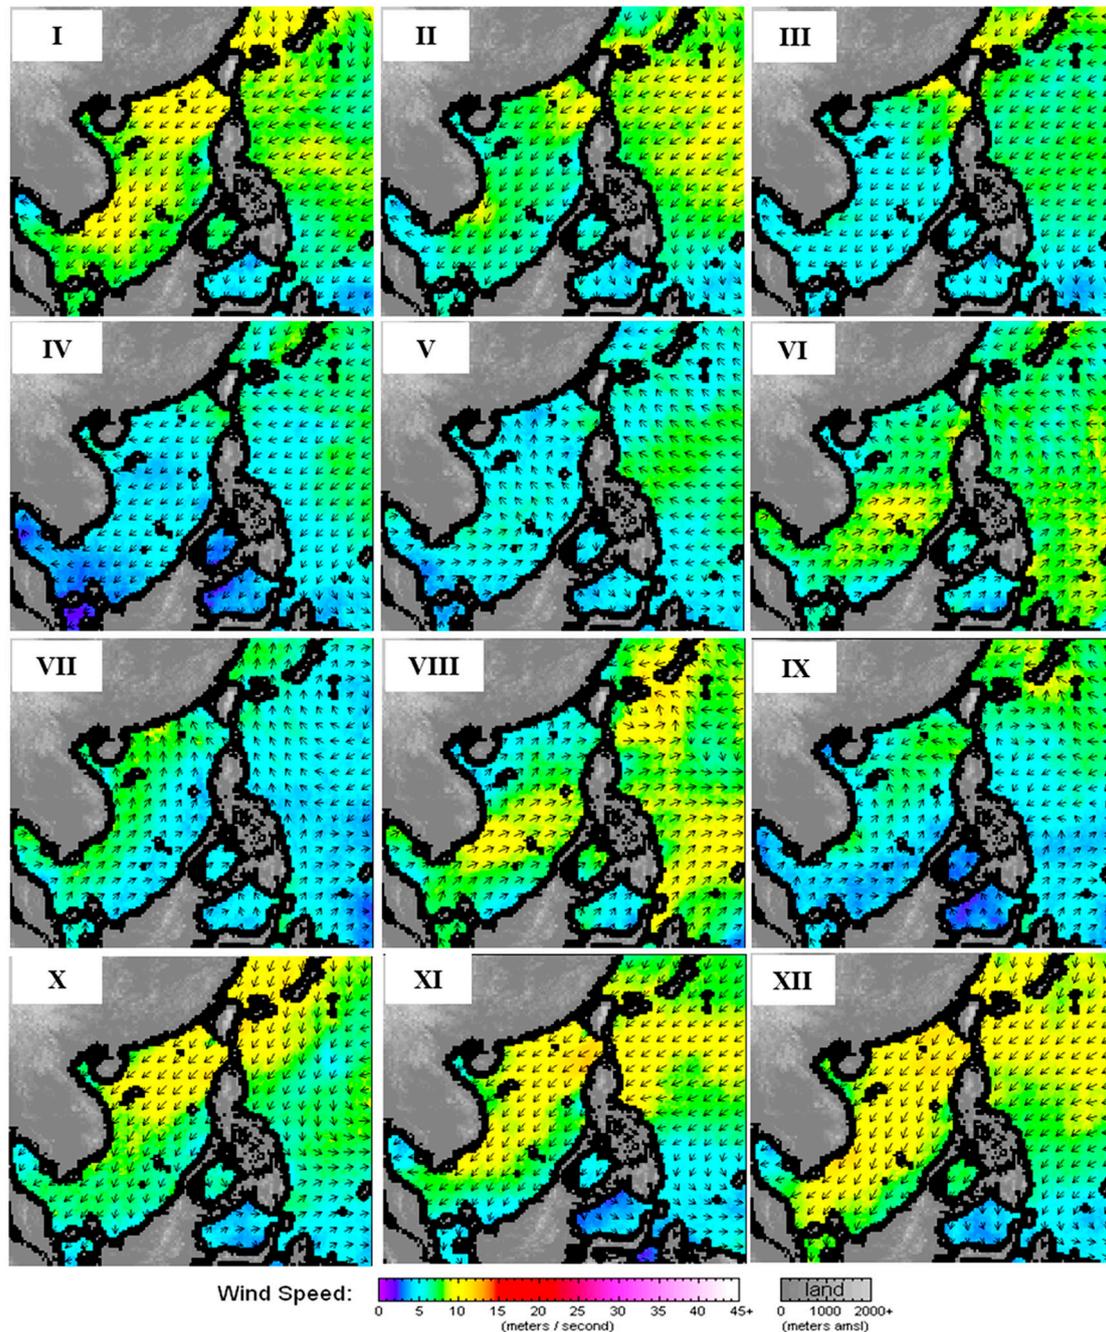
Figure 7. Typical average annual wind speed in 2004 of the Southeast Asian Sea, including Bien Dong, in relation to the Central Vietnam shoreline (Image source <http://poet.jpl.nasa.gov>).

year. The monthly distribution of wind speed is typically represented in Figure 7 for 2004. In response to the monsoon wind forcing, the currents along Central Vietnam's coasts generally move northward in the dry season, and southward in the rainy season [27].
