# Morphostructural, Meteorological and Seismic Factors Controlling Landslides in Weak Rocks: The Case Studies of Castelnuovo and Ponzano (North East Abruzzo, Central Italy)

**Abstract:** We investigated the role of the morphostructural setting and seismic and meteorological factors in the development of landslides in the piedmont of the Abruzzo Apennines. In February 2017, following a heavy snow precipitation event and a moderate seismic sequence (at the end of the Central Italy 2016–2017 seismic crisis), several landslides affected the NE-Abruzzo chain and piedmont area. This work is focused on the Ponzano landslide (Civitella del Tronto, Teramo) and the Castelnuovo landslide (Campoli, Teramo) in the NE Abruzzo hilly piedmont. These landslides consist of: (1) a large translational slide-complex landslide, affecting the Miocene–Pliocene sandstone clay bedrock sequence of the piedmont hilly sector; and (2) a complex (topple/fall-slide) landslide, which occurred along a high and steep scarp on conglomerate rocks pertaining to terraced alluvial fan deposits of the Pleistocene superficial deposits. Both of the landslides are typical of the Abruzzo hilly piedmont and both of them large

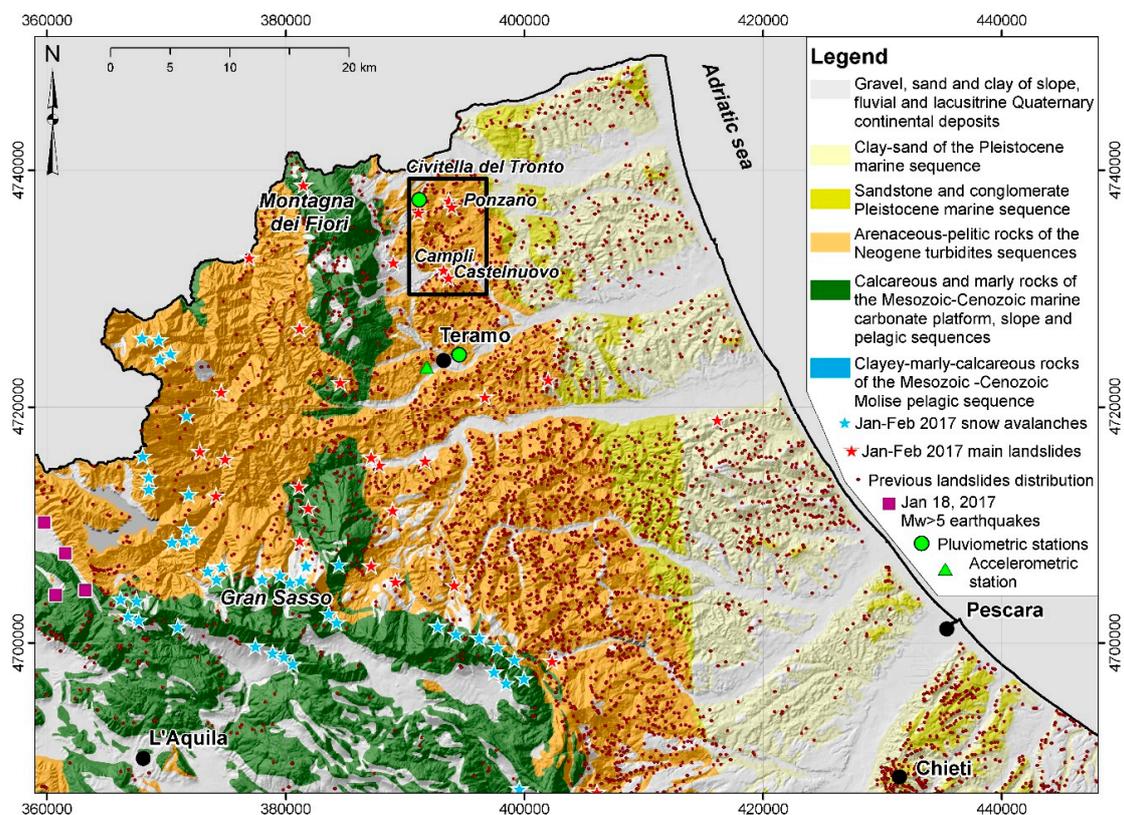
**Figure 2.** Lithological scheme of the NE-Abruzzo region and distribution of the main landslides. The study area is in the black box. Previous landslides derived from IFFI Project [26]; January–February 2017 avalanches and landslides provided by Protezione Civile Abruzzo Region and from local chronicles and field survey.

The bedrock consists of a sequence of marine pelitic-arenaceous rocks (Upper Miocene–Lower Pliocene) arranged in a fold and thrust setting, affected by regional NNW-SSE oriented Pliocene thrusts and high-angle normal faults, which are still connected to active moderate seismicity. It is overlain by a sequence of marine clayey-sandy-conglomeratic rocks (Upper Pliocene–Lower Pleistocene) in a gently NE-dipping homoclinal setting. Patches of travertine deposits and entrenched fluvial and alluvial fan

deposits, as well as slope, colluvial and landslide superficial deposits (Middle Pleistocene–Holocene) extensively cover the bedrock [25,50–55] (Figure 2).

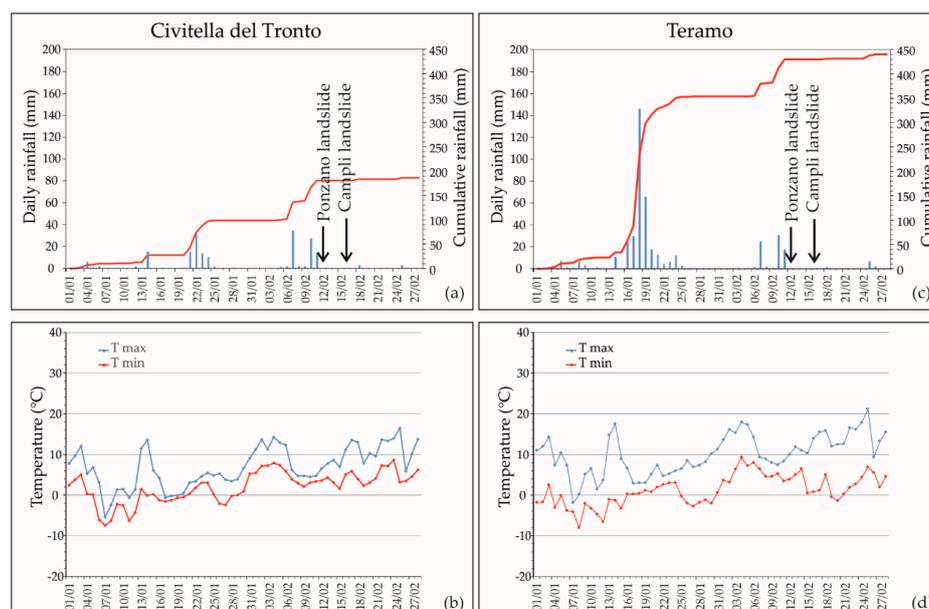
**Figure 3.** Daily rainfall–temperature diagrams for Civitella del Tronto (a,b) and Teramo (c,d) meteorological stations (location in Figure 2).

In the first months of 2017, Abruzzo was affected by intense snowfall and rainfall. In January 2017, cold currents from the Balkans caused an abrupt decrease in temperature (Figure 3), causing up to 2–3 m of snow cover from the main eastern Abruzzo ridges down to the coastal areas (1–1.5 m in the hilly piedmont).

This induced major damage, civil protection issues (road blockage, large blackout, telephone line failures, aqueduct failures, etc.) and even casualties [17,18]. Temperature and rainfall data for January and February 2017 (provided by the Functional Centre and Hydrographic Office of the Abruzzo Region) were analysed for the meteorological stations of Civitella del Tronto and Teramo, close to the study areas (Figure 2). In both stations (Figure 3), daily rainfall of ~30 mm was recorded during the days before the landslides. In Teramo station, the maximum daily rainfall exceeded 140 mm (18 January, around one month before the sliding) mostly consisting of snow due to low temperature, with a two-month cumulative value of almost 450 mm. Lower values were recorded in the Civitella del Tronto station, with a two-month cumulative value of ~200 mm and no very high daily values. The temperature trend shows two periods with maximum temperatures  $\leq 0$  °C, corresponding to the main snowfall events (around 7–11 and 16–19 January), when many snow avalanches also occurred. From 29 January and again around 11 February, temperature rises occurred, inducing rapid snowmelt.

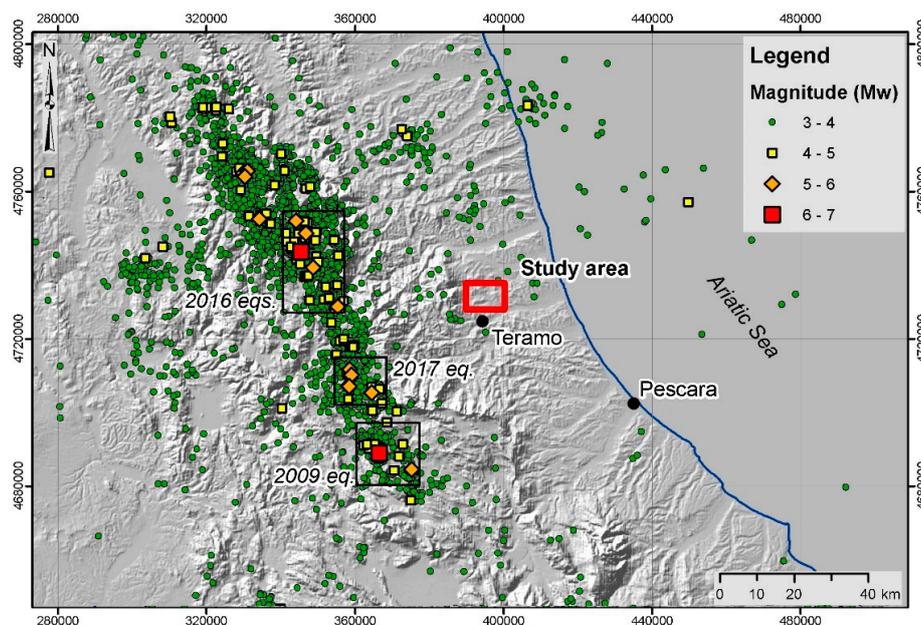
**Figure 4.** Recent seismicity of the Central Italy area and affecting the Apennines piedmont hilly area of NE-Abruzzo; earthquakes (Mw > 4) occurring since 1985 (from ISIDE working group (2016) version 1.0, DOI: 10.13127/ISIDE).

The Central Italy area has been affected by historical and recent strong seismicity [62–64] connected to the Apennine chain extensional tectonics; moderate seismicity also hits the piedmont area. In recent decades, the area was particularly affected by the 2009 L'Aquila earthquake (Mw 6.3) and by the 2016–2017 Central Italy earthquakes (maximum Mw 6.5) (Figure 4). Between 2016 and 2017, Central Italy was struck by a strong and long-lasting seismic sequence that comprised over 65,800 shocks from 24 August 2016 to 30 April 2017. Four main events occurred: (1) on 24 August 2016, two shocks with Mw 5.3 and 6.0; (2) on 26 October 2016, two shocks with Mw 5.4 and 5.9; (3) on 30 October 2016, the strongest, with Mw 6.5; and (4) on 18 January 2017, four shocks with Mw 5.0–5.5 (INGV, [www.ingv.it](http://www.ingv.it)). The latter events were located at 40–45 km SW from the Ponzano and Campli landslides. Moreover, during the first two weeks of February, several minor shocks were recorded (i.e., 283 shocks of Mw 2–3, 22 shocks of Mw 3–4 and two shocks of Mw  $\geq 4$ , at >50 km from the study area; INGV, [www.ingv.it](http://www.ingv.it)). From 10 to 16 February, in the days before the landslide events, 36 shocks occurred with Mw 2.0–3.1 and depths of 6 to 21 km (INGV, [www.ingv.it](http://www.ingv.it)) and a single stronger shock (Mw 3.6) was recorded on 14 February but >40 km from the landslide areas.

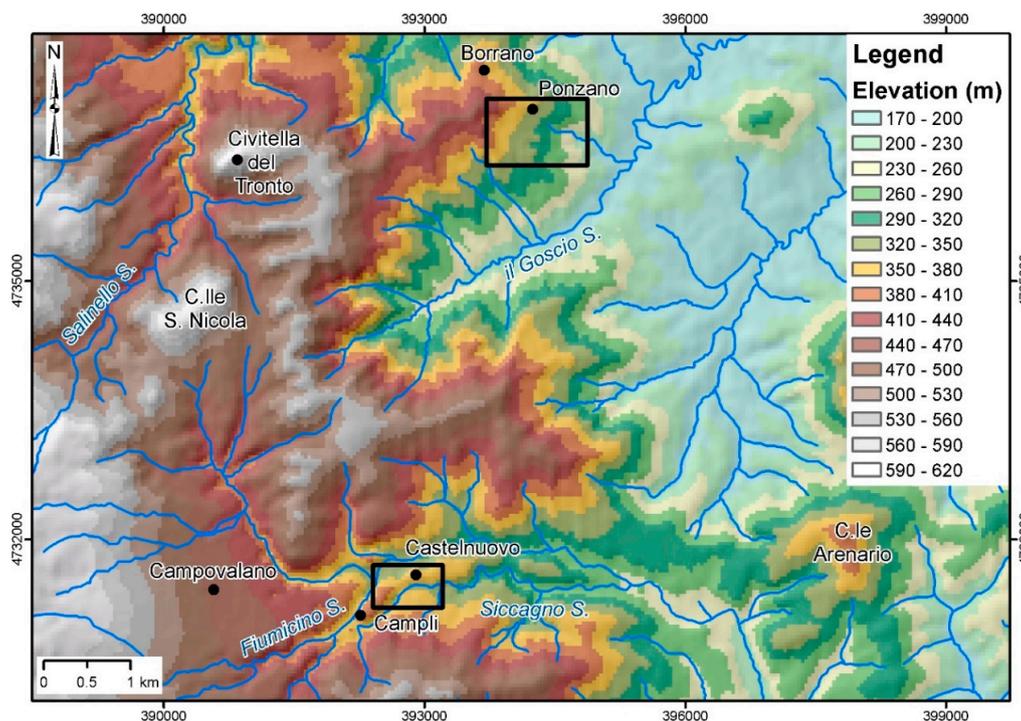
**Figure 5.** Elevation and hydrography map of the study area. The black boxes indicate the Ponzano landslide and Campli landslide areas.

The Ponzano landslide (Civitella del Tronto, Teramo) and the Castelnuovo landslide (Campli, Teramo) are located at elevations of 150–400 m a.s.l. in the North-eastern sector of the hilly piedmont of Abruzzo, between the Montagna dei Fiori ridge to the west, the Salinello River valley to the north and the Tordino River valley to the south (Figures 2 and 5). The landscape (typical of the NE-Abruzzo Adriatic hilly piedmont area) is characterized by elongated hills and valleys, generally with a WSW-ENE orientation and secondary from N-S to NNW-SSE orientations. The elevation range is that of mid-to-high elevation hills (from <200 m to >600 m). These hills are crossed by the incisions of the minor watercourses, mostly along NNW-SSE or WSW-ENE orientations. The overall drainage network is arranged in an angular pattern and locally in a trellis pattern.

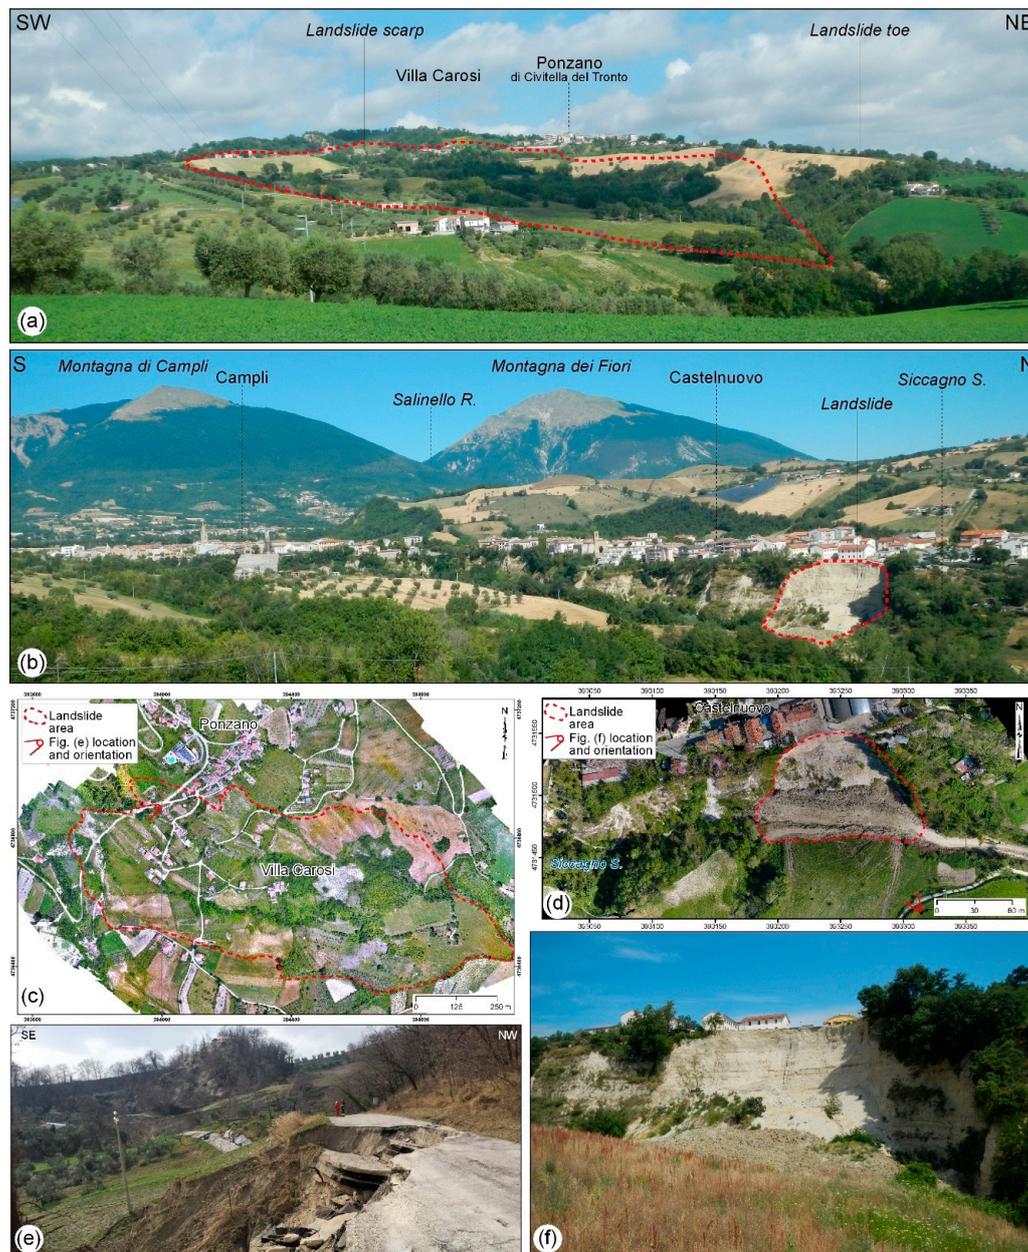
**Figure 6.** (a) Panoramic view of the Ponzano di Civitella del Tronto area (the red dashed line marks the landslide). (b) Panoramic view of the Castelnuovo di Campli area (the red dashed line marks the landslide). (c) Orthophoto of the Ponzano landslide derived by unmanned aerial vehicle (UAV) survey. (d) Orthophoto of the Castelnuovo landslide derived by UAV survey. (e) Panoramic view of the Ponzano landslide scarp. (f) Panoramic view of the Castelnuovo landslide.

The Ponzano area is located on the Eastern slope of the Civitella-Ponzano WSW-ENE ridge, with a top elevation ranging from 400–550 m a.s.l. Minor sharp NNW-SSE-oriented ridges are present on top of the landslide area. The slope affected by the landslide is around 1.5 km in length and ranges from 400 m to 150 m a.s.l. in elevation with a slope of  $\sim 10^\circ$  (Figure 5). It features flat surfaces in the upper-intermediate area and steep scarps in the upper part as well as in the lower part of the slope. It lies on a NNW-SSE oriented hog-back relief developed on pelitic rocks with thick arenaceous beds (up to tens of meters) pertaining to the Upper Miocene–Lower Pliocene Laga formation. A thick cover of colluvial deposits blankets the bedrock. On 12 February 2017, a large landslide affected Ponzano village, close to Civitella del Tronto (Figure 6a,c,e) reactivating a known landslide [26,58]. The landslide is composed of many connected movements over an area of  $\sim 56$  ha. The overall mechanism was a combination of translational sliding, with local rotational sliding in the upper part, which evolved to flow in the lower part of the landslide. After several years of almost stability or very slow movement (a 10–40 cm deformation was detected in 14 years [22]), the movement developed abruptly in the first days and very slowly over the following months [23]. The landslide involved both agricultural land and inhabited areas. The main and secondary roads, as well as utility service and buildings, suffered serious damage or collapse and consequently, more than 30 buildings were evacuated.

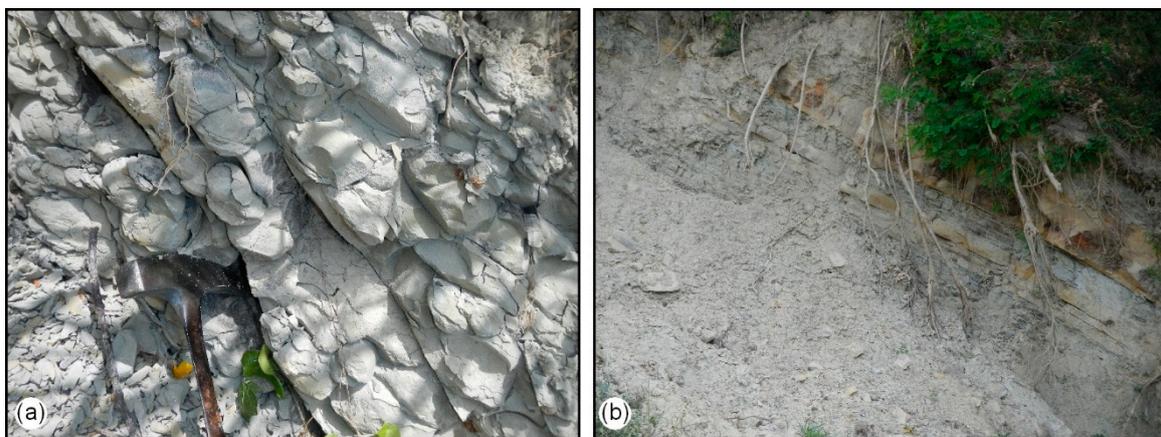
**Figure 7.** Lithological features of the bedrock arenaceous layers in the Ponzano area: (a) thick sandstone layers; (b) alternating sandstone layers with thin clay levels.

In the Ponzano area, the bedrock consists mostly of a sequence of pelitic-arenaceous layers (Figures 7 and 8). The ridges to the west of Ponzano consist of 30–60-m-thick layers of sandstone with thin clay levels (Figure 7).

The layers are arranged in a NNW–SSE orientation, dip at 40–60° in an ENE direction and are locally folded. The bedrock is blanketed by a cover of colluvial deposits (up to 15 m in thickness) and landslide deposits (up to 70 m in thickness). The morphostructural setting consists of a NNW–SSE oriented double hog-back (Figure 8). The landslide involved the whole colluvial cover and the upper part of the clayey bedrock (Figure 9).

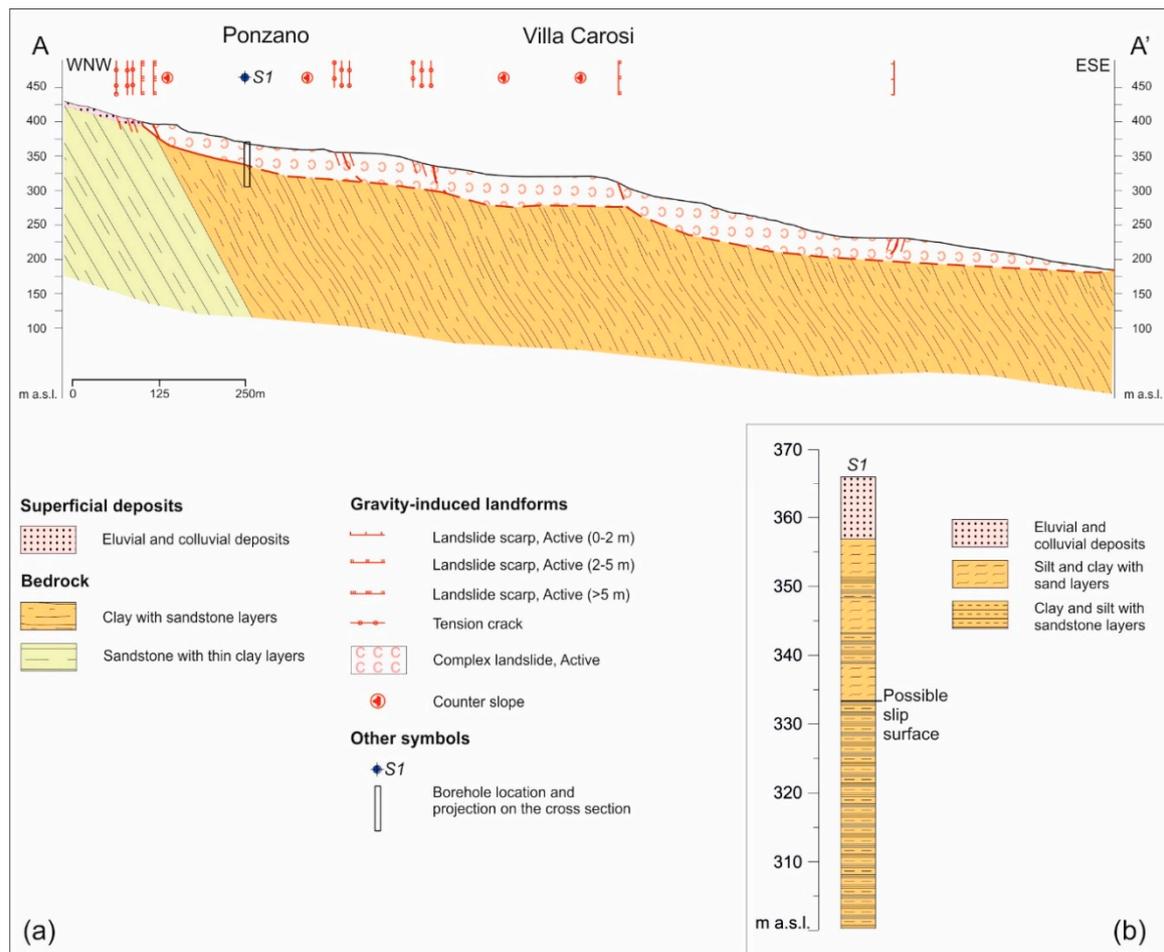
**Figure 9.** (a) Geological and geomorphological cross-section of the Ponzano area (location in Figure 8). (b) Stratigraphy of the borehole S1 (location in Figure 8).

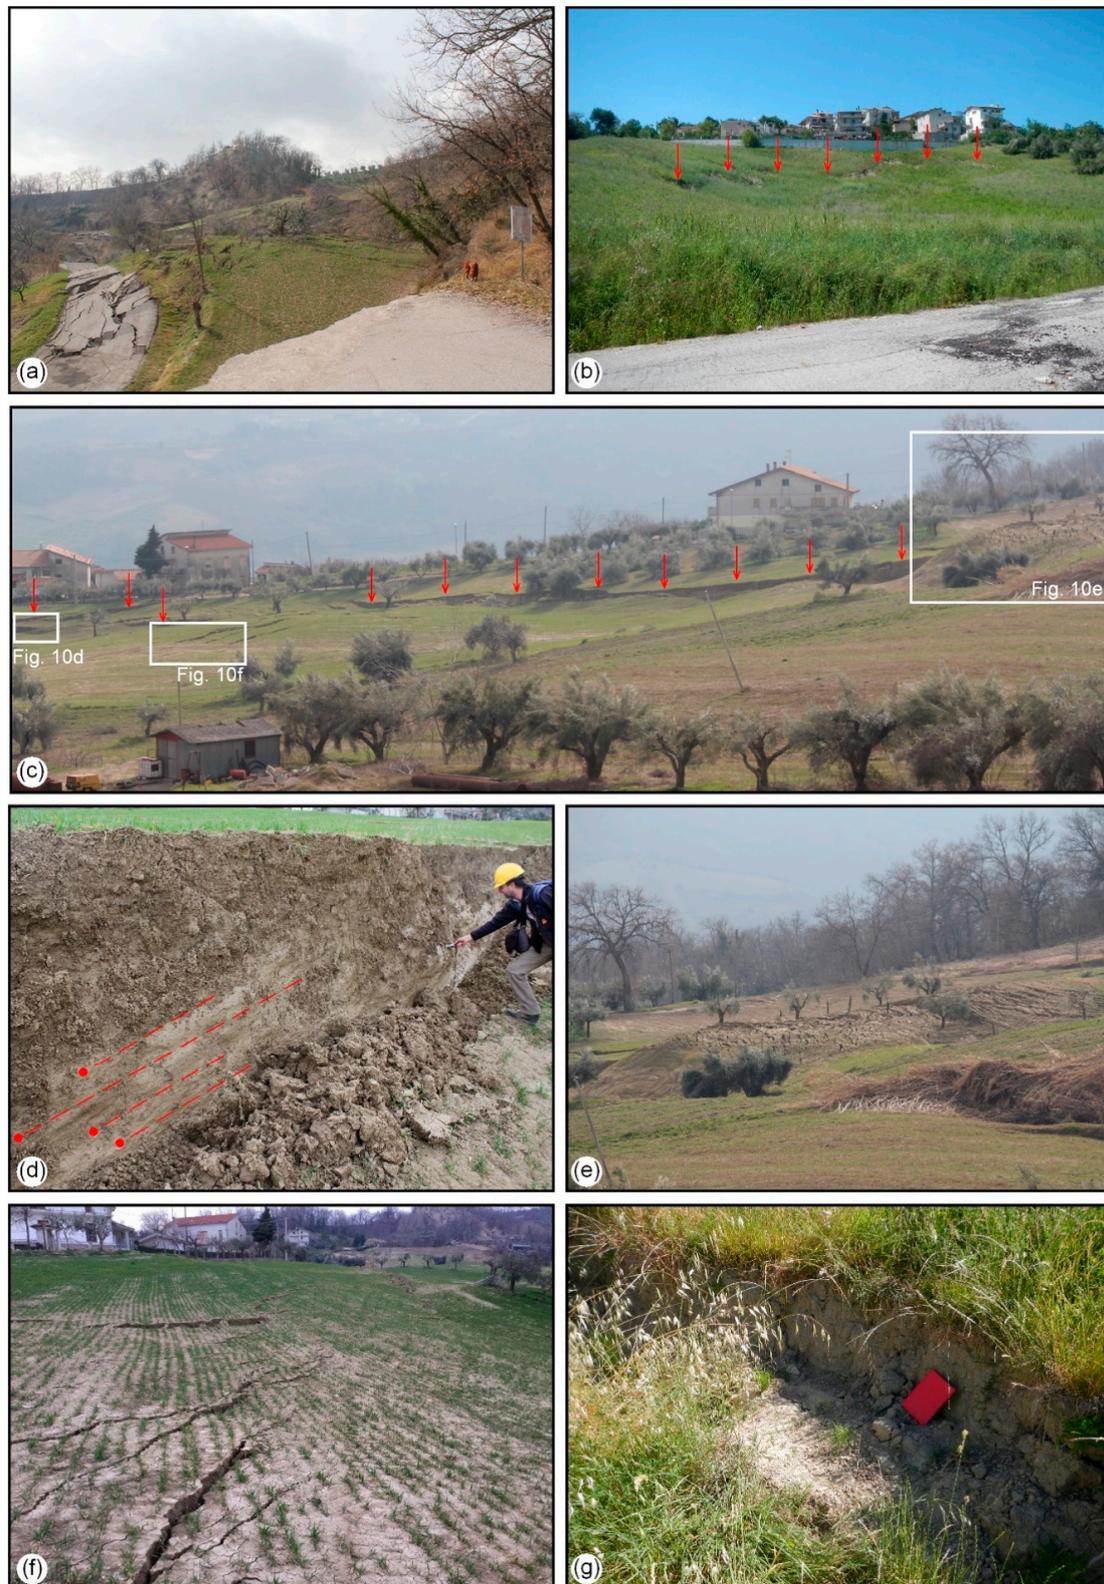
**Figure 10.** Geomorphological features of the Ponzano landslide. (a) upper part of the main southern scarp (up to >10 m high); (b) main northern upper scarp close to the Ponzano village (up to 5 m high); (c) lateral scarp in the southern side of the landslide; (d) detail of the lateral scarp, with grooves outlining the translational movement; (e) push ridges on the southern lateral scarp; (f) tension cracks in the mid part of the landslide; (g) minor scarps in the mid-lower part of the landslide.

The centre of the landslide is characterized by counter slopes, ridge or bulging, which outline a large landslide terrace in the mid-to-upper part of the slope, largely affected by tension cracks and minor scarps (Figure 10f). This area was the most severely damaged, with several buildings being destroyed due to a large bulging. During the sliding, this area was pervasively affected by tension cracks, trenches and occasionally by pseudo mud volcanoes connected to mud ejection. The northern side of the landslide is a system of minor sliding blocks mostly connected to translational sliding. The mid-to-lower part of the slopes was affected by several minor scarps (both downslope and

upslope (Figure 10g), push ridges and bulging outlining the complex movement of the landslide with translational sliding combined with flow. The mid and lower parts of the landslide are affected by minor gully features, which affected the area before and after the 2017 sliding.

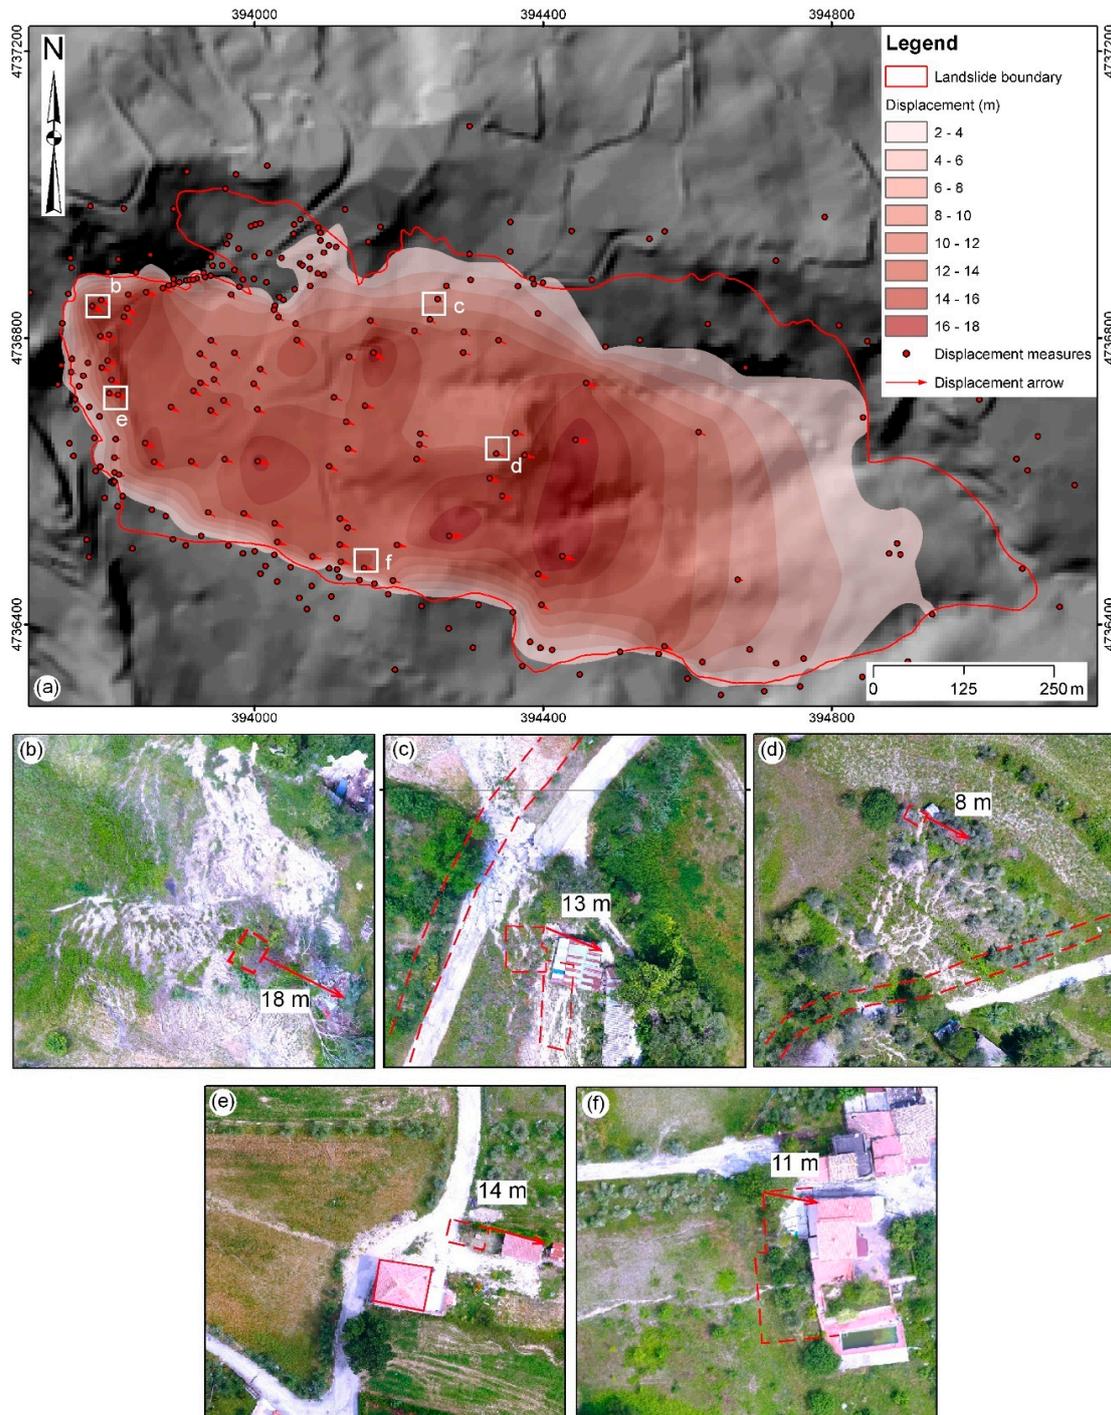
**Figure 11.** (a) Displacement distribution in the Ponzano landslide. (b–f) Significant measurement points observed in the landslide area; the image is derived from UAV post-landslide orthophoto and the red dashed lines mark the pre-landslide locations (derived from 2010 orthophotos); the measurement location is in (a).

A photogeological analysis of pre-landslide (2010–2013 orthophoto) and post-landslide (May 2017 UAV survey) orthoimages of the Ponzano landslide area was carried out in order to investigate the displacement pattern of the landslide and to outline the different blocks of the composite landslide (Figure 11a). The displacement of ~240 homologous point in pre and post-landslide images (e.g., roads, houses, etc., Figure 11b–f), although with a poor resolution (~±1 m), outlined a displacement varying within the landslide from almost zero to >18 m toward ESE. The analysis outlined the highest deformation (up to >15 m) to have occurred in three main areas within the landslide. One located in the upper part close to the main Southern scarp; the second in the central part along the landslide terrace (south from Ponzano); and the third one in the mid-to-lower part, downslope from Villa Carosi. The displacement is up to 13 m along the southern lateral scarp of the landslide, while it decreases to zero in the northern scarp and in the northern side. Downslope, the displacement decreases and progressively drops to zero in the lower part of the landslide.

The deformation is documented to have occurred mostly on 12 February 2017 and in the next few days (up to >8 were detected by a GPS survey carried out by the Civitella del Tronto Municipality [23], after a pre-2017 very slow movement [22]), which is congruent with our geomorphological field observation. Moreover, after 23 February and in the following months, a detailed monitoring of the landslide documented minor and localized movements connected to the main rainfall events (5–65 cm in ~5 months [23]).

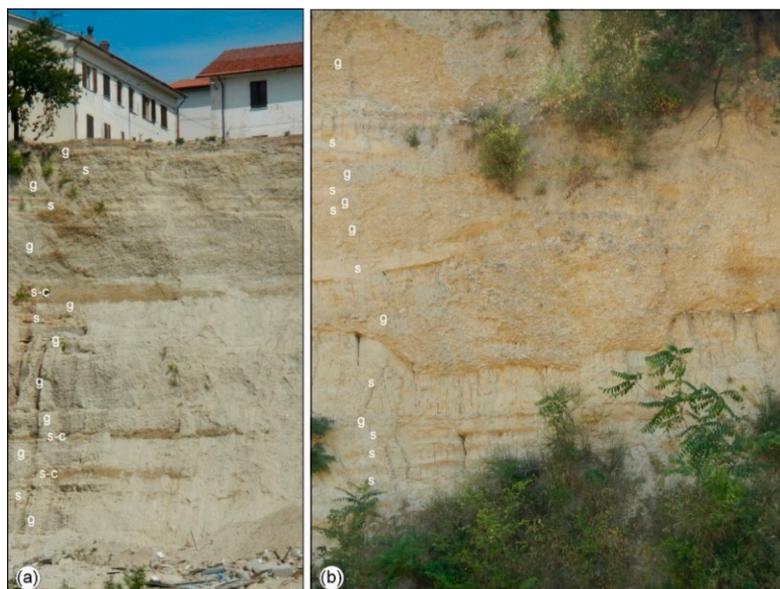
**Figure 12.** Lithological features of the terraced Middle Pleistocene alluvial fan deposits: (a) alternating gravel (g), sand (s) and clayey-sand (s-c) on the entire landslide scarp; (b) close up of the lithological features of the scarp.

The geological model of the Castelnuovo area consists of a thick conglomerate-sandstone interval, arranged in decimetre-to-meter-thick conglomerate layers, with minor sand-sandstone layers and lenses and with weak to moderate cementation (Figure 12). The whole conglomerate-sandstone interval is up to 70 m in thickness and lies above pelitic-arenaceous rocks of the bedrock, as documented in previous borehole investigations, with the bottom of the layer lying below the base of the scarp (Figure 13). The conglomerate-sandstone layer thickness decreases toward the south and north and outlines that the alluvial fan deposits filled up a paleo valley, whose axis is now below Castelnuovo village.

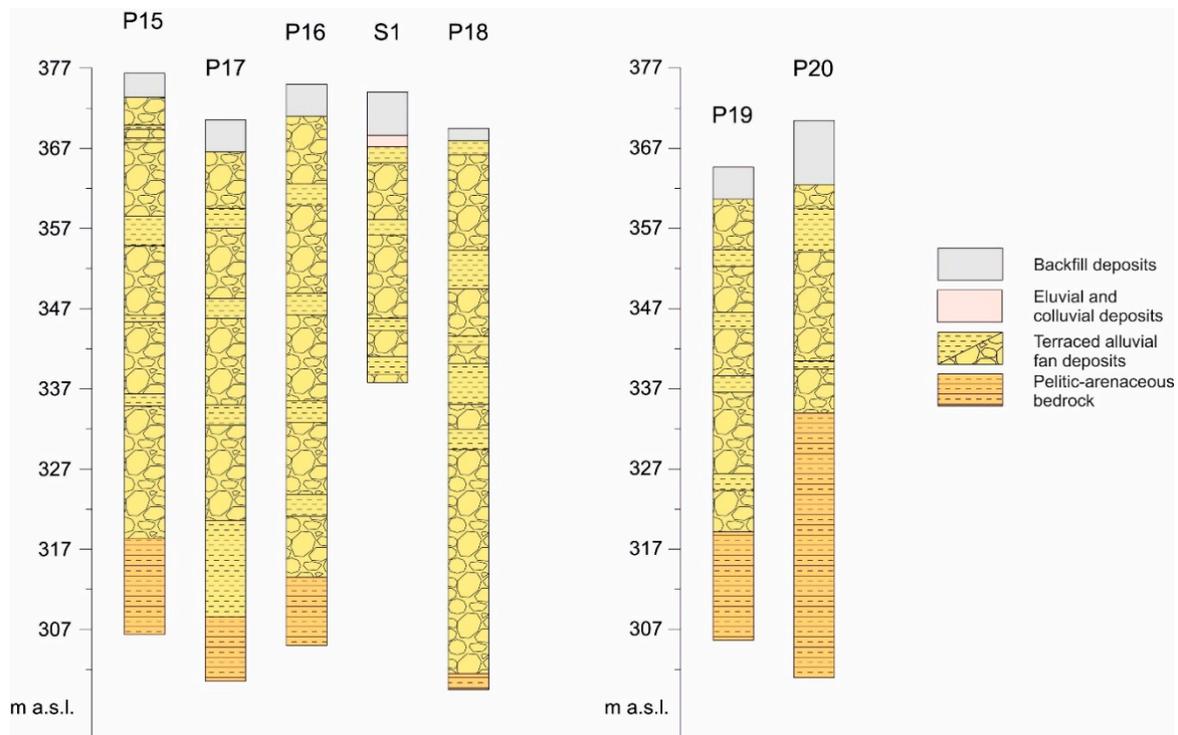
**Figure 13.** Borehole stratigraphy of the Castelnuovo area (location in Figure 14).

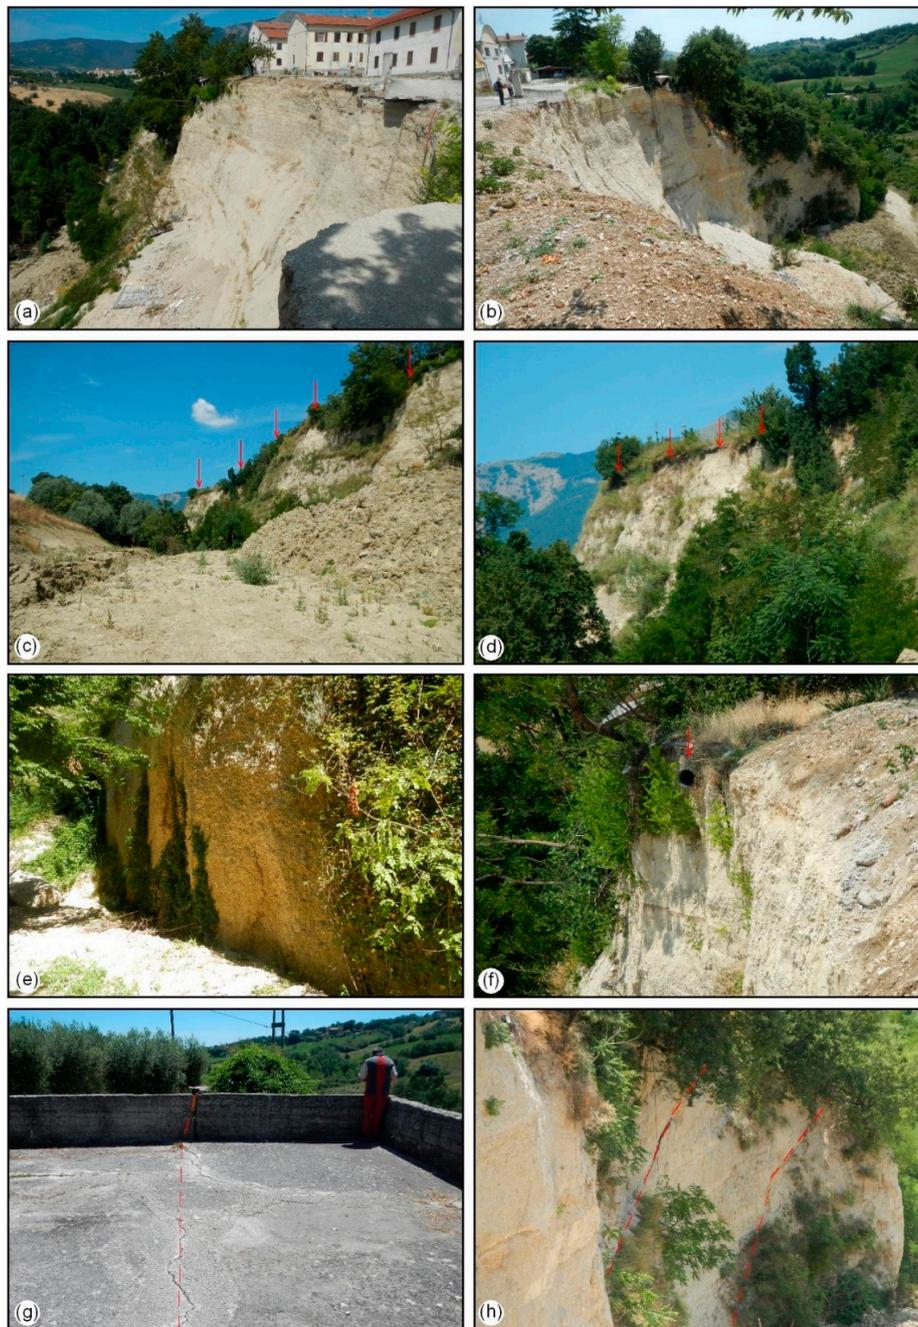
**Figure 15.** Geomorphological features of the Castelnuovo landslide: (a) main landslide scarp (western part); (b) main landslide scarp (eastern part); (c) polygenetic scarps (red arrows) of the Castelnuovo mesa relief (in the foreground the landslide body); (d) structural surface (red arrows) on top of the main scarp; (e) fluvial erosion scarp at the base of the main scarp; (f) damaged water pipe along the landslide scarp; (g) tension crack along a joint affecting the slope; (h) main joints affecting the slope in the landslide area.

Damaged drainage pipes are also to be mentioned. Two of them were found in the main scarp area (Figure 15f) inducing possible water drainage issue and additional infiltration in the scarp area during the heavy meteorological events and the snowmelt.

The overall setting of the main scarp are defined by combined features outlining a polygenetic scarp surrounding the mesa relief: (1) a step-like arrangement to the top surface given by minor straight 1–5 m-high scarps, oriented from WNW–ESE to ENE–WSW; (2) an angular arrangement of the main scarp bounding the top surface along the same WNW–ESE and ENE–WSW orientations, consistent with the orientation of the main joints (Figure 15g,h).

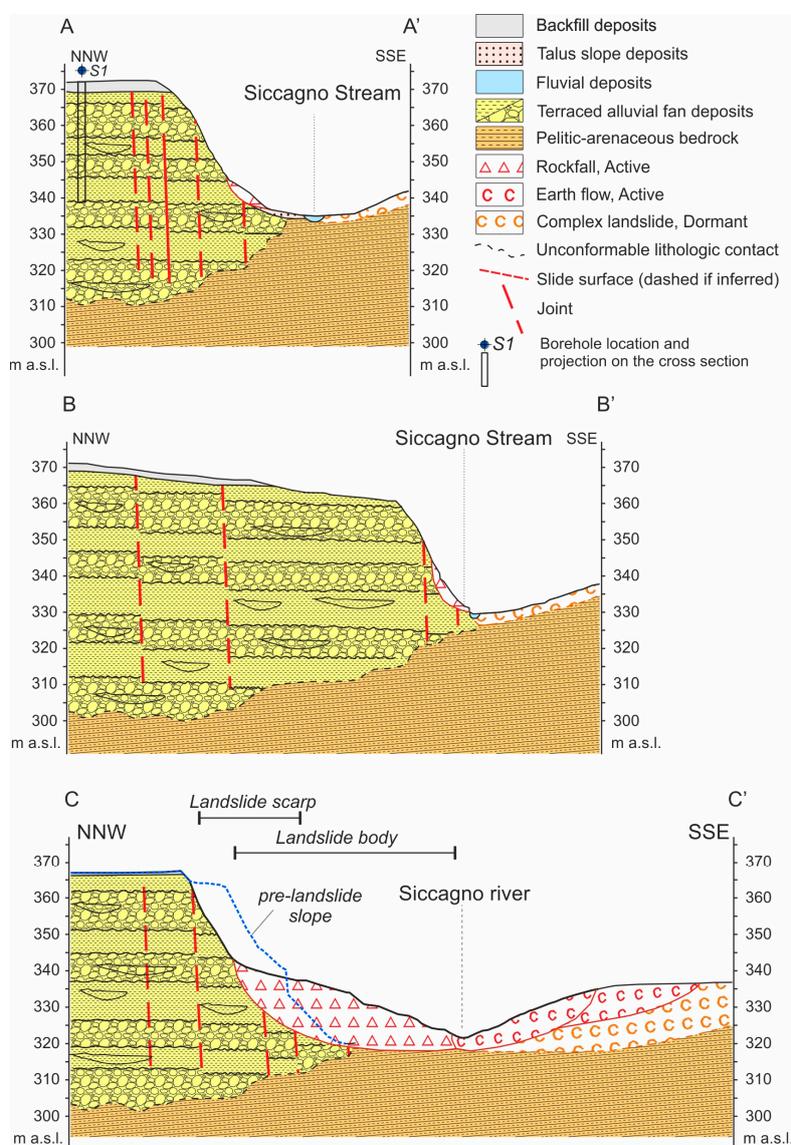
**Figure 16.** Geological and geomorphological cross-sections of the Southern slope of the Castelnuovo area (location in Figure 14); in Section C-C' the dashed blue line show the reconstructed pre-landslide topography (cfr. Figure 17).

The main geological and geomorphological features outline the 3D geological and morphostructural model of the Southern slope of the Castelnuovo mesa relief (Figures 14 and 16). It is characterized by polygonal conglomerate-sandstone wedges (as large as 20–50 m in width, 80–120 m in length and ~50–70 m in height) separated by major joints, laying over the pelitic-arenaceous bedrock. The investigation allowed also to define the pre-landslide geological and morphostructural model summarized in the section of Figure 17.

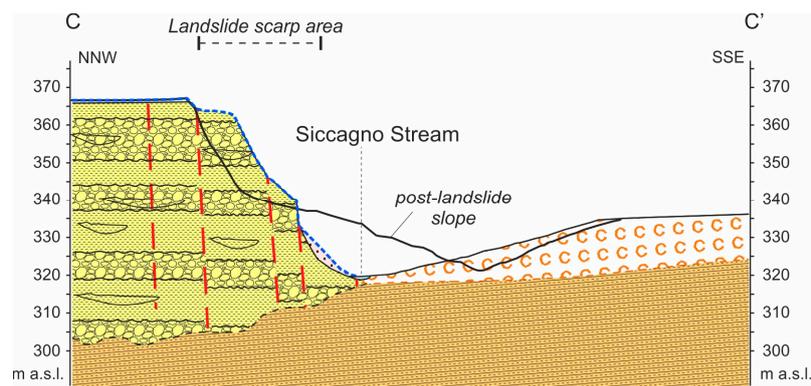
**Figure 17.** Pre-landslide geological and geomorphological cross-sections of the Castelnuovo landslide area (location in Figure 14); the thick black line is the post landslide topography (cfr. Figure 16).

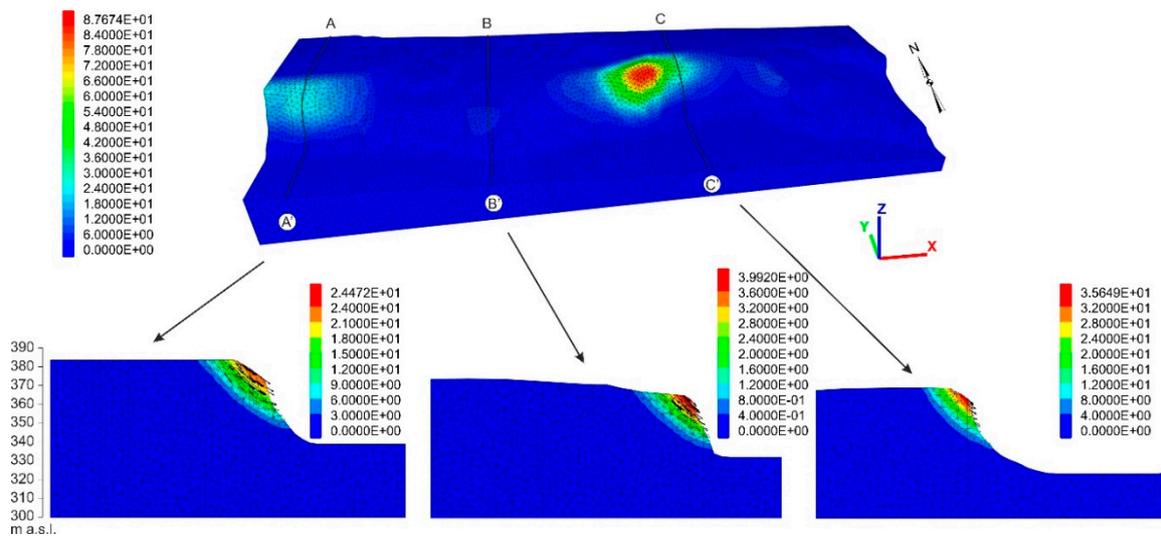
**Figure 18.** Contour 3D displacements and displacement vectors (sections) of the pre-landslide model without discontinuities.

Two 3D models were defined for the numerical modelling: the first in the pre-landslide conditions in order to investigate the trigger of the 16 February landslide and the second in the post-landslide conditions to investigate the expected evolution of the landslide and the residual hazard condition. Both models are 544 m in length ( $x$ -axis), 188 m in width ( $y$ -axis) and 84 m in height ( $z$ -axis) discretized with variable-sized tetrahedral elements. The models consist of conglomerate-sandstone wedges, while the bedrock is not included since it lies over 15 m below the base of the slope along the Siccagno stream (Figure 16). The main physical-mechanical parameters (assumed constant throughout the model) are [65]: volume weight ( $21 \text{ kN/m}^3$ ), bulk modulus ( $66.7 \text{ MPa}$ ), shear modulus ( $40 \text{ MPa}$ ), internal angle of friction ( $35^\circ$ ) and apparent cohesion ( $30 \text{ kPa}$ ).

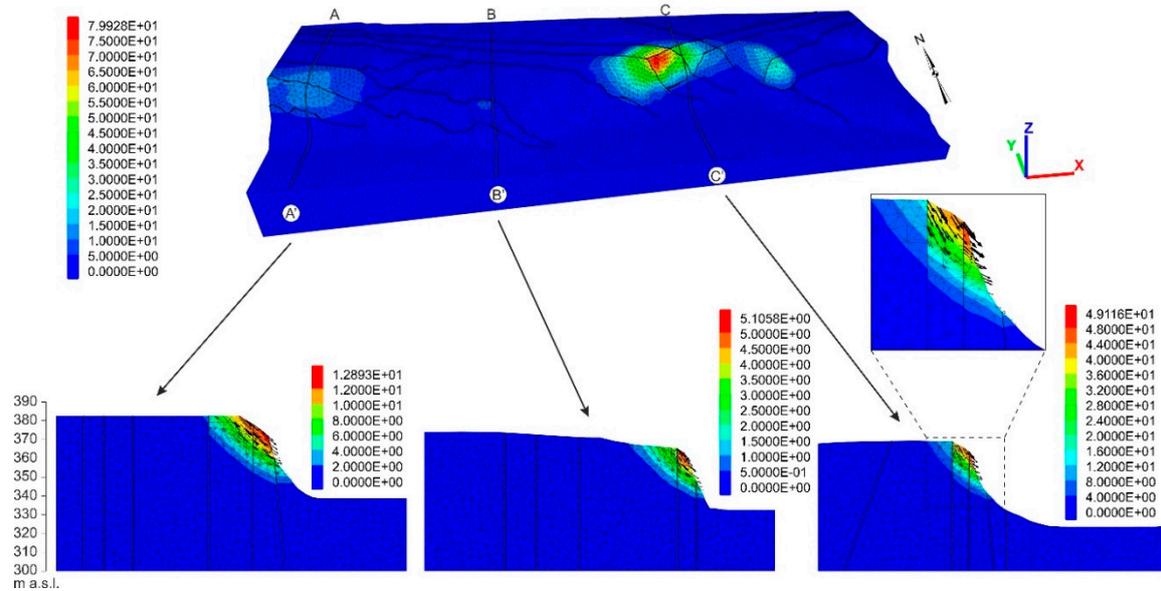
**Figure 19.** Contour displacements and displacement vectors (sections) of the pre-landslide model with discontinuities.

The second analysis was carried out in the complete pre-landslide model with the main discontinuities outlining polygonal wedges. The displacement diagrams (Figure 19) show the control of the joints in the evolution of the slope and in the failure kinematics. The most critical areas, in terms of deformation, are located along the main joints up to 20–40 m from the edge of the scarp, in the area surrounding the main landslide. The sections extracted from the model (Figure 19) help to identify the role of the joints in the failure kinematics. The displacement vectors of the outermost slope part, out of the last joint, range from horizontal to gently downslope dipping, outlining a topple movement. The inner part of the slope shows steep downslope displacement vectors, outlining a pseudo-circular slip kinematics, again controlled by the main joints in the inner part of the slope.

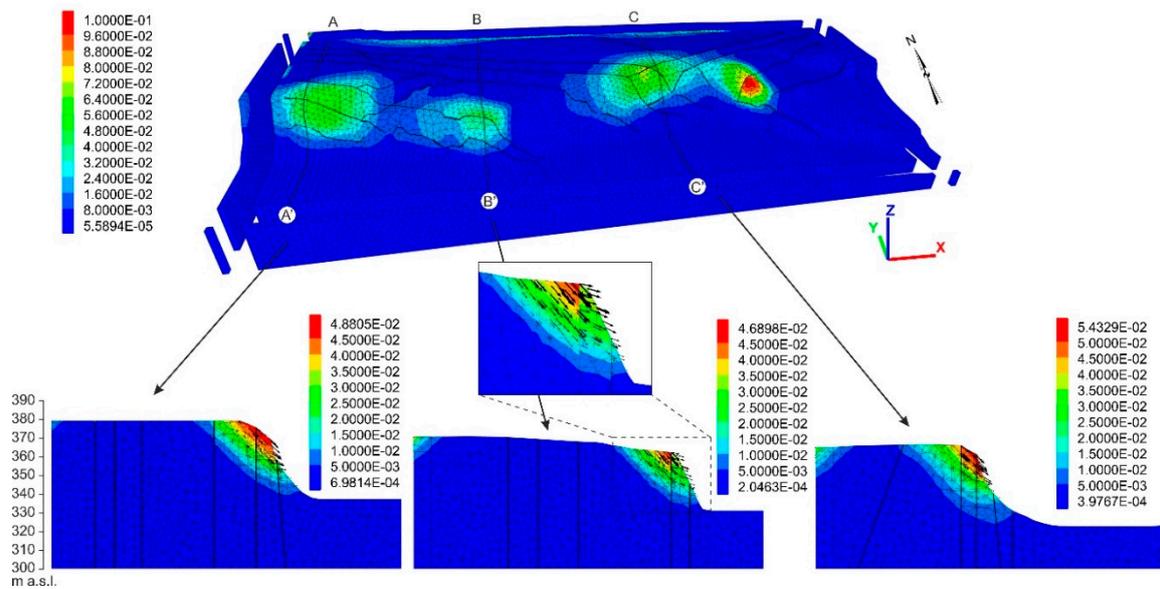
**Figure 20.** Contour displacements and displacement vectors (sections) of the dynamic analysis with Mw 5.5 input on the pre-landslide model with discontinuities.

The dynamic analysis was performed on the complete pre-landslide model (with discontinuities) introducing the seismic input chosen among those recorded in the long 2016–2017 seismic sequence of Central Italy (the Mw 5.5 event occurred on 18 January 2017, around one month before the landslide). The largest displacement occurs in three main areas (Figure 20), which correspond to those expected from the field survey. This is particularly evident in the western area and in the Eastern area, which includes the main landslide area. However, even in dynamic conditions, the model does not reach the failure. As documented by the displacement vectors in the extracted sections, in this case, the deformation kinematics are also controlled by the main joints.

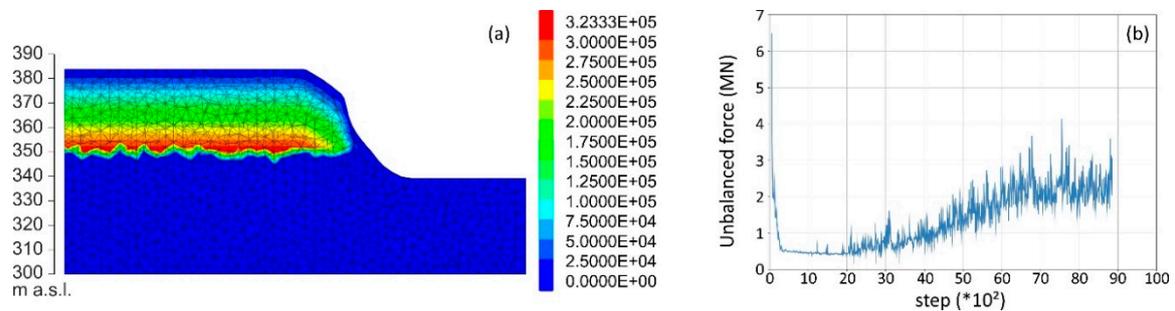
**Figure 21.** (a) Detail of pore pressures in the pre-landslide model. (b) Maximum unbalanced force in the model.

The fourth analysis was carried out to evaluate the influence of pore pressures on the slope stability, introducing water saturation in the upper 15 m of the model from the top of the scarp (Figure 21a).

In this case, the slope reaches the failure (Figure 21b), highlighting the non-convergence of the numerical algorithm of the maximum unbalanced force. All of the outermost wedges of the model, along the main scarp, result to be in failure conditions (Figure 22).

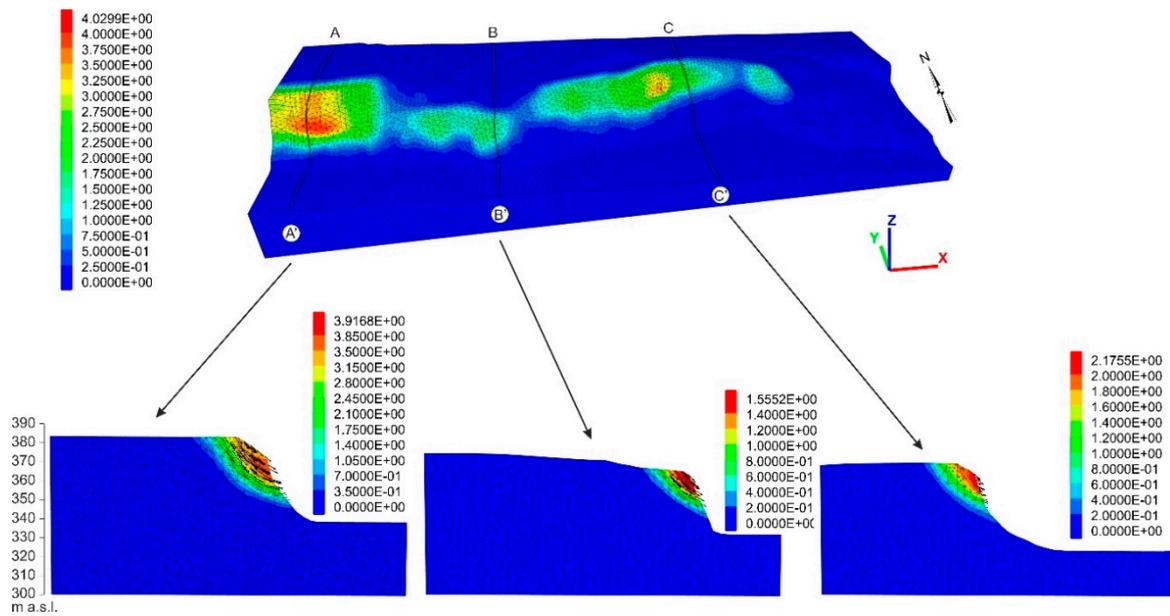
**Figure 22.** Contour displacements and displacement vectors (sections) of the pre-landslide model without discontinuities and with pore pressures.

- snowfall and melting—worsened by poor water drainage on top of Castelnuovo relief—inducing pore pressure increase in the upper part of the slope are found to be the main triggering factor for this landslide.

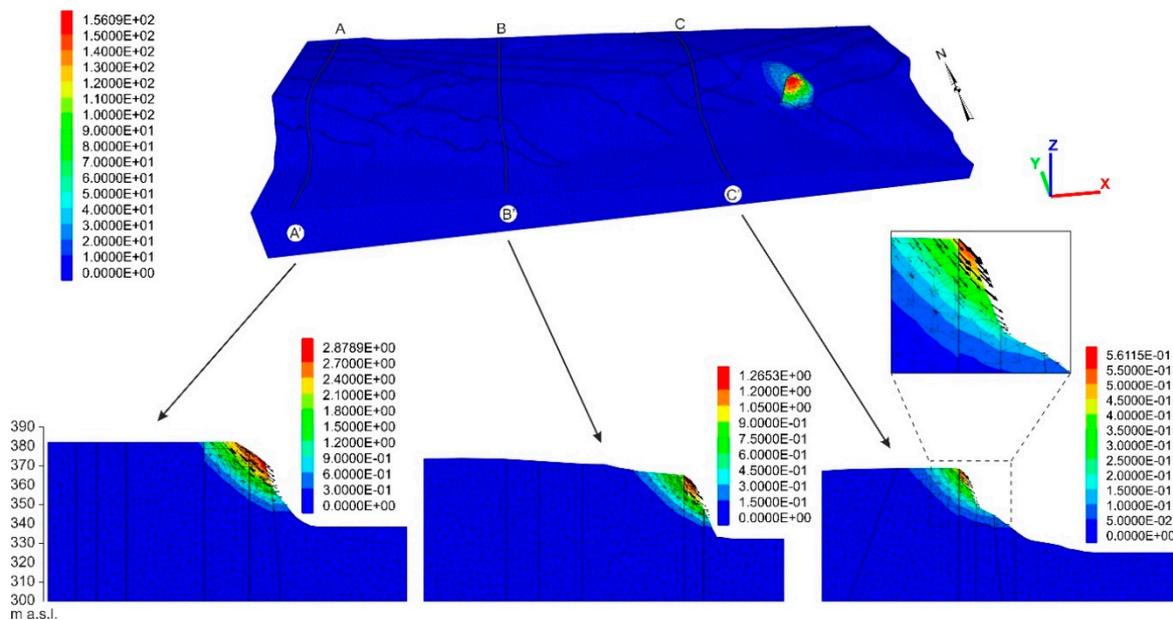
**Figure 23.** Contour displacement and displacement vectors (sections) of the post-landslide model with discontinuities.

A further set of analyses was carried out in the post-landslide model in order to investigate the residual instability conditions after the main landslide. The stability analysis without or with discontinuities, also in this case, outline no failure (static model and no pore pressure) and again suggest the role of the main joint in the expected kinematics of the deformation. The worst critical area resulting from the model with discontinuities (Figure 23) is located along a main joint in the eastern side of the February 2017 landslide scarp. Again, the extracted sections outline the complex kinematics of the expected movement: a combination of toppling in the outer wedge of the slope and sliding in the inner wedge.
