# Morphostructural, Meteorological and Seismic Factors Controlling Landslides in Weak Rocks: The Case Studies of Castelnuovo and Ponzano (North East Abruzzo, Central Italy)

**Abstract:** We investigated the role of the morphostructural setting and seismic and meteorological factors in the development of landslides in the piedmont of the Abruzzo Apennines. In February 2017, following a heavy snow precipitation event and a moderate seismic sequence (at the end of the Central Italy 2016–2017 seismic crisis), several landslides affected the NE-Abruzzo chain and piedmont area. This work is focused on the Ponzano landslide (Civitella del Tronto, Teramo) and the Castelnuovo landslide (Campoli, Teramo) in the NE Abruzzo hilly piedmont. These landslides consist of: (1) a large translational slide-complex landslide, affecting the Miocene–Pliocene sandstone clay bedrock sequence of the piedmont hilly sector; and (2) a complex (topple/fall-slide) landslide, which occurred along a high and steep scarp on conglomerate rocks pertaining to terraced alluvial fan deposits of the Pleistocene superficial deposits. Both of the landslides are typical of the Abruzzo hilly piedmont and both of them large

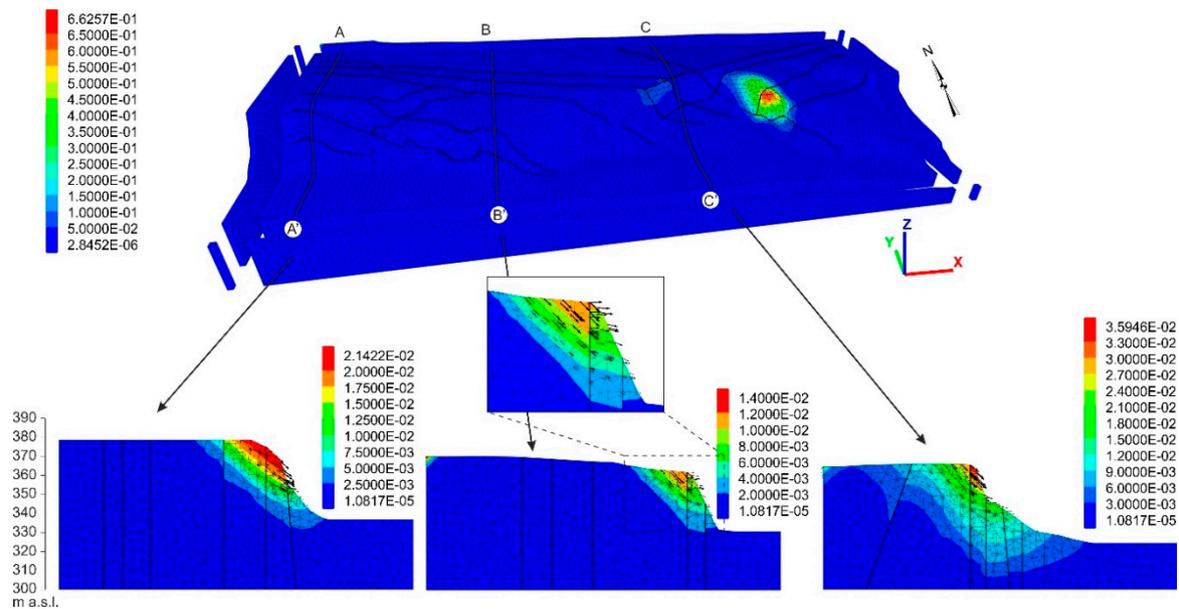
**Figure 24.** Contour displacements and displacement vectors (sections) of the dynamic analysis with Mw 5.5 input on the post-landslide model with discontinuities.

The dynamic analysis was also performed on the complete post-landslide model (with discontinuities), again introducing the chosen seismic input (the Mw 5.5 event which occurred on 18 January 2017). The area with the greatest displacements is located along main joints in the left side of the main scarp of the February 2018 landslide (Figure 24) and corresponds to the area outlined by the static analysis.
